# Pre-Demolition Asbestos Survey Report

Proposed Alder Taylor Retail Project  
17783 Taylor Avenue  
Bloomington, California 92316

March 24, 2026 | Terracon Project Number: LA267070

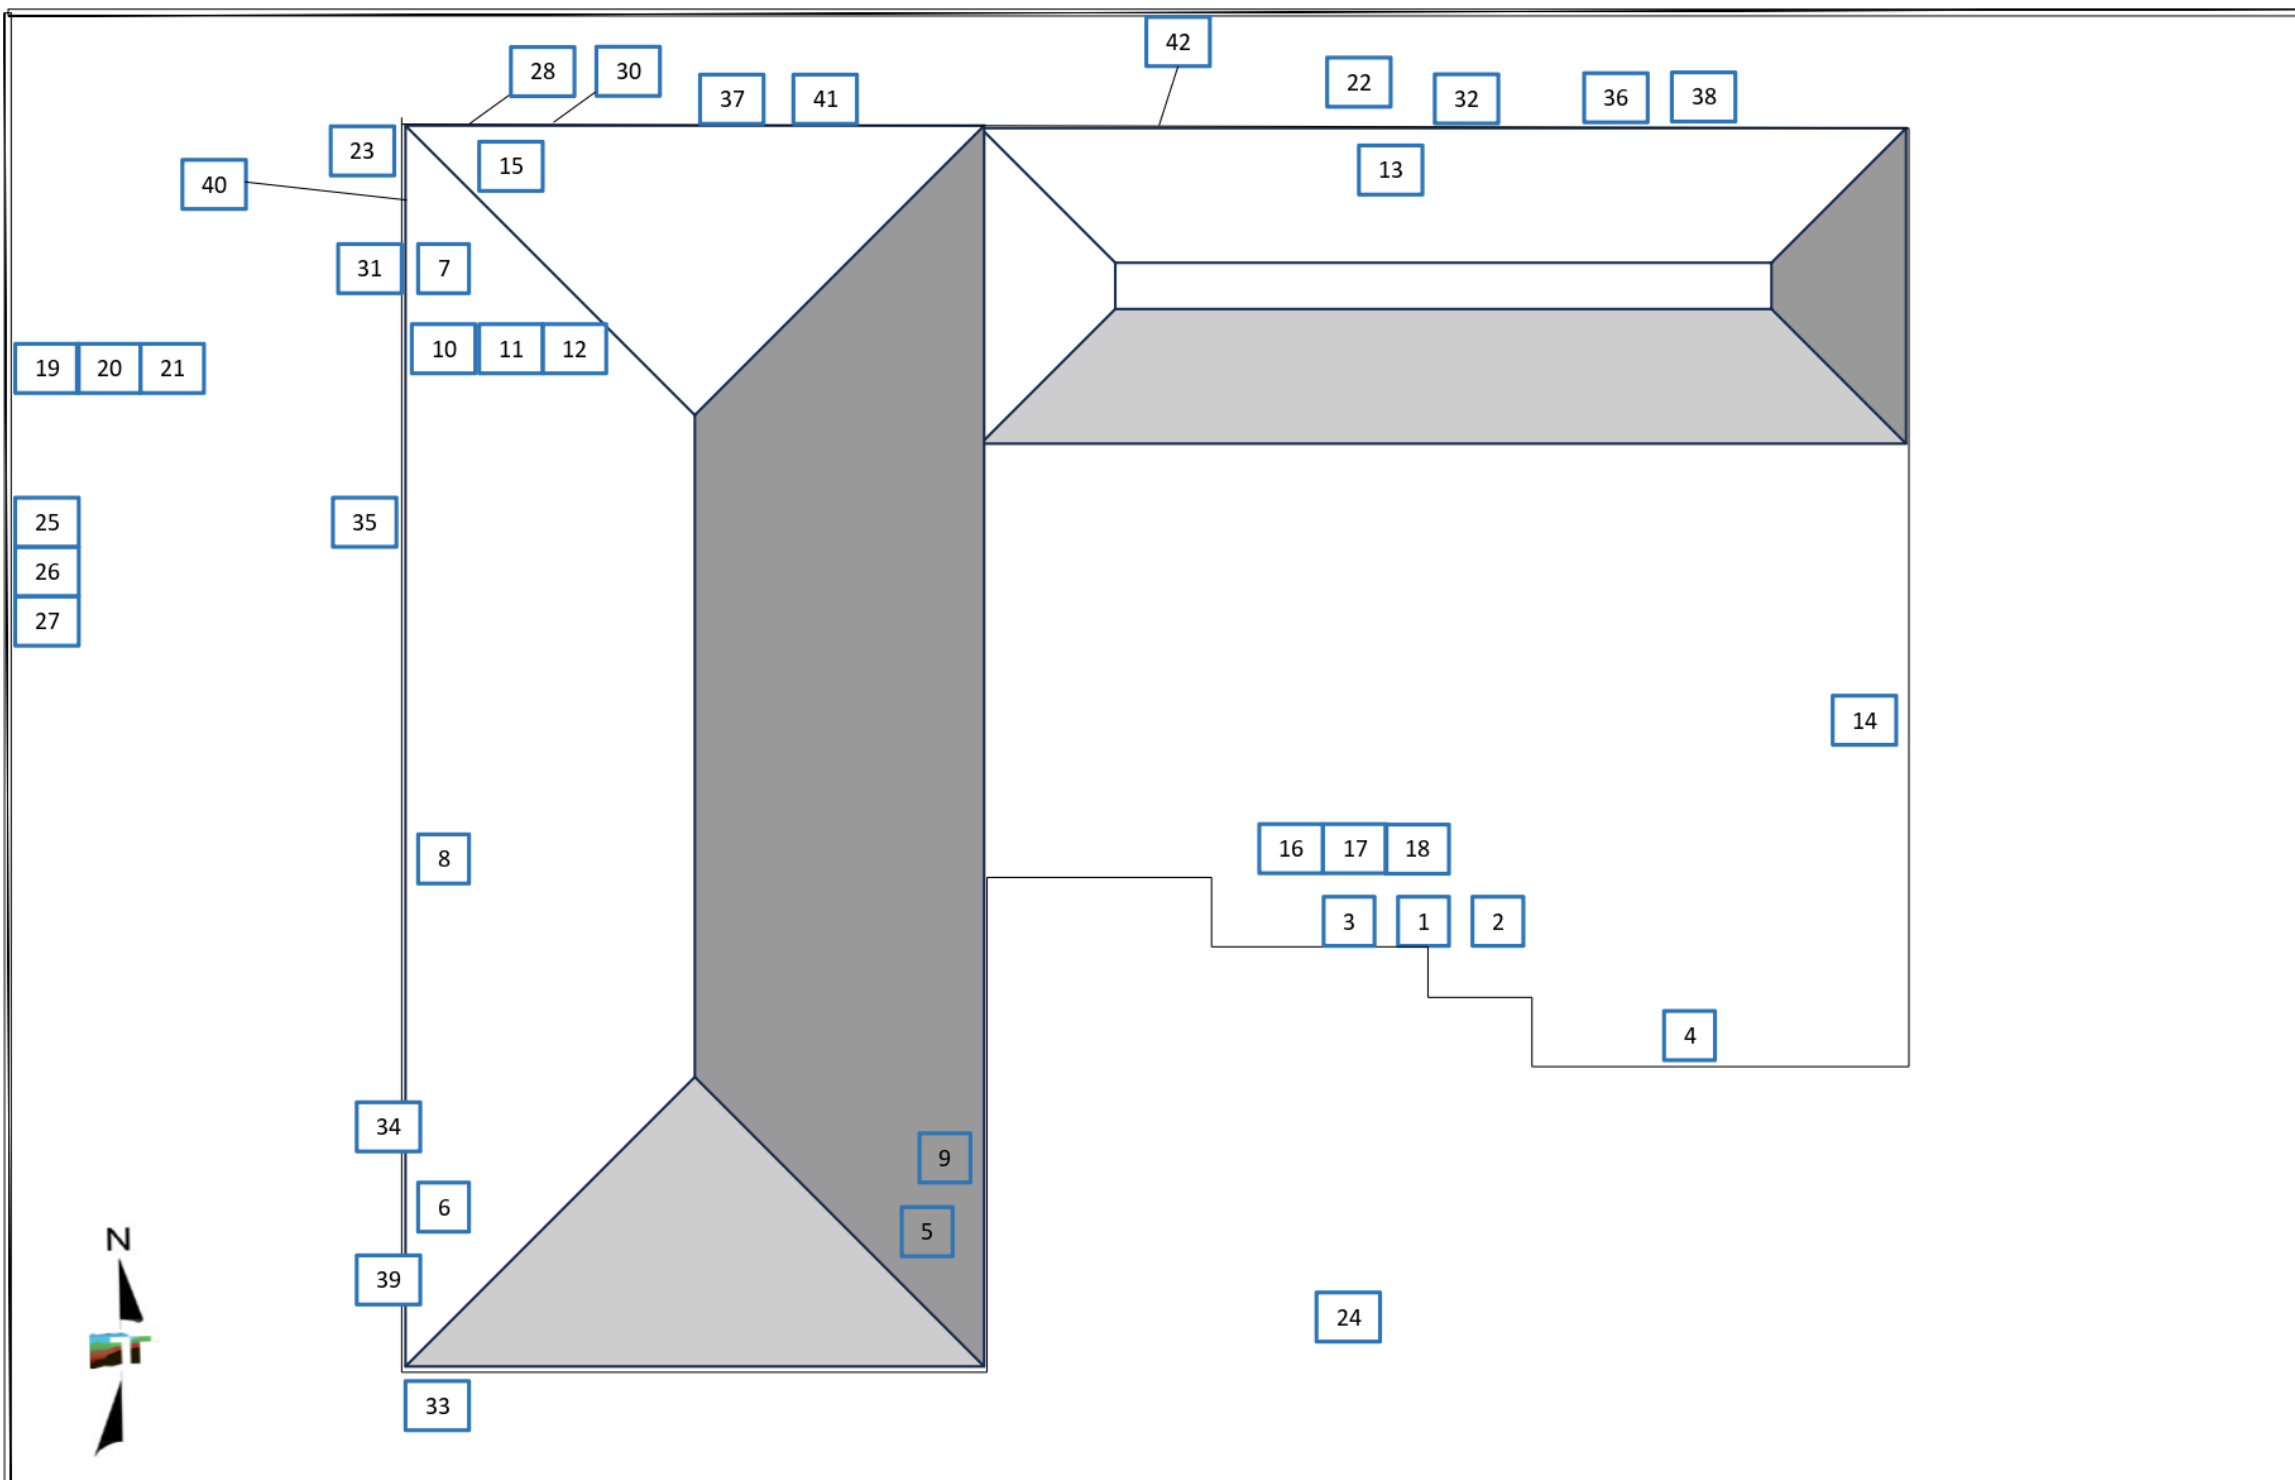
| HA | Material Description | Material Location | Result | NESHAP Classification | Condition | Approximate Quantity* |
|---|---|---|---|---|---|---|
| 2 | Gray Asphalt Rolled Roofing | Roof | Shingles – ND<br>Felt – ND<br>White Roofing – 6% CH | Cat. I | Good | 1,000 SF |

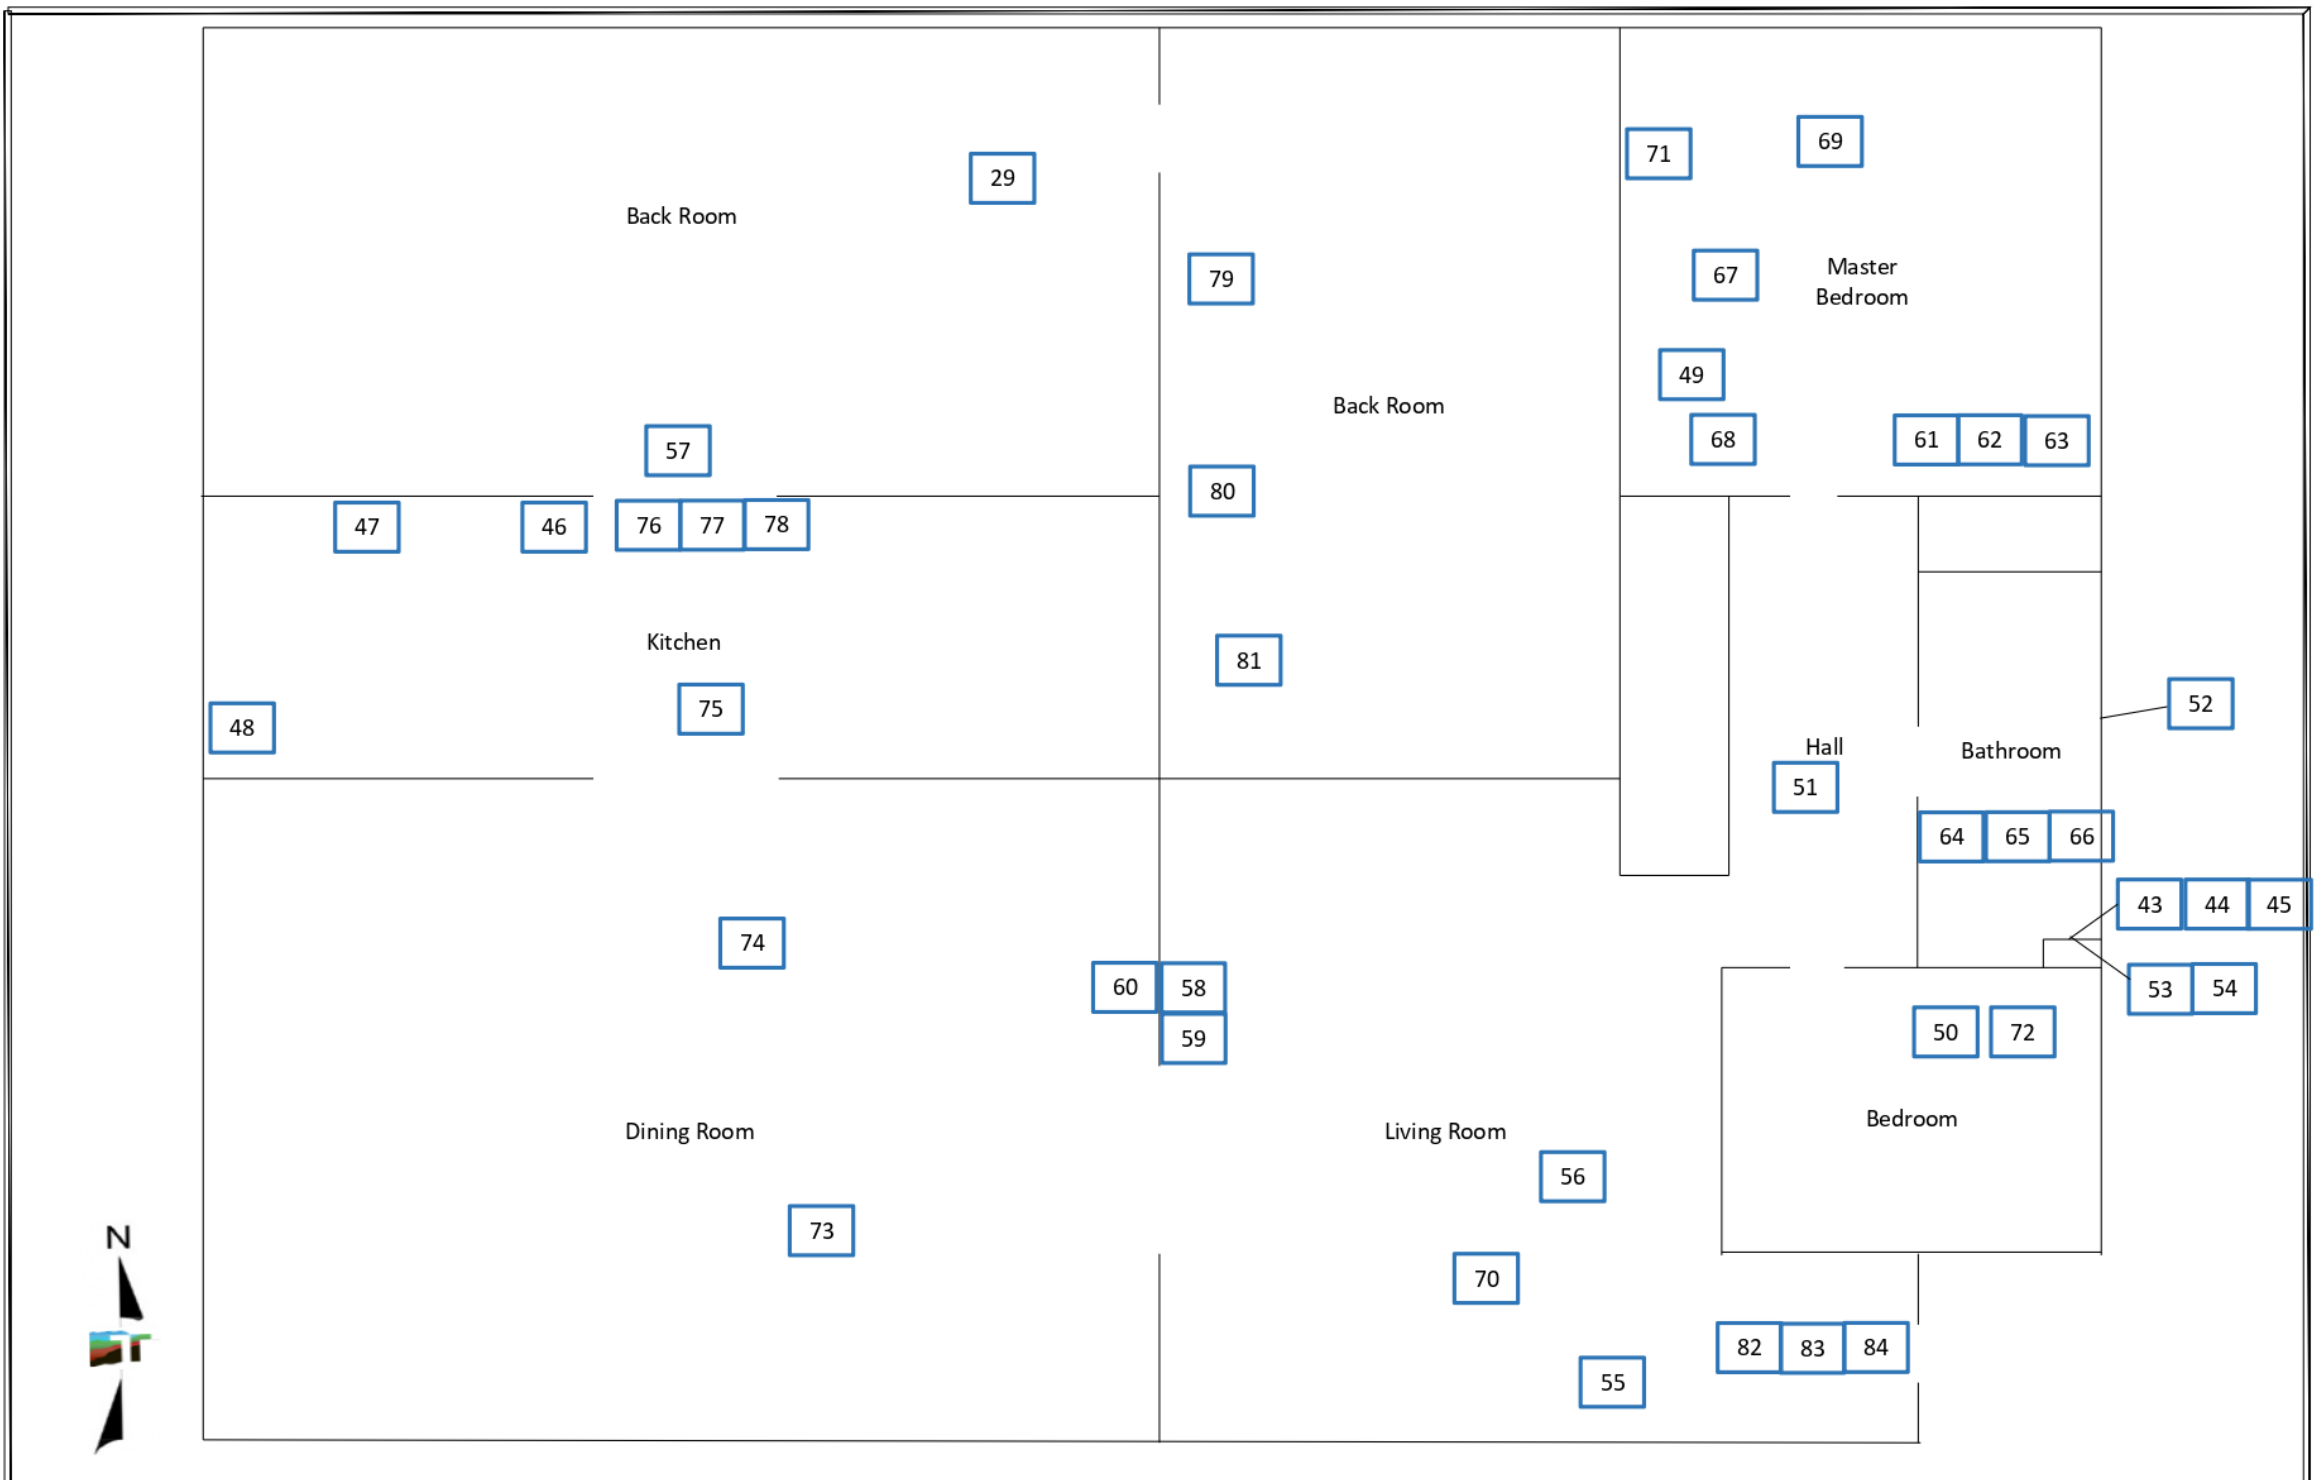
| HA | Material Description | Material Location | Result | NESHAP Classification | Condition | Approximate Quantity* |
|---|---|---|---|---|---|---|
| 20 | Heater Insulation Wrap | Living Room, Dining Room | 35% CH | RACM | Damaged | 50 SF |
| 24 | Wallboard with Joint Compound | Throughout | Joint Compound – 2% CH<br>Drywall - ND | RACM | Significantly Damaged | 2,700 SF |
| 25 | 9"x9" Red Vinyl Floor Tile with Black Mastic (Multiple Layers) | Dining Room and Kitchen | Red Tile – 3% CH<br>Black Mastic – ND<br>Beige Sheet Flooring – ND<br>Brown Mastic - ND | Cat. I | Significantly Damaged | 400 SF |

Since the damaged ACM materials have been identified, South Coast Air Quality Management District, Rule 1403 requires that a Procedure-5 Abatement Work Plan must be developed to facilitate the removal of the damaged asbestos-containing materials.
