Consulting Arborist's Report

Tree and Palm Evaluation

For: 1314 Le Borgne Avenue, Baldwin Park

Date: **August 27, 2024**

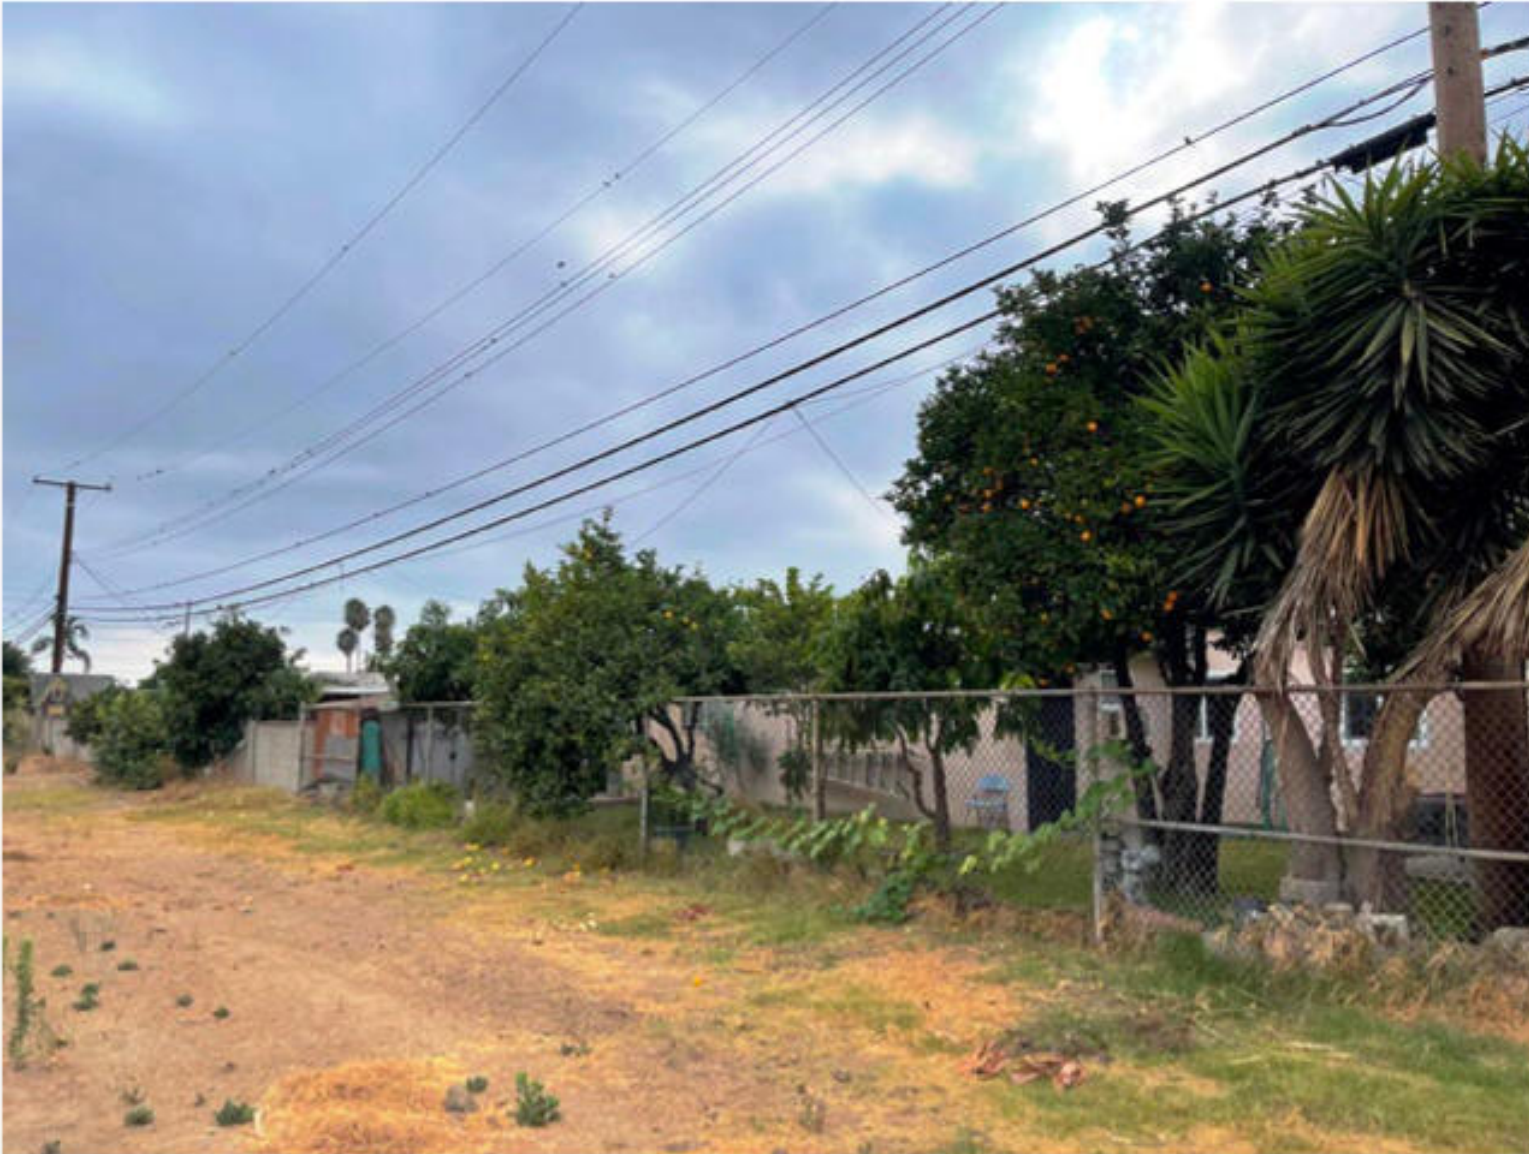
Most of the adjoining neighbors have few overhanging trees and few adjoining weed trees.

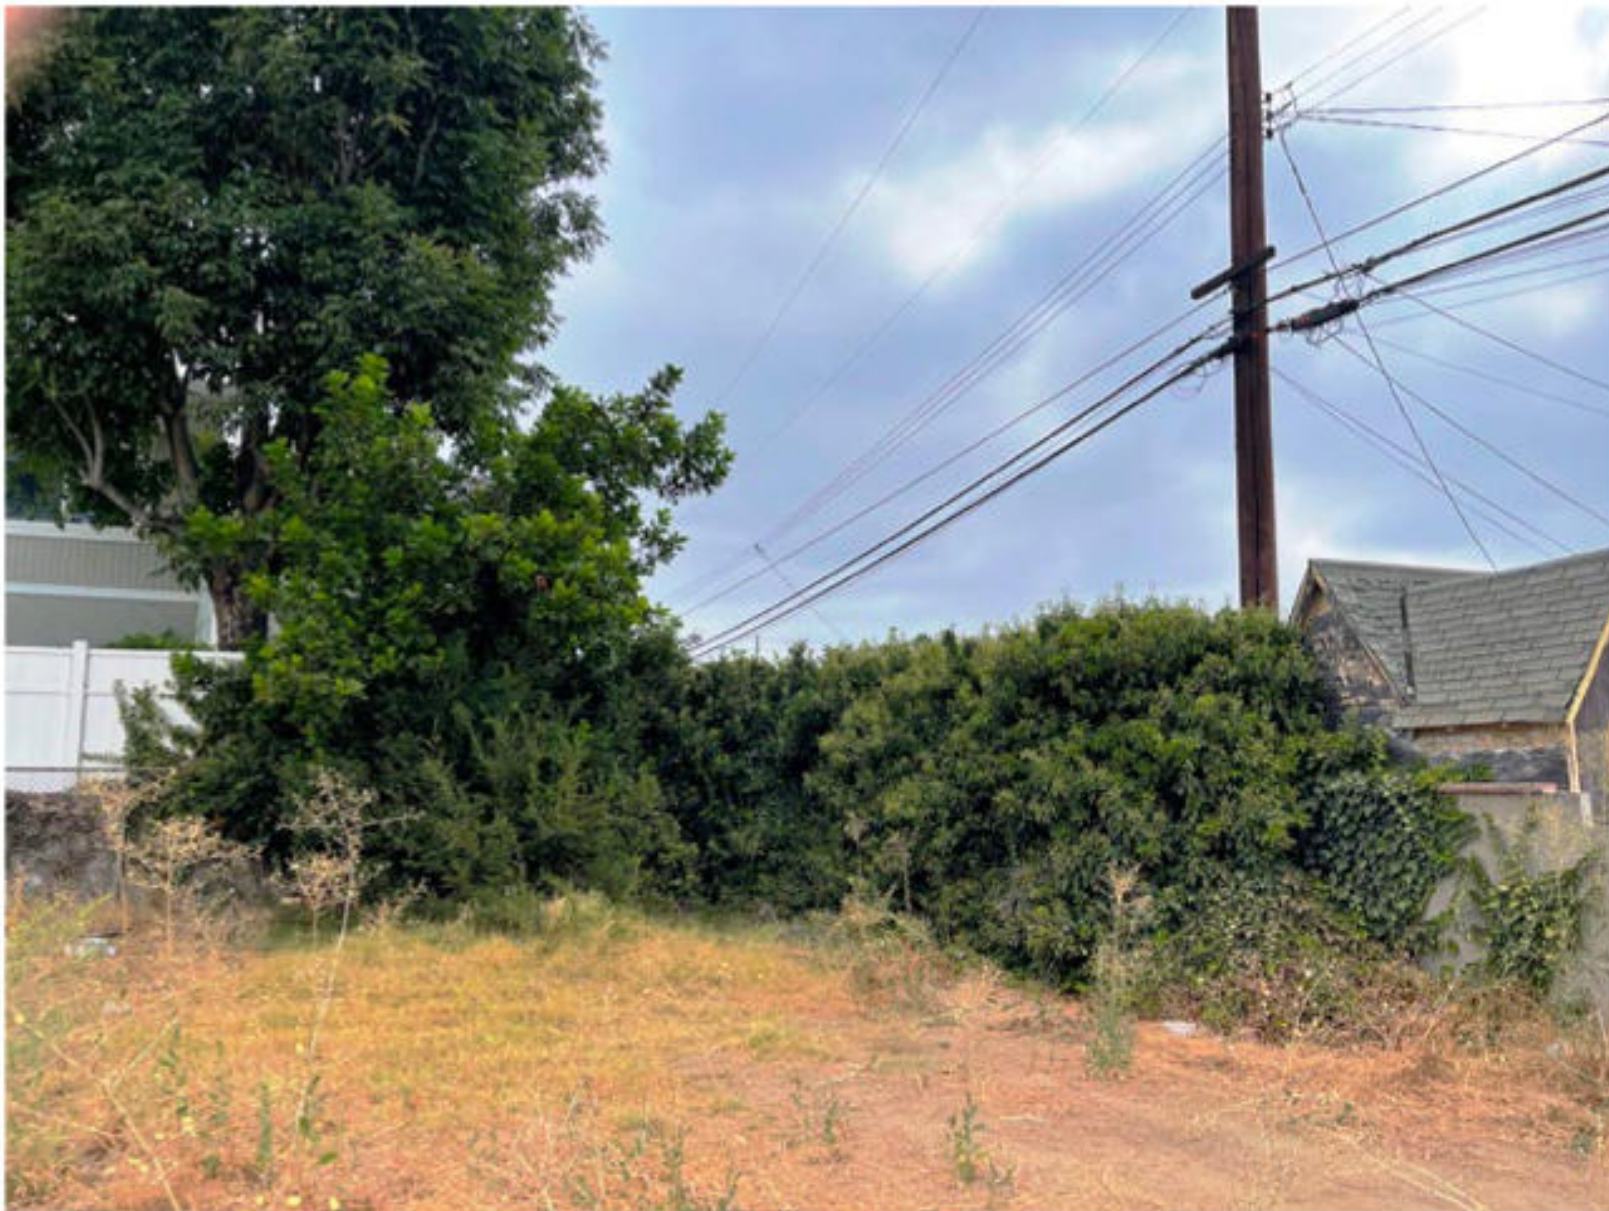
Tag	Species	DBH	Ht.	Wd.	Health	Structure	Roots	Comments
1	Cupaniopsis anacardioides	6”	20	18	B	C-	1sRF	by wall, sup under neighbor's ash
2	Schinus terebinthifolius	bush	20	30	A	D	1s	on PL. Foliage to the ground
3	Washingtonia robusta		20'th	12	B	A	covered	dead fronds to the ground
4	Washingtonia robusta		17'th	12	B	A	covered	dead fronds to the ground
5	Washingtonia robusta		20'th	12	B	A	covered	dead fronds to the ground

Tree #1 is a carrotwood, with competing mature ivy and the neighbor's Shamel ash overhanging it.

Both the ash and the carrotwood are known to have roots that are destructive to paving. Also, both have weak structures. They should be removed as well.

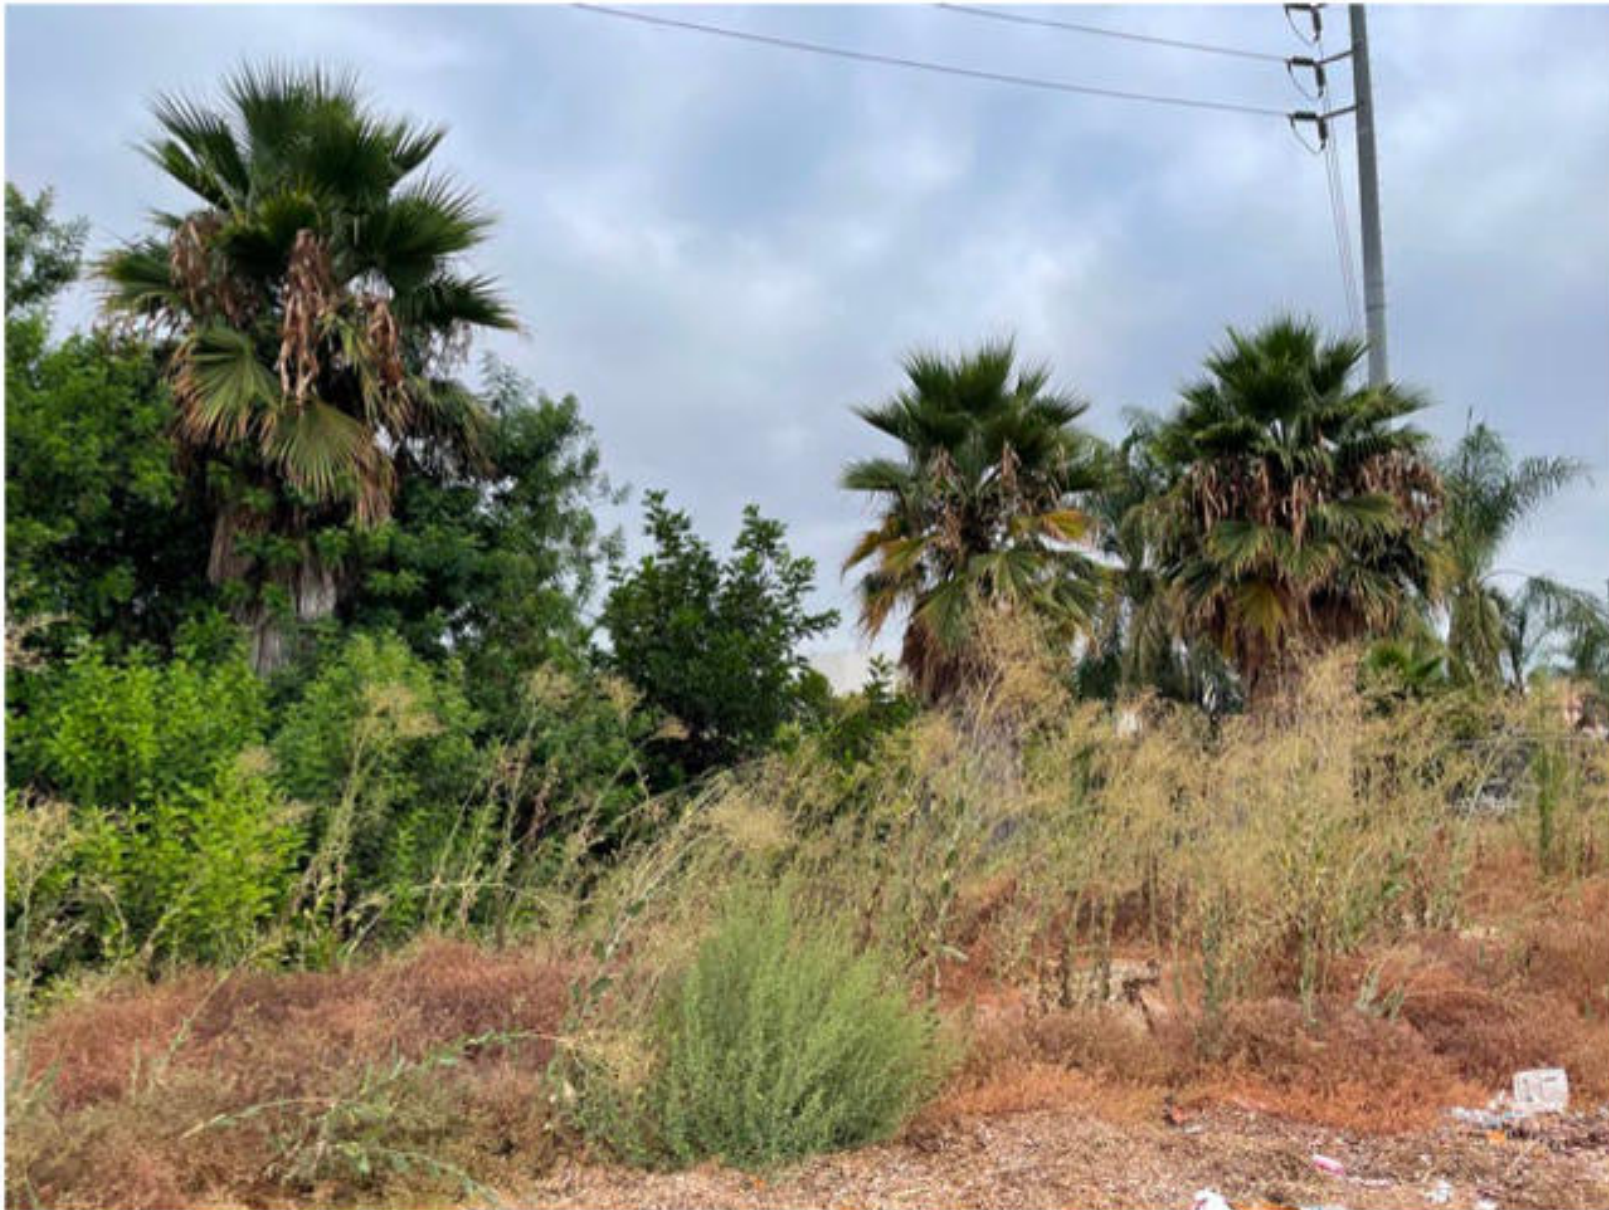
Pepper #2 and Mexican fan palms #3, 4 and 5 – Note full skirts to the ground.

Due to their lack of training and suitability for landscape use, they are not recommended for retention. While the palms *may* have use in the new landscape, they are remarkably inexpensive. The cost of digging, moving to a temporary location, and moving them back into a suitable landscape location is more than the cost of buying and planting new ones. Since we do not know at this time if there is a good use for them in the new landscape, it is even less reasonable to dig, store and replant them. Also, it is unlikely to be a good landscaping choice due to the cost and risk of semi-annual trimming, and the lack of scale for what becomes a 100-foot tall palm.

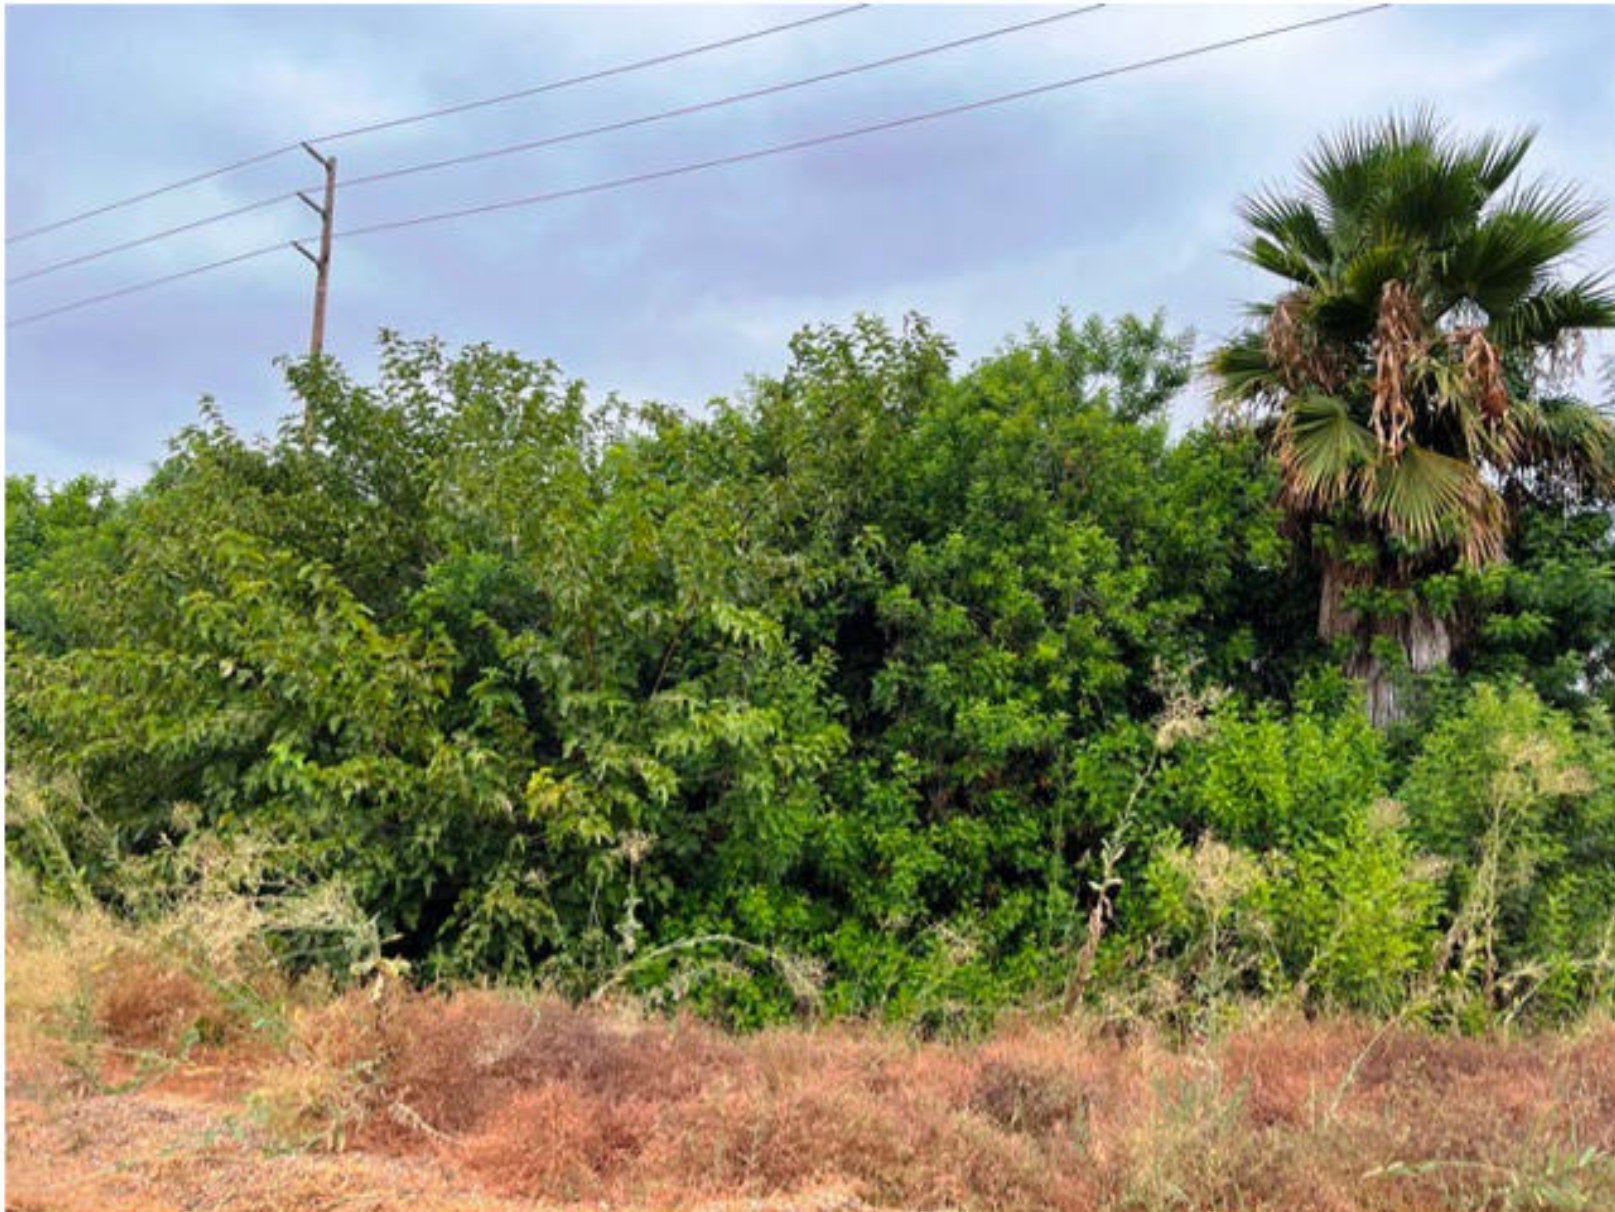
Pepper #6 and mulberries #7 and 8 – full to the ground and no trunks.

Due to the extreme likelihood that seed and pieces of the roots will sprout in the new landscape, a combination of early herbicide use and removal are warranted. Monitoring and controlling their sprouting and regrowth will be expensive, if their removal and control is not diligent. Management includes: Controlling Brazilian peppertree, *Schinus terebinthifolius*, infestations requires a combination of methods due to its aggressive nature. Here are some effective strategies:

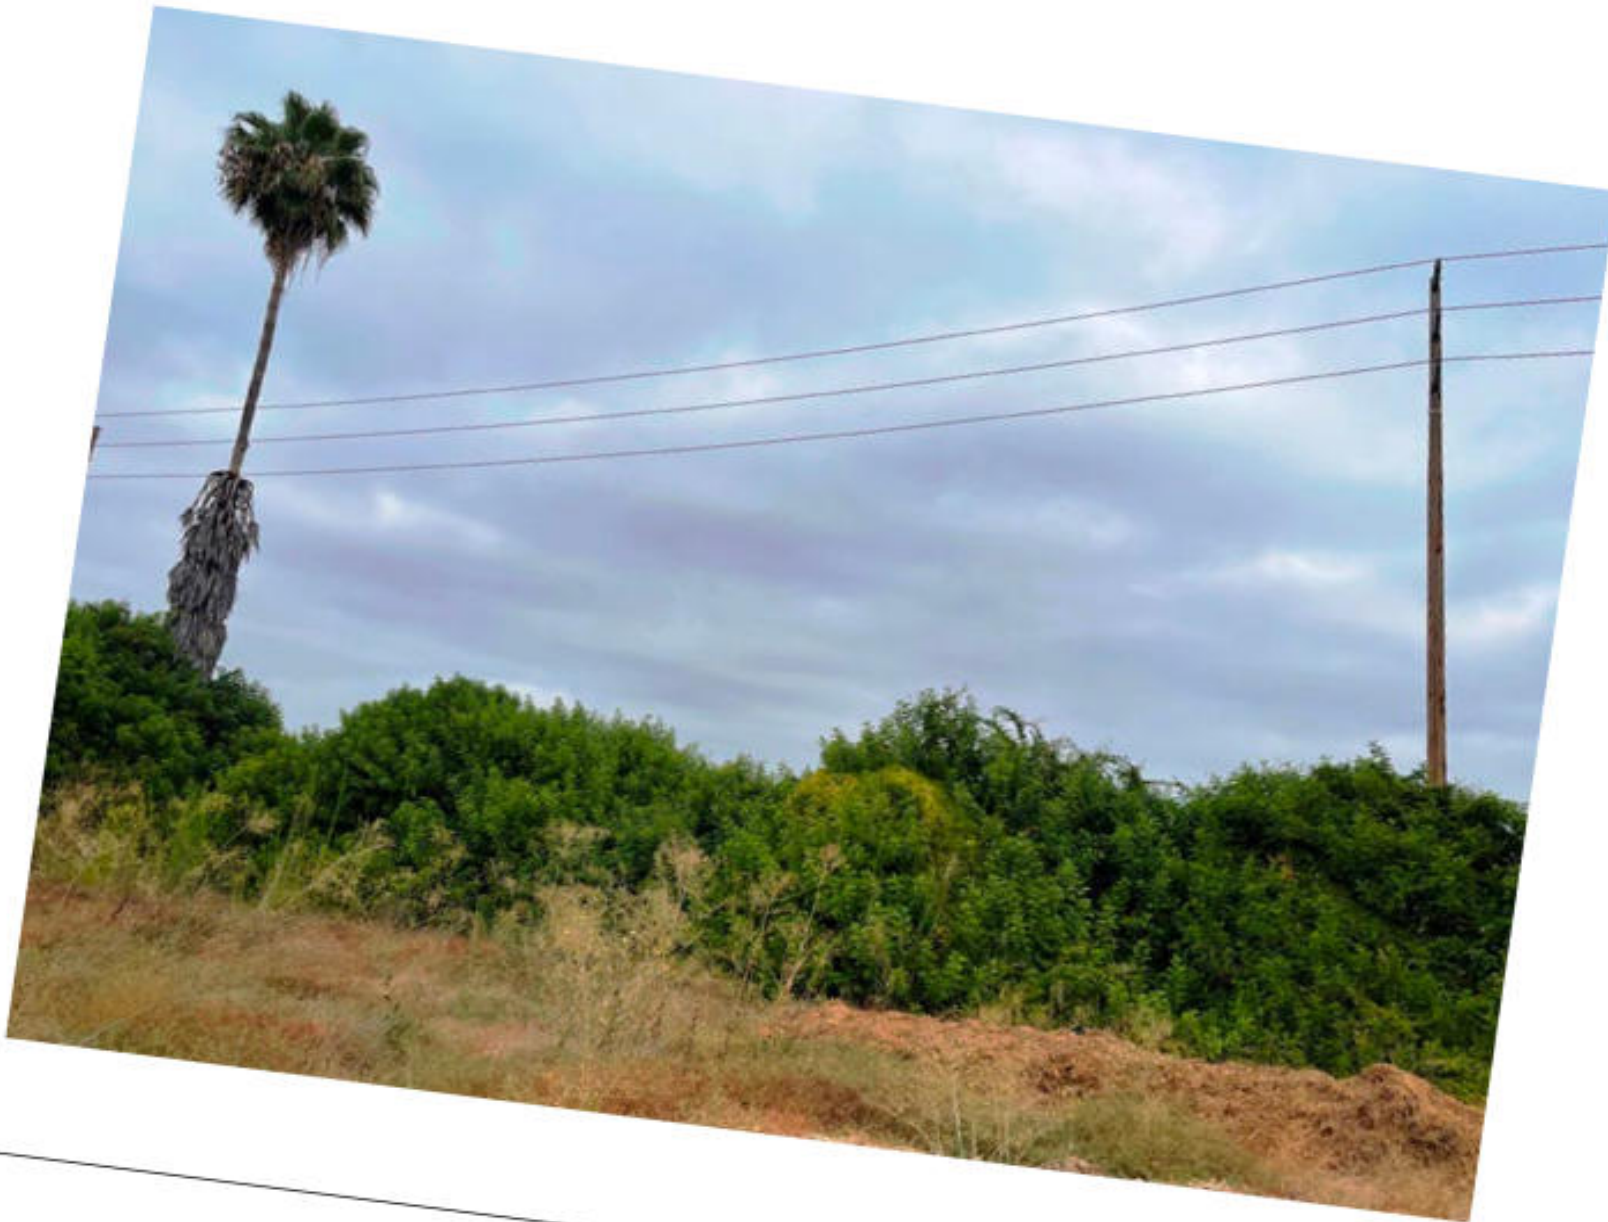
Peppers #9, 10 and 11, with Mexican fan palm #12 at the left. Note beginning of self-cleaning stage.

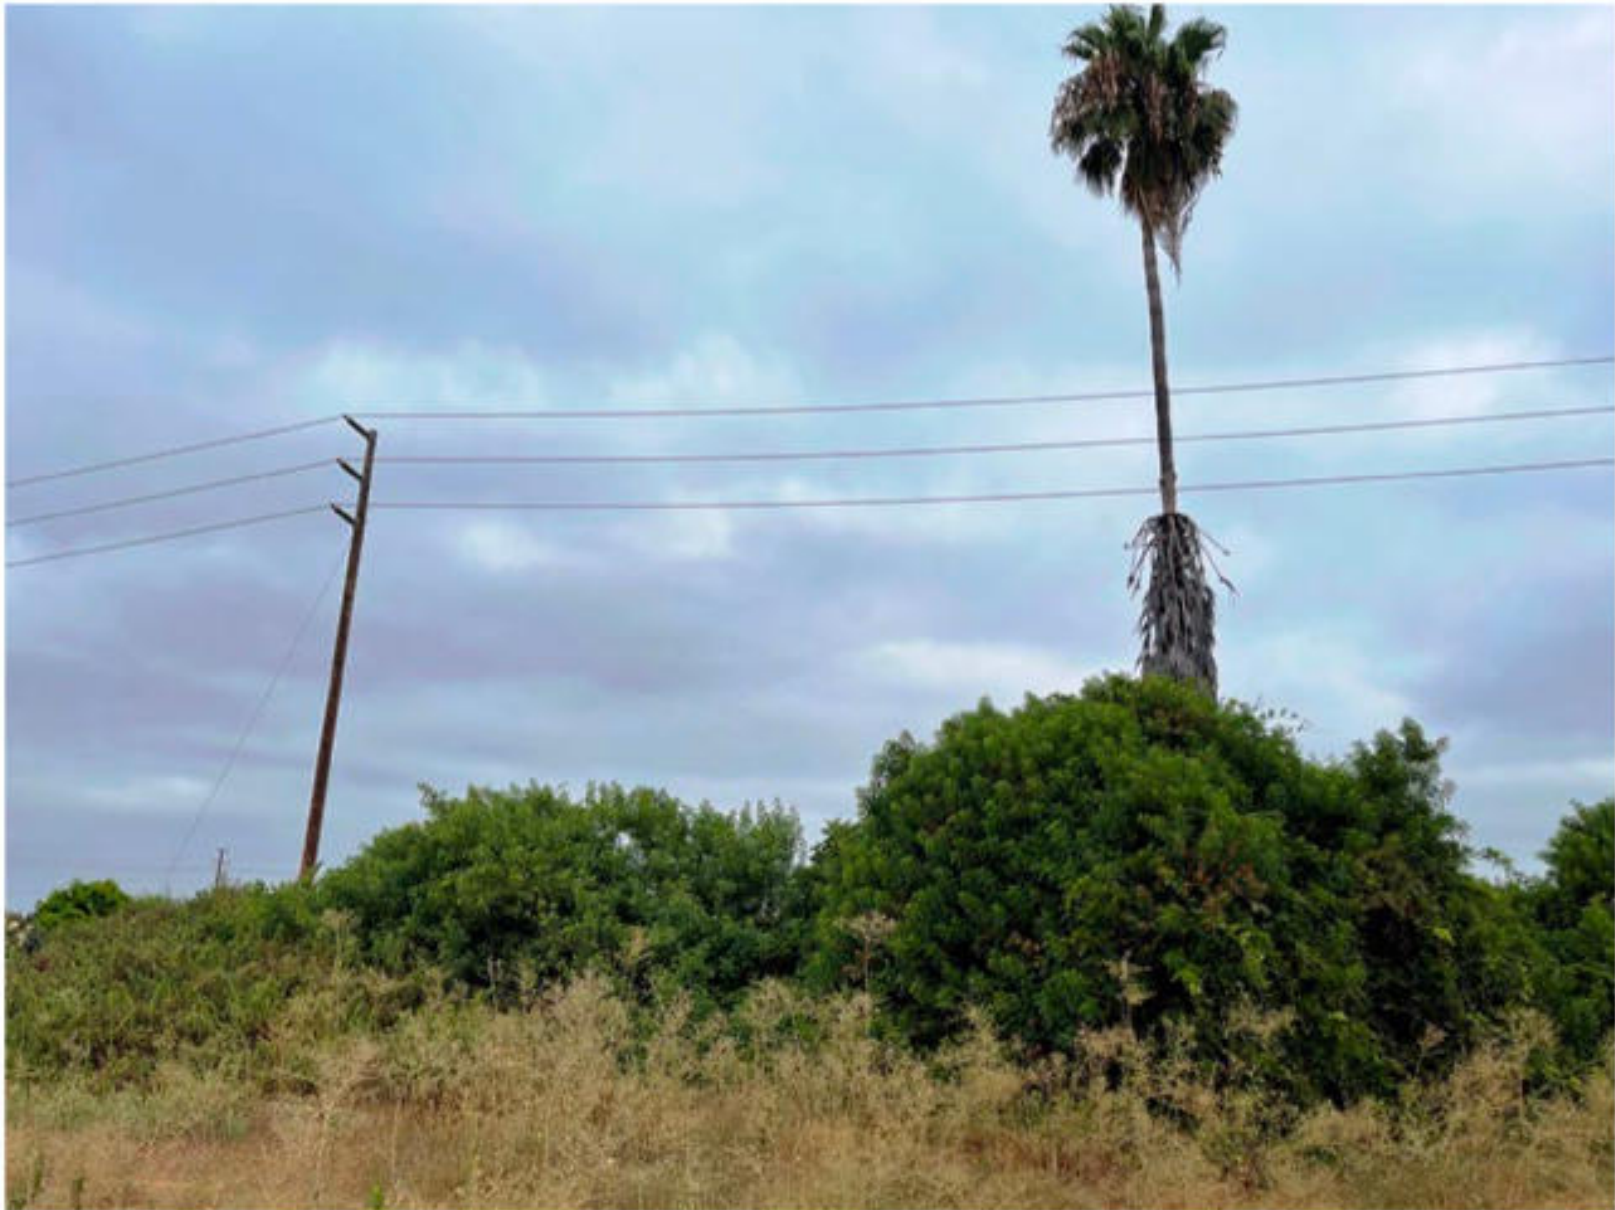
Mexican fan palms #12 and peppers #13 and 14 – full to the ground and no trunks.

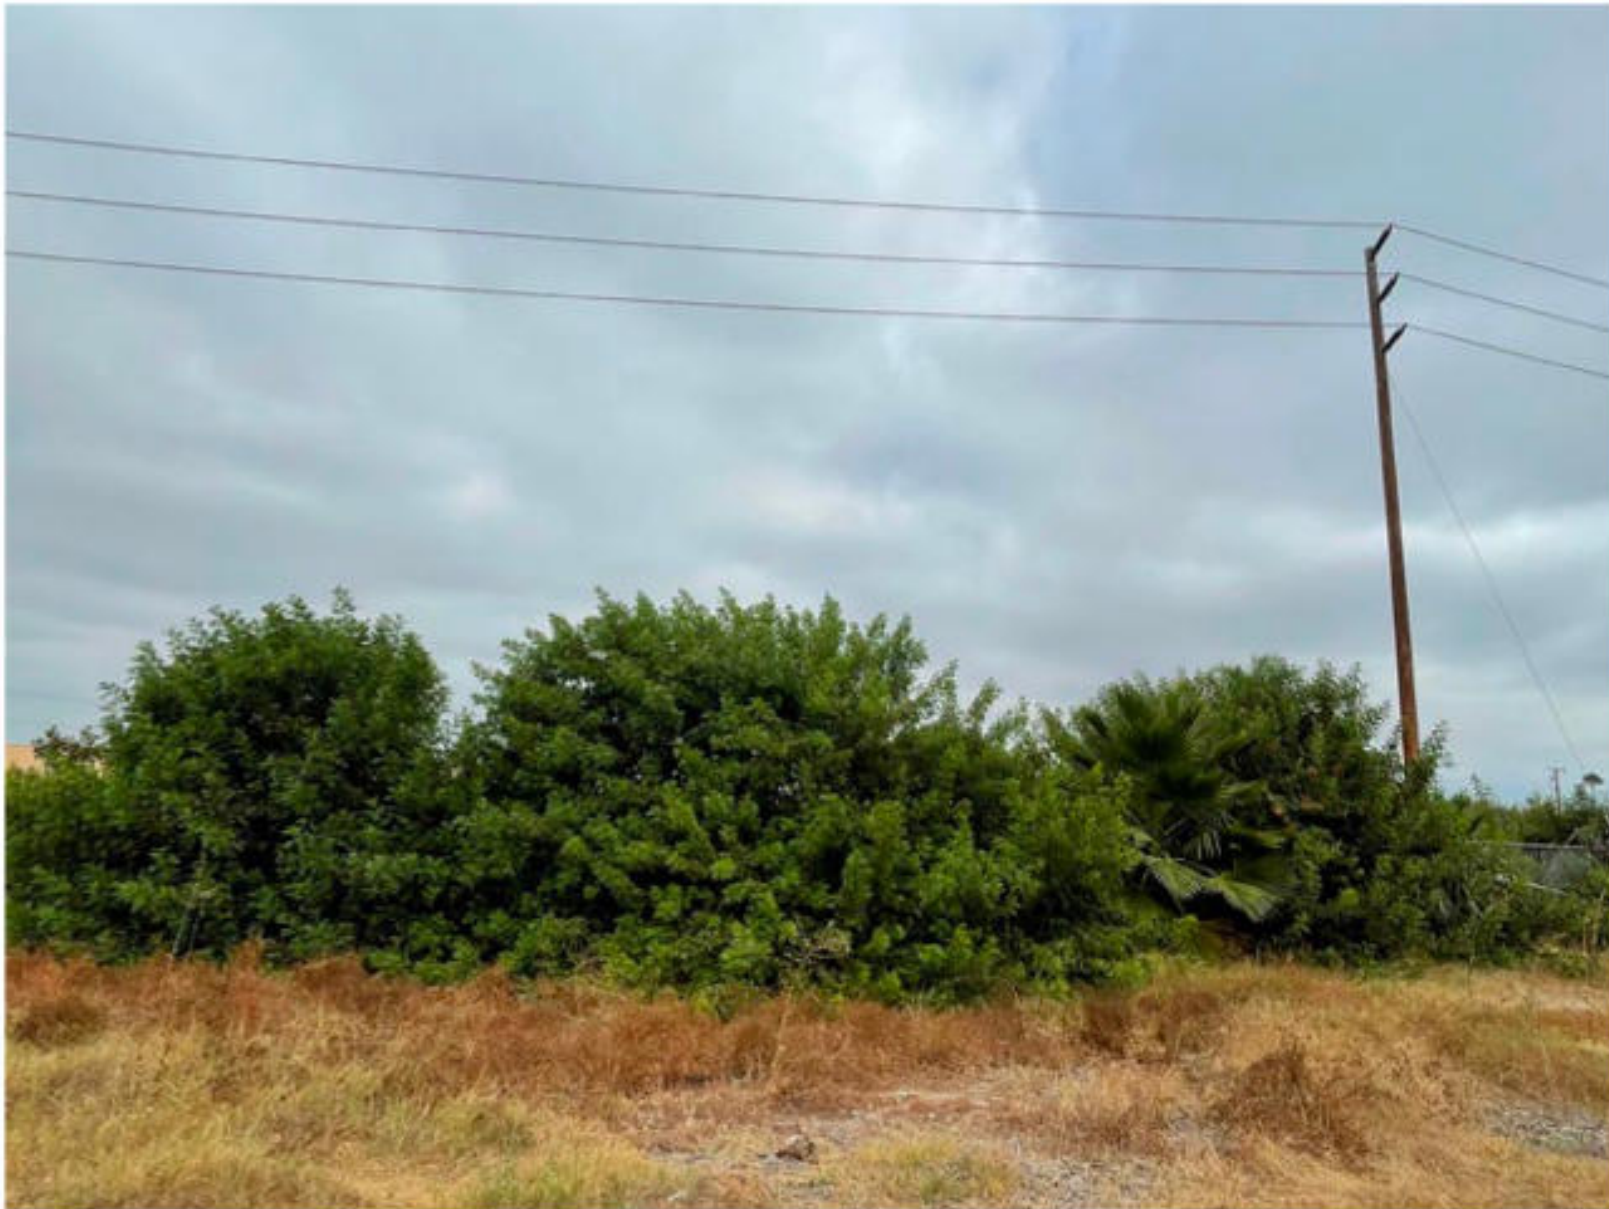
#15, 16 and 17 (right to left) peppers are full to the ground and have no trunks.

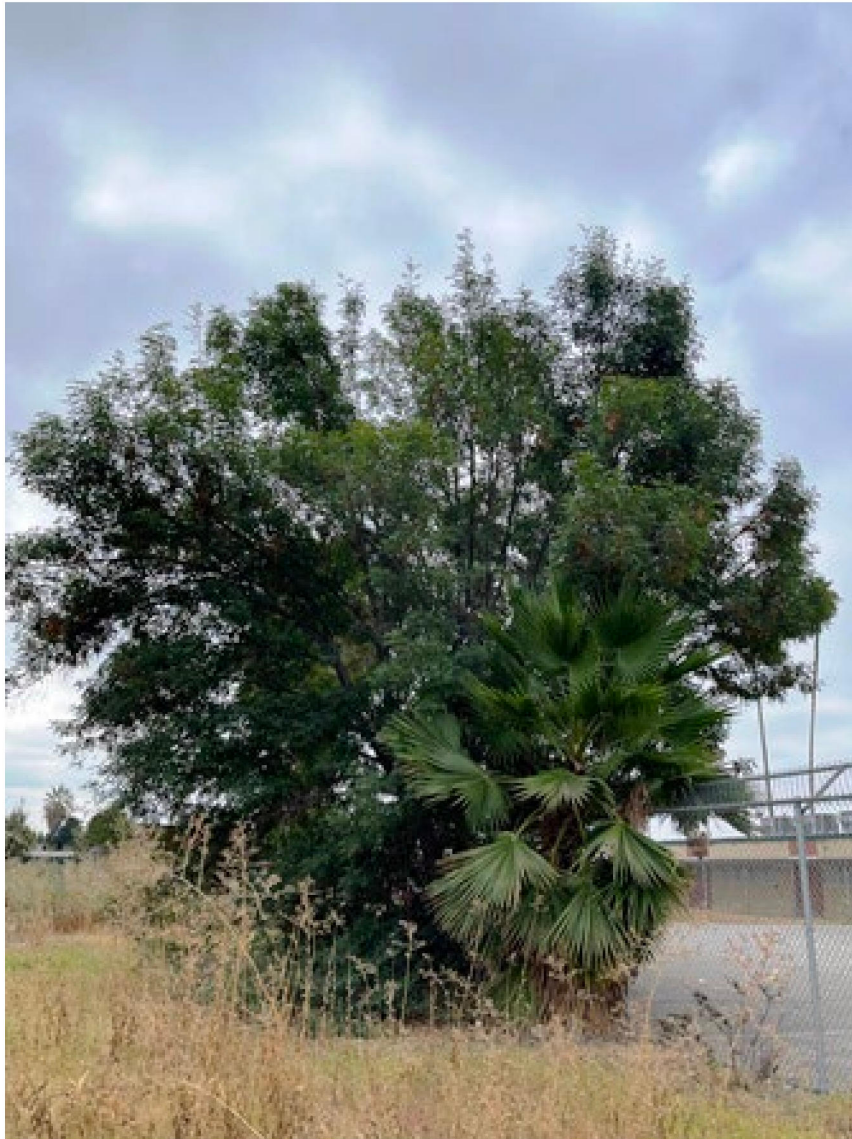
19	Fraxinus uhdei	23 @ 1'	55	40	B	C-	shallow	Cod inc Low branched
20	Washingtonia robusta		28'th	12	B	A	covered	dead fronds to the ground
21	Washingtonia robusta		28'th	12	B	A	covered	dead fronds to the ground

#18 Mexican fan palm and #19 Shamel ash.

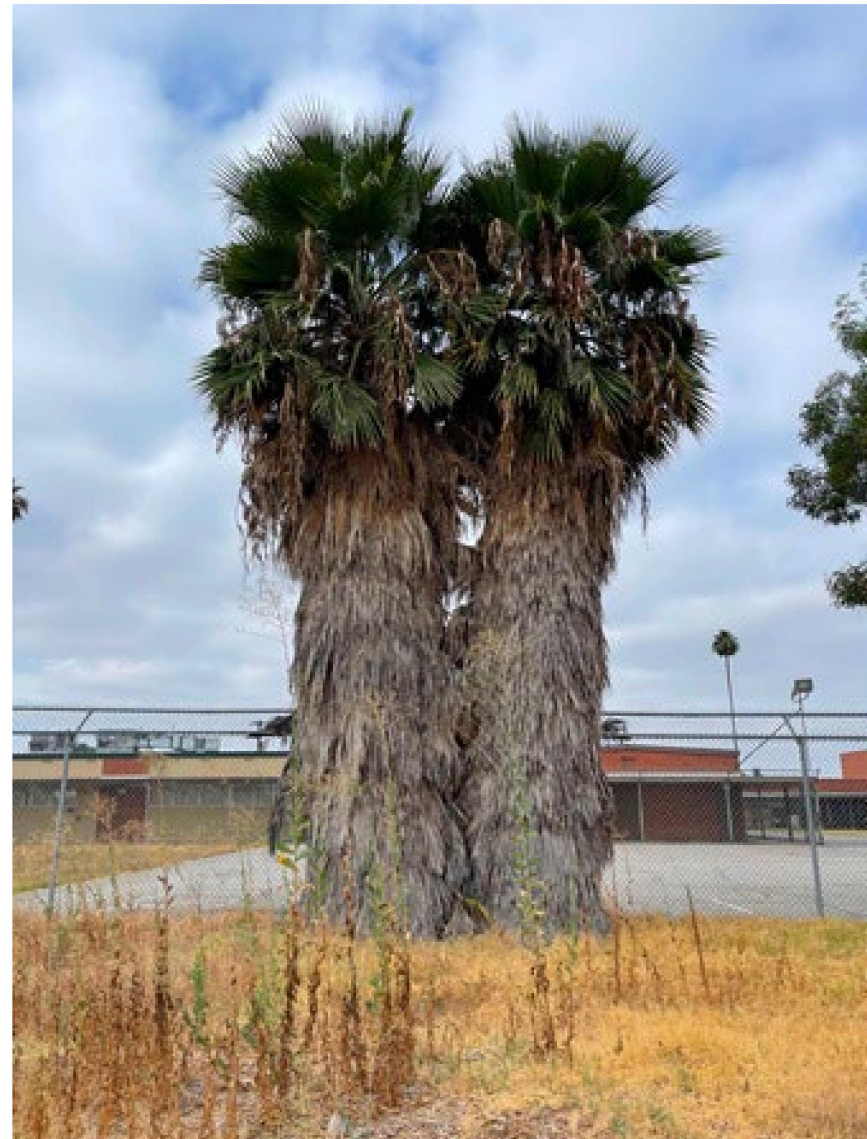
Mexican fan palms #20 and 21

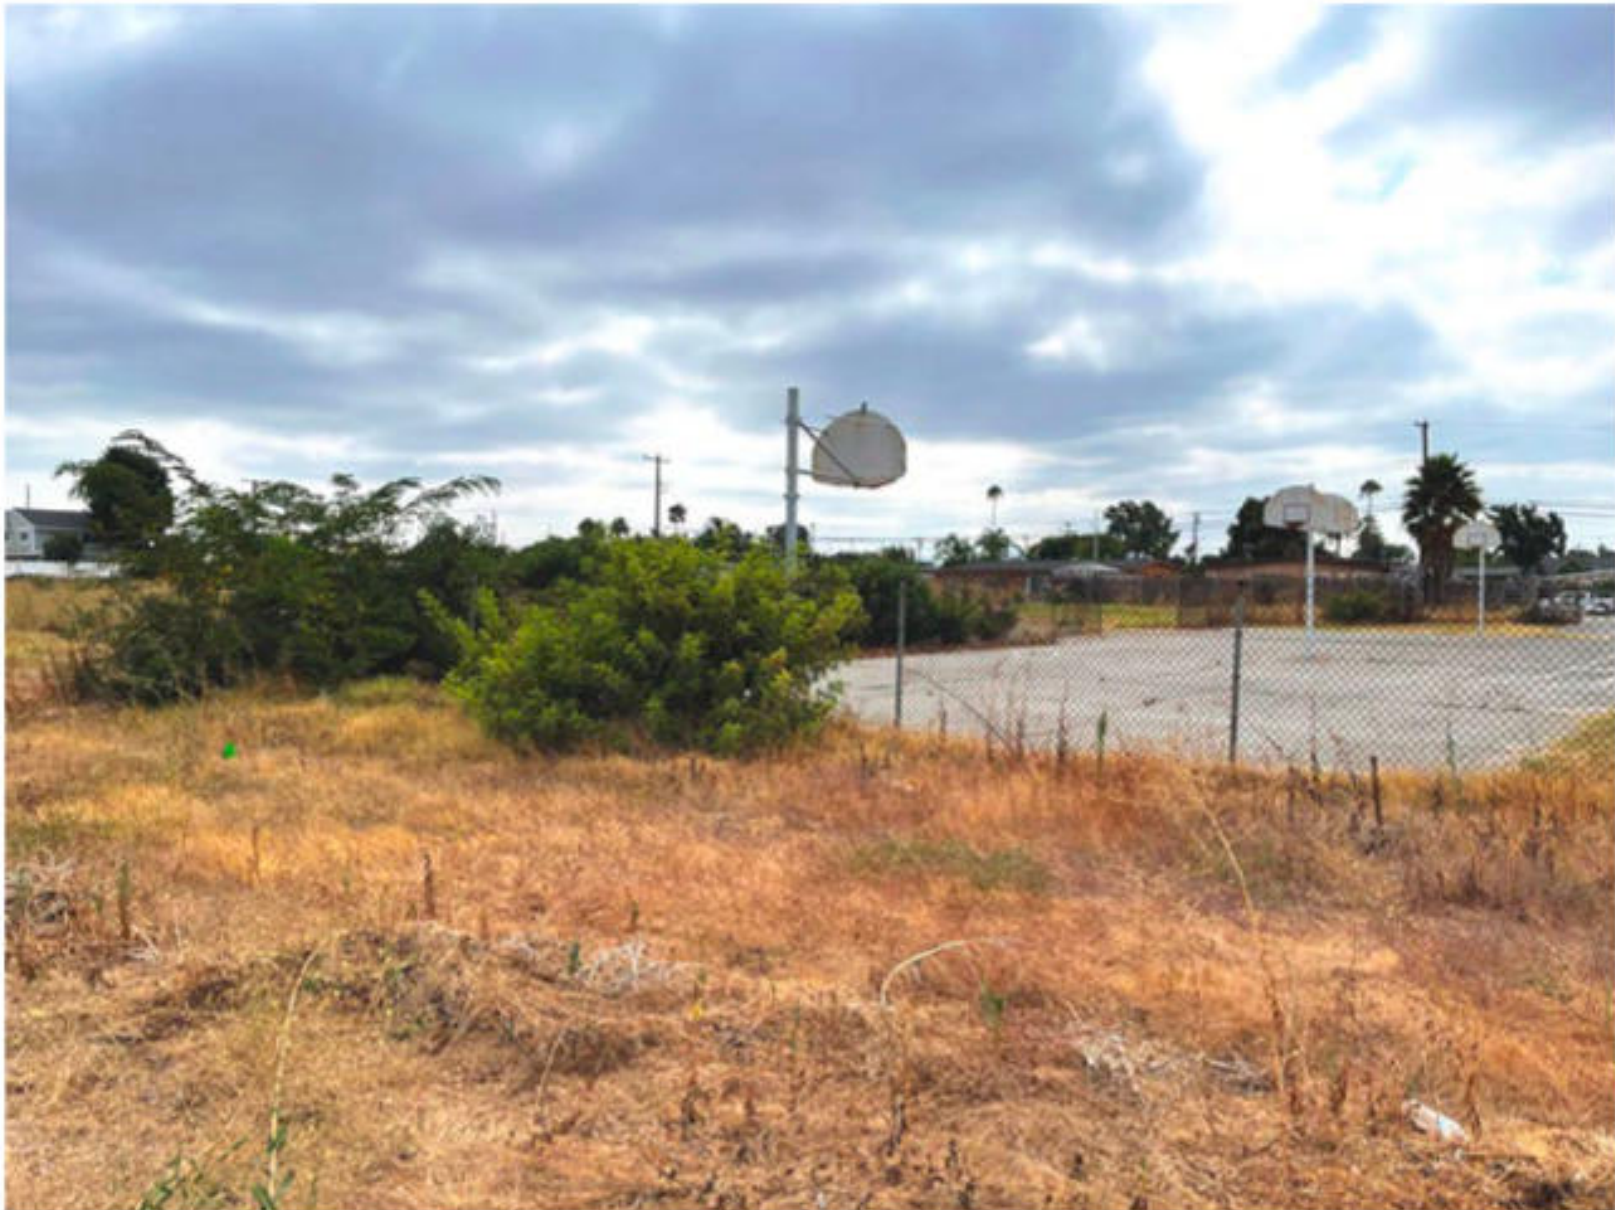
Unlisted peppers and Chinese elm.

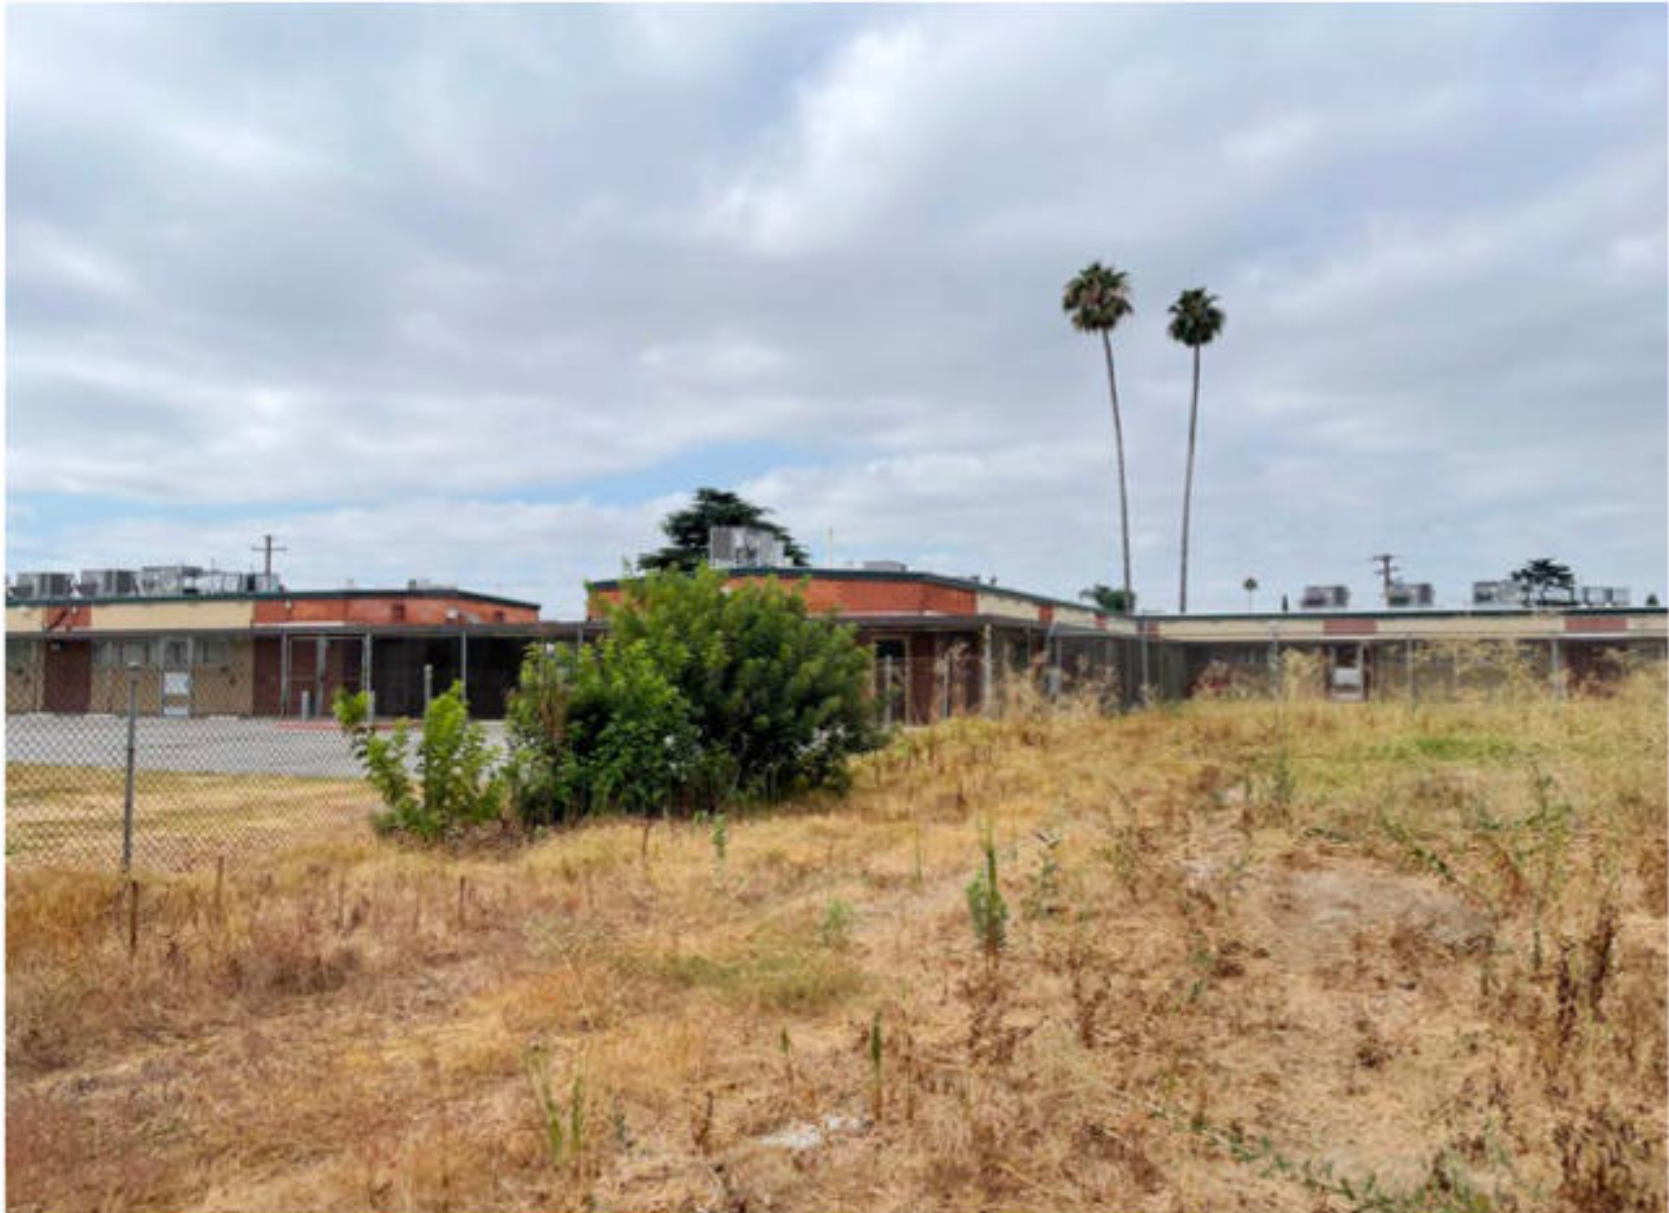
Unlisted peppers are too small to require inclusion.

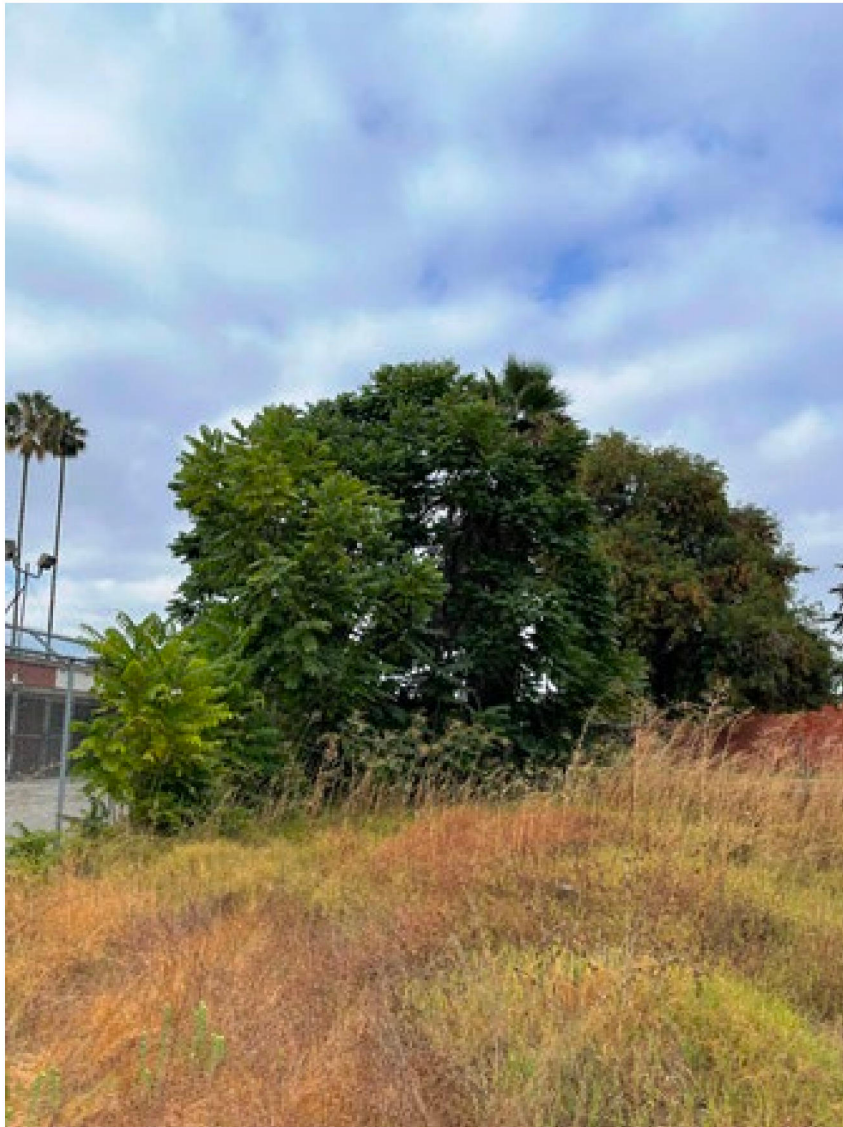
Trees of heaven are also weed trees, but below the south edge.

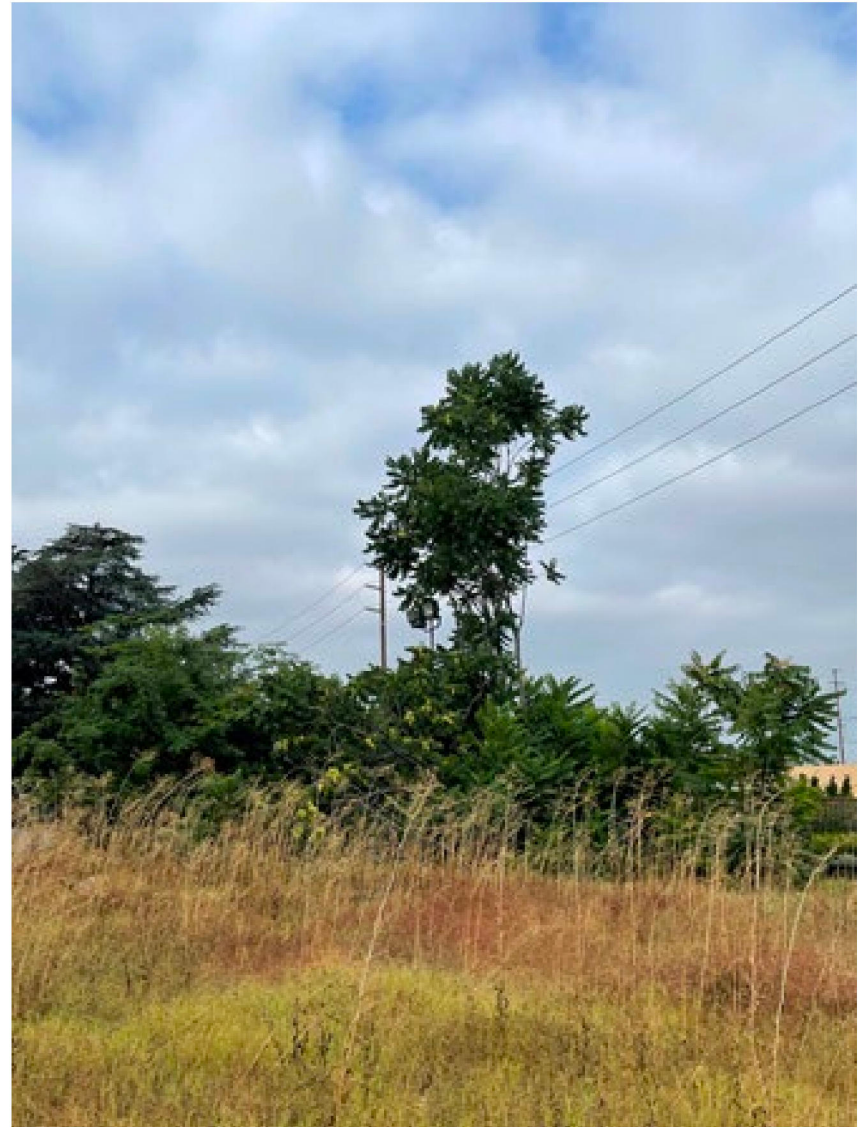
Trees of heaven are also weed trees, but off-site.
