Consulting Arborist's Report

Tree and Palm Evaluation

For: 1314 Le Borgne Avenue, Baldwin Park

Date: **August 27, 2024**

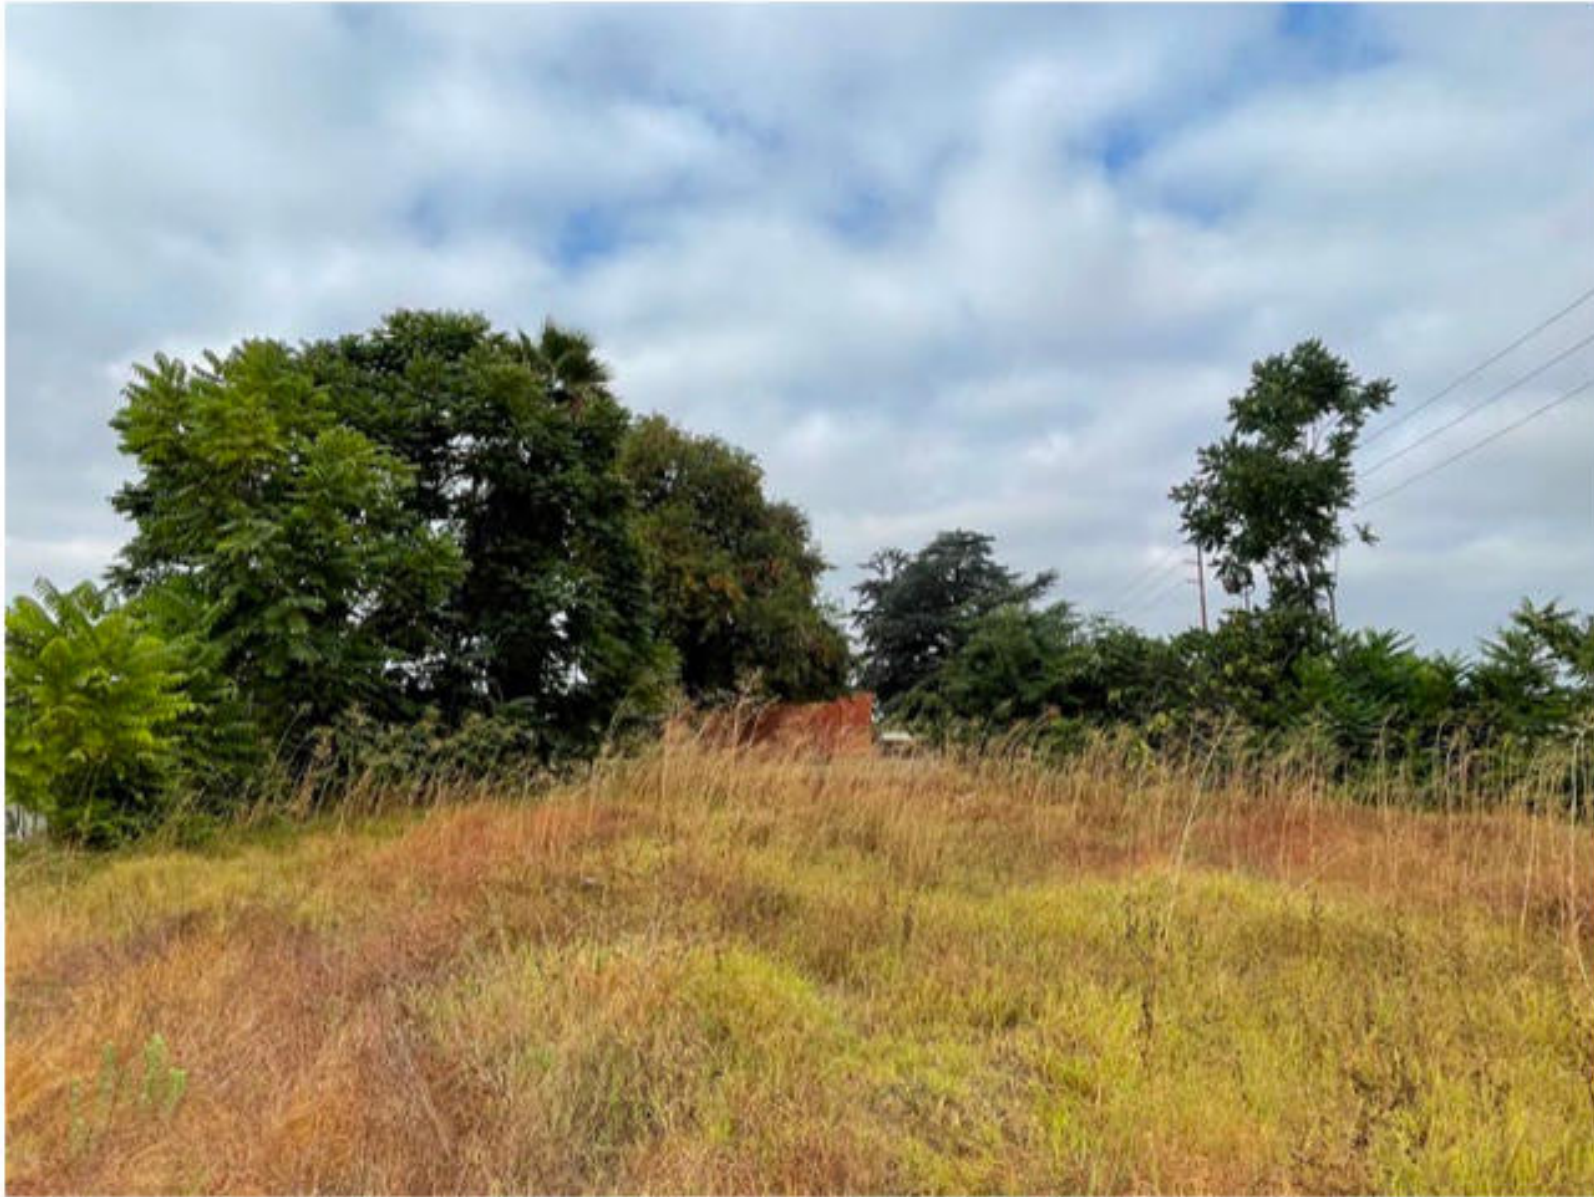
Below the south edge of the site are mostly tree-of-heaven weed trees.
