November 8, 2024

Landslide Hazard Evaluation
Wappo Hill Vineyard Block 1A
APN 039-040-050
Napa, California

Project Number: 7542.012.09.2

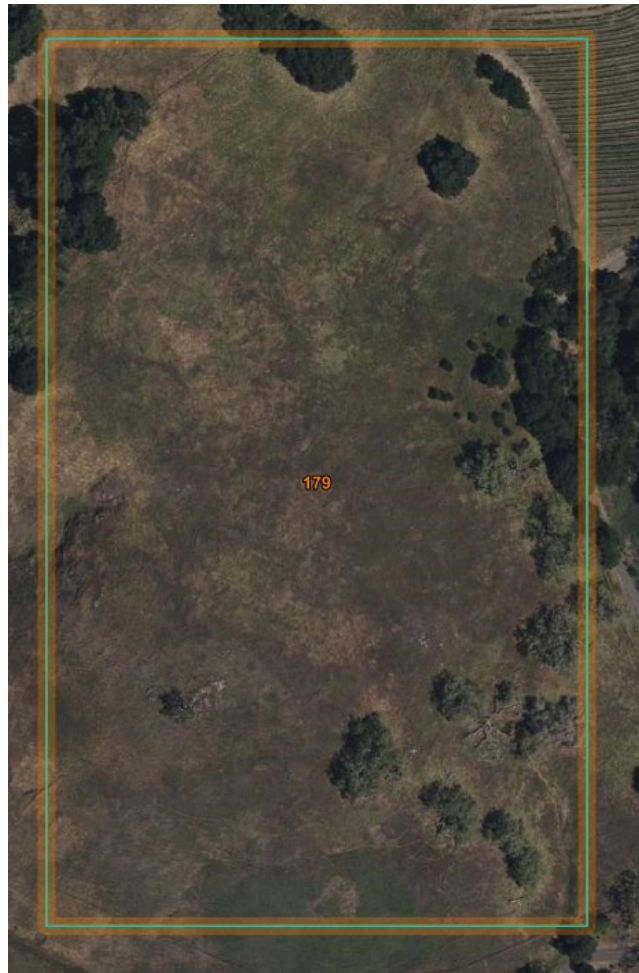
Based on our geologic review we compiled the image and table below indicating the soil types and depth of materials. This information was collected from the NRCS Web Soil Survey listed above.

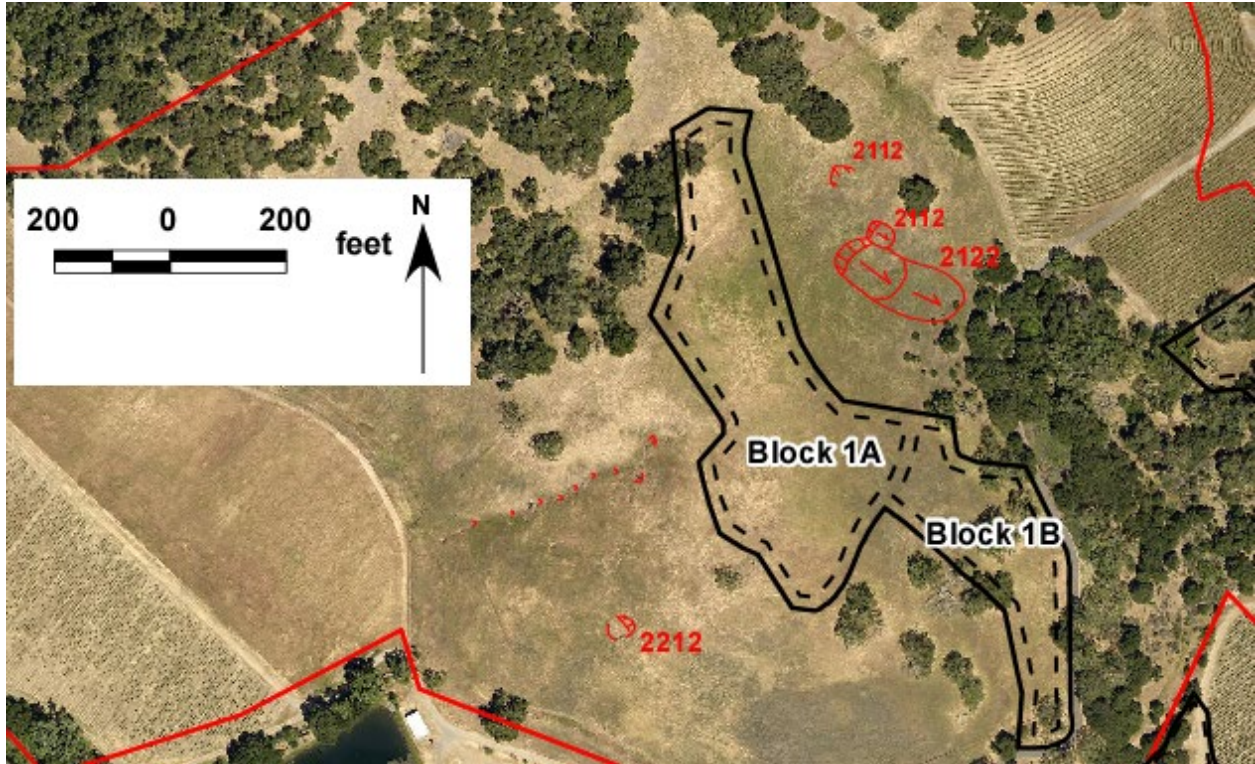
On November 4, 2024, we performed a geologic reconnaissance of the site and vicinity. We observed the areas within and surrounding the planned vineyard block and various access roads. We paid particular interest to drainages and steeper sloping areas. A reconnaissance map presenting the surficial features we observed are presented below. Our landslide identification nomenclature is presented following the reconnaissance map.

The landslides we observed were estimated to be translational, definite to probable certainty of identification, less than 5 feet thick to between 5 and 20 feet thick and dormant. The landslides identified to the northeast of the vineyard block extend to within about 100 feet of the planned vineyard Block 1A. A probable landslide to the southwest of the vineyard block extends to within about 230 feet of the planned vineyard Block 1A. These landslides are located along the relatively steep flanks of the gently sloping ridgetop that is planned for planting.

Based on our geologic review and reconnaissance, we judge that it is geologically feasible to grade and plant the subject vineyard slopes as planned. We did not identify any large-scale slope instabilities within the vineyard blocks during our publication review and did not observe any slope failures or landslides within the vineyard block during our reconnaissance. We did observe dormant landslides along the flanks of the ridge that is planned for planting. Provided vineyard grading does not increase surface water flow paths toward these landslides, we judge that the vineyard grading does not increase the risk of reactivation of these landslides.

Provided site grading does not increase flow paths toward the mapped landslides flanking the planned vineyard, we judge the risk of global slope instability, both currently and after vineyard development, to be low. As such, erosion of the site surface soils should be considered the primary slope condition of concern. If erosion control measures are installed and maintained in accordance with County of Napa Regulations, we judge the risk of erosional failure at the site to be low.
