January 13, 2025

## **TREE ASSESSMENT, PROTECTION, AND MITIGATION PLAN**

**Job Location: 1 HOT SPRINGS RD., Santa Barbara, CA 93108**

Bill Spiewak Consulting Arborist

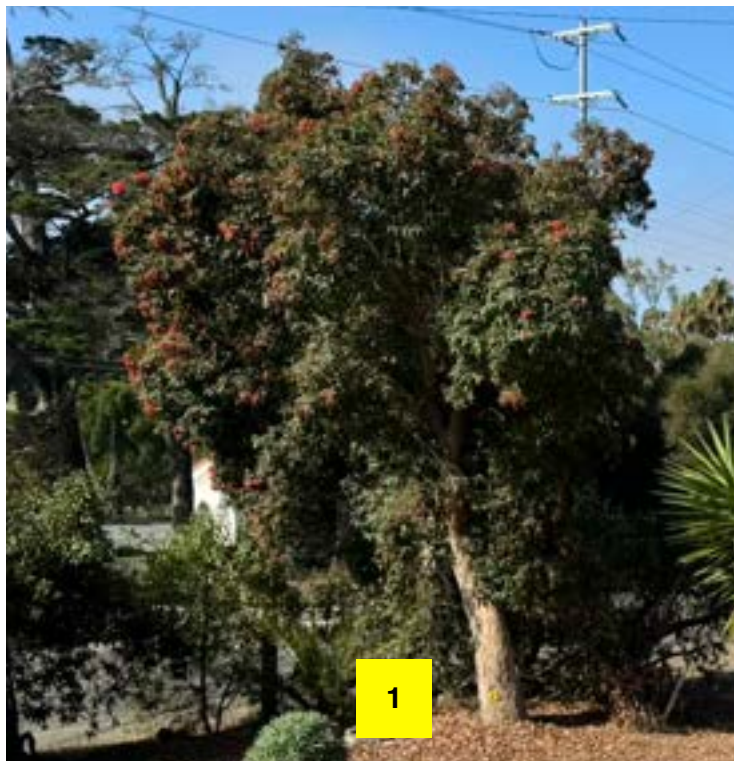
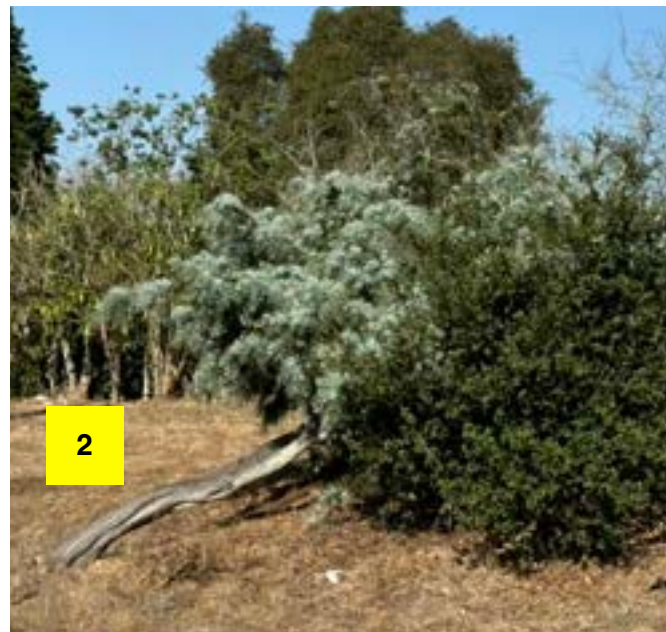
| # | Type | DBH " | CRZ r' | Height | Condition | Comment | Project Impact |
|---|---|---|---|---|---|---|---|
| 1 | Flowering euc | 19 | | M | F | Topped | Remove |
| 2 | Acacia | 9 | | S | P | Small horizontal tree | Remove |
| 3 | Cypress | 34 | | L | F | Senescent, dead top and declining | Remove |

**#1, a Flowering Eucalyptus (not a true euc) is in the proposed entryway along with #2, a fallen Bailey Acacia and #3 a young Silver Wattle Acacia. Cypress #3 is also in the middle of the project and is in decline.**

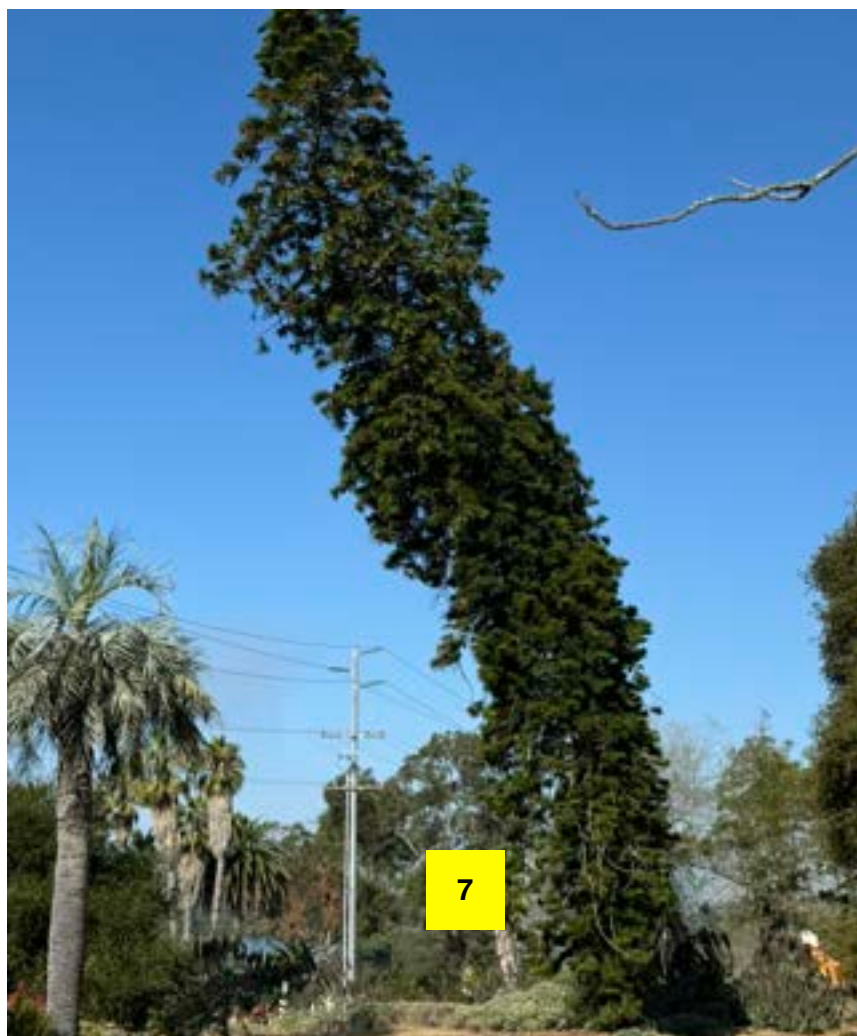
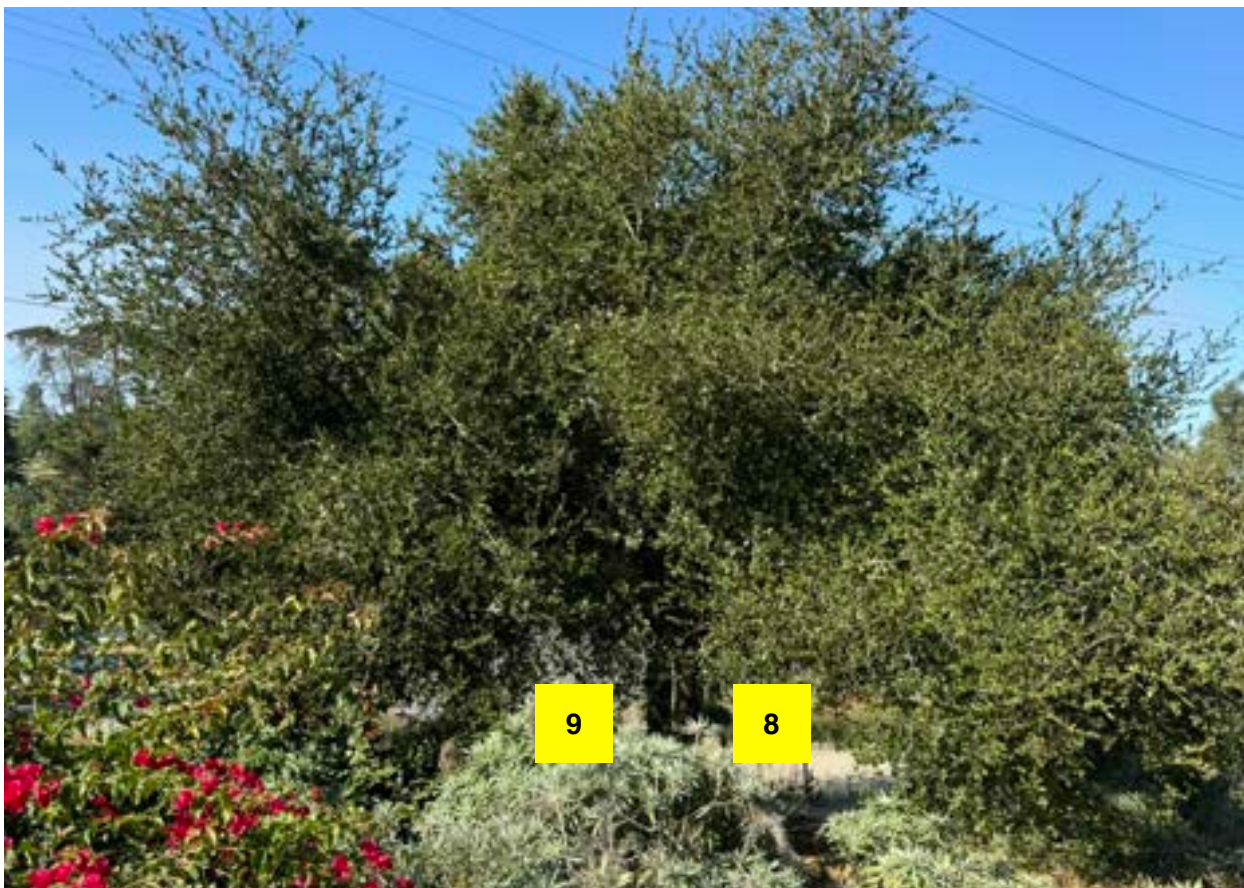
| # | Type | DBH " | CRZ r' | Height | Condition | Comment | Project Impact |
|---|---|---|---|---|---|---|---|
| 10 | Pittosporum | 12 | | M | P | Adjacent dead pitt | Remove |

Oak #8 and 39 are side by side and west of the project area.  
Pittosporum #10 is in decline and needs to be removed.  
Oak #11 is also west of the project area.

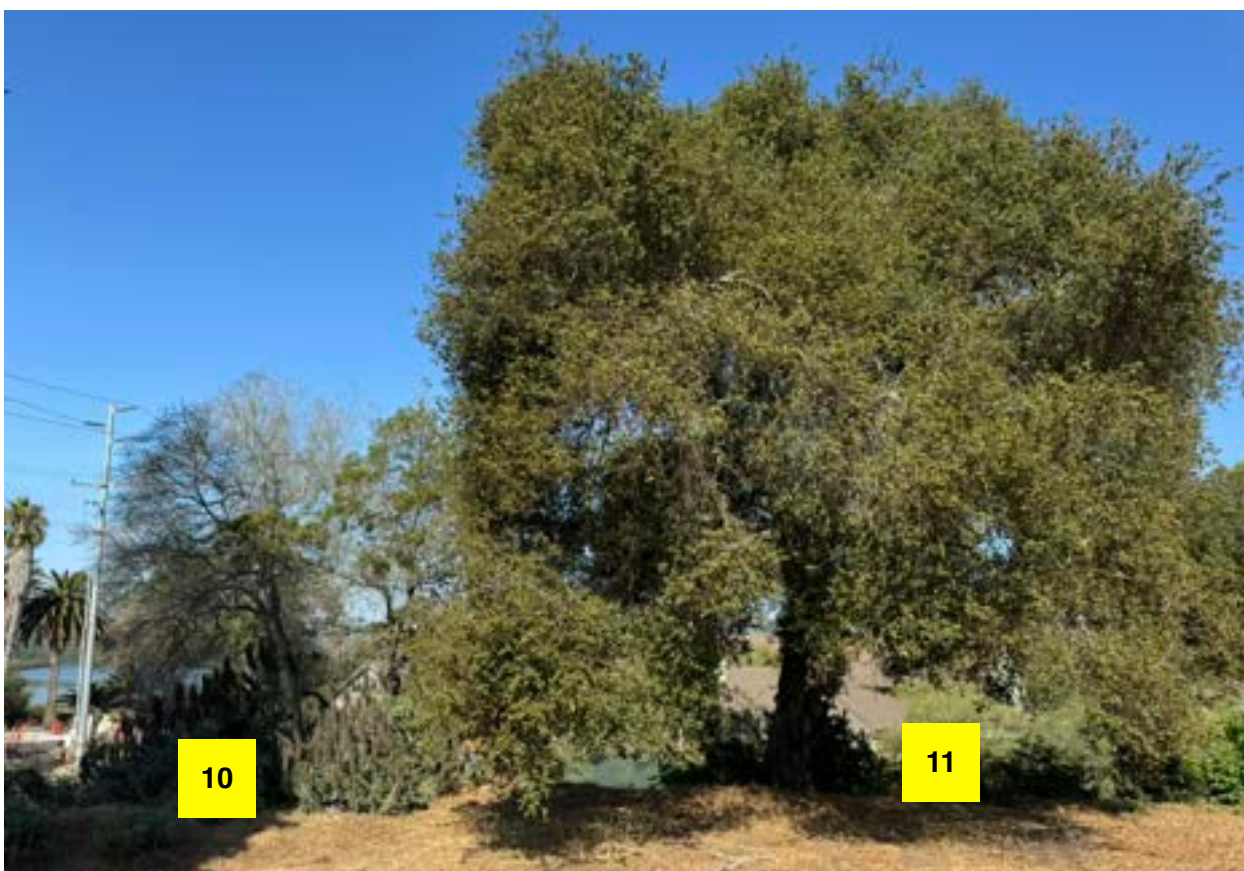
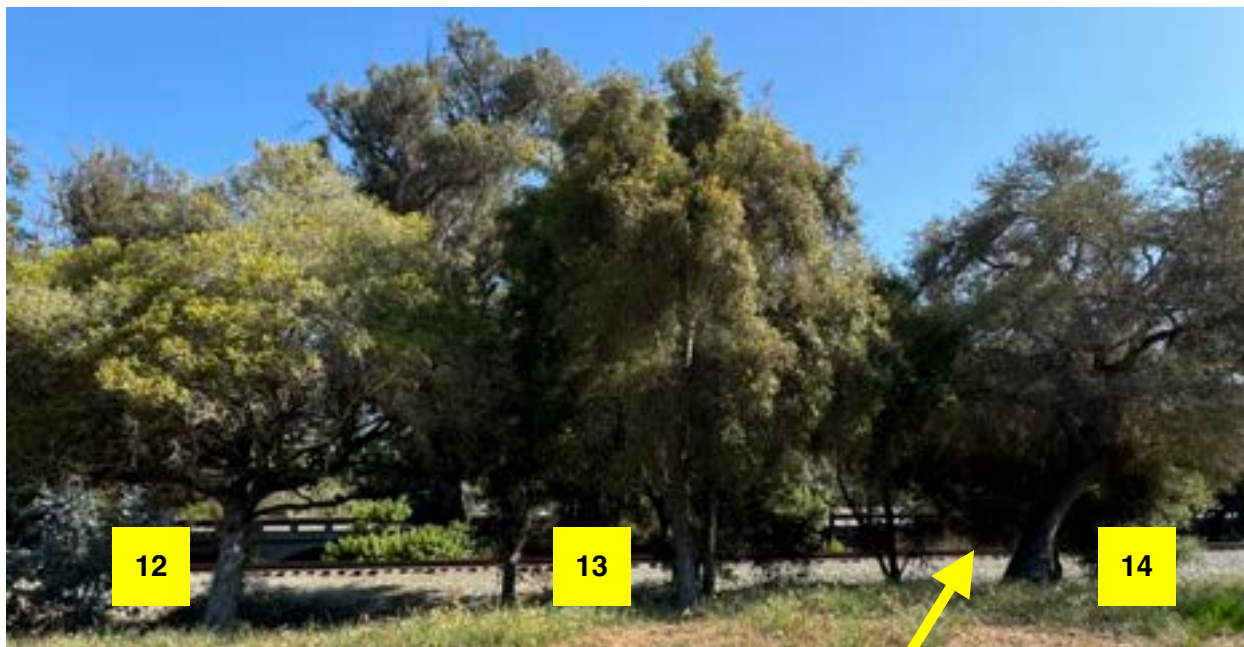
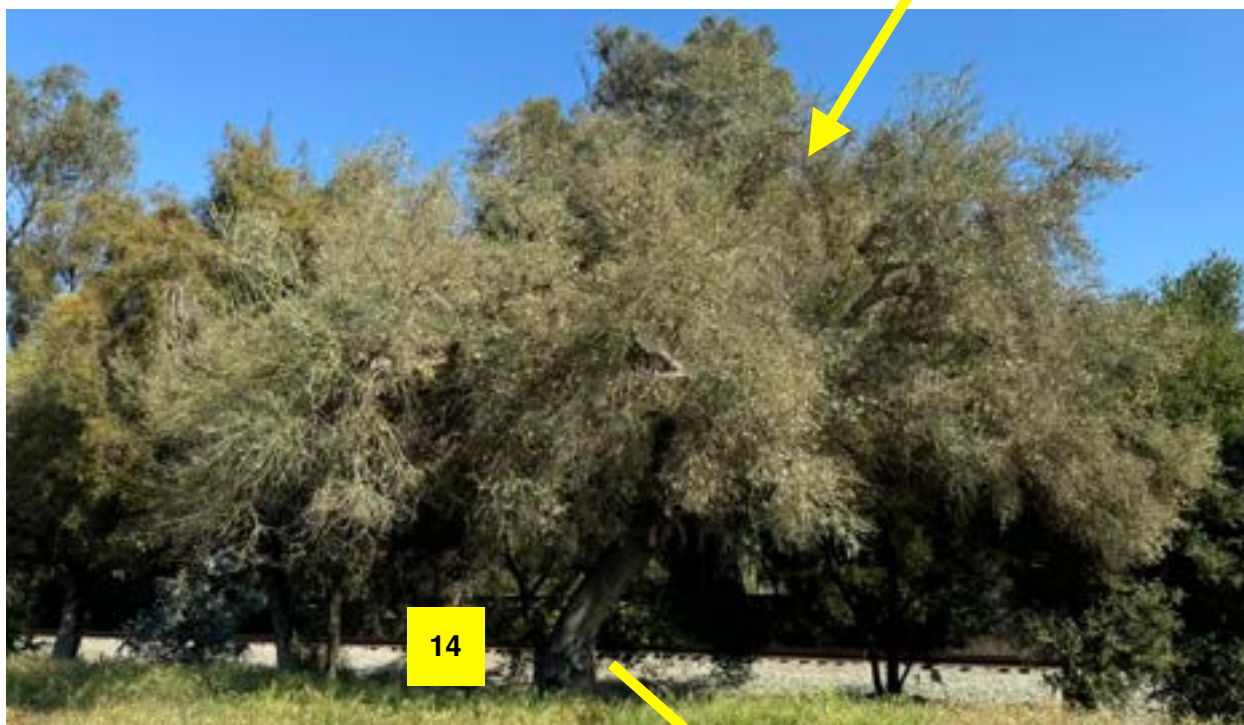
| # | Type | DBH " | CRZ r' | Height | Condition | Comment | Project Impact |
|---|---|---|---|---|---|---|---|
| 14 | Oak | 26 | dead | M | Dead | Infested with oak bark beetles | Remove |

Oak #14 is dead from oak bark beetle infestation. Small inset shows holes in the trunk where beetles entered and bored into the xylem (water conduction tissue). This is easier to see in the field.

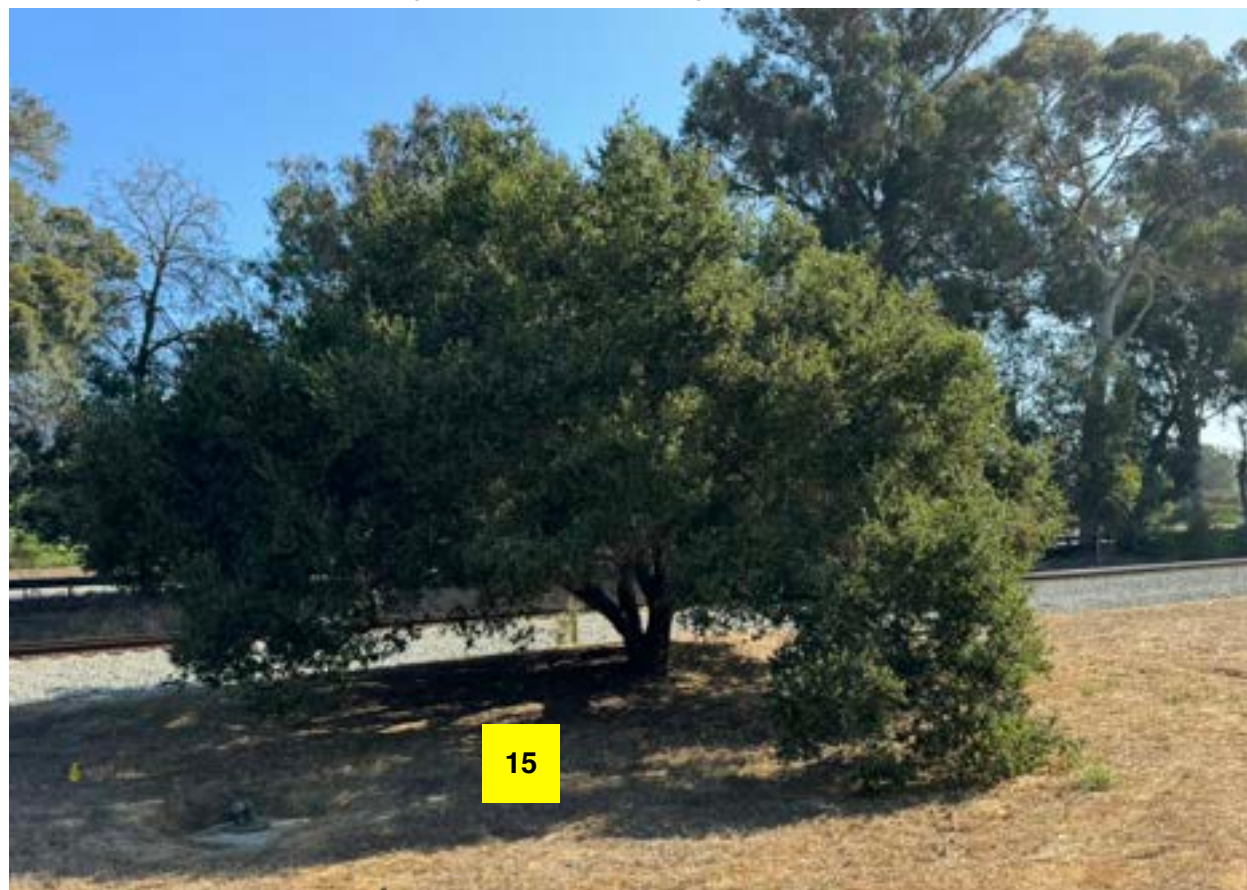
| # | Type | DBH " | CRZ r' | Height | Condition | Comment | Project Impact |
|---|---|---|---|---|---|---|---|
| 15 | Oak | 13 | 13 | M | G | Along north prop line | Remove |

Oak #15 is to be removed.

7. Activities within construction areas where trees are to be protected must be monitored by the project arborist, primarily near oak #15.

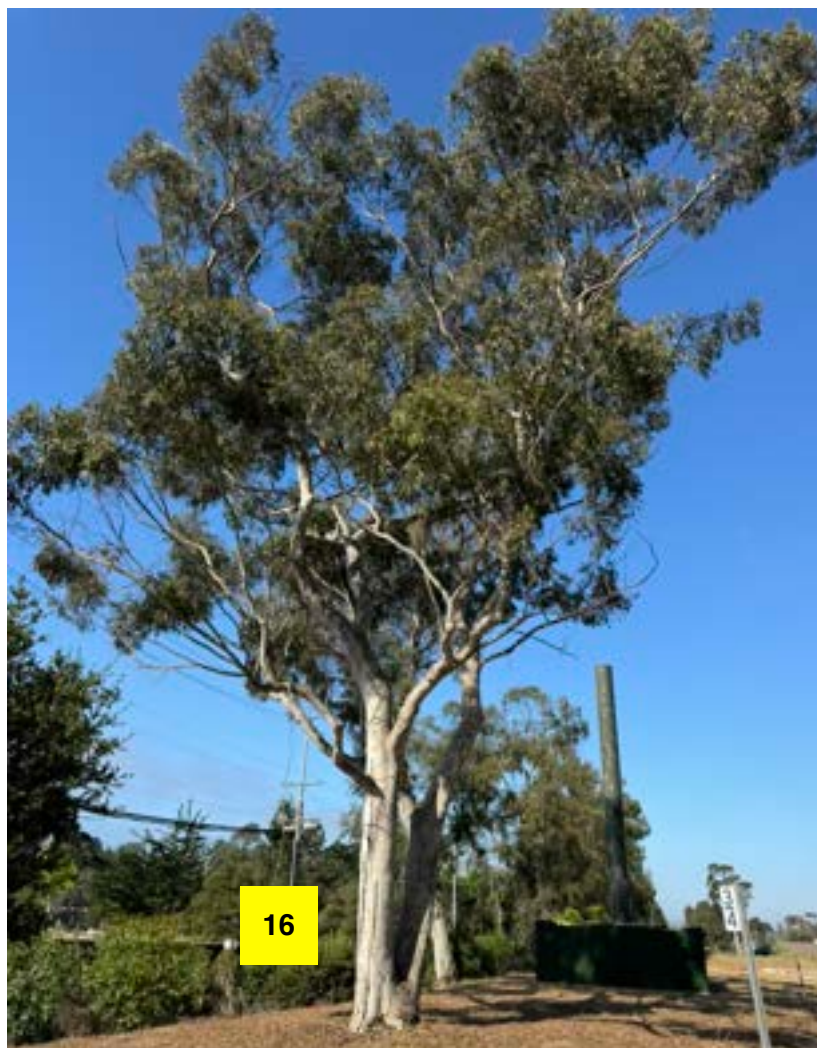
| # | Type | DBH " | CRZ r' | Height | Condition | Comment | Project Impact |
|---|---|---|---|---|---|---|---|
| 16 | Sugar gum euc | 36/ 33 | | L | G | Needs cleaning, lots of deadwood | Protect-outside of area |

Sugar Gum Eucalyptus #16 is east of the project area and can be retained and poses a low risk if properly pruned.

6. Prior to construction, prune trees to be retained. Remove the deadwood and lift low and heavy limbs where they may conflict with workers and construction.

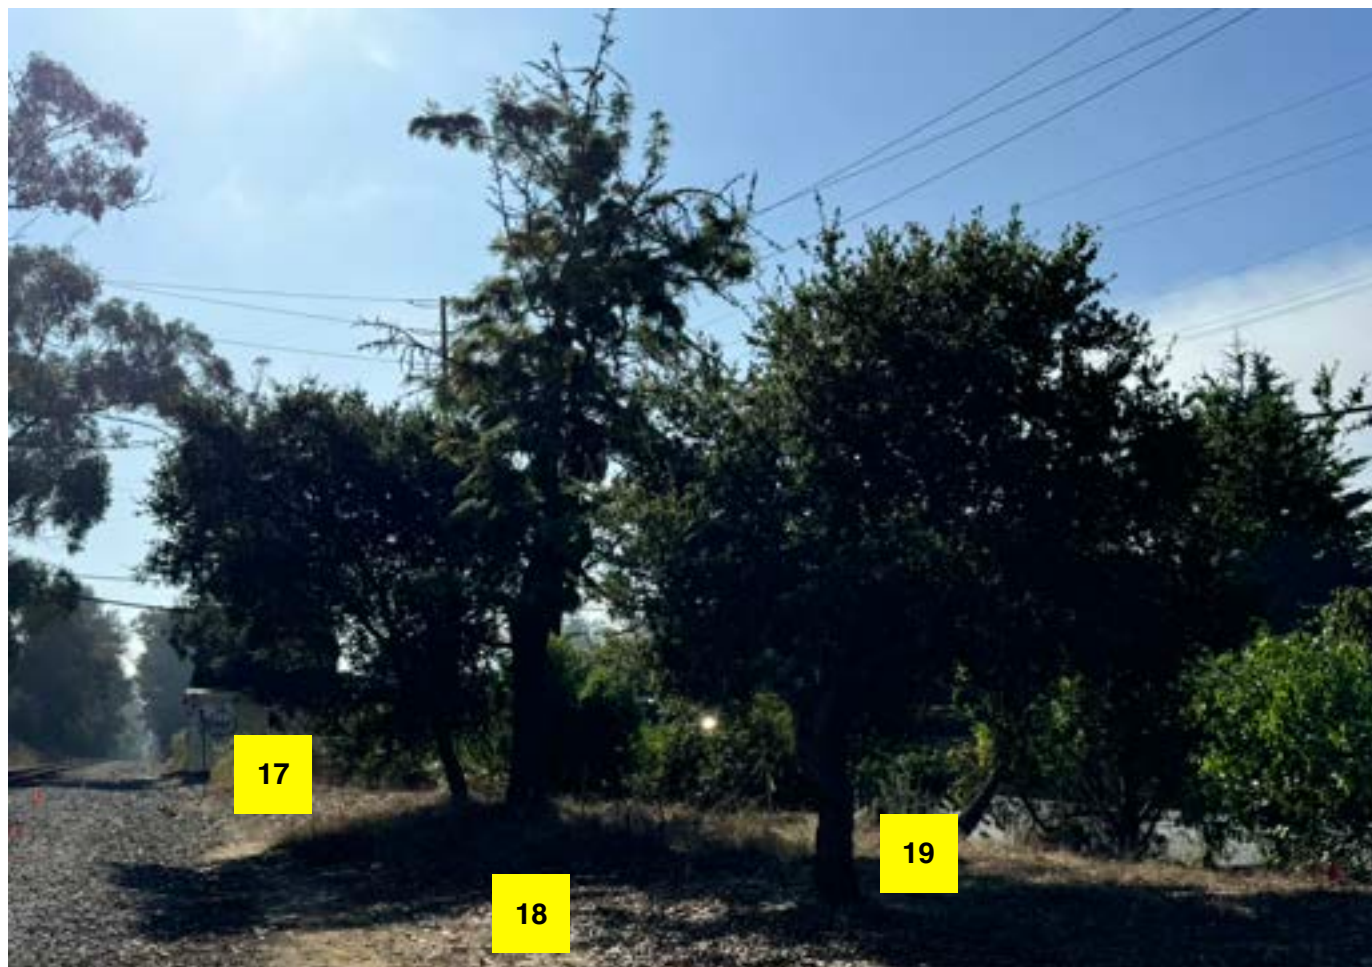
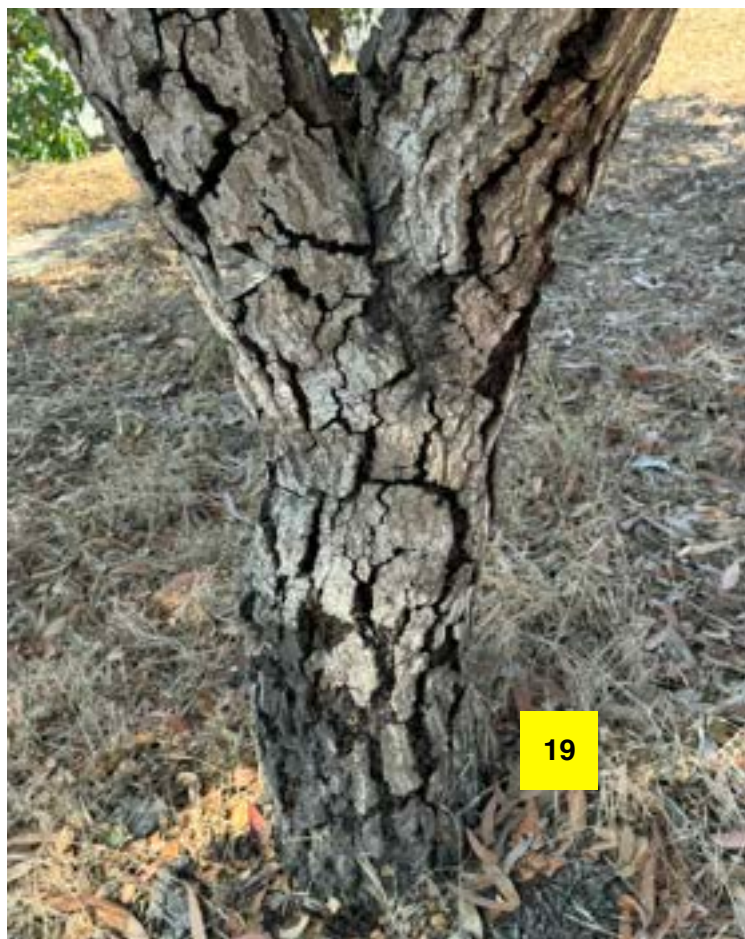
| # | Type | DBH " | CRZ r' | Height | Condition | Comment | Project Impact |
|---|---|---|---|---|---|---|---|
| 17 | Oak | 11 | 11 | S | P | Severe sycamore borer | Protect-outside of area |
| 18 | Silk oak | 20 | | M | P | Dying back | Remove |

Trees #17 - #19 are also east of the project area. #18 is a Silk Oak (non-native) and in poor condition. Oak #19 is infested with sycamore borer but can be retained and is likely to survive.

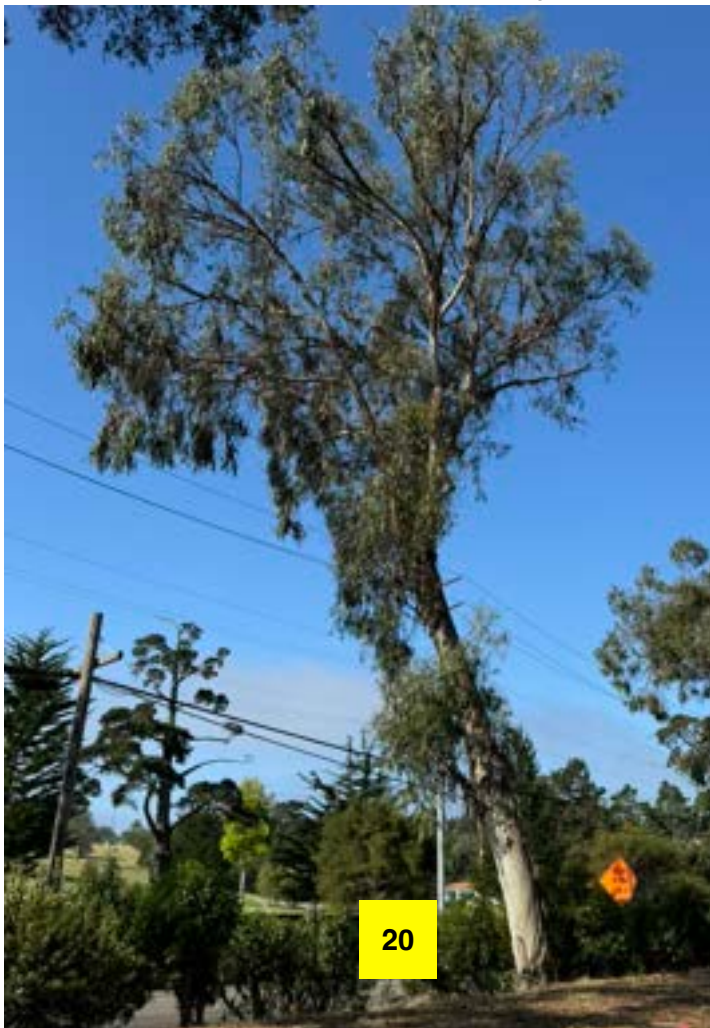
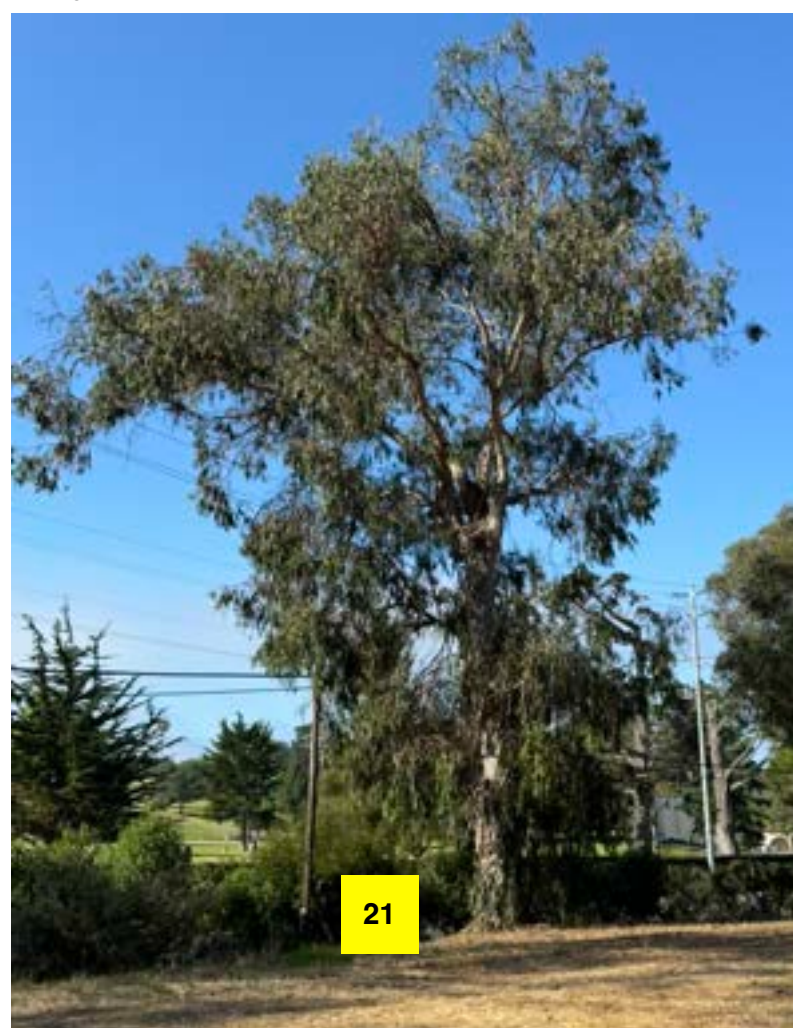
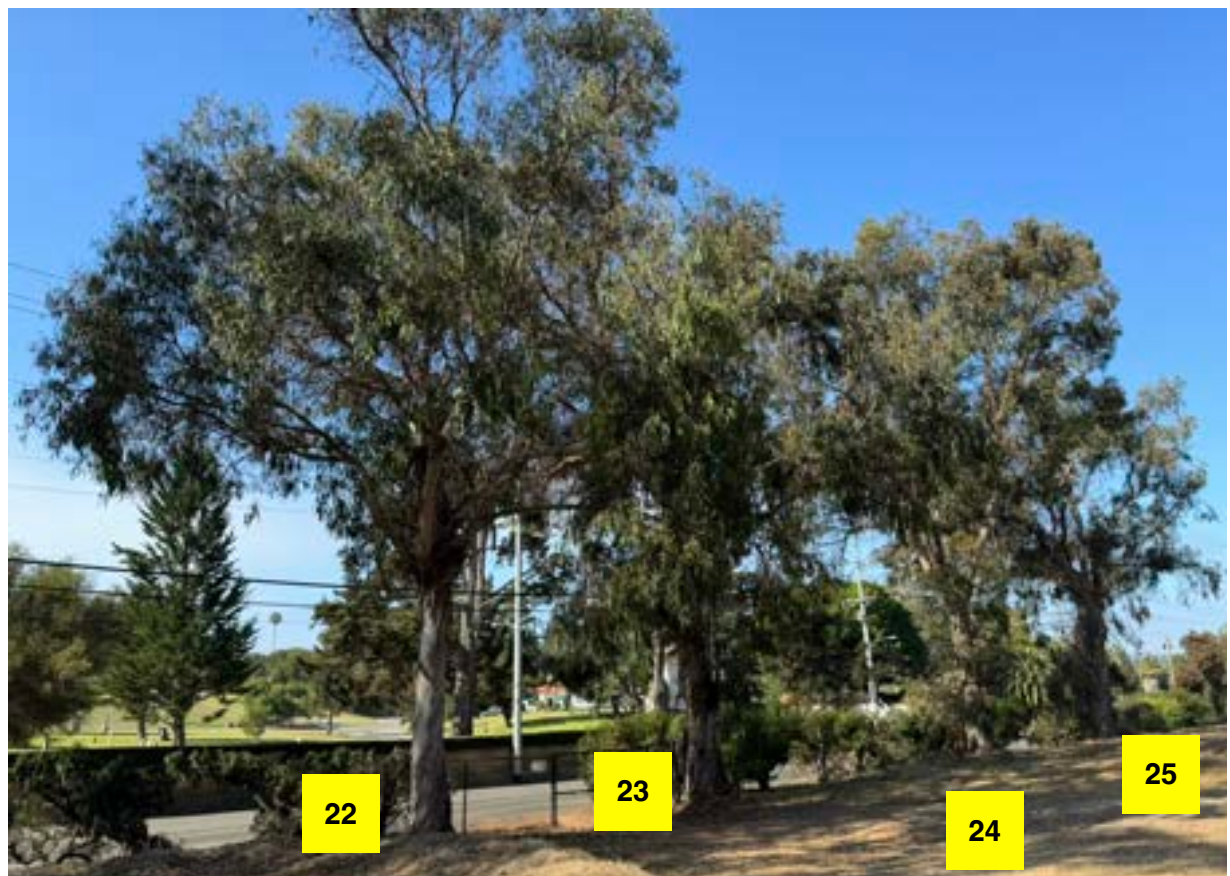
Six Blue Gum Eucalyptus along the project site that overhang Channel Drive and the proposed new residences. These are proposed to be removed.
