March 20, 2023

Landslide Hazard Evaluation  
Lloyd Cellars Wooden Valley  
APN 033-020-040  
Napa, California

Project Number: 7646.01.09.2

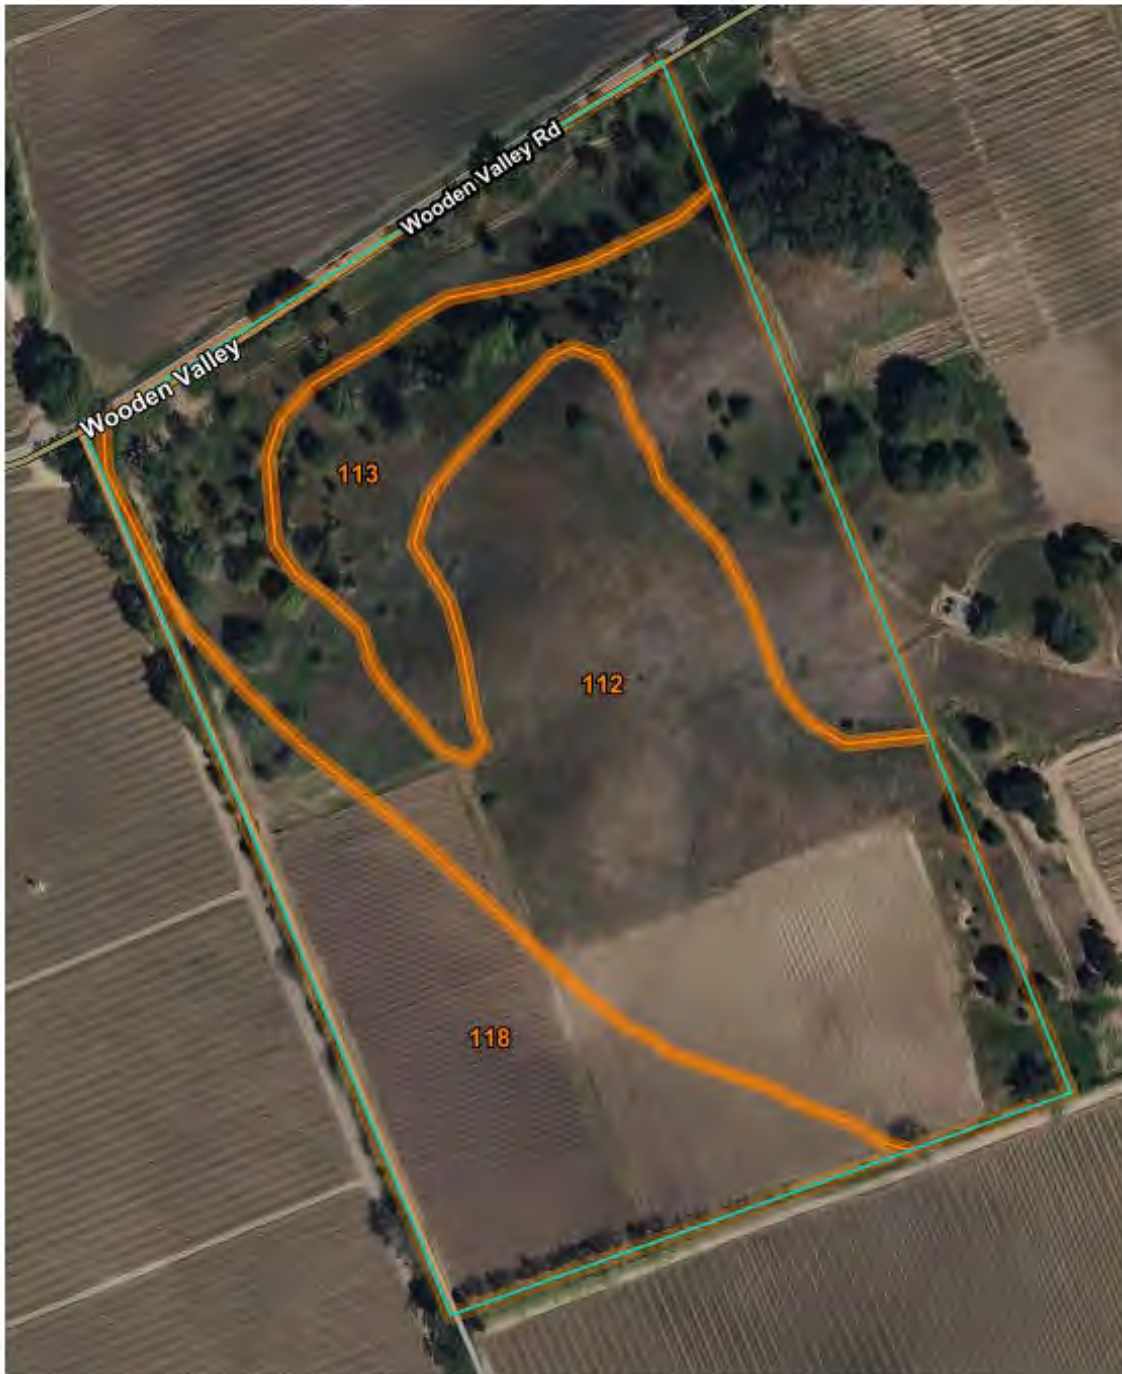
Based on our geologic review we compiled the image and table below indicating the soil types and depth of materials. This information was collected from the NRCS Web Soil Survey listed above.
