# Geotechnical Evaluation S-7 Sewer Lift Station Rehabilitation Long Beach Water Department Long Beach, California

July 15, 2022 | Project No. 211941001

**Ninyo & Moore**  
Geotechnical & Environmental Sciences Consultants

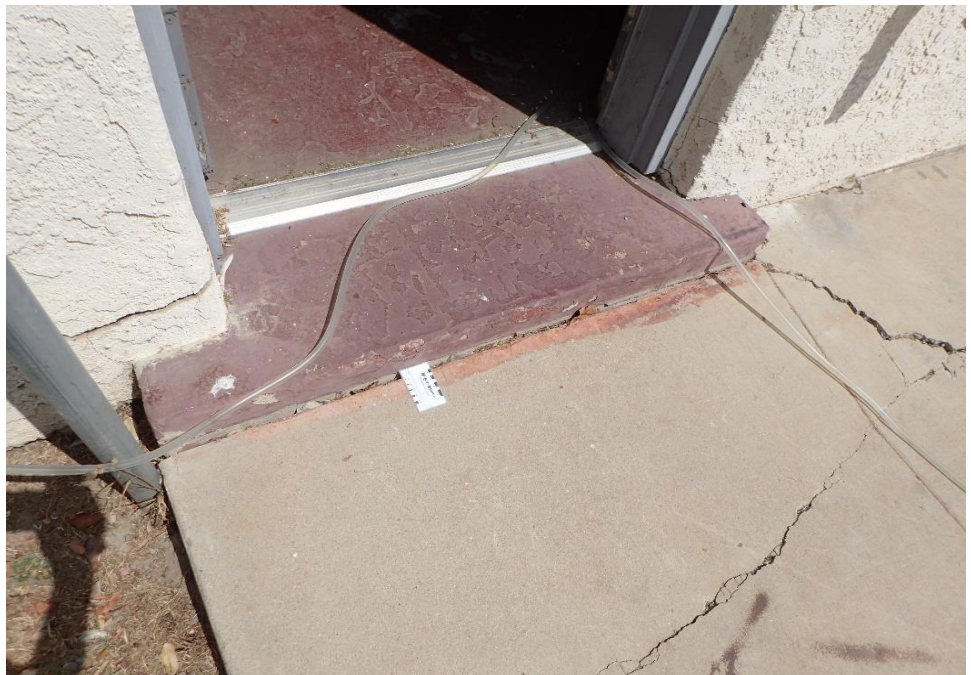
**Photograph 4:** Separation between the building entrance and the sidewalk.

Due to the cracking and settlement of the exterior sidewalk slab, we recommend that the existing sidewalk be removed, and the soil beneath be overexcavated and replaced with clean, non-expansive structural backfill. The subgrade and compacted fill should be prepared in accordance with the recommendations presented in the Earthwork section of this report.

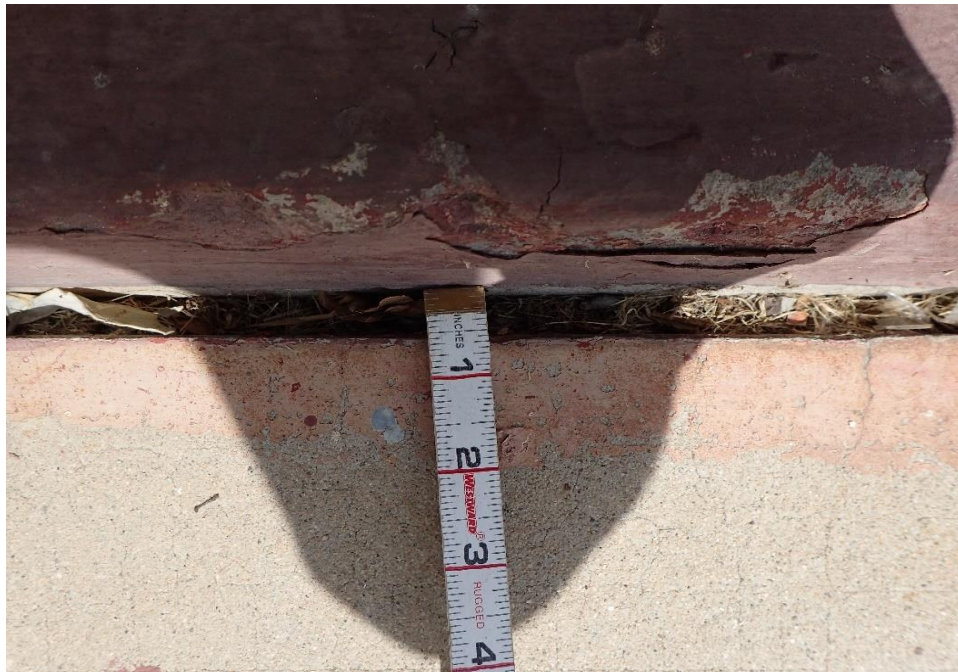
**Photograph 5:** Close up of 1/2-inch horizontal separation in photograph 4.

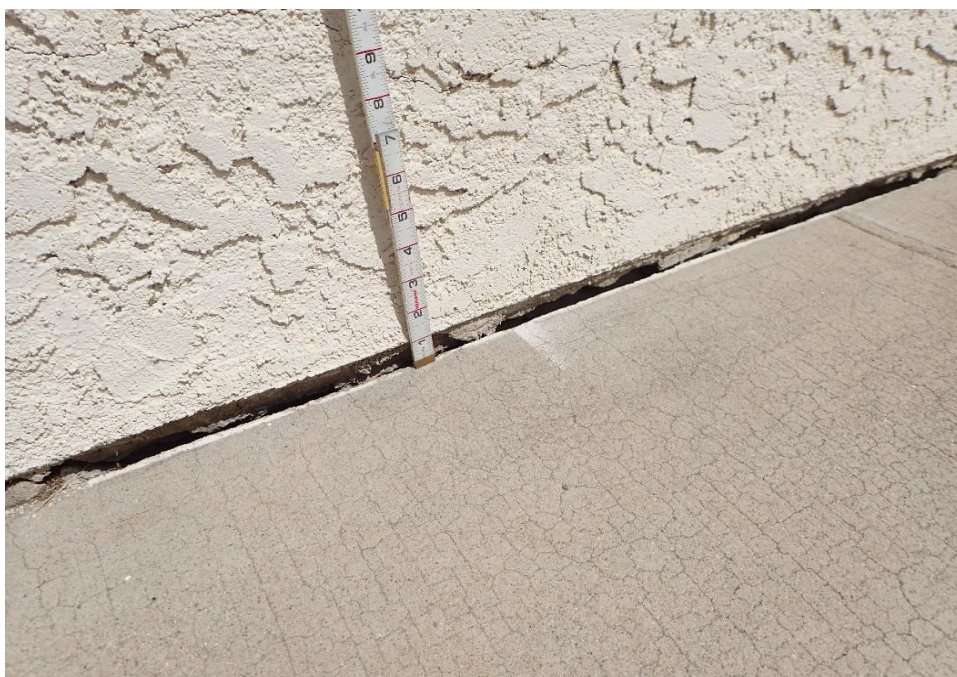
- We conclude that the settlement of the exterior sidewalk slab was caused by flooding of the site and poor drainage, poor subsurface soil conditions (very loose clayey sand and fat clay), and possible overwatering of the nearby landscaping.

**Photograph 6:** 1-inch vertical separation between the southeast side of the building and the sidewalk.

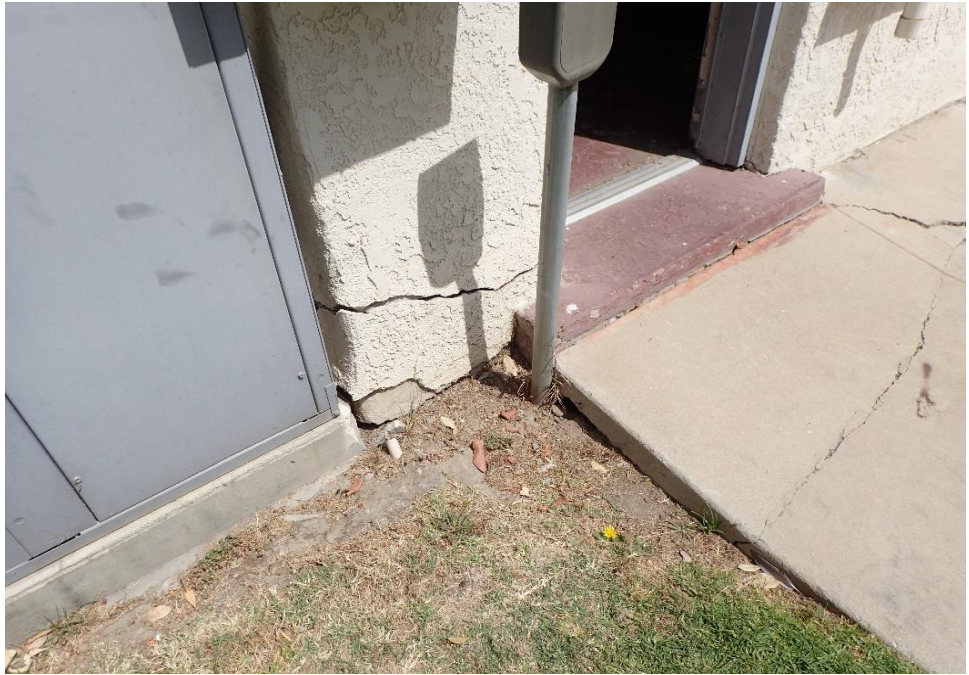
Based on our evaluation, we conclude that the settlement and cracks in the south side of the upper building were caused by long-term consolidation settlement of the soft to very stiff clay soils underlying the building footings. The caissons on the south side of the building, which have experienced the most settlement, extend to a depth of 13 feet and are supported on native fat clay. The north side of the building is supported on the lower level sump structure, which extends to a depth of approximately 25 feet into a sandy silt layer. Long-term differential settlement due to the different foundation structures could contribute to the cracks and settlement in the upper building. Our laboratory consolidation test results indicate that after almost 100 years since the construction of the lift station, most of the long-term consolidation settlement of the existing building has already taken place.

**Photograph 7:** A crack on the south corner of the building was noted, as well as a vertical separation between the sidewalk and the ground surface.

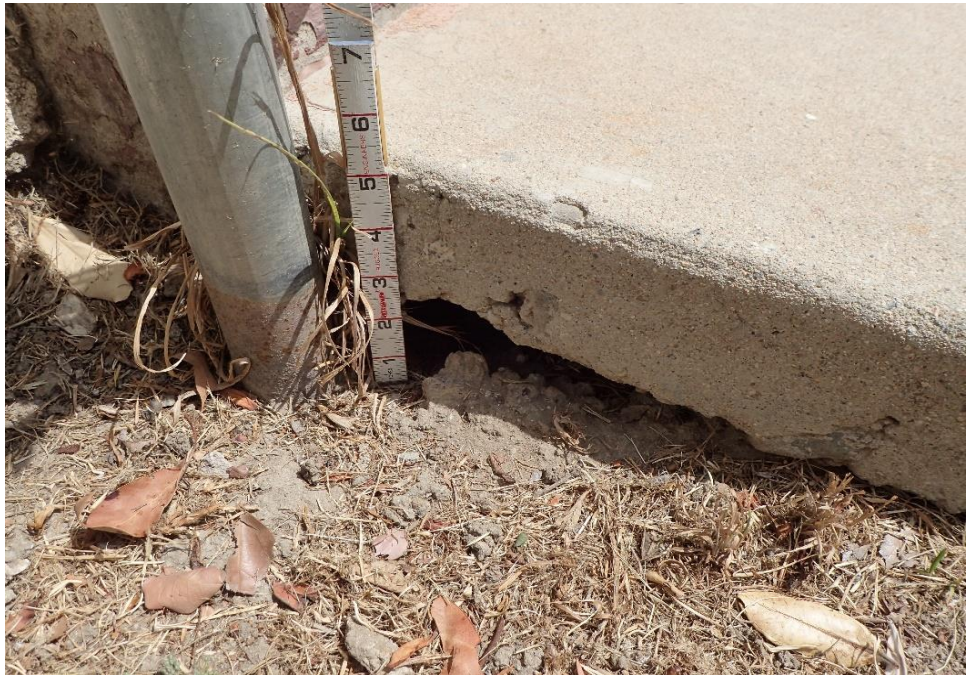
**Photograph 8:** Close up of 2½ inches of separation between sidewalk and ground surface in photograph 7.

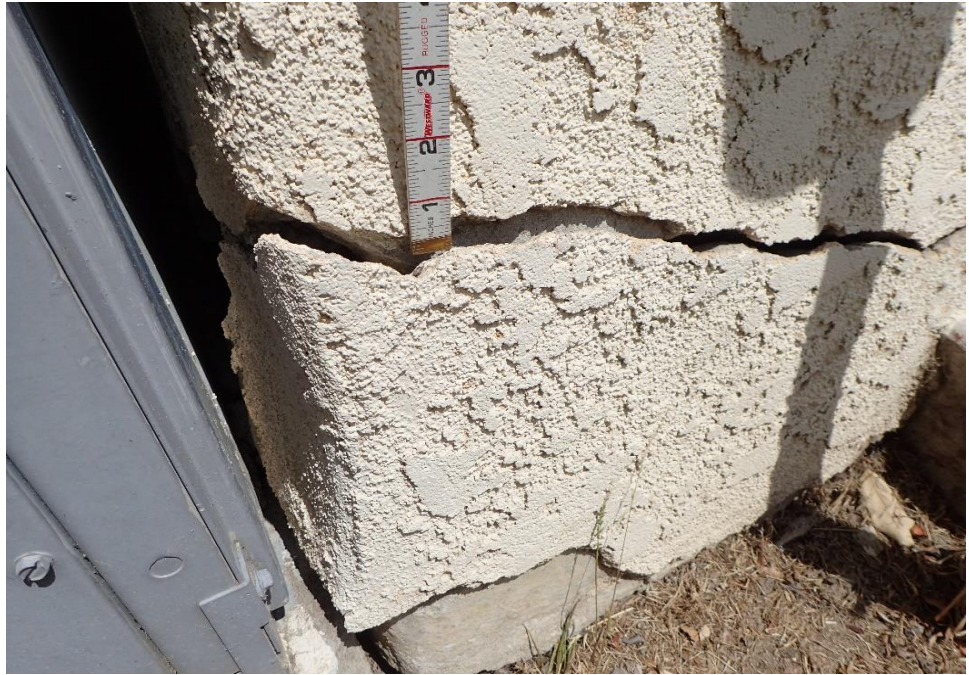
**Photograph 9:** Close up of ½-inch-wide crack on the south corner of the building in photograph 7.

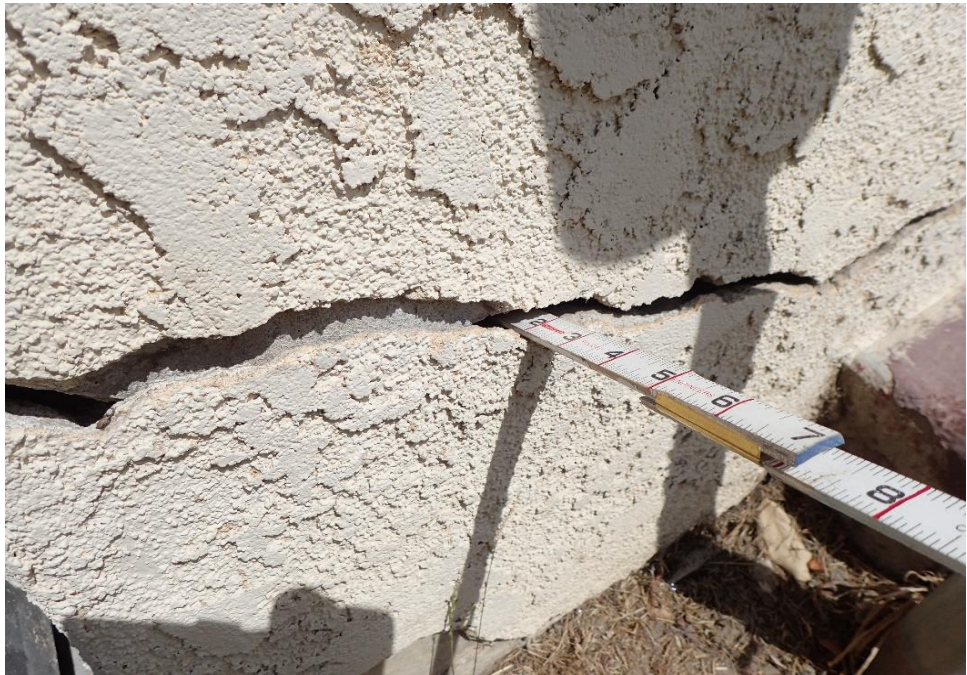
**Photograph 10:** Close up of 2-inch-deep crack on the south corner of the building in photograph 7.

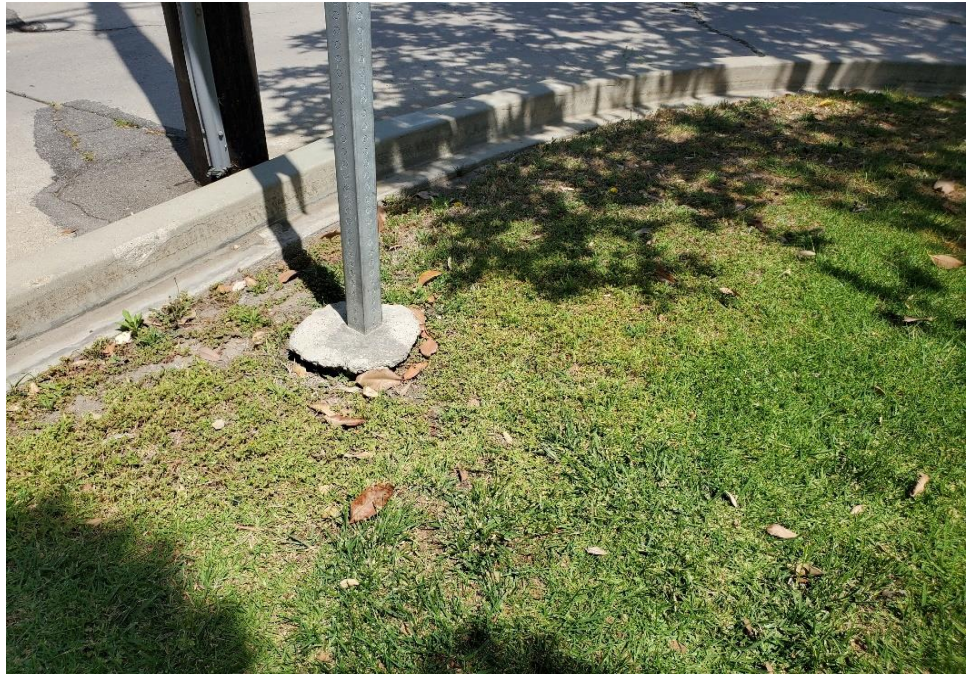
**Photograph 11:** Settlement of the ground surface around a street sign on the north corner of the property, looking north.

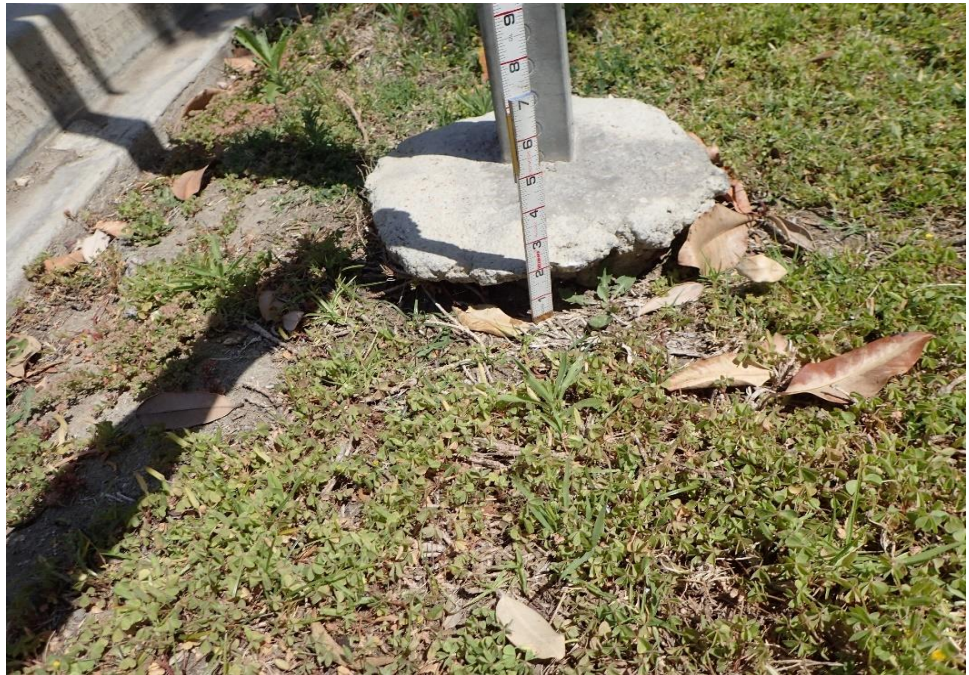
**Photograph 12:** Close up of 2 inches of settlement of the ground surface in photograph 11.

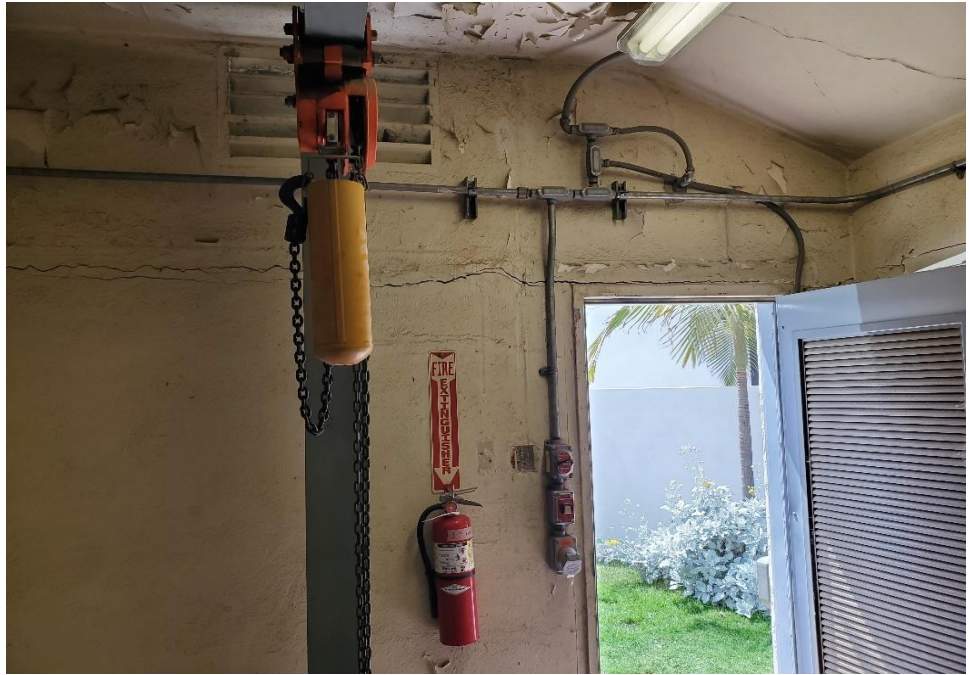
**Photograph 13:** Horizontal crack on the upper floor of the lift station, above the doorway on the southeast wall of the building, looking southeast.

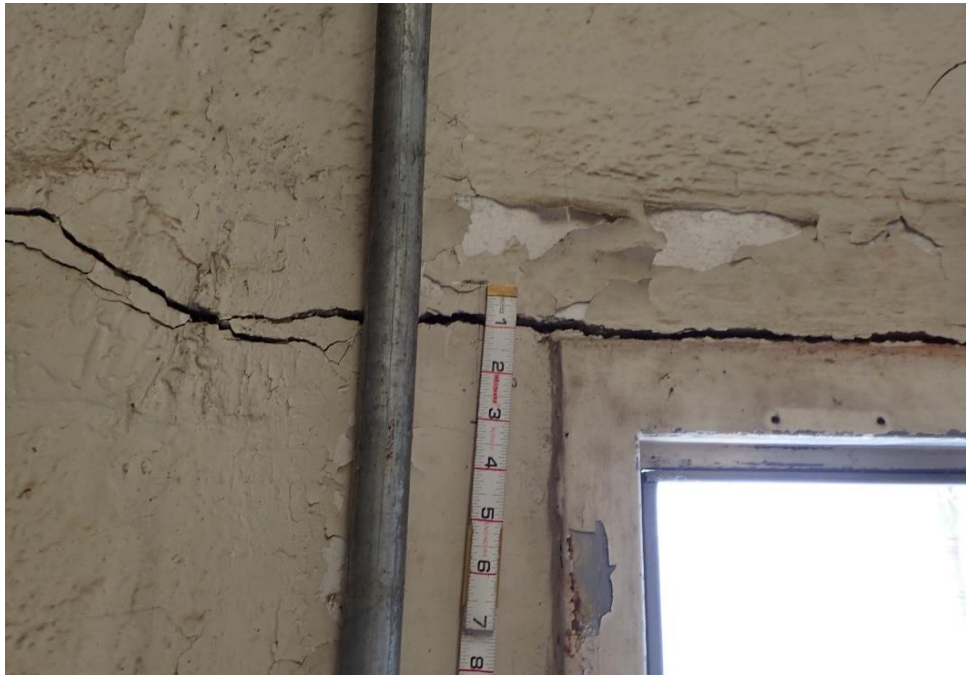
**Photograph 14:** Close up of 1/4-inch-wide crack in photograph 13, above the doorway on the southeast wall of the building.

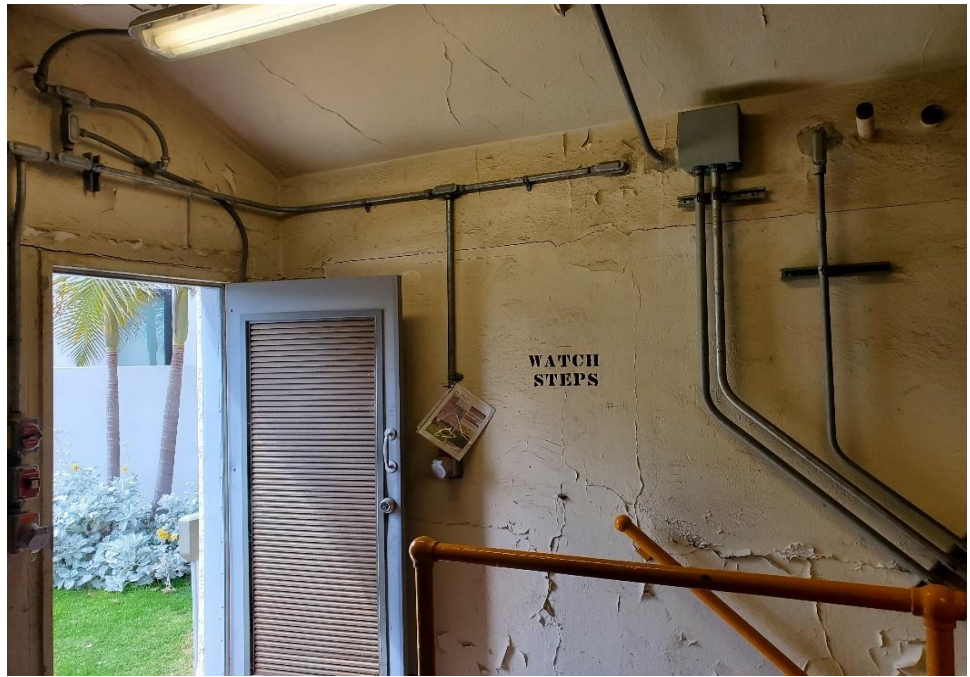
**Photograph 15:** Horizontal crack on the upper floor of the lift station, on the southwest wall of the building, looking south.

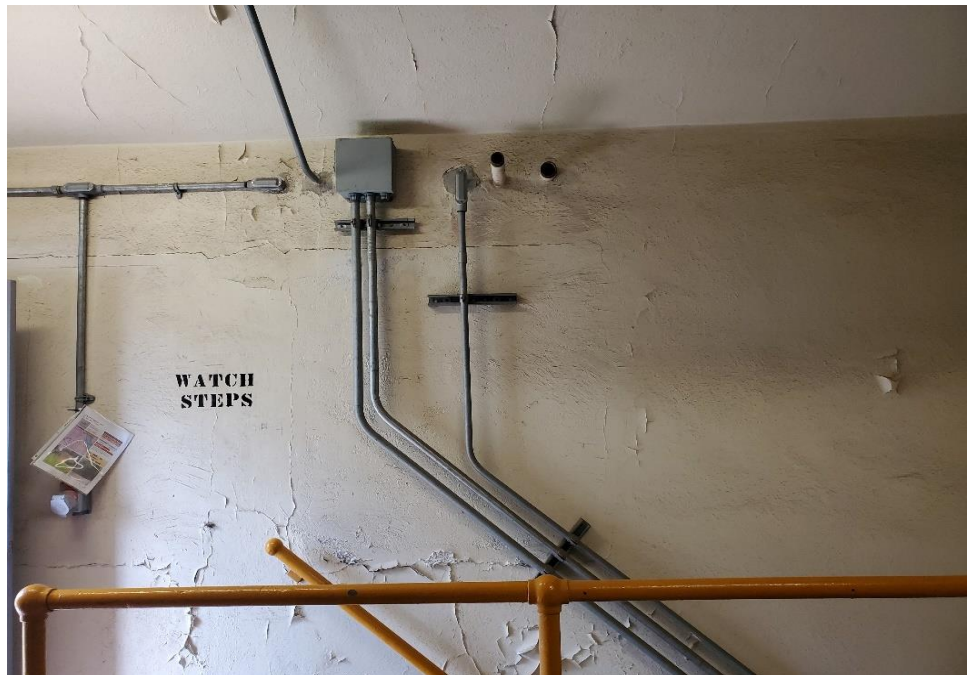
**Photograph 16:** Continuation of crack in photograph 15, on the southwest wall.
