**7400 CATHEDRAL OAKS ROAD**  
**GOLETA, CALIFORNIA**

## **PRELIMINARY GEOTECHNICAL REPORT**

July 14, 2025  
Revised July 31, 2025

**PROJECT NO.**  
8724.001.000

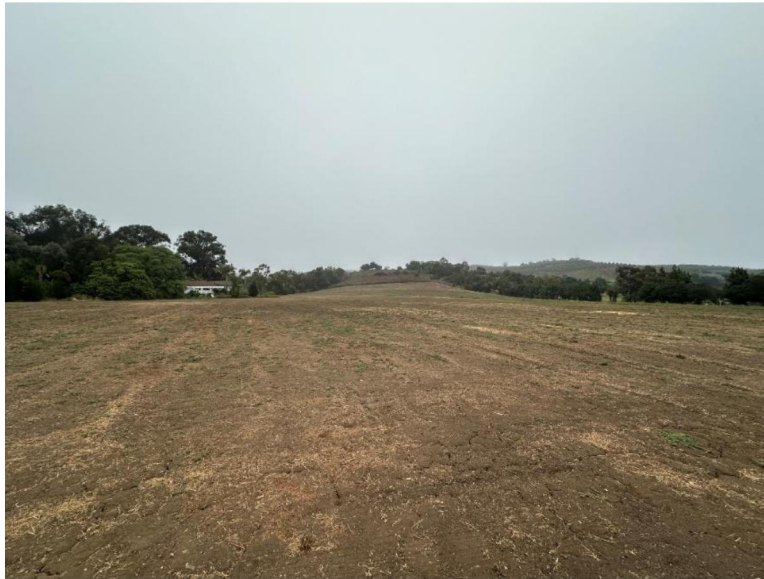
We performed a site visit on July 1, 2025, to observe the current conditions of the project site. The vegetation in the southern three-quarters of the project site has been mowed and mature trees were observed along the project boundary. The northern slope was covered with overgrown grasses, scrubs, and trees. Any trees related to the previous orchard appeared to have been removed. A wood chopping operation is present in the southeastern corner of the project site. We were not able to observe the current creek banks due to fencing and dense vegetation. We observed large desiccation cracks throughout the area up to about 2 to 3 inches in width and about 1½ feet deep.

**PHOTOGRAPH 2.3-1: Project Site Looking North**

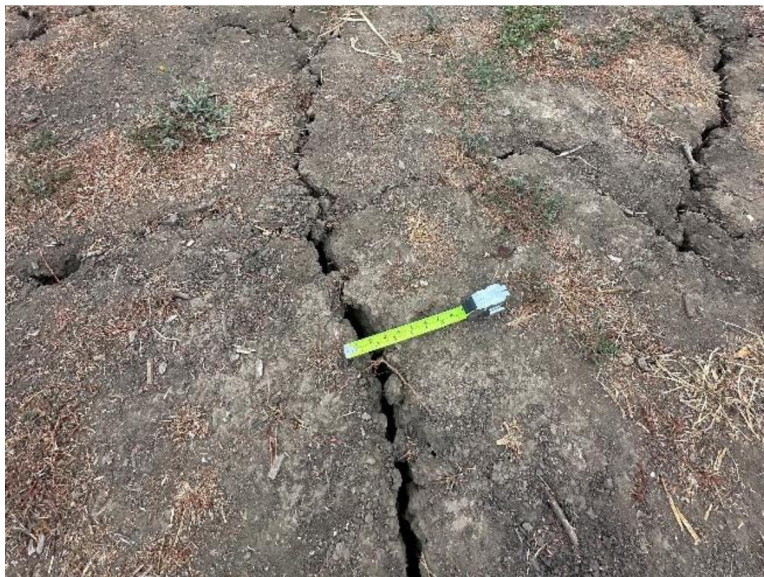
**PHOTOGRAPH 2.3-2: Example Desiccation Cracks**

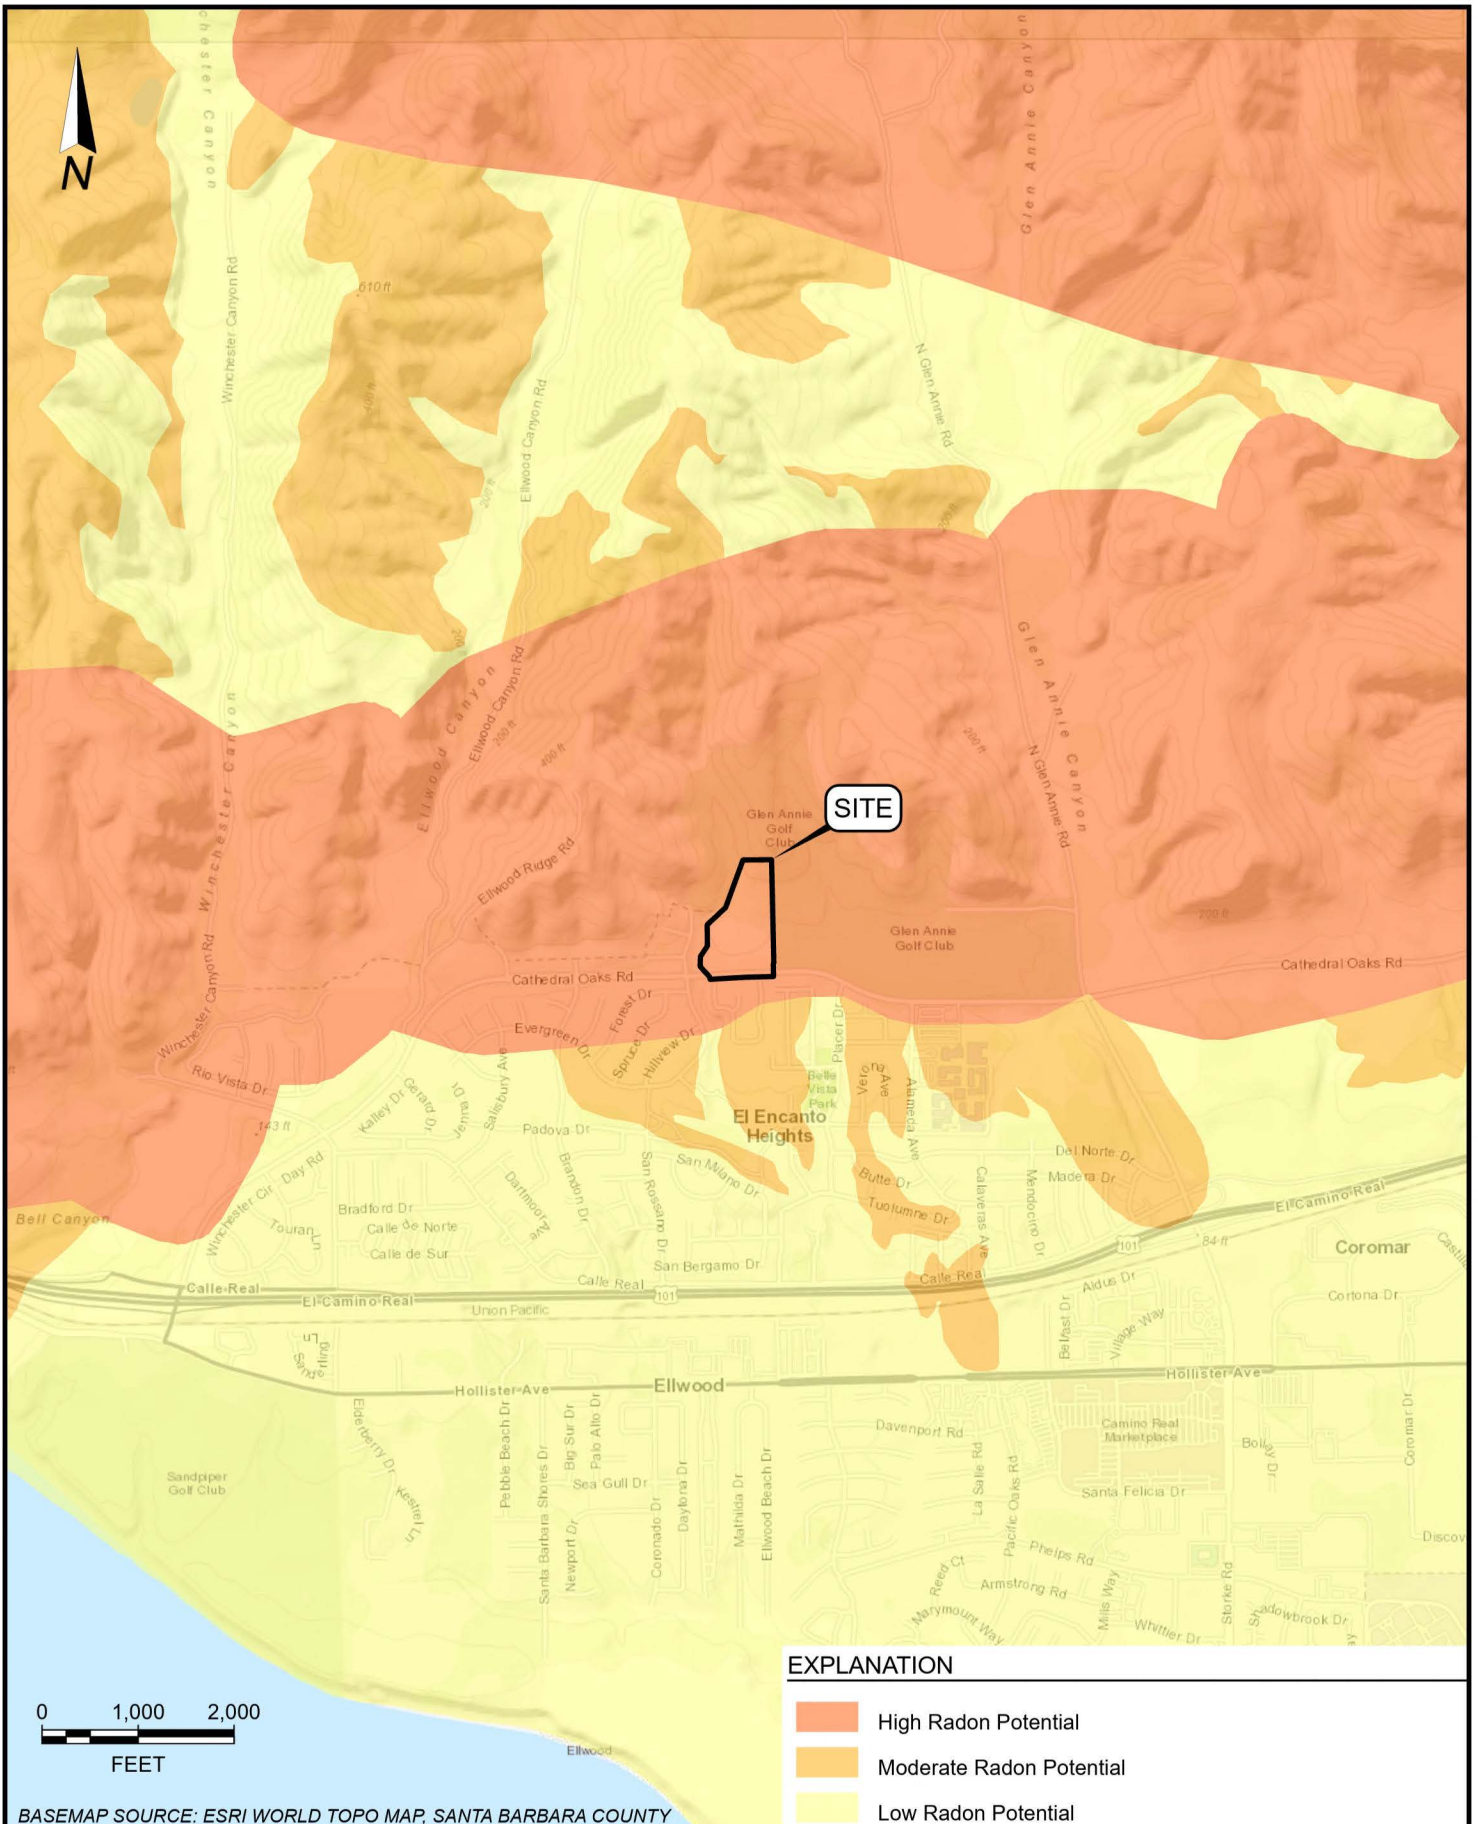
FIGURE NO.  
**9**

As shown in Figure 9, CGS has mapped in the project area within high risk for indoor Radon gas. Project planning should assume implementation of Radon collection systems and we recommend further consultation with an Environmental Engineer.

**INDOOR RADON POTENTIAL**  
7400 CATHEDRAL OAKS ROAD  
GOLETA, CALIFORNIA
