UPDATE TO GEOTECHNICAL INVESTIGATION AND SLOPE STABILITY ANALYSIS FOR BEYER BOULEVARD

**SOUTHWEST VILLAGE
VESTING TENTATIVE MAP
SAN DIEGO, CALIFORNIA**

**TRI POINTE HOMES
SAN DIEGO, CALIFORNIA**

**FEBRUARY 16, 2022
PROJECT NO. 06847-42-05**

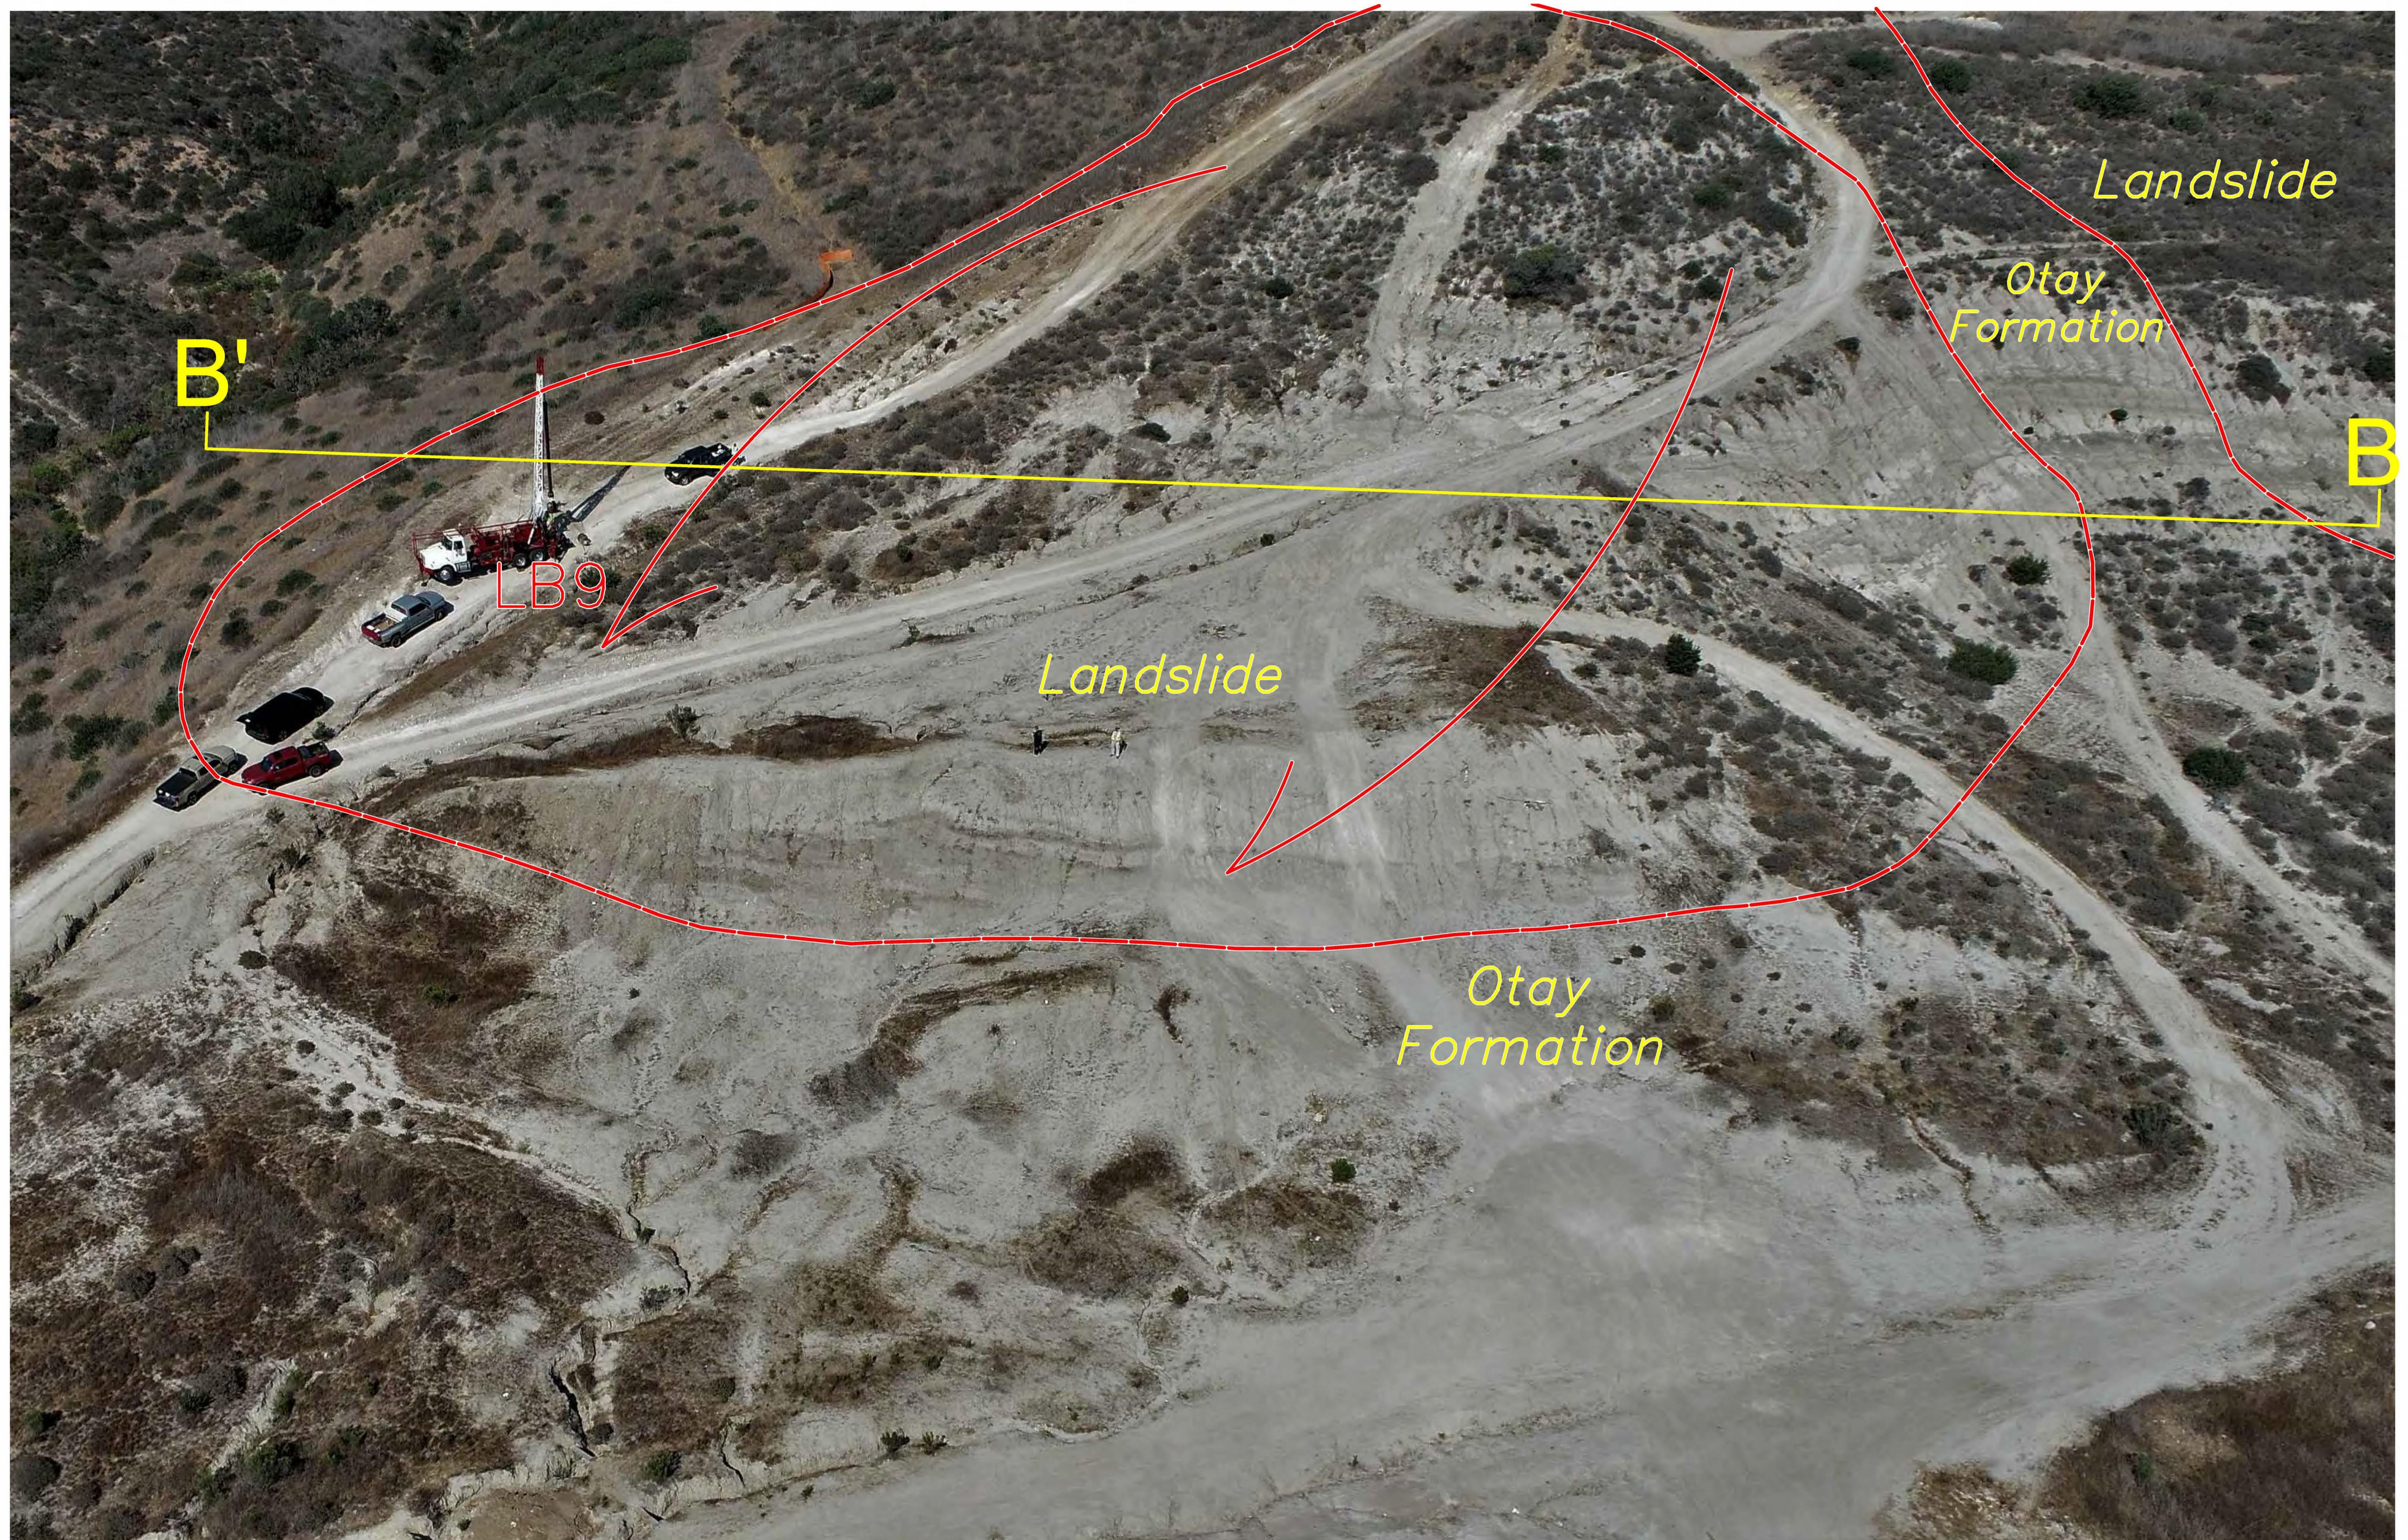
LANDSLIDE EXPOSED IN BORROW SITE CUT
BEYER BOULEVARD EXTENSION
SOUTH OTAY MESA
SAN DIEGO, CALIFORNIA

The geologic units encountered during our investigation were Landslide Debris, Very Old Paralic Deposits and the Otay Formation. A discussion of these units is contained in our March 2019 report. Information from our previous studies was considered during our current investigation, however, the additional subsurface data enabled refinement and in some cases reinterpretation of the geologic conditions. A revised geologic interpretation along the proposed roadway alignment is presented on the Geologic Map and Cross Sections (Figures 1 through 9). Figures 10 through 12 present photographs of the landslide and adjacent bedrock area in the vicinity of proposed Beyer Boulevard Station 15 through 20. The relationship between the geologic units is exposed in an excavation that was made during grading of a presumed “borrow site”.
