APPENDIX F1:  
DUE DILIGENCE REPORT

| <b>Type of Services</b> | <b>Due Diligence Report - Geotechnical Feasibility</b> |
| <b>Project Name</b> | <b>Notre Dame de Namur University</b> |
| <b>Date</b> | <b>February 26, 2021</b> |

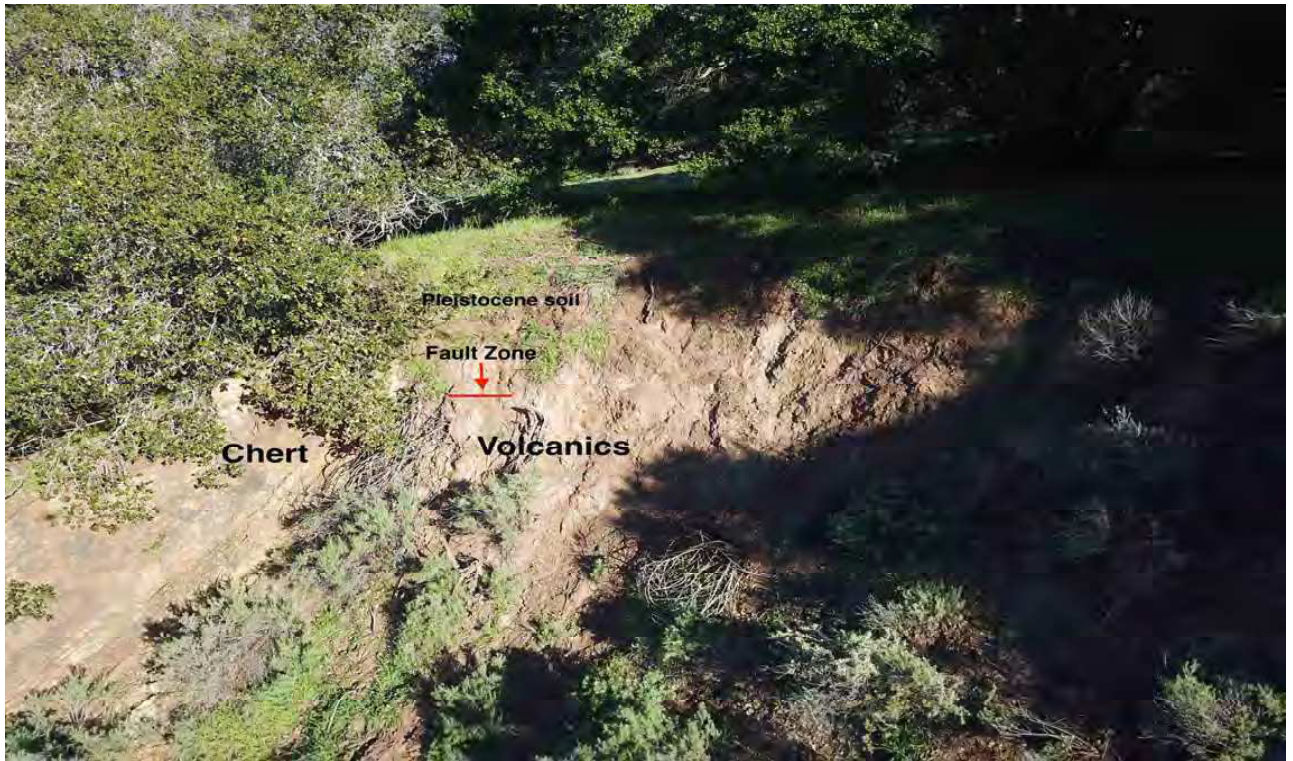
Looking north at the northern cut for the parking lot. Chert bedrock is on the left and Volcanic rocks (tuff) is on the right. The fault is in the center.

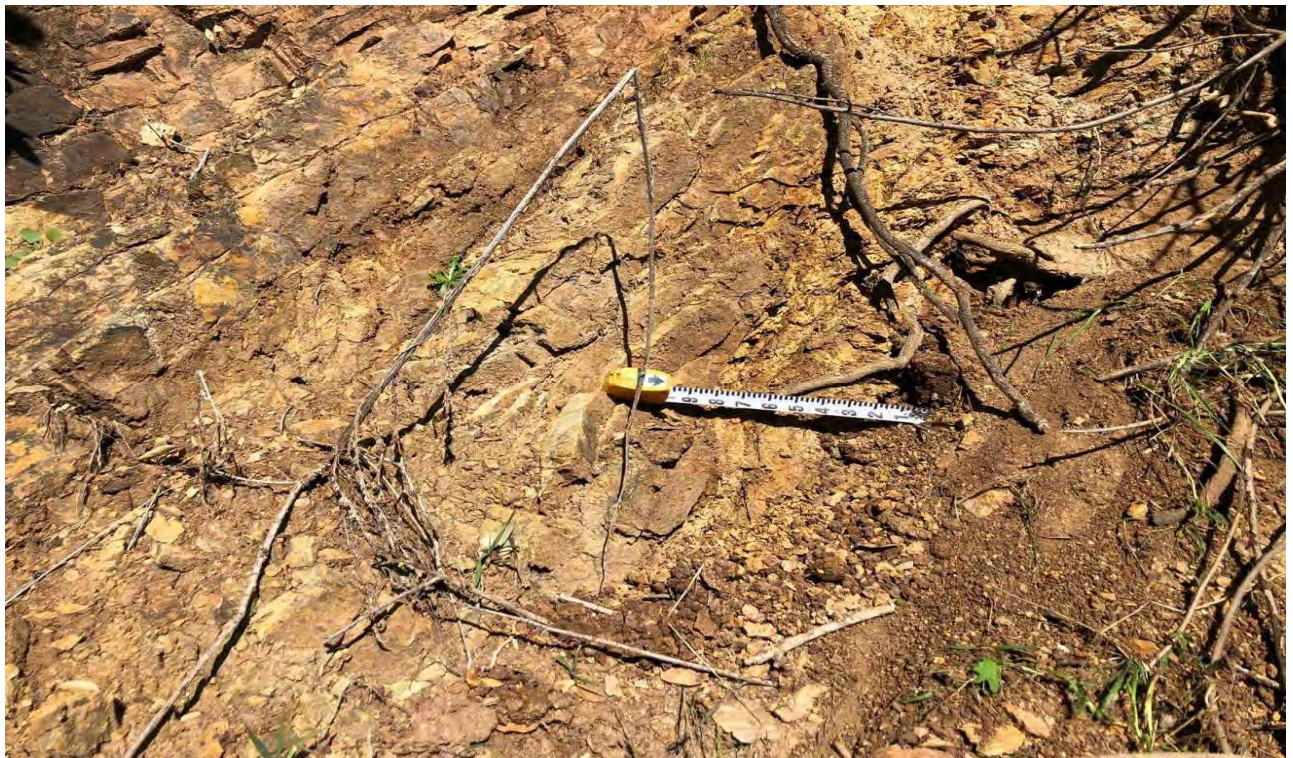
Closeup of shear zone. Chert is the on left and sheared volcanic rock is in the center (shearing is spanned by the measuring tape).

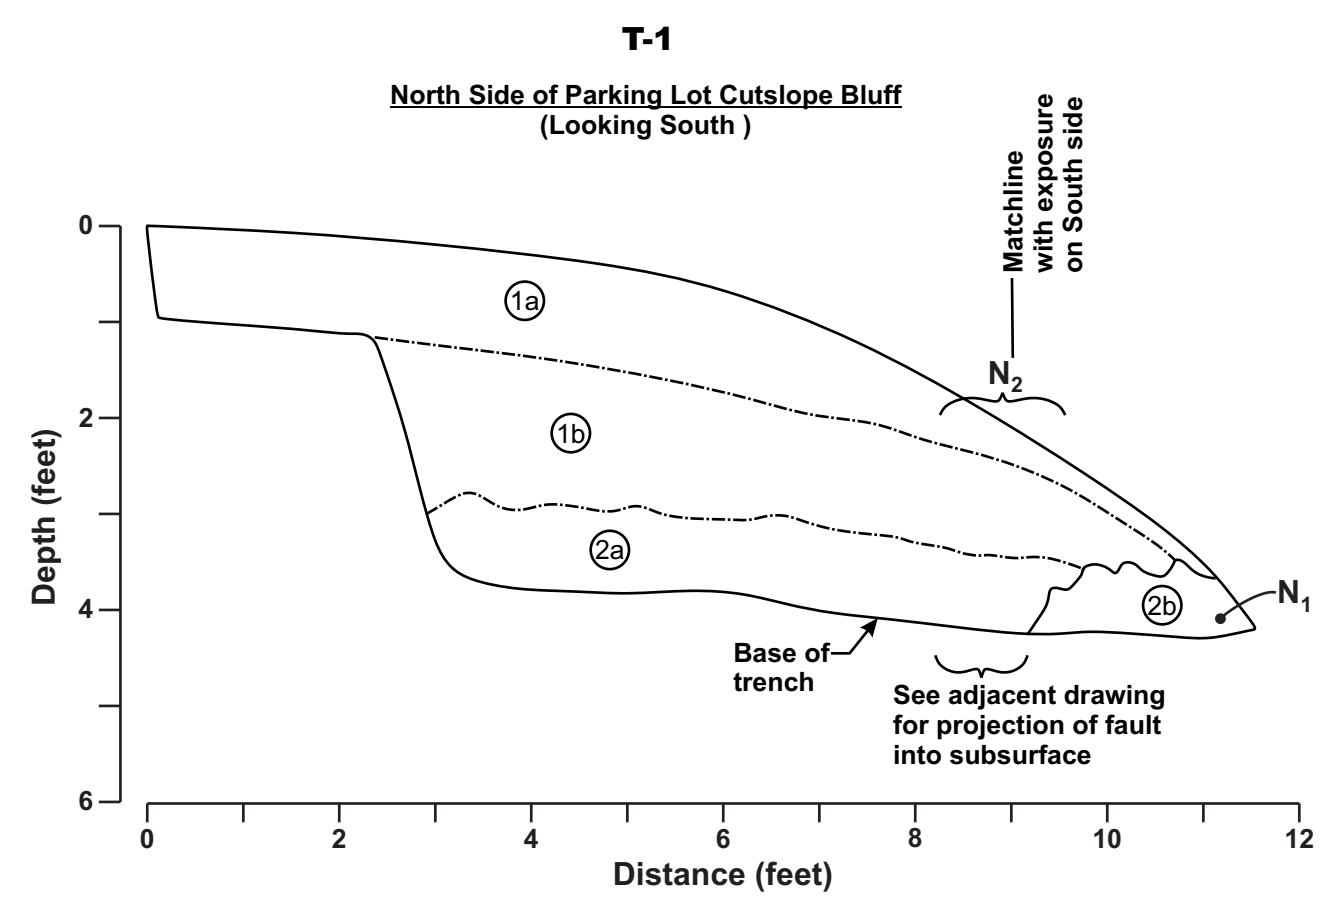
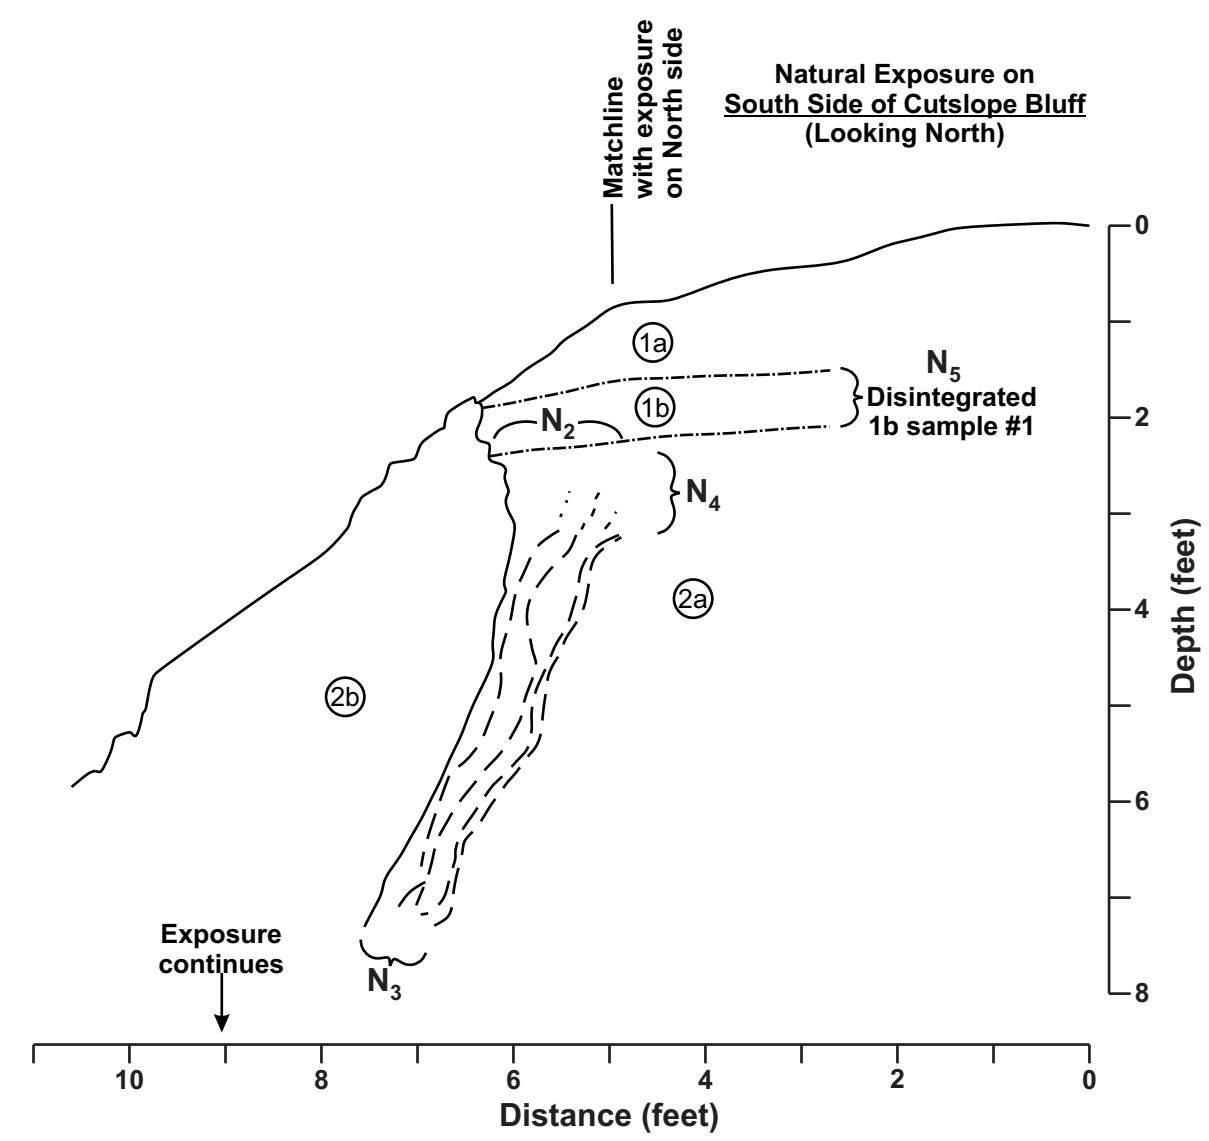
- N<sub>1</sub> = N33°W/58°SW: thin bedding in chert.
- N<sub>2</sub> = no truncation, offset or warping of unit 1b across 2a/2b contact.
- N<sub>3</sub> = sheered fabric within 2a adjacent to contact with 2b. Pre-Quaternary fault zone.
- N<sub>4</sub> = sheering at 2a/2b contact does not extend up into this upper portion of 2b.
- N<sub>5</sub> = bulk sample collected for potential radio carbon age date analysis.
