San Mateo County Department of Public Work							
555 County Center, 5th F	Floor, Redwood City, CA 94063 Phone: (650) 363-4100 Fax: (650) 361-8220						
Filing of Notice of Exemption in Compliance with Section 21152(b) of the Public Resources Code (CALIFORNIA ENVIRONMENTAL QUALITY ACT). The fiting of this Notice begins a 35-day Statue of Limitations on court challenges to this approval.	For Clerk Use Only FILED ENDORSED IN THE OFFICE OF THE COUNTY CLERK RECORDER SAN MATED COUNTY CALIF						
Project Name:	FEB 06 2024						
obitos Creek Culvert- Ernergency Debris Ianagement	MARK CHURCH, County Clerk By						
Project Location:							
obitos Creek, Half Moon Bay, CA. Site located on Ve Creek, 0.3 miles from Highway 1.	rde Rd at Lobitos Project Number: RM010 Responsible Unit: Roads						
Description of Project:							
mailer woody debris accumulated at the double box c ebris was obstructing and deflecting streamflow, caus ulvert wingwalls from further scour. Also, if immediate ebris accumulation could create additional flooding co roject activities occurred in the following sequence: b	iological survey, best management practice (BMP) implementation, equipment staging, and small woody

L

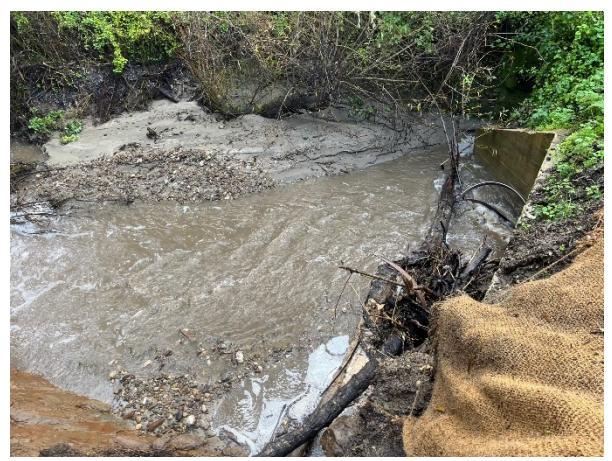
Photo 1. Lobitos Creek, facing southeast wingwall (1/23/2024).

At the Project site, the County owns and maintains a double box culvert that passes Lobitos Creek below Verde Road. Due to the recent rains, two logs and smaller woody debris have accumulated at the double box culvert inlet. The debris is completely obstructing one box and the other box is at half capacity. This debris is currently obstructing and deflecting streamflow, causing erosion and scouring at the culvert wingwall. The purpose of this emergency work is to protect the culvert wingwalls from further scour. Also, if immediate work is not performed prior to the additional forecasted heavy rainfall and high streamflow, additional debris accumulation could create additional flooding concerns and cause further scour at the culvert inlet.

Project activities would occur in the following sequence: biological survey, best management practice (BMP) implementation, equipment staging, and small woody debris removal. Standard sediment and erosion control BMPs will be on-hand to control any unanticipated increases in turbidity. Turbidity will be actively monitored during construction. For the duration of the Project, materials and equipment will be positioned on the paved roadway and shoulder. Operation of heavy equipment and vehicles will be limited to the roadway. Equipment used to complete the debris management will include a Gradall or Bobtail. Equipment access to the creek channel will not be required. A chain or wench will be attached to the equipment and will be used to clean pluck accumulated debris from the culvert inlet (above OHW and non-USACE regulated). The accumulated debris is not of significant size or diameter to be beneficial as large wood debris and habitat structures. A biologist will be on site to monitor all work. Dewatering will not be performed. The work is expected to take 1 day to complete.
