April 9, 2025

Project 08874.00001.001

**Subject: Arborist Survey for the Willowgrove Project, City of Davis, Yolo County, California**

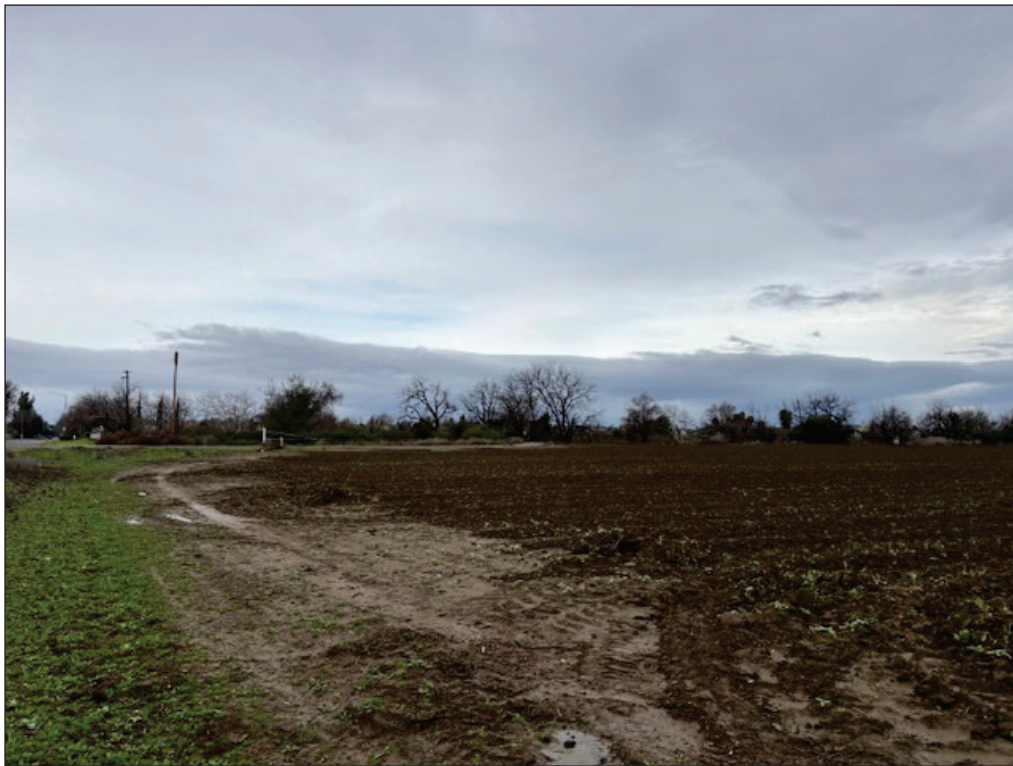
View of the site from the southern border of the study area facing west. Date: 2/3/2025. Photographer: Dena Elimelech

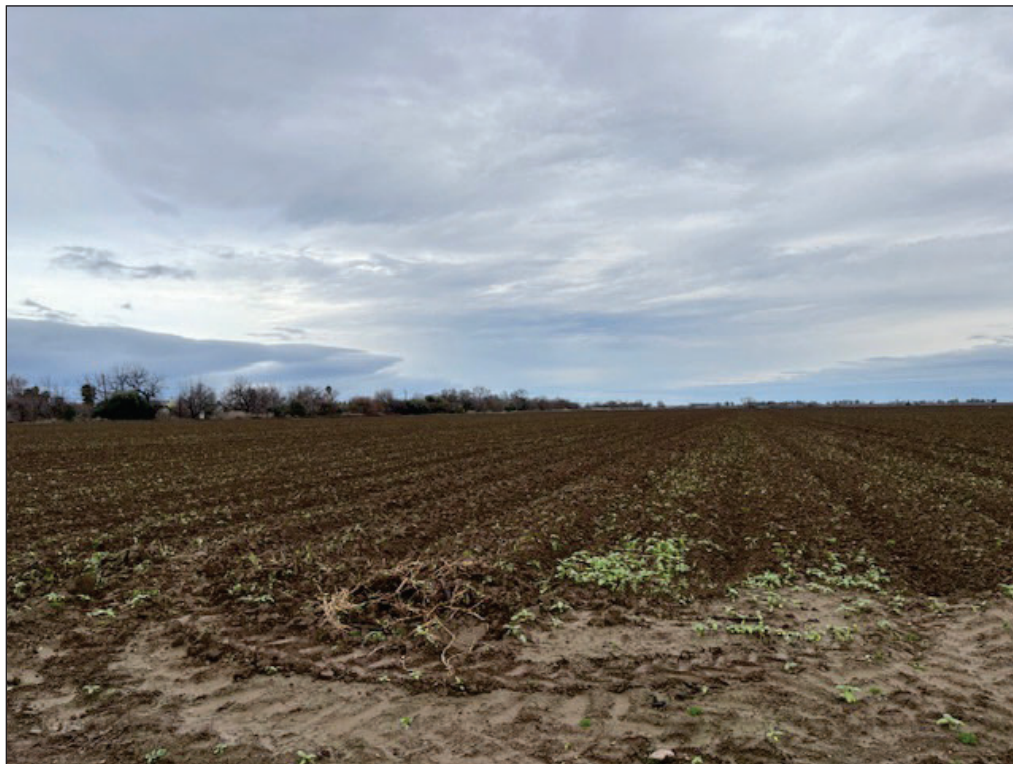
Representative image of the study area from the southern border, facing north. Date: 2/3/2025. Photographer: Dena Elimelech

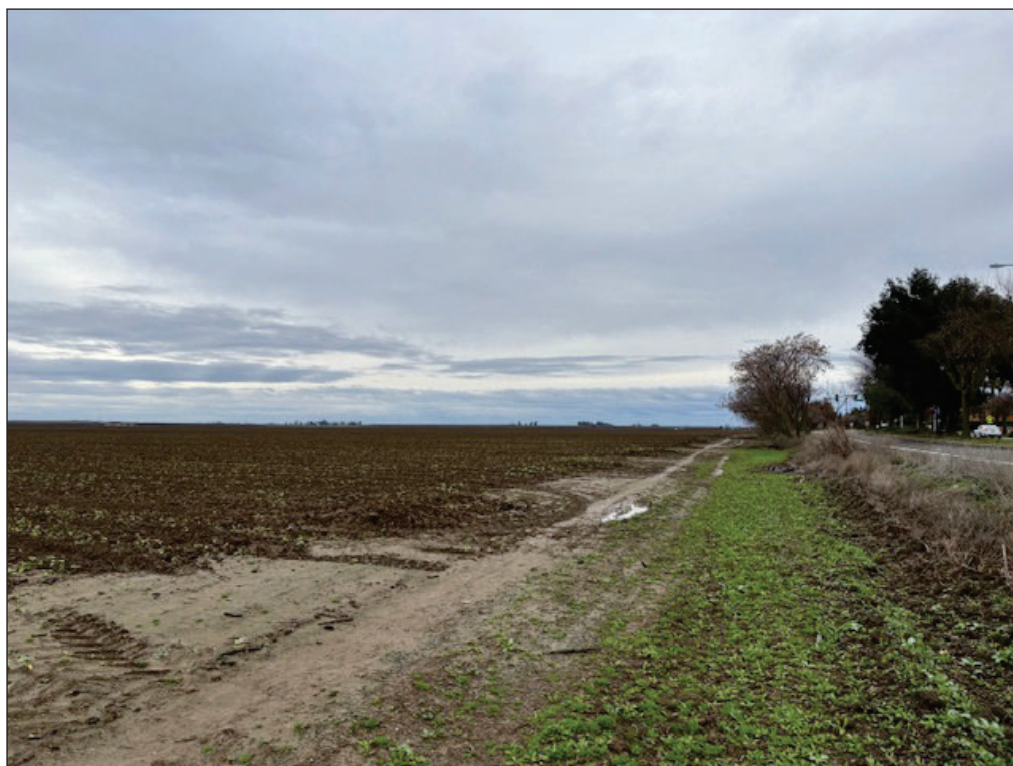
View of the southern border of the study area, including East Covell Blvd, facing east. Date: 2/3/2025. Photographer: Dena Elimelech

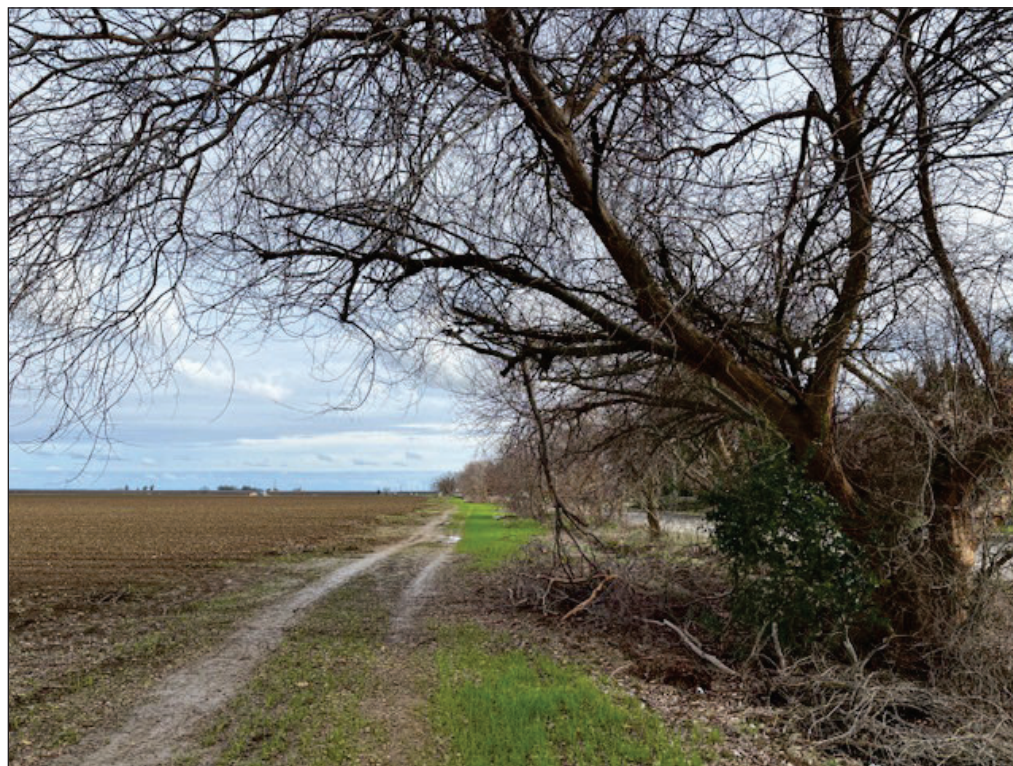
Image of tree number 127, Chinese elm, on the southern border of the study area. Date: 2/3/2025. Photographer: Dena Elimelech

| 127 | Chinese elm<br>( <i>Ulmus parvifolia</i> ) | 5 | 19.2, 18.6, 11.5, 7, 6 | 62.3 | 25 | 40 | Fair | Fair-Poor | Pruning cuts, multistem, dead branches, epicormic growth, poor soil, some CODIT, decent canopy. |

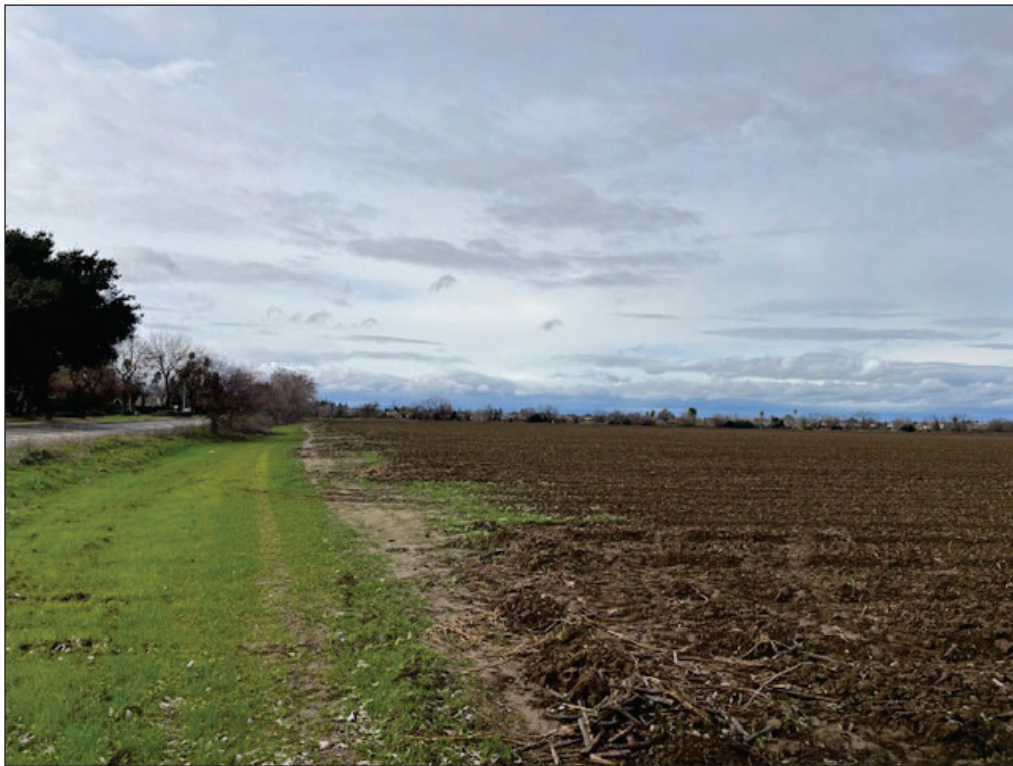
Representative image of the southern border of the study area, facing west.  
Date: 2/3/2025. Photographer: Dena Elimelech

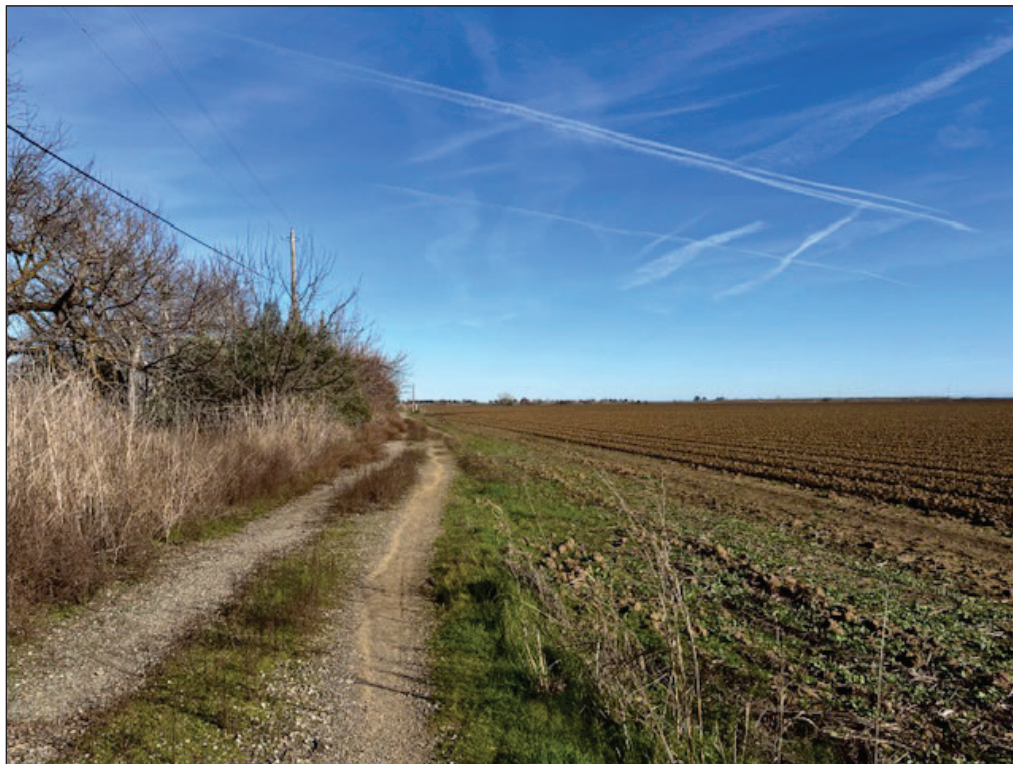
Representative image of the western border of the study area facing north.  
Date: 2/10/2025. Photographer: Dena Elimelech

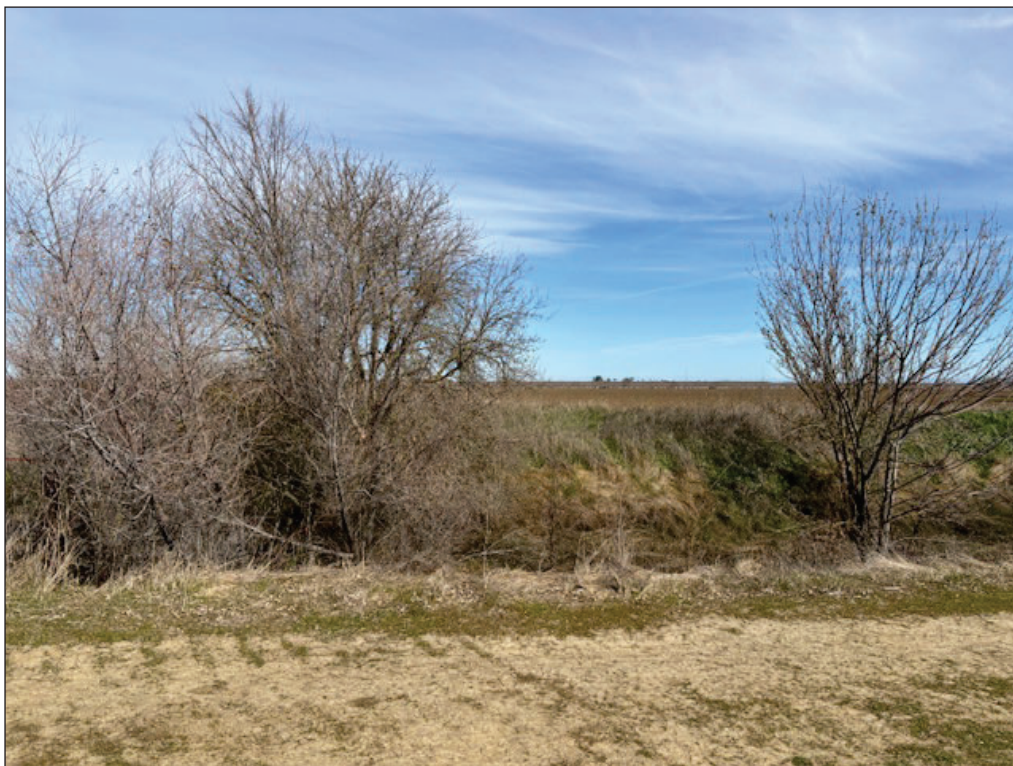
Representative image of the drainage in the northern area of the study area, on the southern side, facing north. Date: 2/10/2025. Photographer: Dena Elimelech

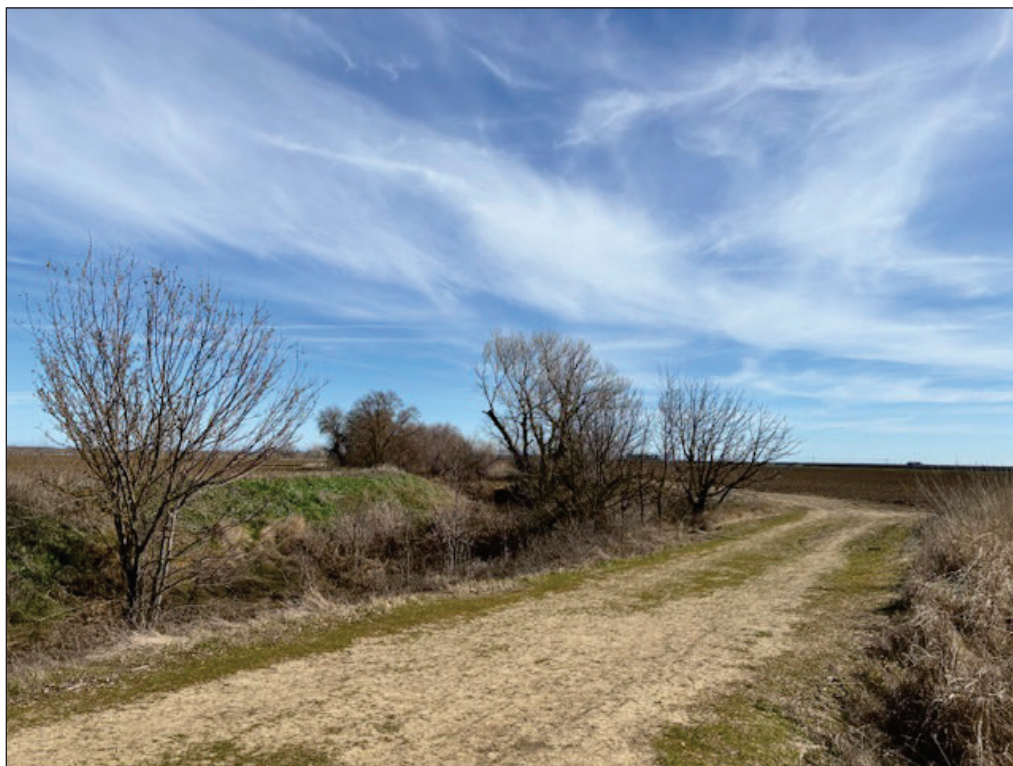
Image of the drainage from the southern side, facing east. Date: 2/10/2025. Photographer: Dena Elimelech

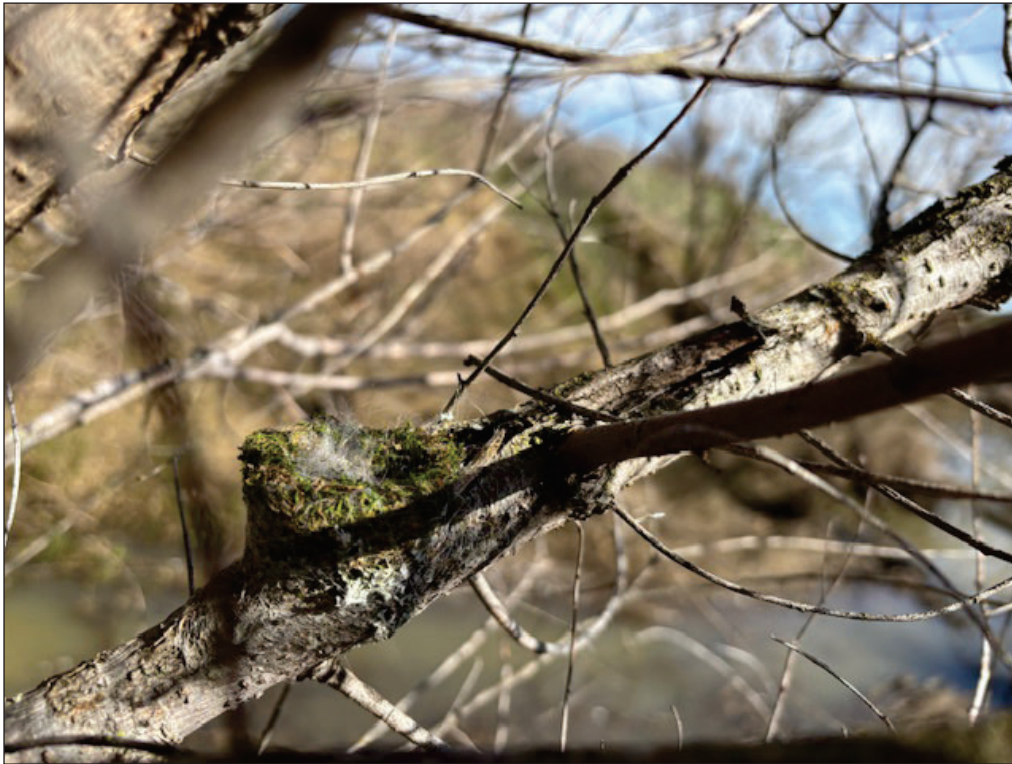
Anna's hummingbird nest in tree number 162, a willow tree, within the drainage. Date: 2/10/2025. Photographer: Dena Elimelech

| 162 | Willow ( <i>Salix sp.</i> ) | 4 | 6.1, 4.2, 4, 3 | 17.3 | 12 | 20 | Fair | Fair-Poor | Broken branches, in drainage, epicormic, Anna's hummingbird nest on low branch. |

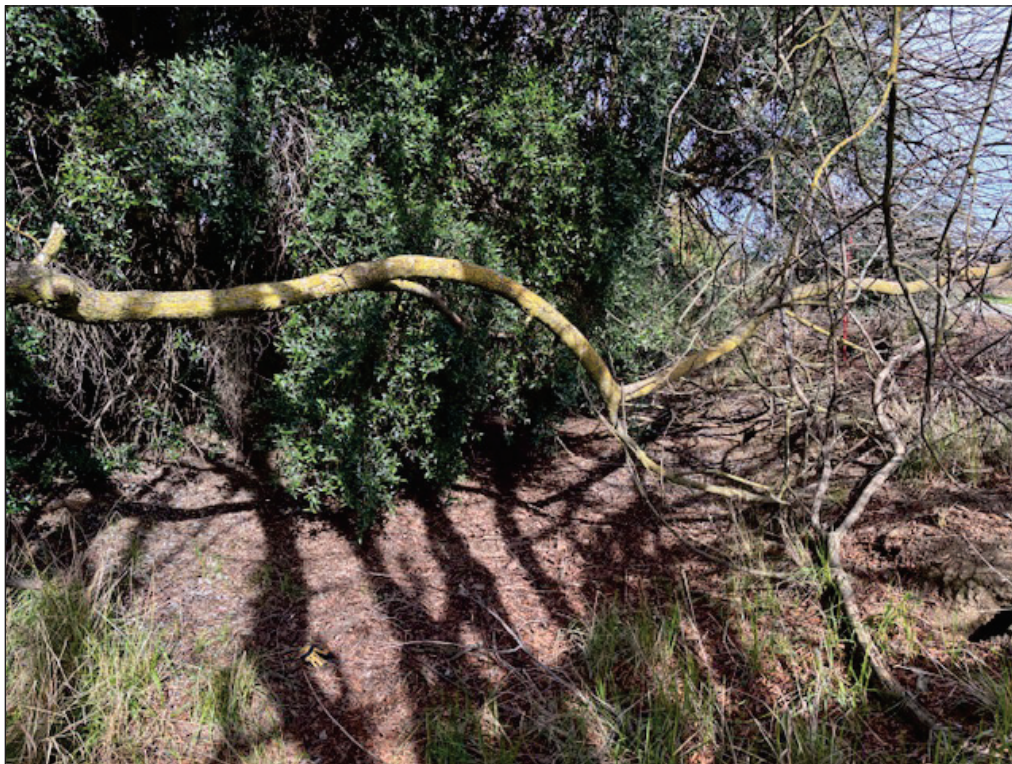
Image of long-eared owl roost adjacent to tree number 40, black walnut. Date: 2/12/2025. Photographer: Dena Elimelech

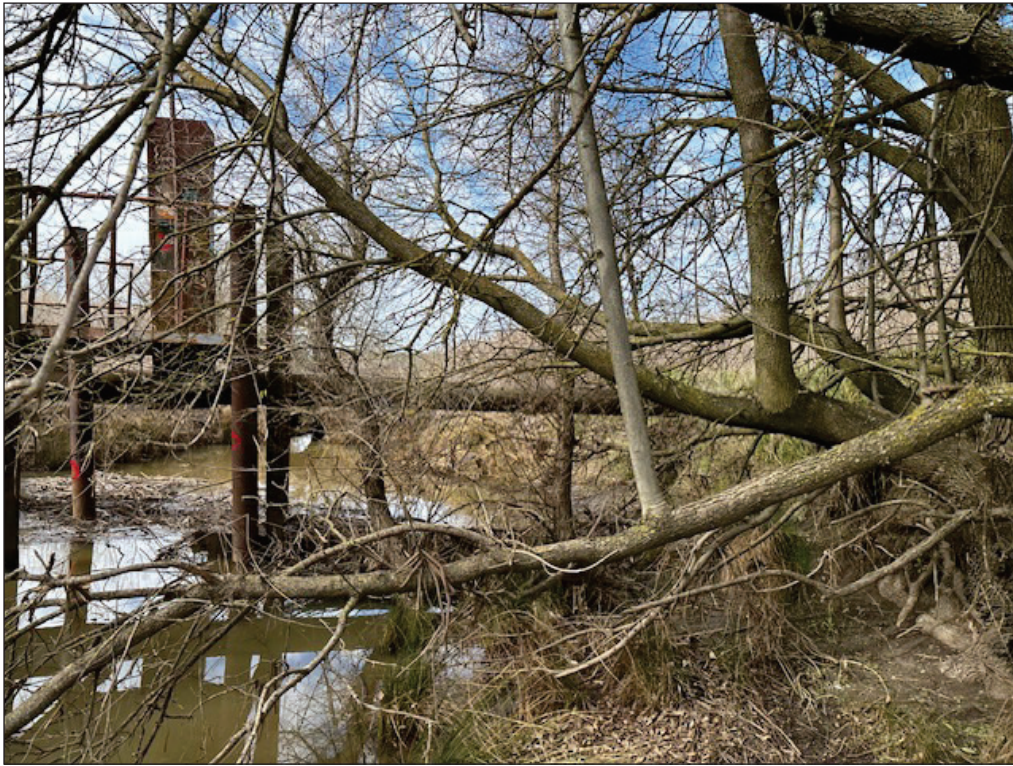
Representative image of the drainage in the northern area of the study area, facing west. Date: 2/12/2025. Photographer: Dena Elimelech
