# Arborist Report of Findings

## Excelsior Oaks Sub-Division Project

**May 2019**

Bargas Environmental Consulting, LLC  
3031 F Street, Suite 203  
Sacramento, CA 95816

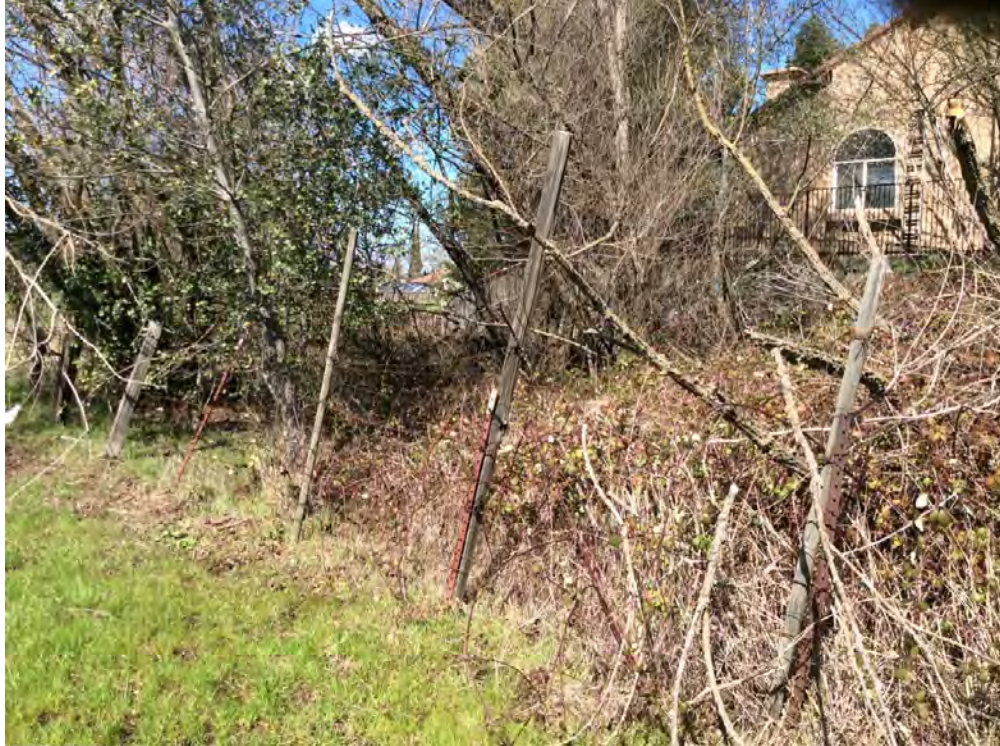
**Photo 1:** Photo of a portion of the inaccessible trees located behind barbed wire in the northwest corner, including interior live oaks, Pacific willows, and Oregon ash. Photo looking northwest.

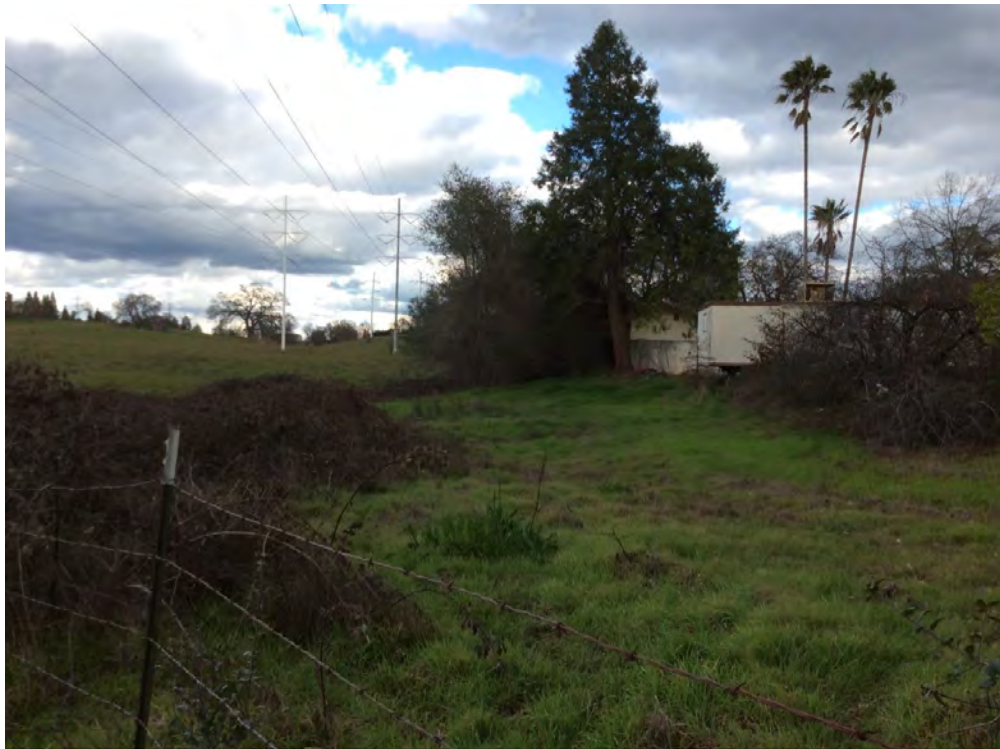
**Photo 2:** Photo of a portion of the inaccessible trees located behind barbed wire near the southwest corner, including interior live oaks, blue oaks, and pines. Photo looking northwest.
