Hazardous Building Material Survey Long Beach City College – Liberal Arts Campus Veterans Stadium and Ticket Booth Structures 4901 East Carson Street Long Beach, California 90808

Long Beach Community College District 4901 East Carson Street – G21 | Long Beach, California 90808

May 9, 2024 | Project No. 210407005

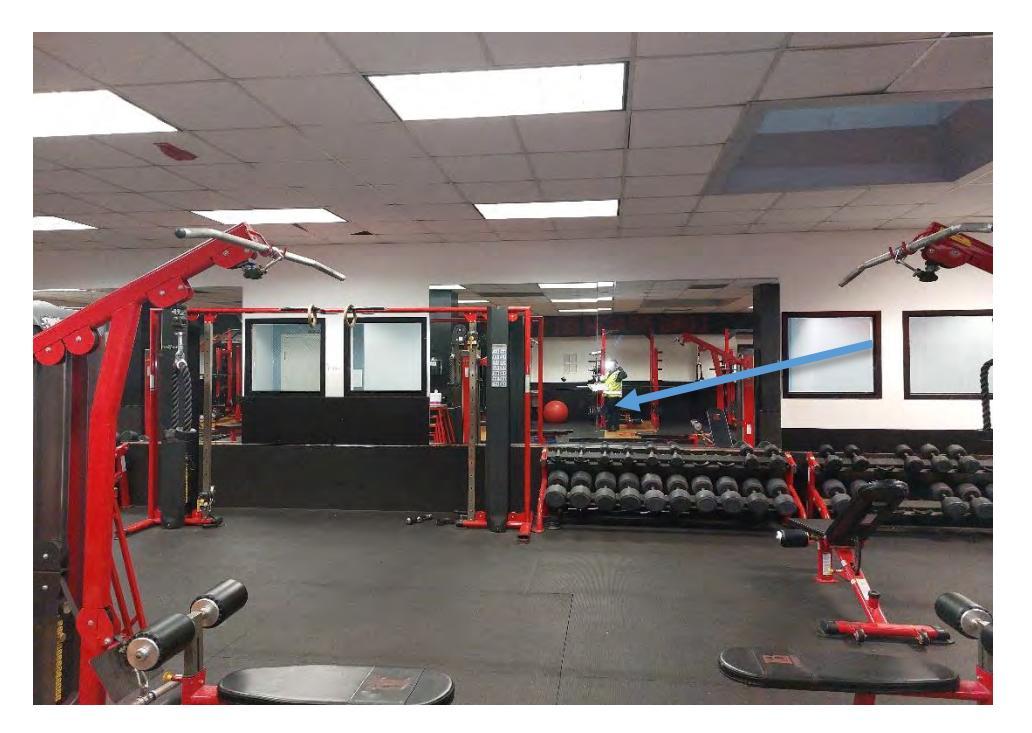
Photograph 2:

View of the assumed asbestos containing mirror mastic within the gym.

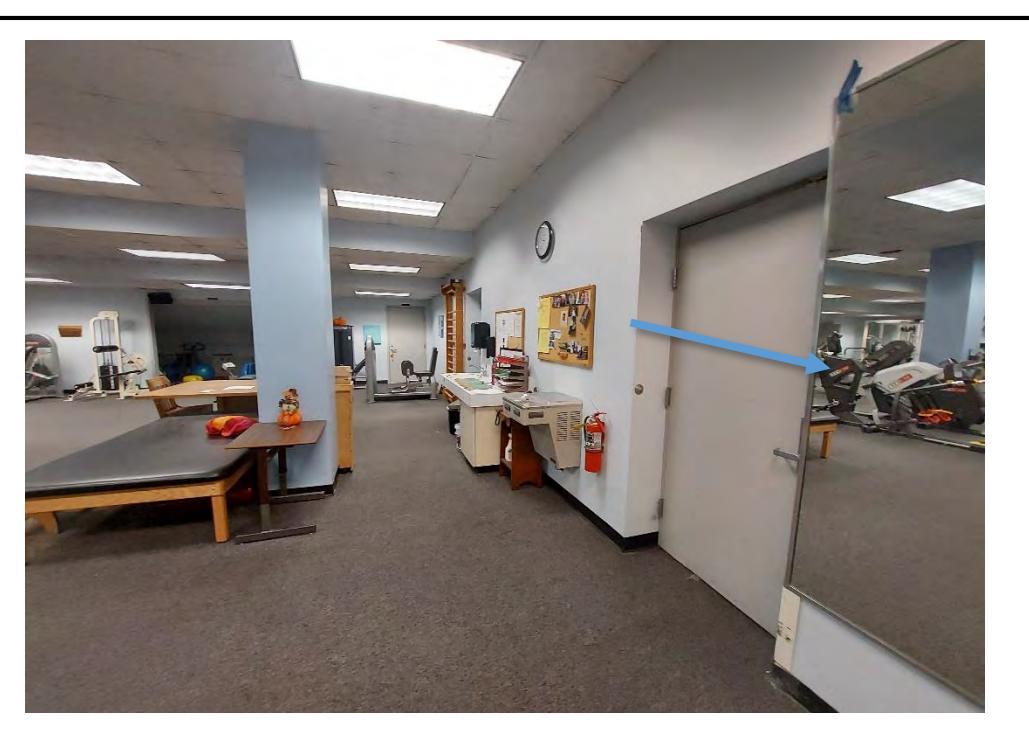
Photograph 3: View of the assumed asbestos containing mirror mastic within the adaptive facility.

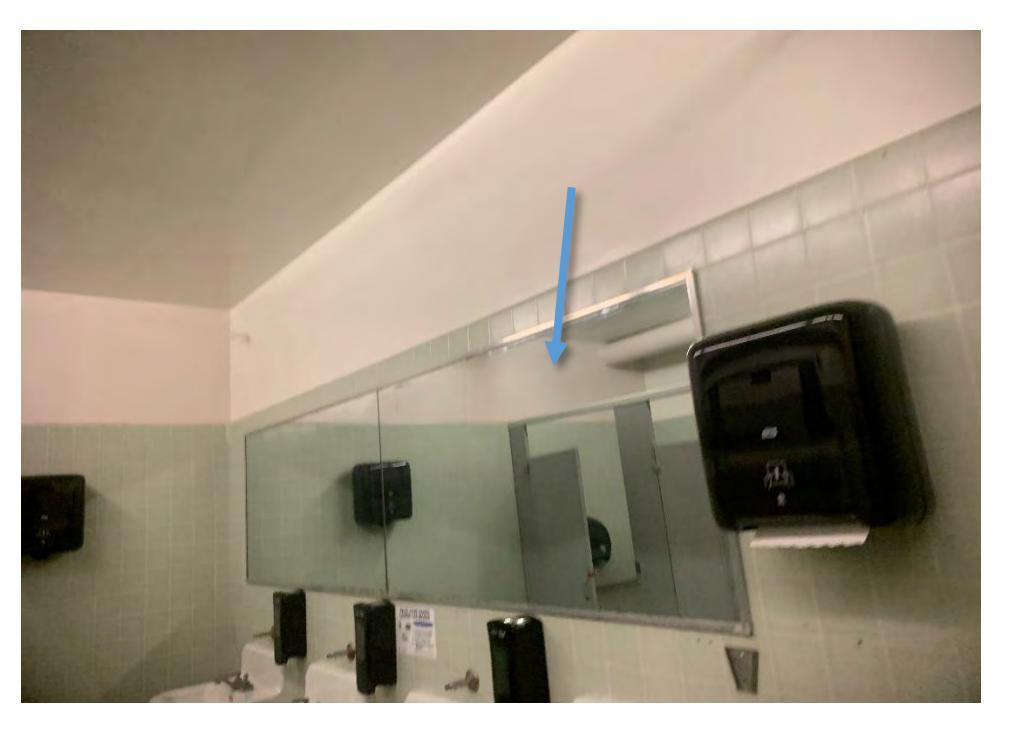
Photograph 4:

Representative view of the assumed asbestos containing mirror mastic throughout restrooms.

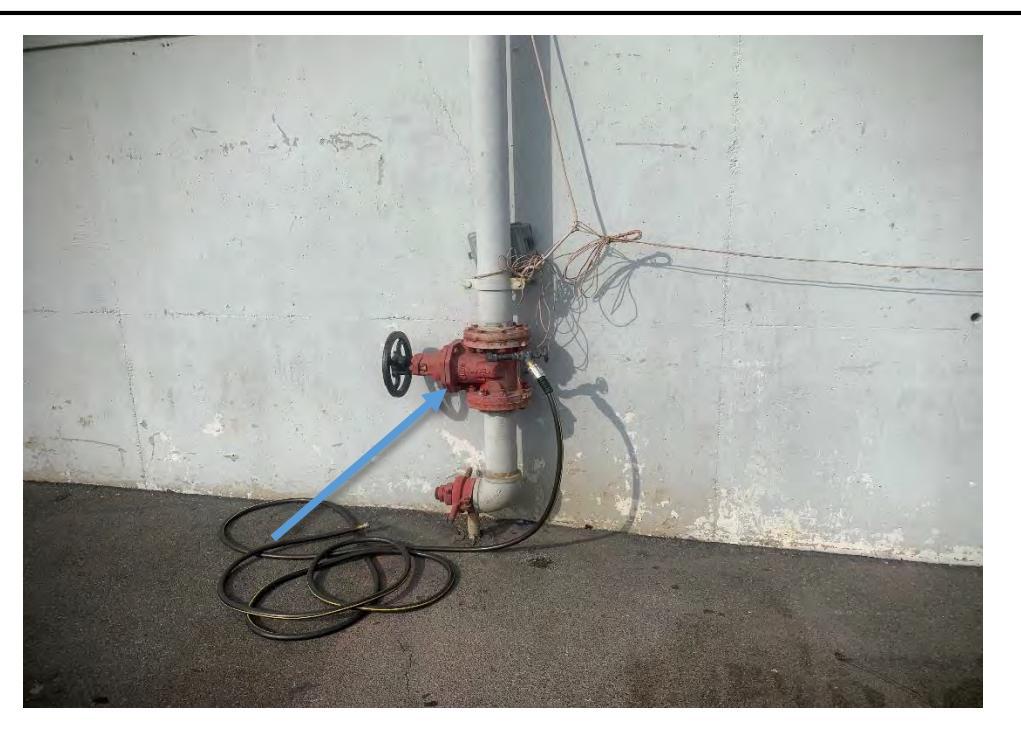
Photograph 5: View of the assumed asbestos containing pipe gaskets associated with the fire riser on the exterior southern end of the building.

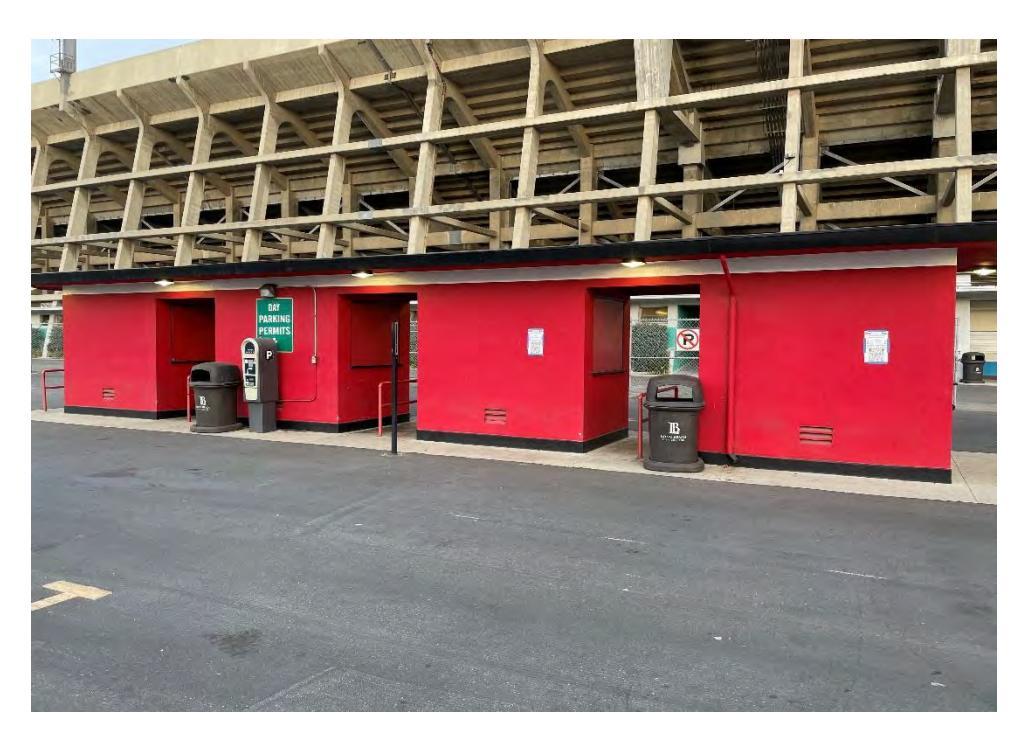
Photograph 6:

View of Ticket Booth adjacent to Veteran's Stadium with asbestos containing tar and gravel roofing material.

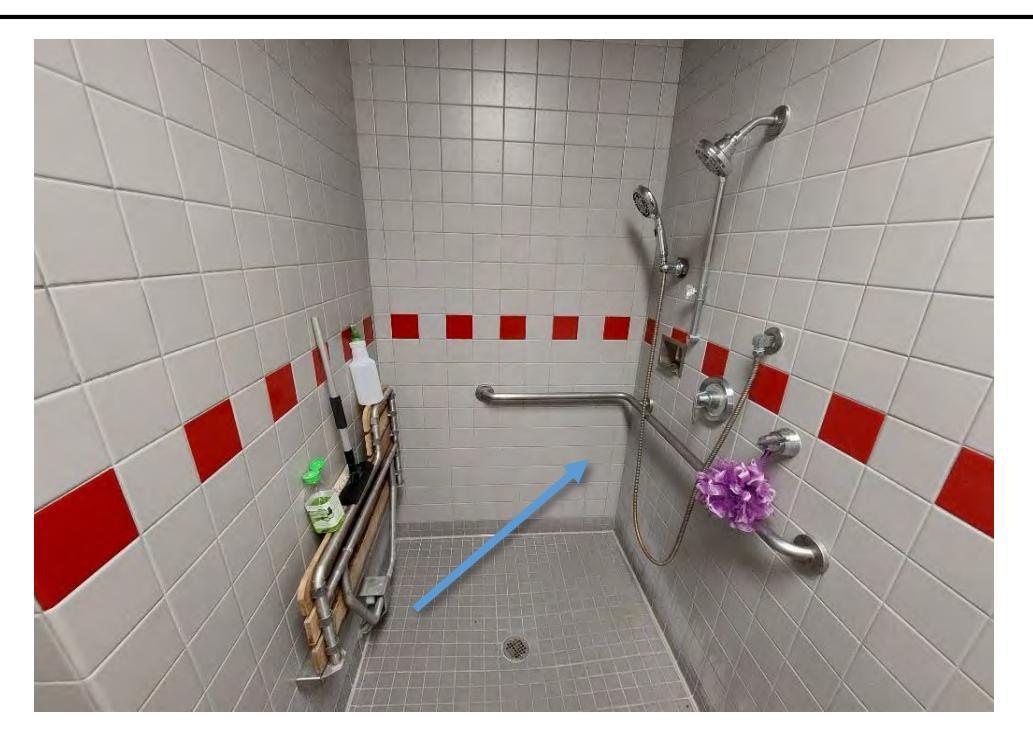
Photograph 7: Representative view of the lead containing 4"x4" Light Gray and Red ceramic wall tile in the men's & women's locker rooms.

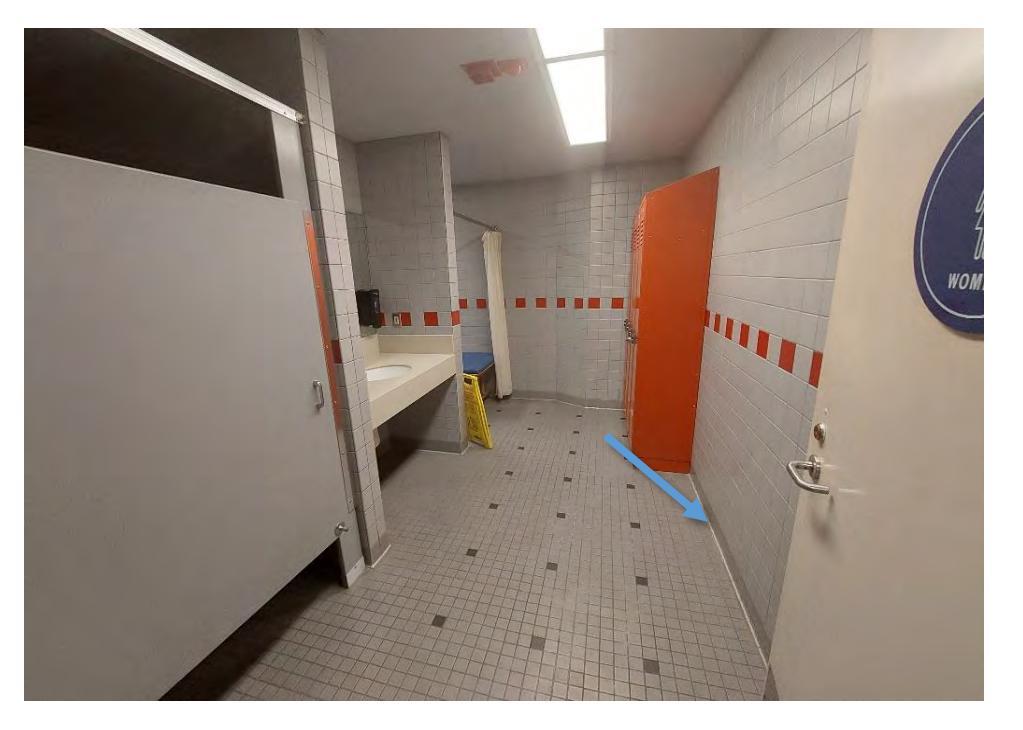
Photograph 8:

View of the view of the lead containing 4"x4" gray ceramic cove base within the men's and women's locker rooms.

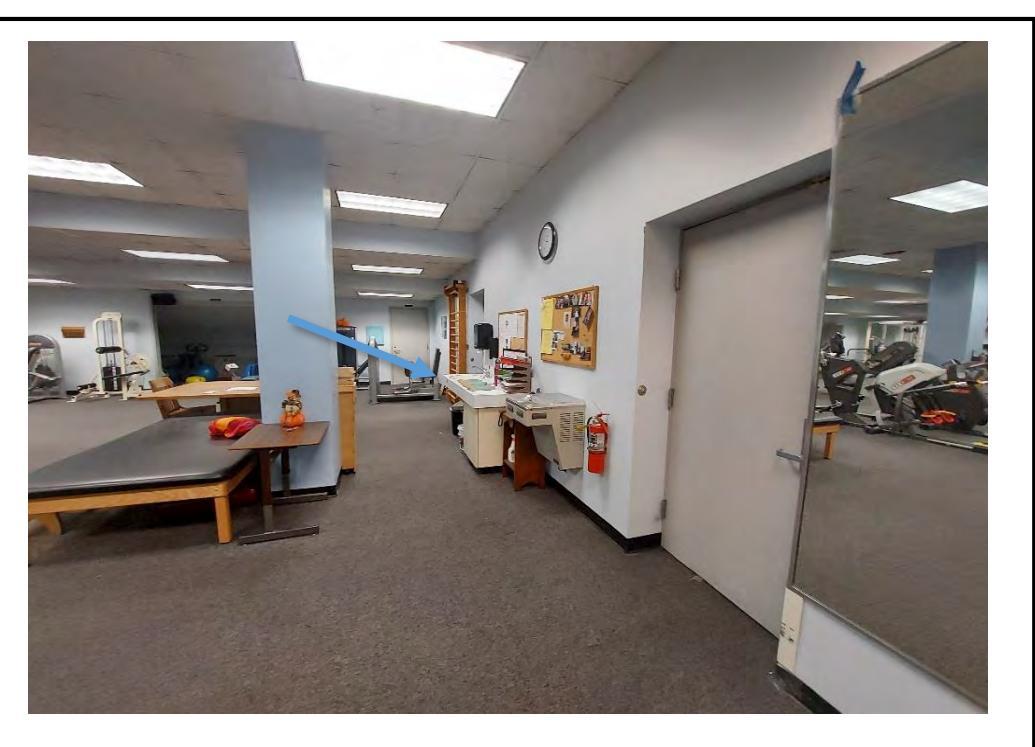
Photograph 9:

View of the lead containing sink within the adaptive facility room.

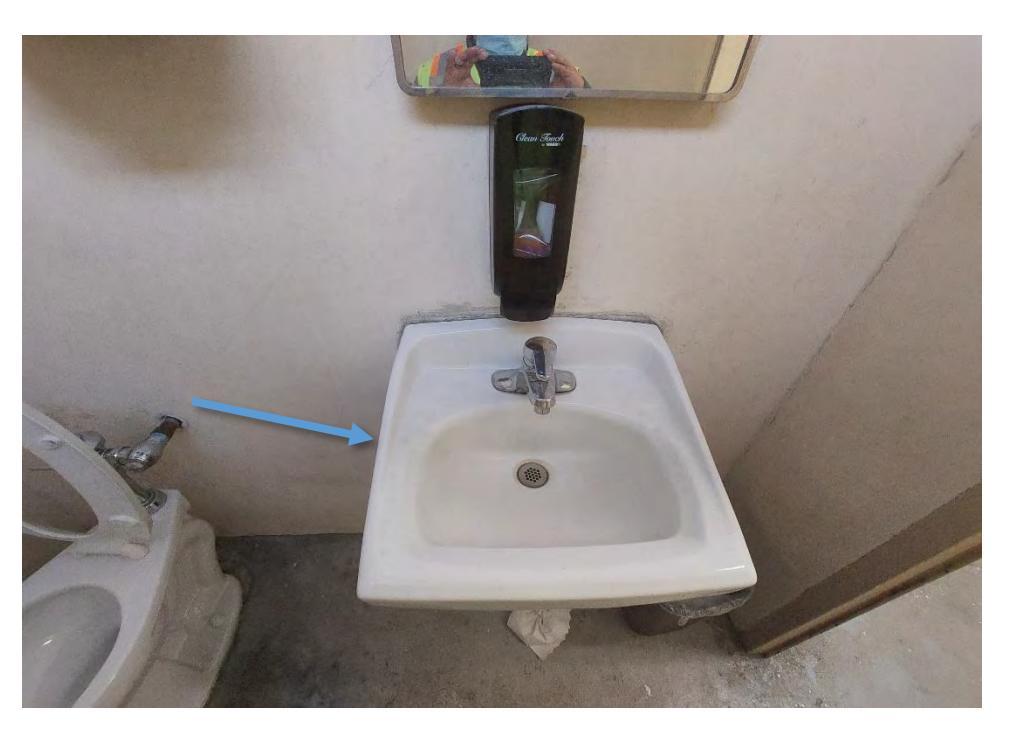
Photograph 10:

Representative view of the lead containing sinks within restrooms.

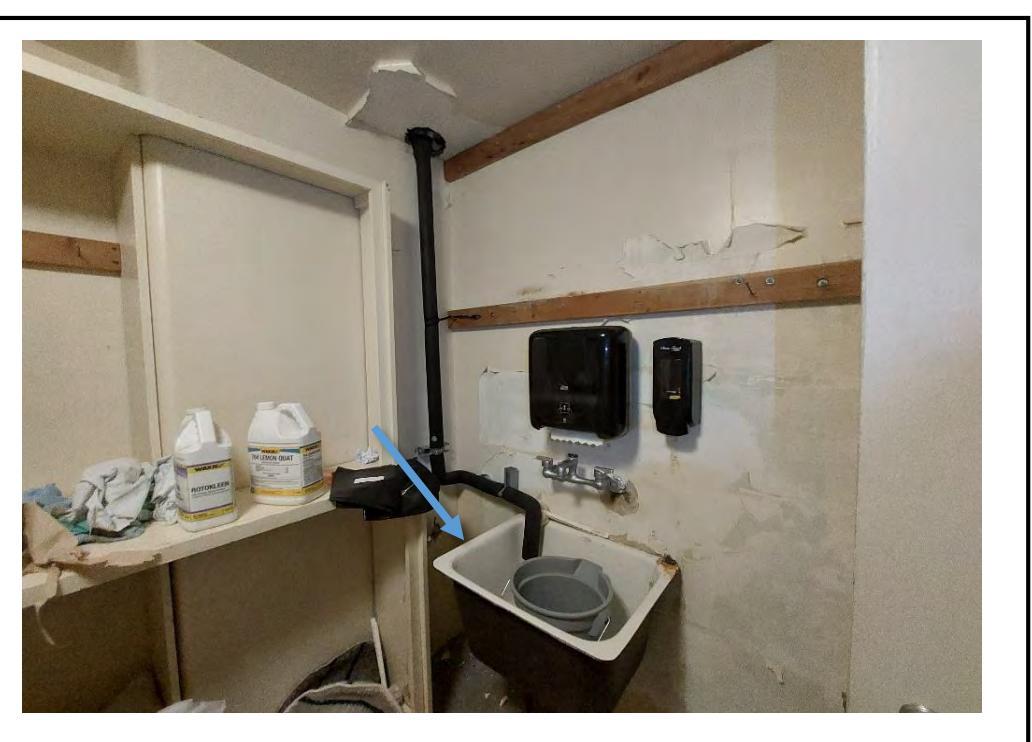
Photograph 11: Representative view of the lead containing deep sinks within janitor's closet and locker room 4 storage room.

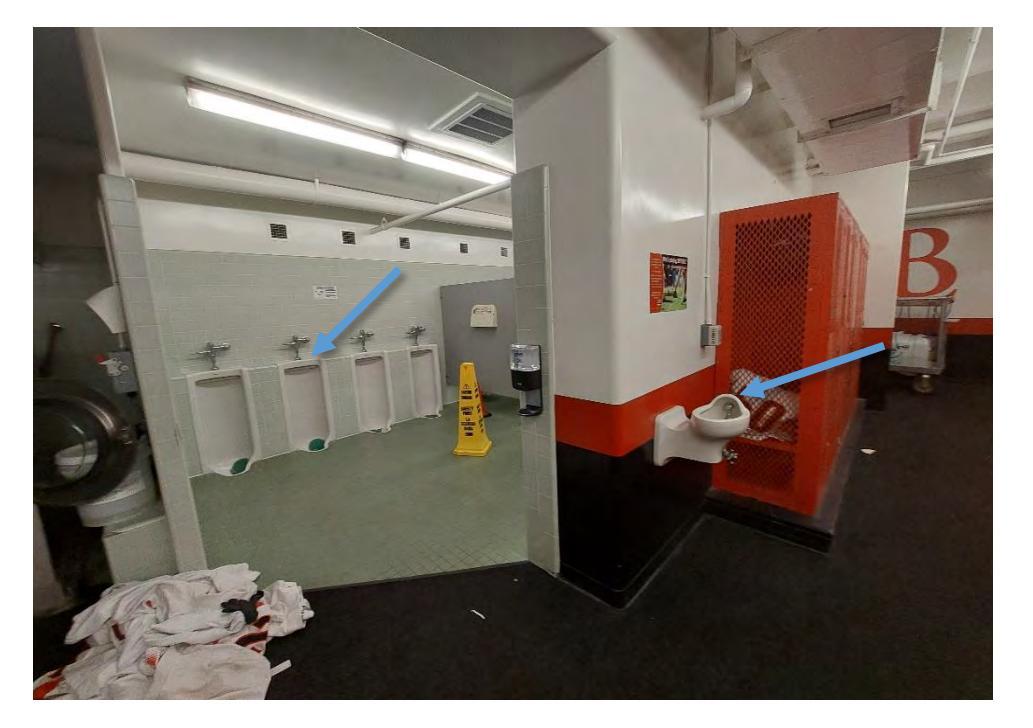
Photograph 12:

Representative view of the lead containing water fountain and urinals throughout locker rooms 1-4.

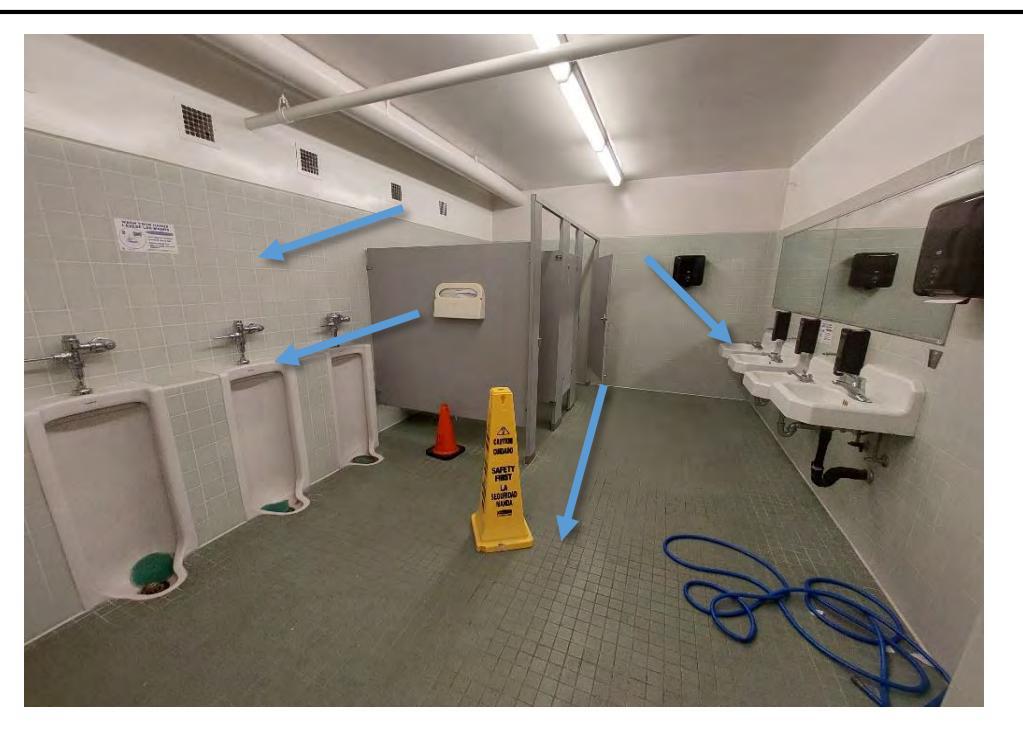
Photograph 13:

Representative view of the lead containing 4"x4" ceramic wall tile, 2"x2" green ceramic floor tile, urinals, and sinks found throughout locker rooms 1-2.

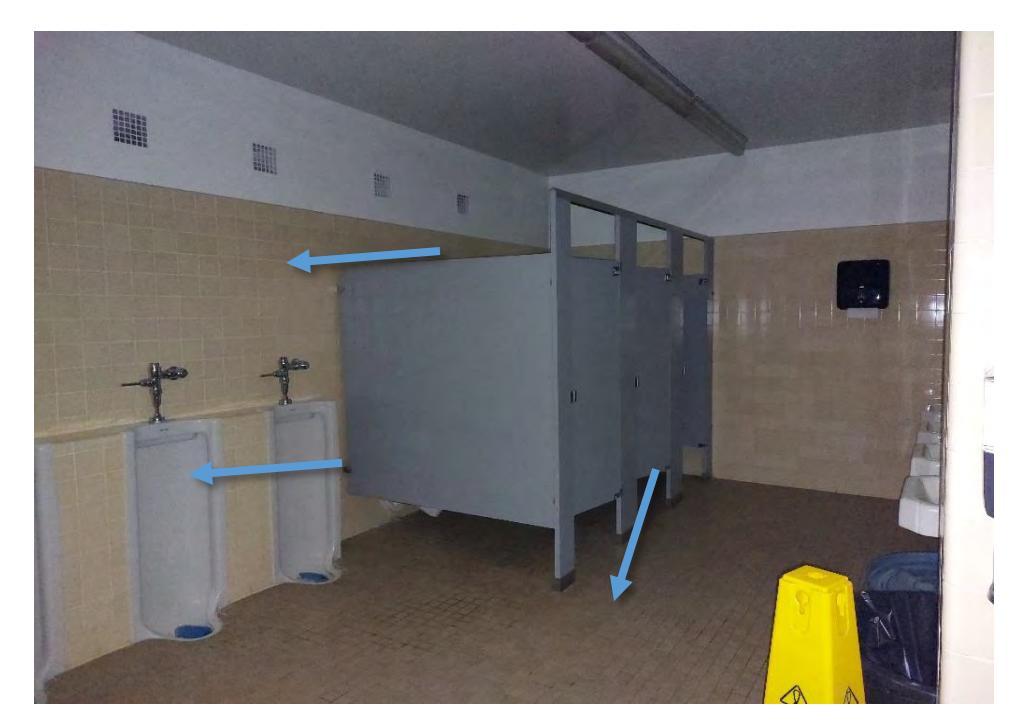
Photograph 14:

Representative view of the lead containing 4"x4" yellow ceramic wall tile, 2"x2" brown floor tile and urinals throughout locker rooms 3-4.

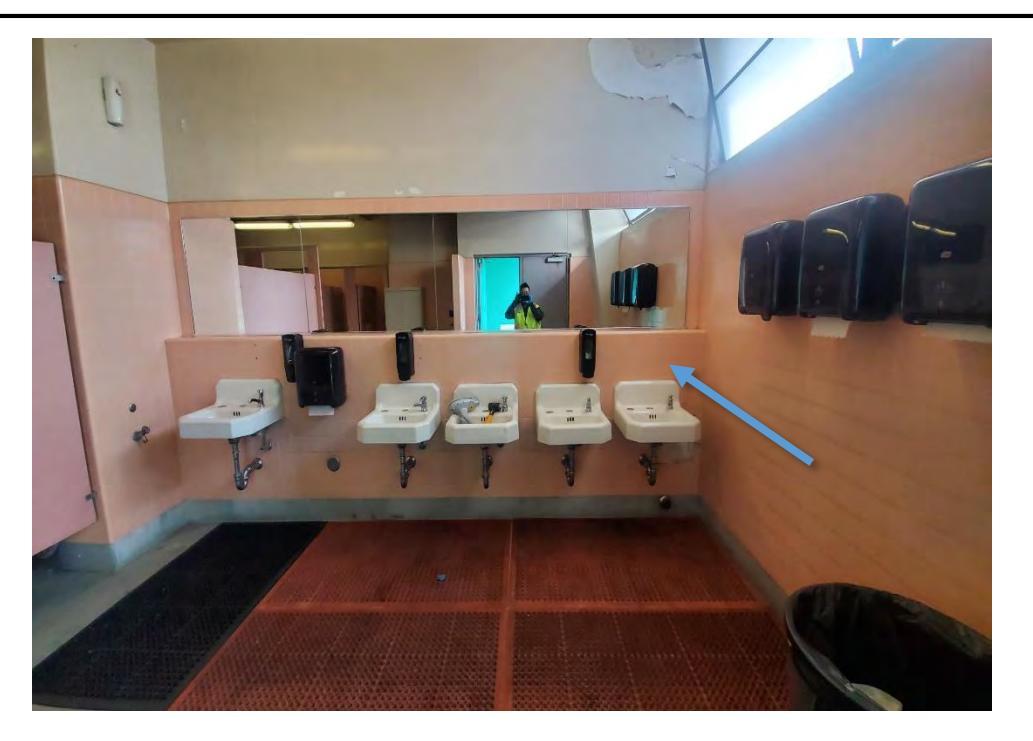
Photograph 15: View of the lead containing 4"x4" pink ceramic wall tile throughout women's restrooms.

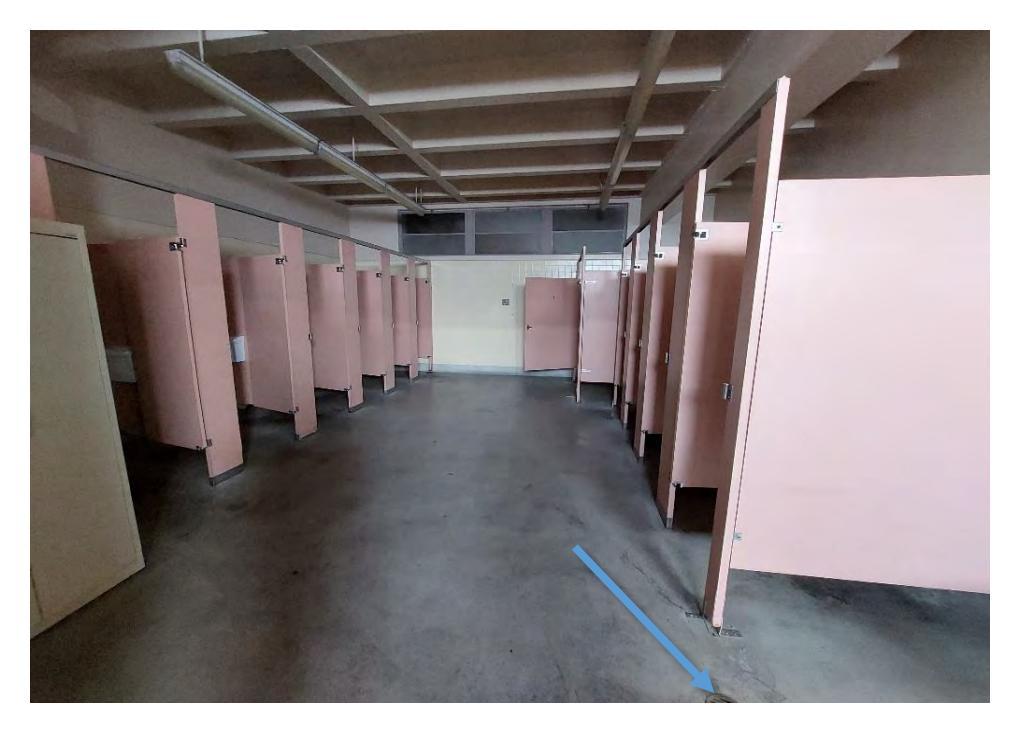
Photograph 16:

View of the lead containing floor drain screen in the throughout men's and women's restrooms.

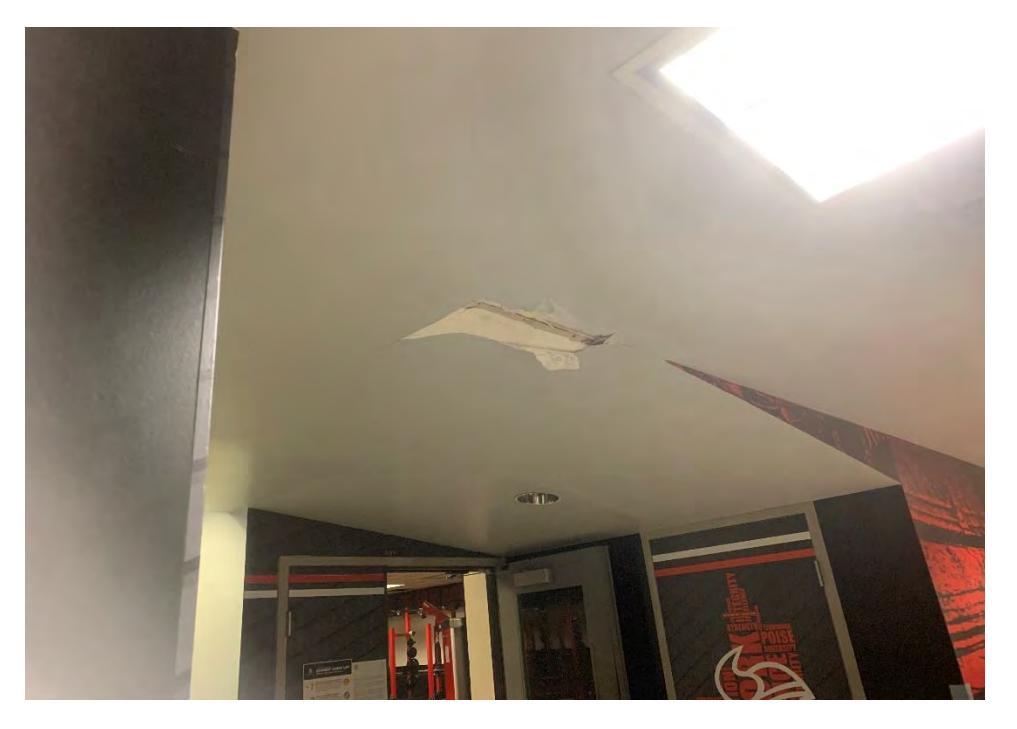
Photograph 20:

View of the water staining/damage on the drywall ceiling within the north corridor 04.

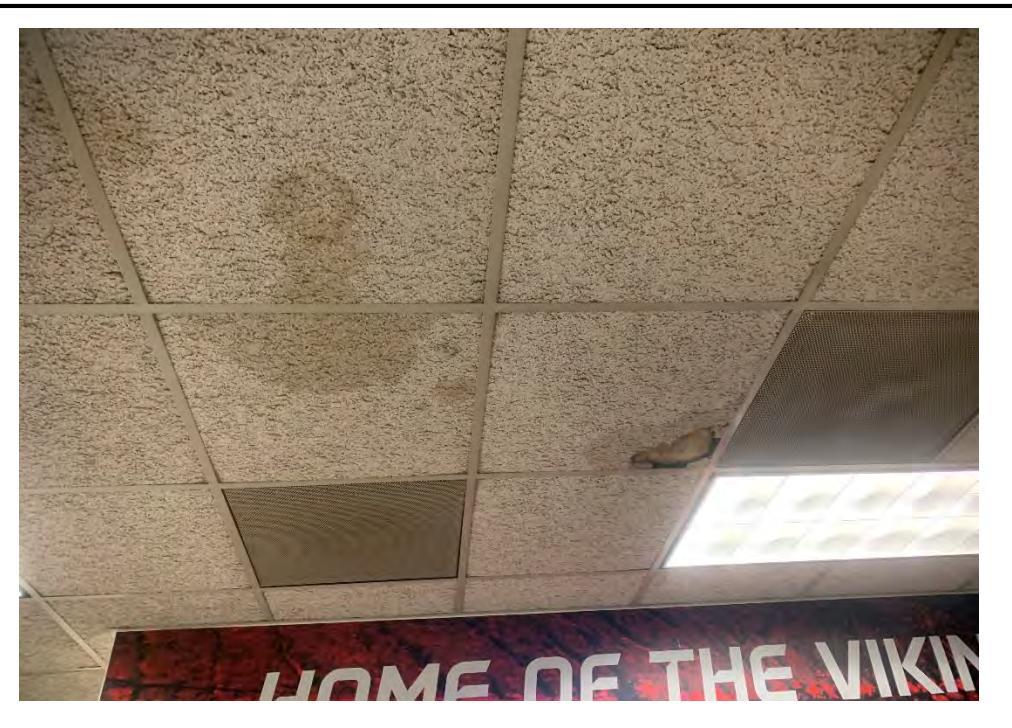
Photograph 21: View of the water staining/damage on the laid-in ceiling tiles within office 21.

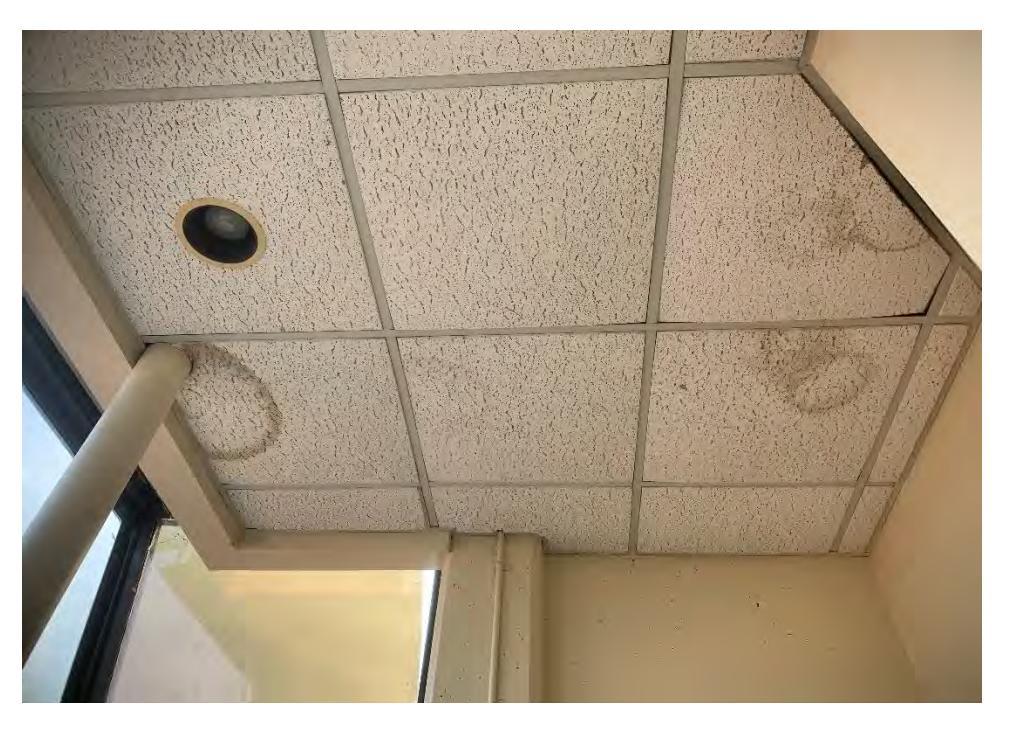
Photograph 22:

View of the water staining/damage on the laid-in ceiling tiles within the press box (glued on ceiling tiles above).

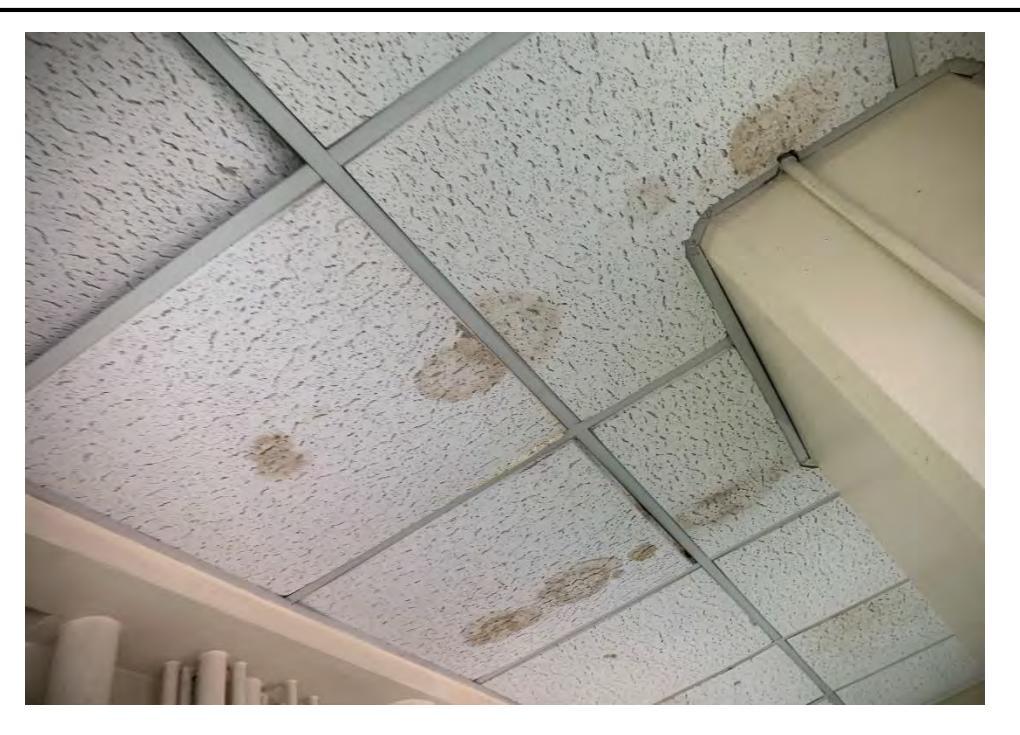
Photograph 23: View of the water staining/damage on the laid-in ceiling tiles within the press box (glued on ceiling tiles above).

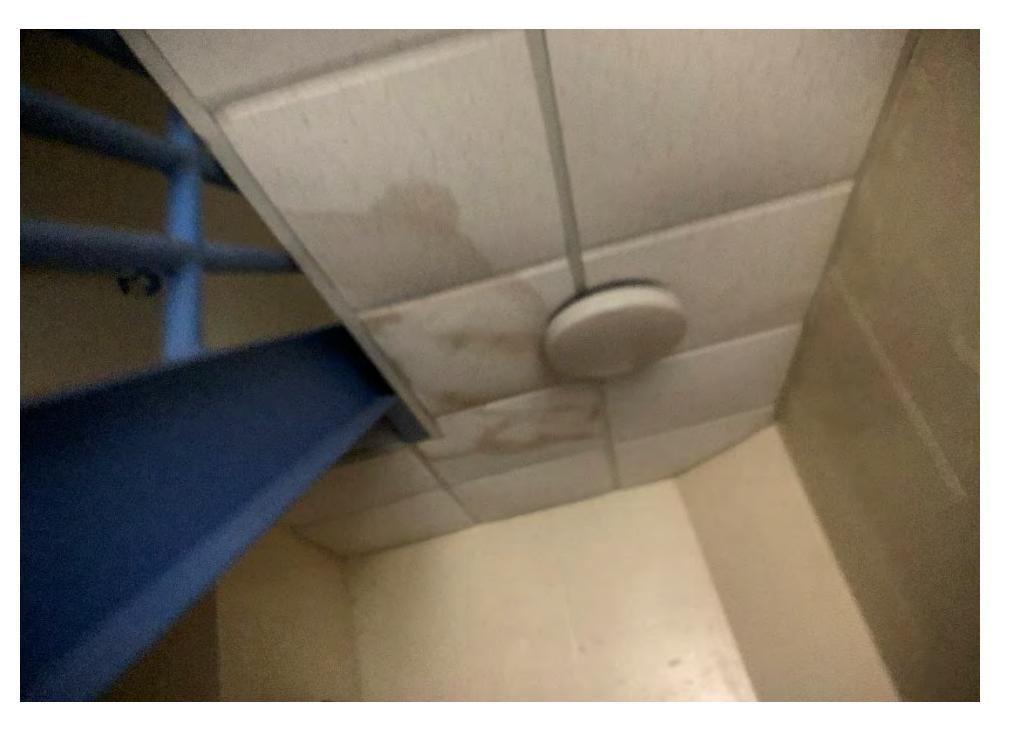
Photograph 24:

View of the water staining/damage on the laid-in ceiling tiles within the press box (glued on ceiling tiles above).

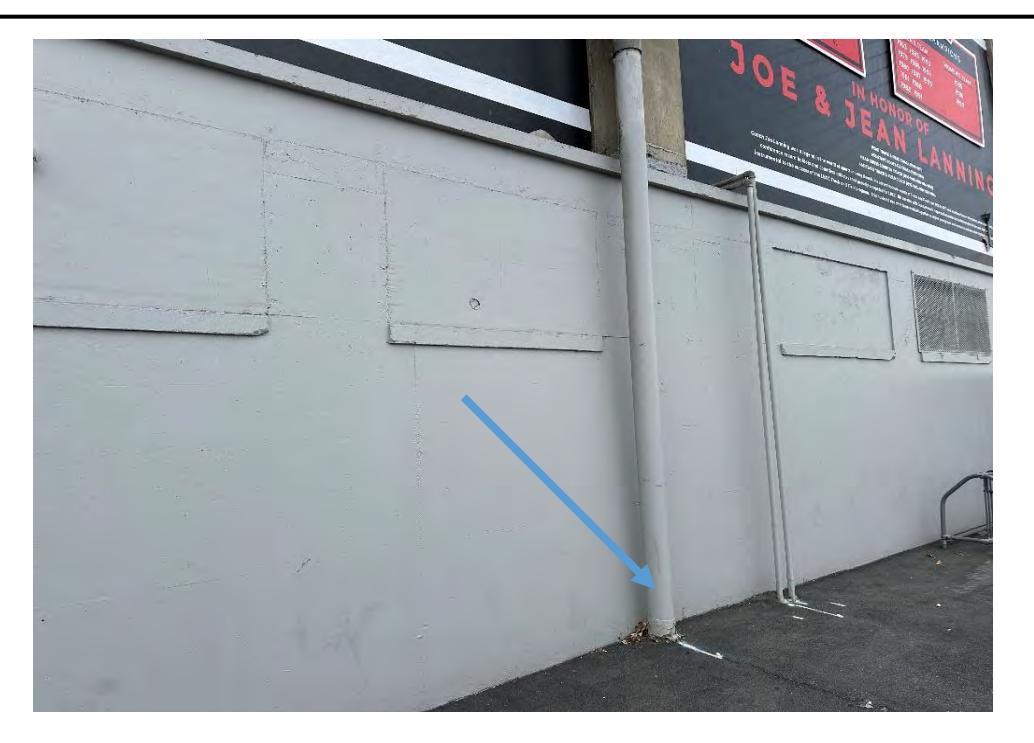
Photograph 3: Representative view of the asbestos containing pipe wrap.

- Asbestos abatement monitoring consulting services should be performed by a third-party environmental consultant, to include oversight of abatement contractor activities to be performed in accordance with the abatement specifications, daily air monitoring, clearances, verification of complete removal of hazardous materials, and preparation of a closeout report summarizing the abatement activities.

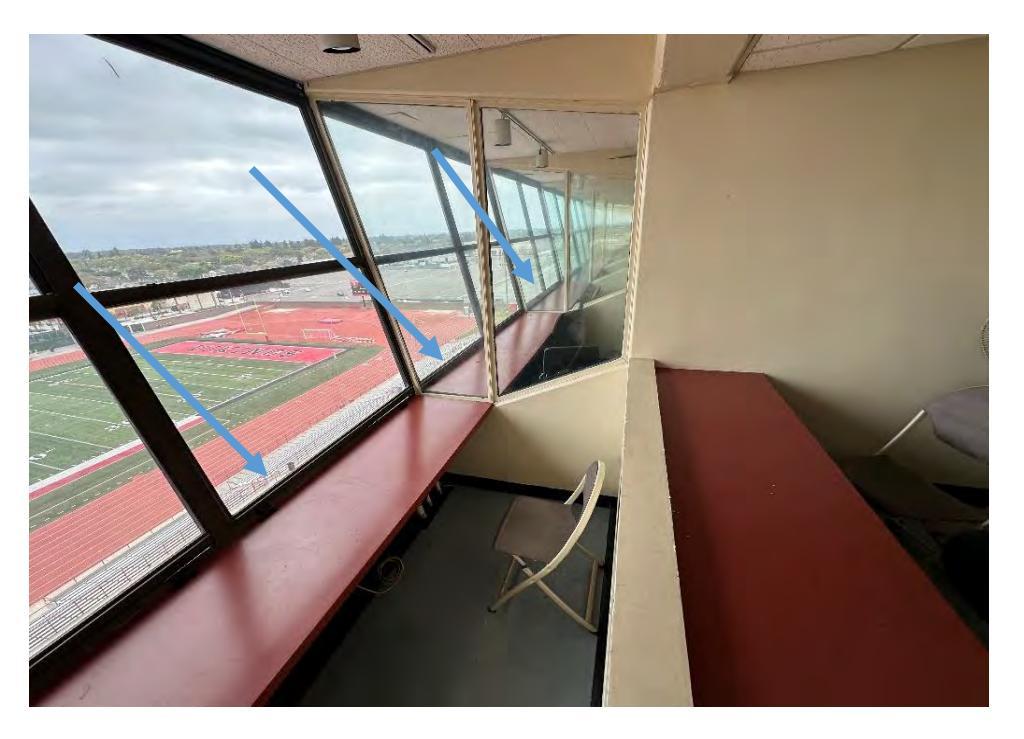
Photograph 4:

Representative view of the asbestos containing construction material window caulking.

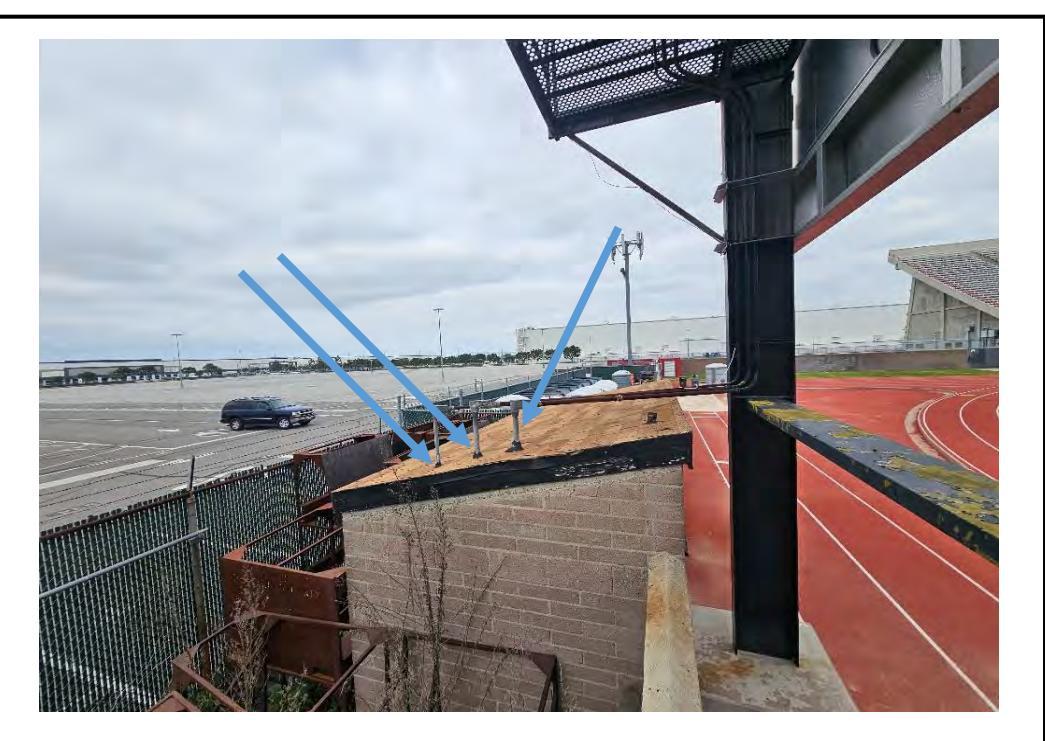
Photograph 5: Representative view of the asbestos containing penetration mastic on the scoreboard storage building.

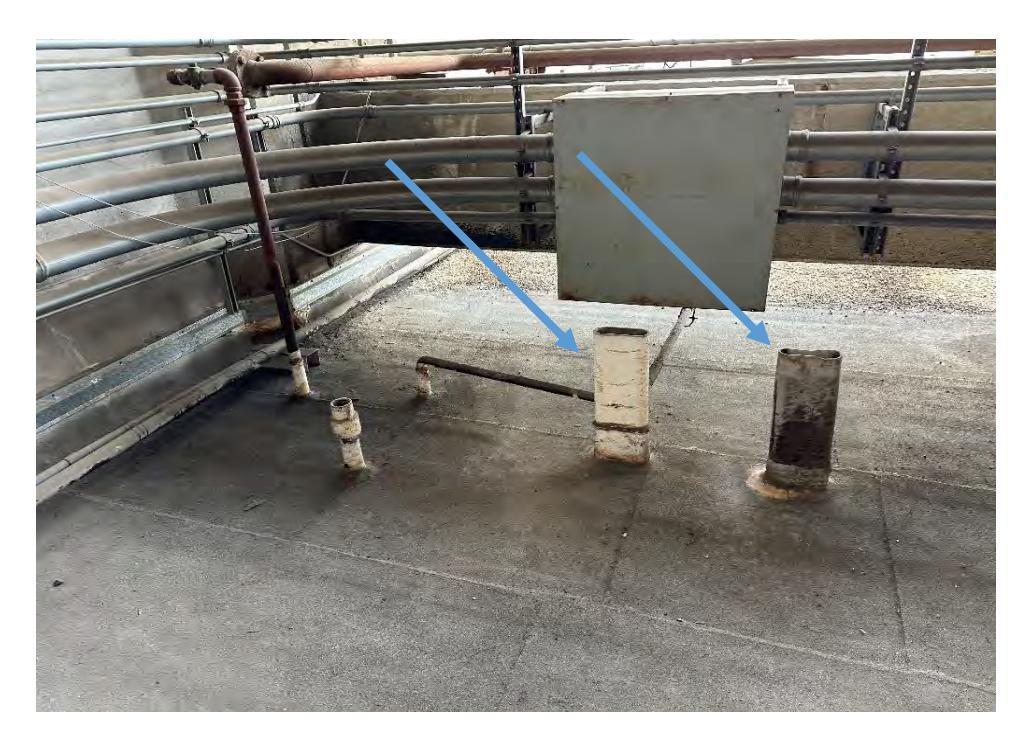
Photograph 6:

Representative view of the asbestos containing cementitious pipe on the stadium office roof.

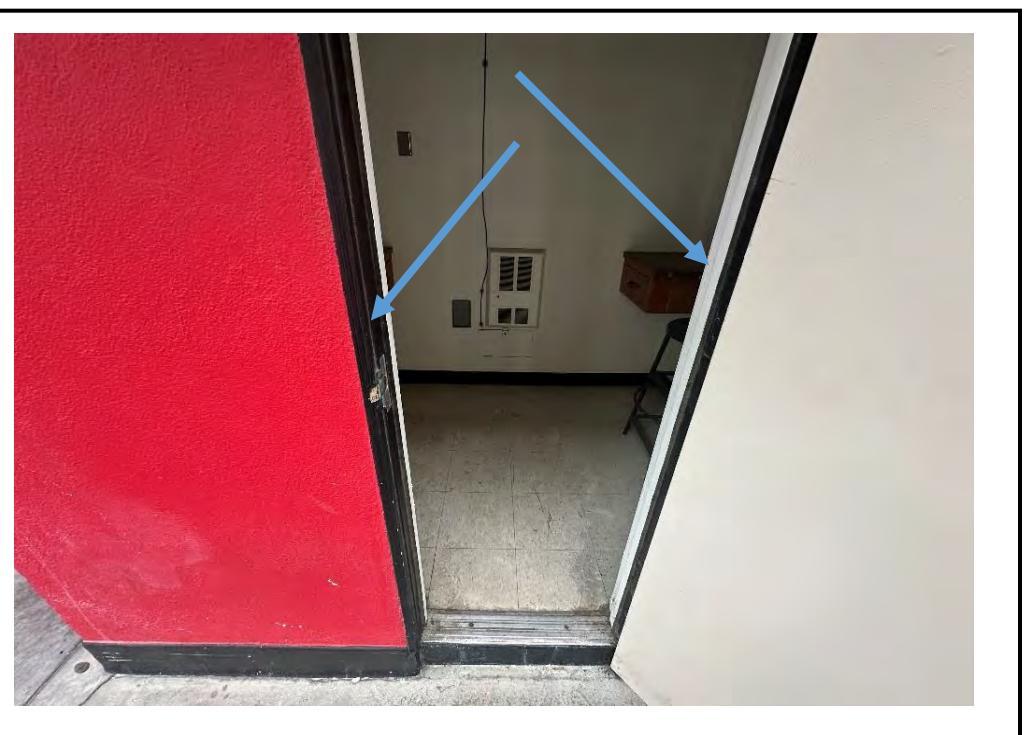
Photograph 7: Representative view of the lead based black/white paint on the door jamb and frame of the ticket booth.

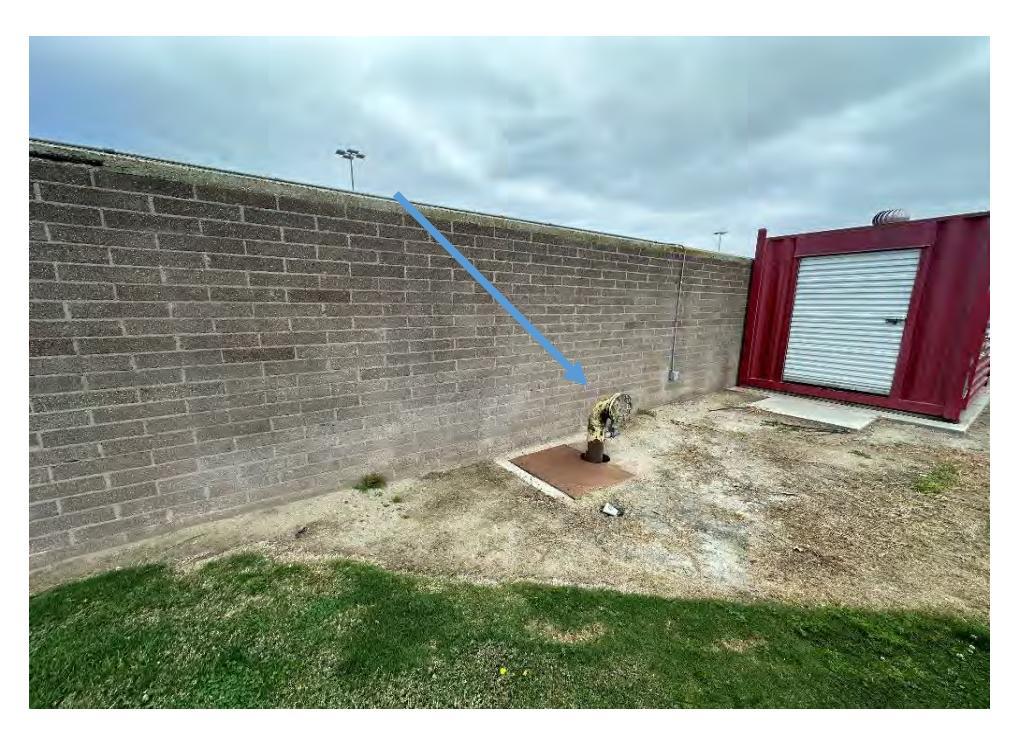
Photograph 8:

Representative view of the lead based yellow paint on the metal pipe.

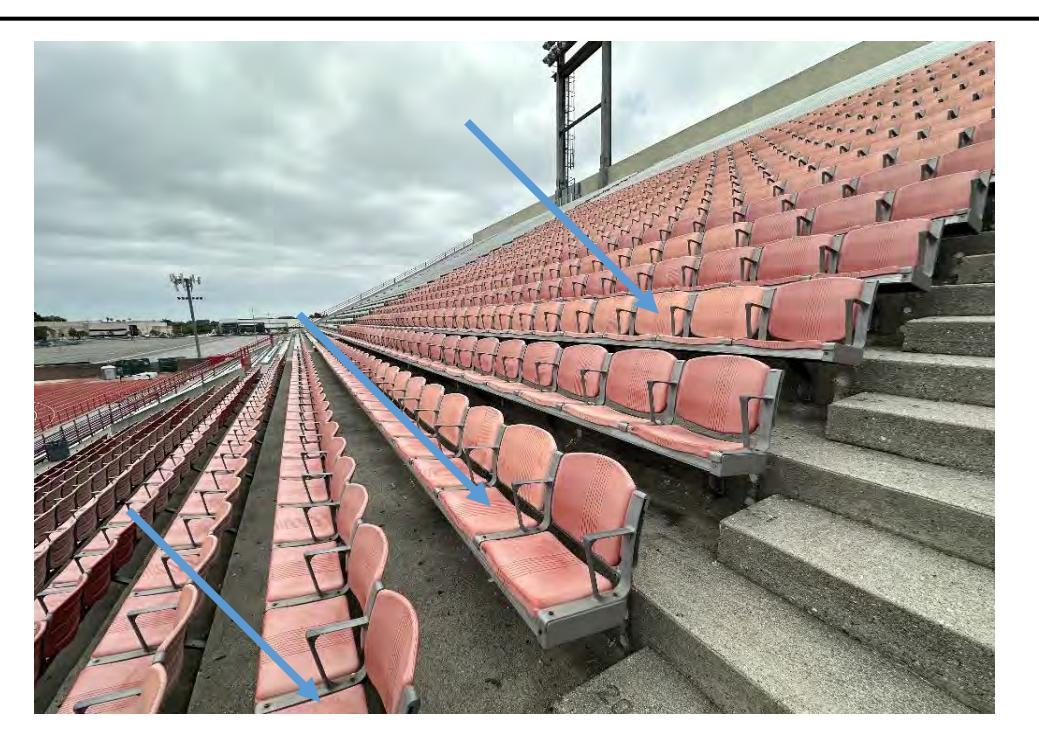
Photograph 9: Representative view of the lead containing red plastic bleacher chairs.

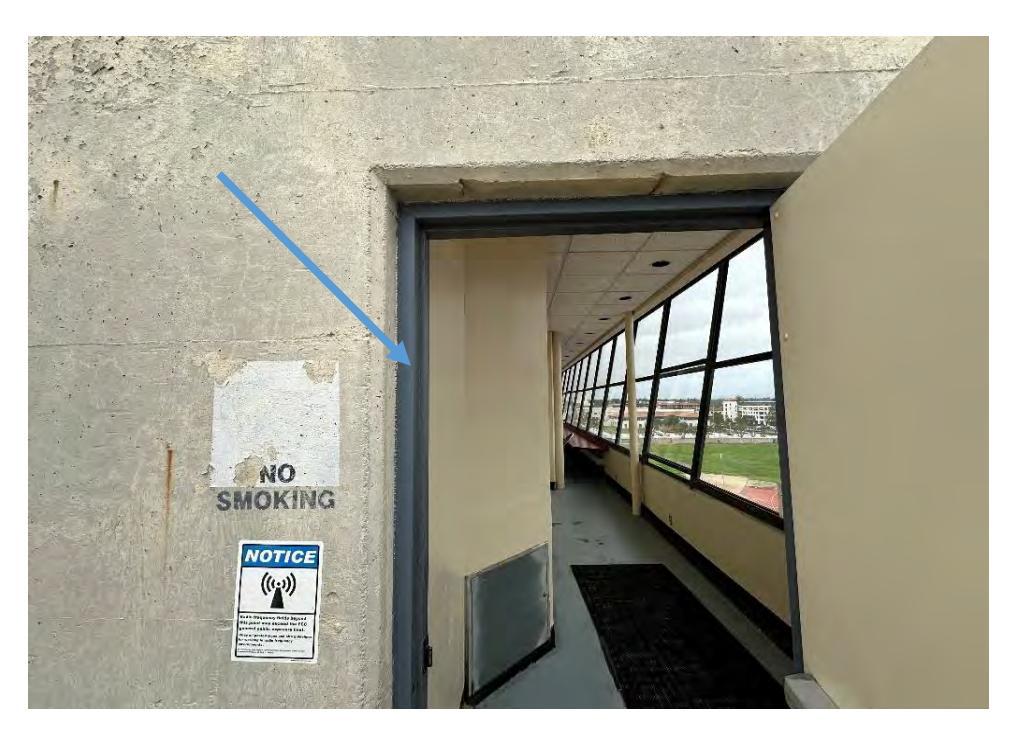
Photograph 10:

Representative view of the lead containing gray paint on the door frame of the press box.

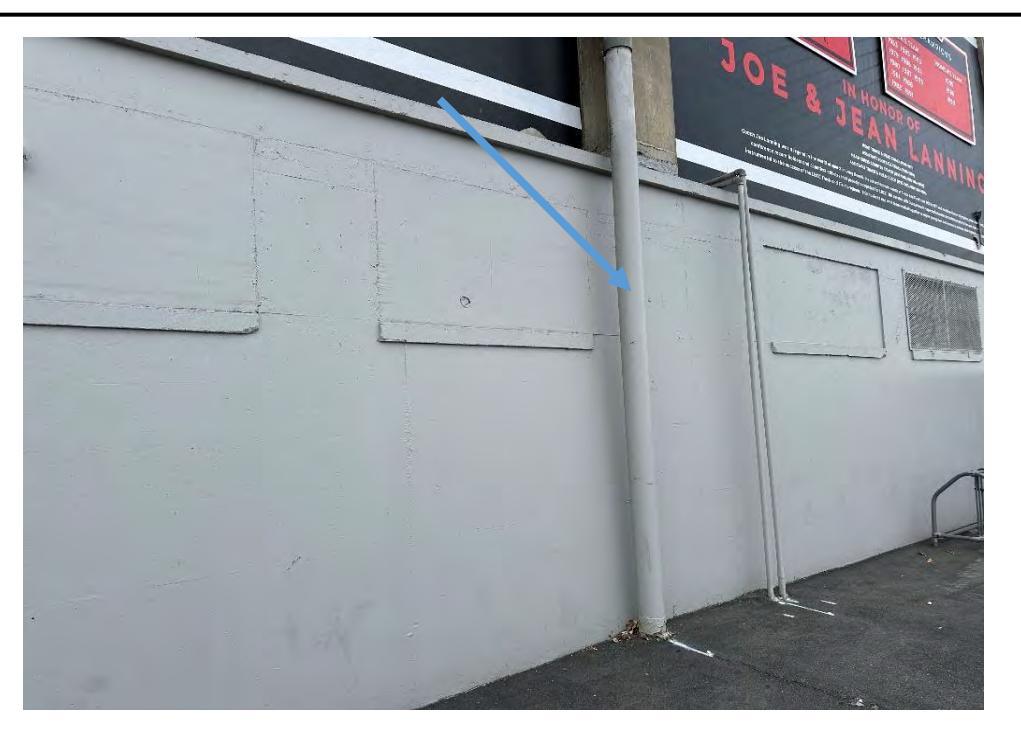
Photograph 11: Representative view of the lead containing gray paint on the steel pipe located on the north wall of the stadium.
