Hazardous Building Material Survey Long Beach City College – Liberal Arts Campus Veterans Stadium and Ticket Booth Structures 4901 East Carson Street Long Beach, California 90808

Long Beach Community College District 4901 East Carson Street – G21 | Long Beach, California 90808

May 9, 2024 | Project No. 210407005

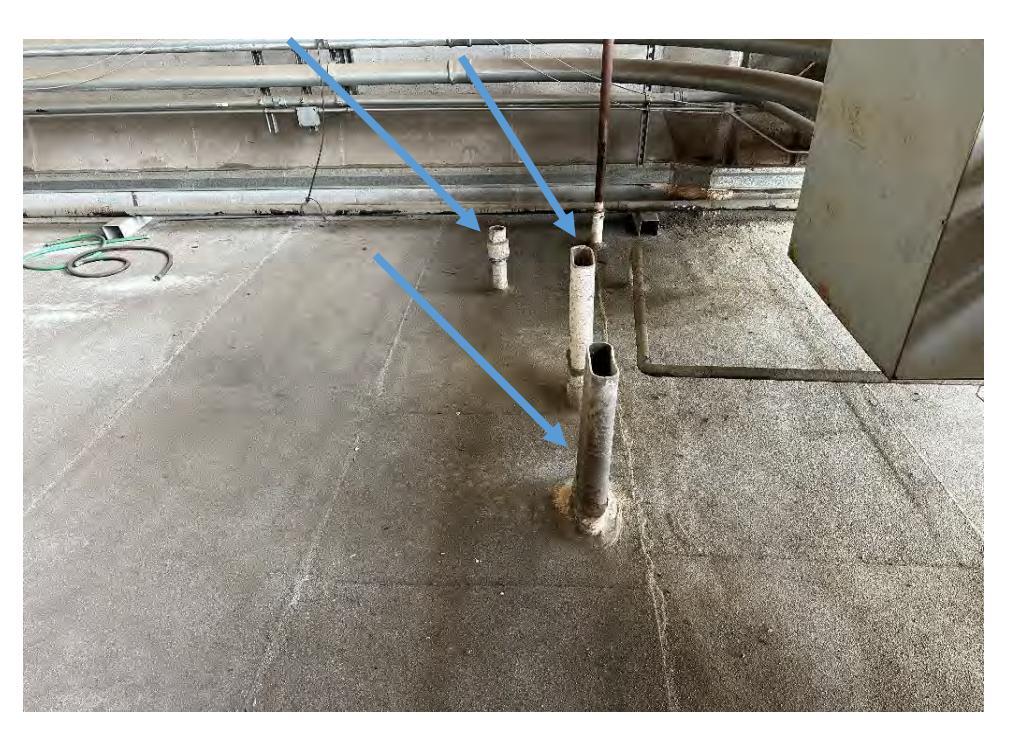
Photograph 12:

Representative view of the lead containing white paint on steel and cementitious pipes on the stadium office roof.

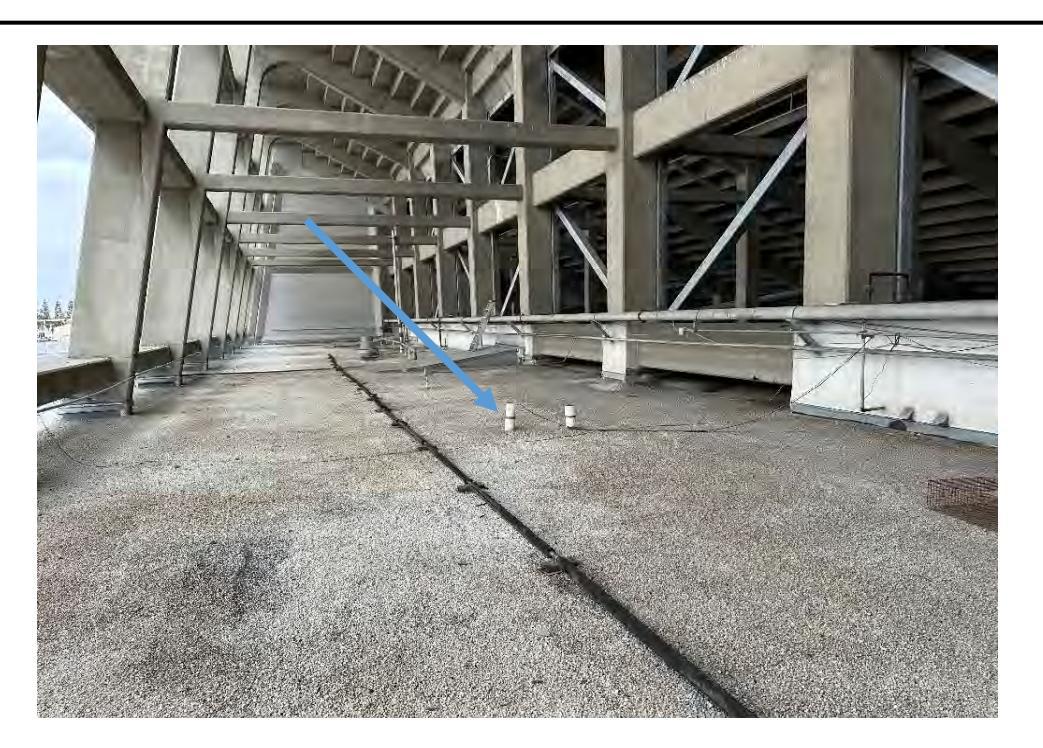
Photograph 13: Representative view of the lead containing white paint on vent pipes on the stadium office roof.

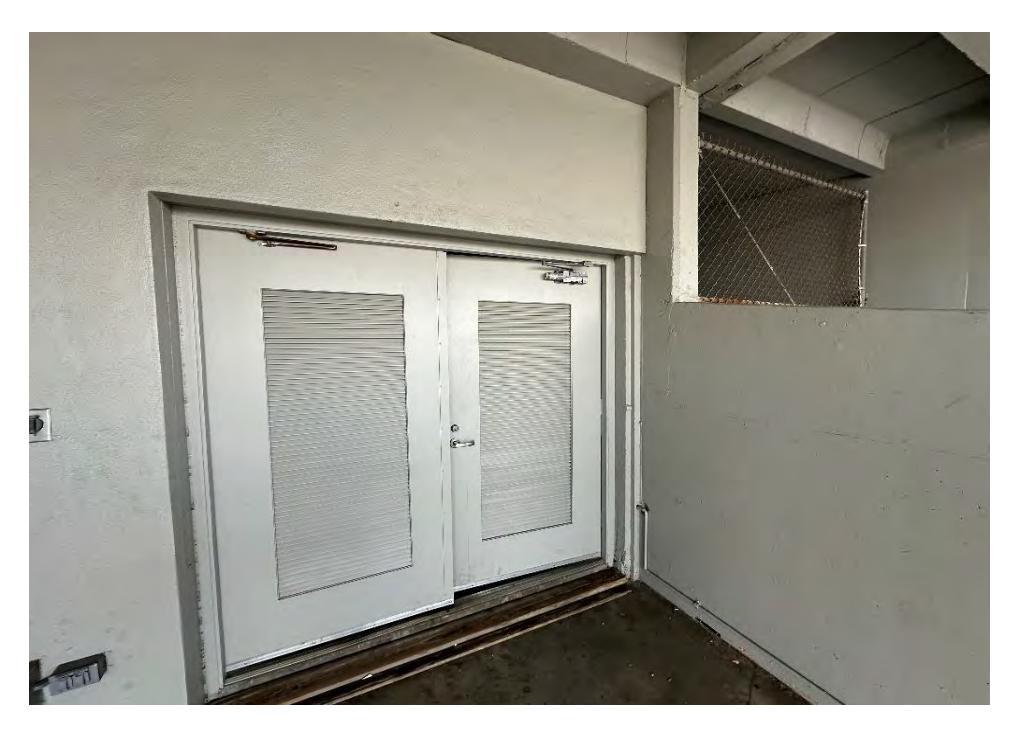
Photograph 14:

Representative view of the lead containing gray paint on the door frame of the mechanical room.
