**PRELIMINARY GEOLOGICAL AND GEOTECHNICAL
ASSESSMENT REPORT
Big Rock 2 Cluster Solar and Storage Project
Imperial County, California**

November 27, 2024

Imperial County Planning & Development Services Department

HDR Engineering, Inc.
3220 El Camino Real, Suite 200
Irvine, CA 92602

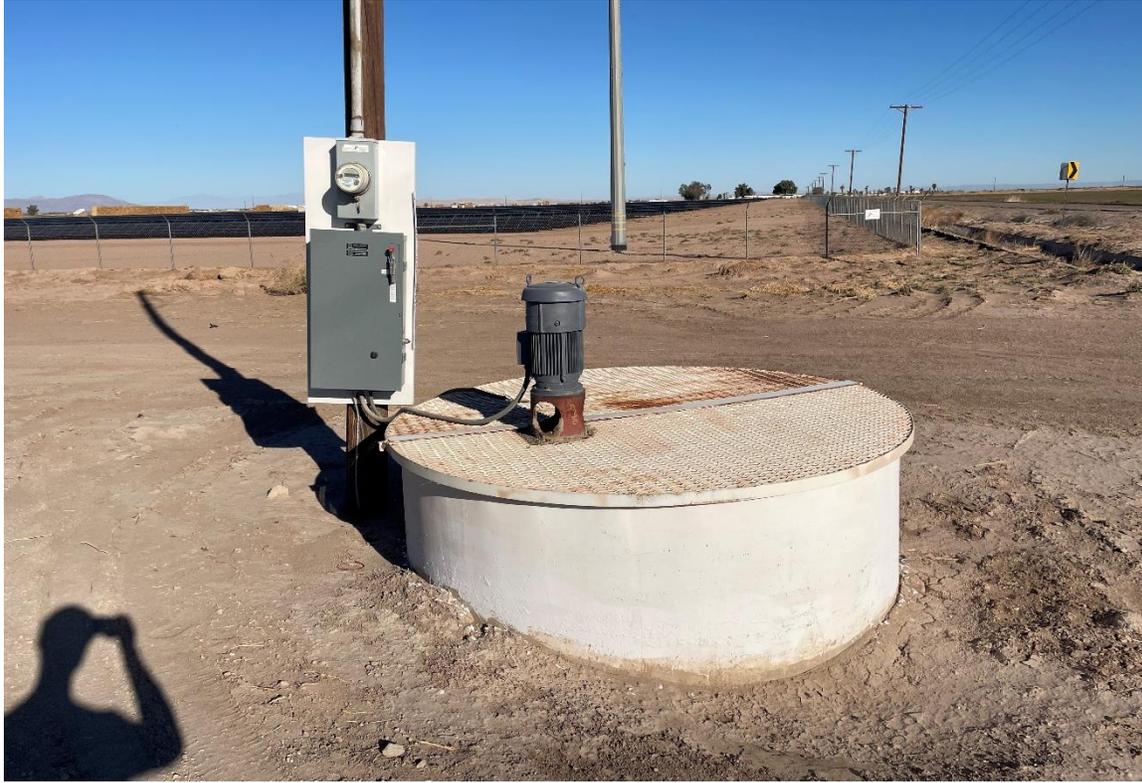
CUP #2 and CUP #4 (Big Rock 2 Cluster South and West): CUP #2 and CUP #4 are located on the southern and western portion of the Project, respectively. These CUPs are surrounded by agricultural fields to the north and west, and a solar project to east. The Imperial Irrigation District (IID) Westside Main Canal (Westside Main Canal) is located to the south and west of CUP #4 and south of CUP #2. Additionally, the Foxglove Canal and Dixie Drain Two run north to south along CUP #4 while the Westside Drain and Dixie Lateral One run east to west along CUP #4. Surface water was observed within these canals. Surface water was also observed in the farmed crop area on the southern side of CUP #4 as seen in PL04 in Appendix C. This water flowed into the site from the Westside Main Canal. Although most of the surface soils consisted of dry dense silty sands, the southern portion of CUP #2 had areas of dry soft to stiff lean clays. Generally, the properties are undeveloped with the surface covered with alfalfa, bermuda grass, or similar crops. Access to these CUPs was through unpaved roads, Mandrapa Road, Hyde Road, and W. Vaughn Road. Minor structures at CUP #2 such as an apparent well to the north and a water tank to the south exist as seen in PL09 and PL13 in Appendix C, respectively. Bird activity among various
