FAULT HAZARD EVALUATION
PROPOSED COMMERCIAL DEVELOPMENT
PARCELS APN 283-280-020, 283-180-001
TEMESCAL CANYON ROAD
COUNTY OF RIVERSIDE, CALIFORNIA
RIVERSIDE COUNTY GEOLOGIC REPORT # 18195

CTE JOB NO.: 40-3640G

FEBRUARY 25, 2019

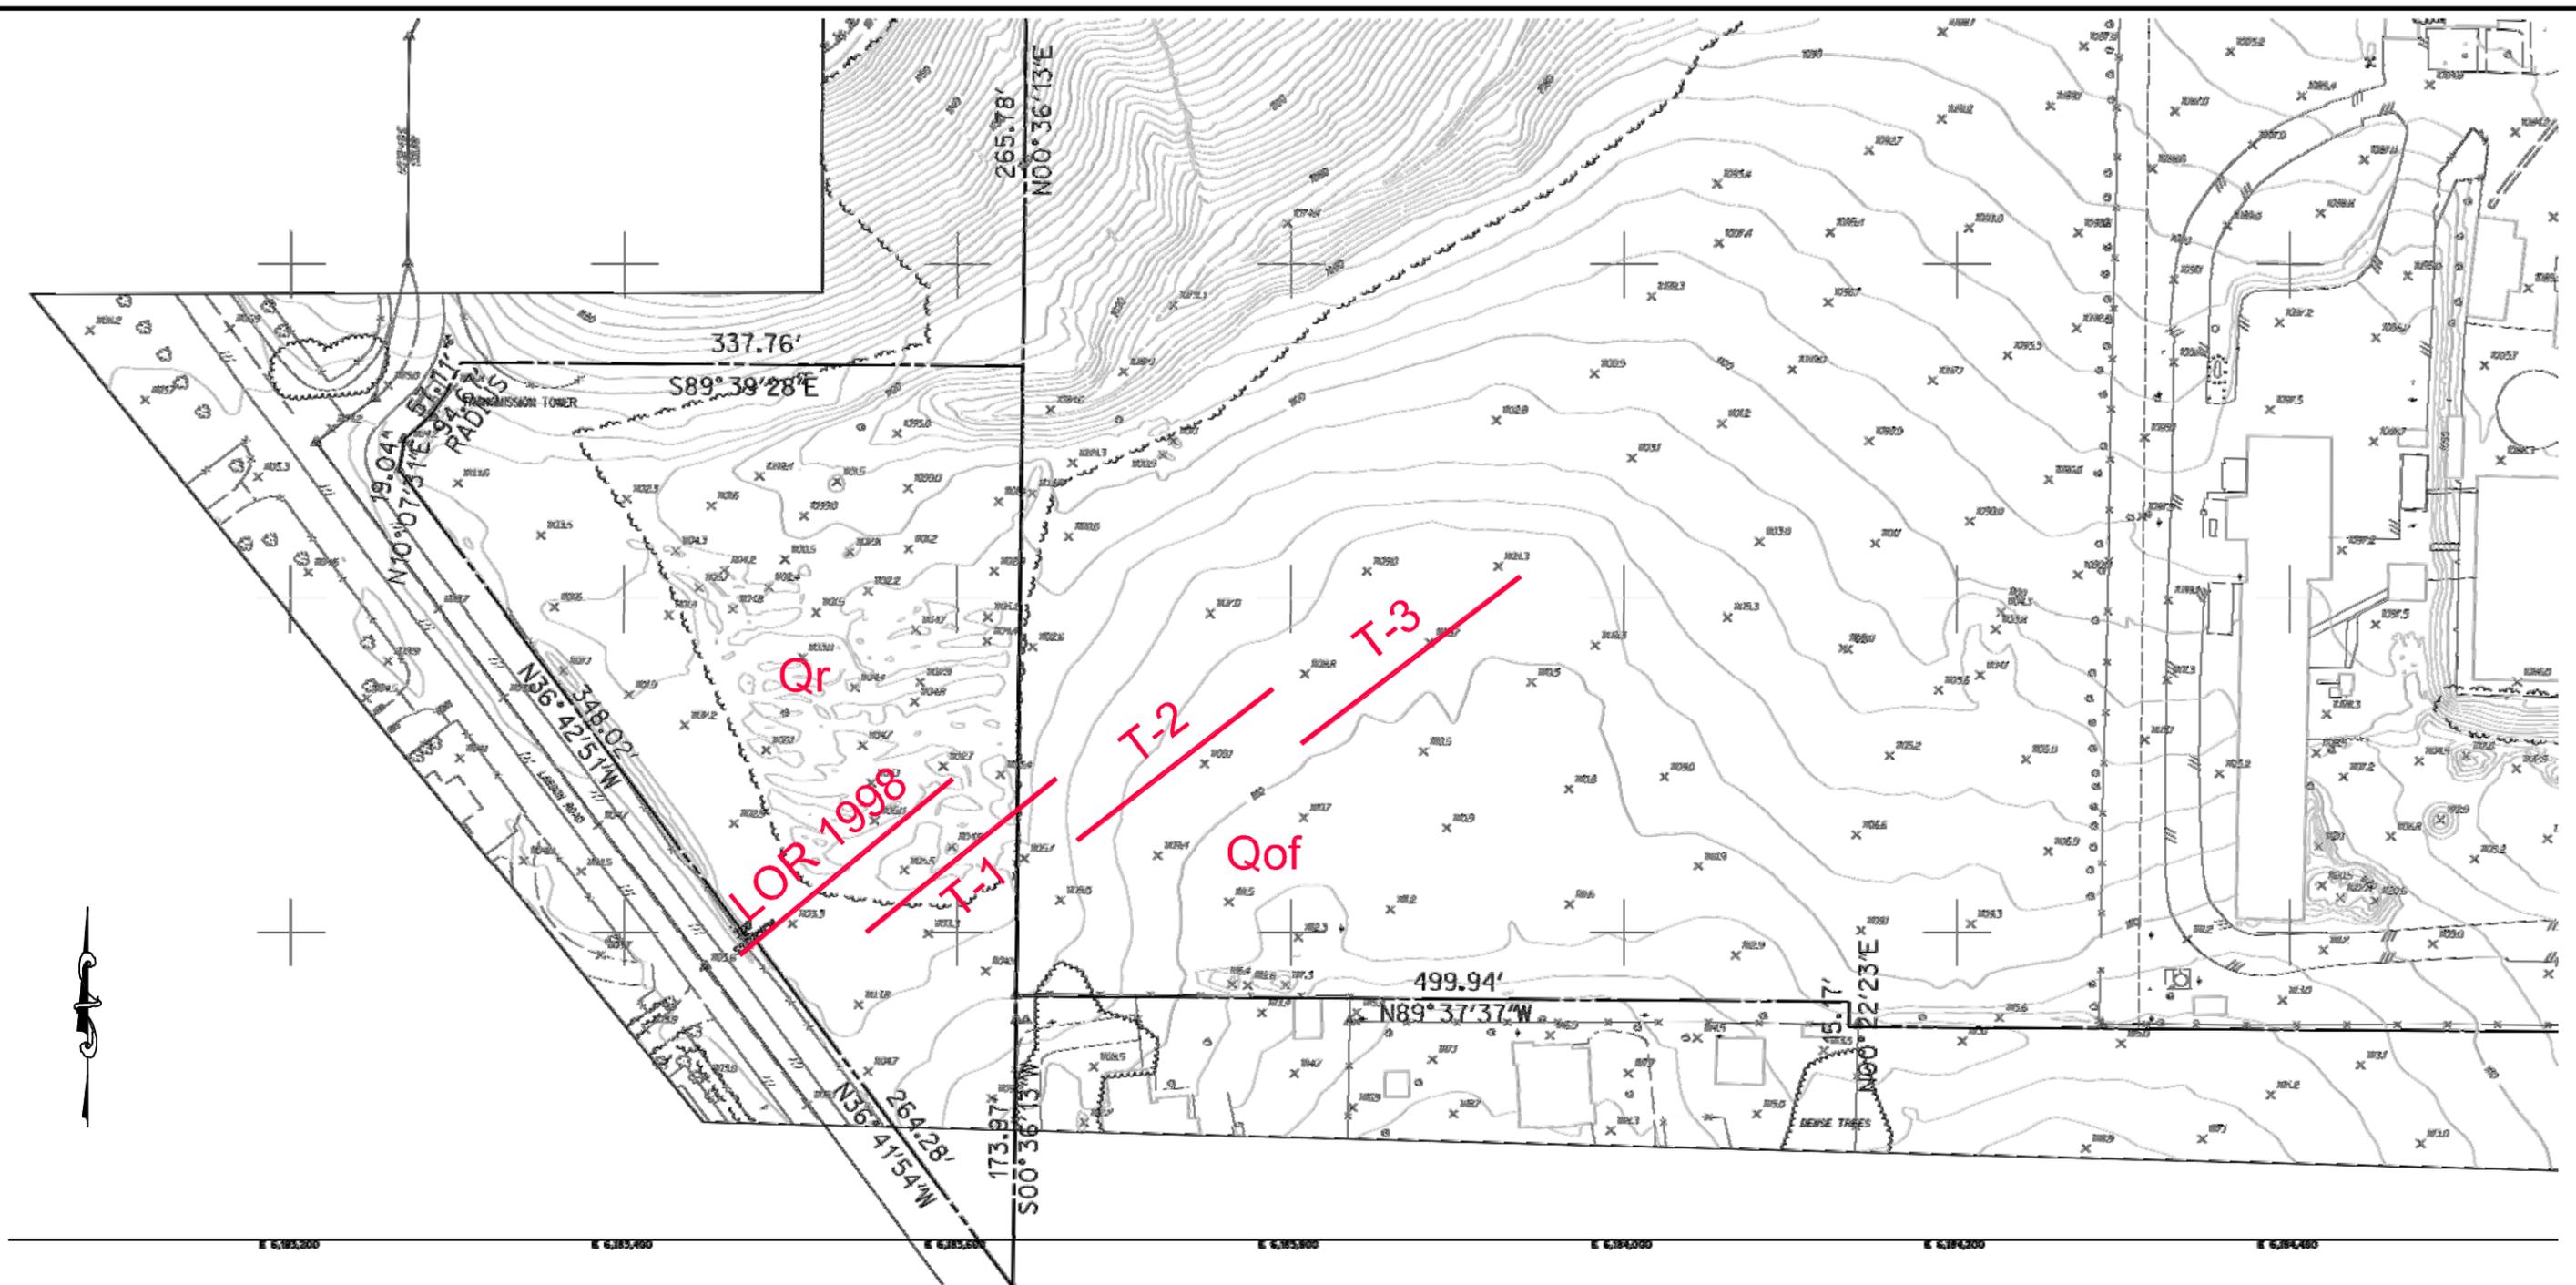
During our previously completed geotechnical investigations dated November 6, 2018, the Old alluvial fan deposits (Qof) were found to consist of brown to red brown, interbedded layers of silty and clayey sand, with gravel in a loose to dense, and dry to moist condition. Layers of sand, fine to coarse gravel and cobbles were also encountered. Qof was observed to unconformably overlie the Silverado Formation (Tsi) at boring location B-1 at an approximate depth of 35 feet which is located in the vicinity of exploratory trench T-1. (Figure 4)

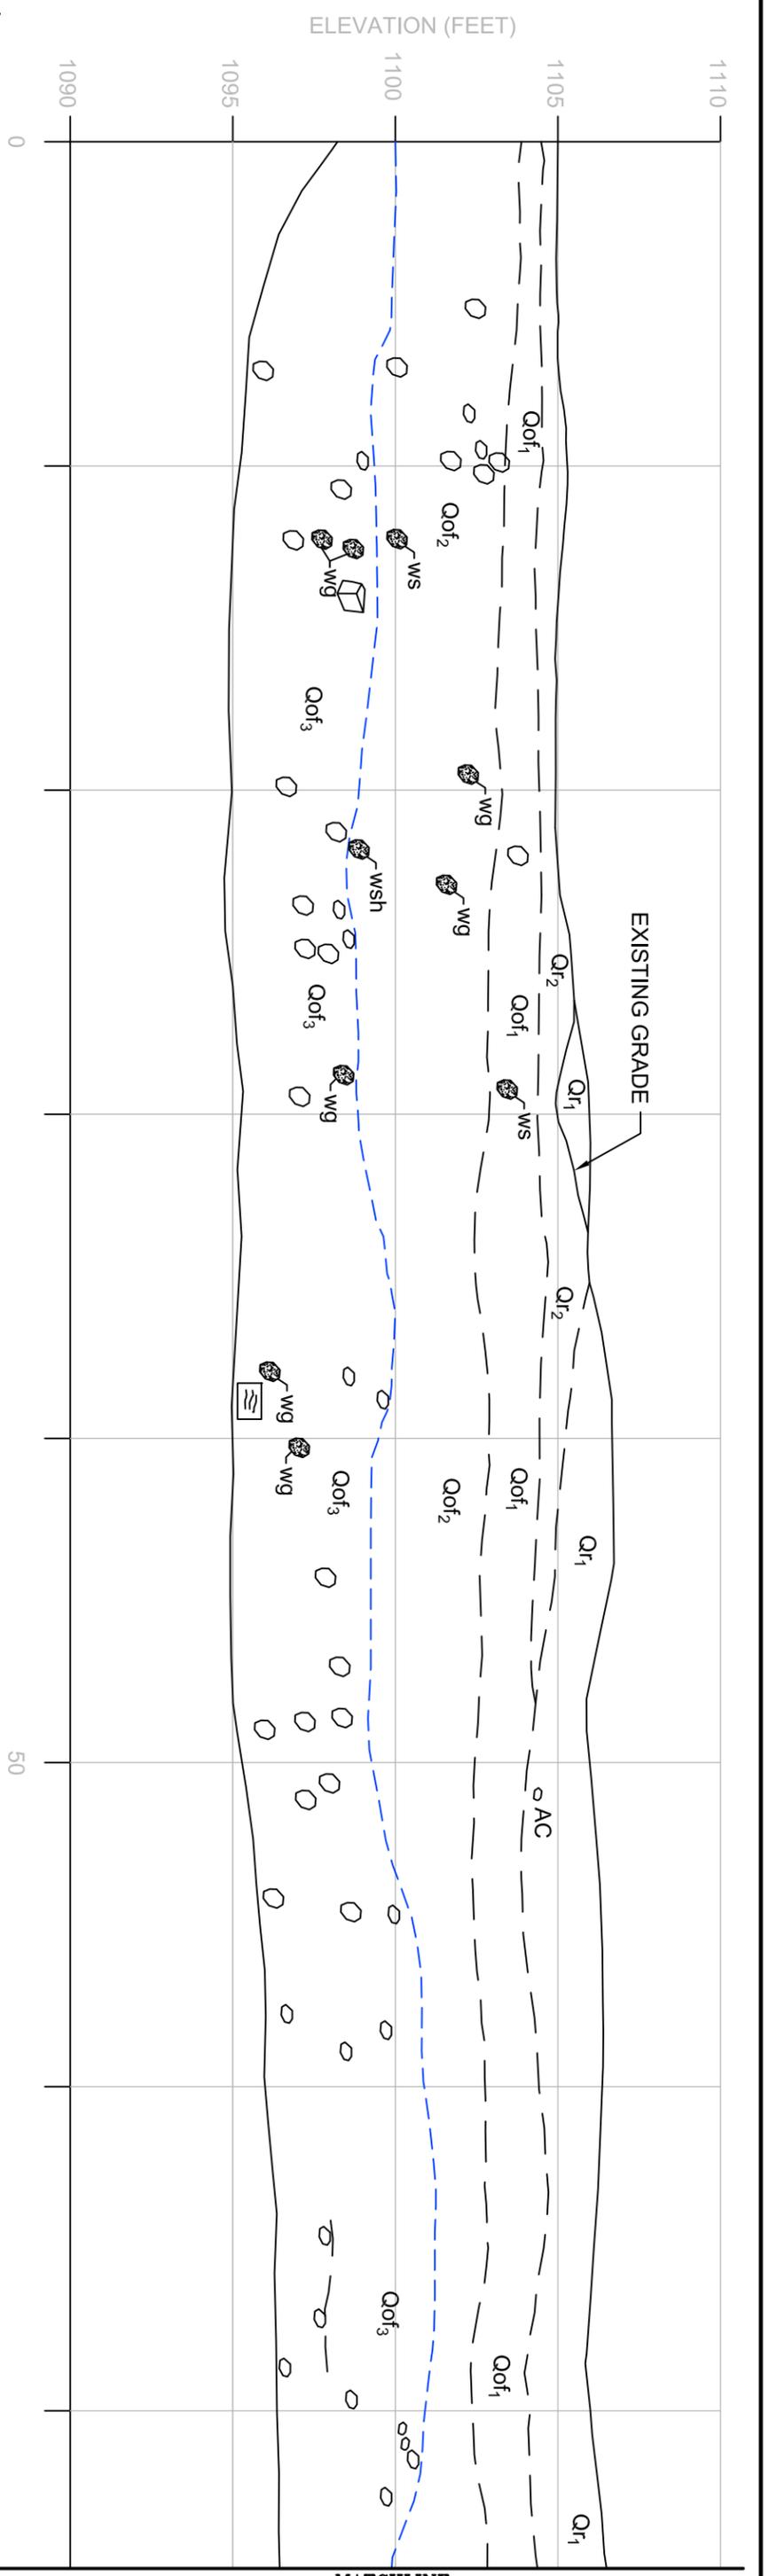
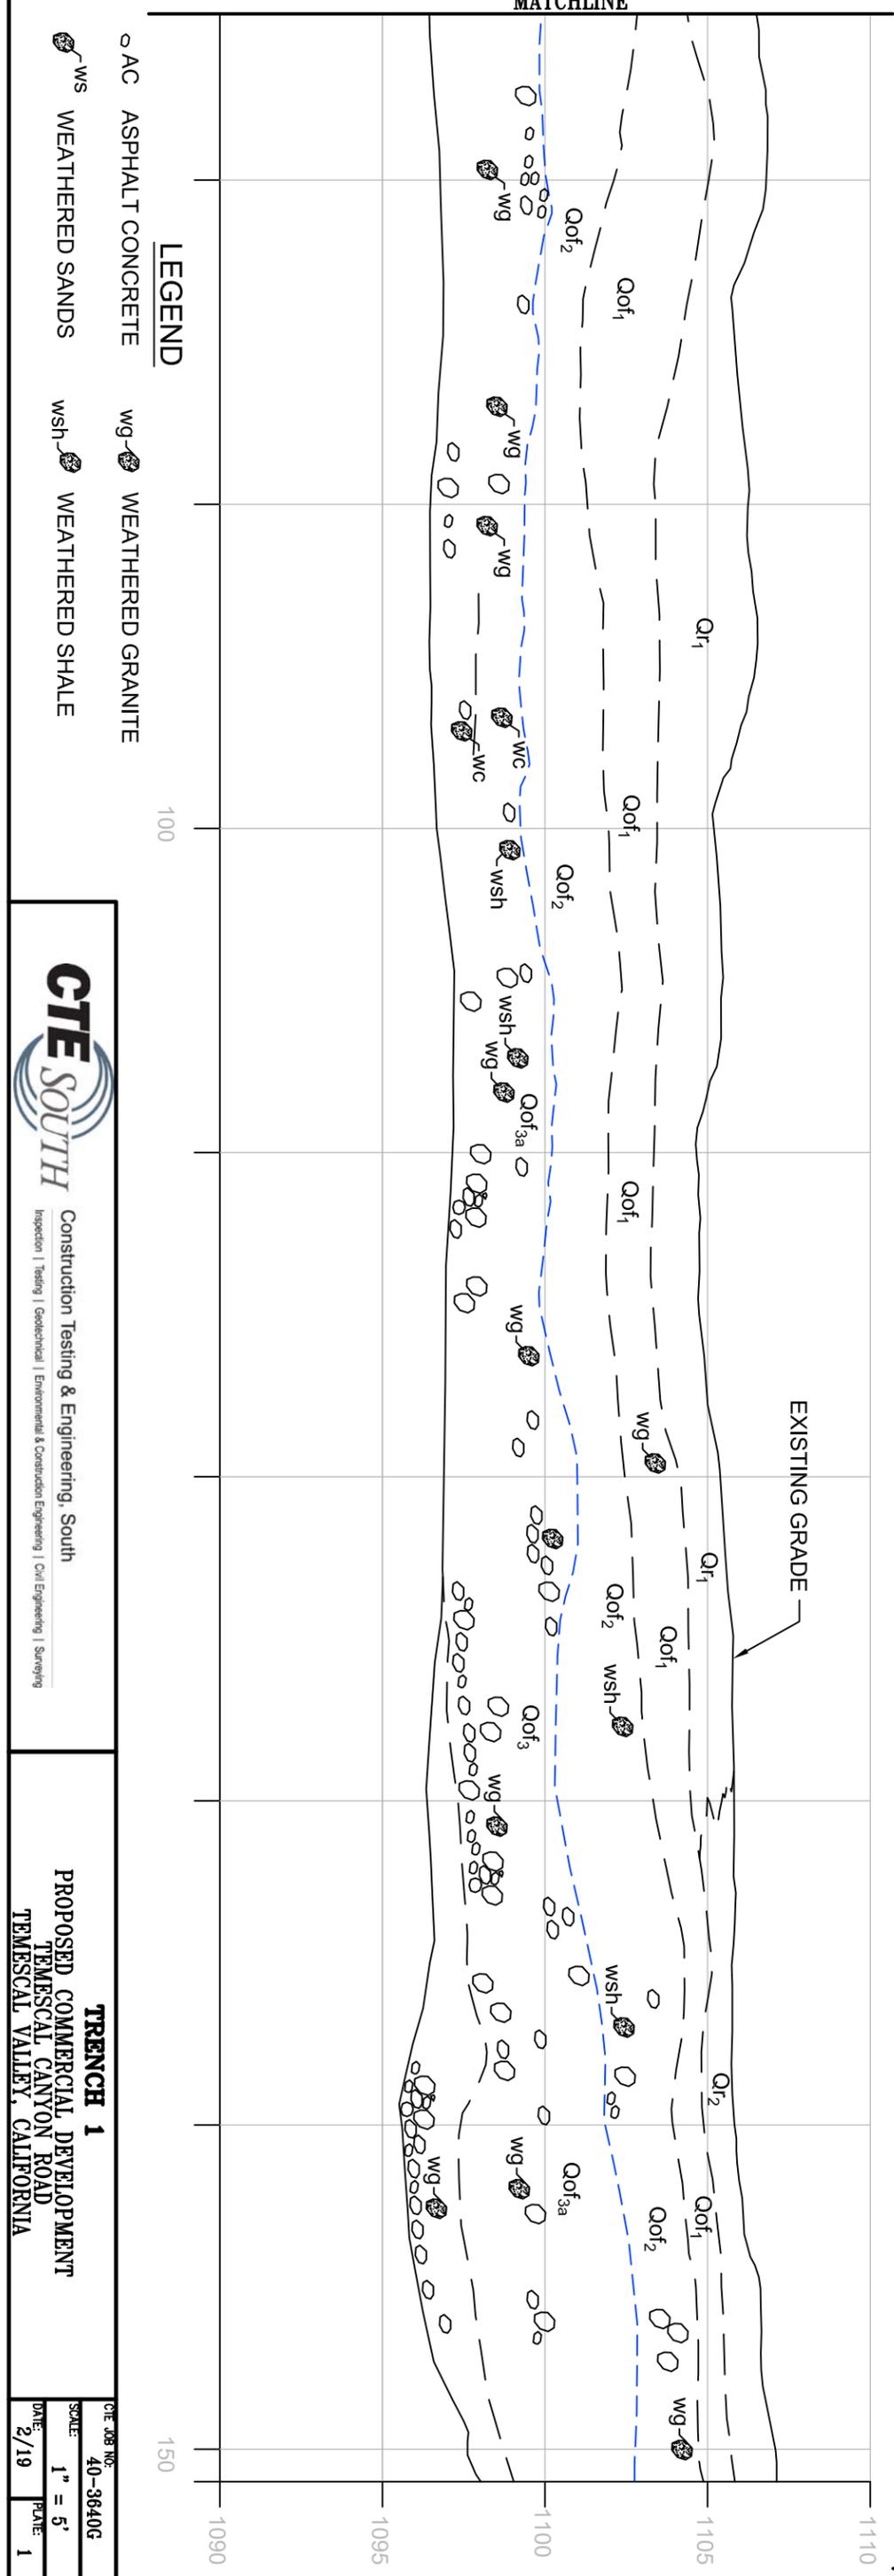
TRENCH 1
 PROPOSED COMMERCIAL DEVELOPMENT
 TEMESCAL CANYON ROAD
 TEMESCAL VALLEY, CALIFORNIA

Recently stockpiled material (Qr₁) is observed in T-1 from approximately. 35- 130 feet.

No evidence of faulting or fissuring was observed in the fault trenches, such as offset of deposited layers, clay gouge zones, or zones of intensely to closely spaced fractures. Locally discontinuous, lateral pinching of layers, lenticular shaped zones, and gradational contacts appear to be characteristic of a fluvial environment.

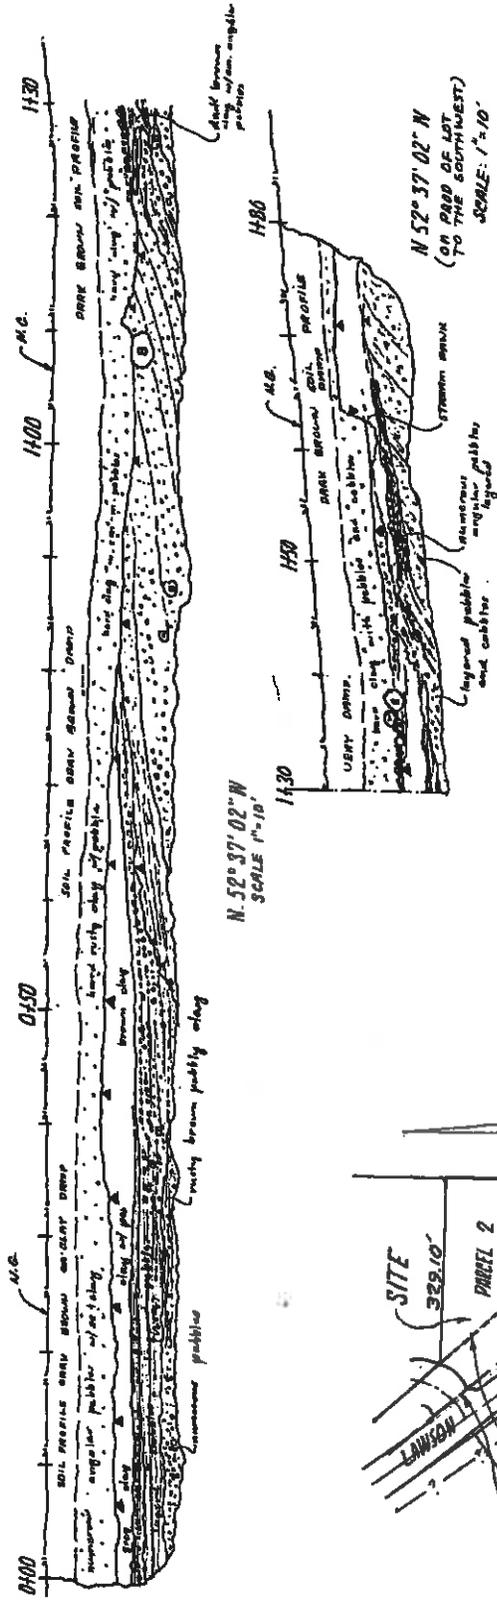
TRENCH CROSS SECTION
 FOR
 PARCEL 2 OF PARCEL MAP NO. 13386
 LEWIS E. LOHR & ASSOCIATES

1. Your exploratory trenching on the subject property revealed that there is no evidence of Holocene faulting on the site.
2. The active, Glen Ivy North fault, a branch of the Elsinore Fault Zone lies approximately 100 feet to the southwest of the subject property. The approximate location of the Glen Ivy North fault is delineated on Plate I, Trench Location Map accompanying your report.
3. It is unlikely that ground rupture could occur across those portions of the subject property that are not located within your fault setback zone as recommended below.
