## Preliminary Arborist Report

**University Station**  
451 El Camino Real  
Santa Clara, CA

**March 2024**

**Updated August 7, 2024**

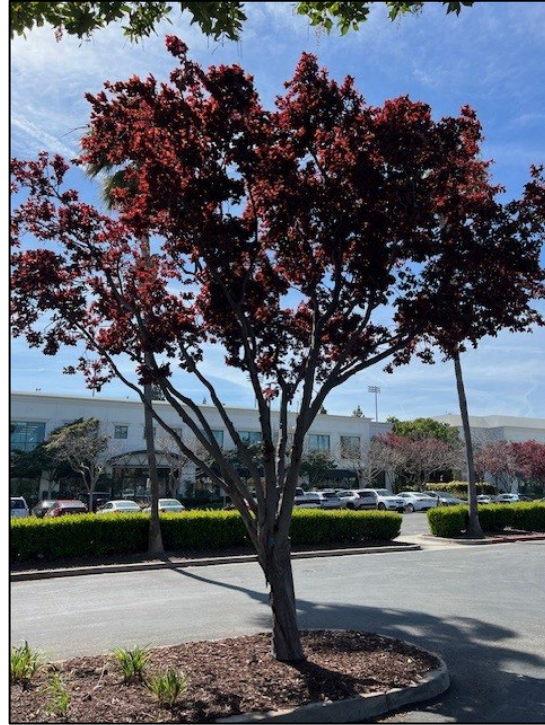
**Photo 1.** Purpleleaf plum #121 had fair structure and form with multiple attachments at 3 feet.

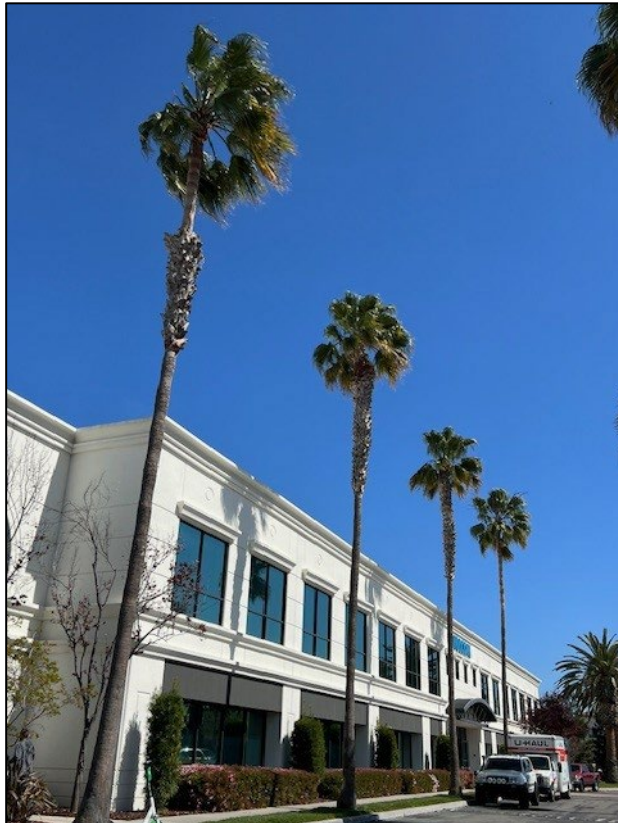
**Photo 2 (left).** Mexican fan palms #81 (L) – 78 (R) were in fair condition with long, slender trunks and full pineapple crowns.

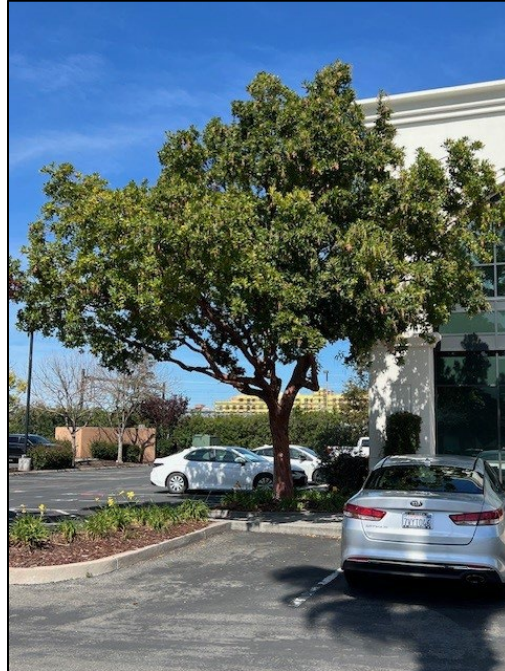
**Photo 3.** Strawberry tree #120 was in good condition with good structure and form and a full crown.

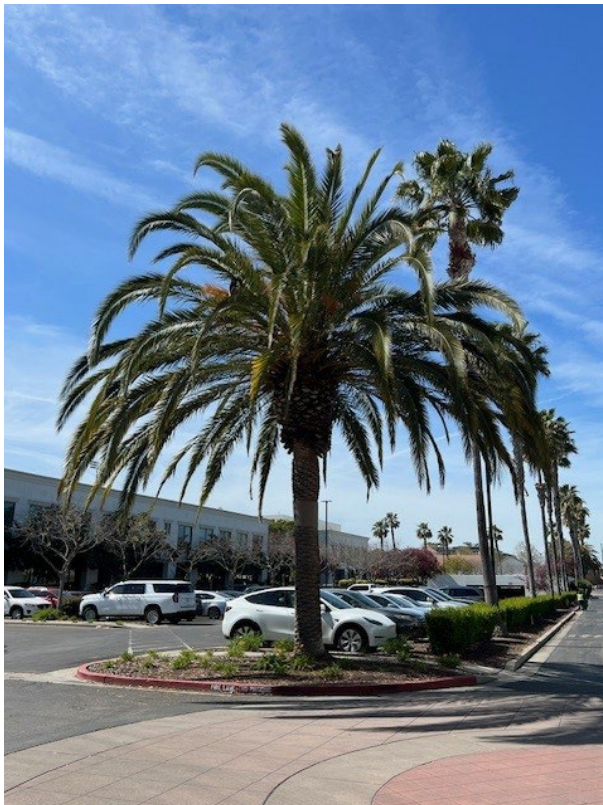
**Photo 4.** Canary Island date palm #122 was in good condition with a full crown and good frond color.

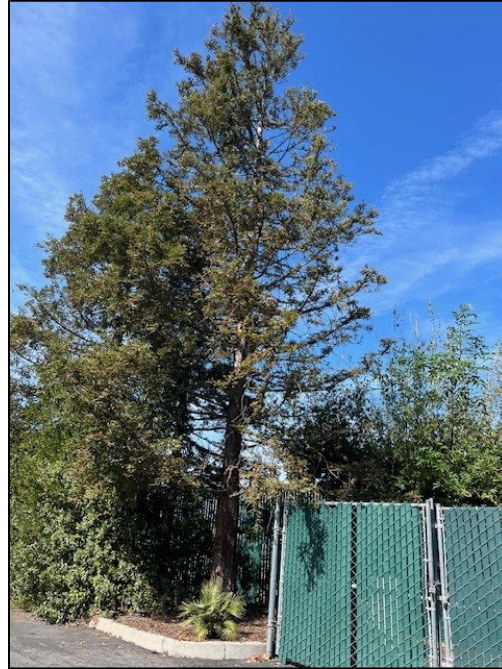
**Photo 5.** Coast redwood #111 was in fair condition with a thin crown and browning leaves.

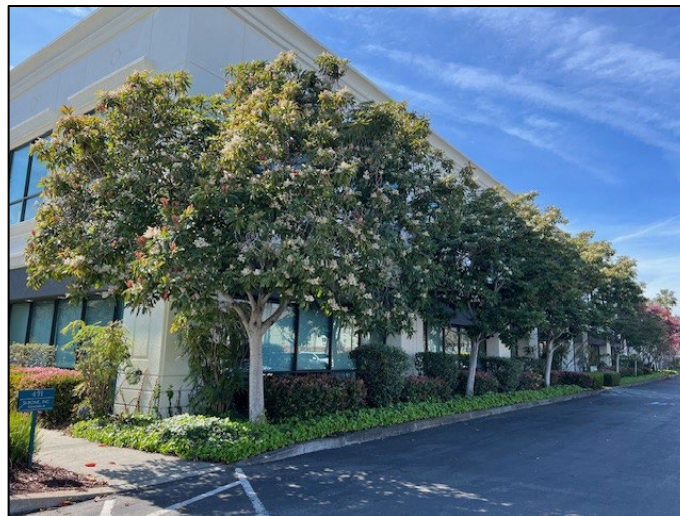
**Photo 6.** Bronze loquats #218 (L) – 216 (R) were in either fair or good condition with fair form.
