Arborist Report

8881 Calvine Chevron Project

Sacramento County, California

November 8, 2023

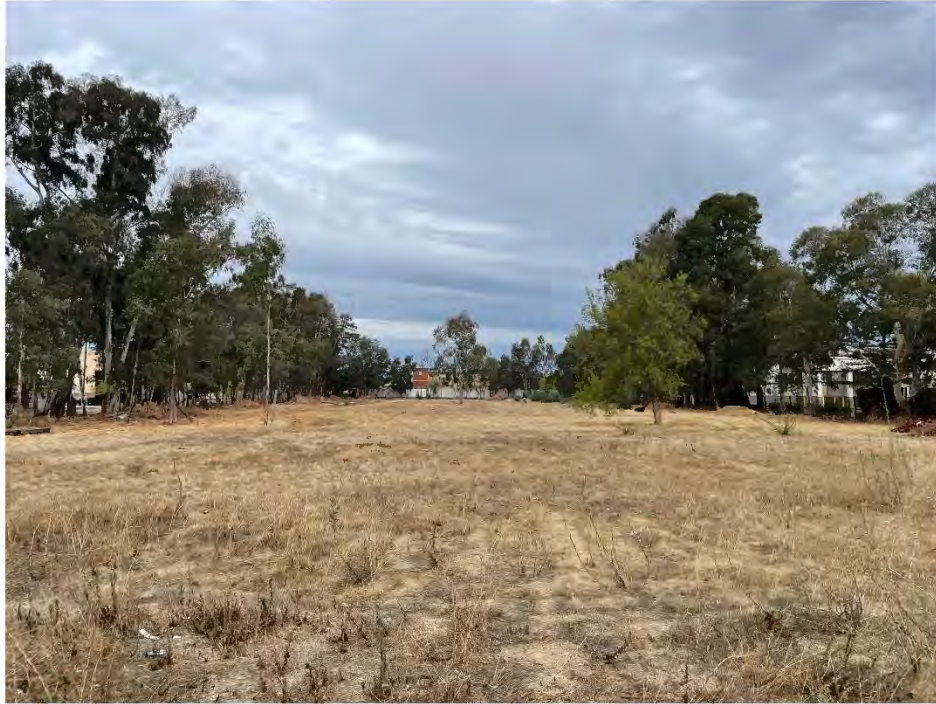
Photo 1. View of the project site looking north from the southern portion of the site, showing the band of Eucalyptus trees around the perimeter.

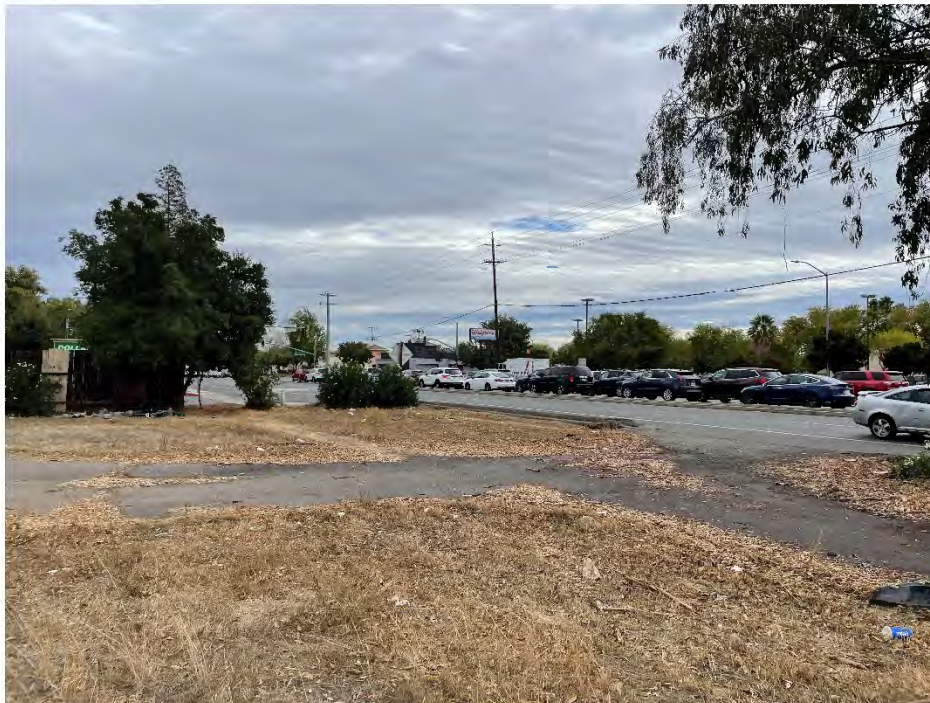
Photo 2. View of the area in the southern portion of the project site that formerly contained a residence. The two native oak trees are visible in the background along the site boundary.

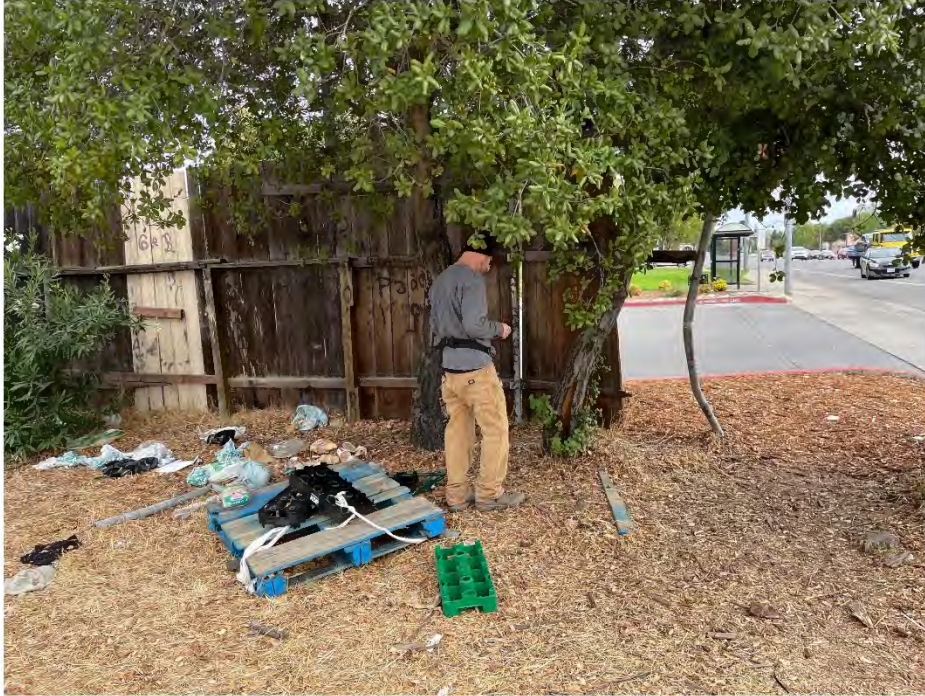
Tag #	Common Name/ Species	DBH (in.)	RPZ (ft)	Health	Structure	Overall Condition	Dripline Environment/ Comments
2002	Interior live oak <i>Quercus wislizeni</i>	11	15	Fair	Fair	Fair	Garbage/debris in dripline. Tree is in fair condition and has average health and structure for the species growing in a semi-natural environment.
2003	Interior live oak <i>Quercus wislizeni</i>	7	10	Poor	Fair	Poor	Garbage/debris in dripline. Large wound on trunk/peeling bark. Tree exhibits crown dieback and is in a state of decline.

Tree # 2003 is recommended for removal because it has a large wound on the trunk and is in decline as evidenced by moderate to severe crown dieback.

Photo 3. Close up view of the two native oak trees with garbage and illegal dumping under the trees.

Tree # 2002 is recommended for preservation on site. Based on the current site plan (Attachment B), it appears the tree will be avoided during construction and its overall condition is good enough that it could thrive on the site. General recommendations for protection of trees to be preserved on site are included as Attachment F. As described in the general recommendations, exclusionary fencing should be

placed at the outer edge of the RPZ of tree 2002 during construction and encroachment into the fencing should be avoided if feasible. If encroachment into the RPZ is necessary, measures should be taken to reduce/prevent root damage and soil compaction such as mulching with 6-8 inches of wood chips or use of steel plates. Post-construction, the use of turf grass or horticultural plantings that would compete with the oak tree should be avoided within the RPZ. The only plant species which should be planted within the RPZ of native oak trees are those which are tolerant of the natural, semi-arid environs of the tree(s) and do not require supplemental irrigation.
