Sacramento County Fuel Station Project

Arborist Report

APNs: 240-006-1002-0000 and 240-006-1001-0000
Address: 4701 & 4705 Auburn Boulevard, Sacramento, CA 95841
Control Number: PLNP2022-00015

May 2022 | 00410.00067.001

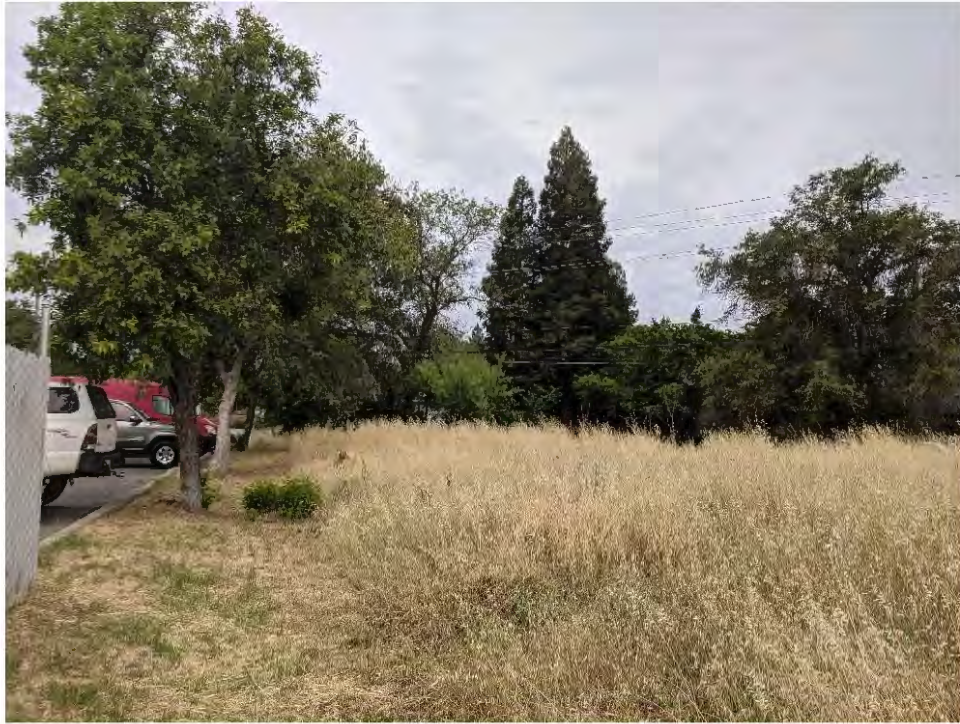
Photo 1. View of blue oak and Oregon ash trees located along the western boundary of the Study Area.

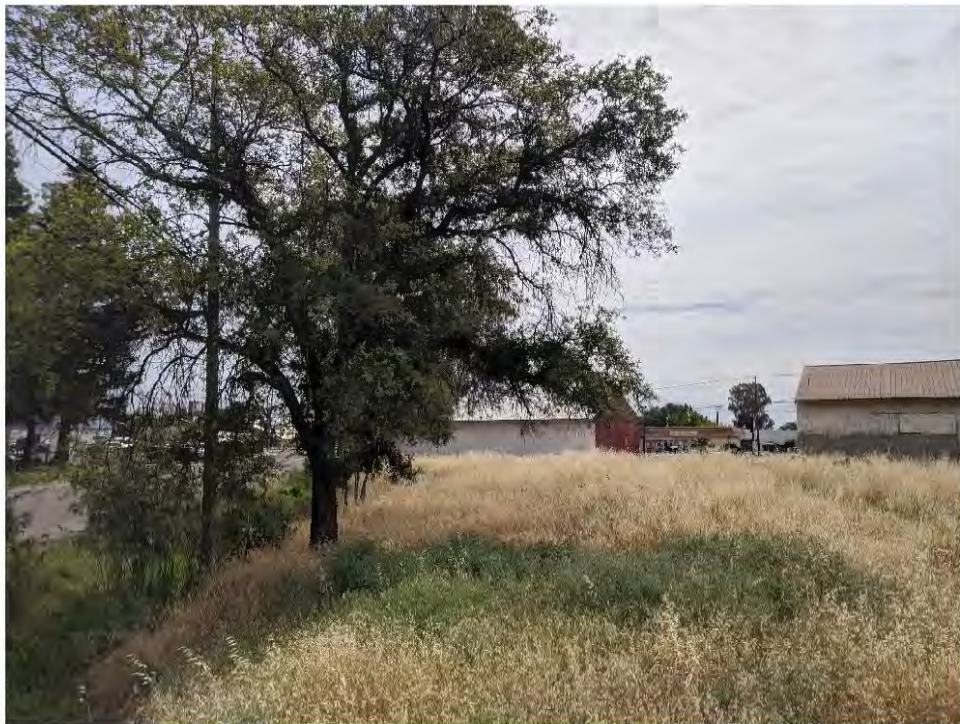
Photo 2. View of valley oak trees along the northern boundary of the Study Area, adjacent to the drainage ditch and Myrtle Avenue.

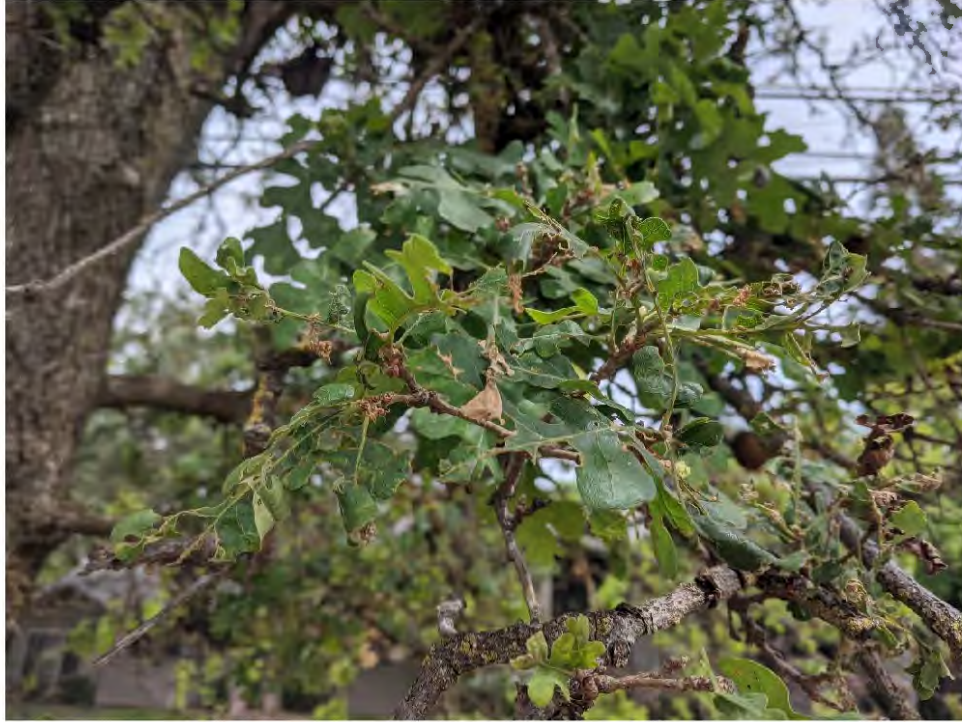
Photo 3. View of insect herbivory affecting Tree #112.

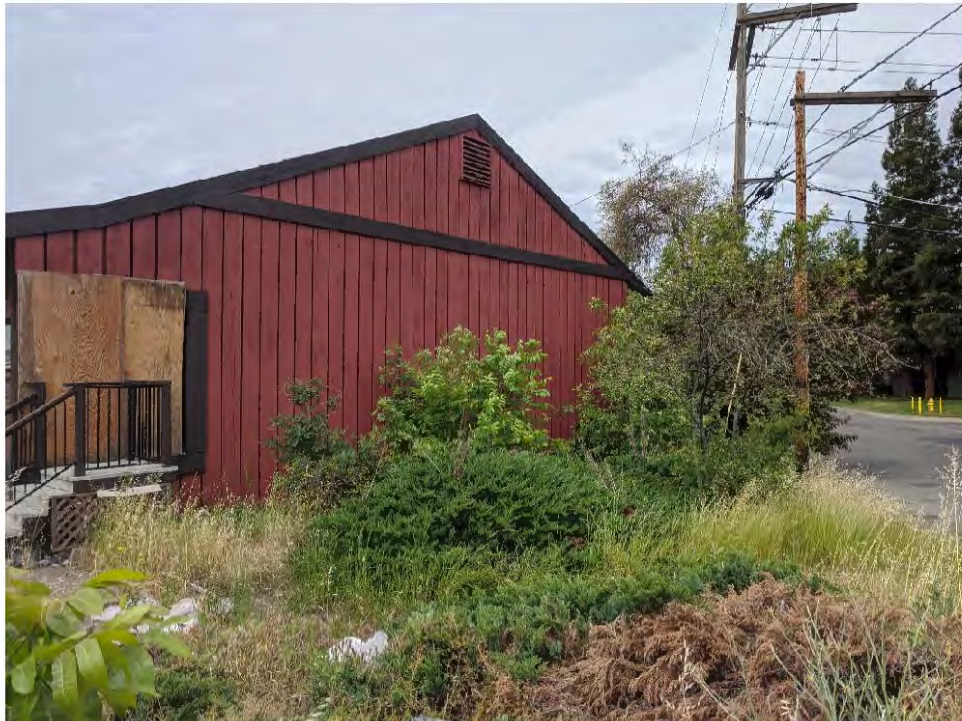
Photo 4. View of shrubs and smaller trees directly adjacent to the vacant commercial building located in the northeastern corner of the Study Area.
