Arborist Report

# Delaney Square Residential Project

City of Azusa, California

OCTOBER 2025

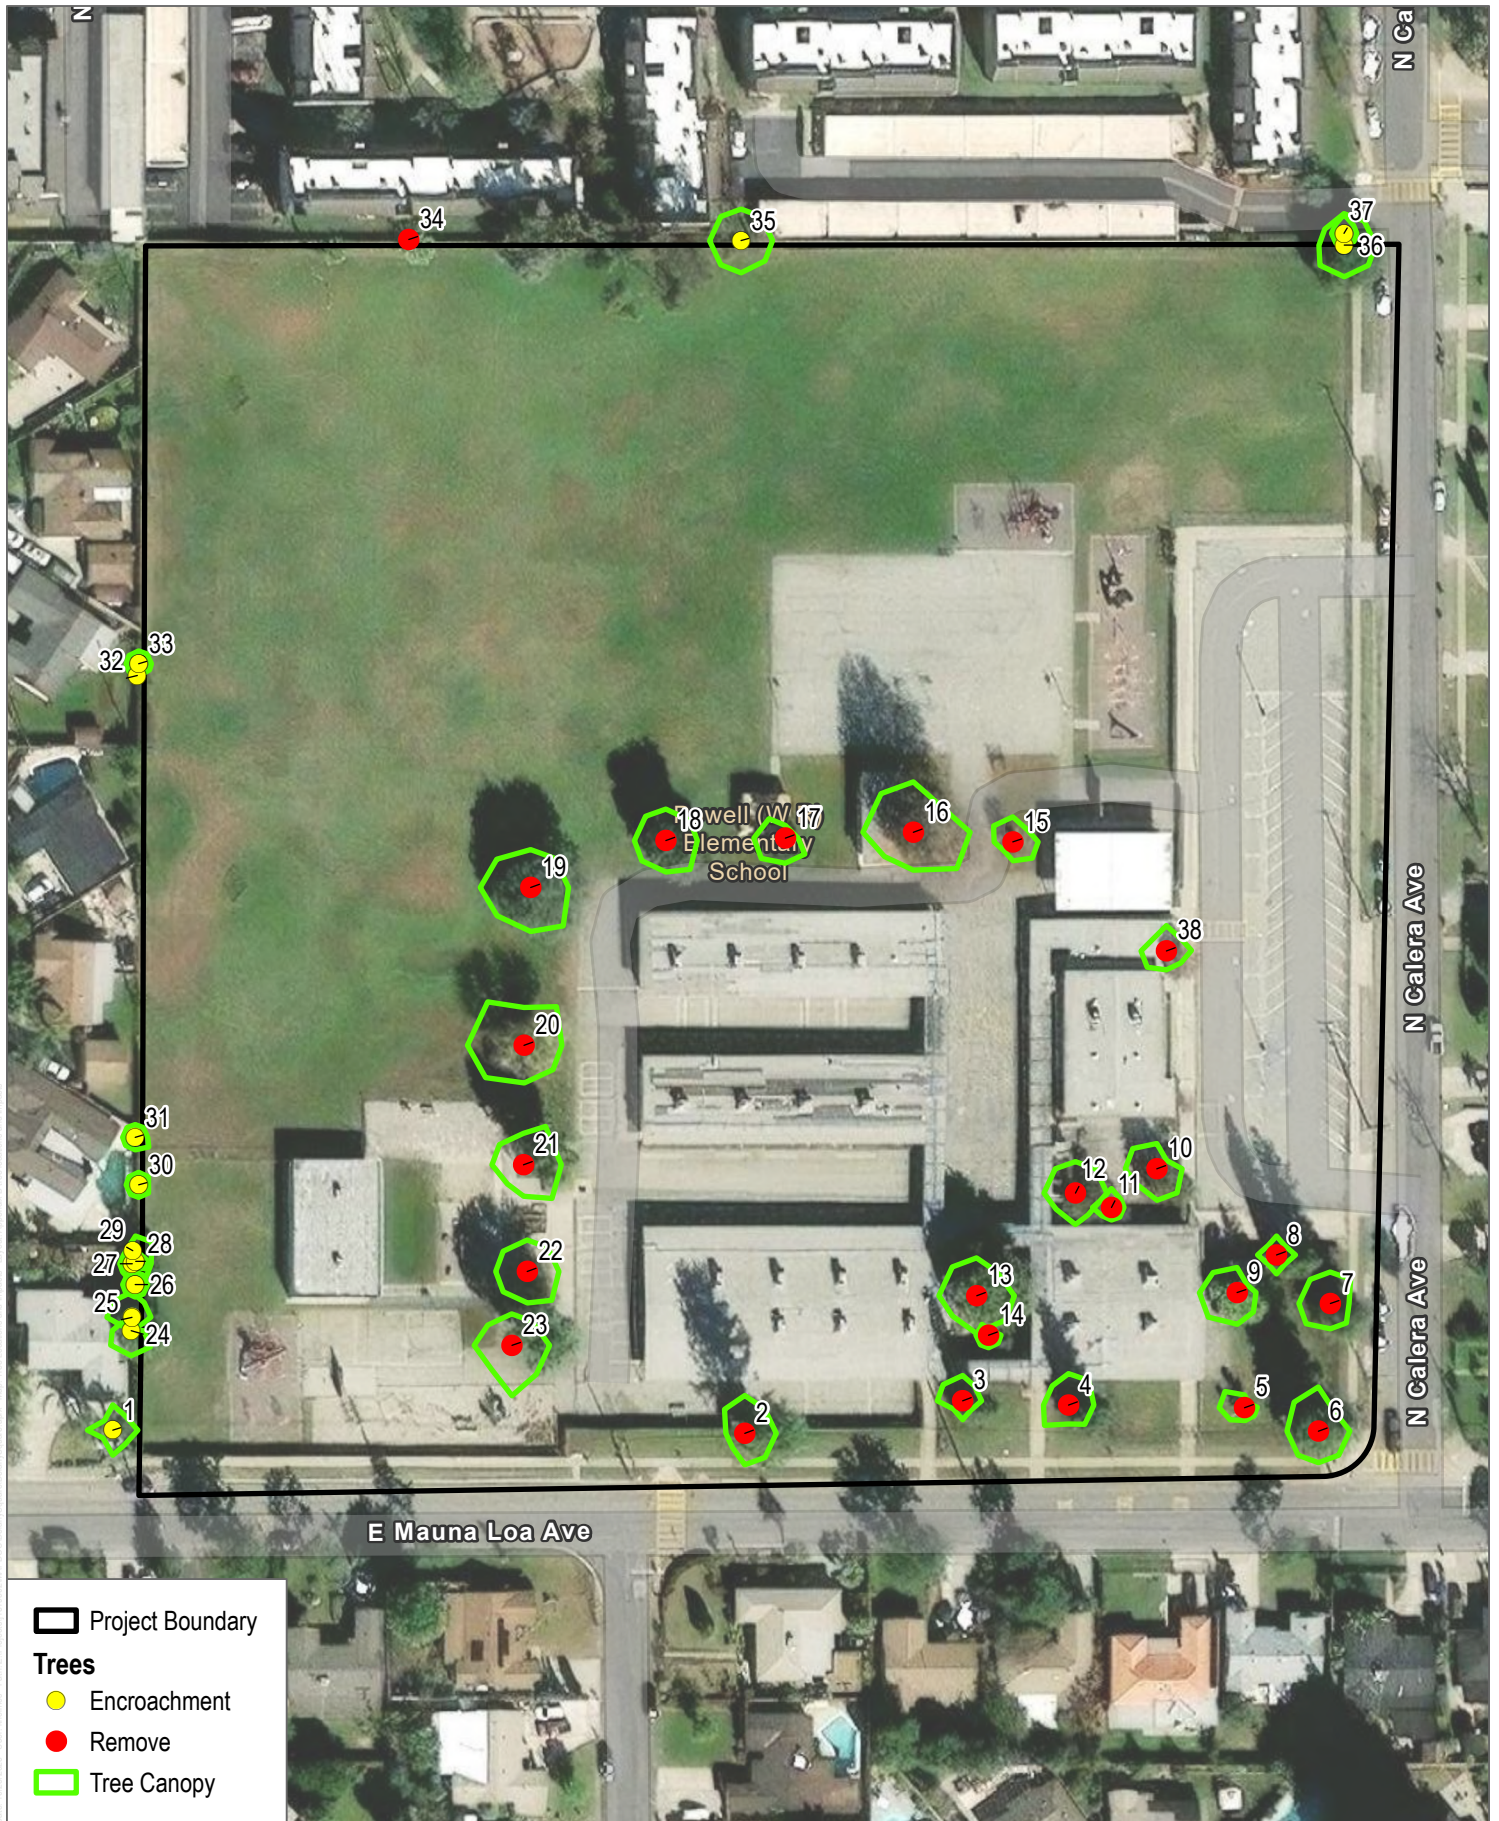
### Tree Locations and Impacts

All 25 trees on-site will require removal, and 13 off-site trees are expected to be encroached upon. Appendix B presents tree locations, categorized by impact type. Measures to minimize the extent of impact to the encroached trees are provided in Section 6, Mitigation Measures. Table 2 provides a summary of the number of trees by species expected to be directly impacted by construction.

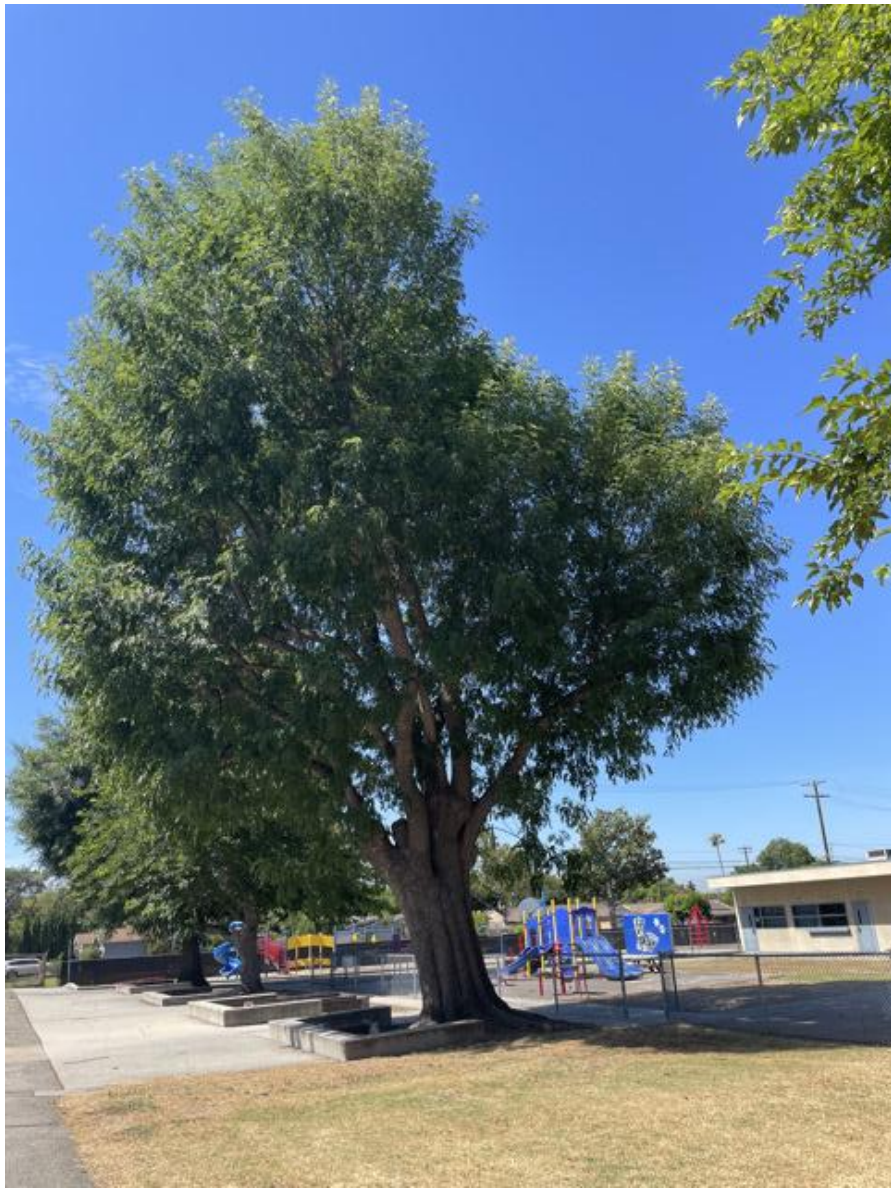
Tree 21

Appendix B presents the location of the individual trees mapped and assessed for the proposed Project. Overall, the trees exhibit growth and structural conditions that are typical of their location in a maintained urban setting. The trees include various trunk and branch maladies and health and structural conditions. As presented in Appendix A, 15.8% of the individually mapped trees (6 trees) exhibit good health, 71.1% (27 trees) are in fair health, 7.89% (3 trees) are in poor health, and 5.26% (2 trees) are dead. Structurally, 5.26% (2 trees) of the individually mapped trees are considered to exhibit good structure, 57.9% (22 trees) exhibit fair structure, 31.6% (12 trees) exhibit poor structure, and 5.26% (2 trees) are dead. The trees in good condition exhibit acceptable vigor, healthy foliage, and adequate structure and lack any major maladies. Trees in fair condition are typical, with few maladies but declining vigor. Termites were observed on tree no. 21. No other pests or pathogens were observed on site.

| Tree Information Matrix | | | | | | | | | | | | | | | | | | | | | | | | |
|---|---|---|---|---|---|---|---|---|---|---|---|---|---|---|---|---|---|---|---|---|---|---|---|---|
| 21 | <i>Fraxinus uhdei</i> | evergreen ash | 51 | 1 | 51 | - | - | - | - | 60 | 15 | 23 | 20 | 22 | 15 | 12 | 17 | 17 | Fair | Poor | Removal | Termite damage on roots | 34.12559639 | -117.8872896 |
