## Preliminary Arborist Report

**3521 Homestead Road  
Santa Clara, CA**

**PREPARED FOR:**  
PulteGroup, Inc.  
4511 Willow Road  
Suite 8  
Pleasanton, CA 94588

**November 2024**

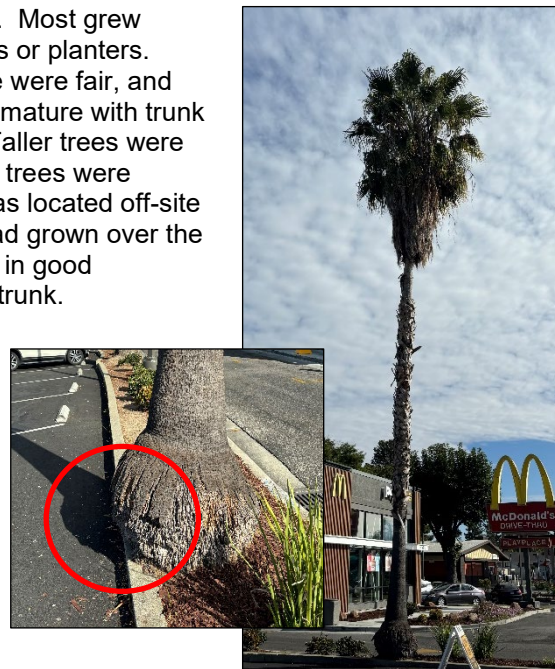
Mexican fan palm was represented by eight trees. Most grew adjacent to the south boundary in landscape strips or planters. Trees #171 and 174 were in good condition, three were fair, and three were poor. Development stage was mostly mature with trunk diameters that averaged 16 inches in diameter. Taller trees were wind-burned with low vigor while younger, shorter trees were vigorous in good and fair condition. Tree #156 was located off-site in a 4-foot landscape strip with a root base that had grown over the curb (Photo 1). Palm #171 was an immature tree in good condition with excellent vigor and 6 feet of brown trunk.

**Photo 1:** Mexican fan palm #156 was off-site with a root base that extended over the curb (inset).

Off-site trees #156 – 163 can be preserved. Successful retention of the trees to be preserved will depend on the care with which work is performed around the trees and all parties committing to the **Preliminary Tree Preservation Guidelines** (next page).

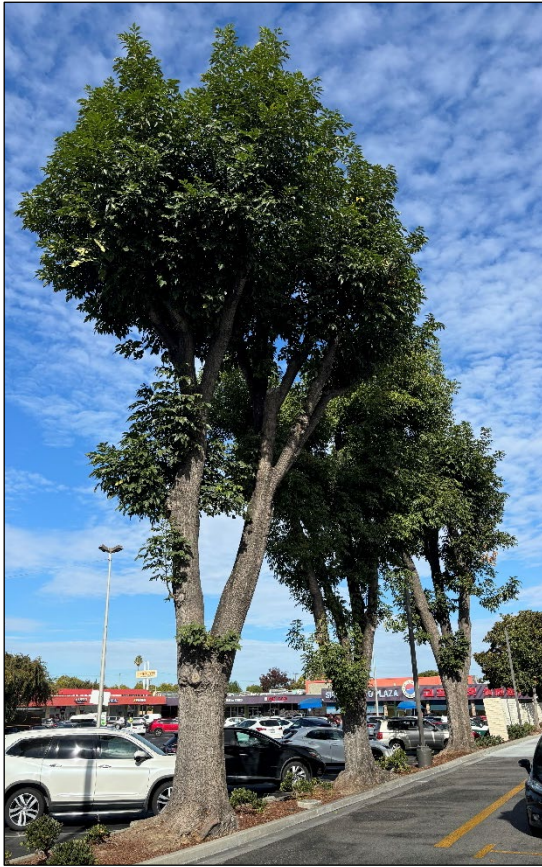
Five evergreen ash trees grew around the perimeter of the site. Condition was mostly poor with four trees having poor structure and a history of poor pruning. Three trees (#157, 158, and 159) grew off-site in a 4-foot-wide landscaping strip (Photo 2). Tree crowns had been raised over the parking lot and repeatedly topped. Surface roots were extensive, root flare had been cut flat on the east, and roots significantly disrupted curbs (Photo 3). Branches extended approximately 20 feet onto the subject property. Tree #176 grew at the edge of a field adjacent to a parking lot. It was in poor condition with multiple narrow attachments at the base and a history of poor pruning. Tree #180 was a large specimen tree located 5 feet from the sidewalk at the northeast corner. The crown was raised and reduced away from power lines, had a history of branch failure, and was severely asymmetric to the south (Photo 4). Condition, however, was fair with extensive shoot growth.

**Photo 2:** Evergreen ashes #157, 158, and 159 (L-R) grew in a narrow planter. Root flares had been cut flat and crowns were repeatedly topped.

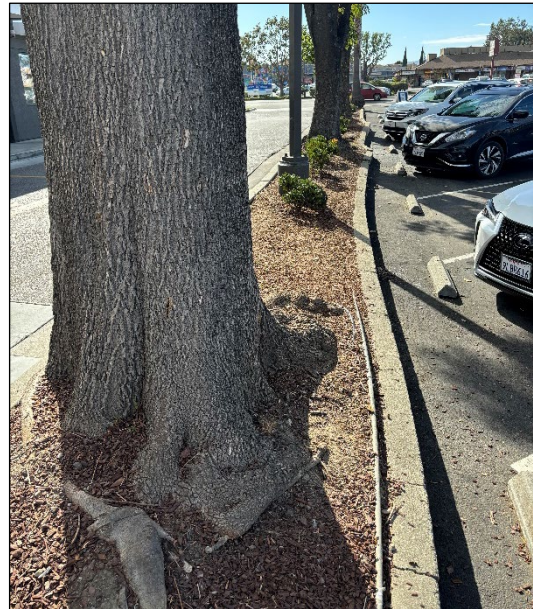
**Photo 3:** Significant curb displacement adjacent to trees #157, 158, and 159.

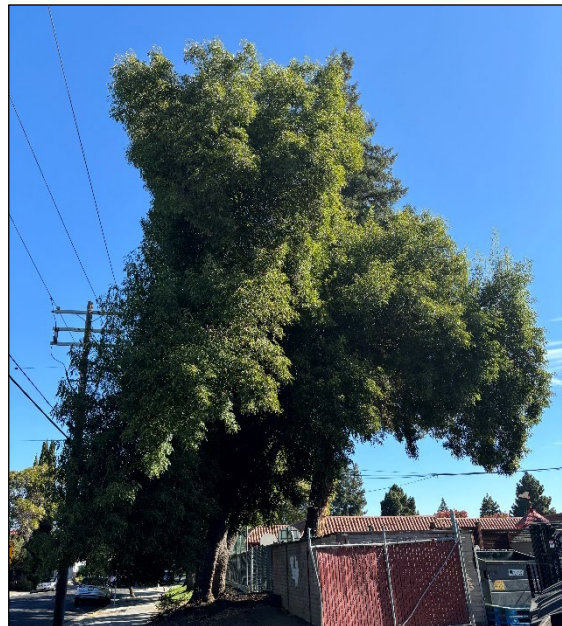
**Photo 4:** Evergreen ash #180 was a mature specimen tree with a severely asymmetric crown.

Based on these criteria, evergreen ash #180 is *Protected* and will require a permit for removal.

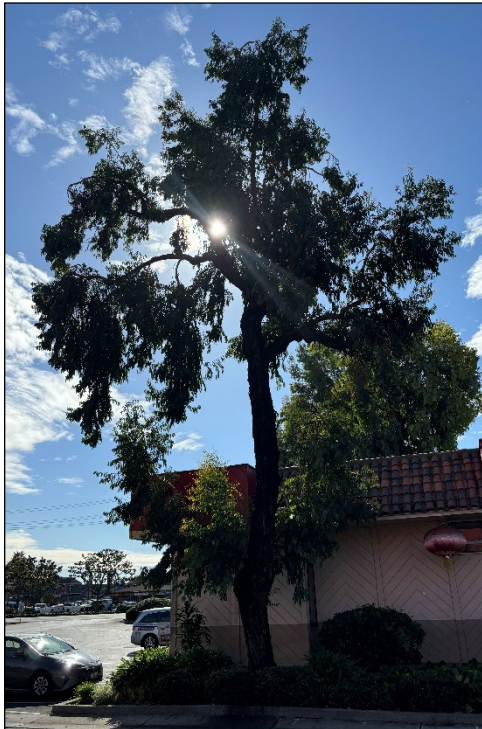
Mature red ironbarks #166 and 167 grew in separate planters between a driveway and building. Tree #166 was in poor condition with a crook at 6 feet, poor structure, a high crown, and history of branch failure (Photo 5). Tree #167 was in fair condition and vigorous with poor structure, extensive epicormic growth, and a dense crown. Extensive girdling roots were amassed on the east side of the base (Photo 6).

**Photo 5:** Red ironbark #166 was in poor condition with poor structure and a high crown.

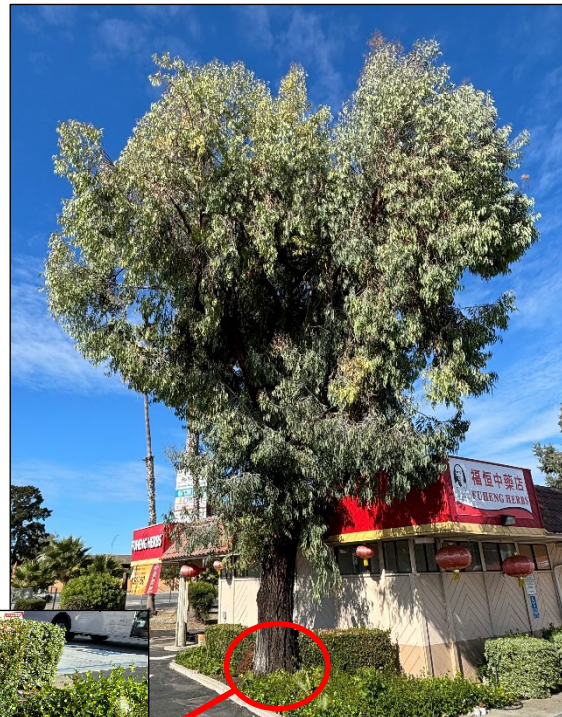
**Photo 6:** Red ironbark #167 had a dense vigorous crown and girdling roots (inset).
