## GEOLOGIC HAZARD REPORT

HOWELL MOUNTAIN CEMETERY  
1225 HOWELL MOUNTAIN ROAD  
ANGWIN, CALIFORNIA

**7775.01.01.2**

October 25, 2023

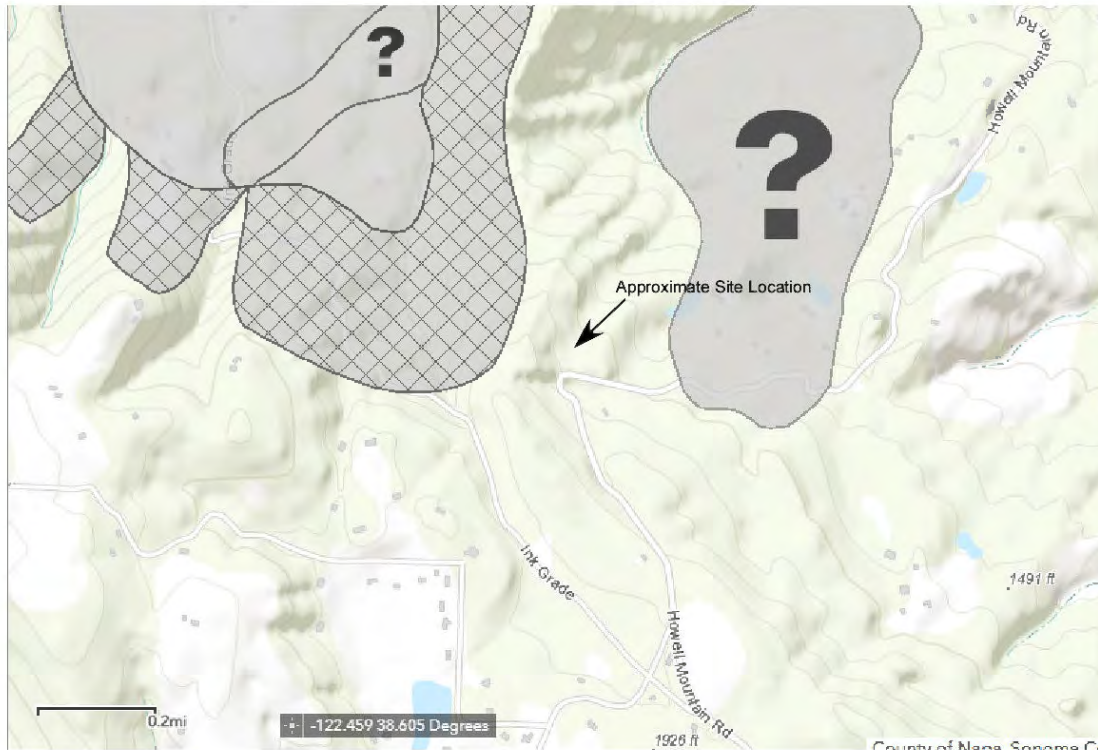
The California Landslide Inventory (CGS, 2023) does not indicate large-scale slope instability at the portion of the site to be developed. However, large-scale landslides are mapped downslope of the project site and on the opposite side of the ridge to the northwest of the development area (see below). Although not shown on the CGS map, the scarp of the landslide downslope of the project site extends upwards toward the project site. The scarp of this large-scale feature exposes undisturbed lithic tuff bedrock. The observed landslide scarp is mapped on Plate 2.

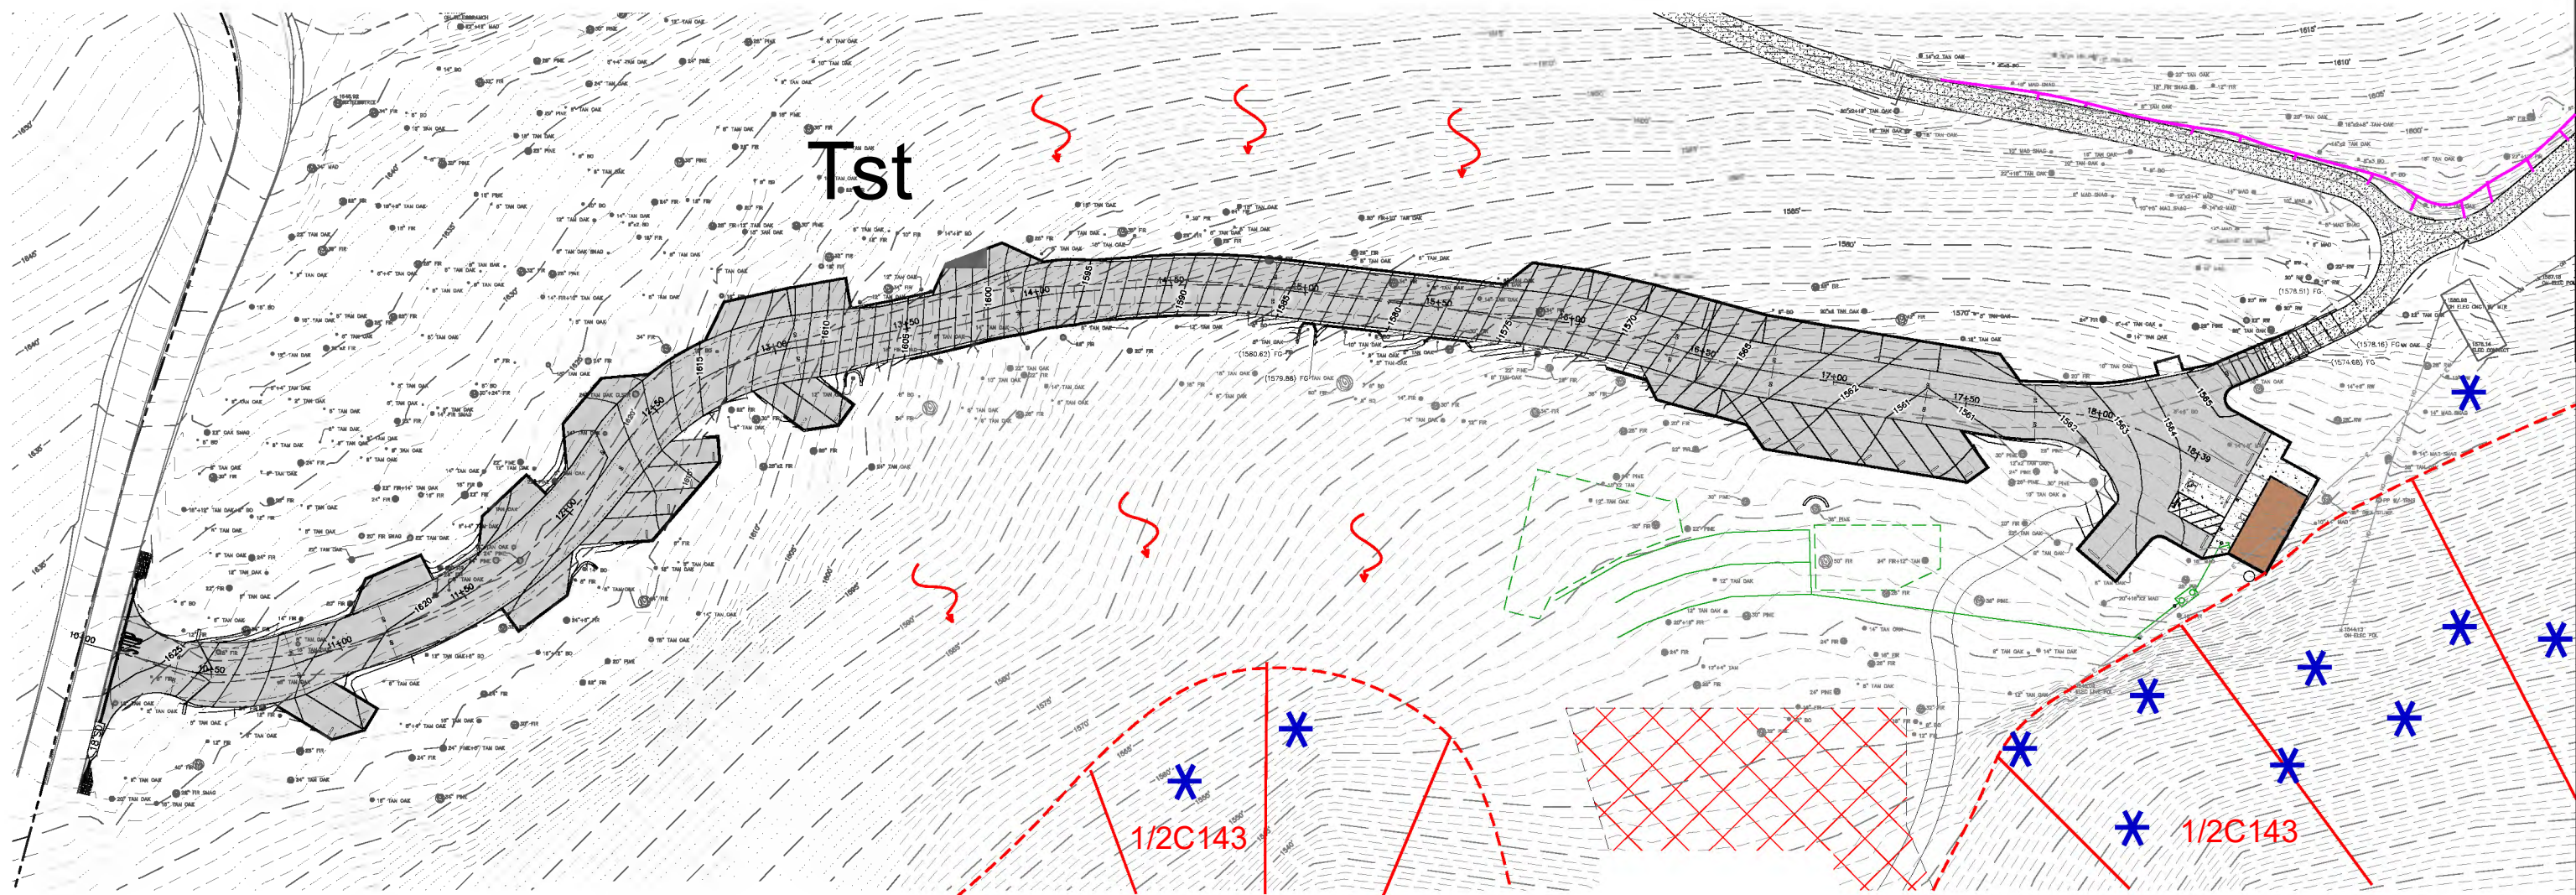
**SITE RECONNAISSANCE PLAN**

As discussed previously, the scarp of a large scale landslide feature was mapped and observed at the project site. The observed landslide features are mapped on Plate 2. We understand that the planned development will not encroach into the landslide features, but the welcome center will be constructed adjacent to the scarp of a large landslide feature. We did observe undisturbed bedrock outcrops exposed in the scarp feature. The welcome center planned adjacent to the scarp feature should gain support in undisturbed bedrock and should have adequate lateral confinement based on the slope geometry and bedrock joint and/or bedding orientations should be considered in the foundation construction. The final geotechnical study should address these issues in detail.

The proposed building envelope for the welcome center must be located outside unstable areas and steep slopes in order to reduce the risks associated with slope instability. The location of the building envelope in relation to such areas is shown on Plate 2. A site-specific study should finalize recommended structural set back and foundation design for the welcome center.
