**LIMITED ADDITIONAL ENGINEERING**

**GEOLOGIC FAULT INVESTIGATION**

**APN 558-41-033, OLD SANTA CRUZ HIGHWAY**

**SANTA CLARA COUNTY, CALIFORNIA**

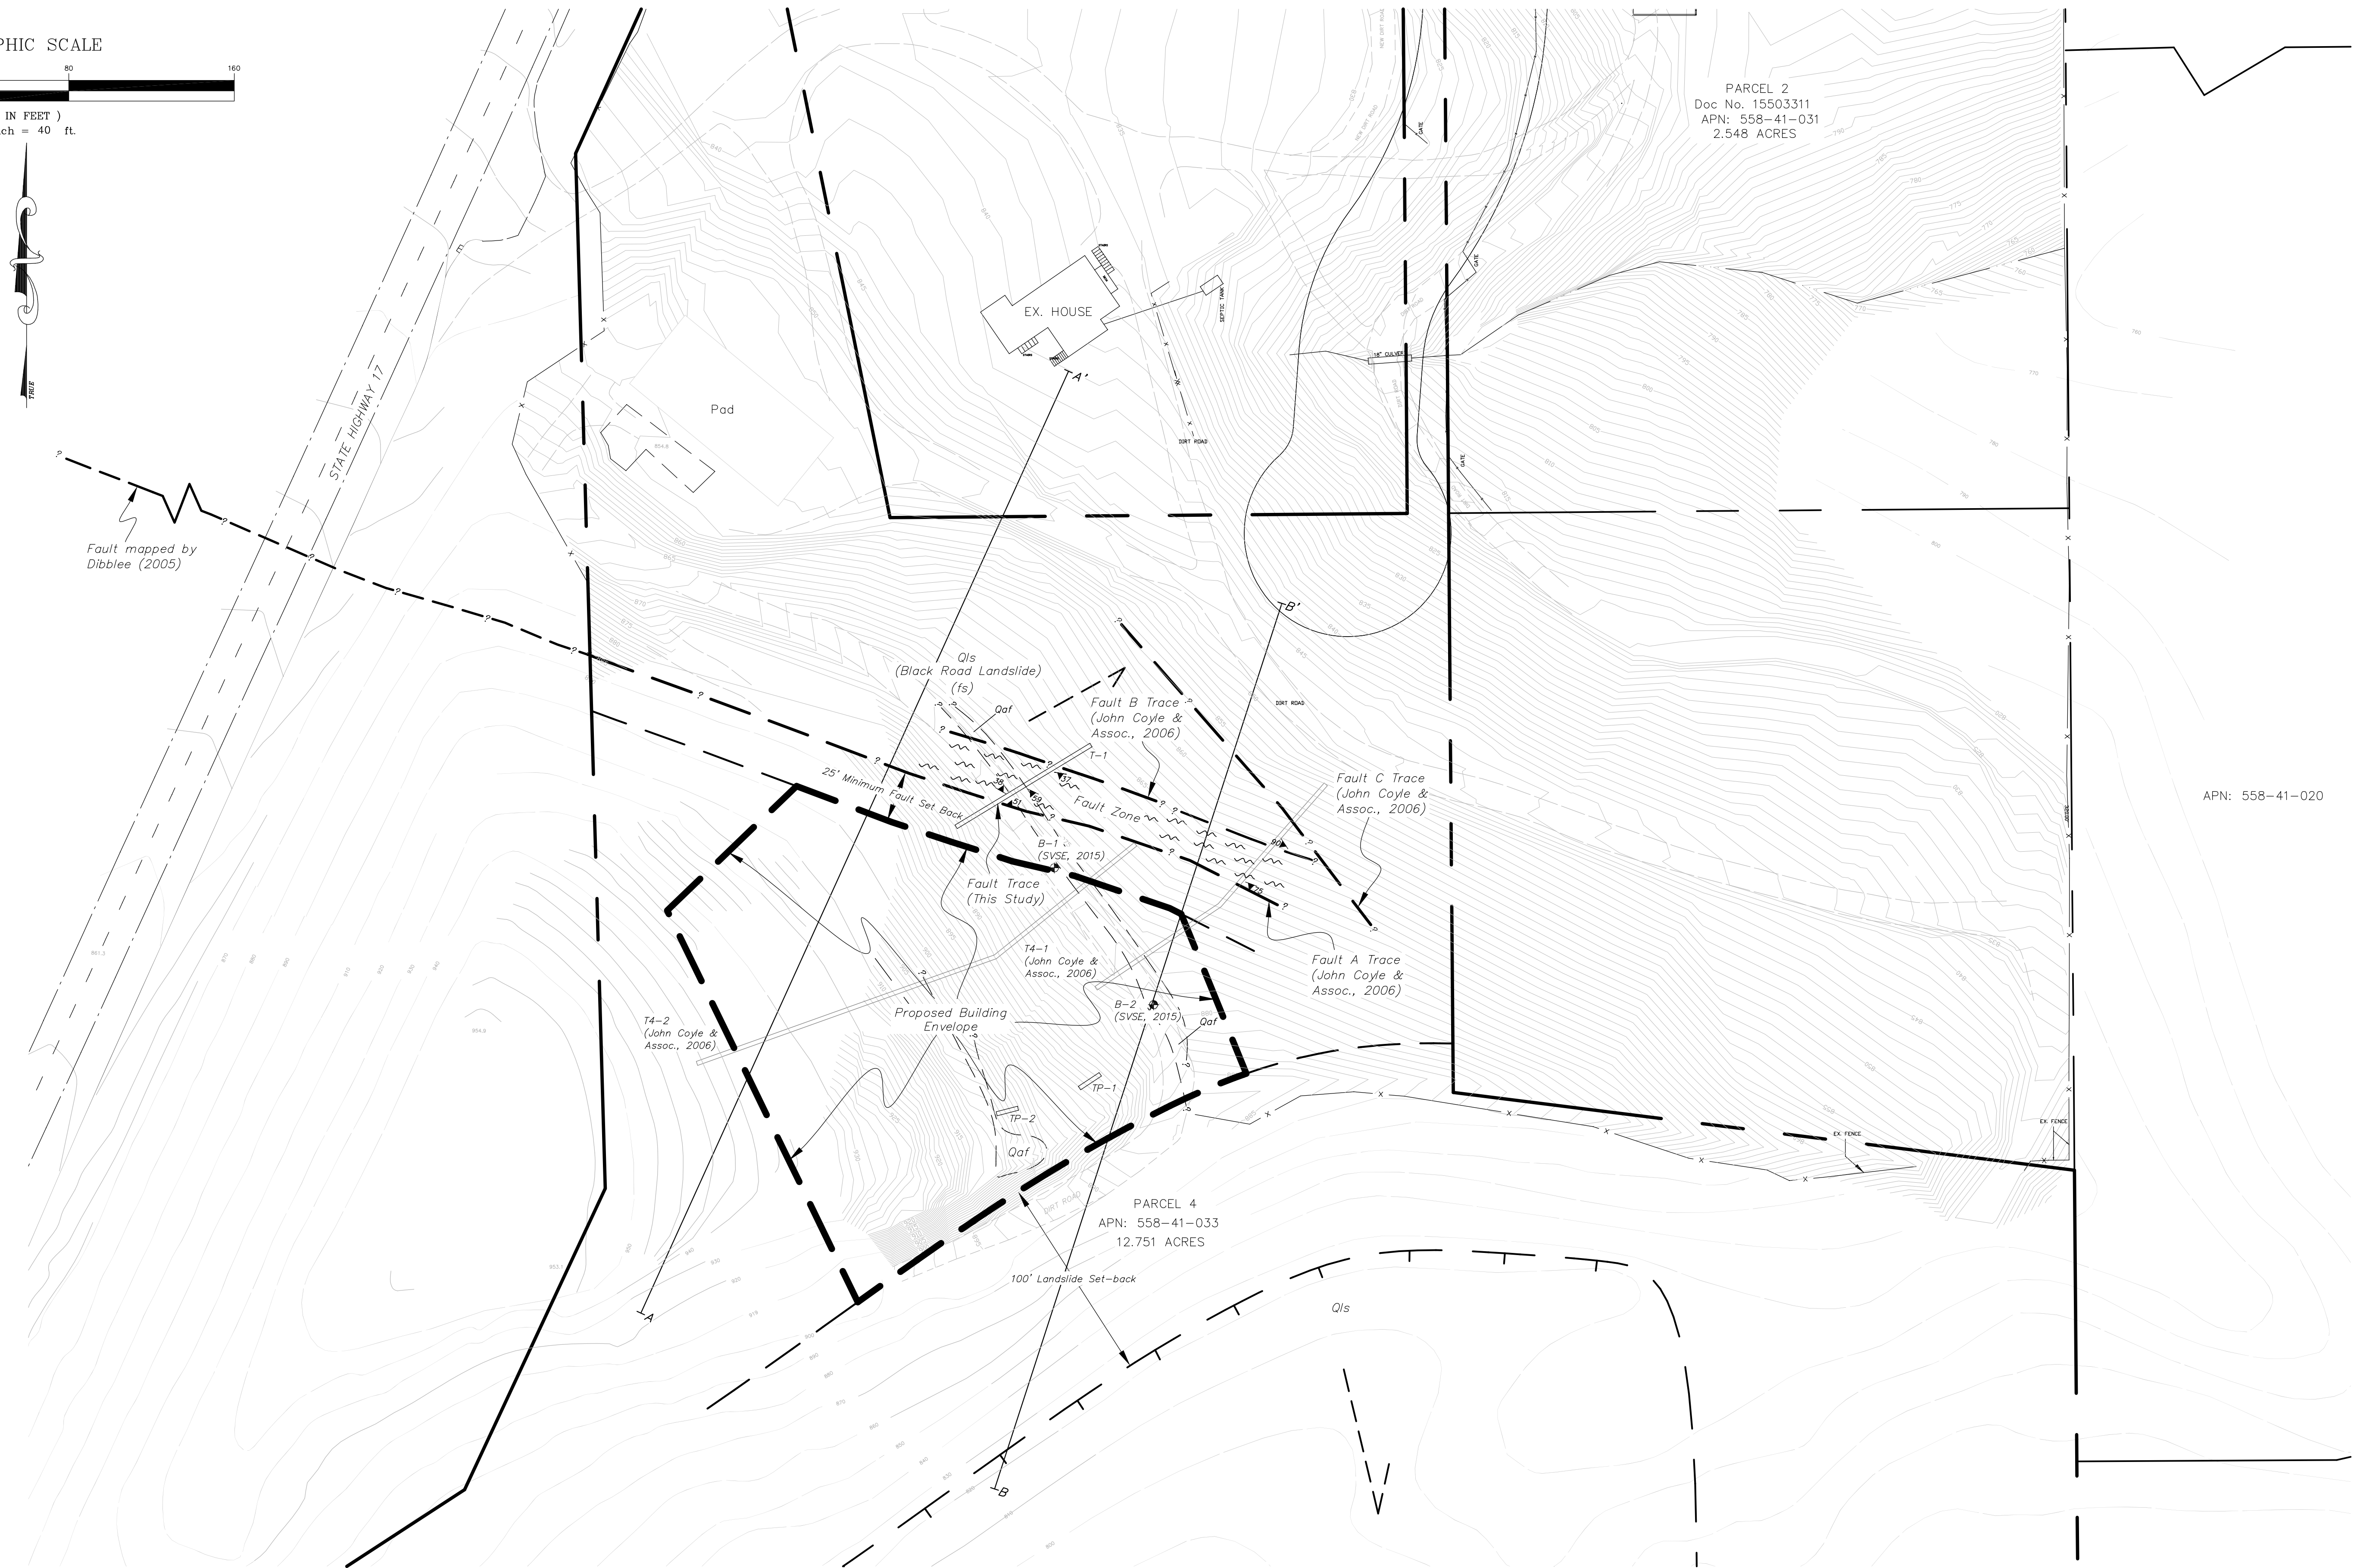
| | Attachment 1 |

Evaluation of the potential for future surface fault rupture at any specific location generally is limited to proving or disproving the presence of direct evidence of past surface fault rupture at that location. When viewed on human time scales, active faulting tends to occur most often on existing fault traces. John Coyle & Associates (2006) reported no fault trace observed in their Trench T4-2, which traverses the entire uphill portion of the Proposed Building Envelope. We have accurately located the active fault trace observed by John Coyle & Associates and us in their trench T4-1 and in our Trench T-1. We recommend a fault setback of at least 25 feet from this fault trace to the Proposed Building Envelope as shown on our Project Site Engineering Geologic Map. We believe that the chance of surface fault rupture occurring through the Proposed Building Envelope should be considered moderate to low within the life expectancy of the proposed house. We recommend that the setback from this fault trace be marked in the field by either us or a Licensed Land Surveyor based on the relationships shown on our Project Site Engineering Geologic Map.

We viewed the extent of the landsliding near the Proposed Building Envelope during our site engineering geologic reconnaissance. We agree the site is upon the very large Black Road Landslide. The smaller landslides mapped by John Coyle & Associates (2006) upon the Black Road Landslide were readily visible southwest of the Proposed Building Envelope. We then excavated two test pits to investigate conditions between the landslide and the Proposed Building Envelope. These test pits were south of the Proposed Building Envelope at the locations shown on our Project Site Engineering Geologic Map. The geologic materials in these test pits were consistent with the soils in our Trench T-1 and with those reported in trench T4-2 by John Coyle & Associates southwest of the active fault trace. We observed no evidence of landsliding in these test pits. We recommend a 100-foot set back from the tops of the landslides mapped by John Coyle & Associates and confirmed by us visually in the field.

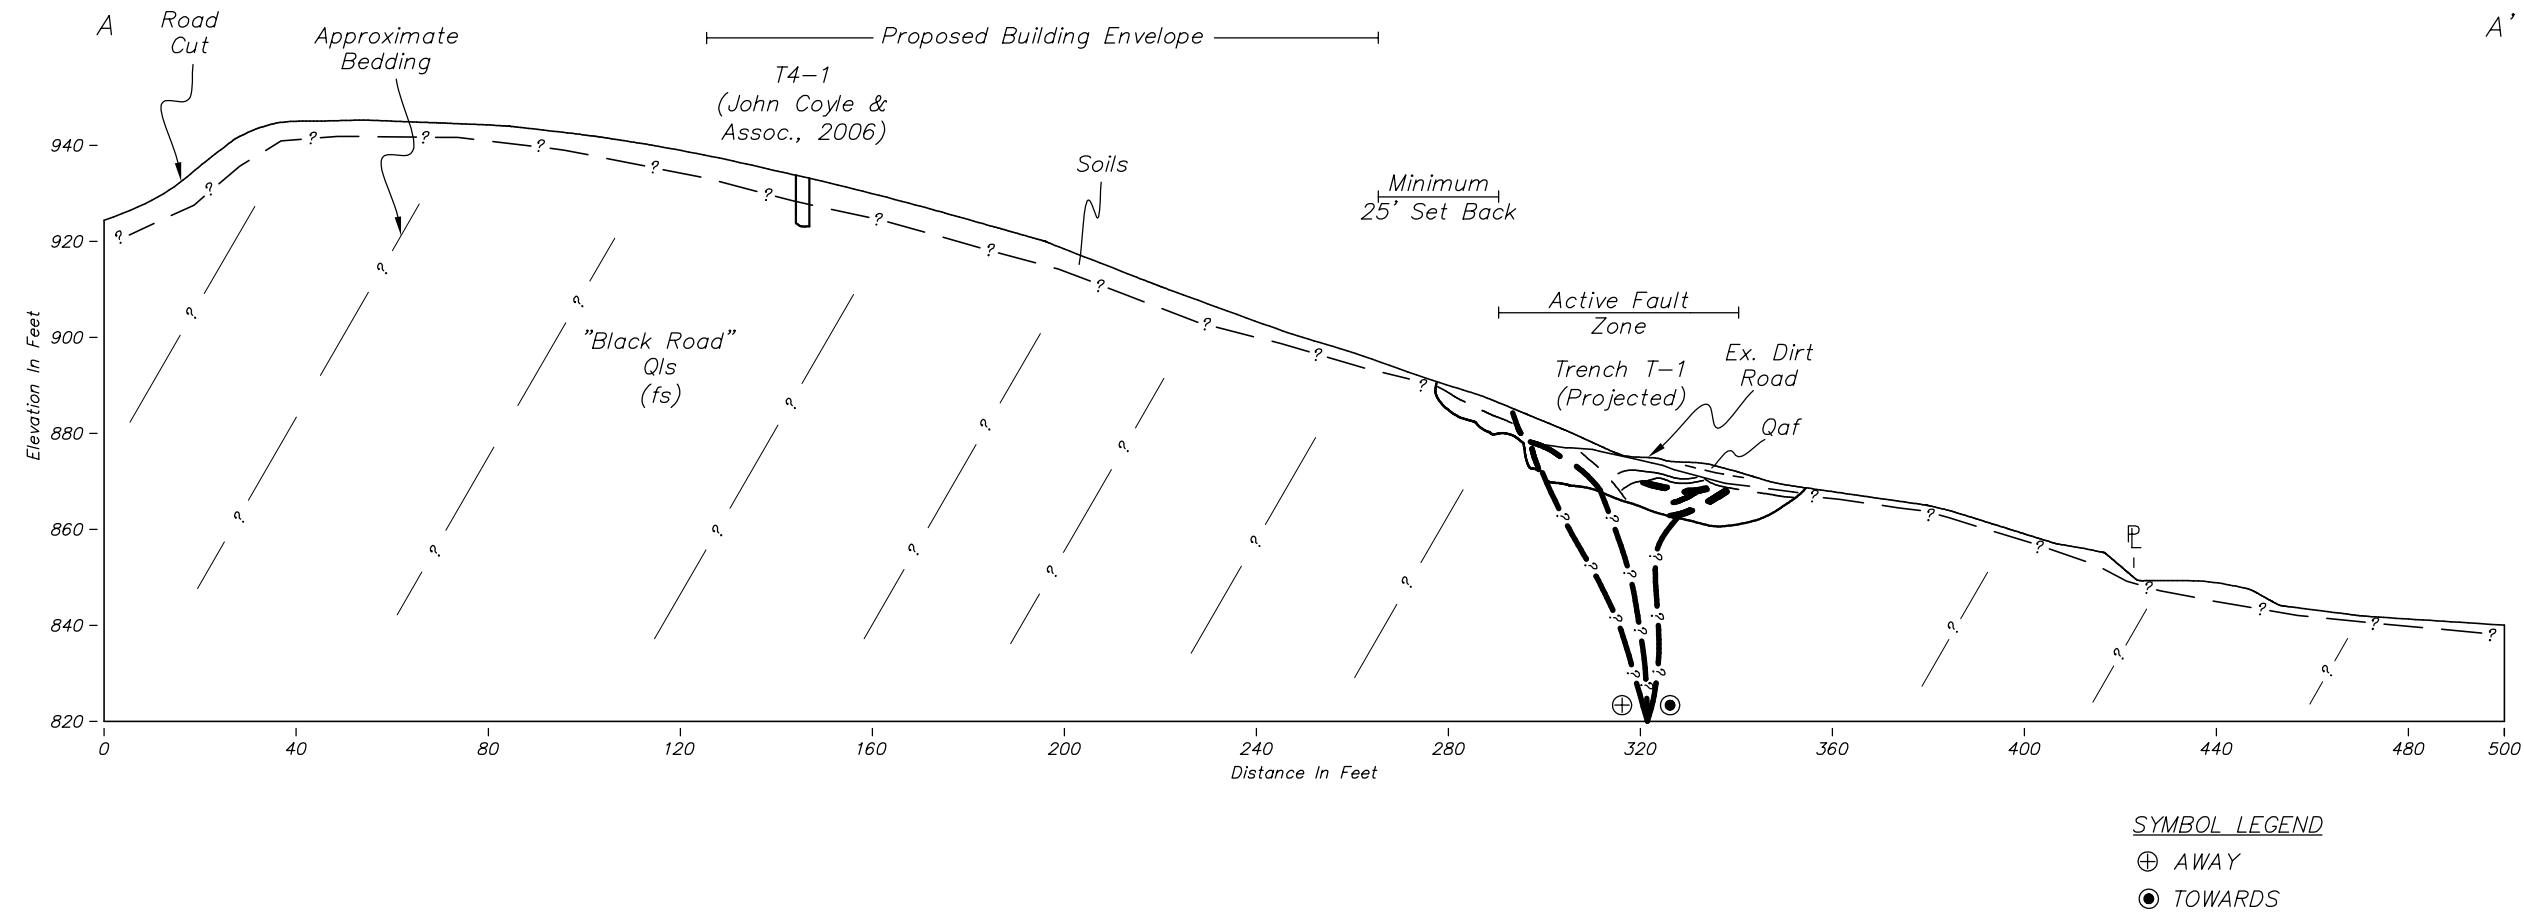
**ENGINEERING GEOLOGIC CROSS-SECTION A-A'**  
APN: 588-41-033, Old Santa Cruz Highway  
Santa Clara County, California

The distribution of these units to the depths investigated is shown on the *Project Site Engineering Geologic Map*, on the trench and test pit logs, and on the *Engineering Geologic Cross-sections (Attachment 4 and 5)*. The trench log and test pits contain detailed descriptions of the units encountered. Attachment 6 displays the Log of Trench T-1, Attachment 7 displays the Logs of Test Pits TP-1 and TP-2, and Attachment 8 is the Explanation for Trench T-1 and Test Pits TP-1 and TP-2.

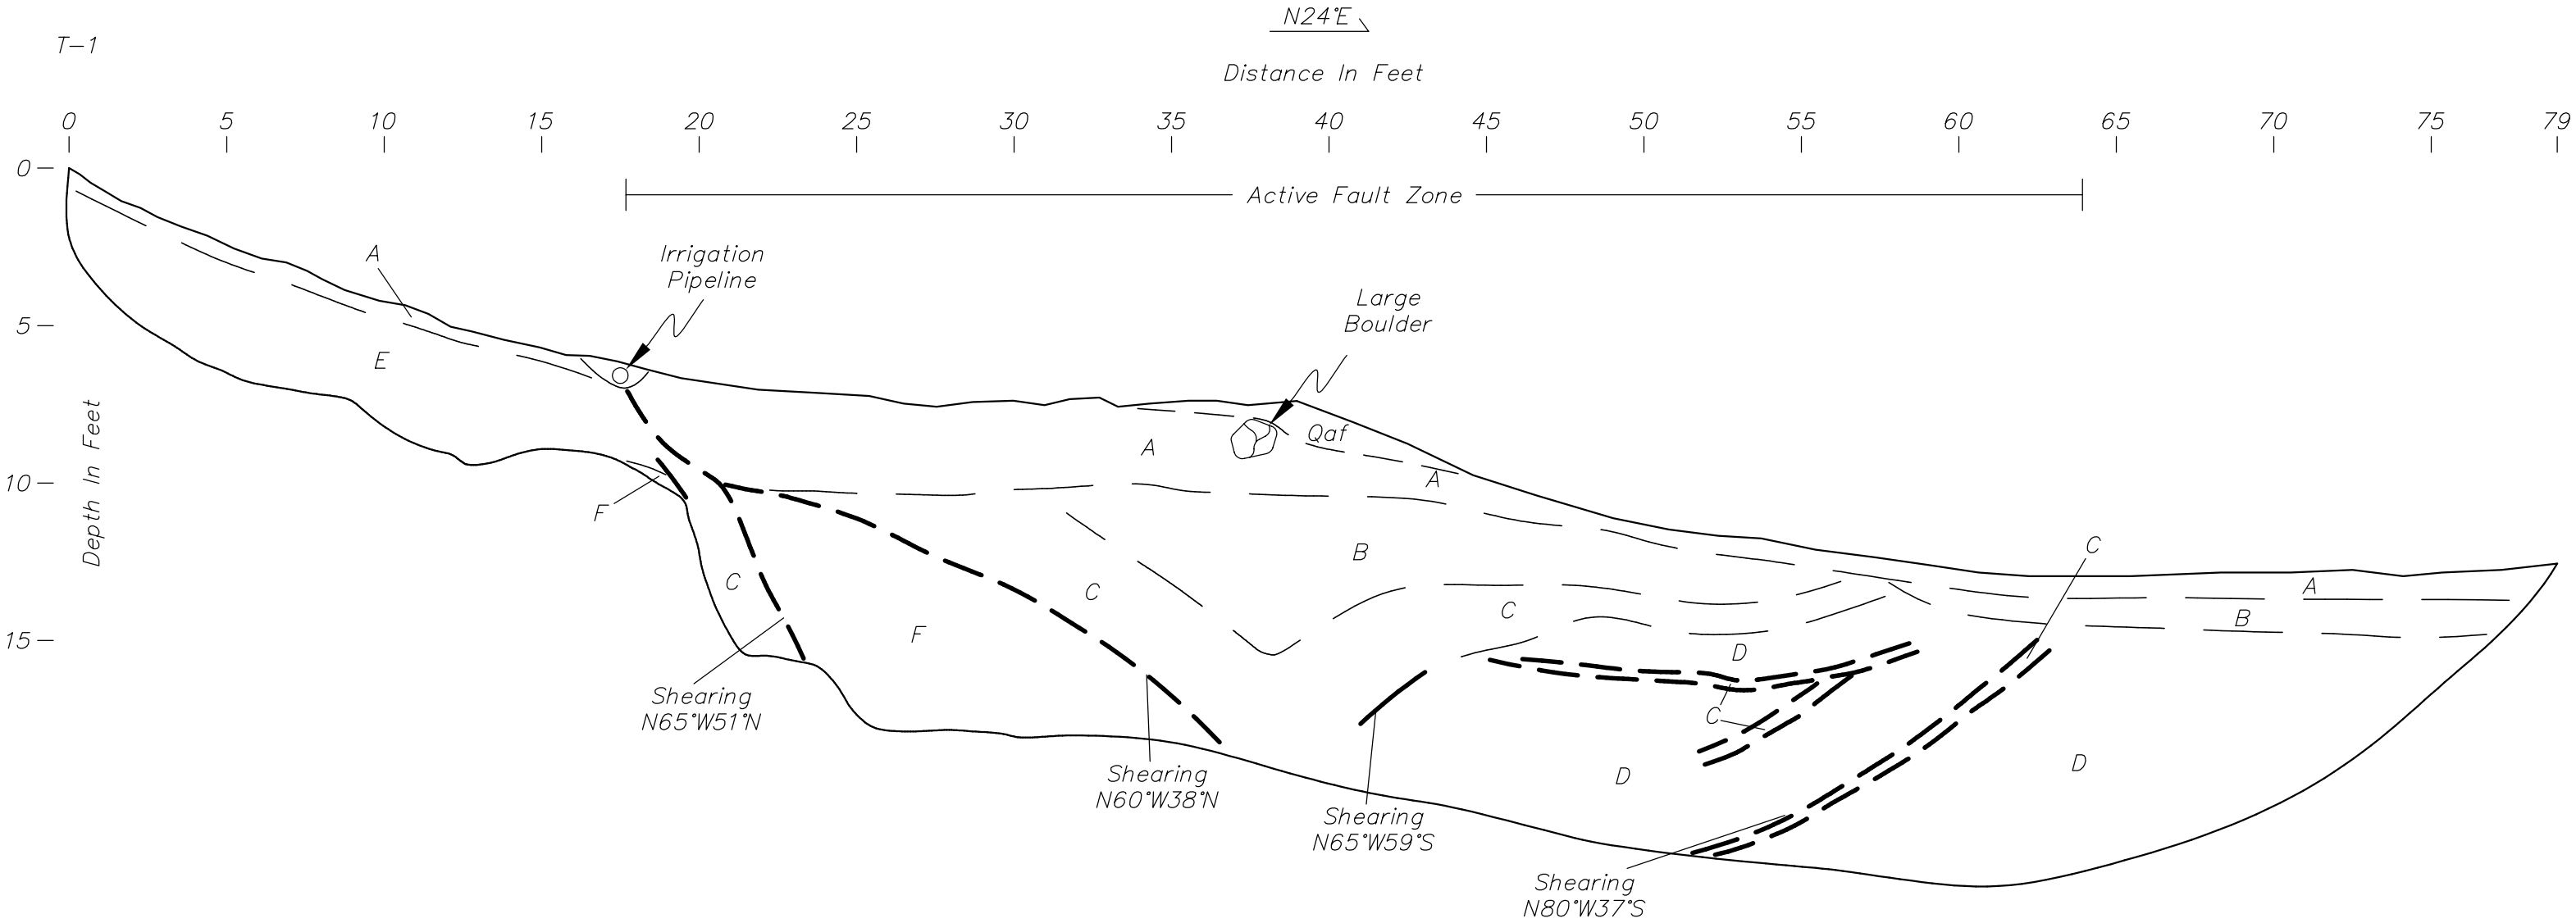
**LOG OF TRENCH T-1**

We observed a zone of faulting in our Trench T-1 at the approximate location John Coyle & Associates (2006) projected in their report. We observed the juxtaposition of different rocks across this zone separated by zones of clay that were sheared, very gummy, and slickensided. This fault zone is about 20 feet wide and dips to the southwest into the hillside at about 59°. It is true that landslide movement – such as movement of the very large Black Road Landslide - can displace near-surface fault traces in a downhill direction and distort them, making correct identification of the location(s) and mode(s) of recent fault activity a complicated task. However, the facts that the surficial A- and B-soils were disturbed and varied in thicknesses at the two locations observed by us (in the portion of trench T4-1 by John Coyle & Associates excavated by us and in our Trench T-1), with discontinuous and missing units, juxtaposing different rocks types at a location of obvious fault movement, indicate to us this is an active trace of the San Andreas fault.

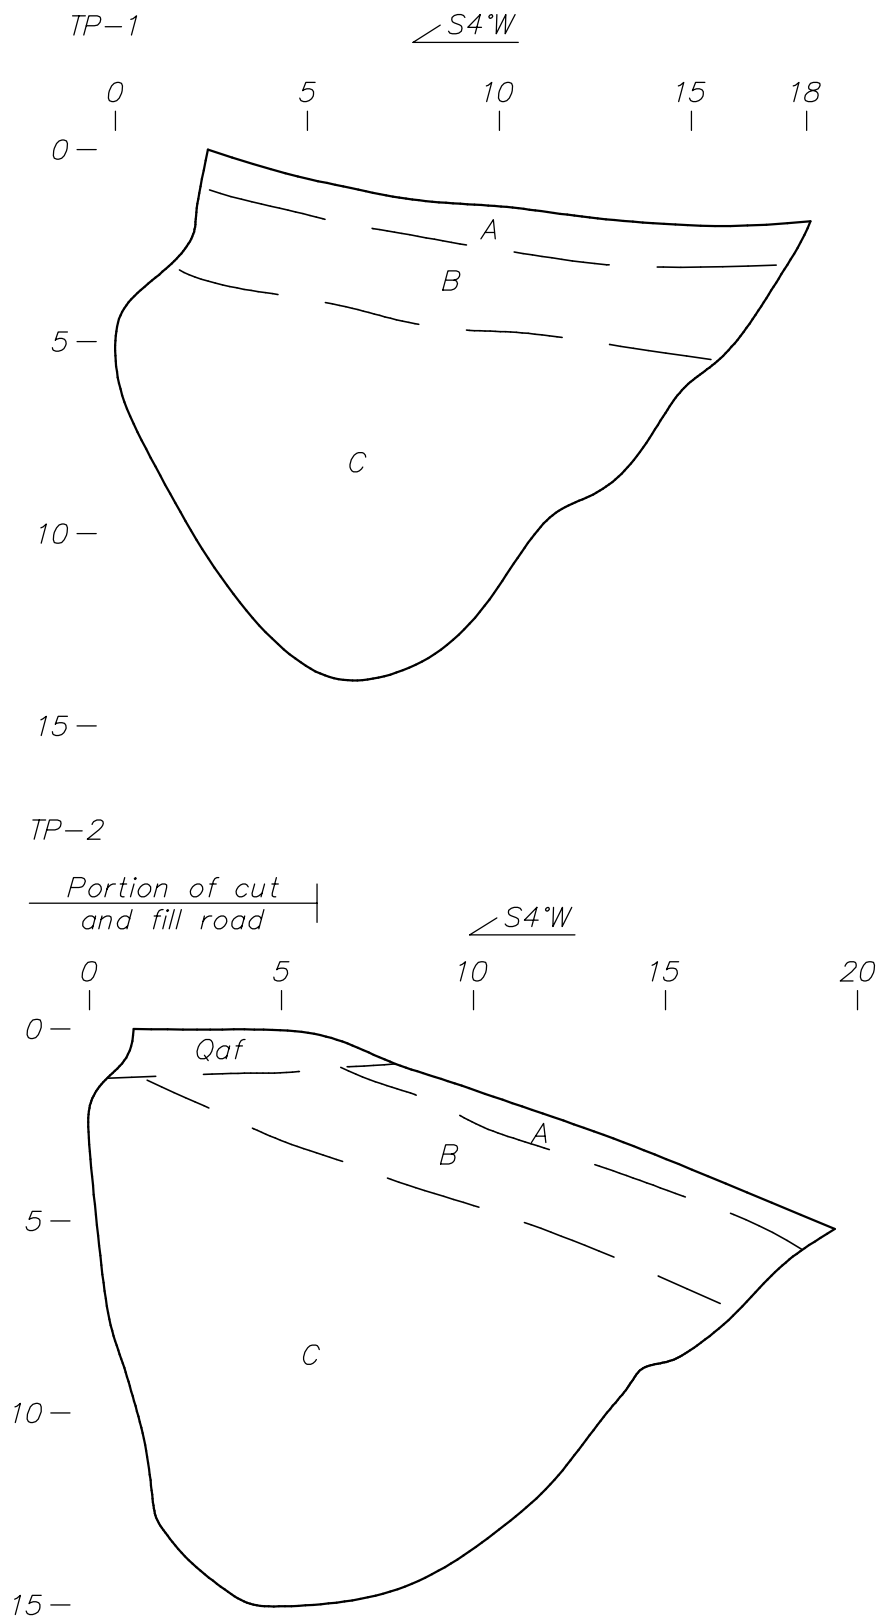
### **LOGS OF TEST PITS TP-1 AND TP-2**

- C – SANDY CLAY, light brownish-gray, slightly damp to damp, high plasticity, stiff; sheared, very grainy, slickensided surfaces measured N65°W59°S. Bent over northward where it approaches the surface. B-soils (subsoils) missing over this feature, but A-soils thickness unaffected.*
