## C.Landslide Hazard Evaluation

December 26, 2024 (Revised May 28, 2025)

Landslide Hazard Evaluation  
The Shire Vineyard  
APN: 022-140-054  
St. Helena, California

Project Number: 7989.002.09.2

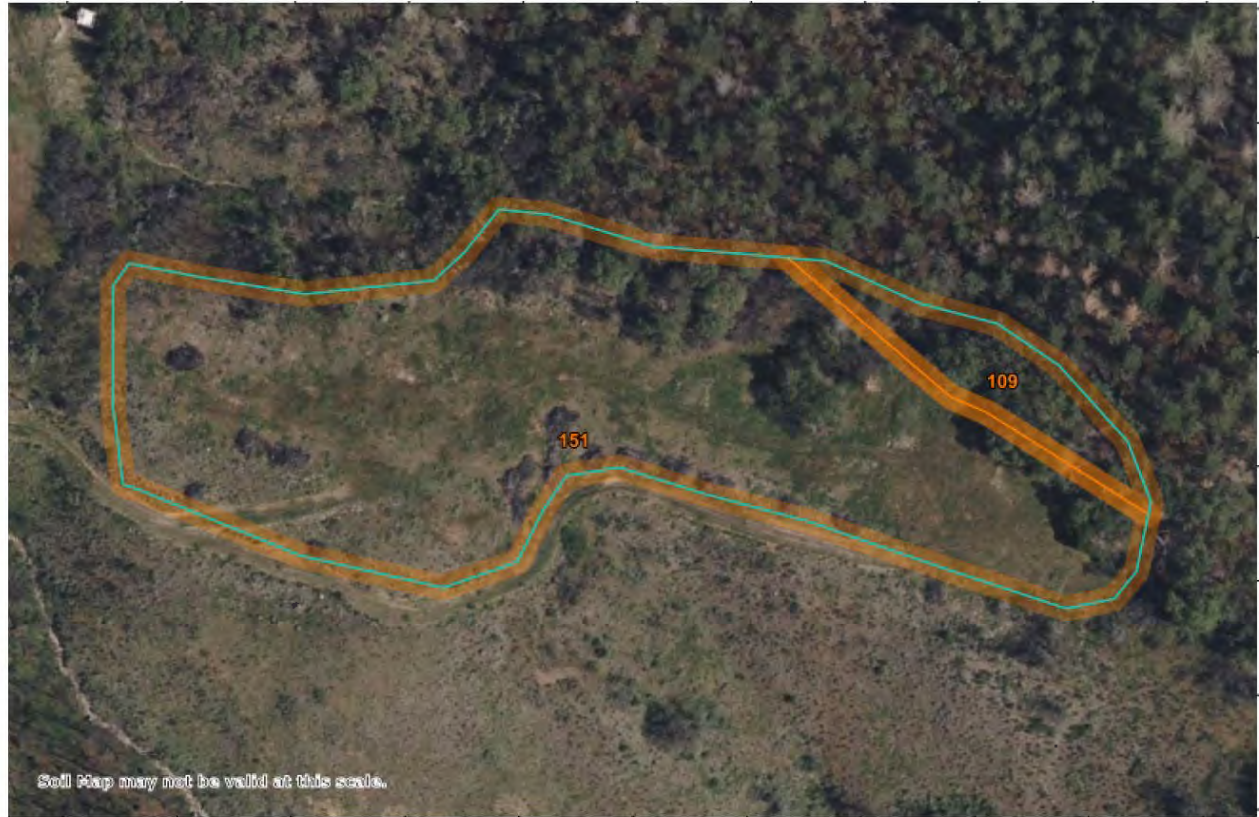
Based on our geologic review we compiled the images and tables below indicating the soil types and depth of materials for the planned vineyard block. This information was collected from the NRCS Web Soil Survey listed above.
