# PROTECTED TREE REPORT

Walnut Business Park

Valley Blvd. & Lemon Ave.

April 14, 2024

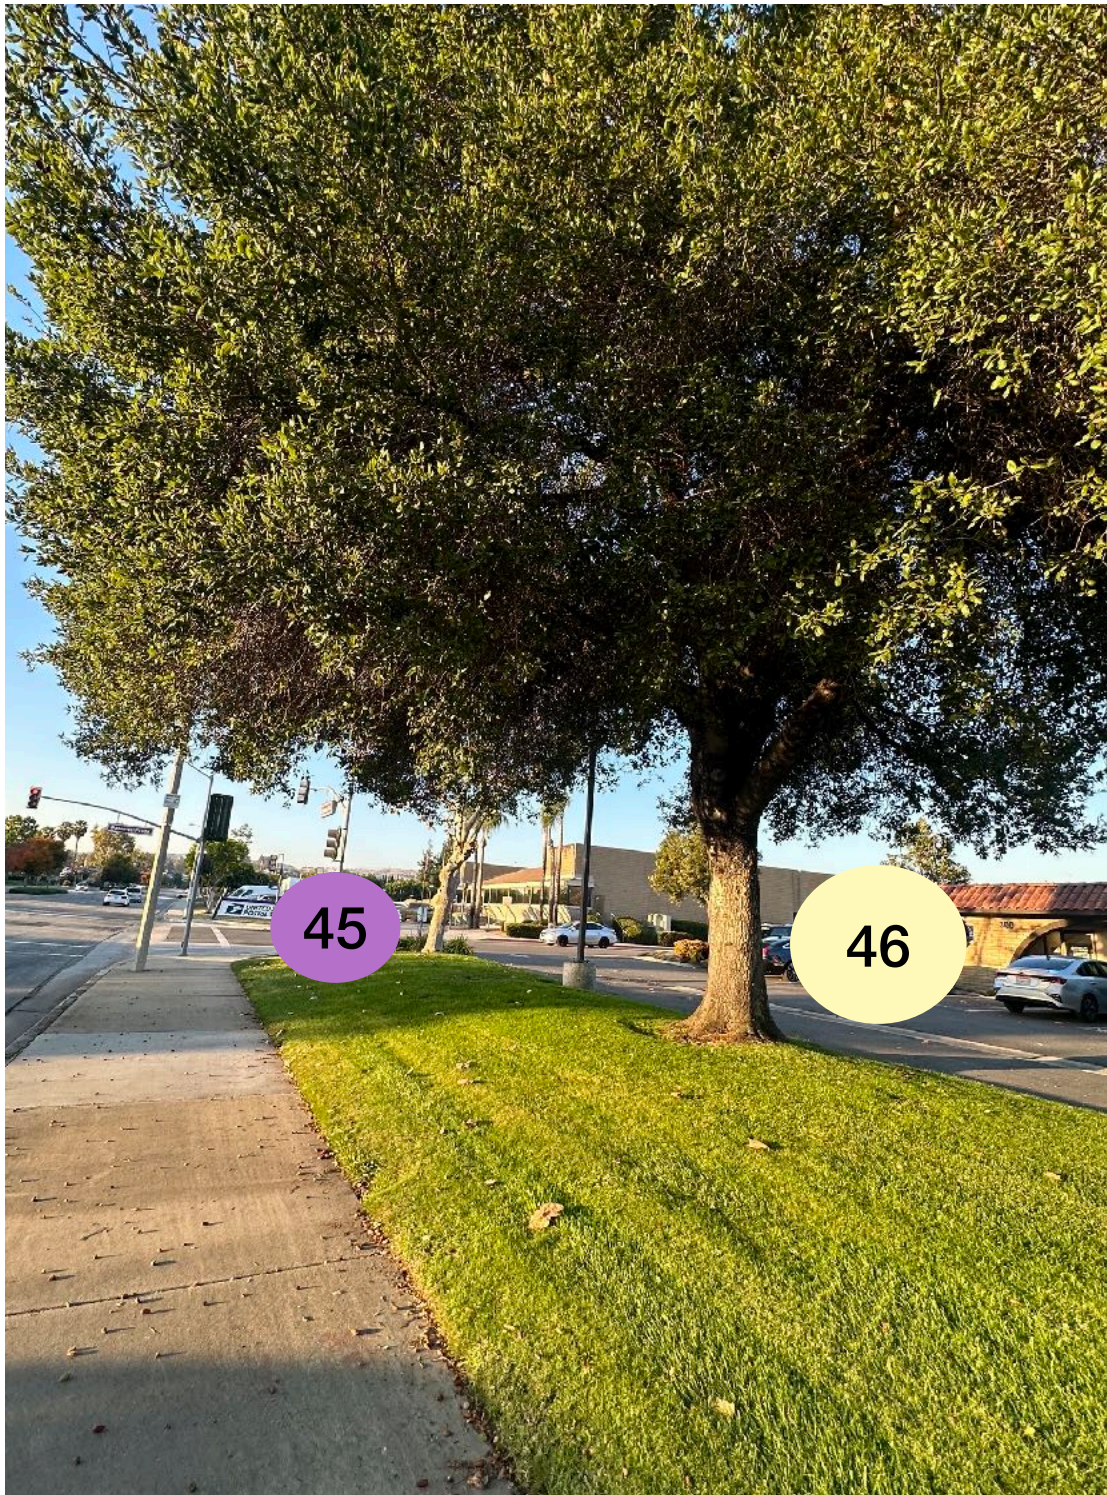
**PHOTO 1** - Shows trees on site, which include London Plane, Brazilian Pepper, and other non-protected trees. Removals are focused on areas of future development and root impacts that will not be tolerable.

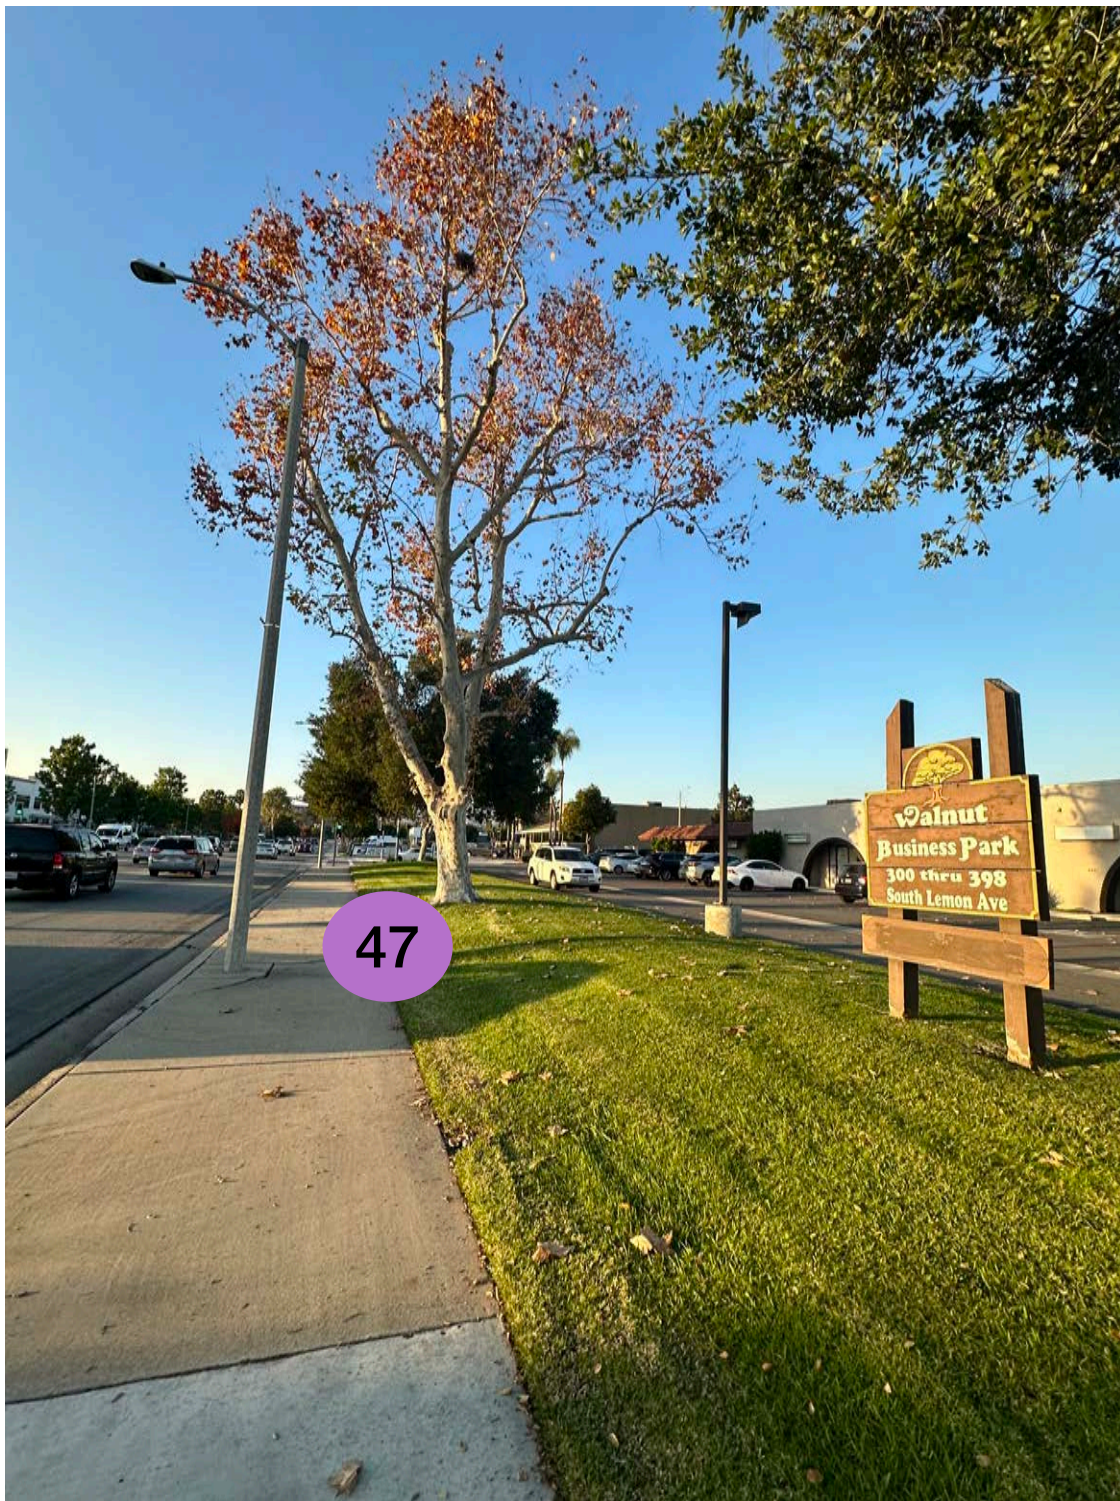
**PHOTO 2** - Shows trees on site, which include London Plane, Brazilian Pepper, and other non-protected trees. Removals are focused on areas of future development and root impacts that will not be tolerable.

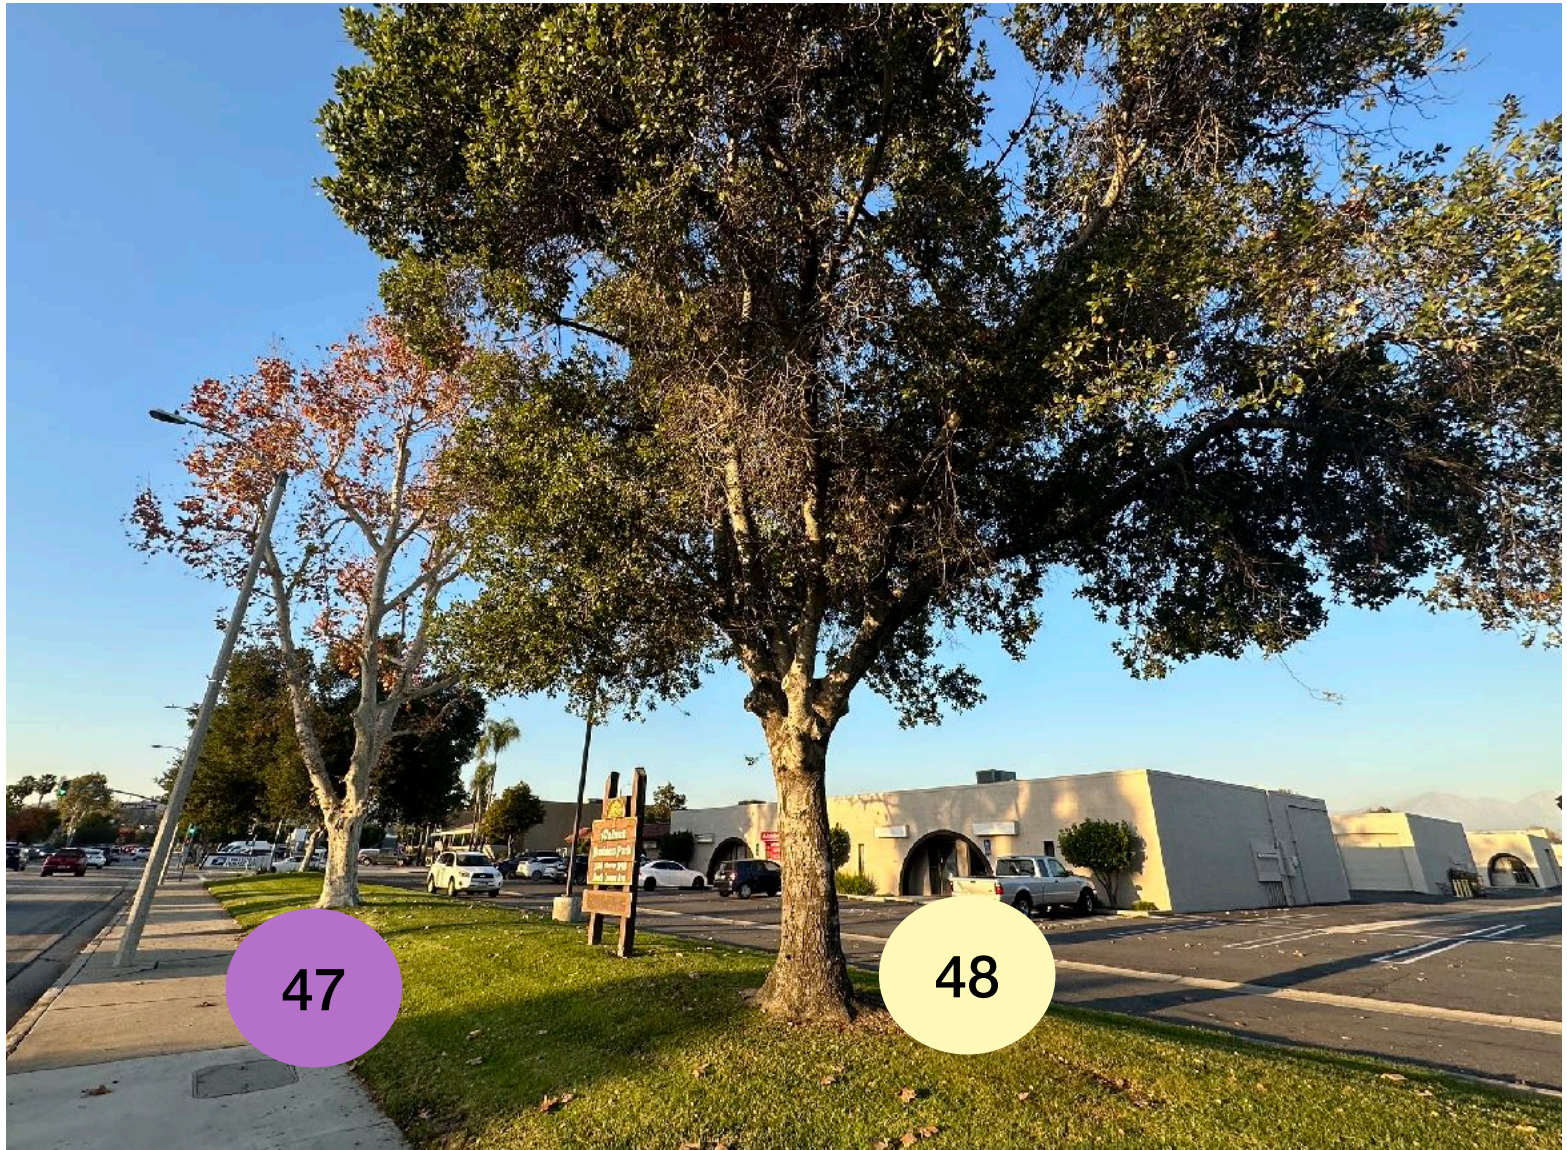
**PHOTO 3** - Shows some of the protected oak and sycamore trees on site. These trees will be retained and protected in place.

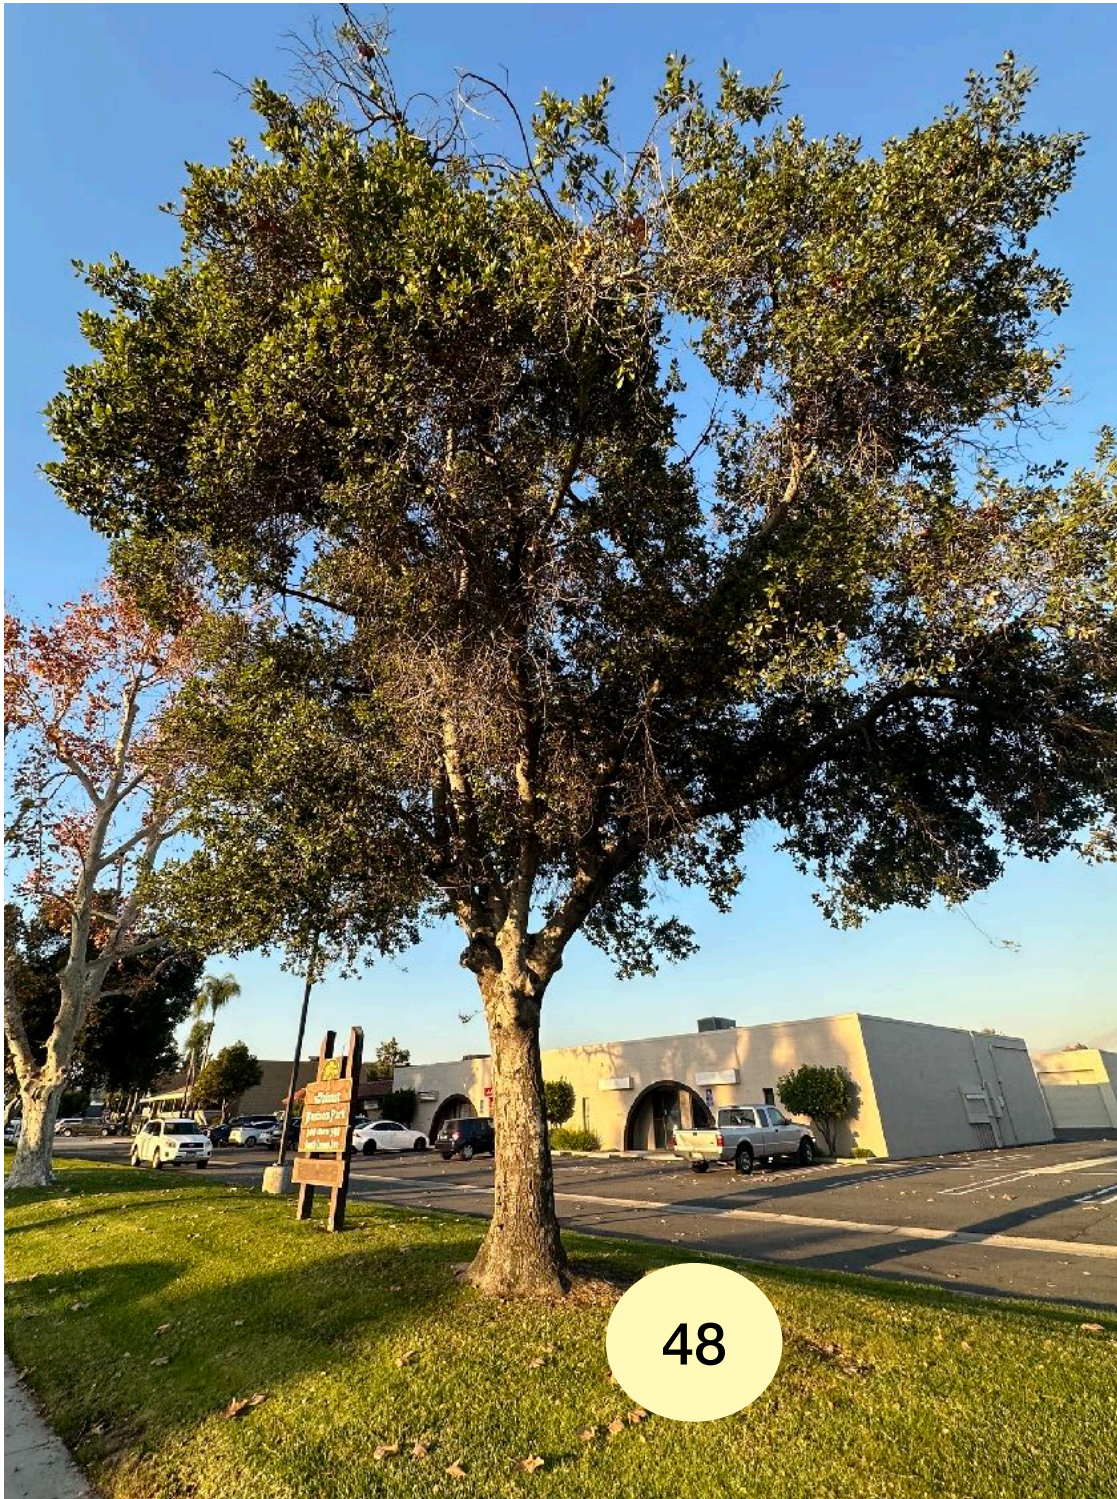
**PHOTO 4** - Shows some of the protected oak and sycamore trees on site. These trees will be retained and protected in place.

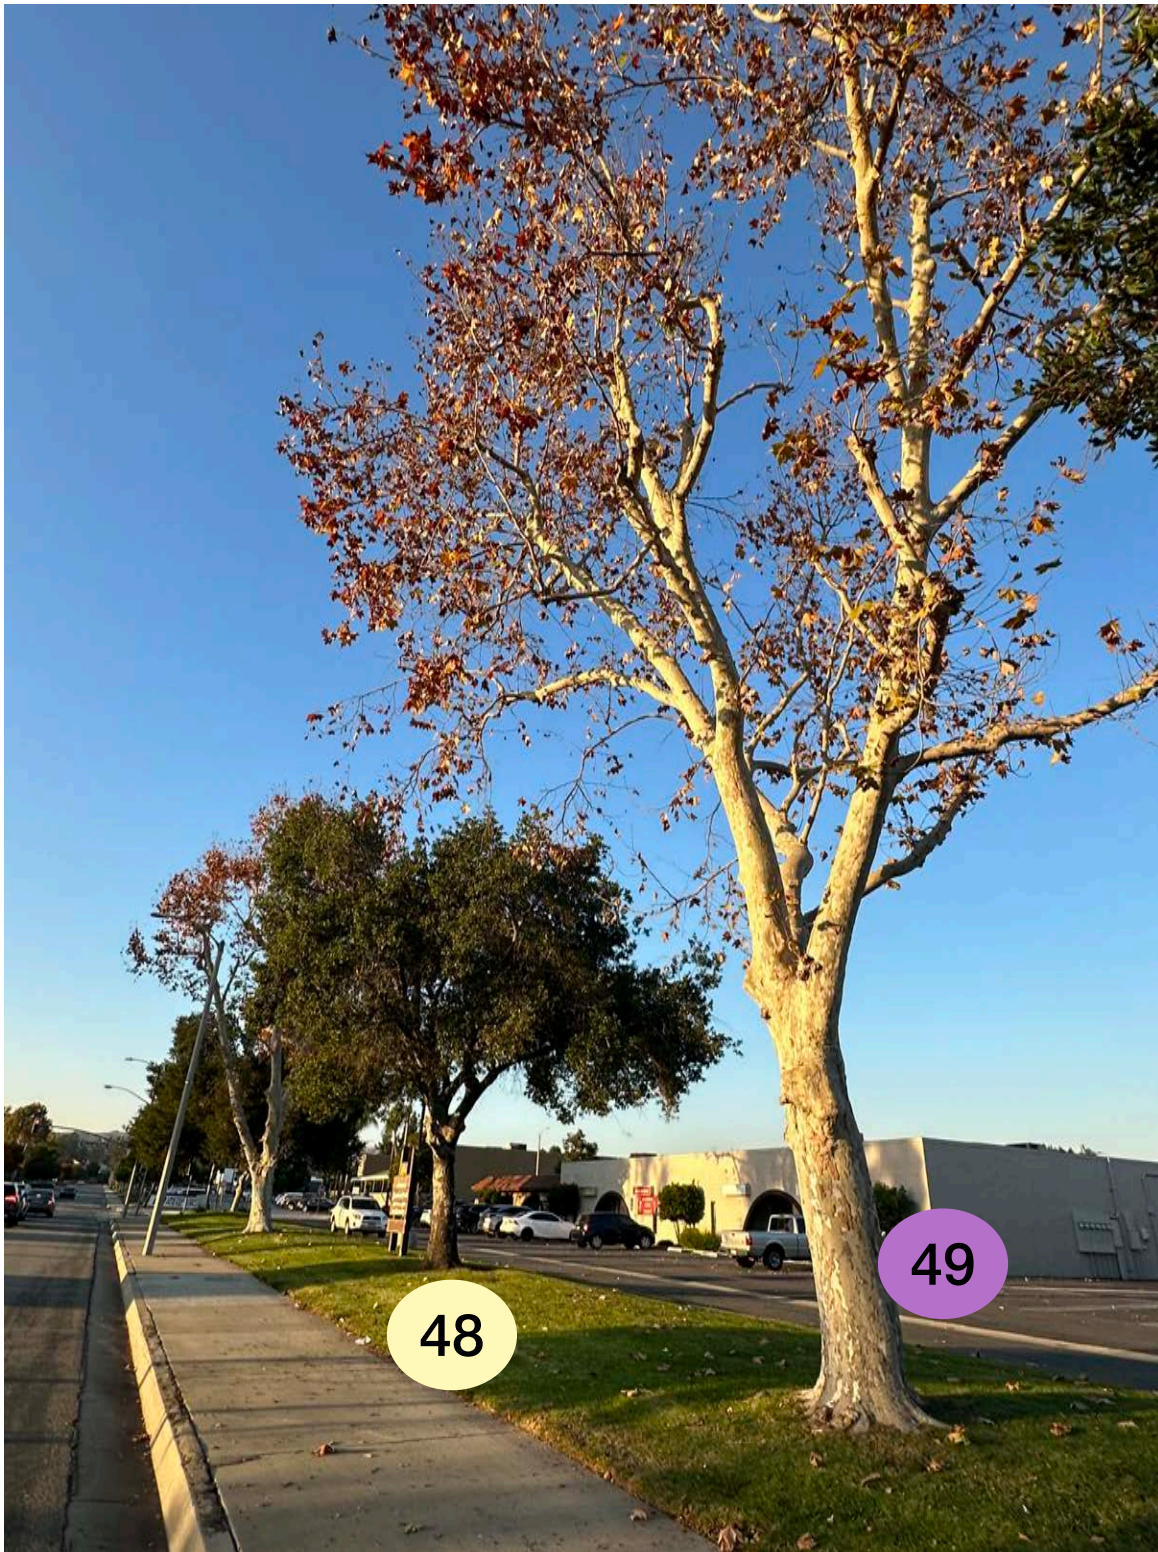
**PHOTO 5** - Shows trees on site, which include London Plane, Brazilian Pepper, and other non-protected trees. Removals are focused on areas of future development and root impacts that will not be tolerable.

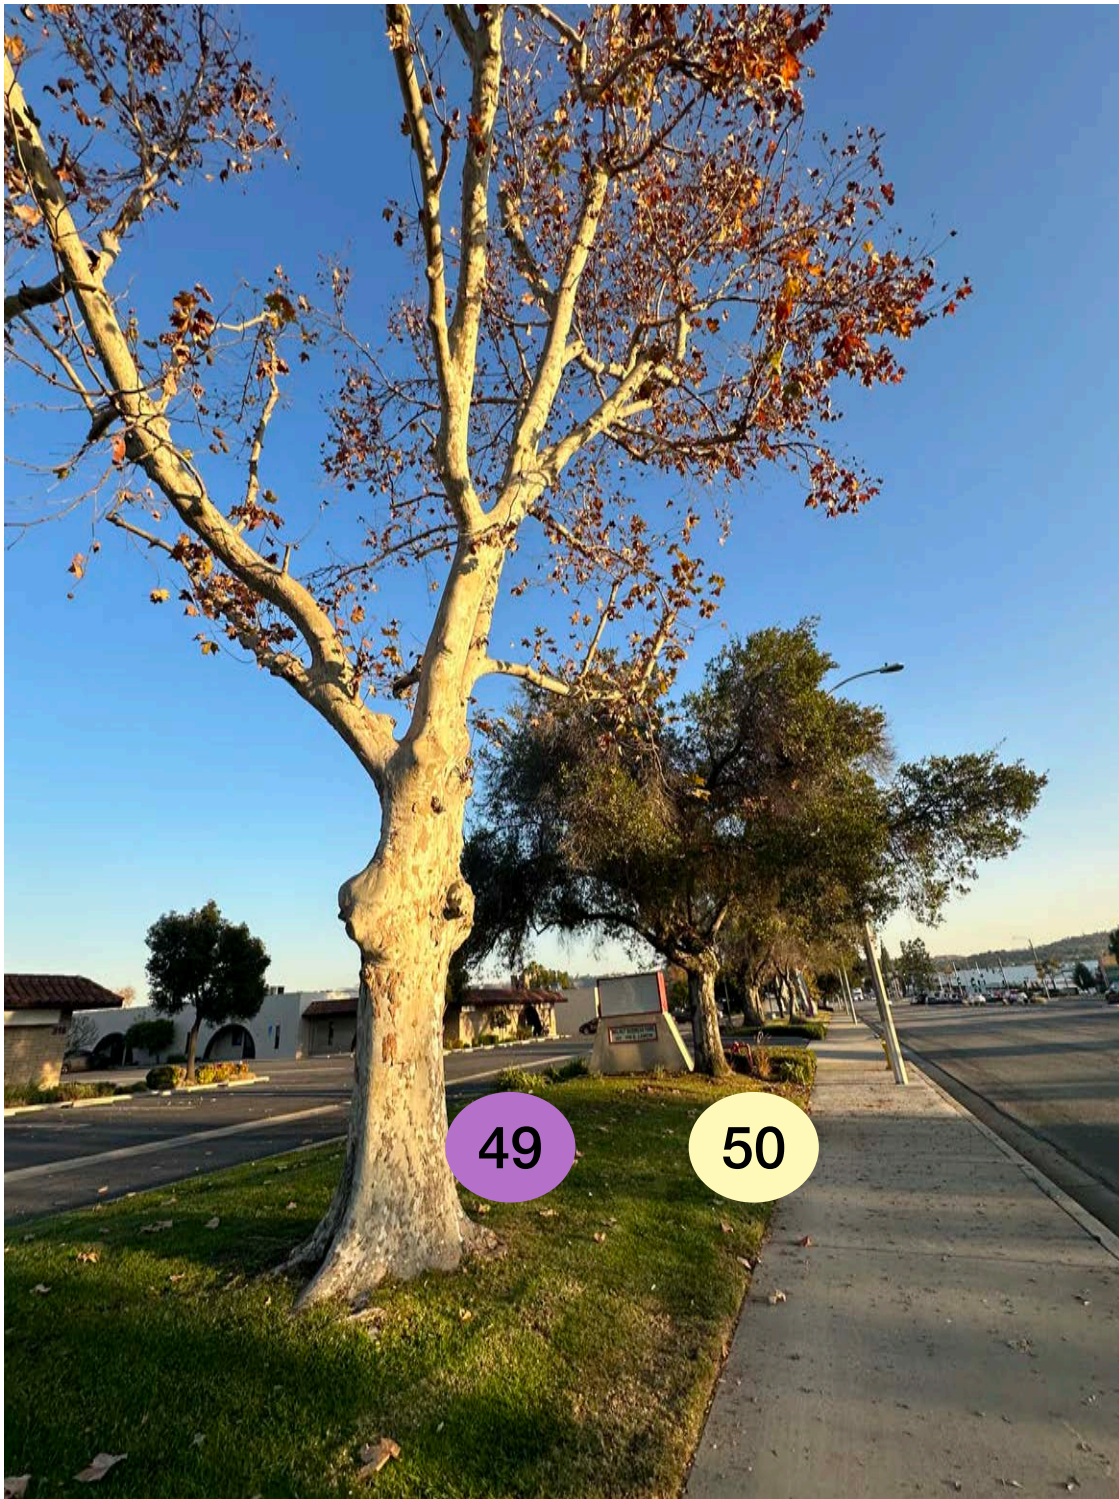
**PHOTO 6** - Shows trees on site, which include London Plane, Brazilian Pepper, and other non-protected trees. Removals are focused on areas of future development and root impacts that will not be tolerable.

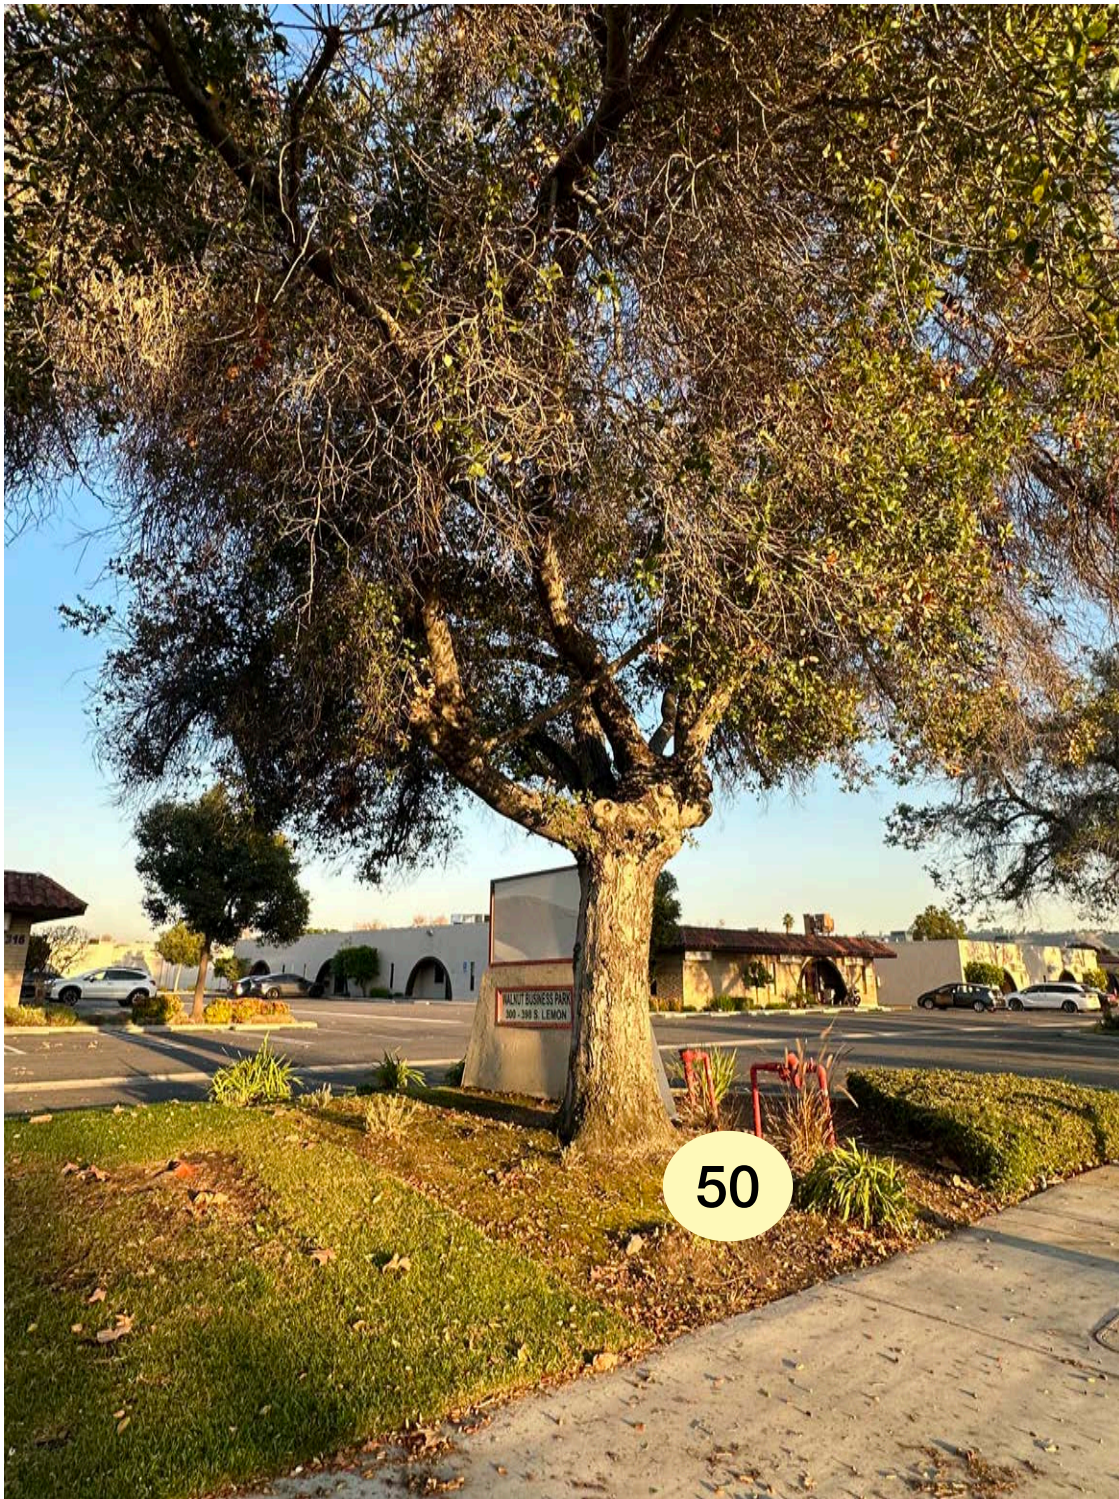
**PHOTO 7** - Shows trees on site, which include London Plane, Brazilian Pepper, and other non-protected trees. Removals are focused on areas of future development and root impacts that will not be tolerable.

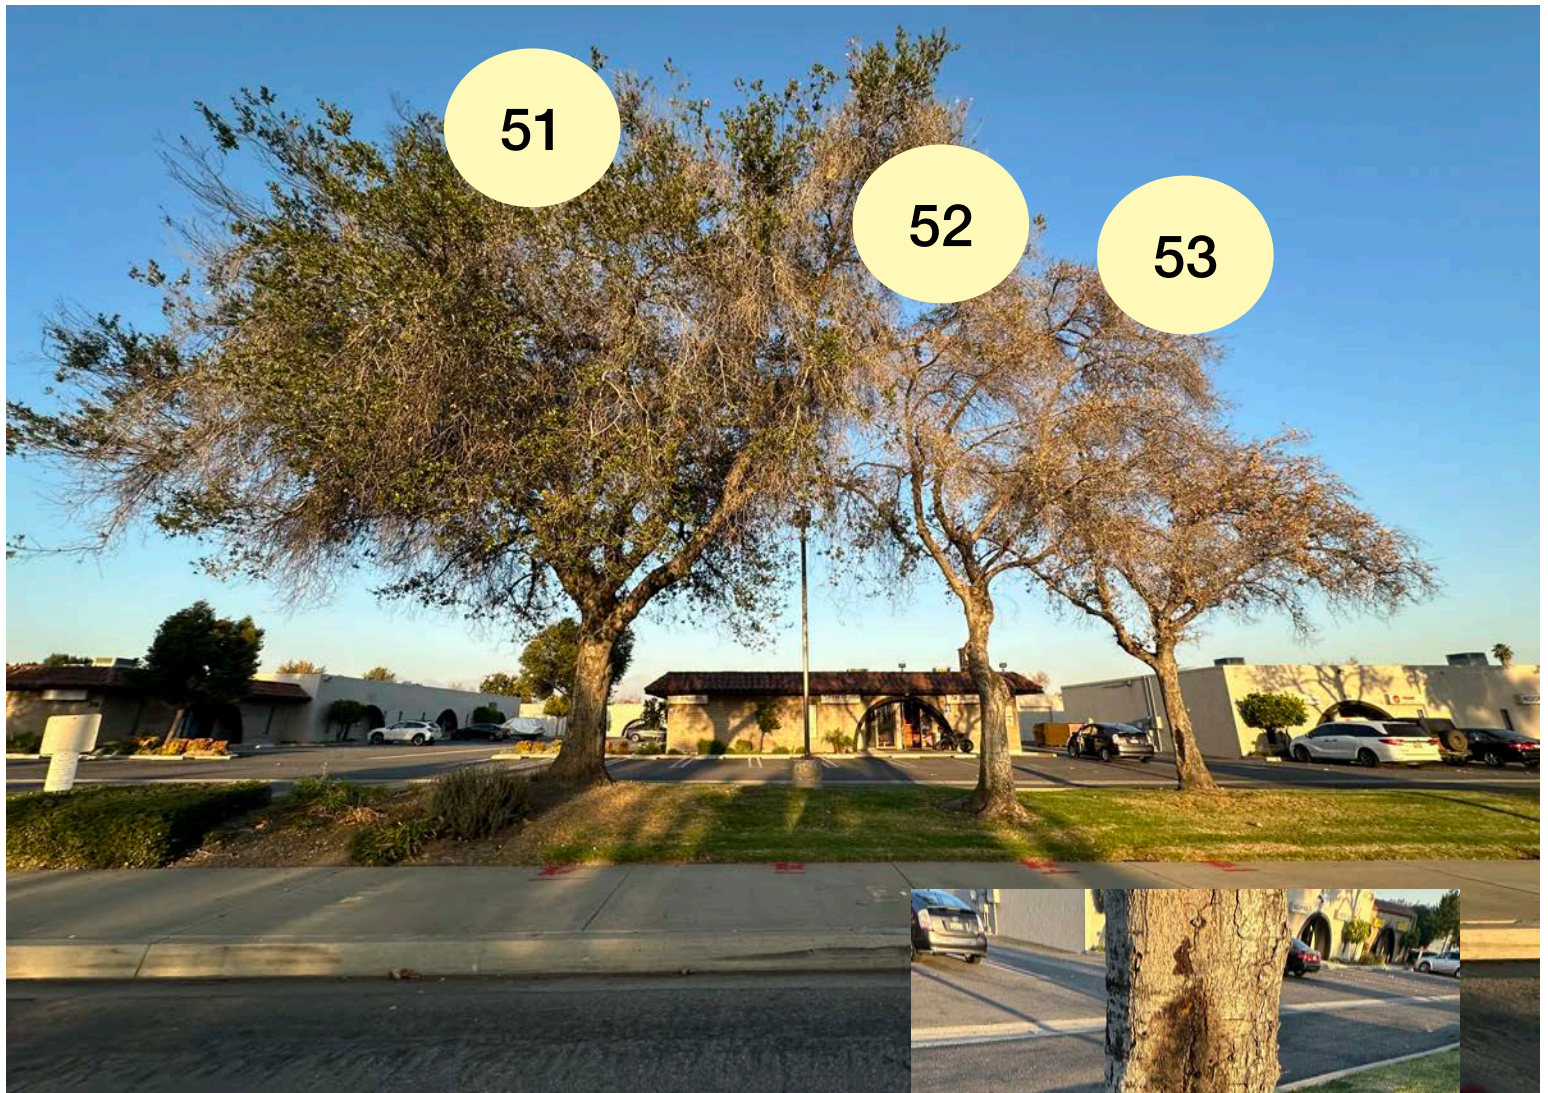
**PHOTO 8** - Shows some of the protected oak and sycamore trees on site. These trees will be retained and protected in place.

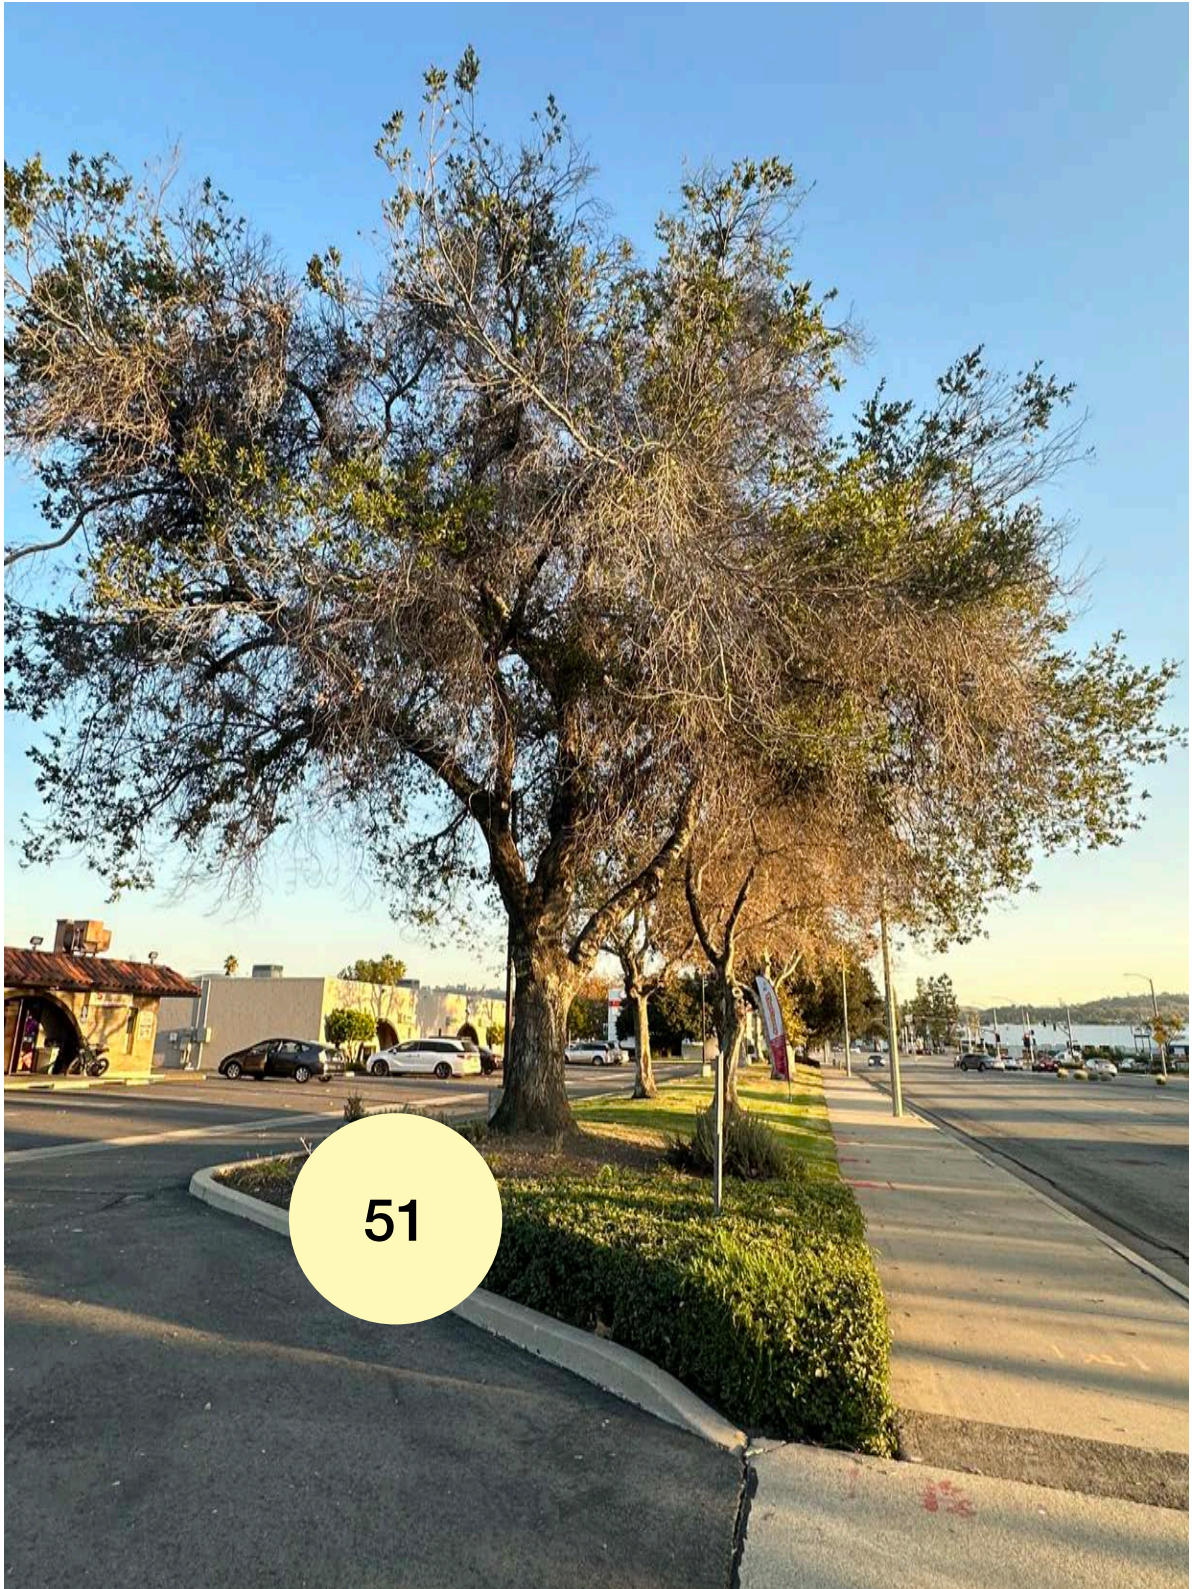
**PHOTO 9** - Shows some of the protected oak trees on site. These trees will be retained and protected in place.

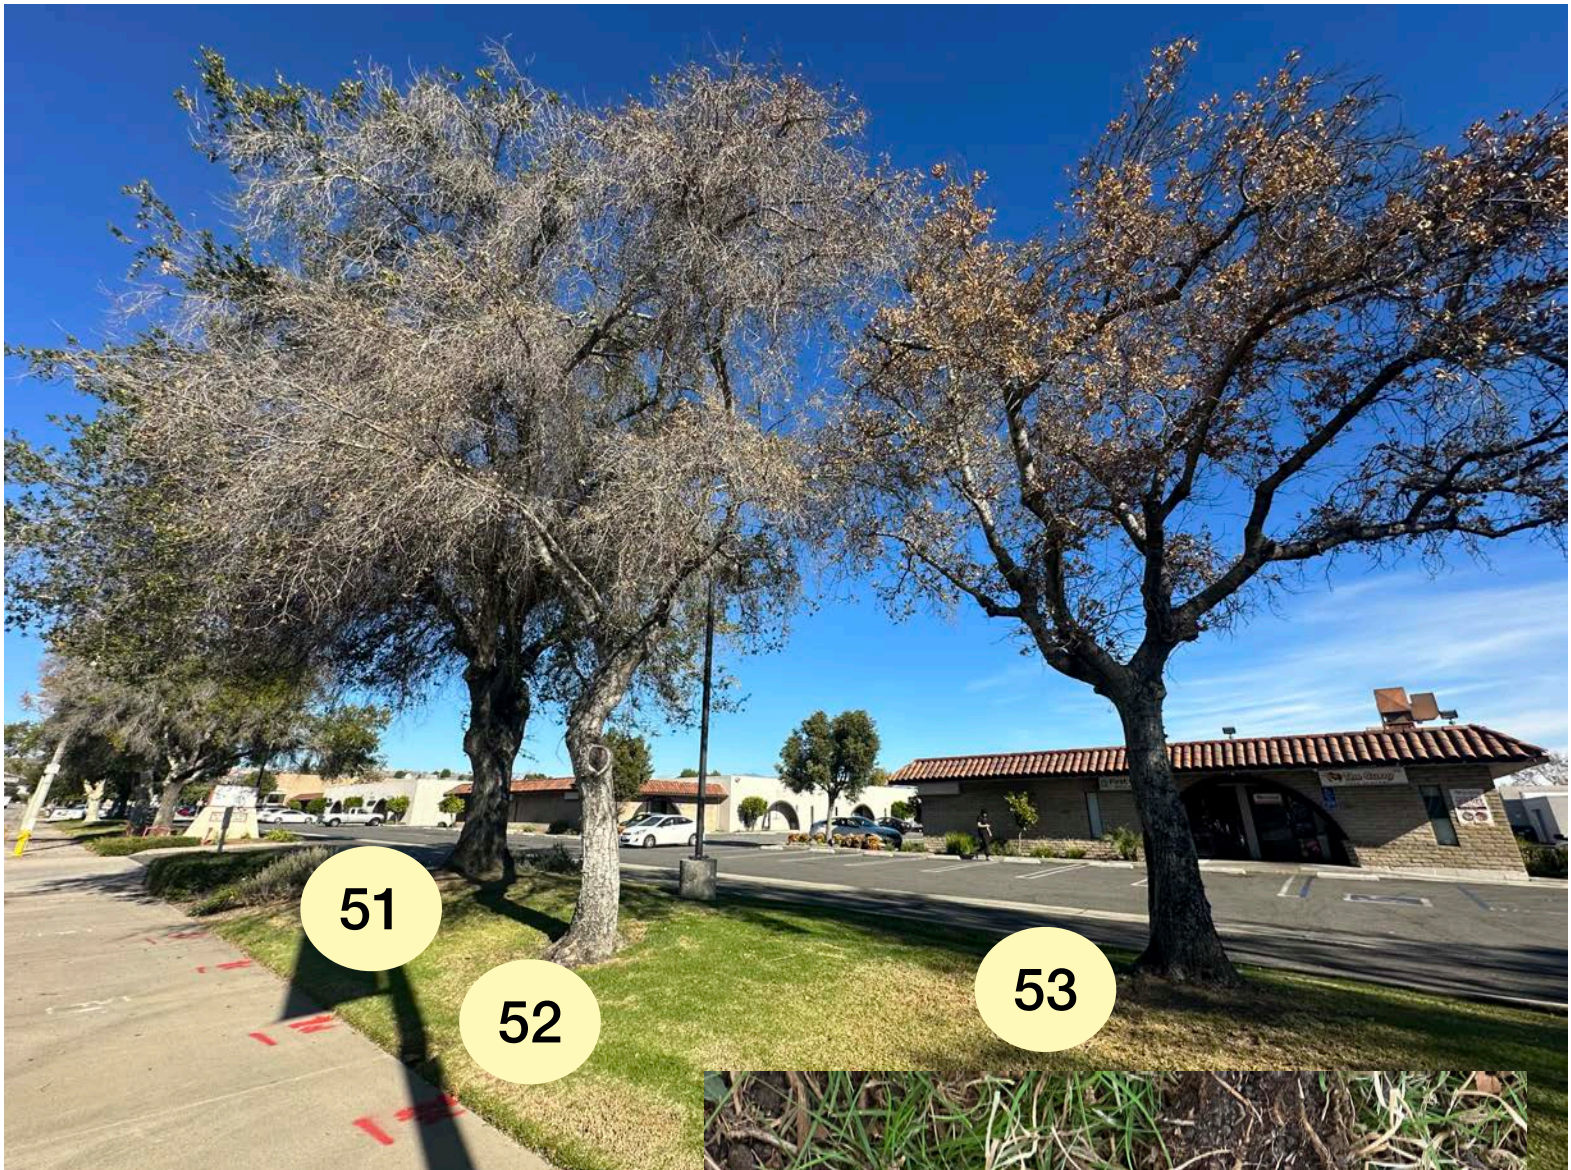
**PHOTO 10** - Shows some of the protected oak and sycamore trees on site. These trees will be retained and protected in place.

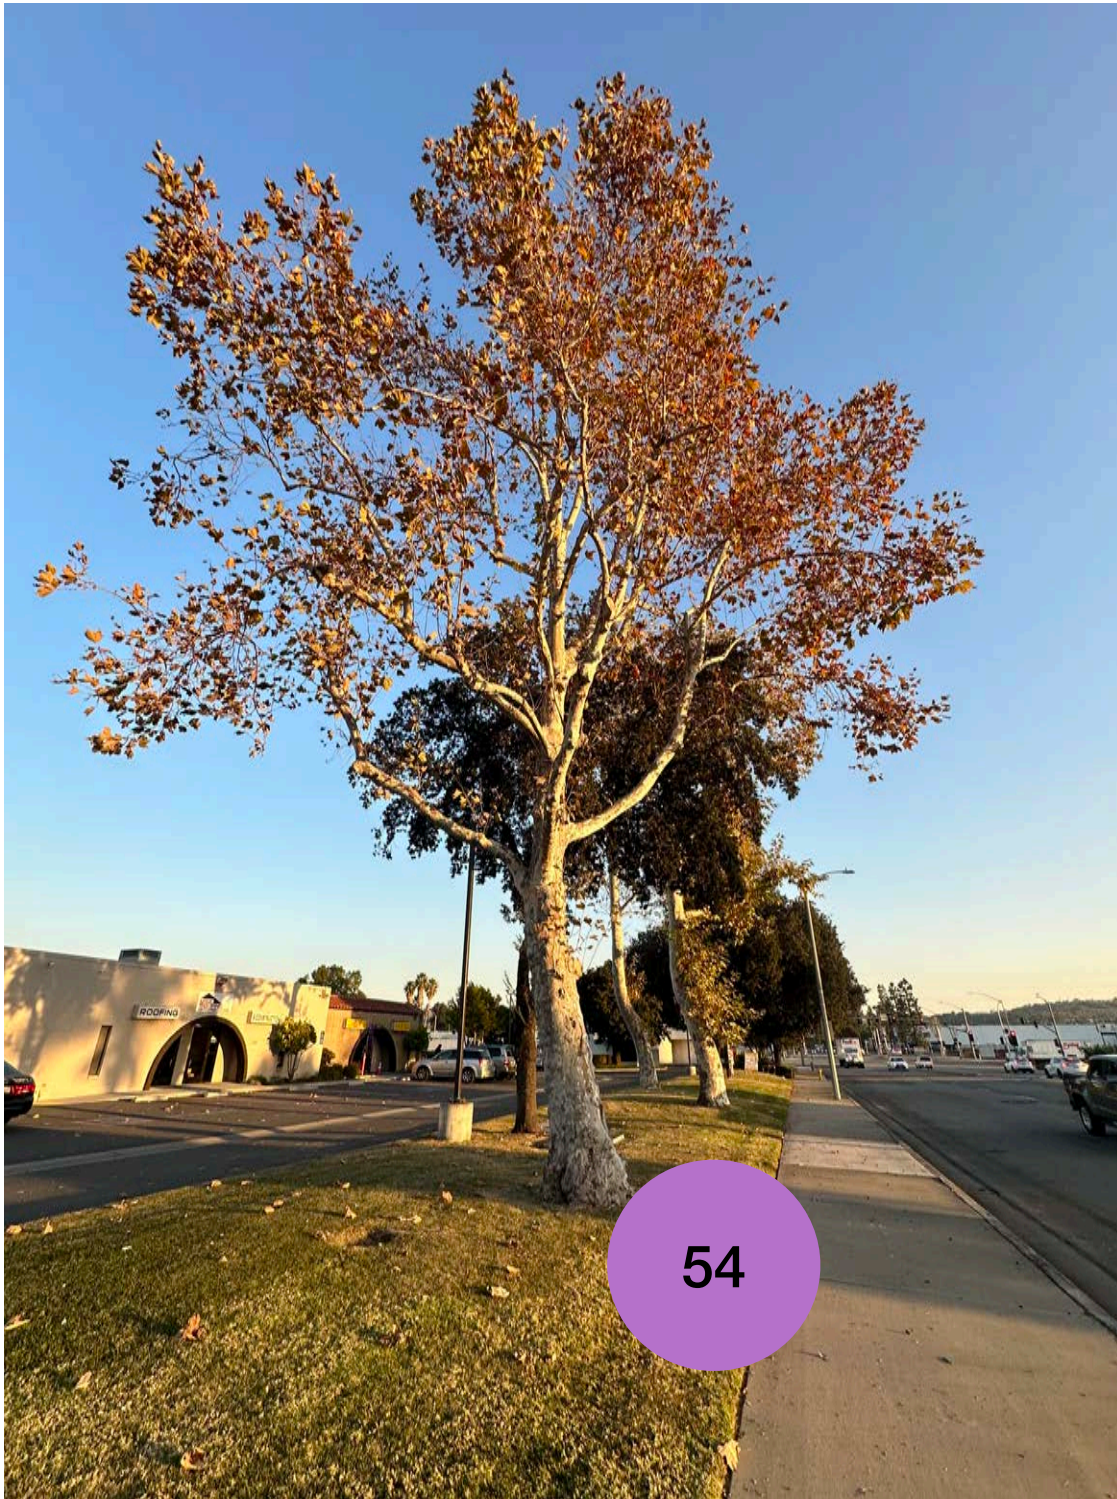
**PHOTO 11** - Shows some of the protected oak and sycamore trees on site. These trees will be retained and protected in place.

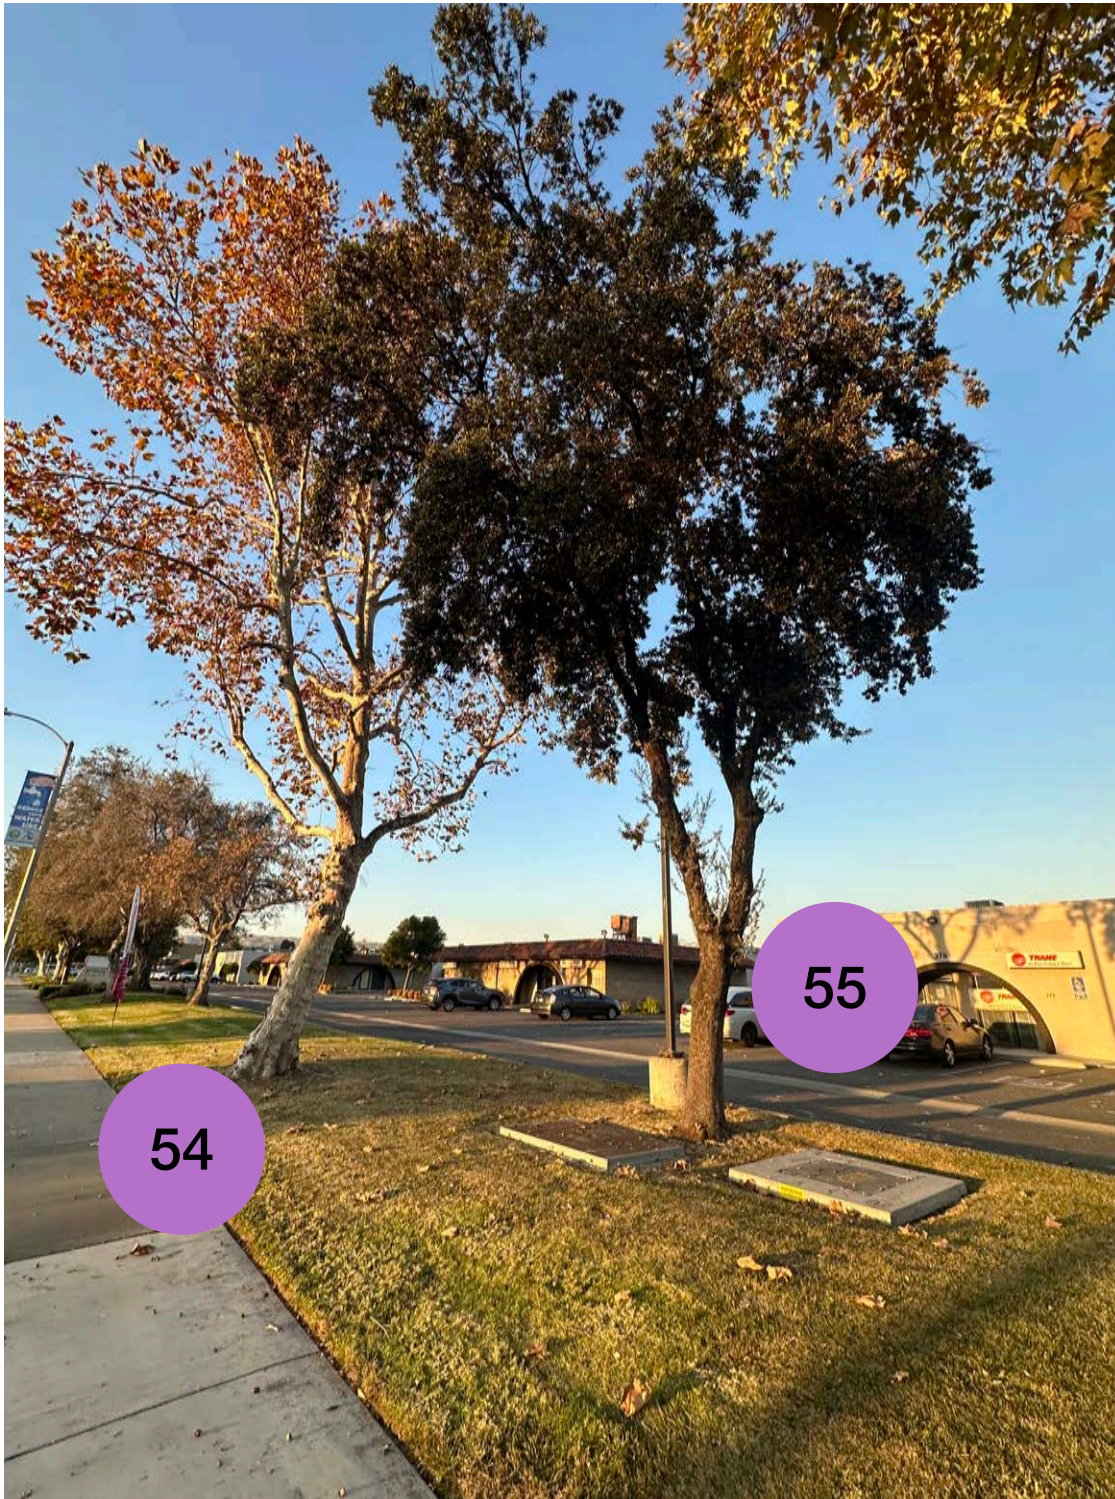
**PHOTO 12** - Shows some of the protected oak and sycamore trees on site. These trees will be retained and protected in place.

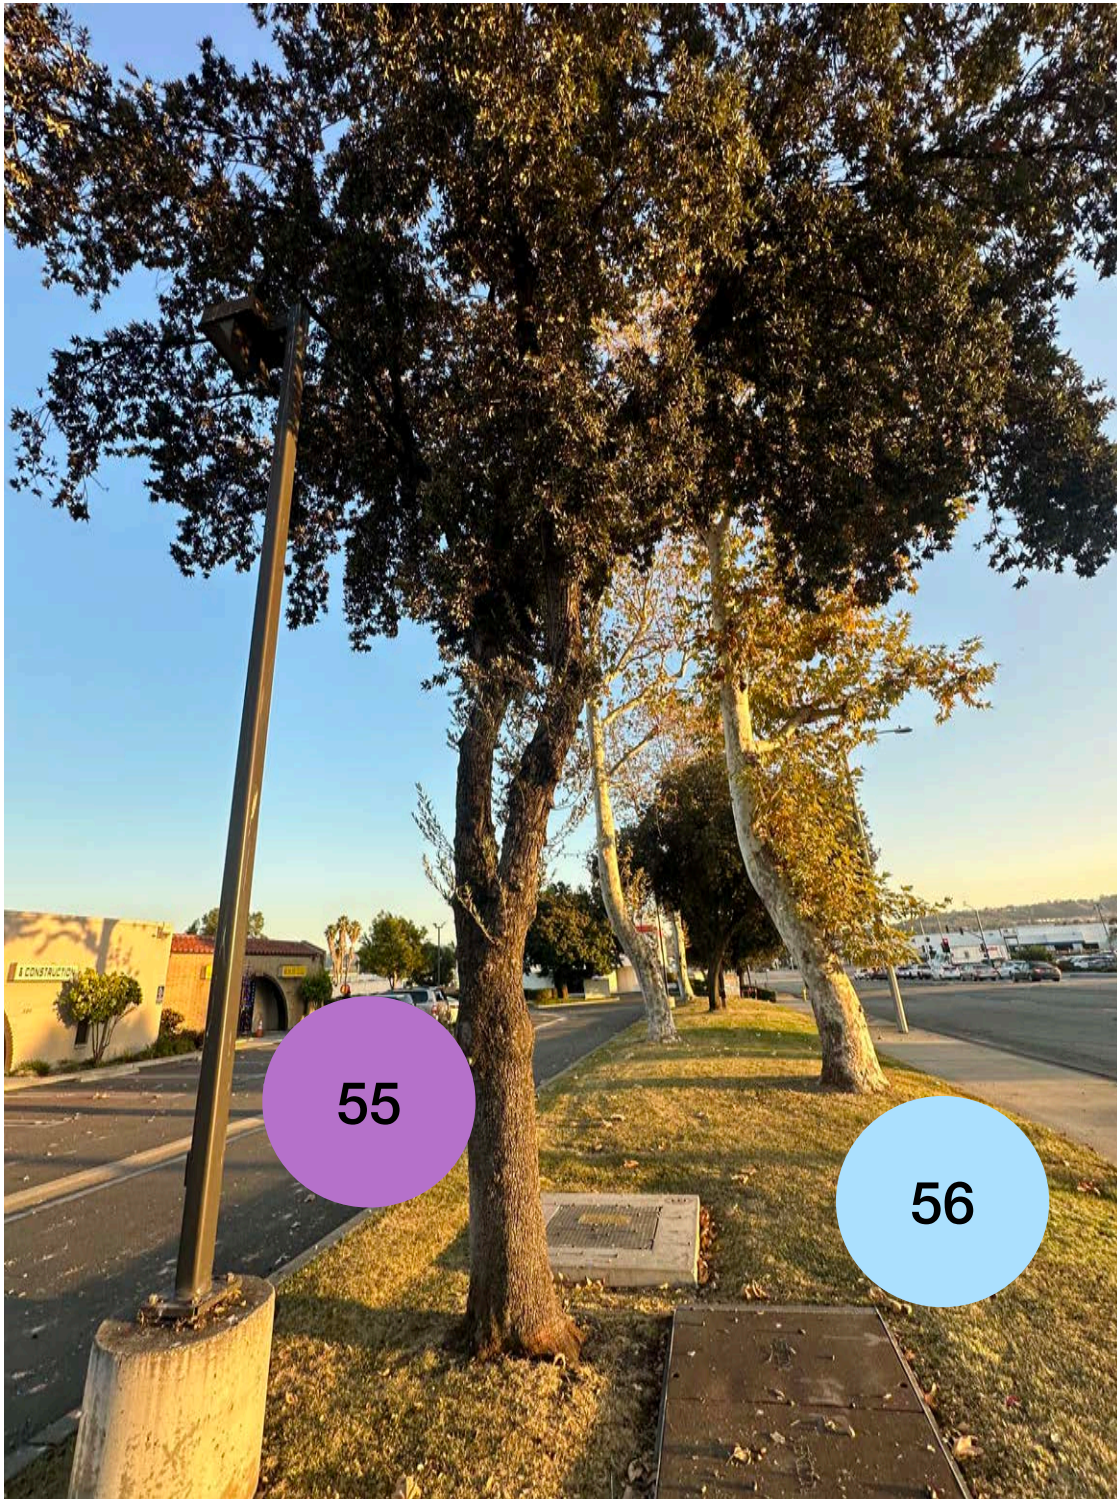
**PHOTO 13** - Shows some of the protected oak and sycamore trees on site. These trees will be retained and protected in place.
