# PROTECTED TREE REPORT

Walnut Business Park

Valley Blvd. & Lemon Ave.

April 14, 2024

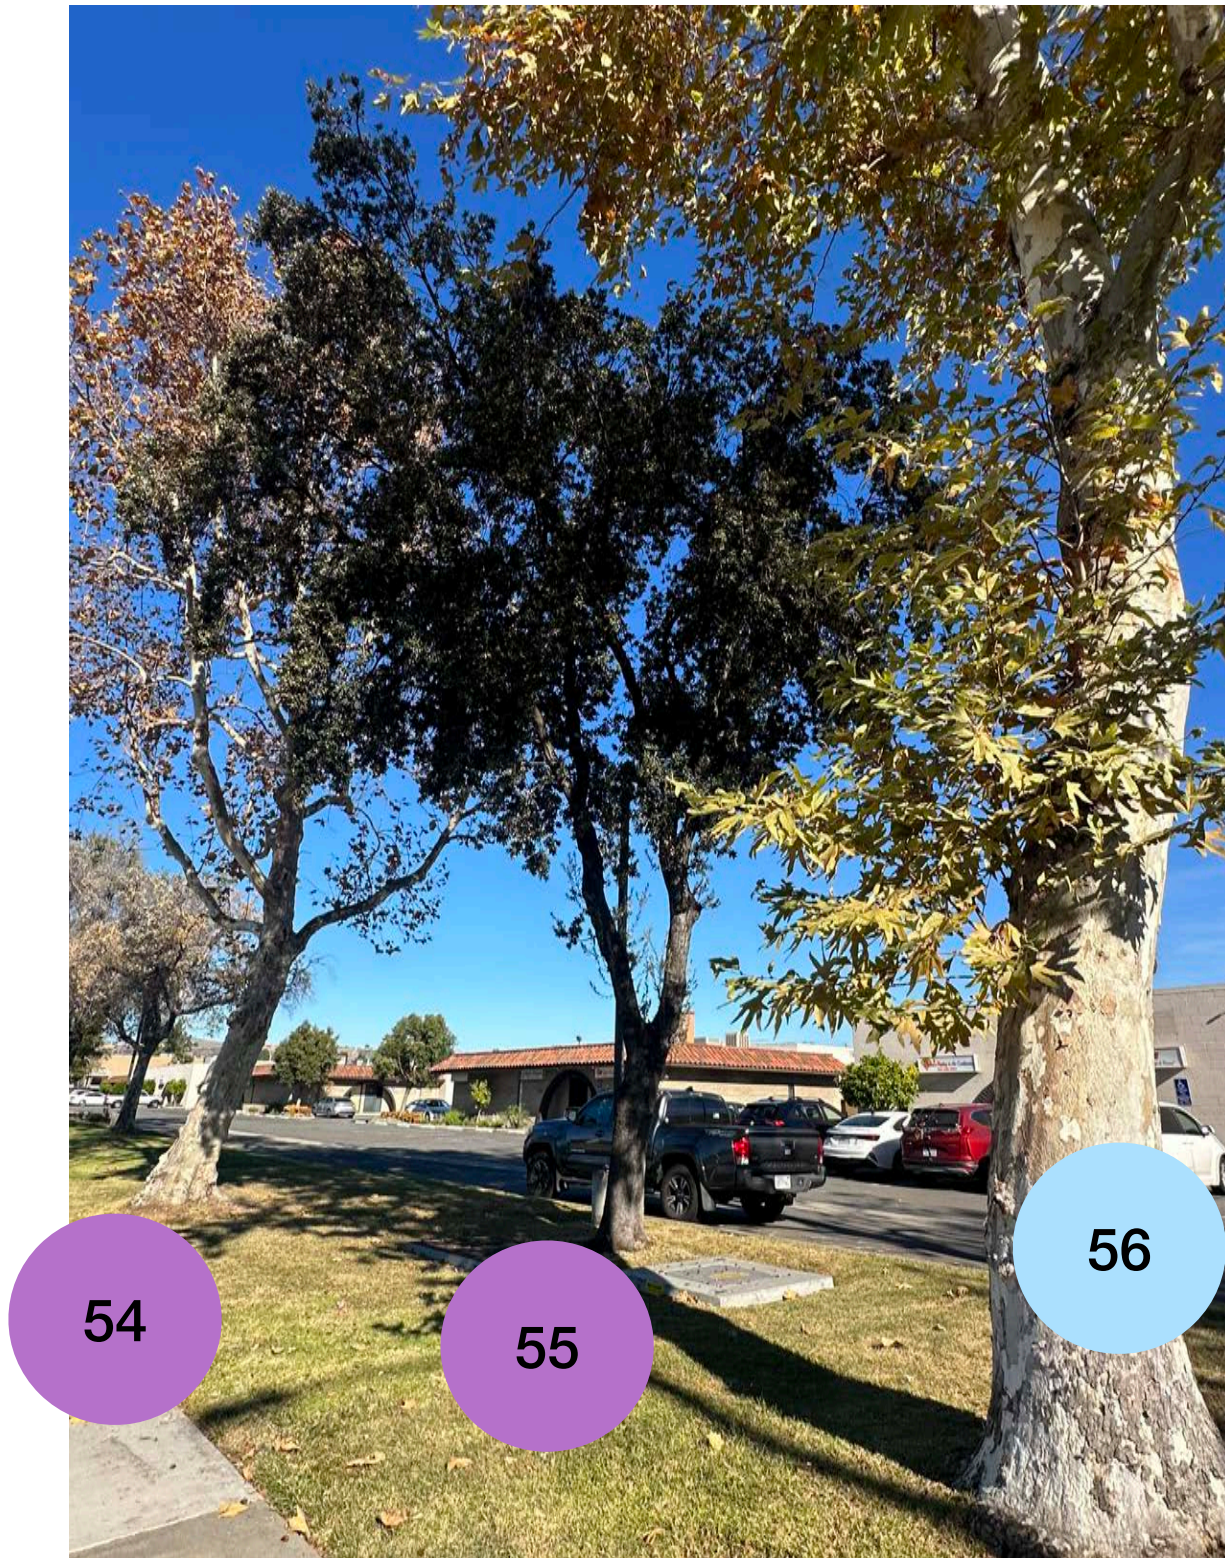
**PHOTO 14** - Shows some of the protected oak and sycamore trees on site. These trees will be retained and protected in place.

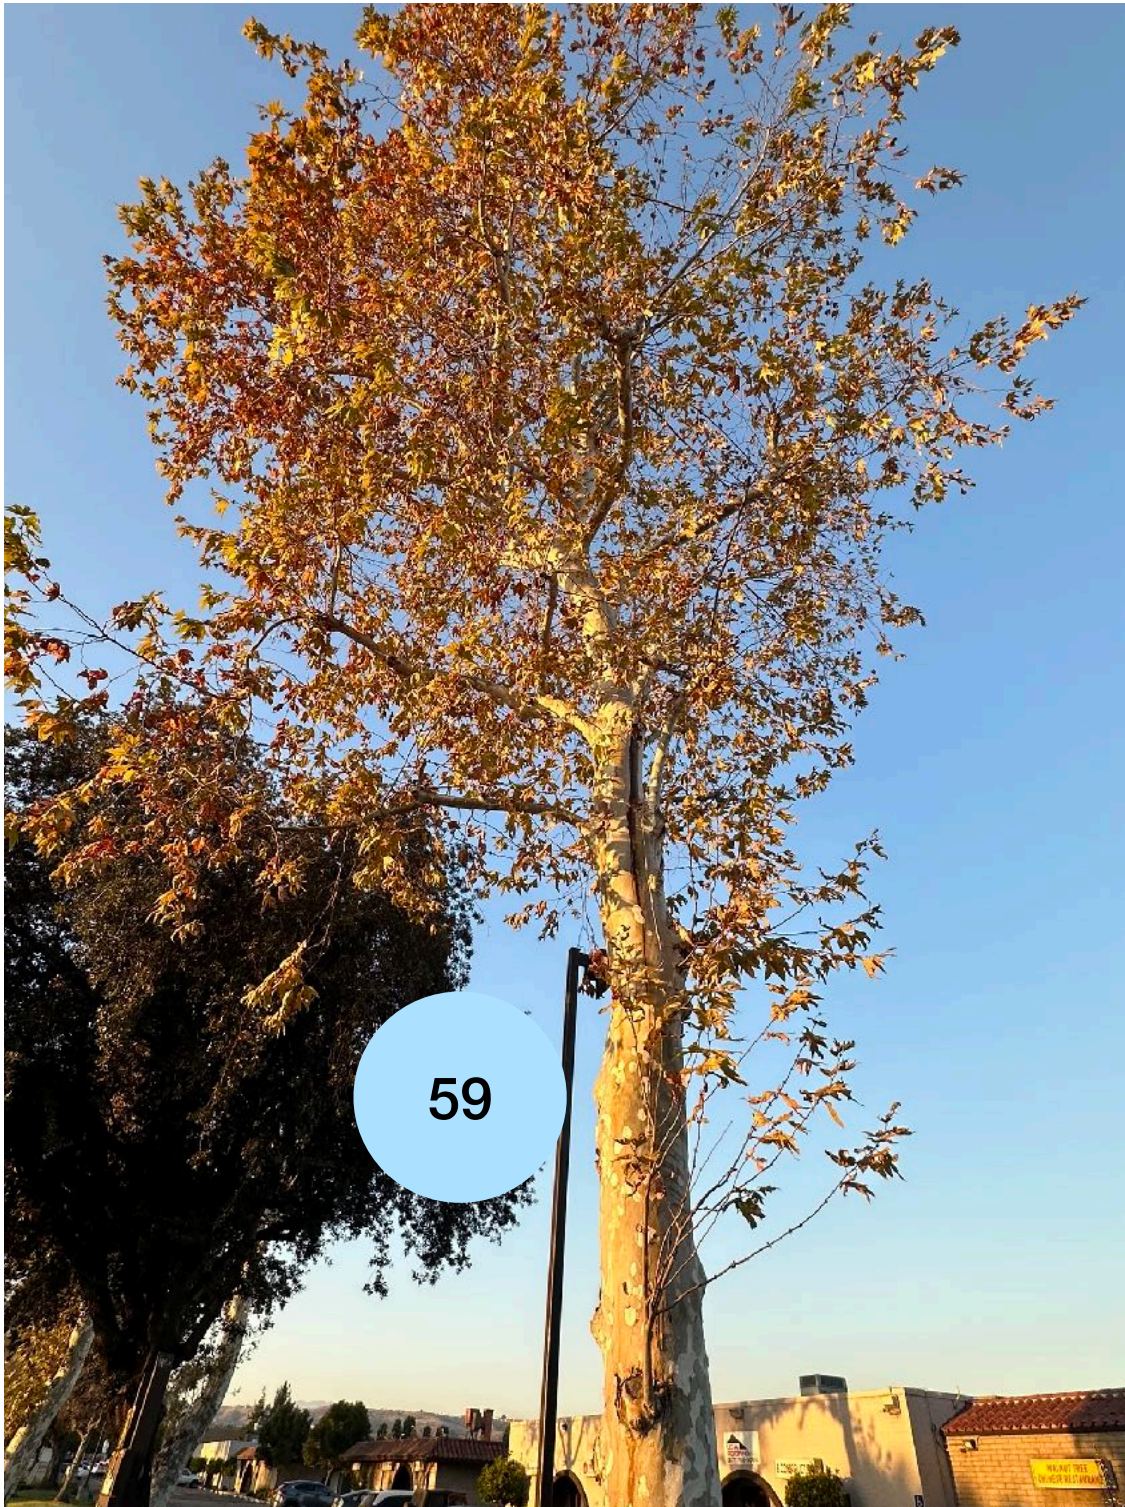
**PHOTO 16** - Shows trees on site, which include London Plane, Brazilian Pepper, and other non-protected trees. Removals are focused on areas of future development and root impacts that will not be tolerable.

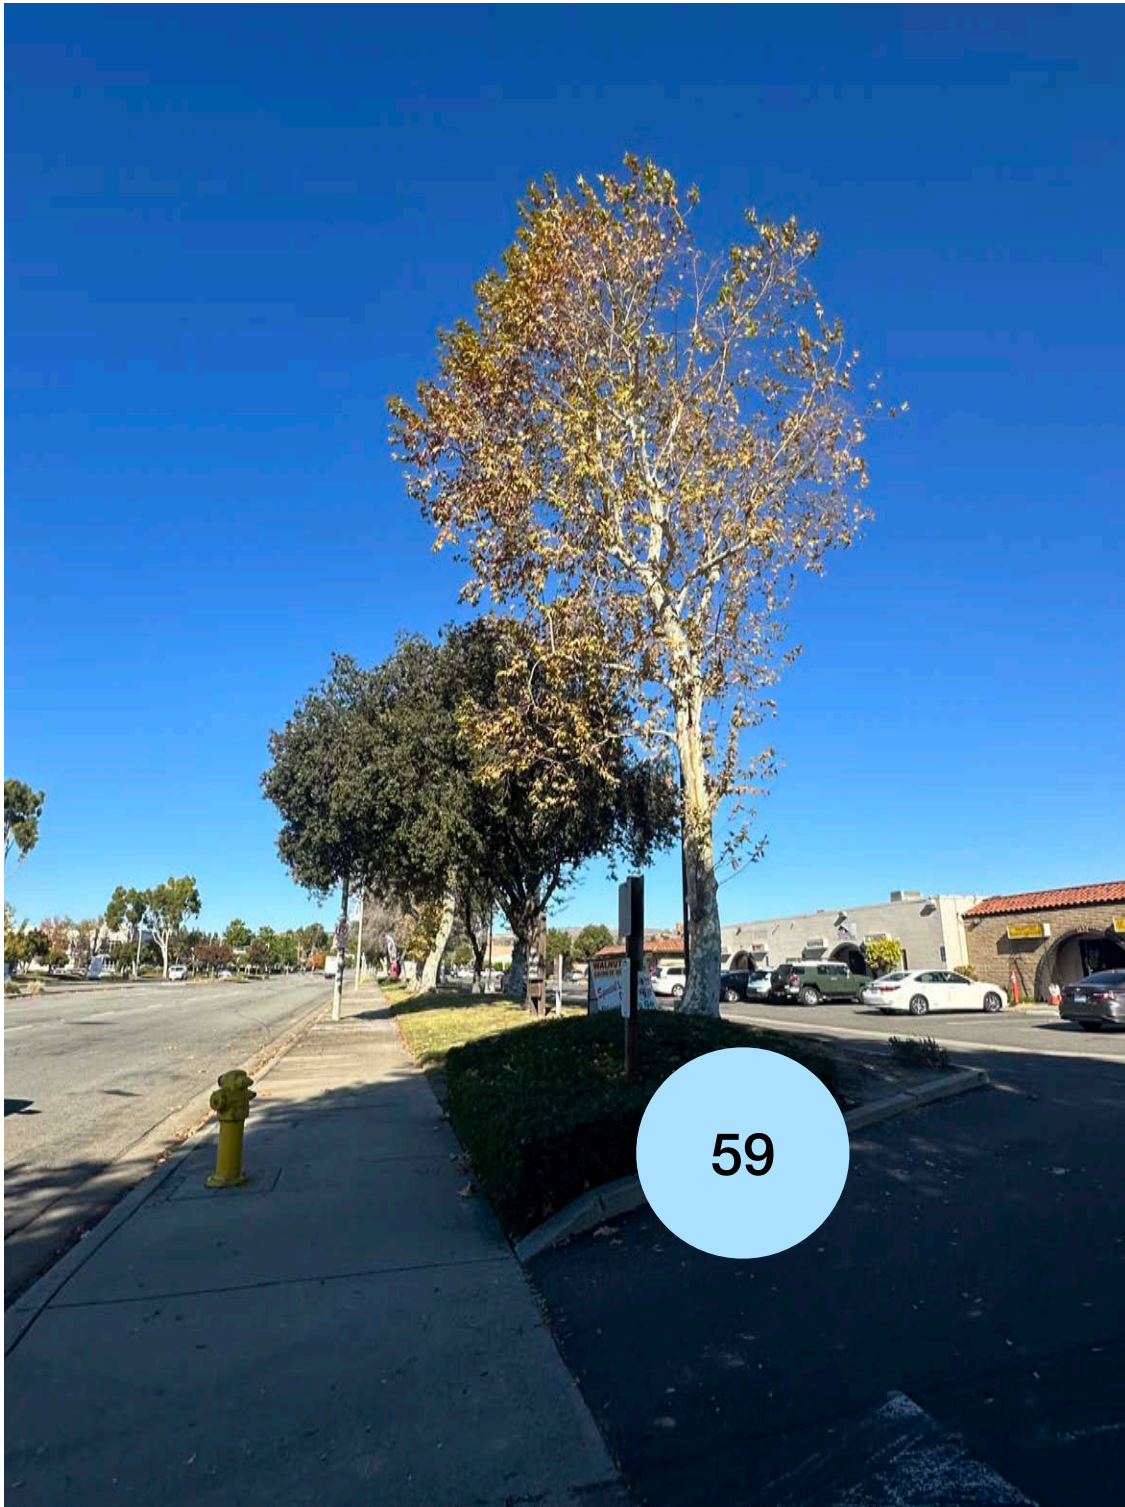
**PHOTO 17** - Shows trees on site, which include London Plane, Brazilian Pepper, and other non-protected trees. Removals are focused on areas of future development and root impacts that will not be tolerable.

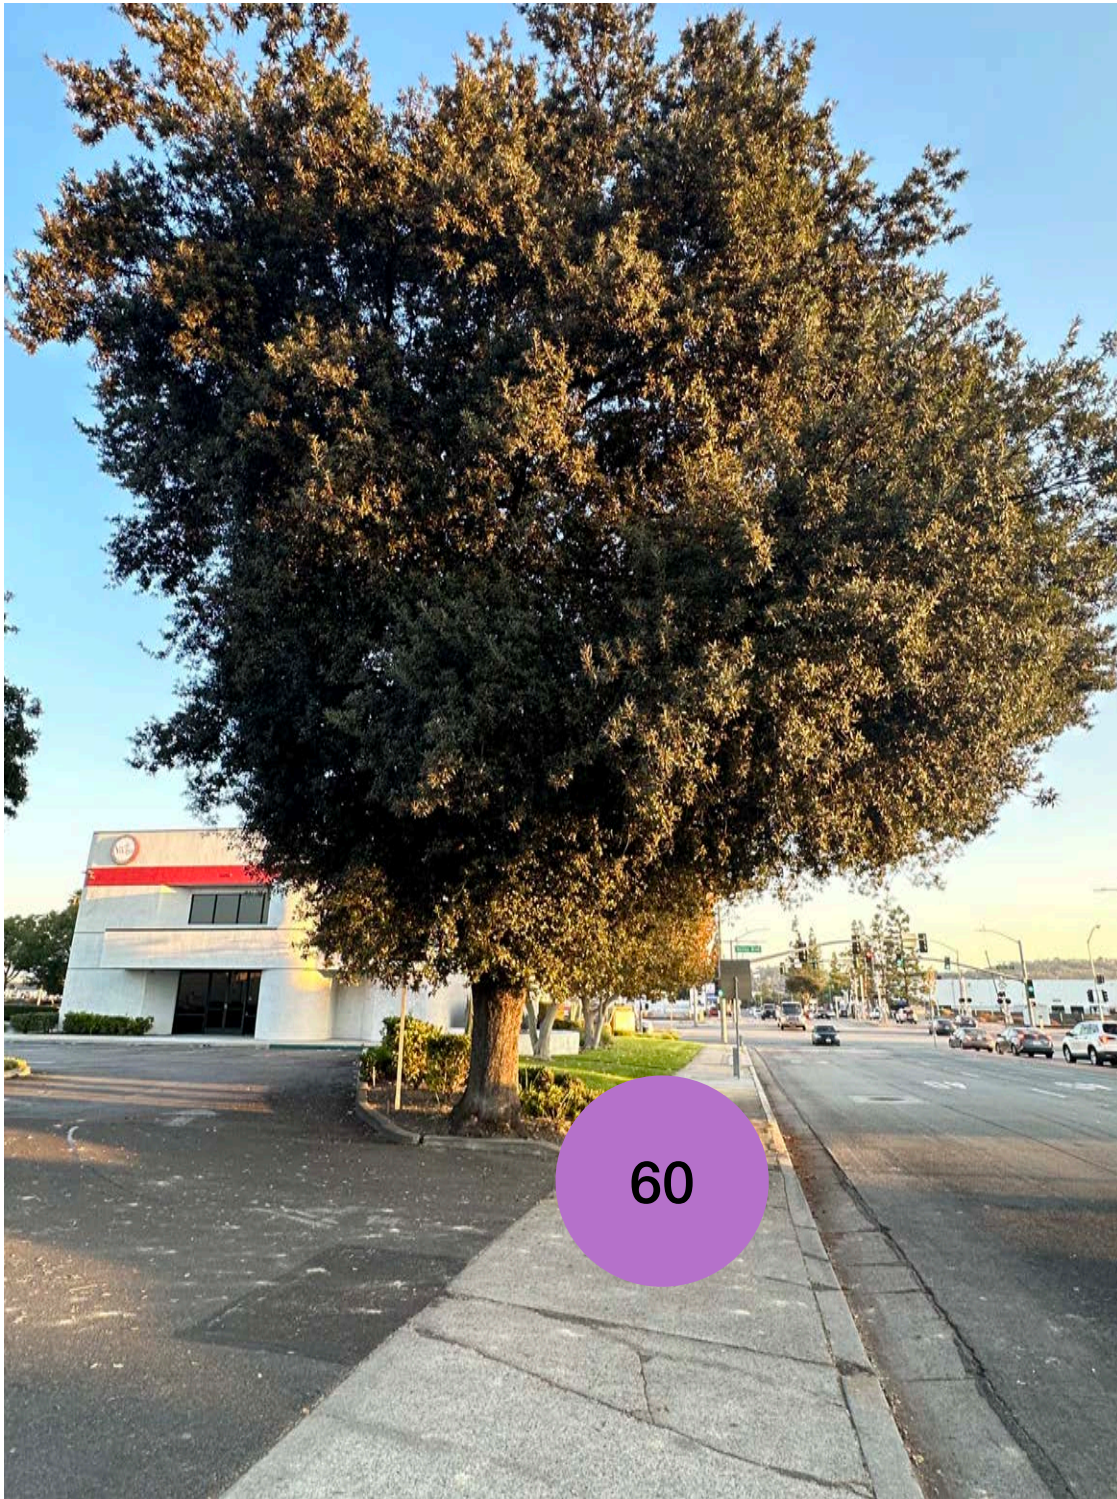
**PHOTO 18** - Shows some of the protected oak and sycamore trees on site. These trees will be retained and protected in place.

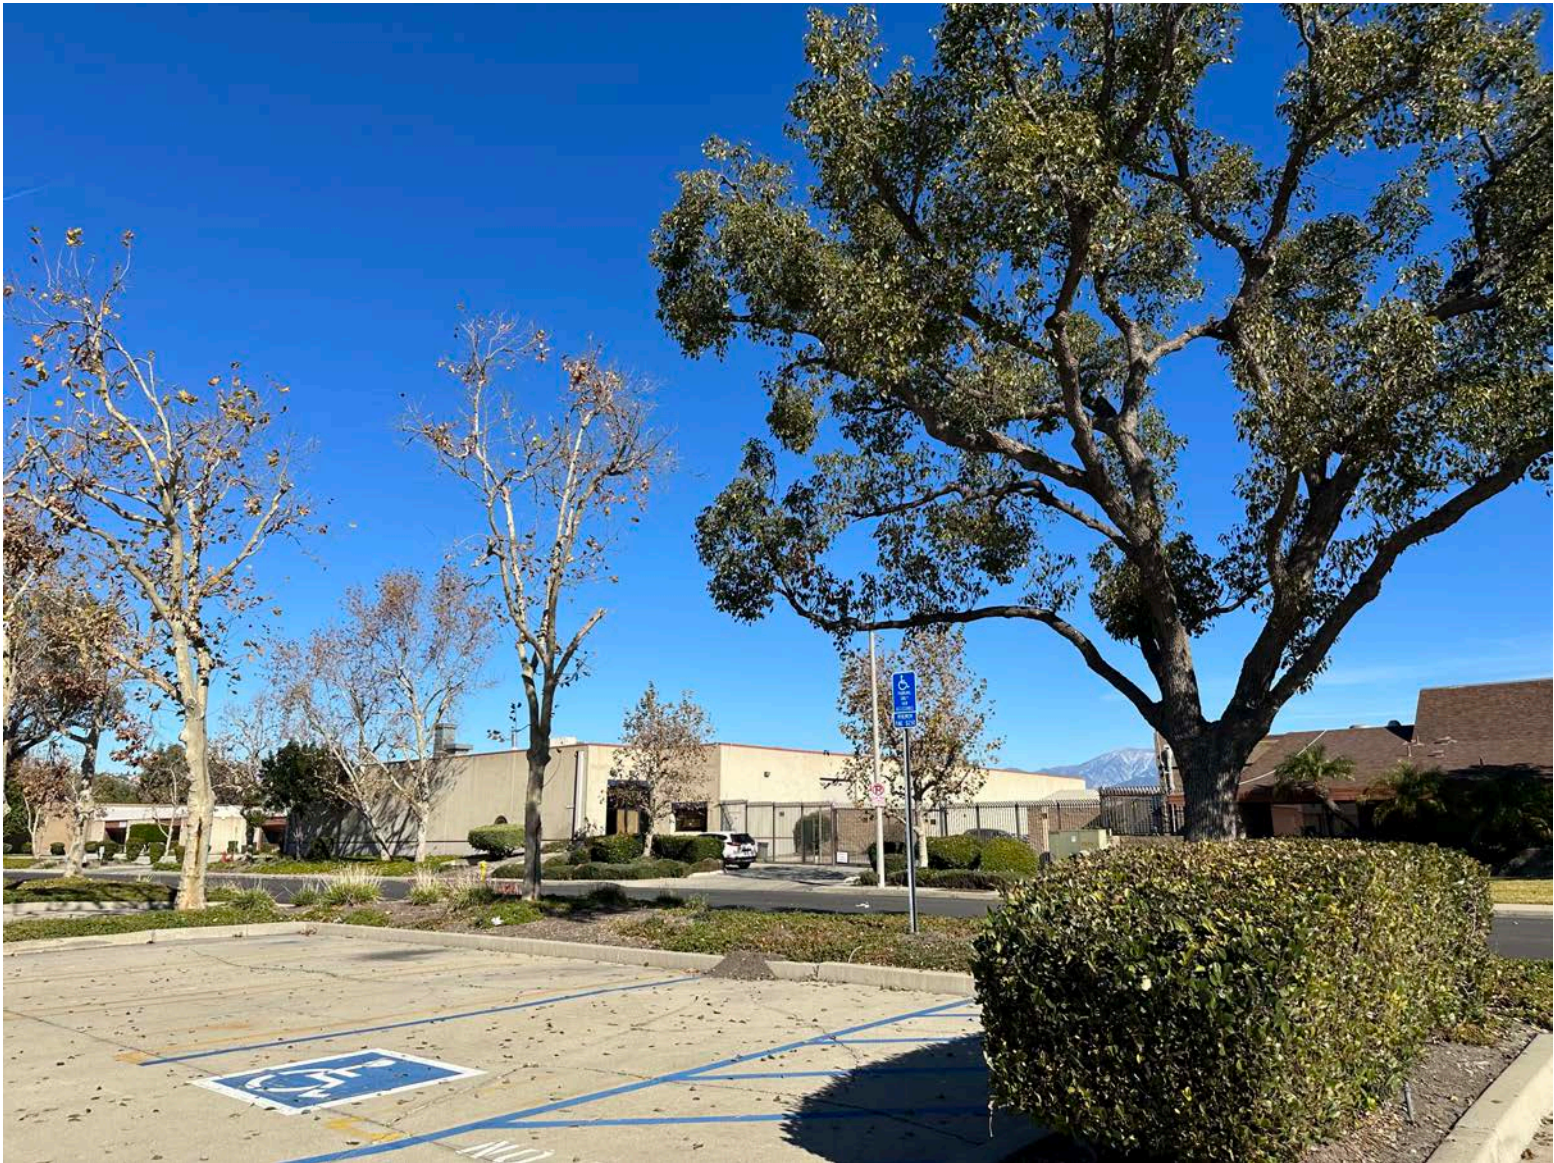
**PHOTO 19** - Shows trees on site, which include London Plane, Brazilian Pepper, and other non-protected trees. Removals are focused on areas of future development and root impacts that will not be tolerable.

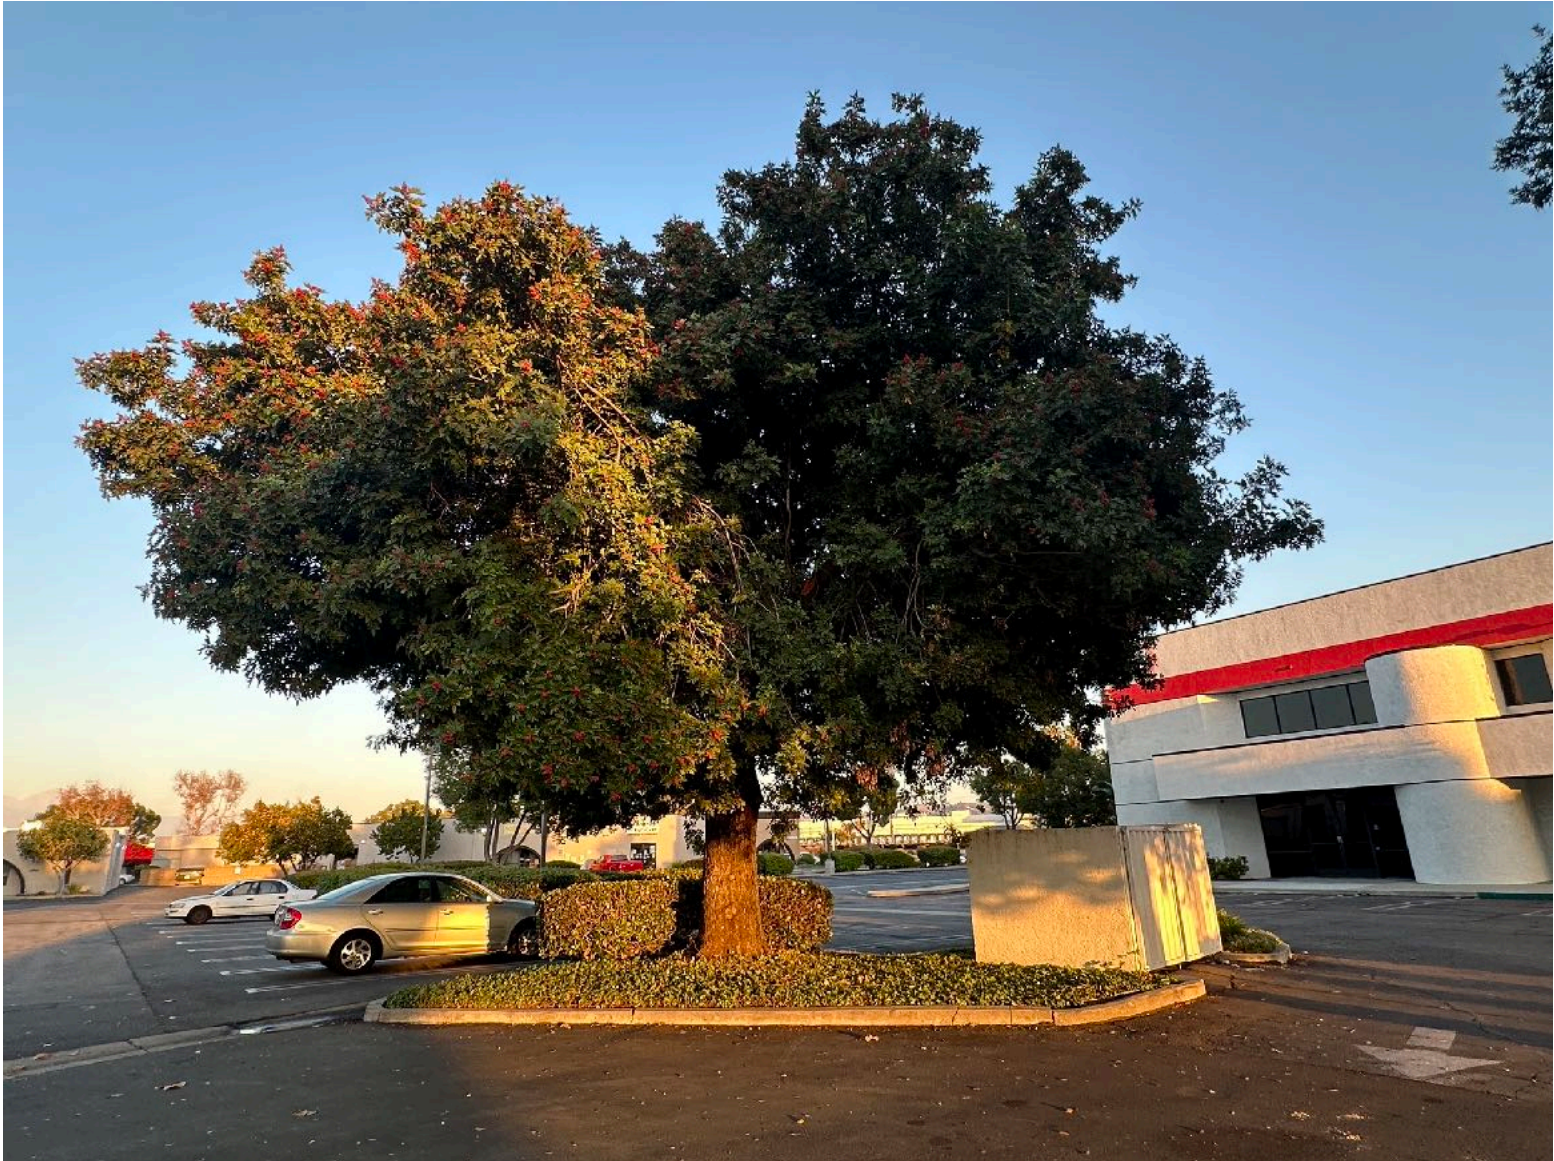
**PHOTO 20** - Shows trees on site, which include London Plane, Brazilian Pepper, and other non-protected trees. Removals are focused on areas of future development and root impacts that will not be tolerable.

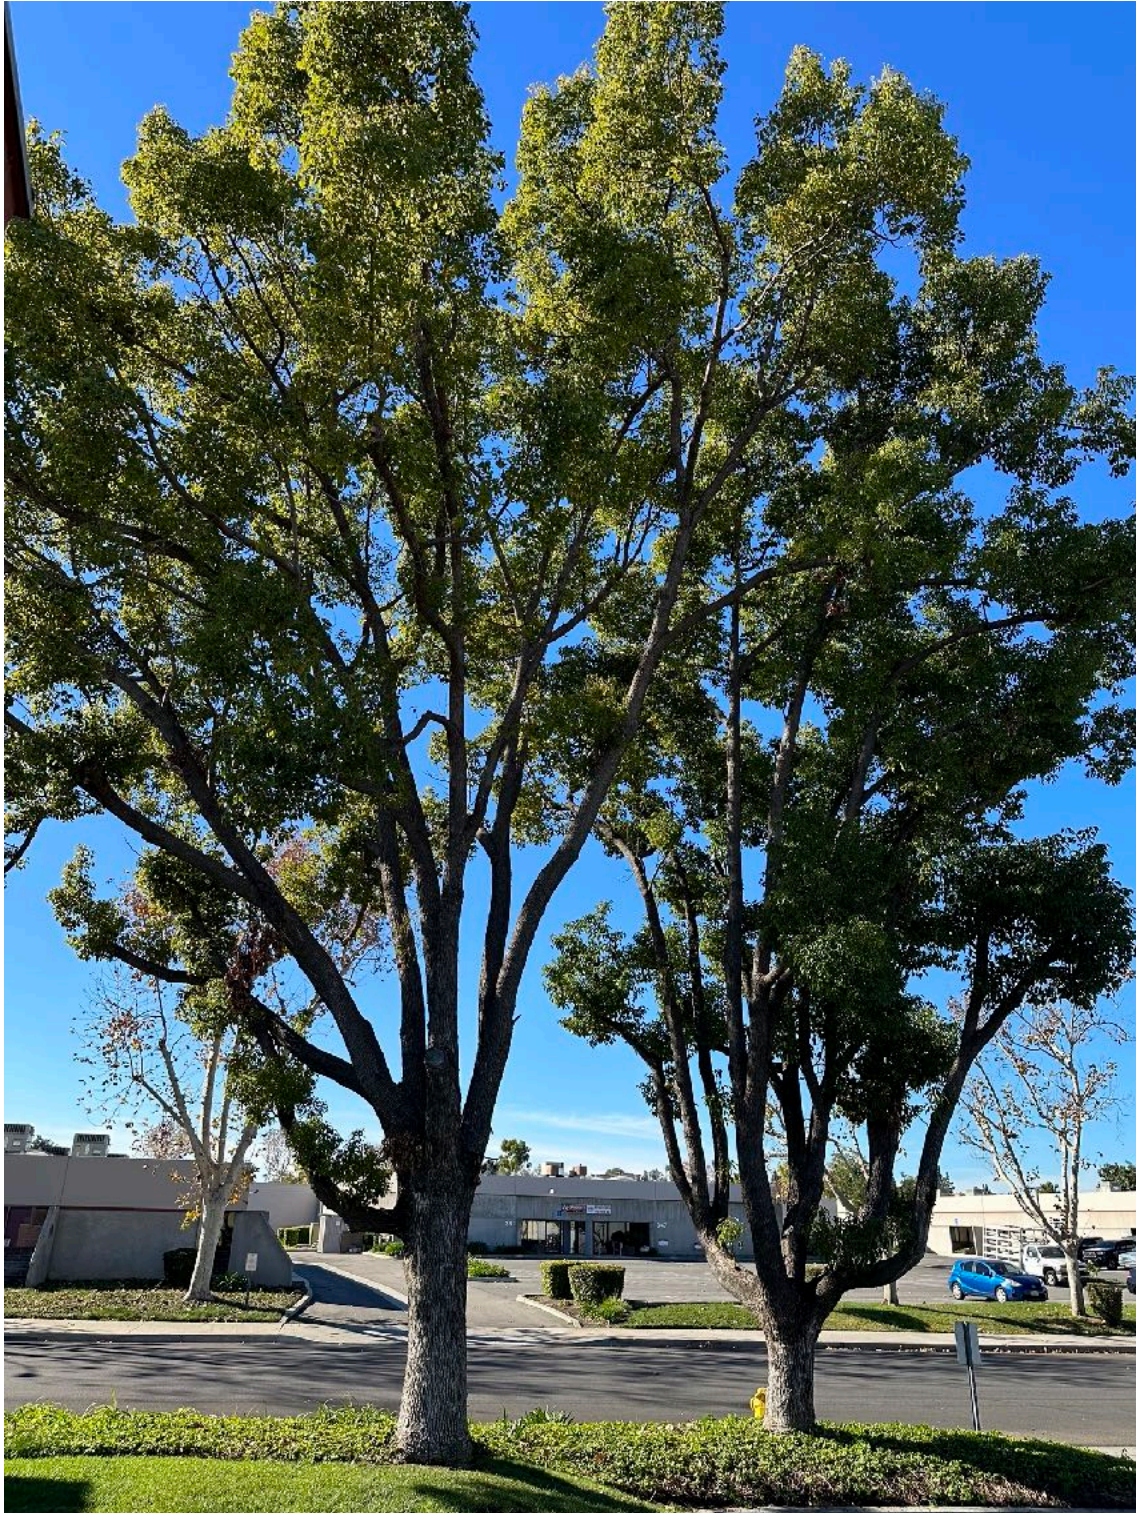
**PHOTO 21** - Shows trees on site, which include London Plane, Brazilian Pepper, and other non-protected trees. Removals are focused on areas of future development and root impacts that will not be tolerable.

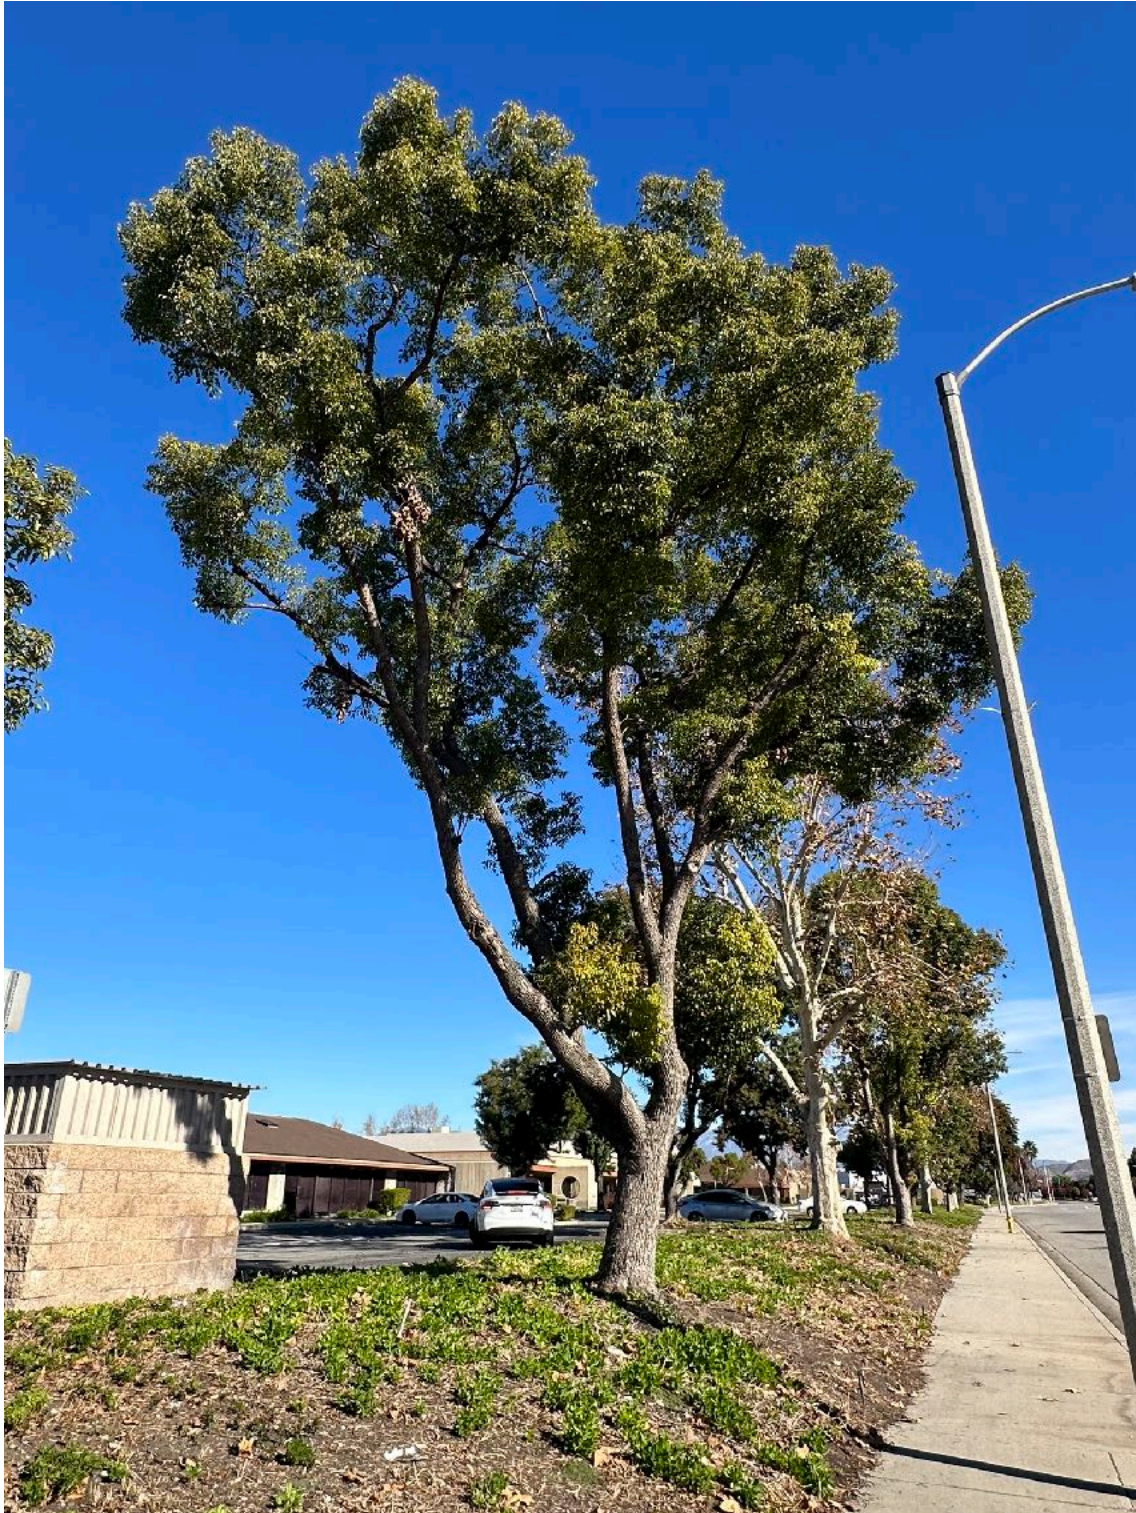
**PHOTO 22** - Shows trees on site, which include London Plane, Brazilian Pepper, and other non-protected trees. Removals are focused on areas of future development and root impacts that will not be tolerable.

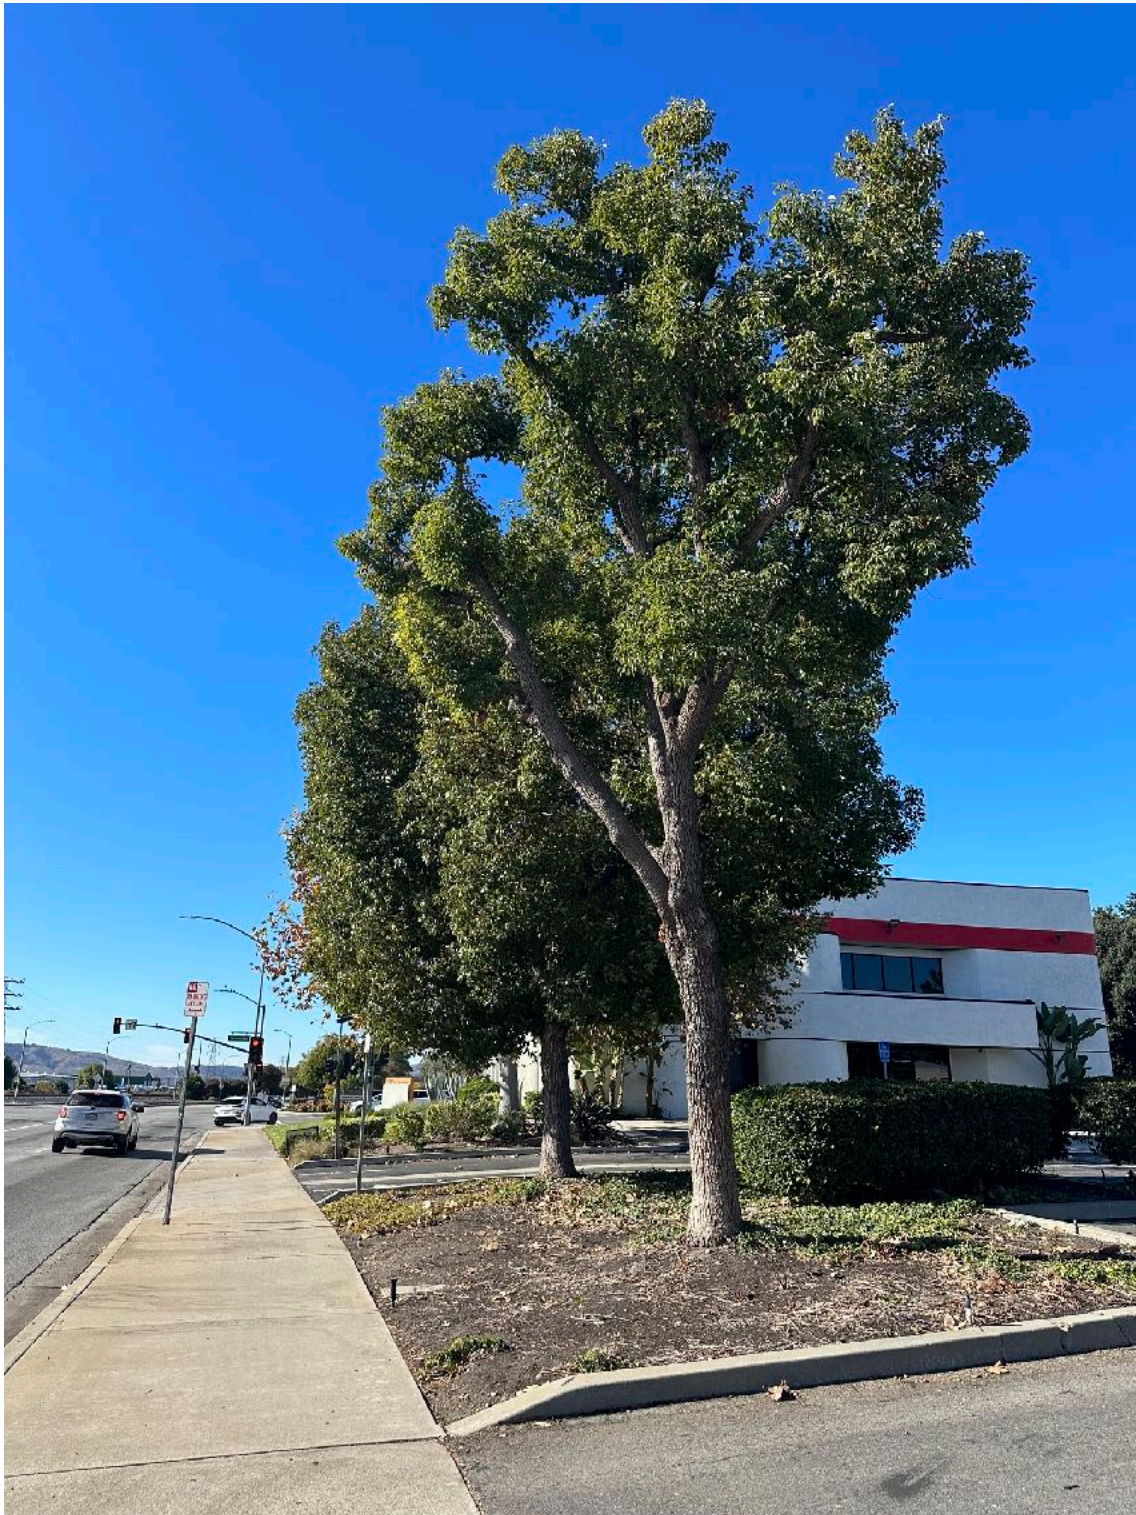
**PHOTO 23** - Shows trees on site, which include London Plane, Brazilian Pepper, and other non-protected trees. Removals are focused on areas of future development and root impacts that will not be tolerable.

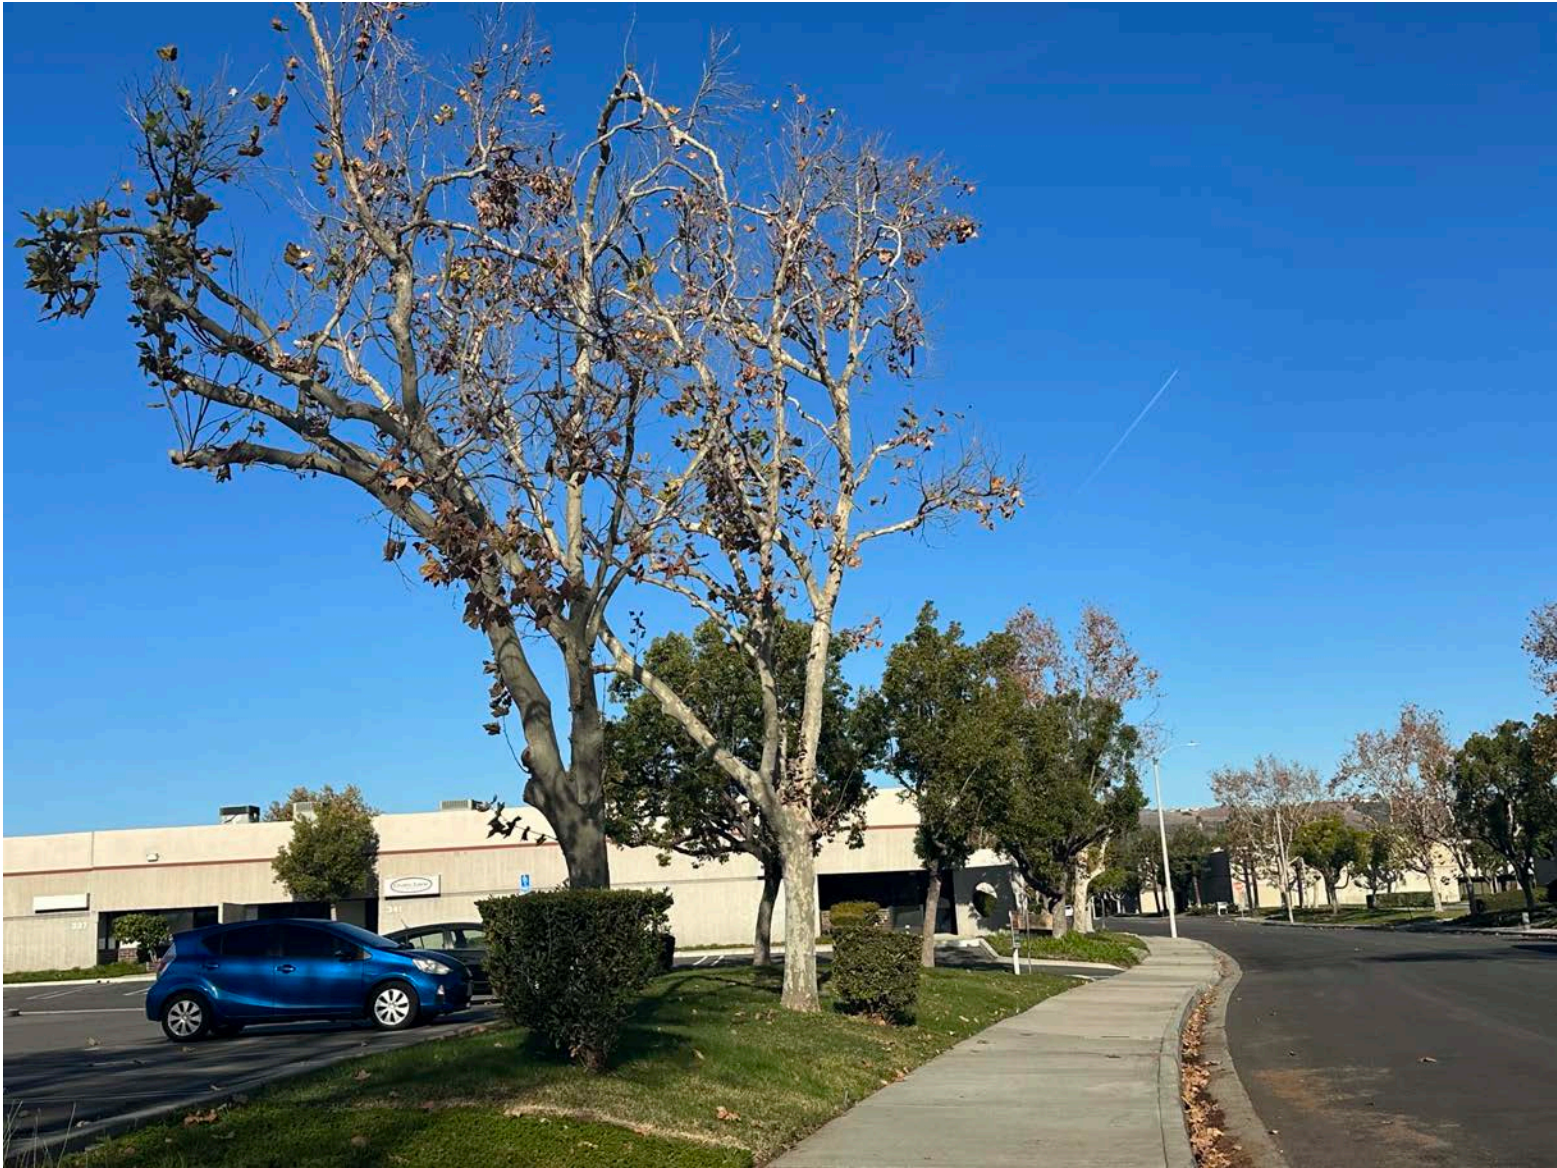
**PHOTO 24** - Shows trees on site, which include London Plane, Brazilian Pepper, and other non-protected trees. Removals are focused on areas of future development and root impacts that will not be tolerable.

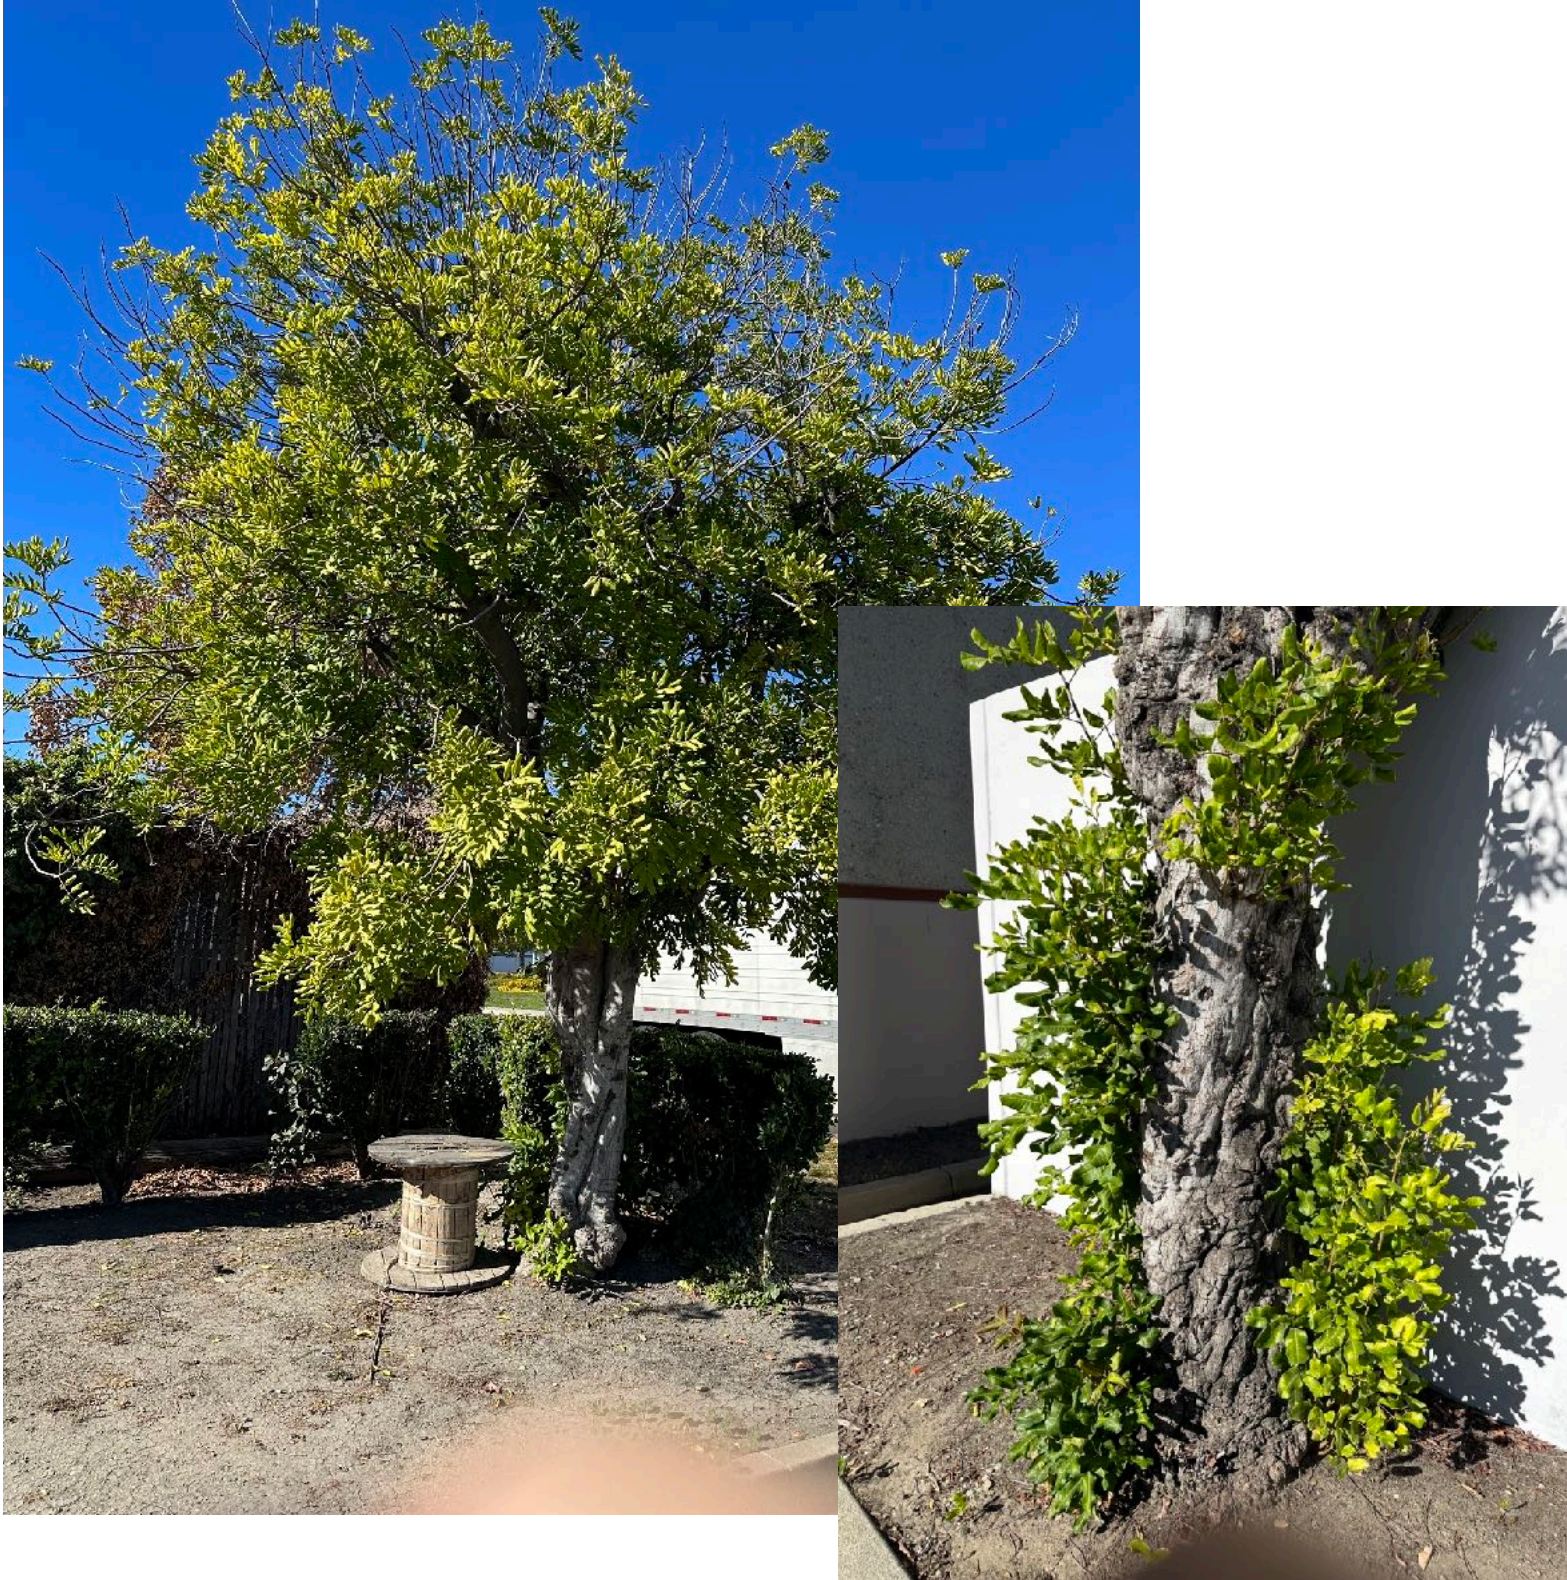
**PHOTO 25** - Shows trees on site, which include London Plane, Brazilian Pepper, and other non-protected trees. Removals are focused on areas of future development and root impacts that will not be tolerable.

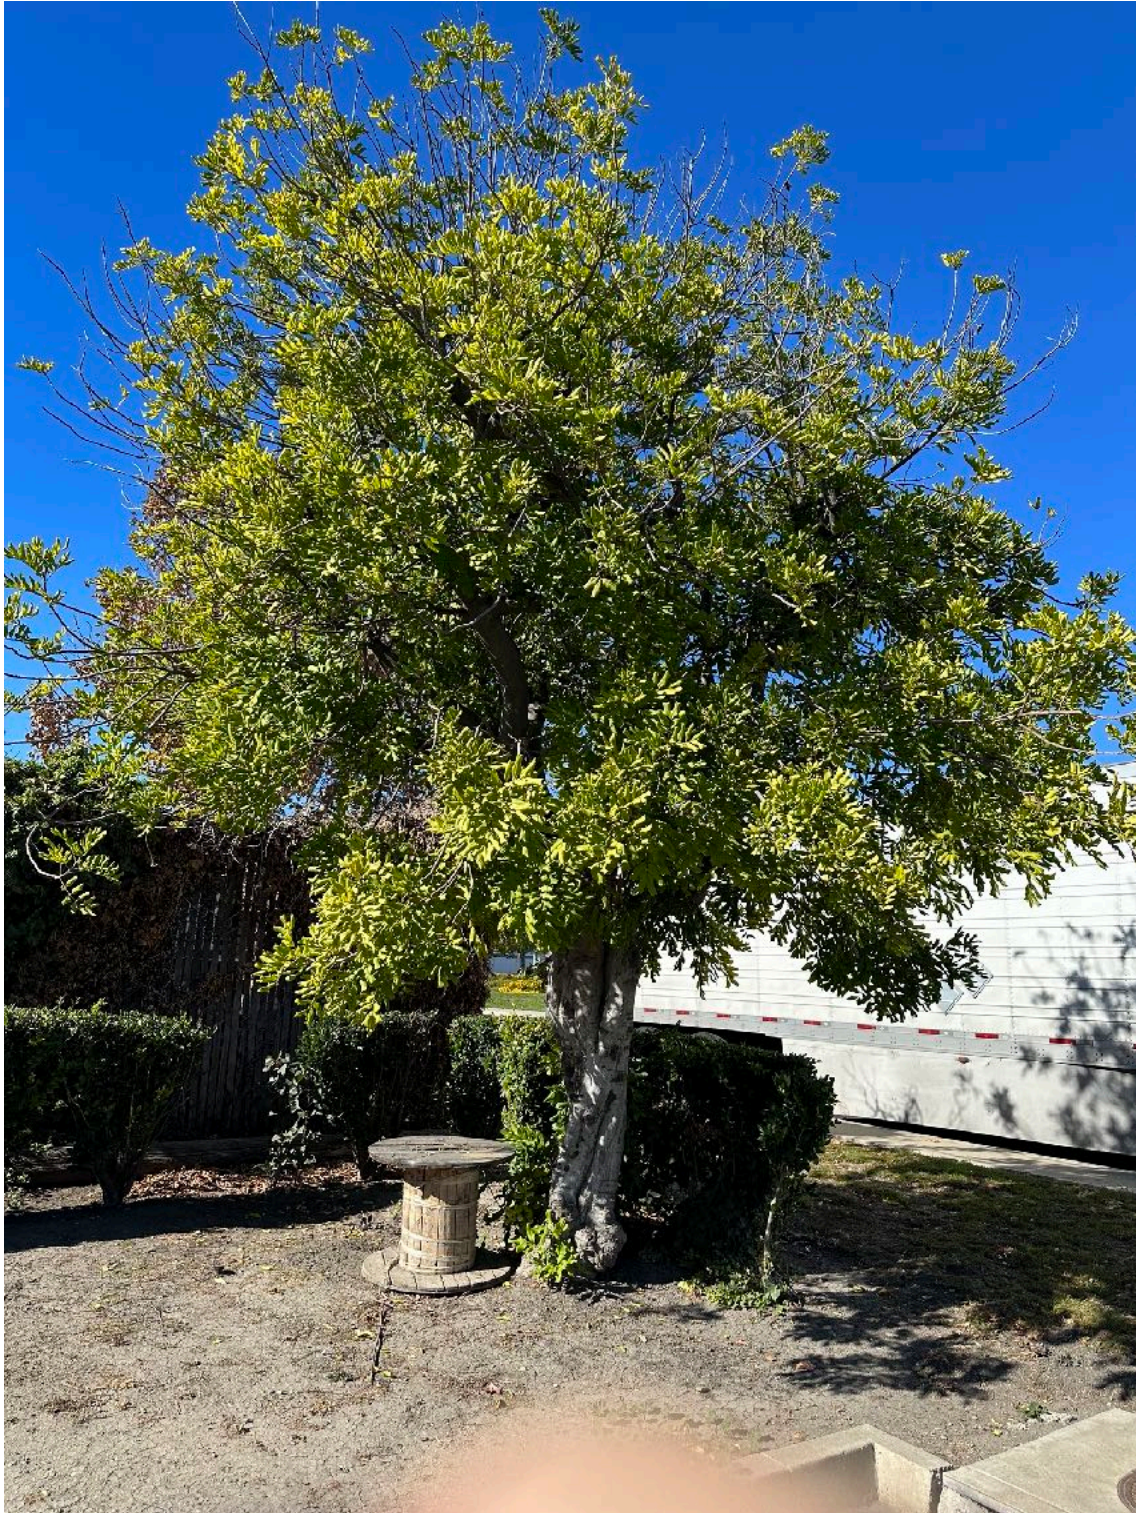
**PHOTO 26** - Shows trees on site, which include London Plane, Brazilian Pepper, and other non-protected trees. Removals are focused on areas of future development and root impacts that will not be tolerable.
