# PROTECTED TREE REPORT

Walnut Business Park

Valley Blvd. & Lemon Ave.

April 14, 2024

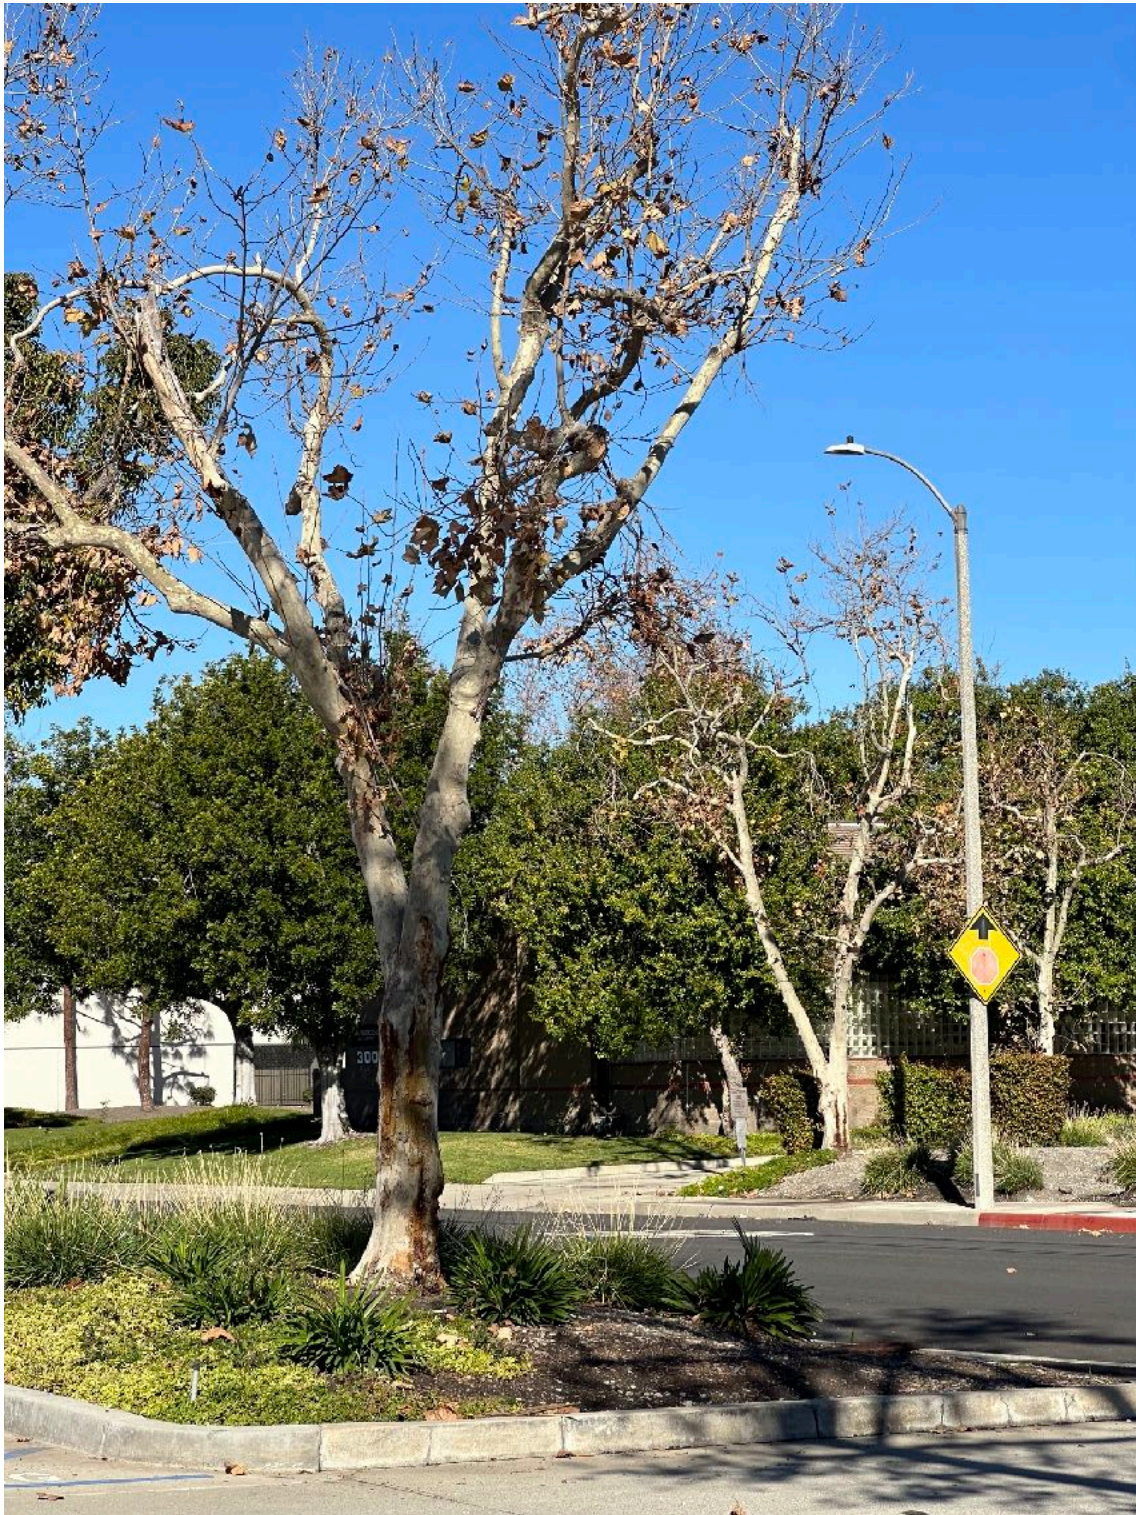
**PHOTO 27** - Shows trees on site, which include London Plane, Brazilian Pepper, and other non-protected trees. Removals are focused on areas of future development and root impacts that will not be tolerable.

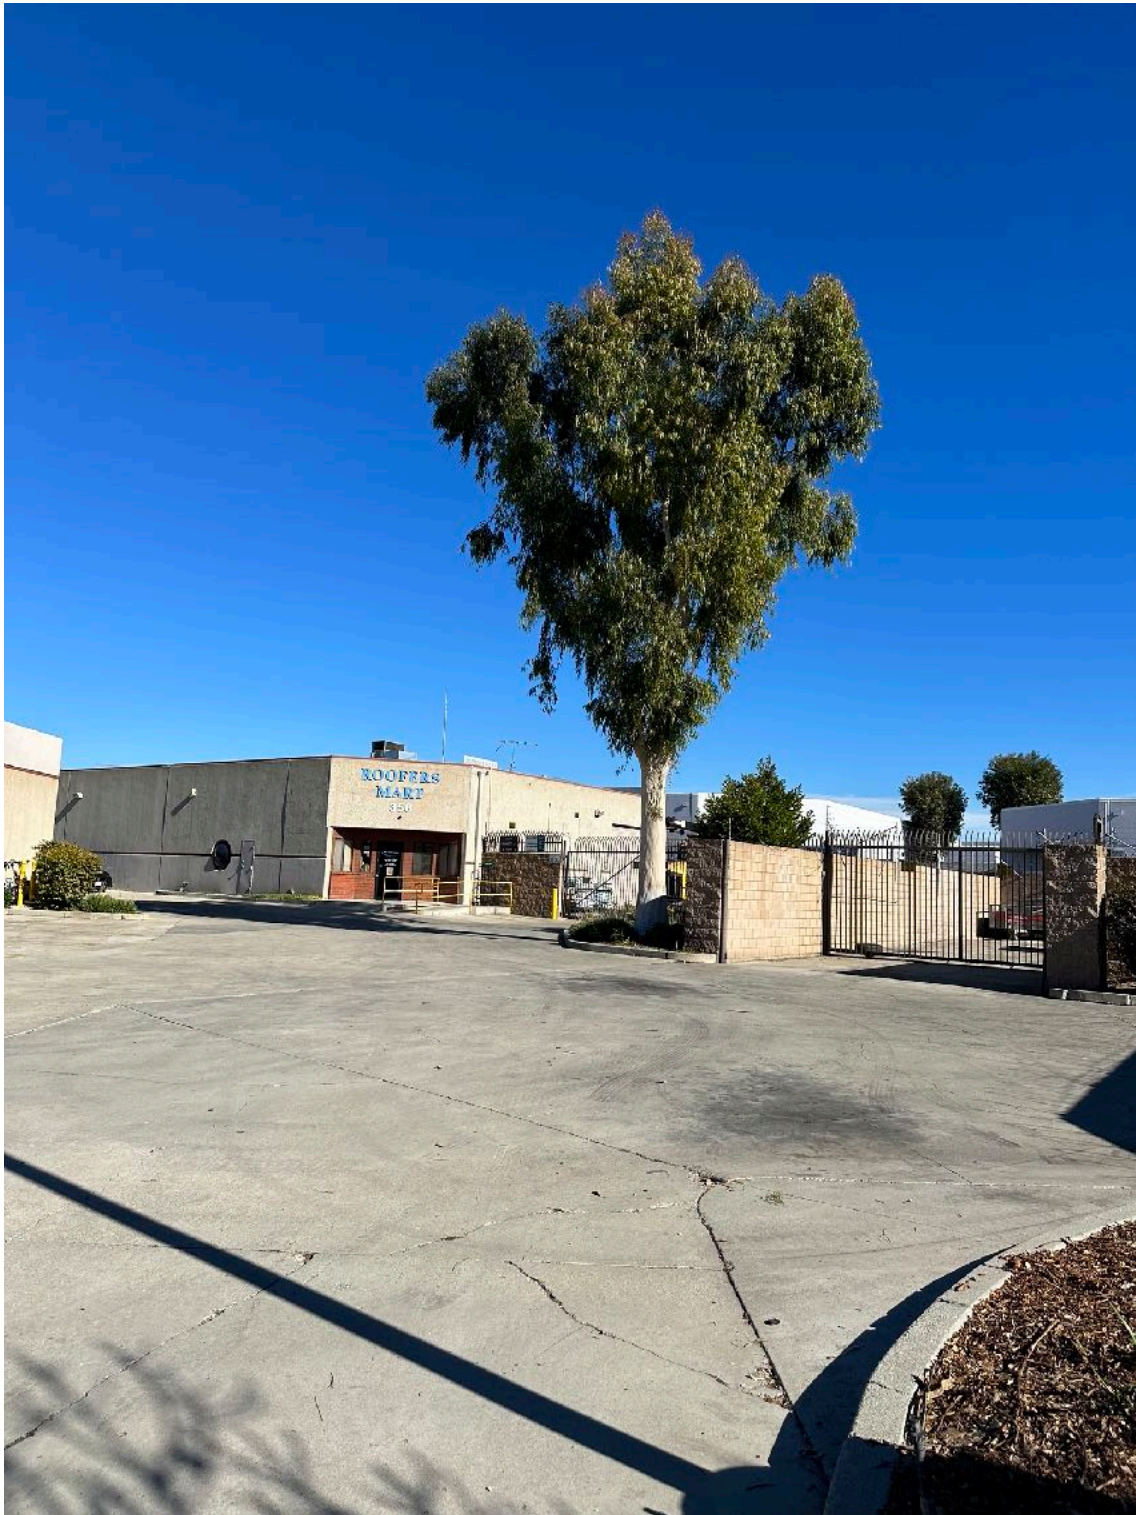
**PHOTO 28** - Shows trees on site, which include London Plane, Brazilian Pepper, and other non-protected trees. Removals are focused on areas of future development and root impacts that will not be tolerable.

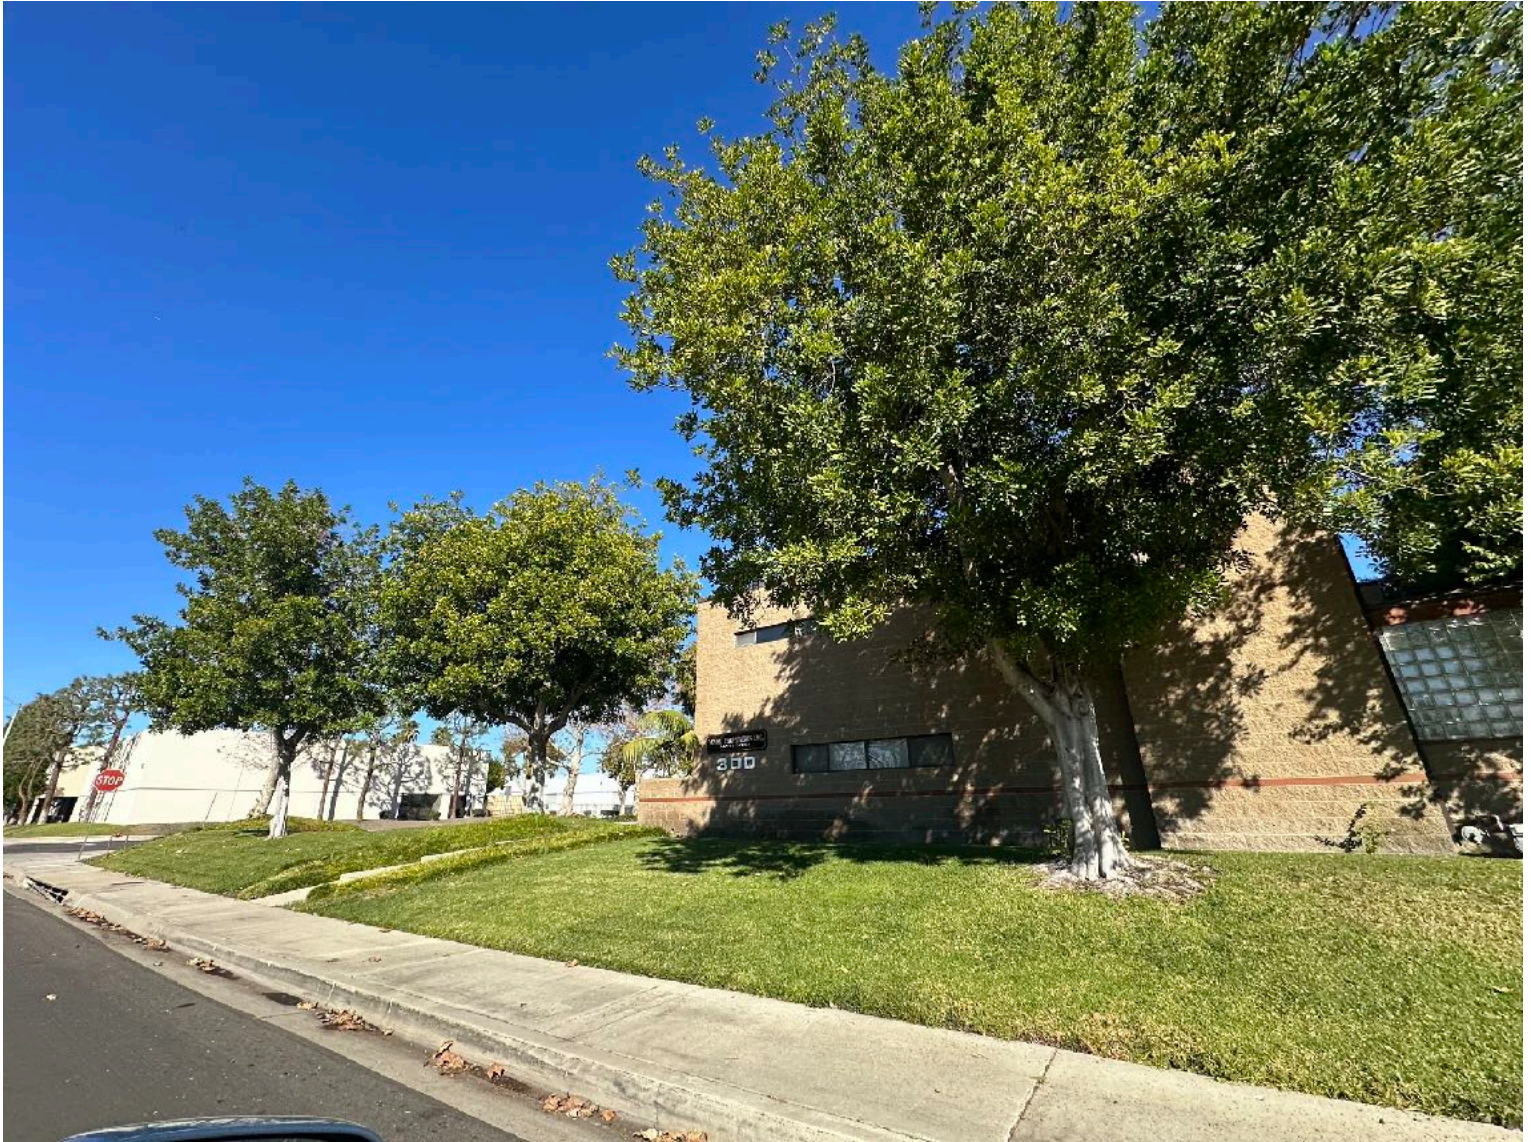
**PHOTO 29** - Shows trees on site, which include London Plane, Brazilian Pepper, and other non-protected trees. Removals are focused on areas of future development and root impacts that will not be tolerable.

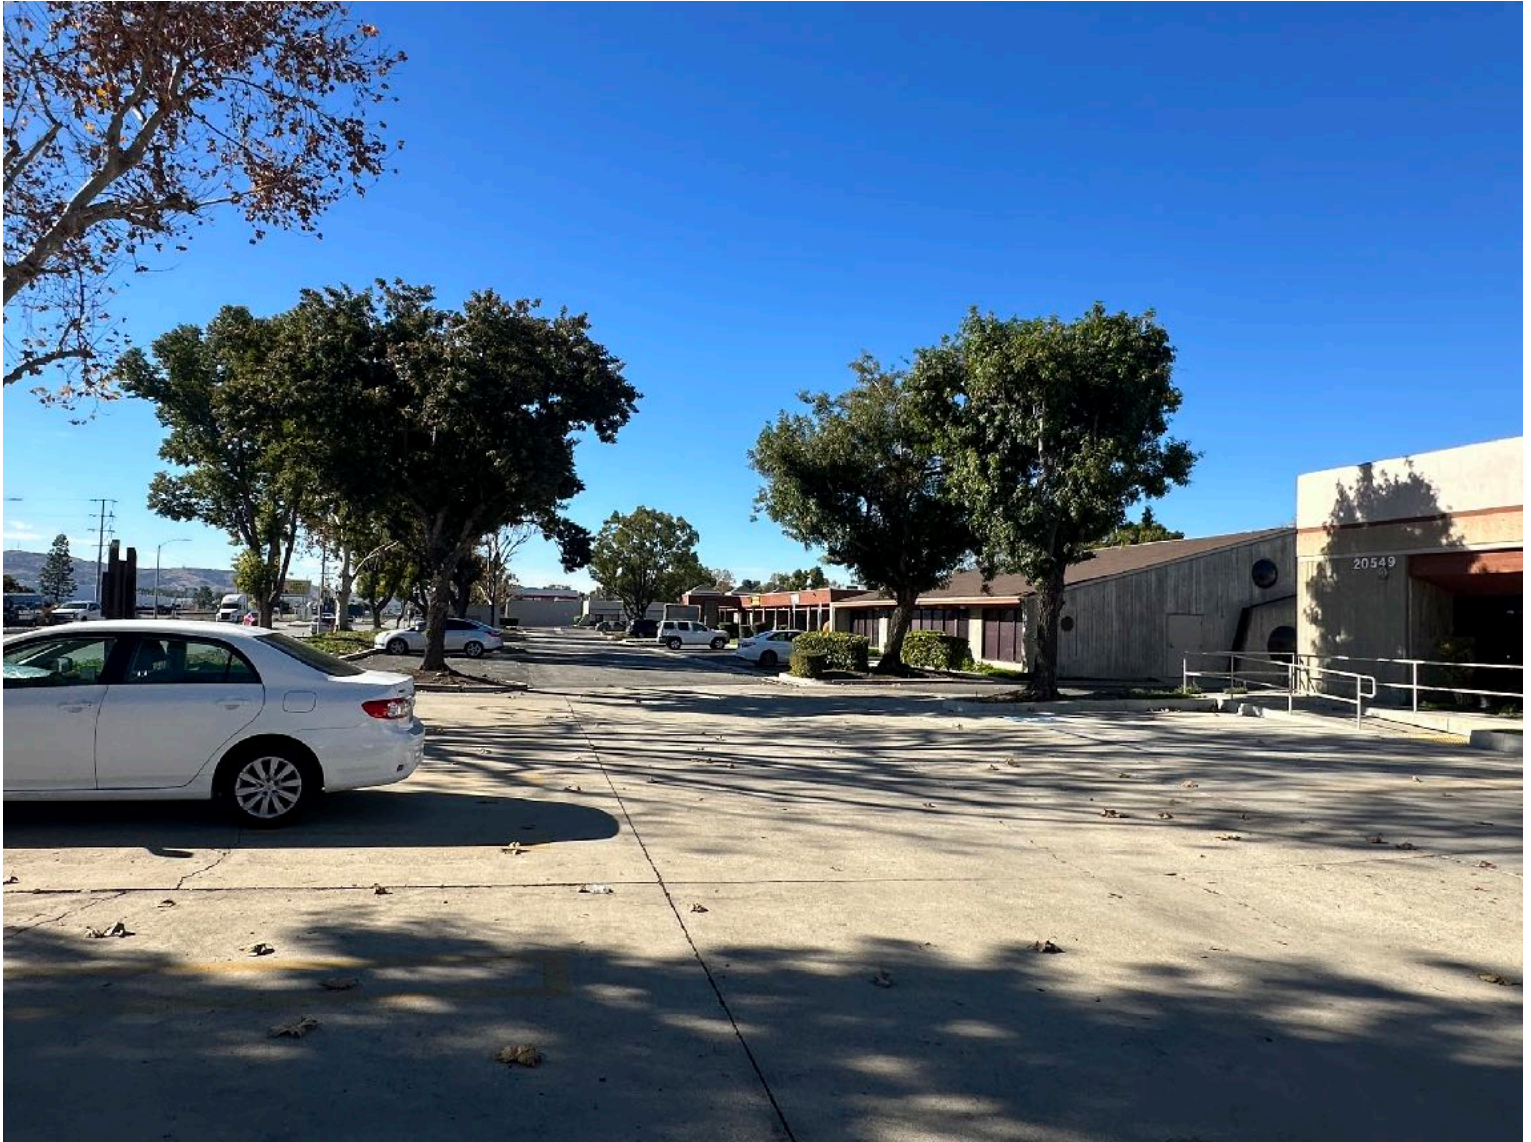
**PHOTO 30** - Shows trees on site, which include London Plane, Brazilian Pepper, and other non-protected trees. Removals are focused on areas of future development and root impacts that will not be tolerable.

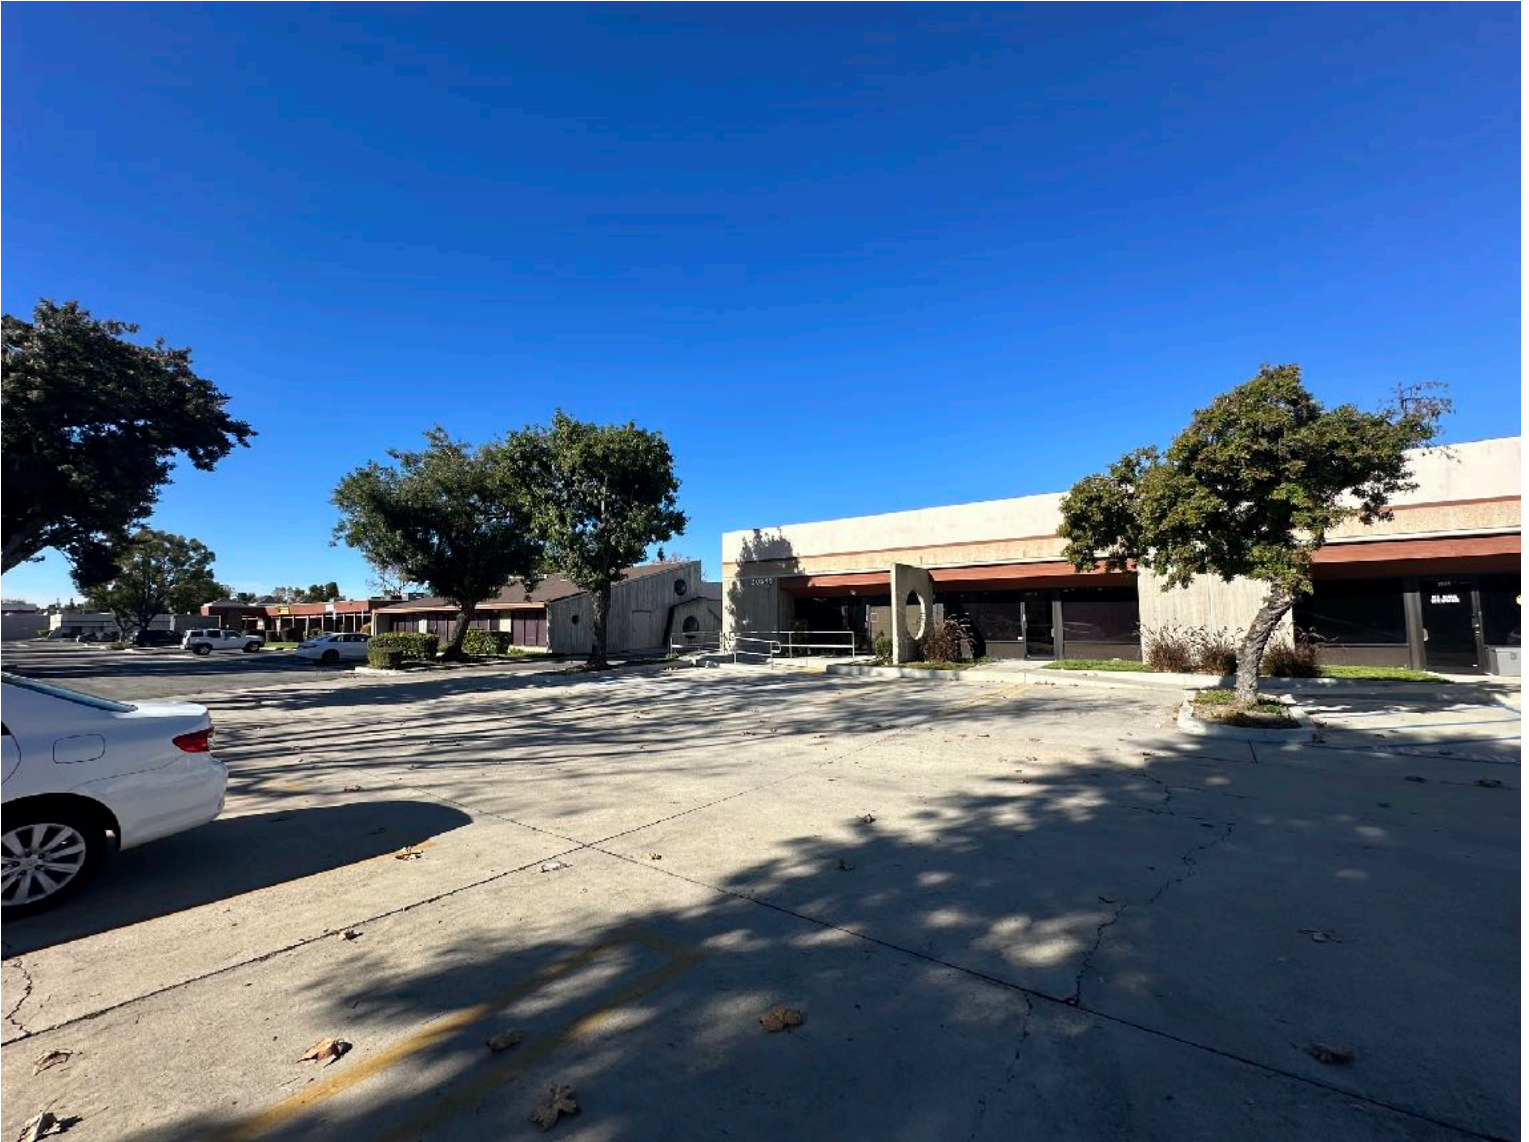
**PHOTO 31** - Shows trees on site, which include London Plane, Brazilian Pepper, and other non-protected trees. Removals are focused on areas of future development and root impacts that will not be tolerable.

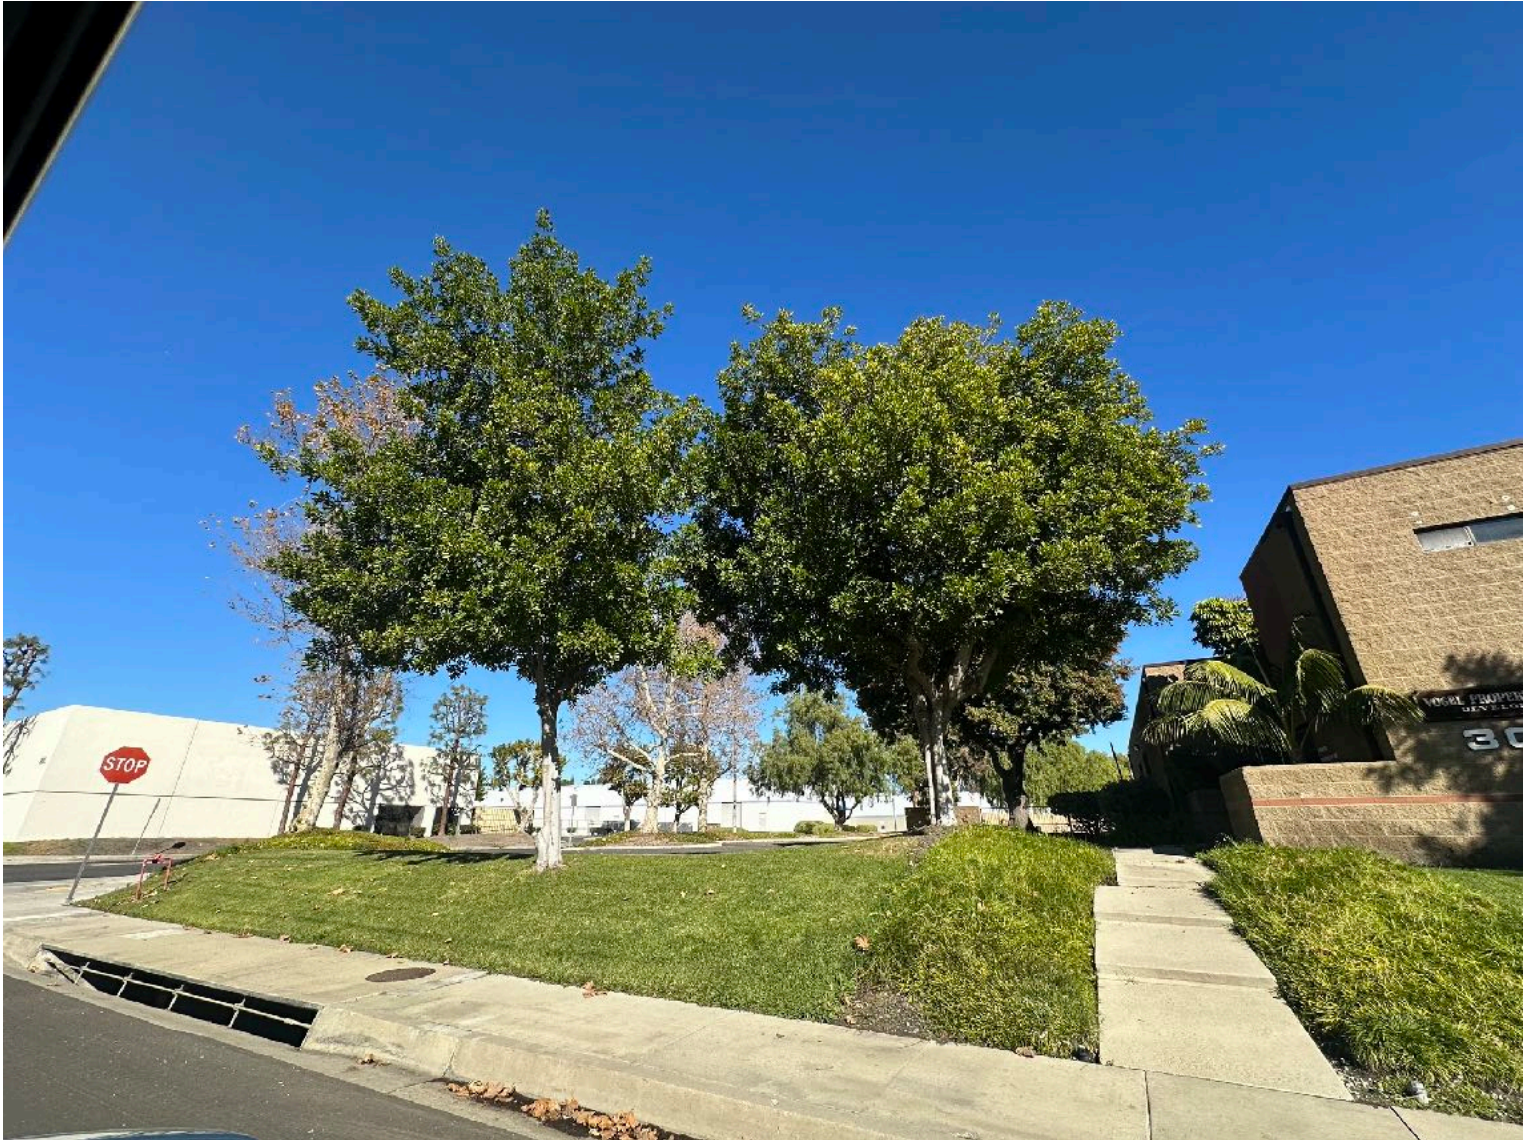
**PHOTO 32** - Shows trees on site, which include London Plane, Brazilian Pepper, and other non-protected trees. Removals are focused on areas of future development and root impacts that will not be tolerable.

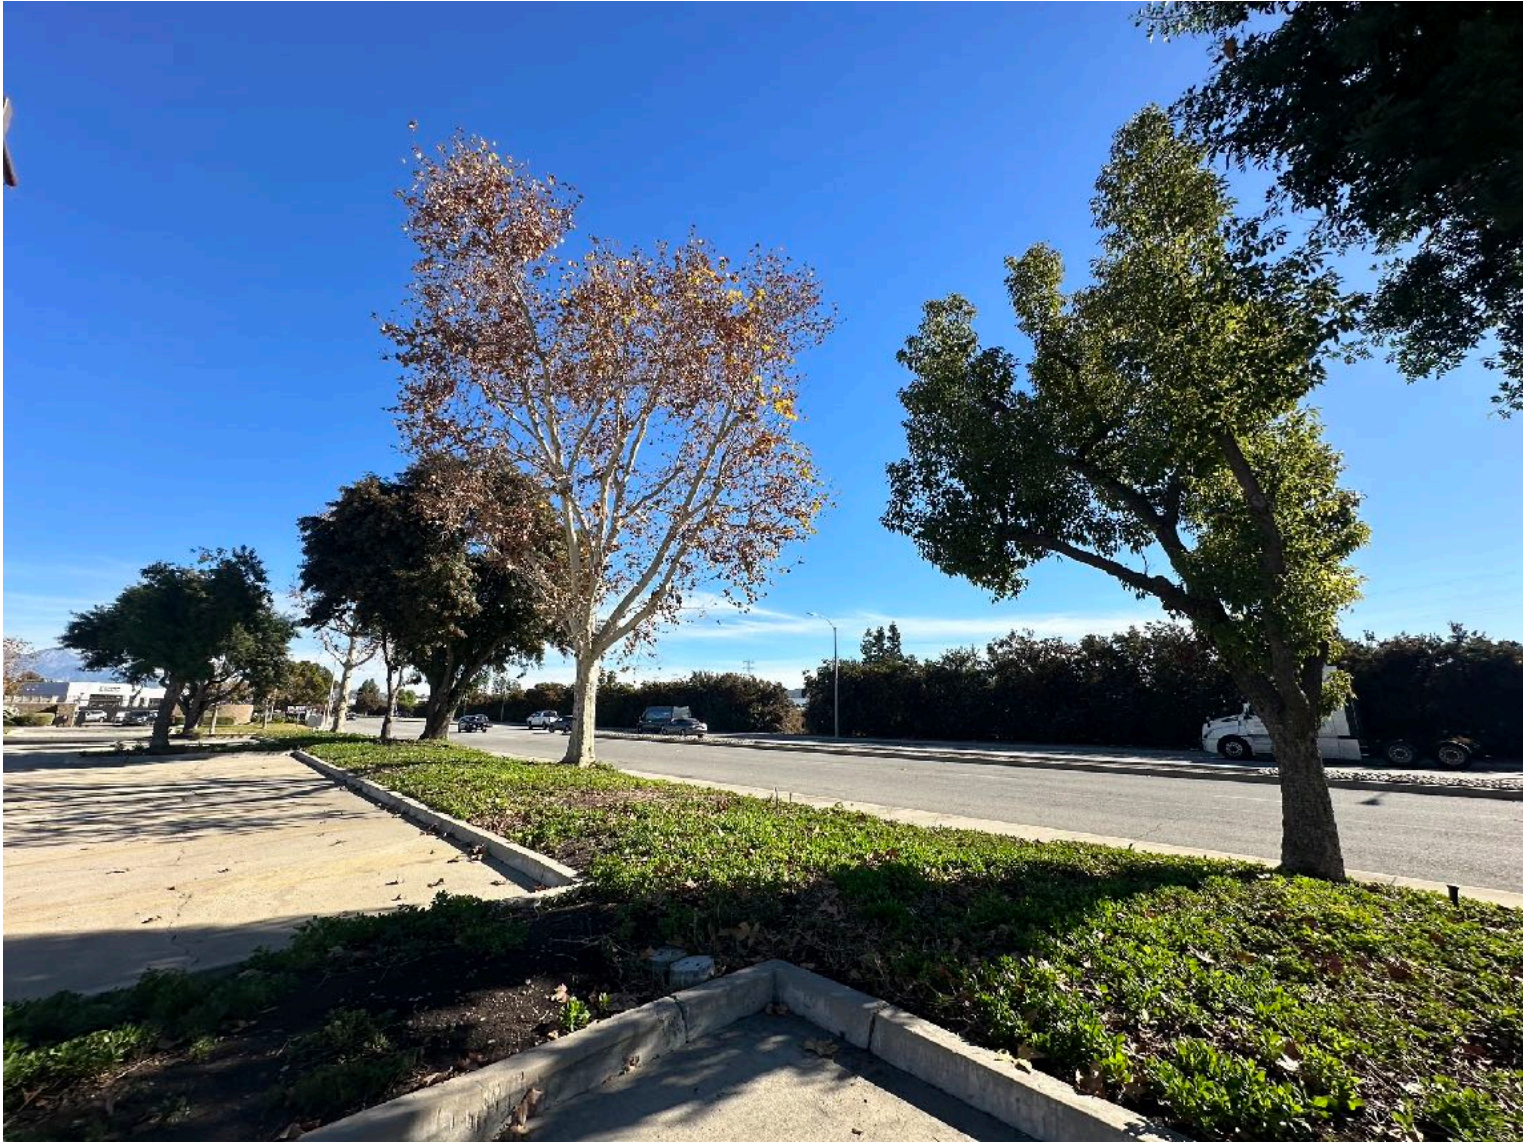
**PHOTO 33** - Shows trees on site, which include London Plane, Brazilian Pepper, and other non-protected trees. Removals are focused on areas of future development and root impacts that will not be tolerable.

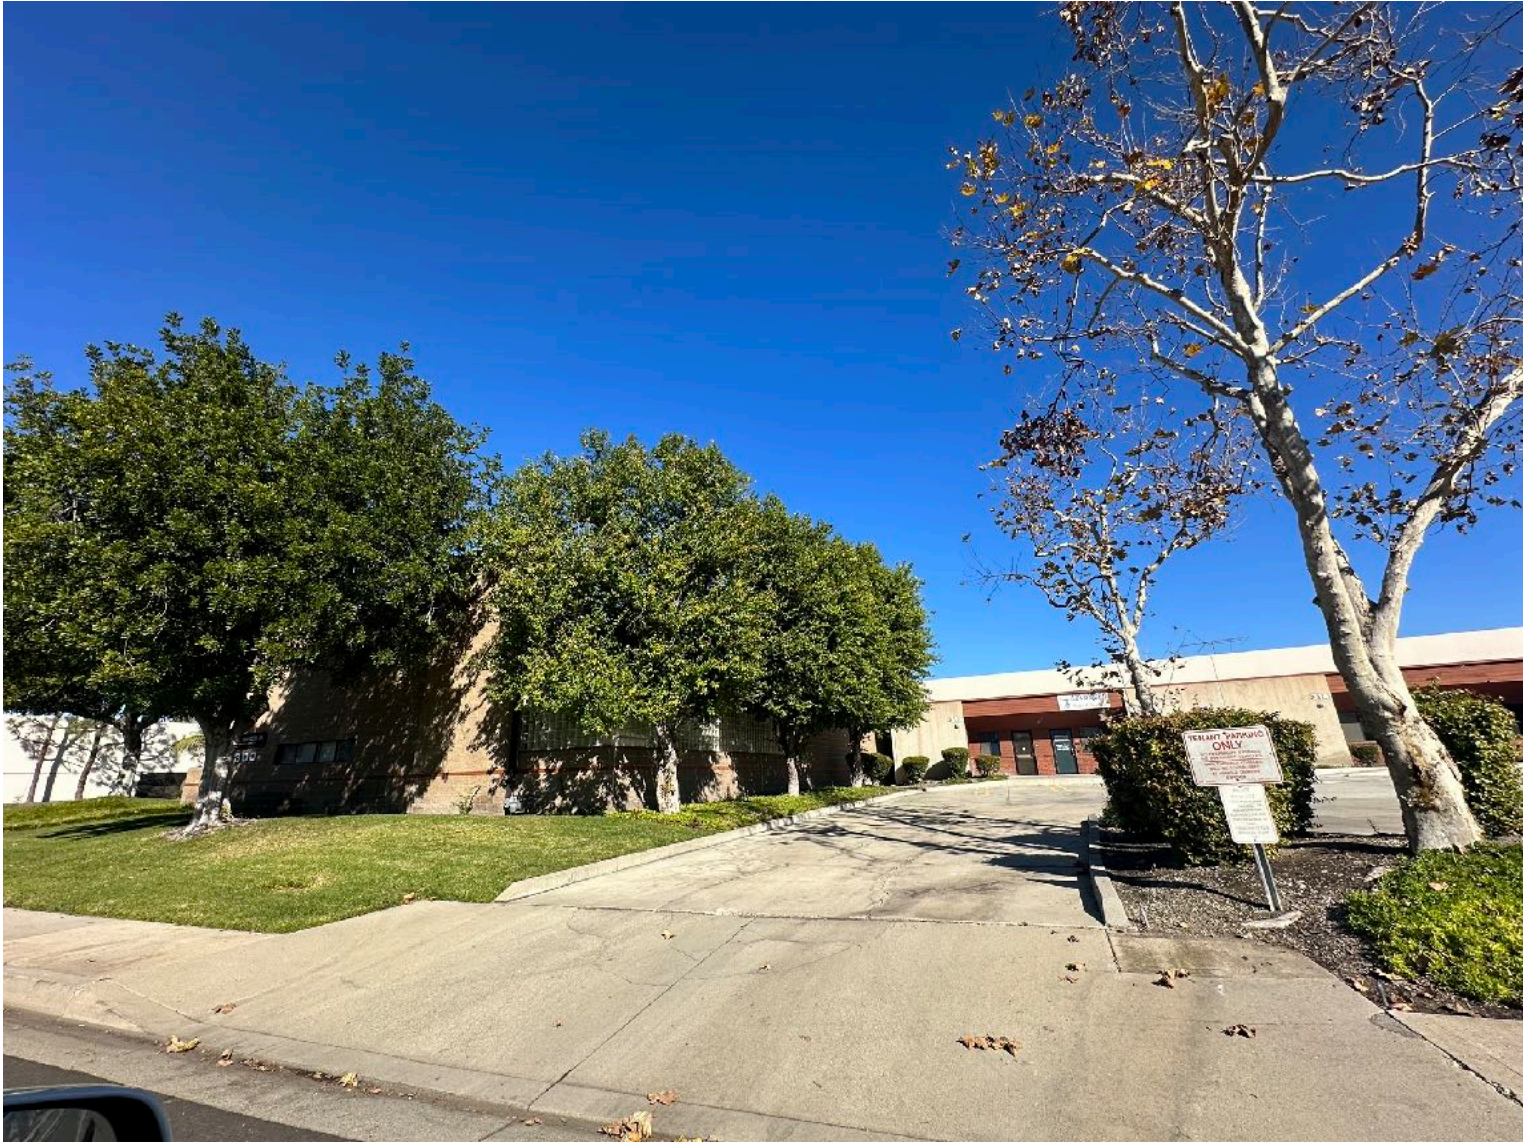
**PHOTO 34** - Shows trees on site, which include London Plane, Brazilian Pepper, and other non-protected trees. Removals are focused on areas of future development and root impacts that will not be tolerable.

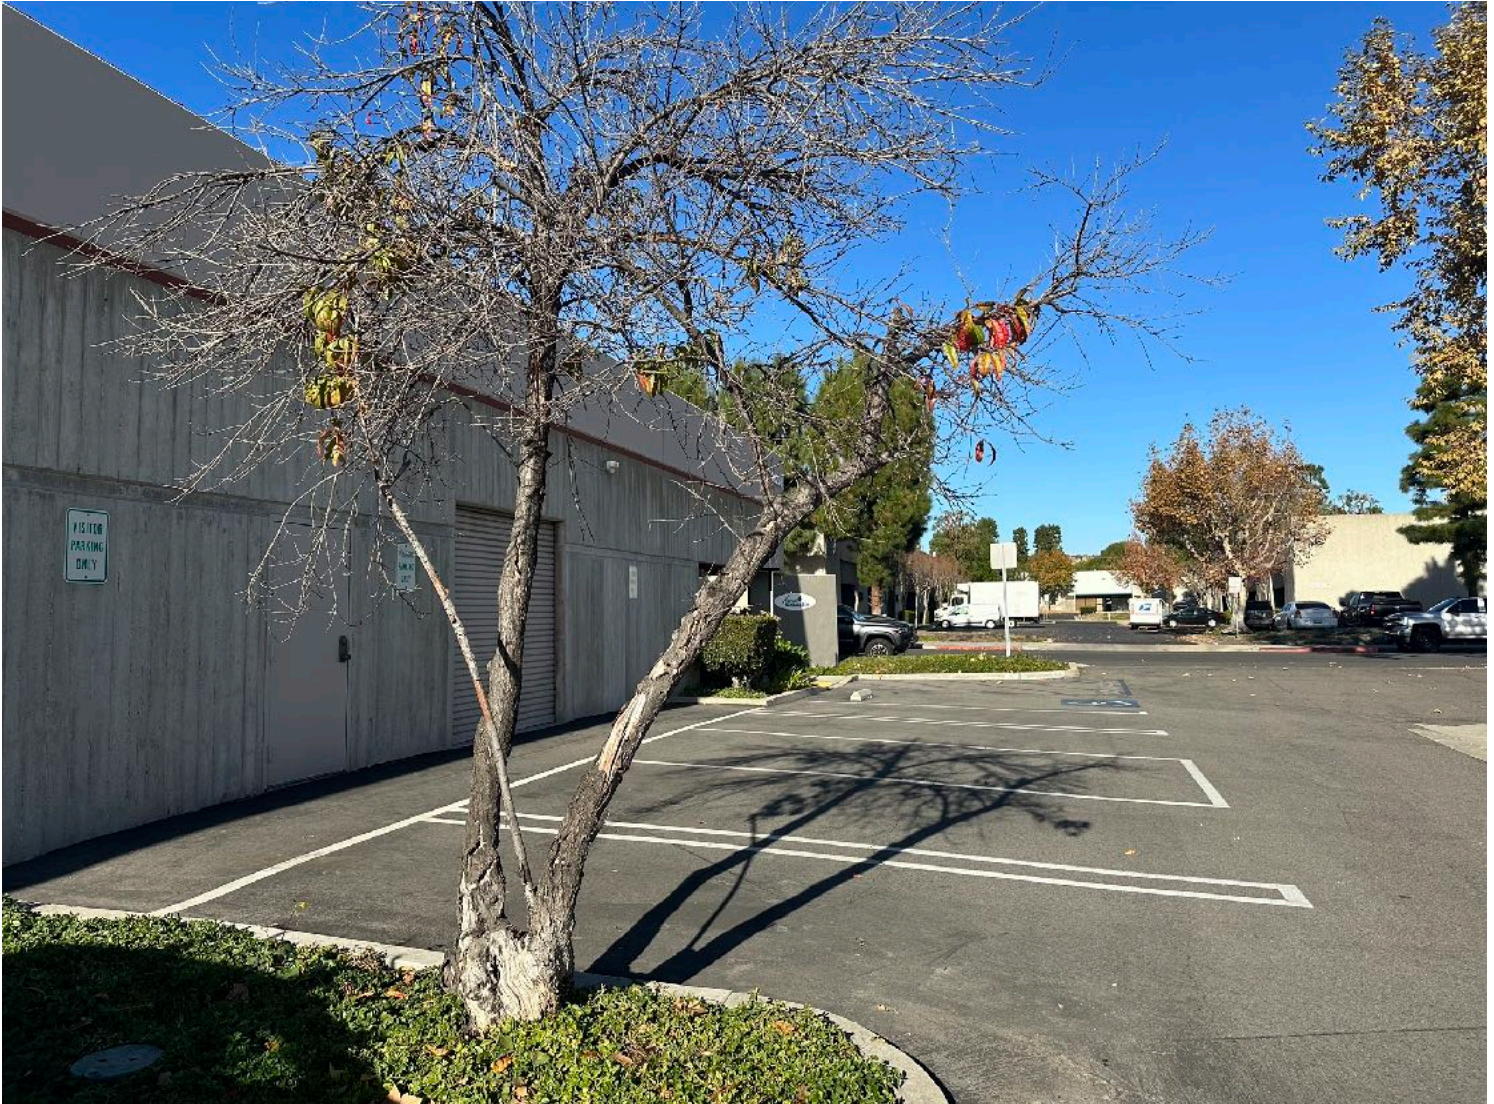
**PHOTO 35** - Shows trees on site, which include London Plane, Brazilian Pepper, and other non-protected trees. Removals are focused on areas of future development and root impacts that will not be tolerable.

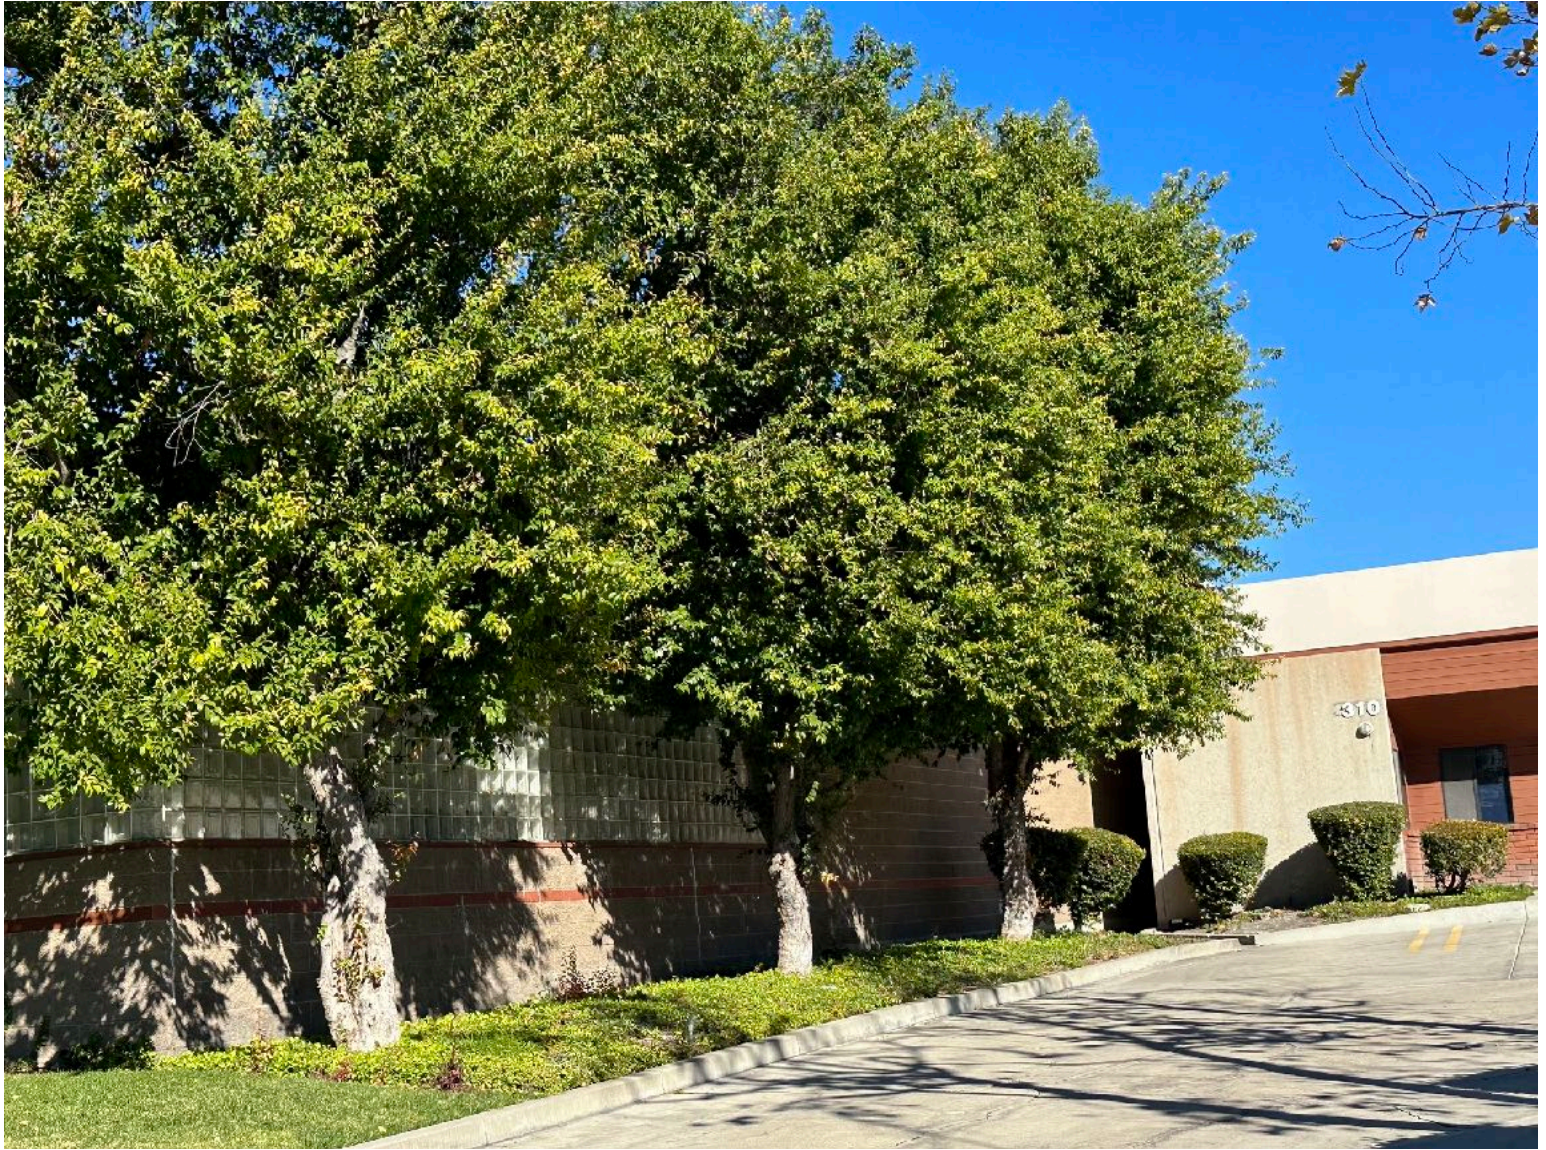
**PHOTO 36** - Shows trees on site, which include London Plane, Brazilian Pepper, and other non-protected trees. Removals are focused on areas of future development and root impacts that will not be tolerable.

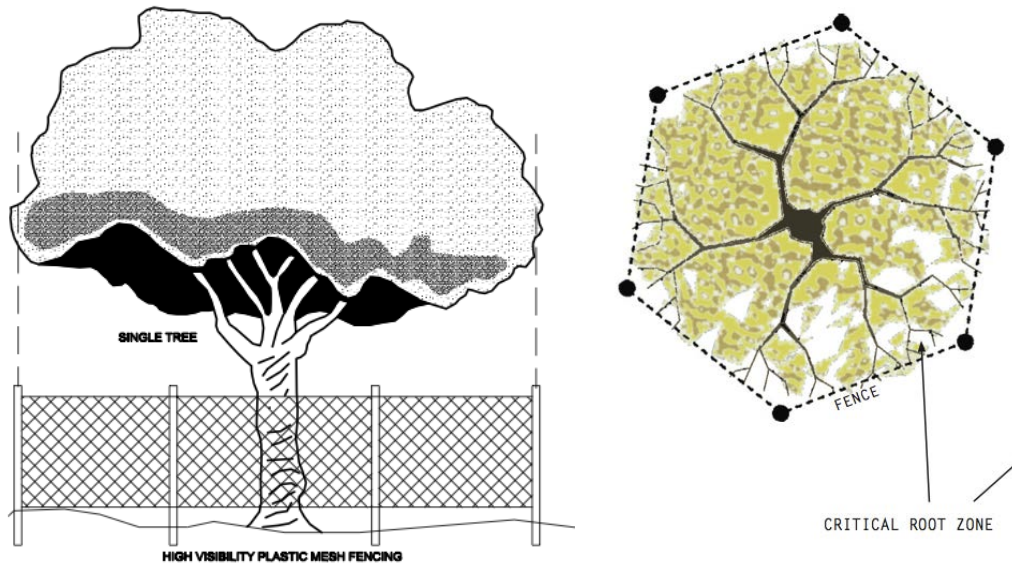
## PROTECTIVE FENCING

Tree protection fencing must be installed at the edge of the Tree Protection Zone (critical root zone) or beyond **prior to the start of any clearing, grading or other construction activity**. If space limits the fencing, place at the furthest possible distance from the trunk.

- 1) Fencing may be of a **flexible configuration or chain-link** and be a minimum of 4 feet in height supported by vertical posts at a maximum of ten-foot intervals to keep the fence upright and in place.
- 2) A warning sign should be posted on the fencing which states, **“Warning: Tree Protection Zone”** and stating the requirements of all workers in the protected zone. Example available upon request.
- 3) Throughout the course of construction, **maintain the integrity of the tree protection zone fencing and keep the site clean and maintained at all times**. No construction staging or disposal of construction materials or byproducts including but not limited to paint, plaster, or chemical solutions is allowed in the Tree Protection Zone.

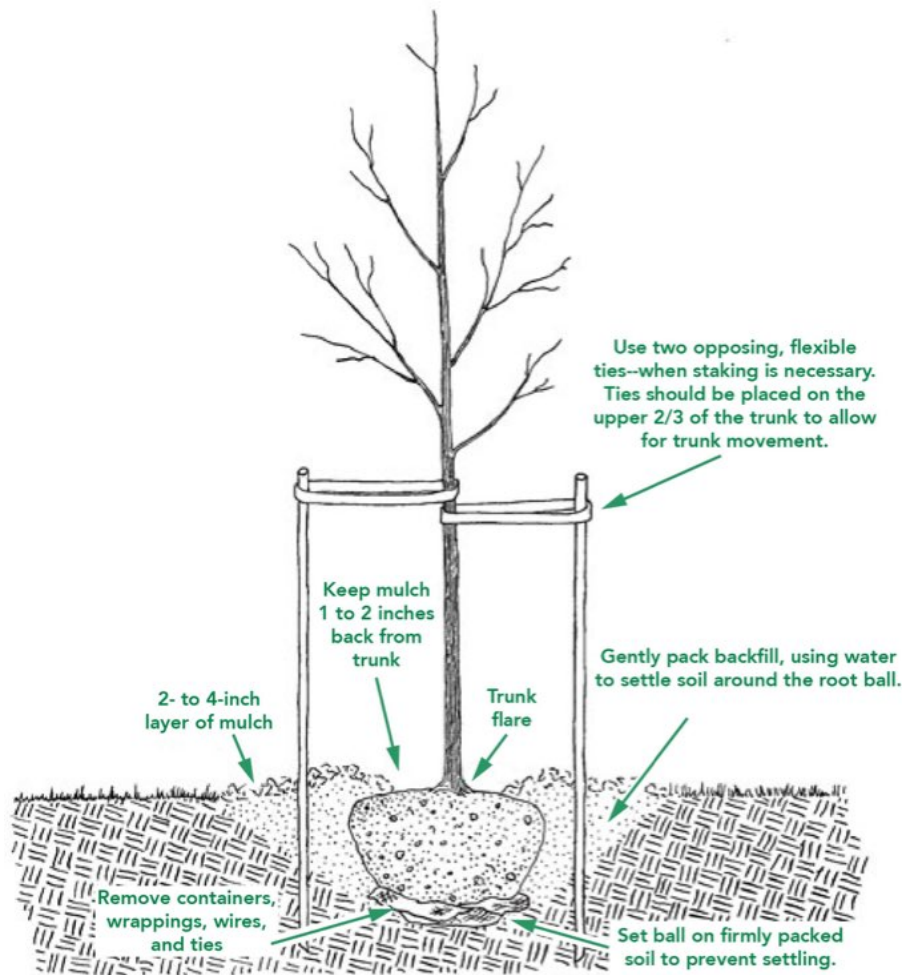
## NEW TREE PLANTING

- 7. Stake the tree, if necessary.** If the tree is grown properly at the nursery, staking for support will not be necessary in most home landscape situations. Studies have shown that trees establish more quickly and develop stronger trunk and root systems if they are not staked at the time of planting. However, protective staking may be required on sites where lawn mower damage, vandalism, or windy conditions are concerns. If staking is necessary for support, there are three methods to choose among: staking, guying, and ball stabilizing. One of the most common methods is staking. With this method, two stakes used in conjunction with a wide, flexible tie material on the lower half of the tree will hold the tree upright, provide flexibility, and minimize injury to the trunk (see diagram). Remove support staking and ties after the first year of growth.
