# Jurisdictional Delineation Report Pico Rivera Regional Bikeway Project

**May 2019**

The purpose of this report is to provide the results of the jurisdictional delineation conducted by VCS Environmental for the Pico Rivera Regional Bikeway Project (Project) as required by the United States Army Corps of Engineers (USACE), California Department of Fish and Wildlife (CDFW), and Regional Water Quality Control Board (RWQCB), collectively called “the Agencies”. This report provides the documentation required to process a Section 404 Nationwide Permit, a Section 1602 Streambed Alteration Agreement, and a Section 401 Water Quality Certification (regulatory permits).

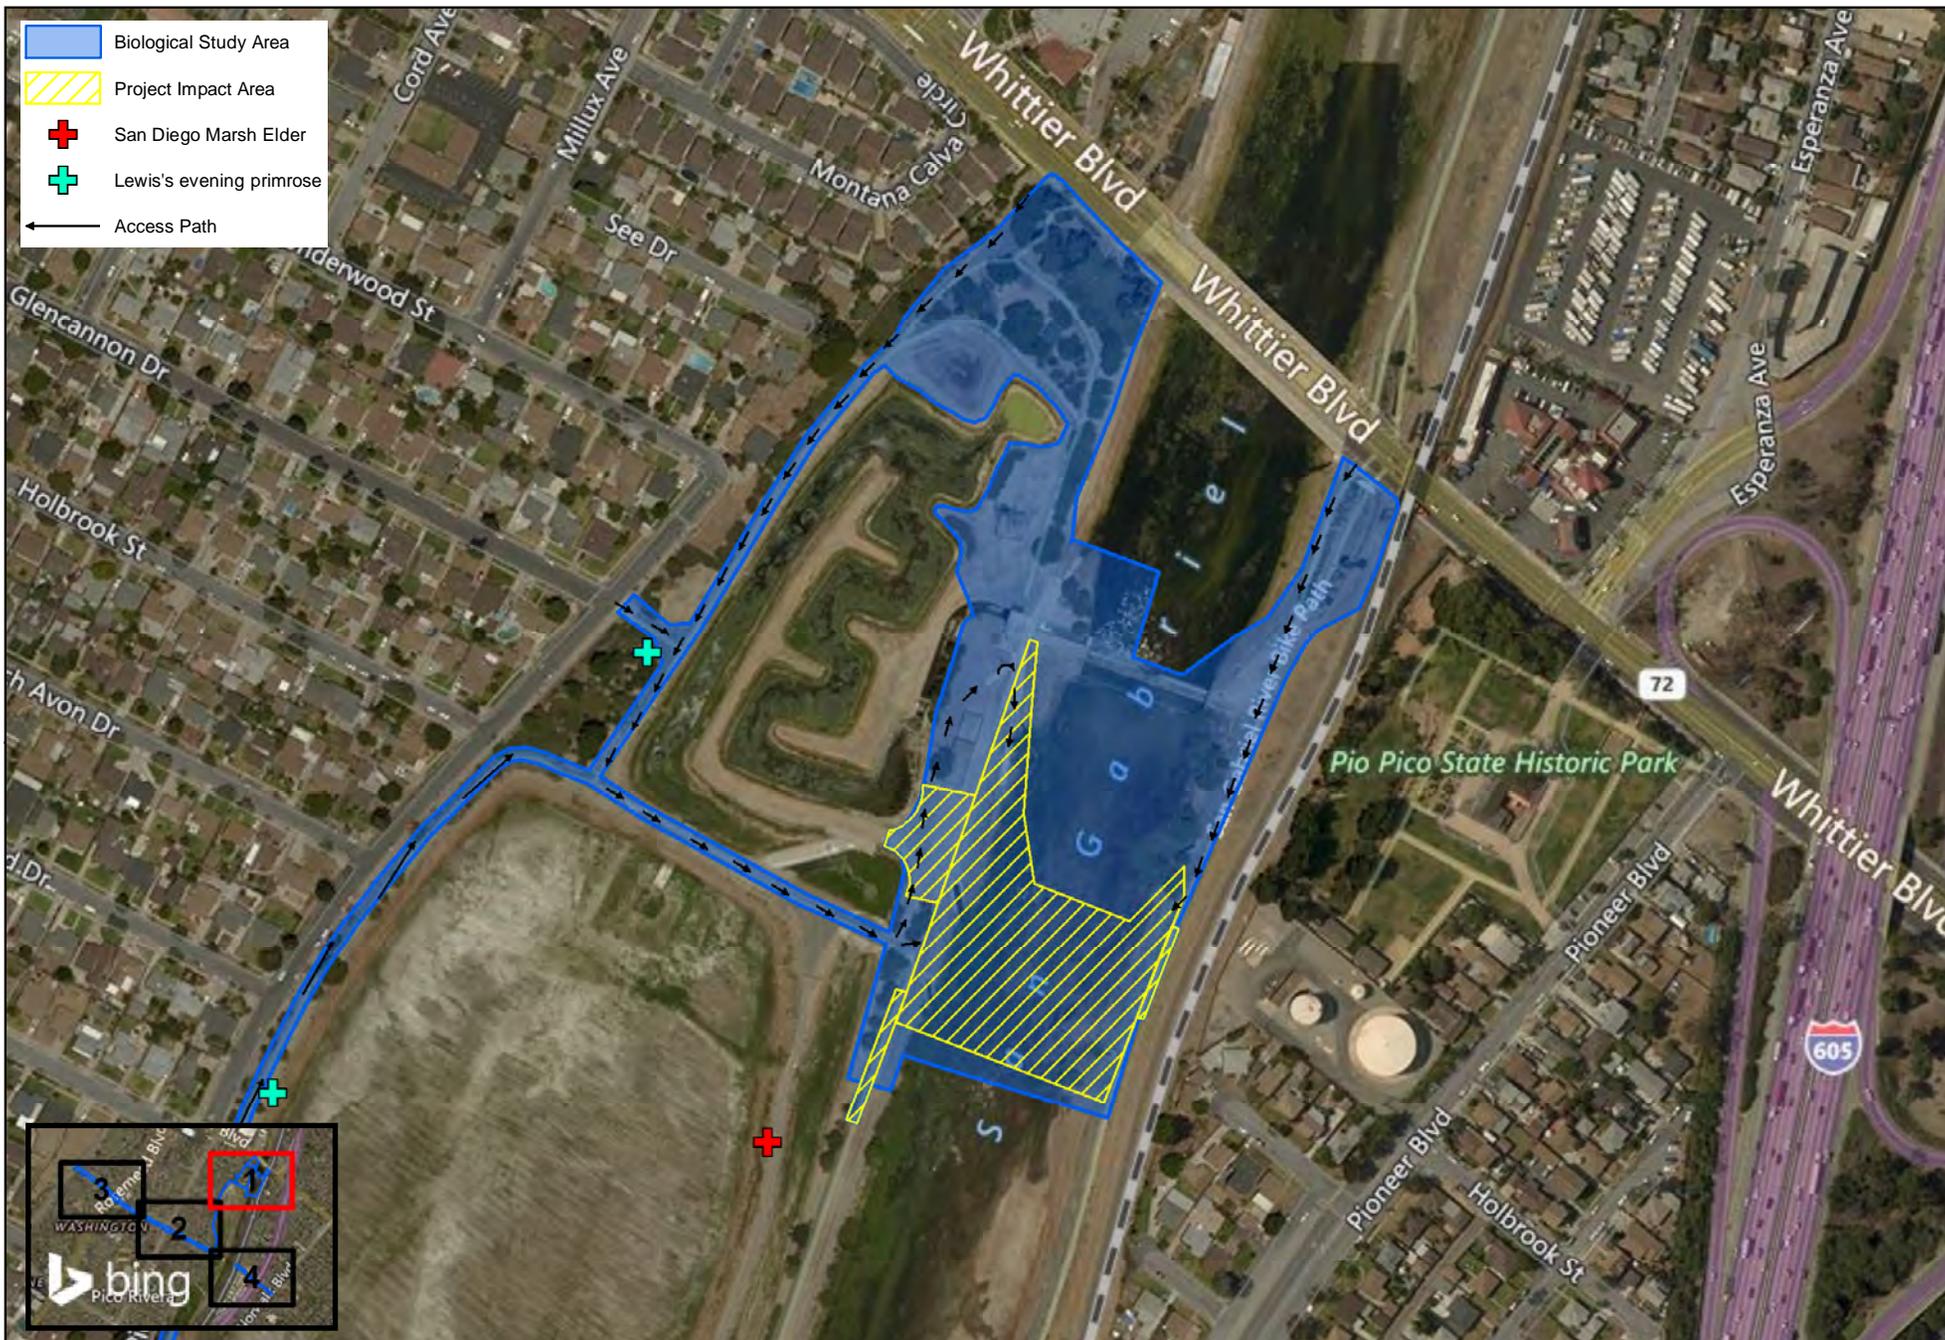
**Figure 3**

Biological Study Area

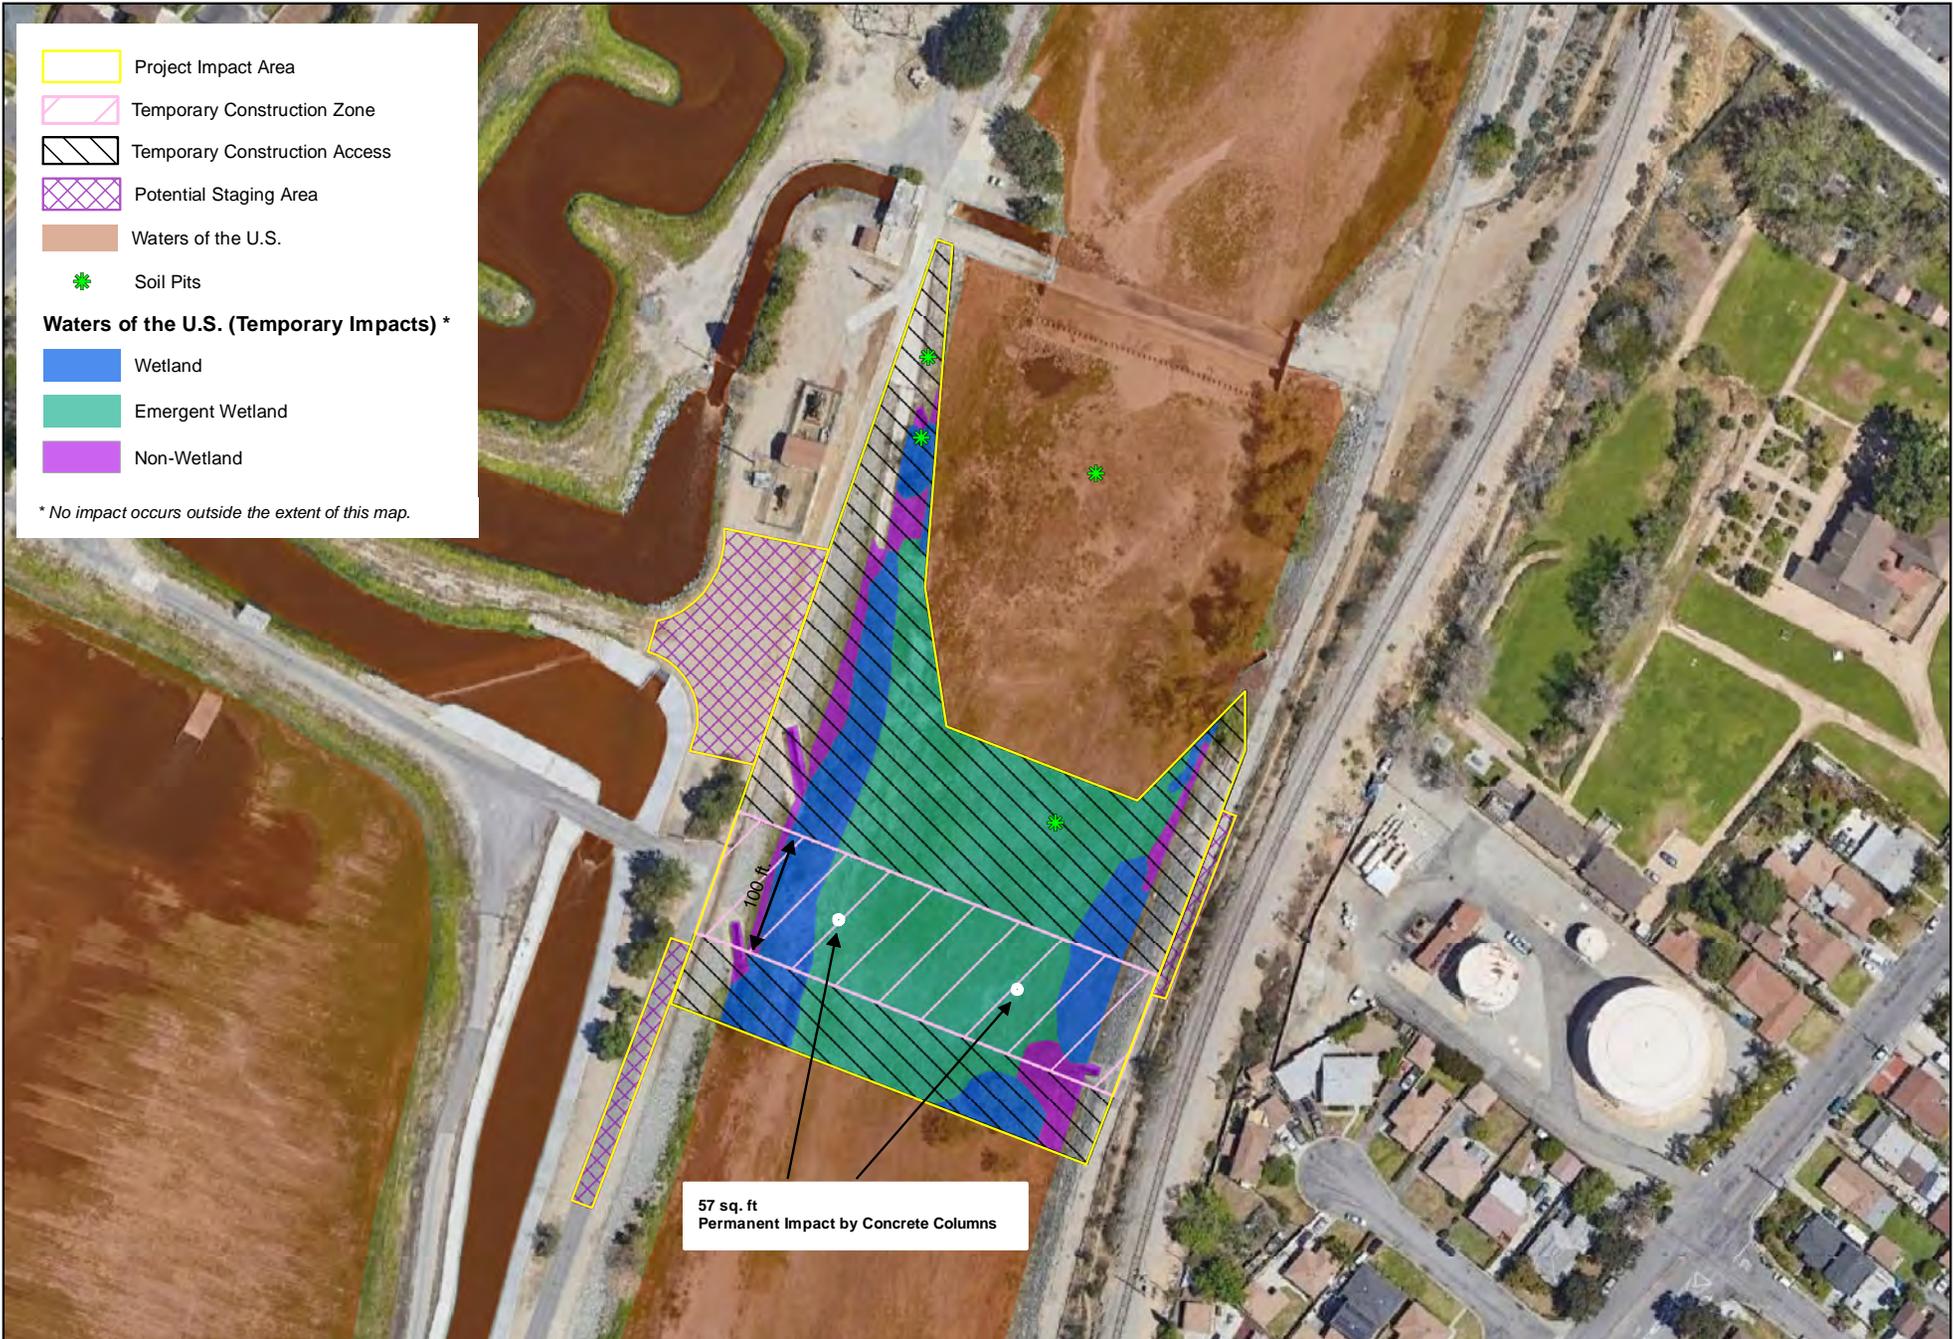
Figure 4a

This portion of the San Gabriel River is a soft bottom channel lined with concrete riprap along the slopes. Adjacent to the Project impacts are the San Gabriel Coastal spreading grounds which contain jurisdictional waters; however, these will not be impacted. During the delineation of the Project, VCS Environmental biologists took soil samples at different locations throughout the BSA to determine wetland and non-wetland areas. Soil sample locations are shown in Figure 4a.

57 sq. ft  
Permanent Impact by Concrete Columns

Permanent impacts to USACE WOUS will be approximately 57.0 square feet (0.001 acres) within the emergent wetland area shown on Figure 4a. USACE jurisdiction through WOUS totals 2.16 acres, with temporary impacts to 0.57 acre of wetlands, 1.38 acres of emergent wetlands, and 0.21 acre of non-wetlands. A Section 404 permit would be required for these impacts.

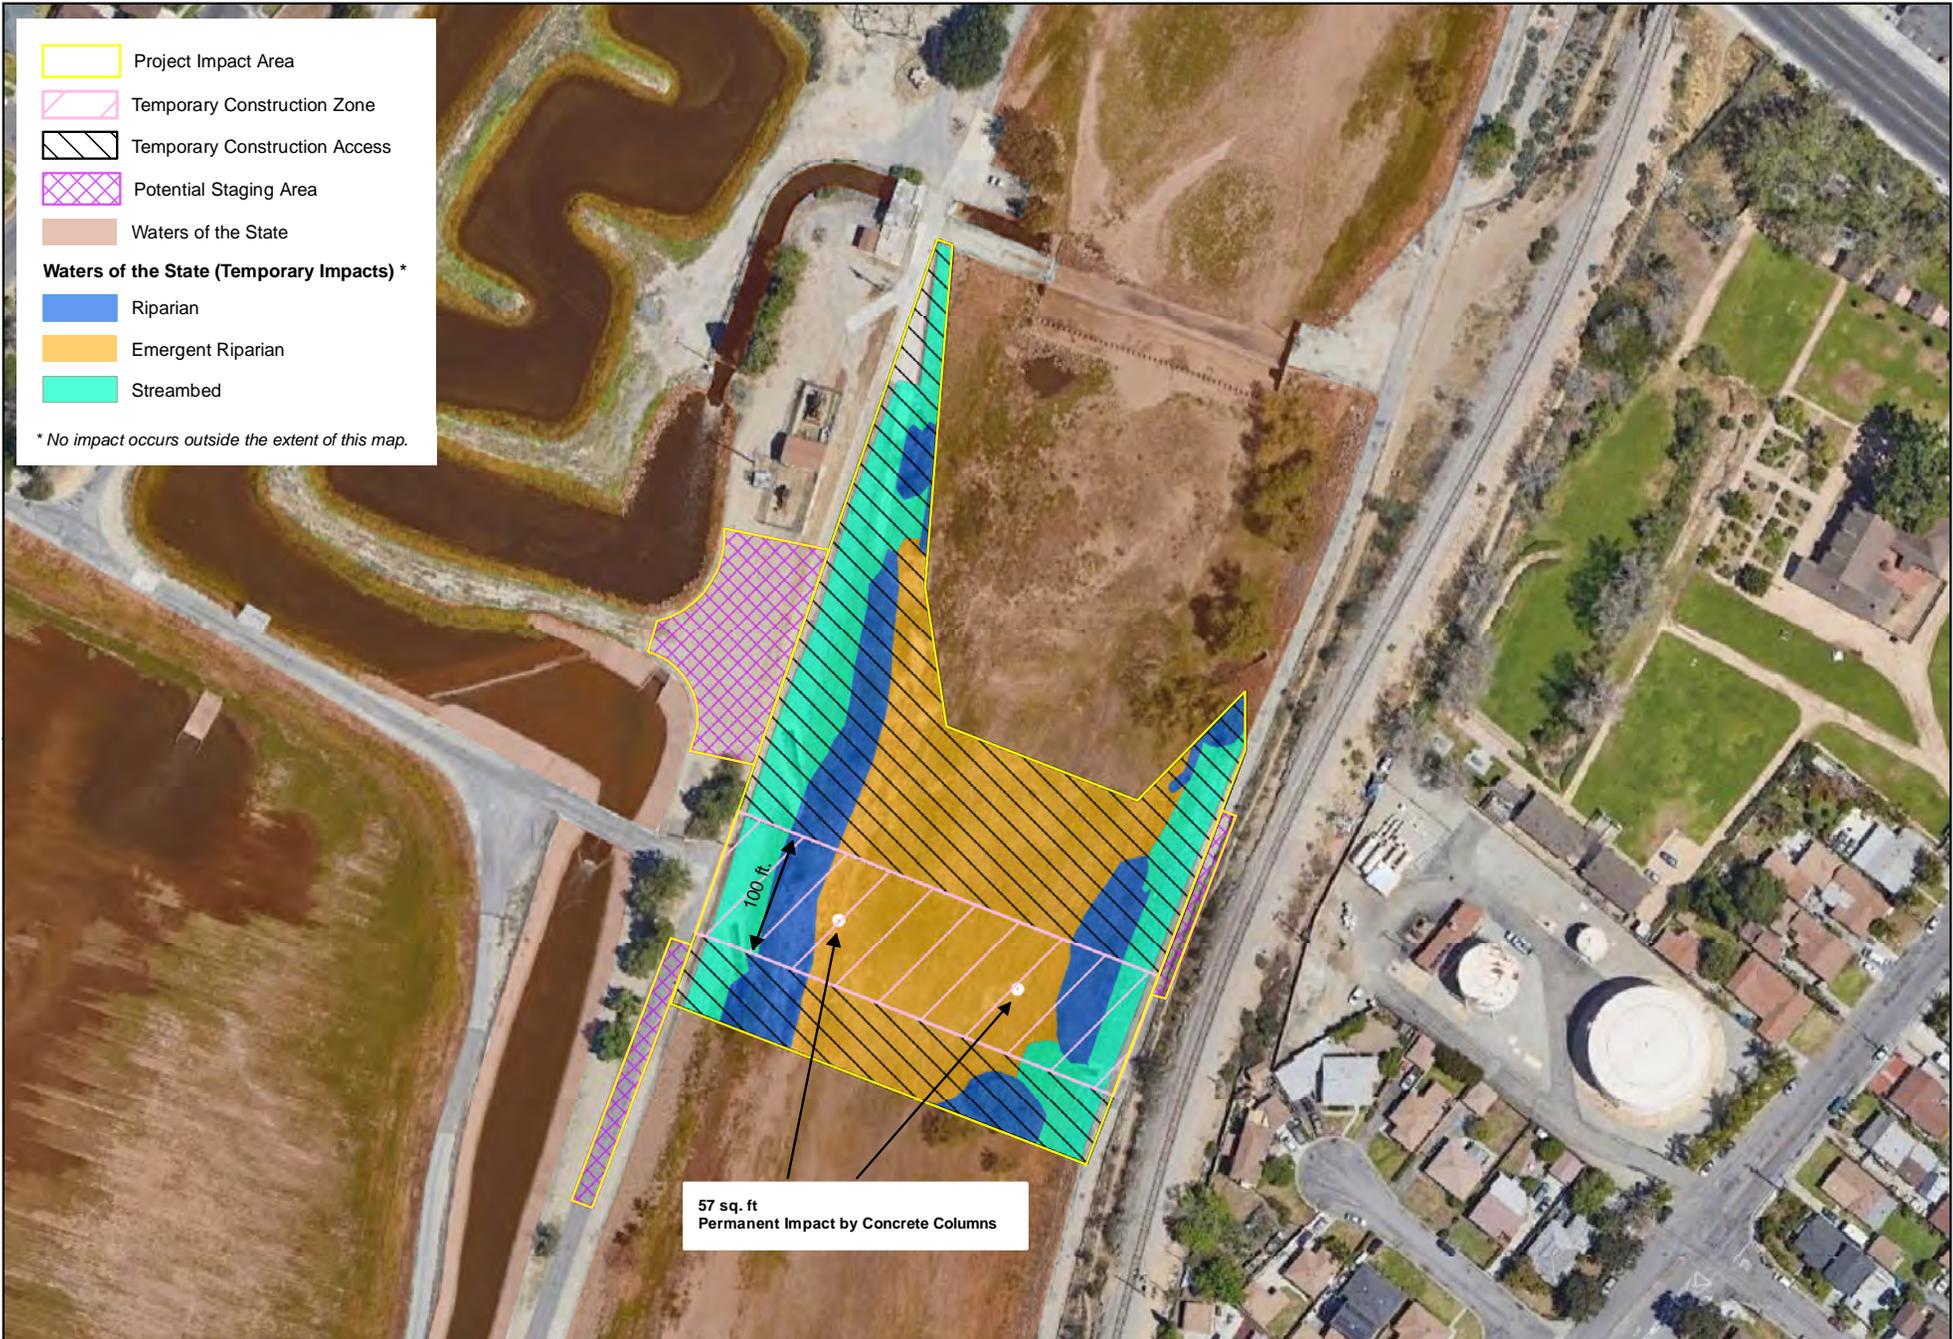
Figure 5

## Vegetation Map

The upland ruderal areas within the San Gabriel River have mostly non-native plant species such as short pod mustard (*Hirschfeldia incana*), wild radish (*Raphanus sativus*), red-stemmed filaree (*Erodium cicutarium*), sow thistle (*Sonchus oleraceus*), prickly lettuce (*Lactuca serriola*), toothed dock (*Rumex dentatus*), and annual barley grassland (*Hordeum murinum*). Vegetation within the lower limits of the San Gabriel River appears to be disturbed with routine annual maintenance; species present include swamp smartweed (*Periscaria hydropiperoides*), Bermuda grass (*Cynodon dactylon*), weakleaf bur ragweed (*Ambrosia confertiflora*), common sunflower (*Helianthus annuus*), English plantain (*Plantago lanceolata*), California bulrush (*Schoenoplectus californicus*), mulefat (*Baccharis salicifolia*), and black willow (*Salix gooddingii*) as shown in Table 1 below. The developed area, which includes the existing bike path, contains ornamental species such as silk floss tree (*Ceiba speciosa*) and carob tree (*Ceratonia siliqua*), and a few native landscaped species, such as California bush sunflower (*Encelia californica*) and white sage (*Salvia apiana*). A Vegetation Map is attached as Figure 5.

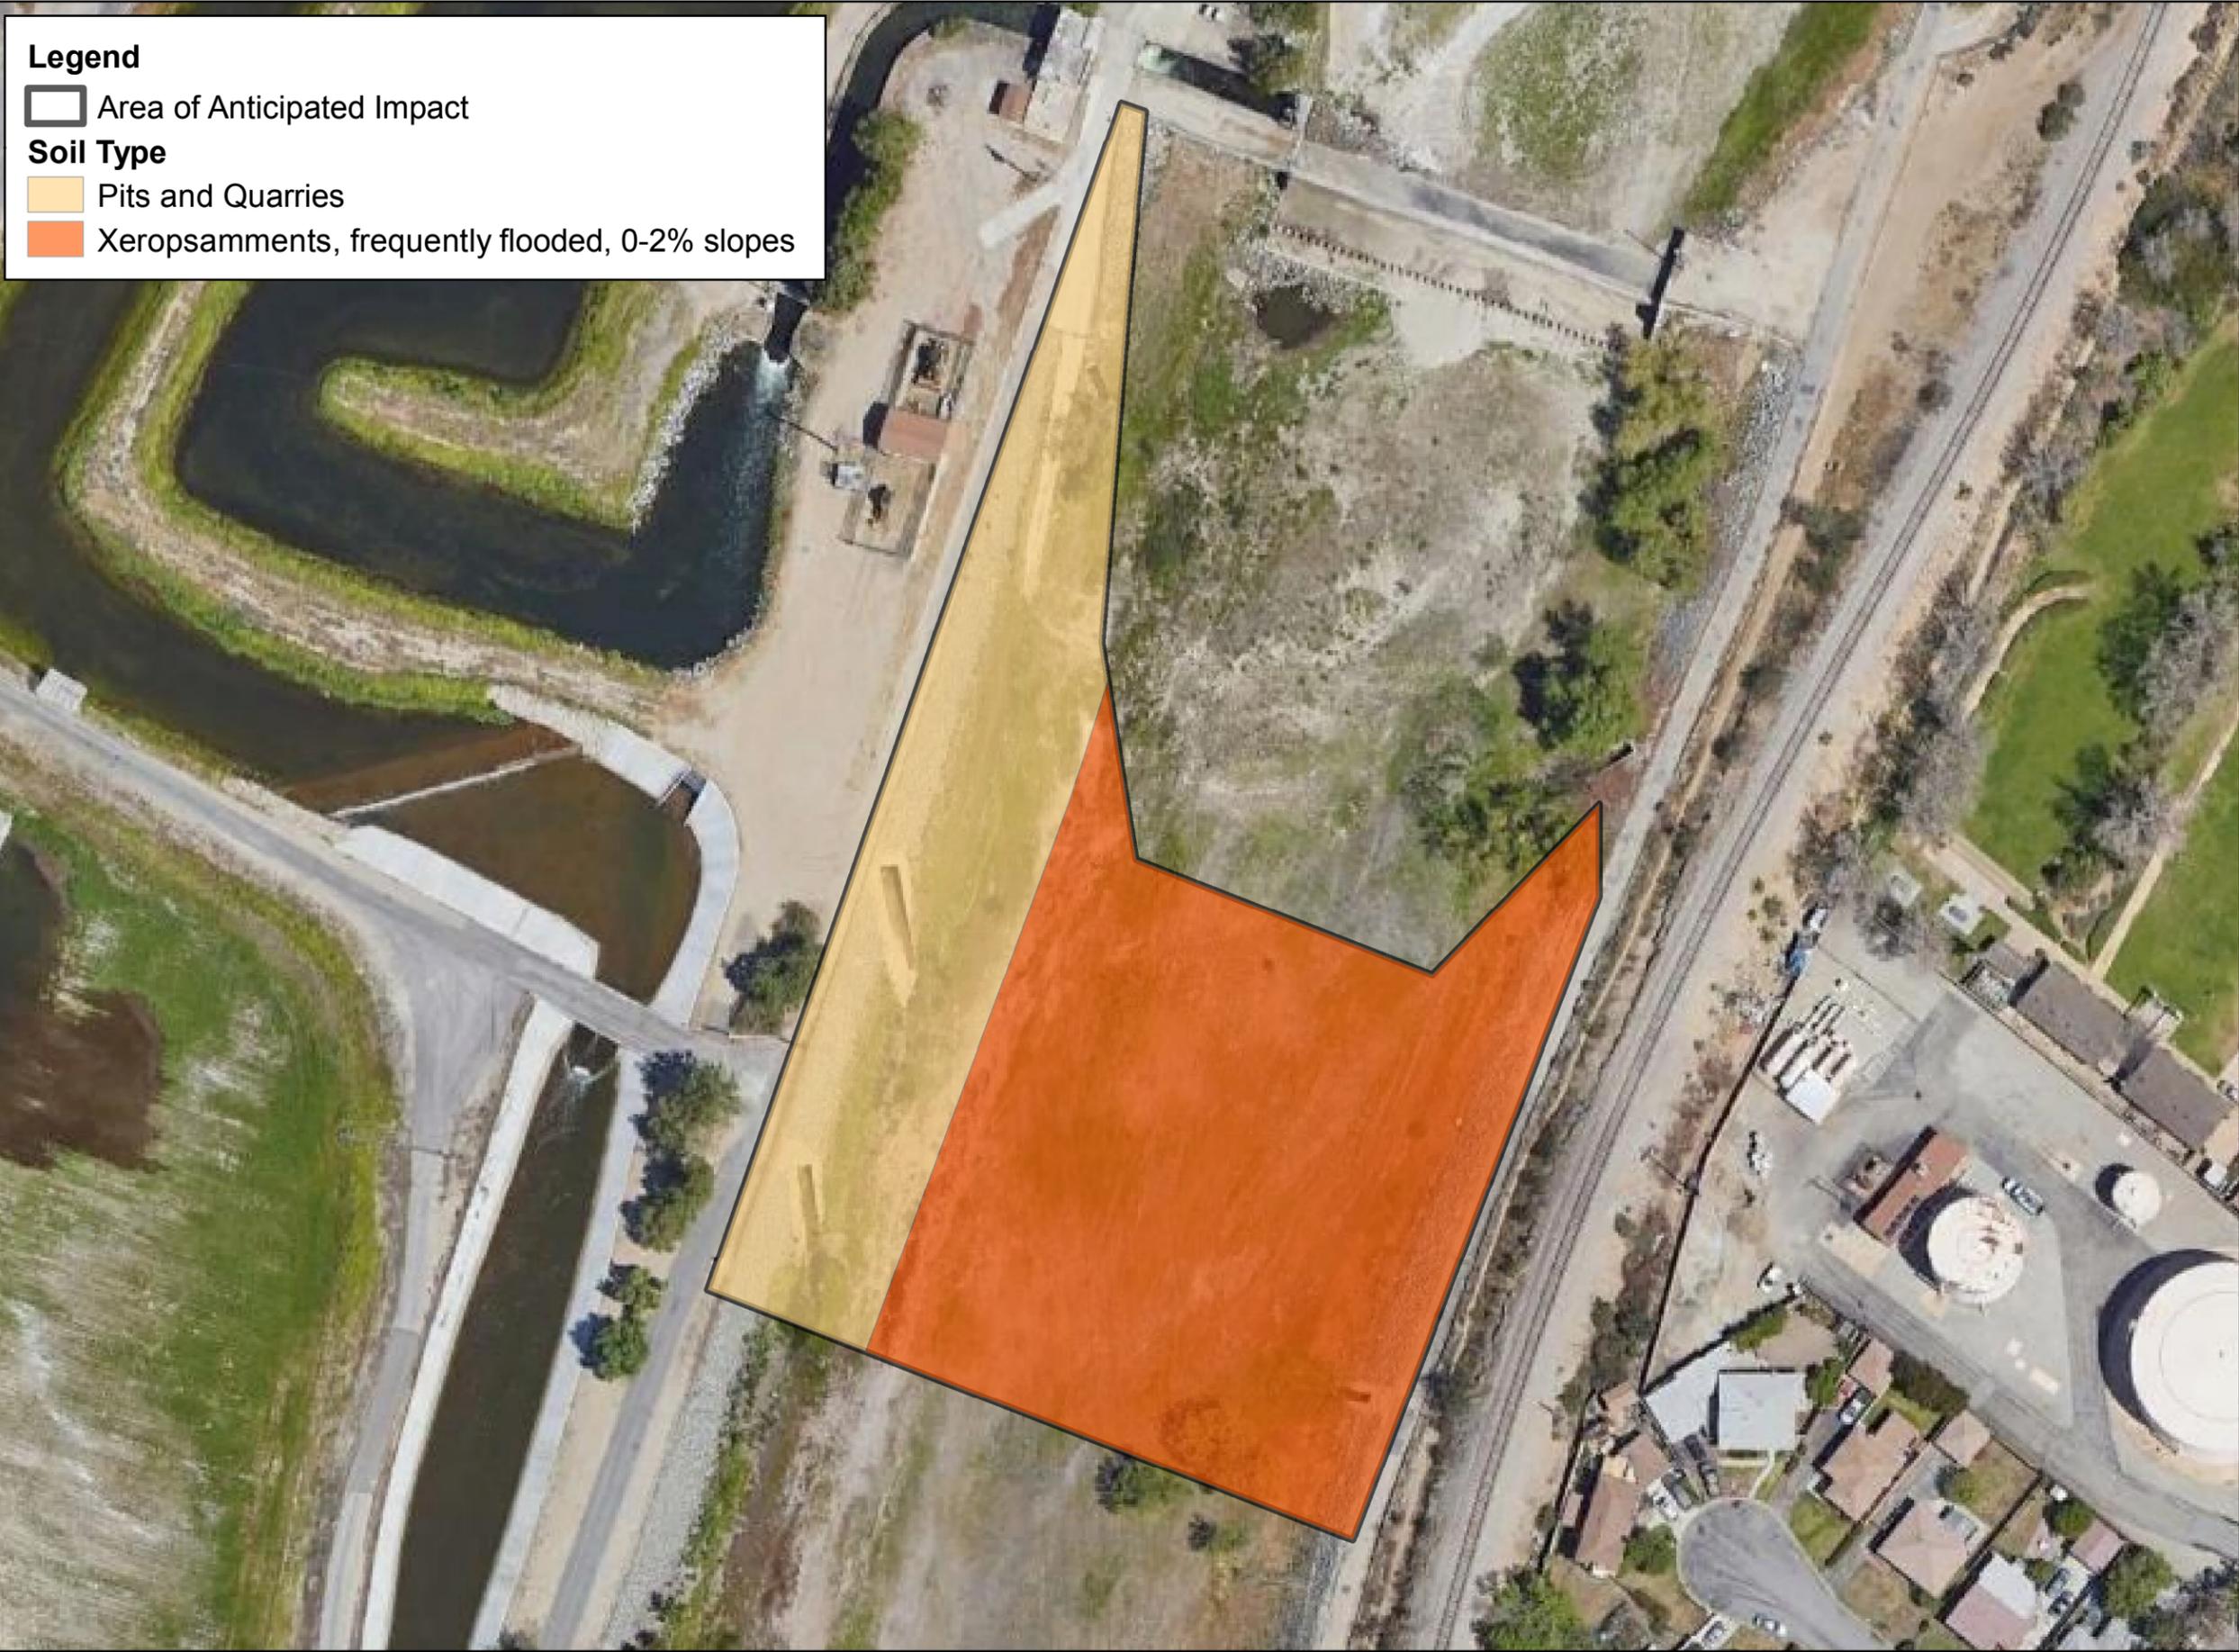
Figure 5

■ Pits and Quarries

■ Xeropsamments, frequently flooded, 0-2% slopes

## Soils

The United States Department of Agriculture (USDA) Natural Resources Conservation Service lists two of the above as hydric soils (USDA 2019), Pits and Quarries [1180] and Xeropsamments [1264]. A soils map is attached as Figure 6.

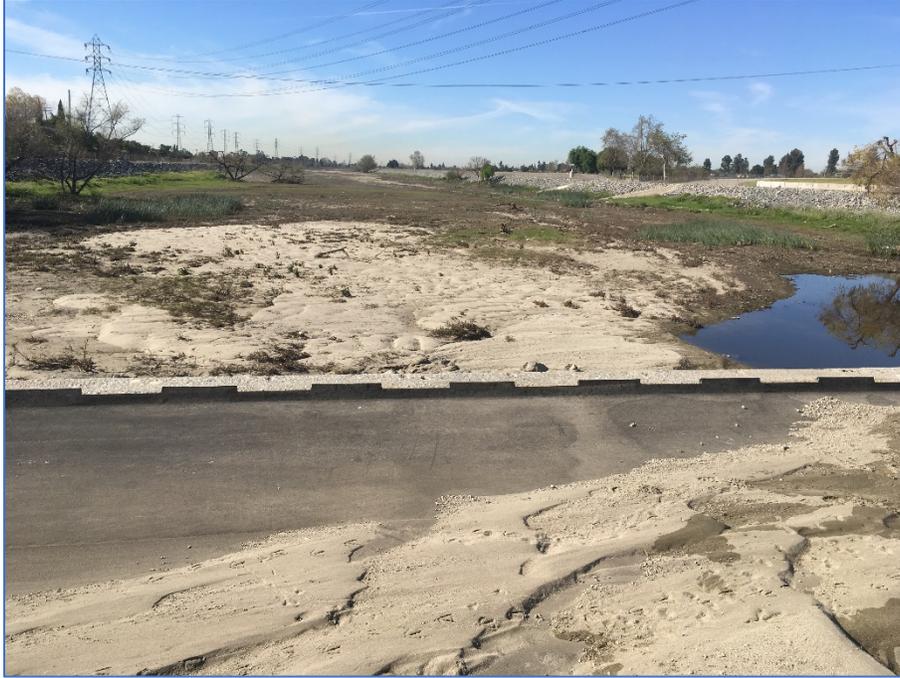
Photo 1: View of potential temporary construction access area for bridge construction within the San Gabriel River, facing south.

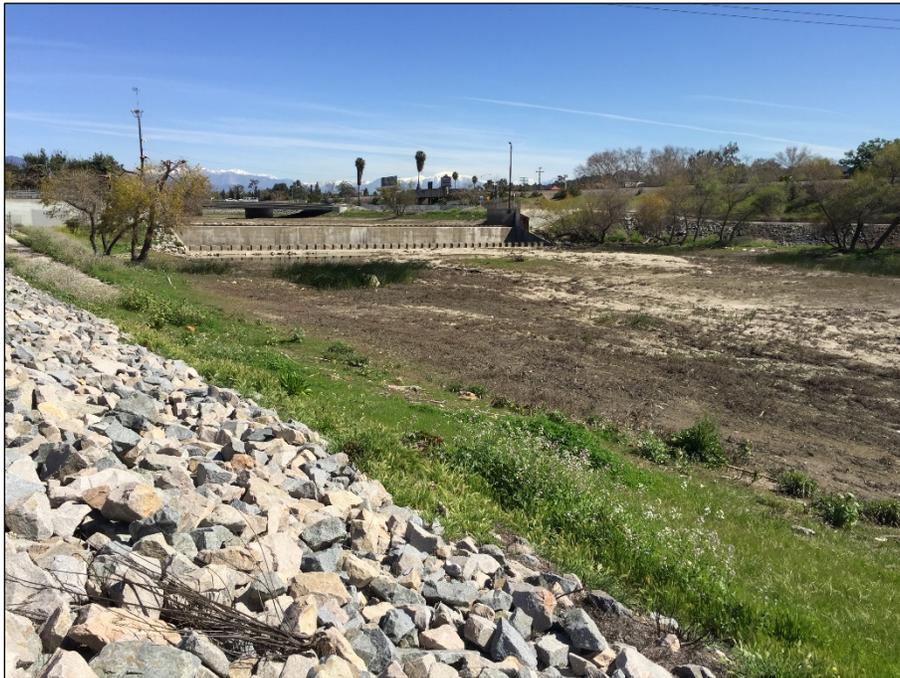
Photo 2: View of potential temporary construction access area within the San Gabriel River, facing northeast.

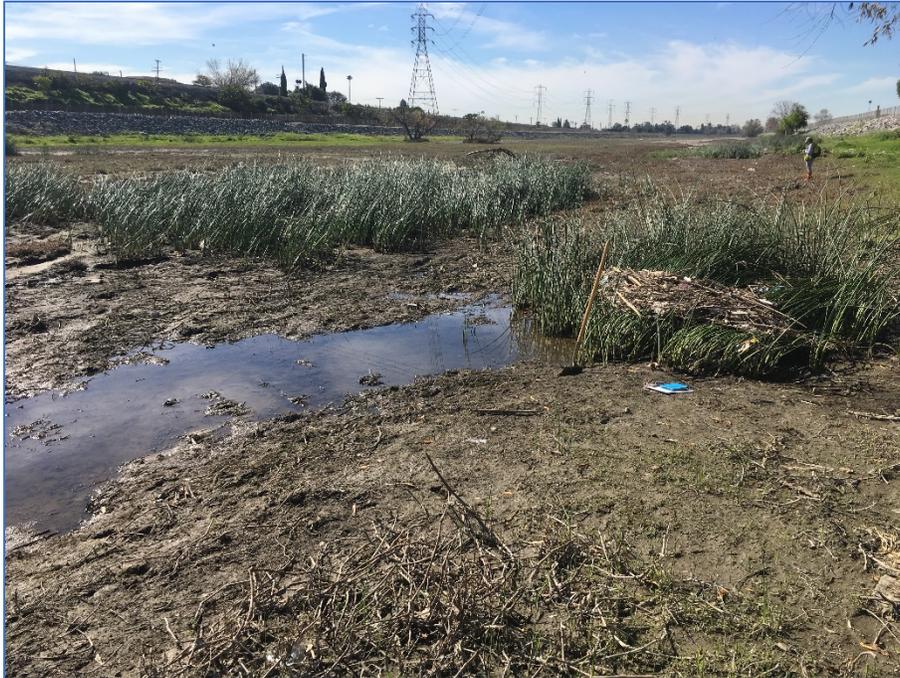
Photo 3: View of California bulrush (*Shoenoplectus californicus*) in the potential temporary construction access impact area within the San Gabriel River, facing southeast.

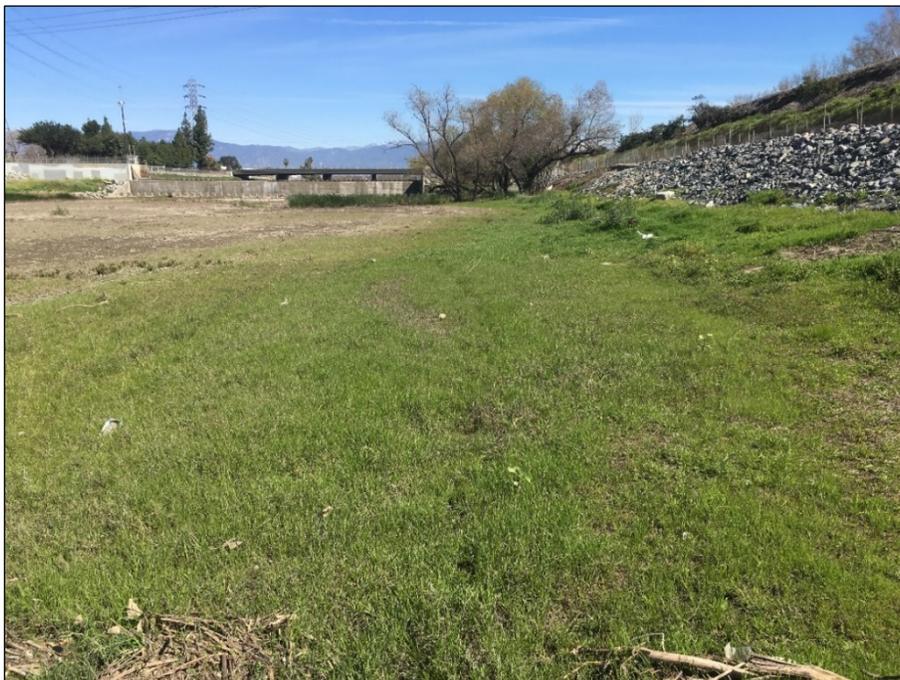
Photo 4: View of annual grasses in the potential construction zone/access impact area within the San Gabriel River, facing north.
