# **APPENDIX M**

## *Preliminary Environmental Site Assessment*

*Campo Wind Project Preliminary ESA*

*Subject: Preliminary ESA for Campo Wind Project*

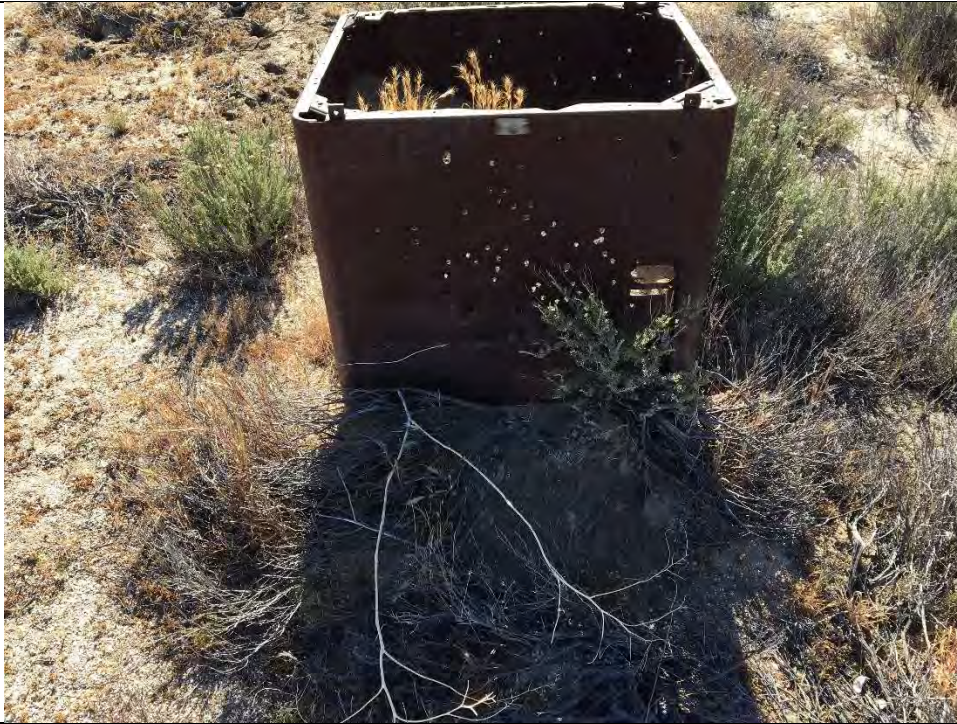
Photo 18. Rusted, empty appliance near the gate entrance.

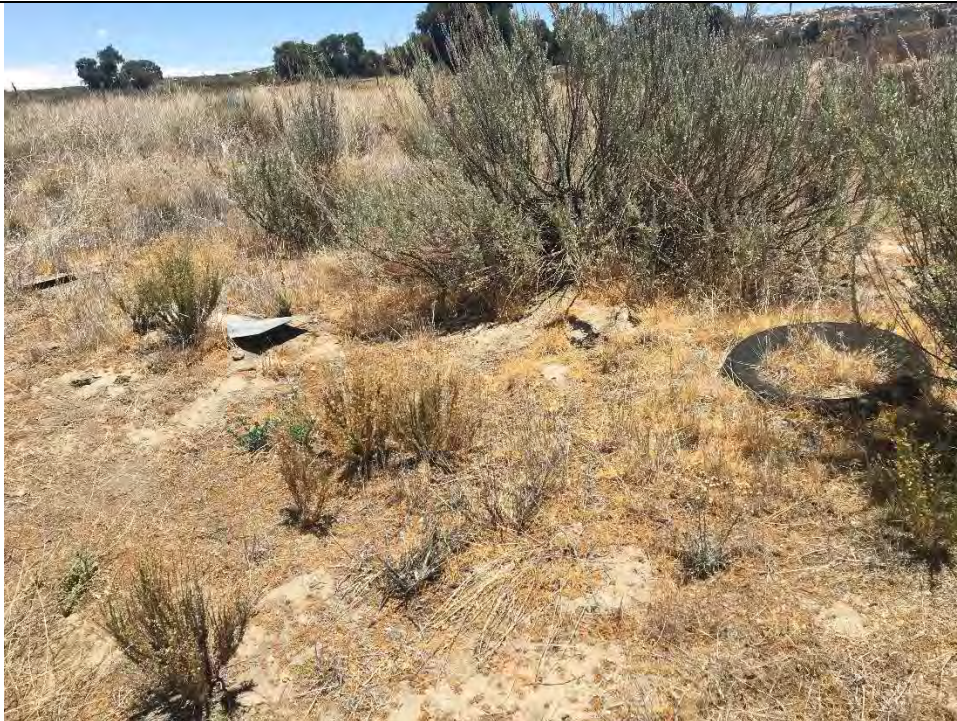
Photo 19. Tires and occasionally scrap metal can be found intermittently across the Subject Property.

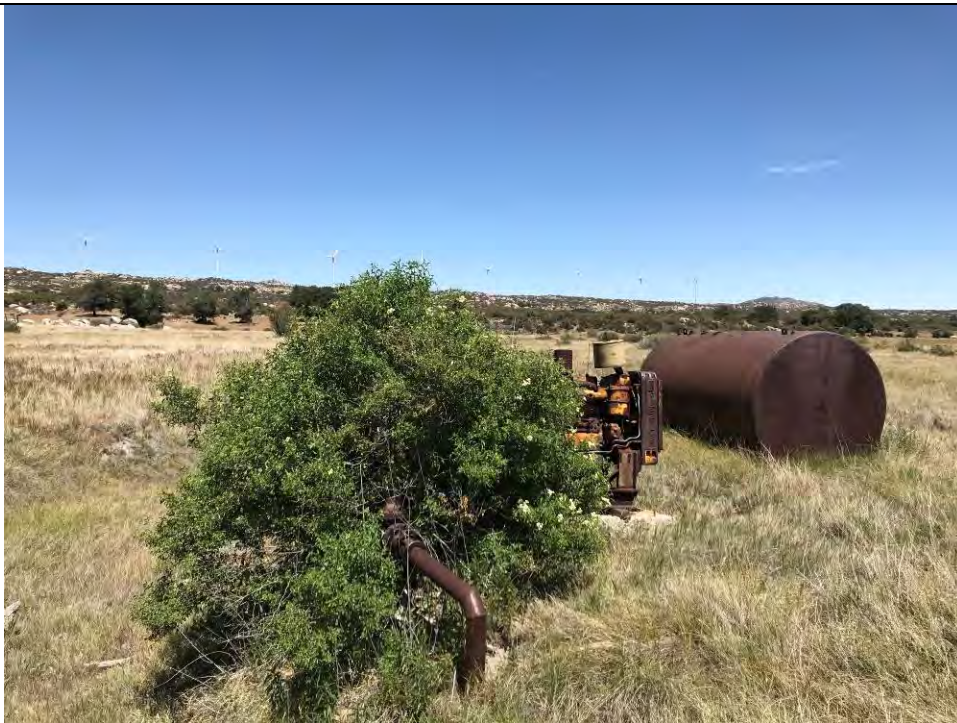
Photo 23. Larger motor and AST with second well south of the smaller well. Well was covered by a bush. Label on AST was rusted over but appeared to be roughly 3-4,000 gallon capacity.

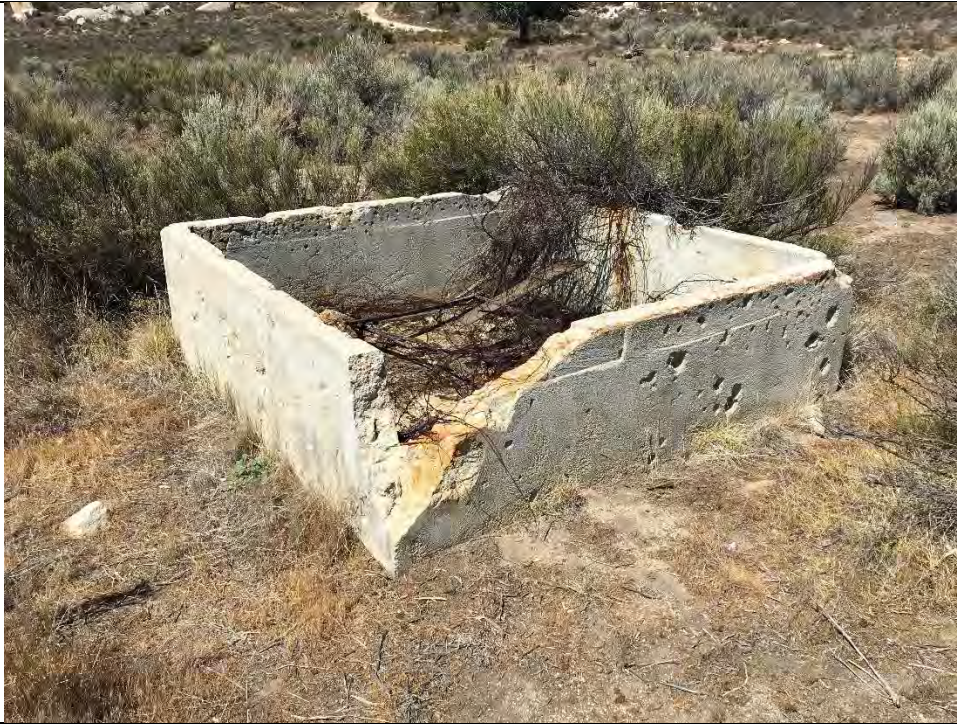
Photo 31. Possible cistern 5' x 5' and about 2' tall. Broken glass, wood planks and metal wiring inside.

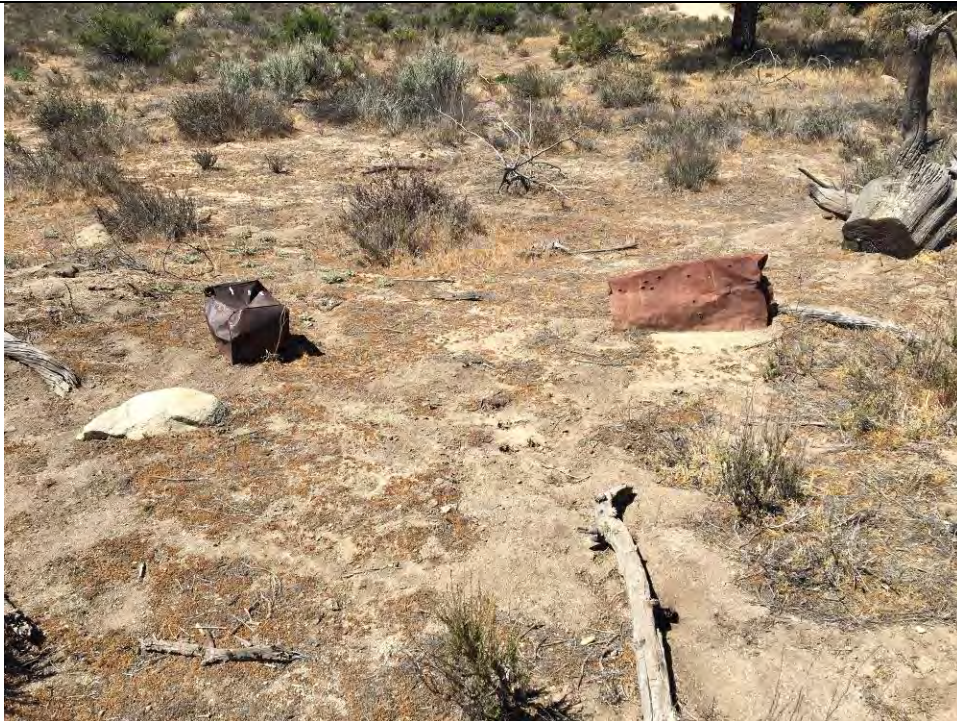
Photo 32. Example of the scattered metal canisters, drums, and scrap within 200 ft around abandoned well.

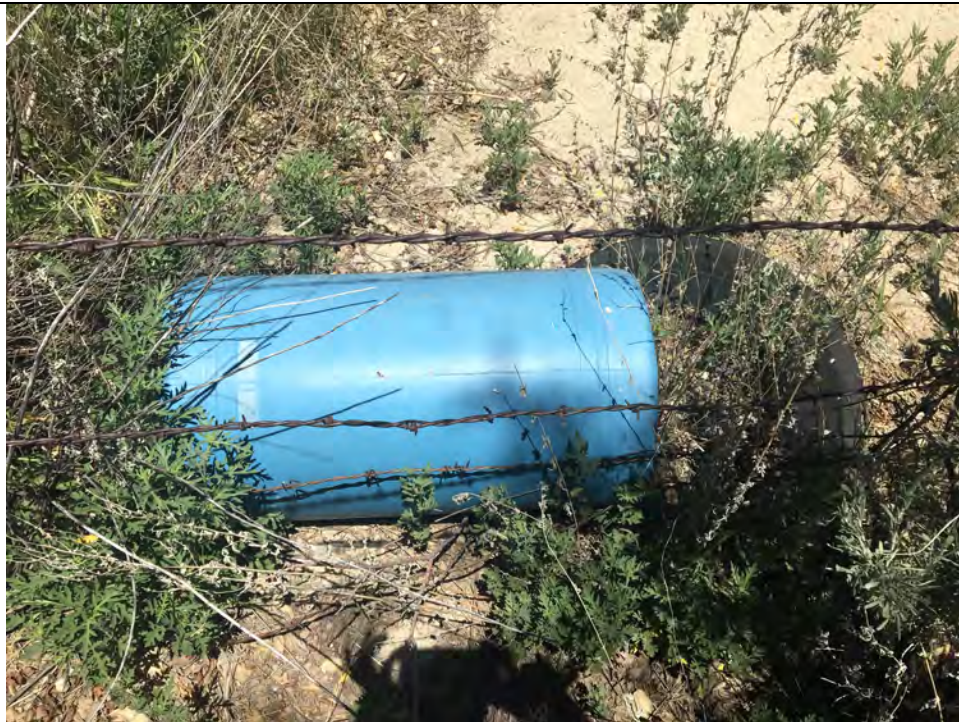
Photo 40. Blue drum further down the dry streambed, around 400' east of the cattle yard. Labeling faded but container appeared mostly empty and no odors were observed.

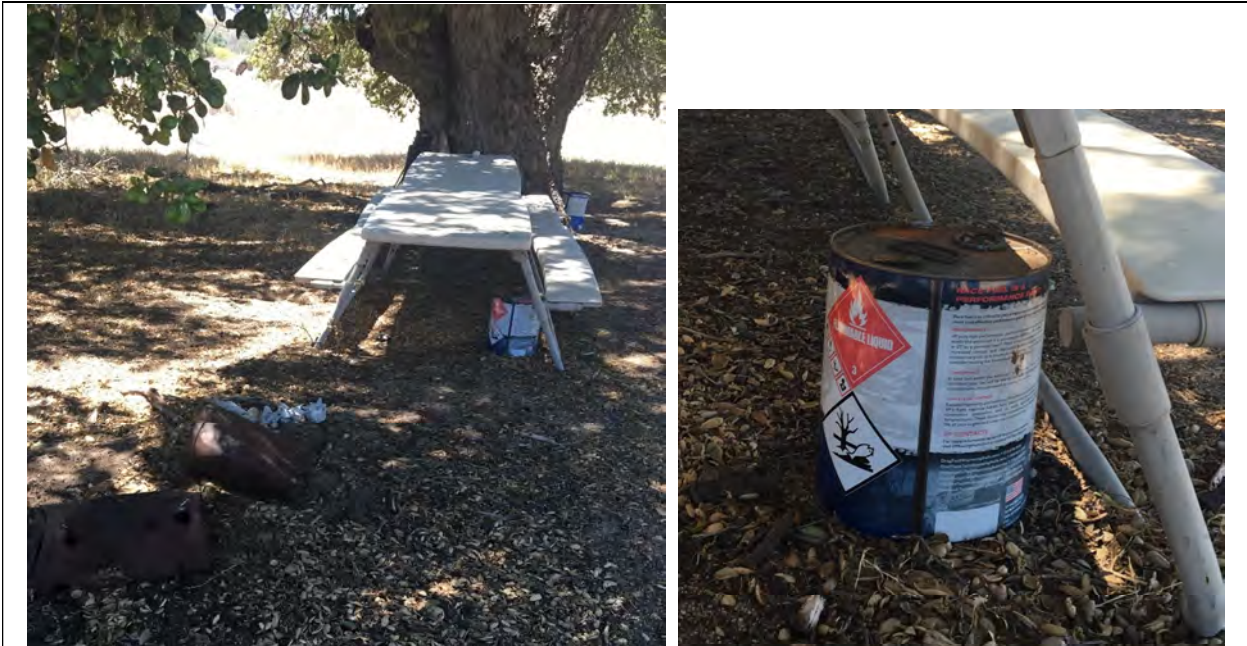
Photo 41 (left). Camping/picnic spot 110' north of cattle yard. Had two 5 gallon fuel containers and rusted empty metal canisters. Photo 42 (right). Close up of one of the fuel containers.

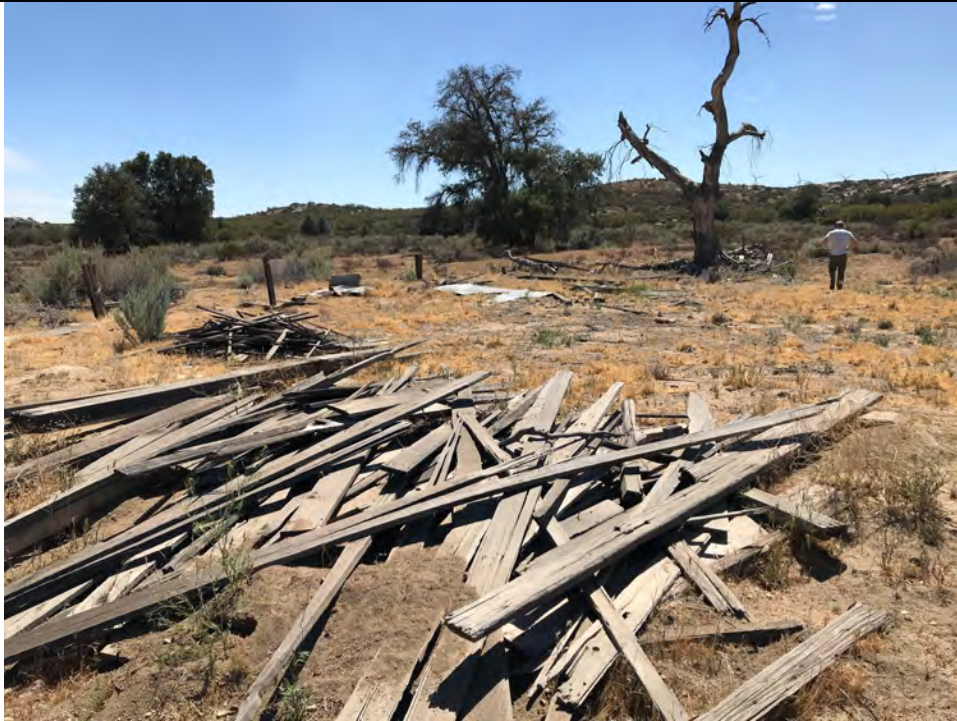
Photo 43. Remnants of a possible collapsed structure 700 feet south of the cattle yard. Wood planks, cut granite blocks, and metal sheet roofing are present. No tanks or other utilities found.

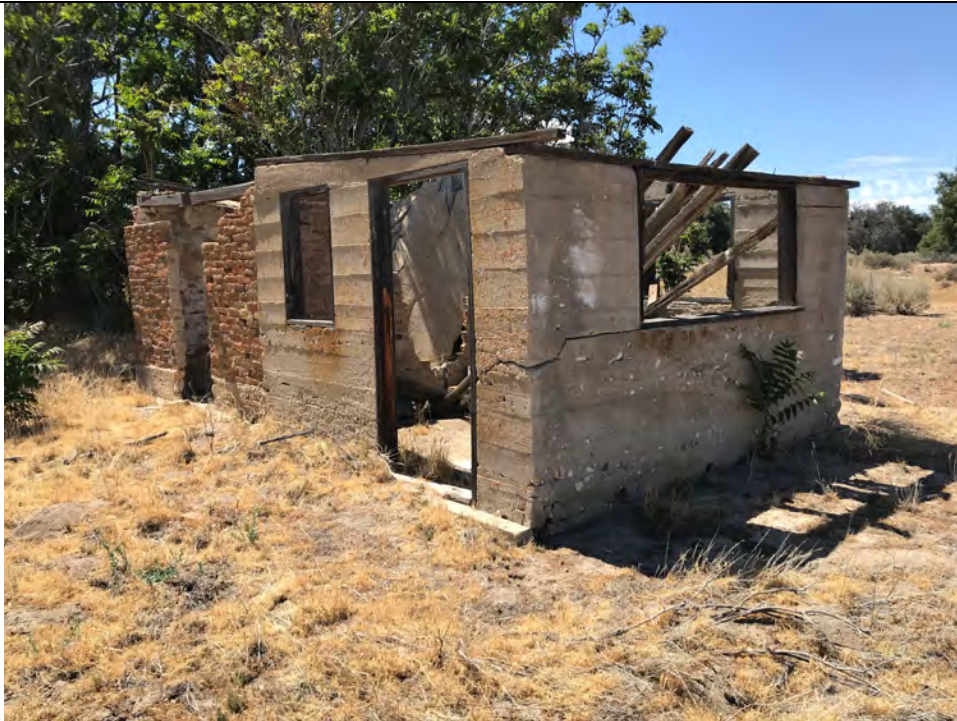
Photo 45. Old residence with collapsed roof. No utilities found.
