APPENDICES

B. STOKES CREEK BRIDGE PRELIMINARY PLAN SET

C. GEOTECHNICAL INVESTIGATION

D. HYDROLOGY AND HYDRAULIC STUDY

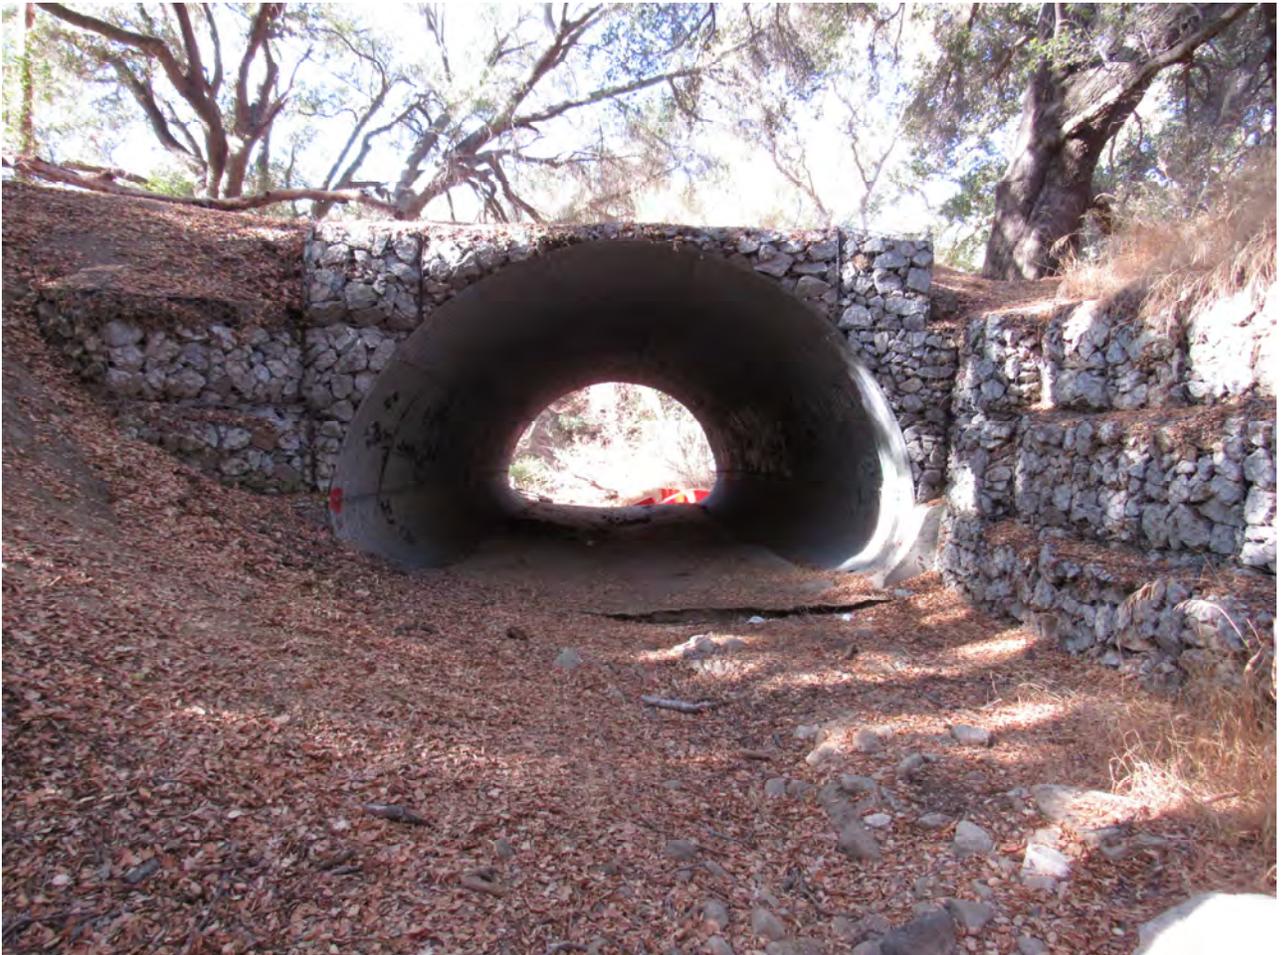
CMP Culvert Upstream

The existing Arch Culvert is on Craggs Rd is 17.5' x 11.5 CMP with pave bottom See photo below. Both upstream and downstream is establish with Gabion head wall to makeup the surrounding grade.

Water was reported having over topped the bridge to cause damage to the road above the culvert and downstream river channel.

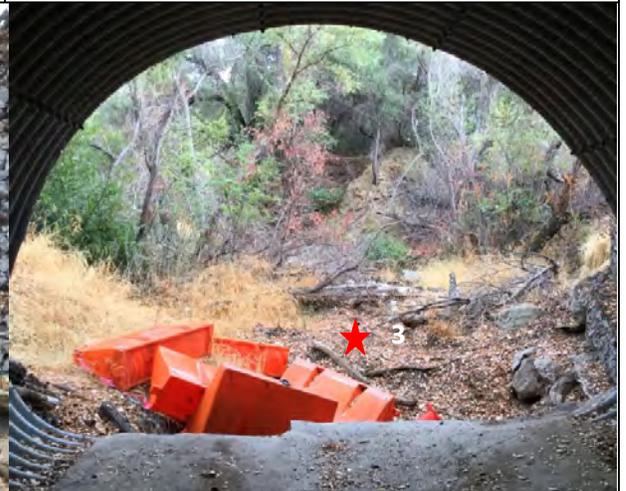
Photo 4: Photo facing downstream from culvert beneath Waycross Rd.

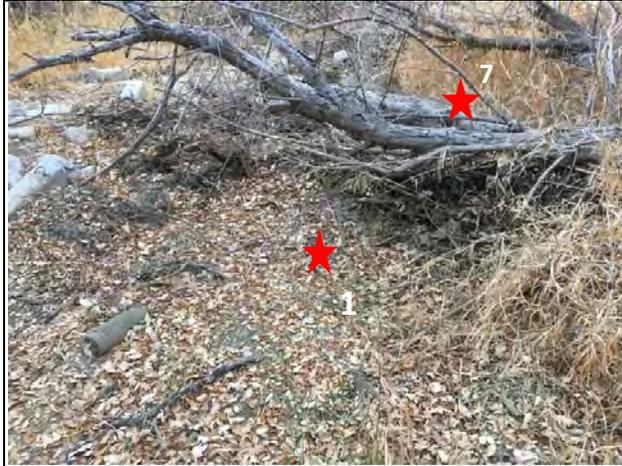
Photo 5. Photo of Stokes Creek Channel downstream of Waycross Rd. Culvert at Sampling Plots 1 & 7. Note break in bank slope & drift deposits demarcating limits of OHWM.

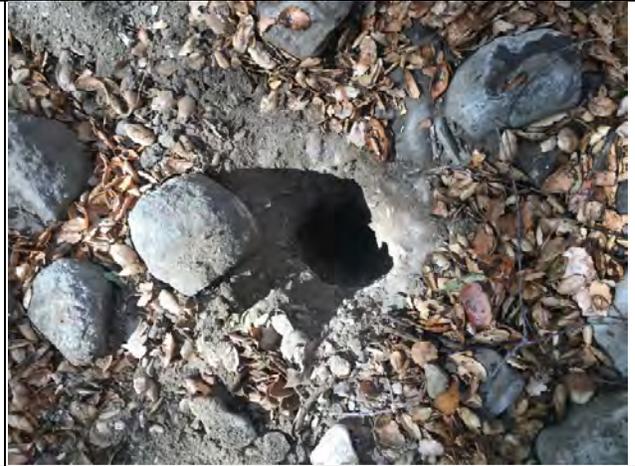
Photo 6. Photo of Sampling Plot 1 soil pit. Note: restrictive layer of bedrock very shallow (pit depth 6"). No indicators of hydric soils or reducing conditions present within soil pit.

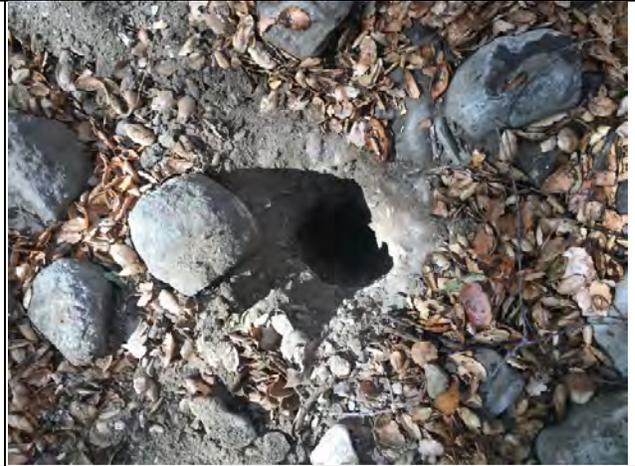
Photo 6. Photo of Sampling Plot 1 soil pit. Note: restrictive layer of bedrock very shallow (pit depth 6"). No indicators of hydric soils or reducing conditions present within soil pit.
