# **Appendix Mountain View Street Condominiums 301 & 305 North Mountain View Street**

Appendices for the  
Initial Study Mitigated Negative Declaration

**Re: 301 North Mountain View Street Air Quality, Greenhouse Gas, & Energy Technical Memorandum  
19237**

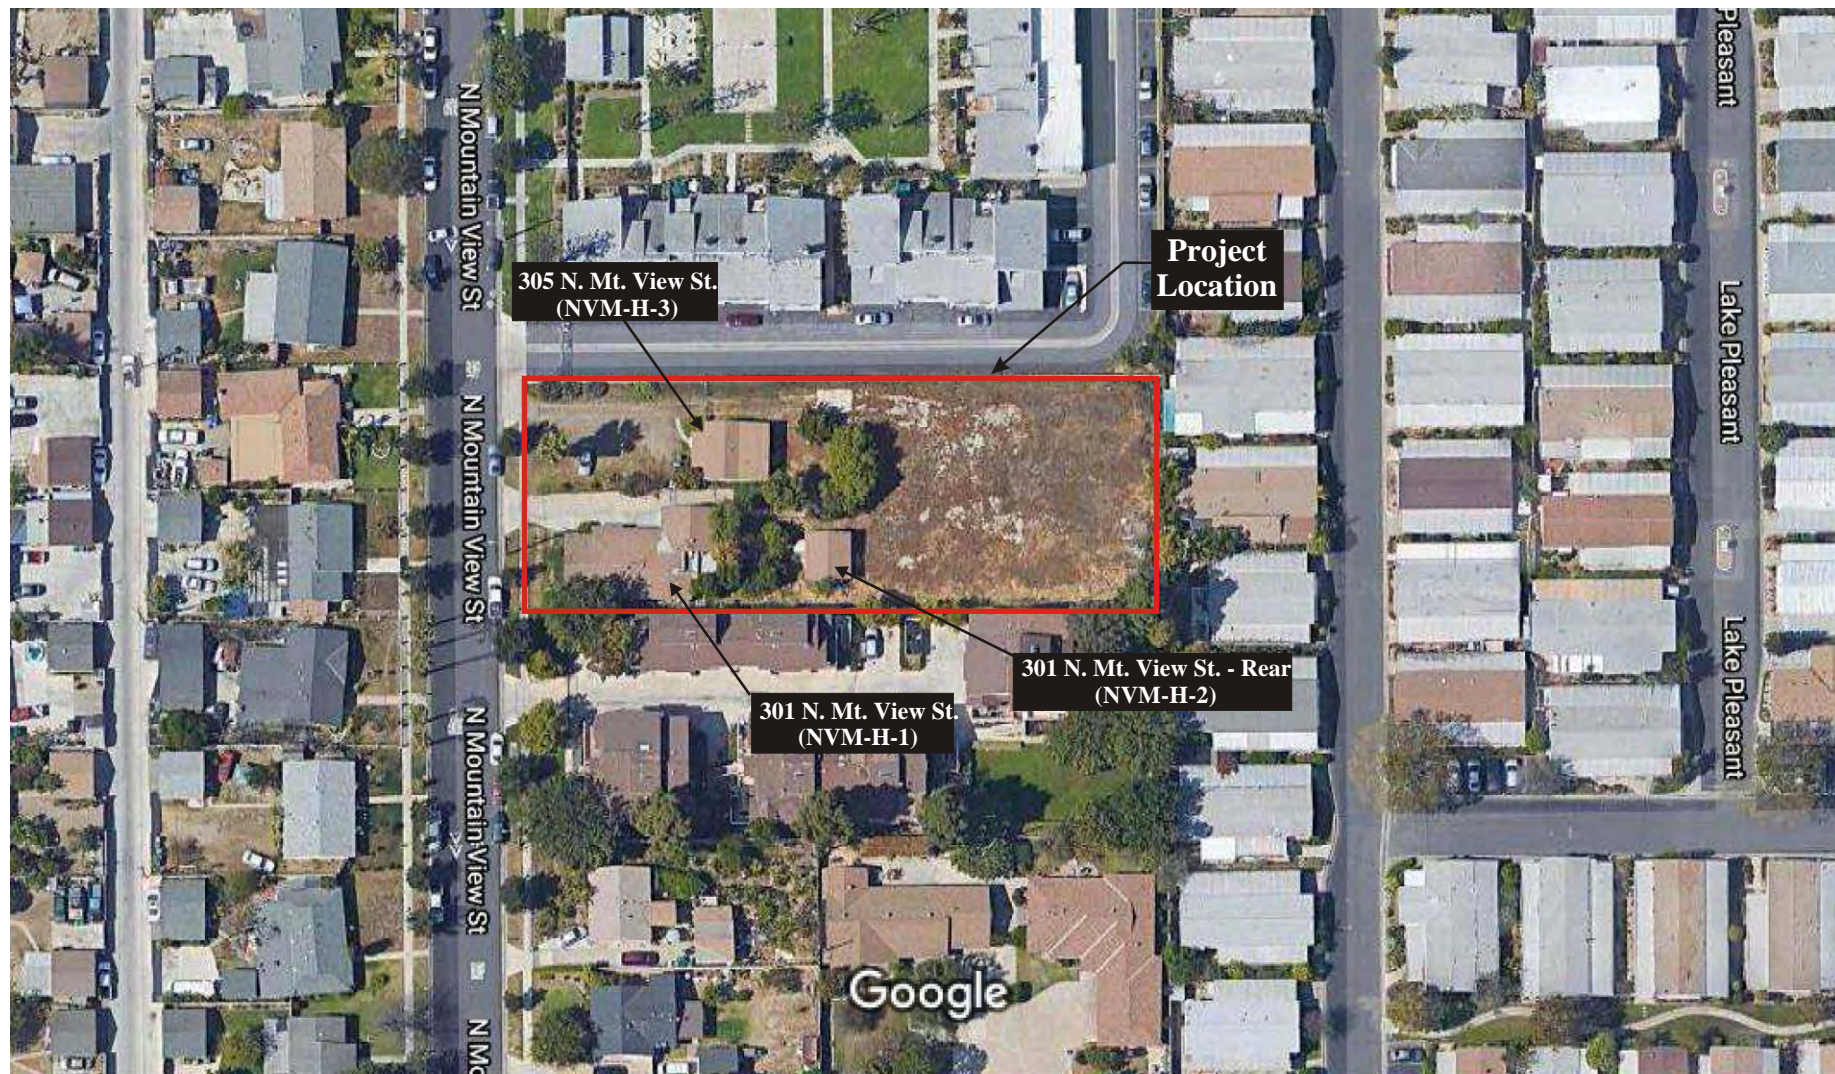
Figure 5  
Structures within the Project Area

The building itself is a 41 by 78 ft. wood-frame stucco structure with concrete slab foundation. The residential portion of the structure has a low-angled gable roof with composite shingles. The roofline changes angle slightly reflecting the front extension of the structure. Eave width varies along the margins of the structure with a slightly larger eave forming a narrow entryway porch and a large overhanging eave on the southwest corner of the building. The underside of the eaves is open beam. A decorative concrete block partition below the eave and three decorative metal eave supports help define an entryway porch. Gutters have been added to the eaves on the front of the garage and the porch area.

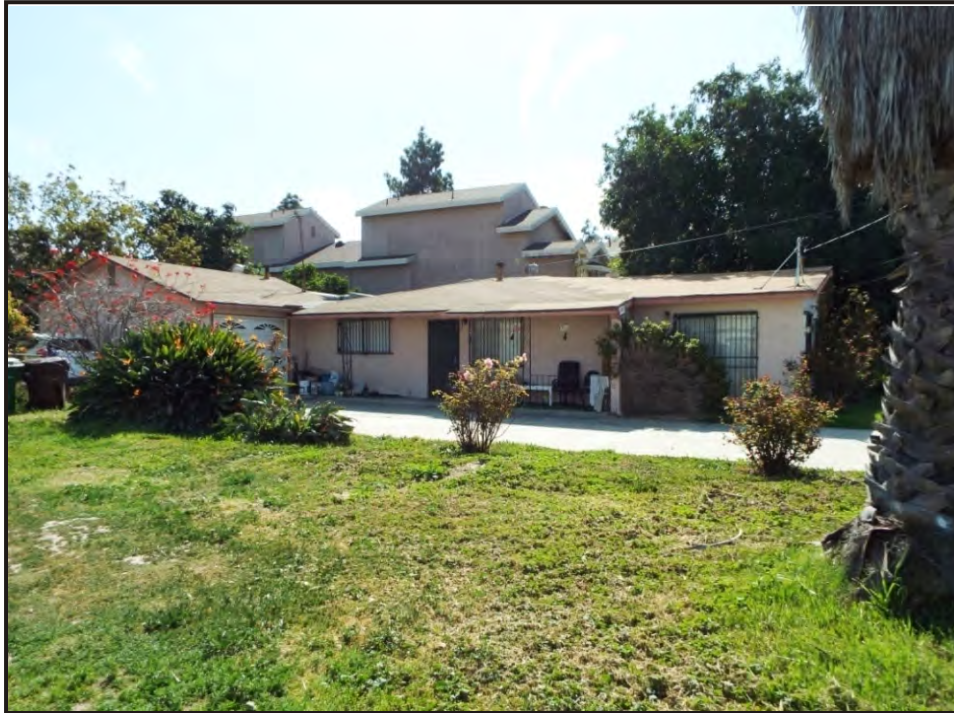
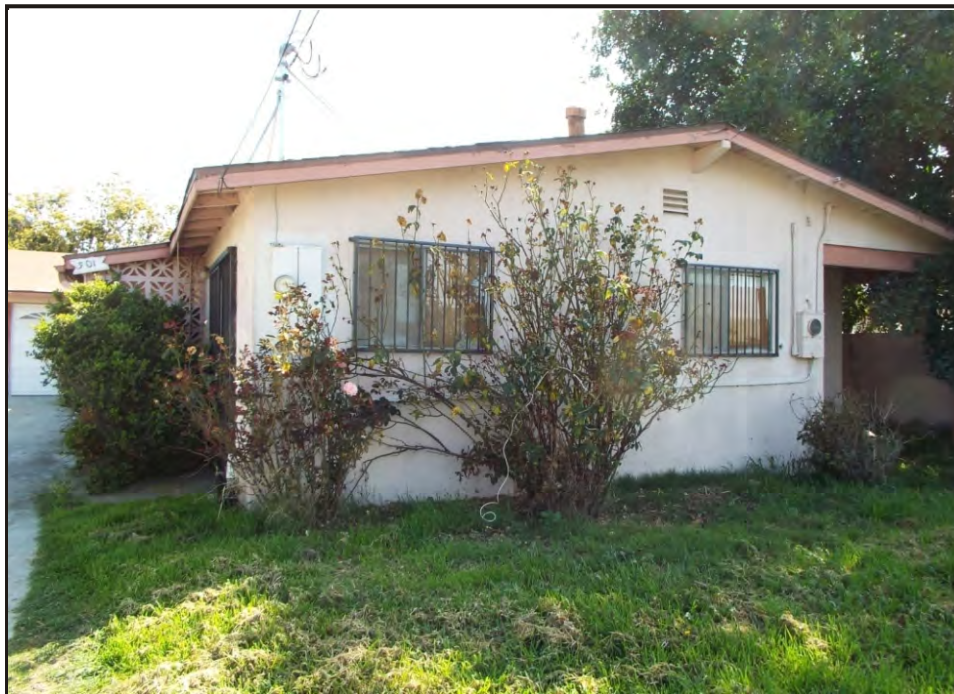
Figure 6  
301 North Mountain View Street Structure

a. House Overview, Looking Southeast (PR-07148-037)

b. House Front, Looking East (PR-07148-005)

The residence at 301 North Mountain View Street is a small Ranch Style structure with an “L” shaped footprint including the attached garage (Figure 6). It was originally built in 1960 (Public Records) and includes a 3 bedroom 2 bathroom house of approximately 1,220 square feet. The 1963 aerial photograph shows a rectangular structure on the property suggesting that the garage is a later addition to the house. The unaddressed structure in the rear of 301 North Mountain View Street is present in the 1963 aerial, suggesting that it may have been the original garage on the property or a workshop. The 1972 aerial photograph appears to show the current attached garage extension, indicating that it was added between 1963 and 1972. The street-front extension of the structure may have also been added at this time.

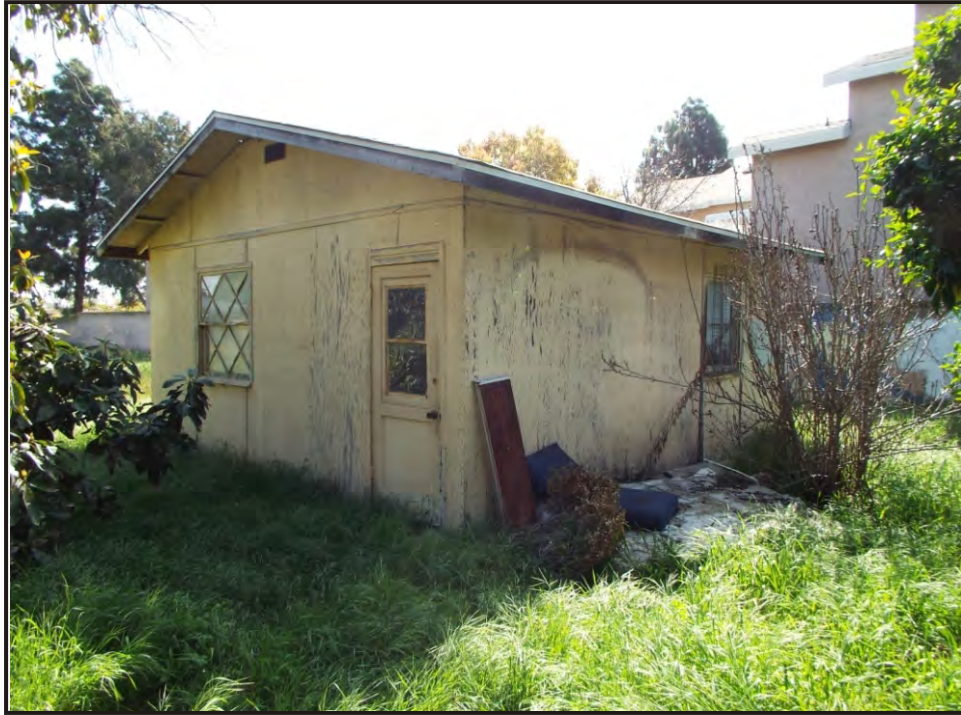
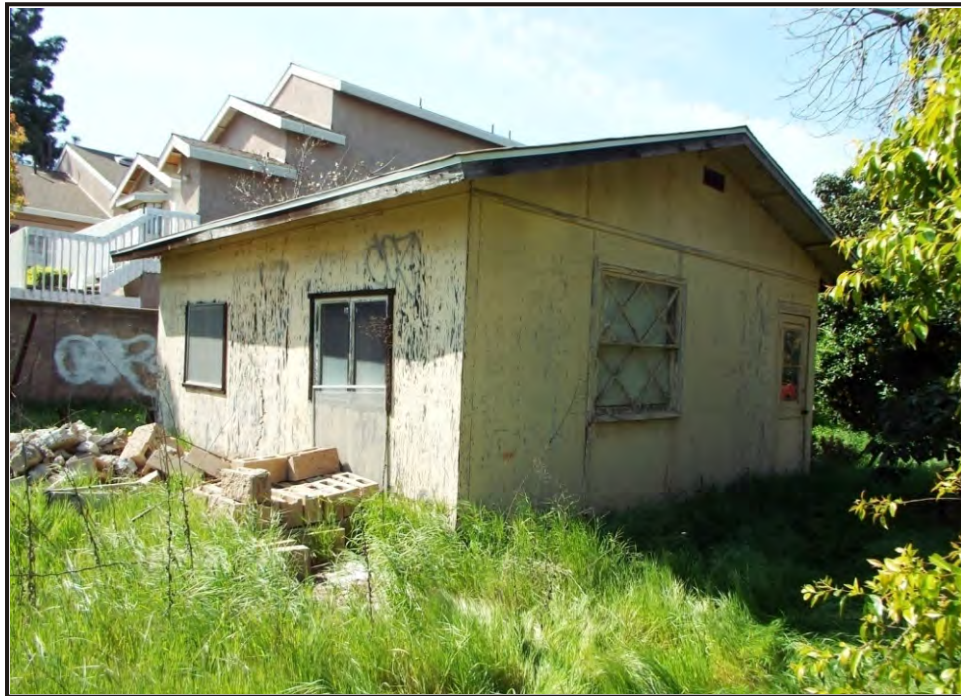
Figure 7  
Rear 301 North Mountain View Street Structure

a. Back Building, Looking Southwest (PR-07148-018)

B. Back Building, Looking Southeast (PR-07148-01823)

The rear of 301 North Mountain View Street contains an unaddressed structure (Figure 7). While the main residence at this address was built in 1960 (Public Records), the window and door style of this smaller structure suggest that it may have been older (1950s). This suggests the possibility that the structure is a move-on or it was built of older, salvaged materials. The structure does not appear in the 1953 aerial photograph of the area. The 1963 aerial photograph shows the main house toward the front of the property. The unaddressed structure in the rear of 301 North Mountain View Street is also present in the 1963 aerial.

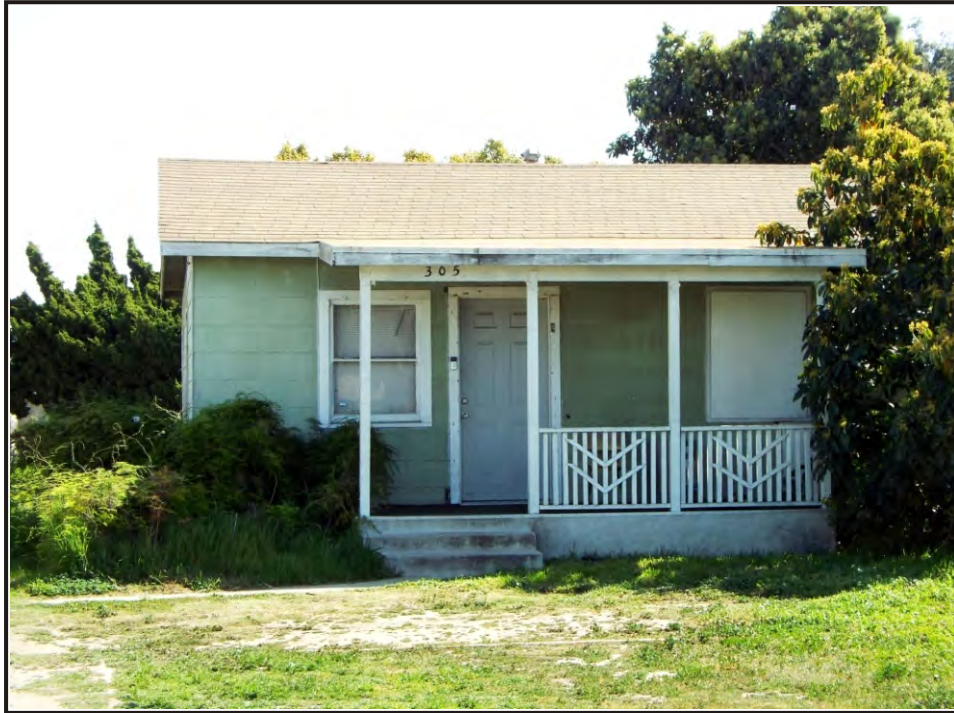
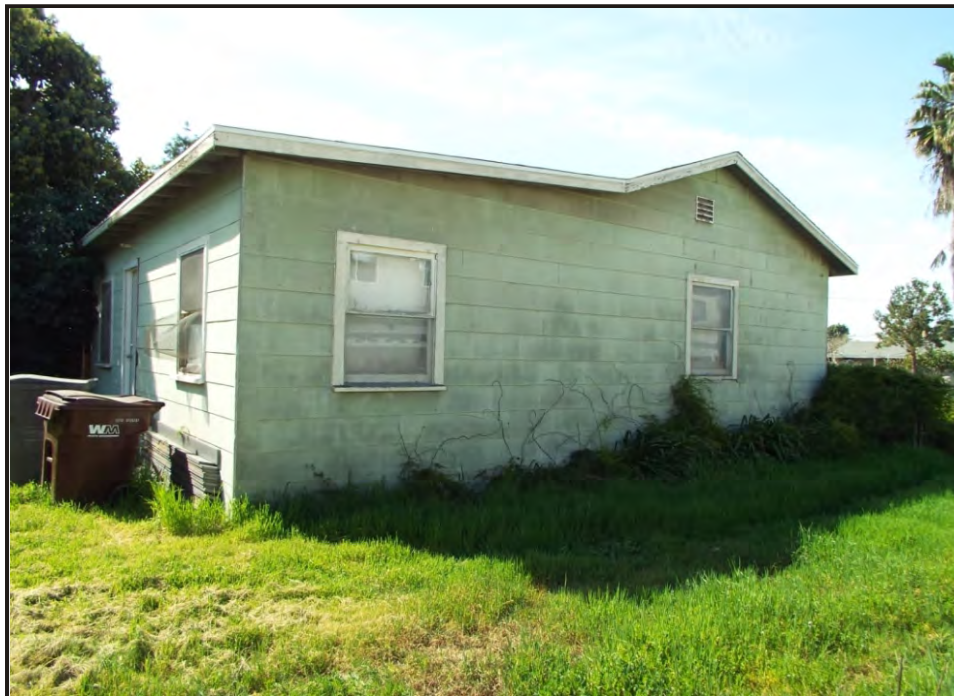
Figure 8  
305 North Mountain View Street Structure

a. House Front, Looking East (PR-07148-002)

b. House Side and Back, Looking Southwest (PR-07148-015)

County assessor records indicate an initial construction date of 1938 for the house at 305 North Mountain View Street. This date is somewhat inconsistent with the architectural style of the house, which is more consistent with post-war construction. This 24 by 31 ft. house is a Minimal Traditional single-story single-family residence (Figure 8). It is a 1 bedroom, 1 bathroom house of approximately 725 square feet. It appears on aerial photographs as early as 1953. USGS Quadrangle maps jump from only a structure south of the property in 1958 to the area being generally urbanized without individual structures shown in 1968. An absence of a structure at this location on the 1943, 1945, and 1951 USGS quadrangles suggests that the 1938 improvements refer to structures not located on the current parcel. The house is wood-frame with a poured concrete and pile foundation. The front roof is gabled with a moderate pitch and composition shingles. The back rooms have a low angled shed roof. Windows are double-hung sash. An open front porch extension is present on part of the structure with a shed roof. The porch has decorative wood railing with chevron designs. Siding on the house is artificial cedar shingle.

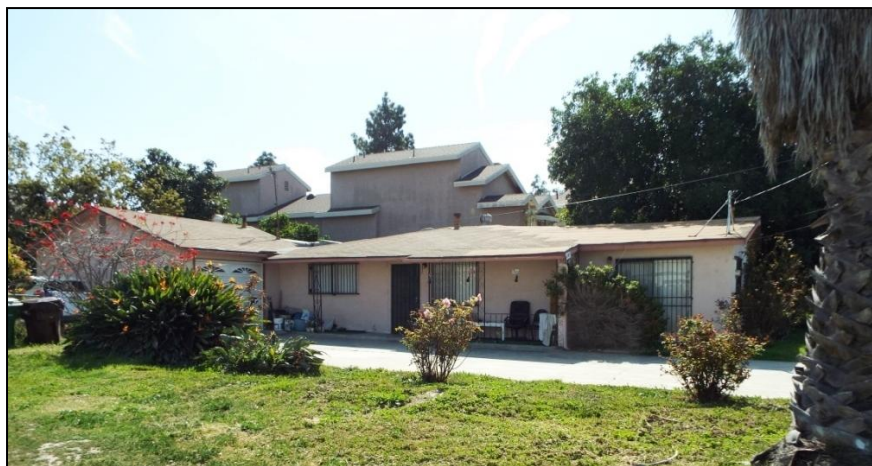
P5b. Description of Photo: View of house, looking SE; 3/6/20; PR-07148-037

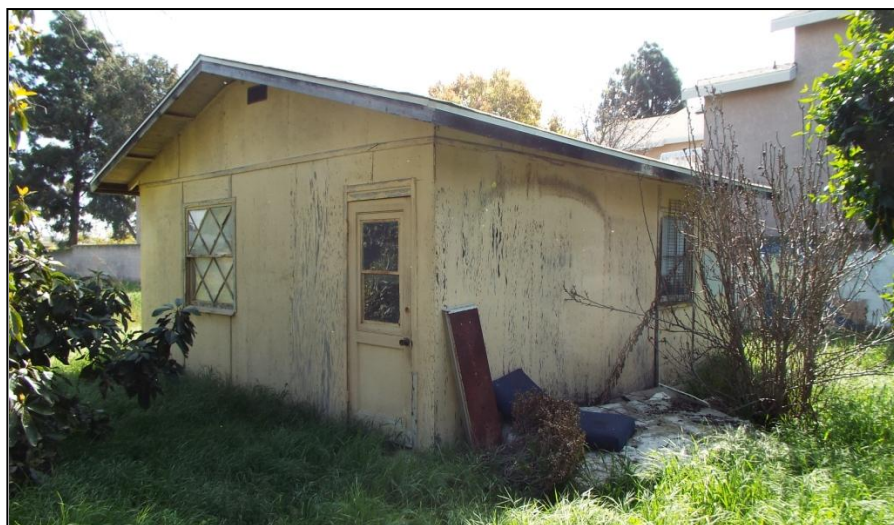
P5b. Description of Photo: View of building, looking SE; 3/6/20; PR-07148-018

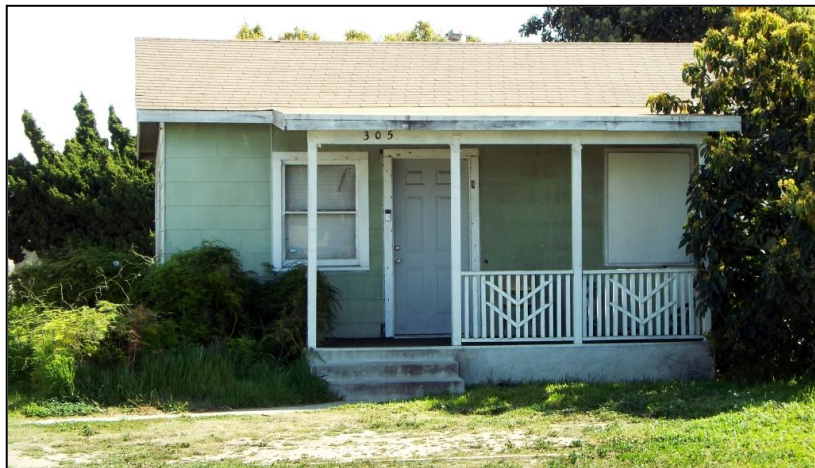
P5b. Description of Photo: Front of house, looking east; 3/6/20; PR-07148-002

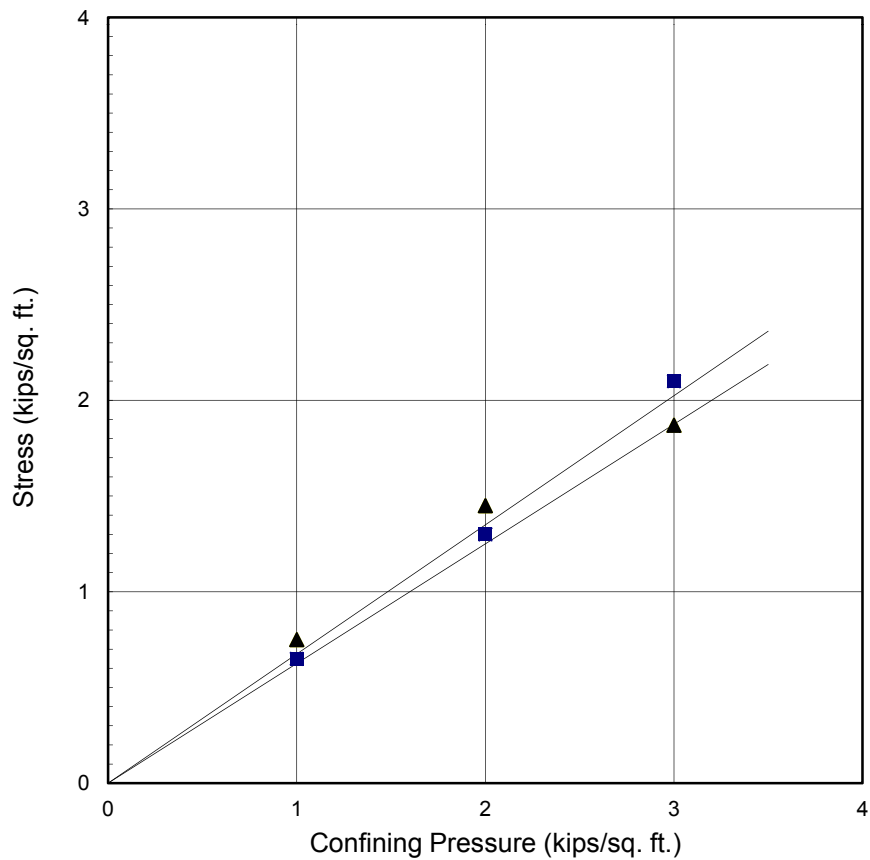
## SHEAR TEST RESULTS

All samples were tested at saturated conditions.

Based on 80% peak strength or ultimate strength, whichever is lower

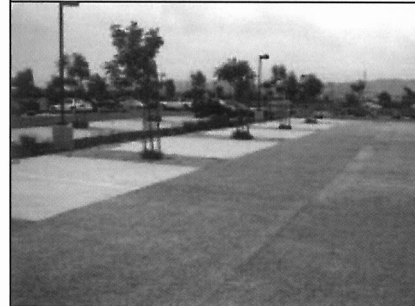
Permeable Pavement  
Source: Geosyntec Consultants

- ☐ All aggregate used to construct permeable pavement shall be thoroughly washed before being delivered to the construction site.
- ☐ The top or wearing layer course (permeable pavement course) should consist of asphalt or concrete with greater than normal percentage of voids, or paving stones.

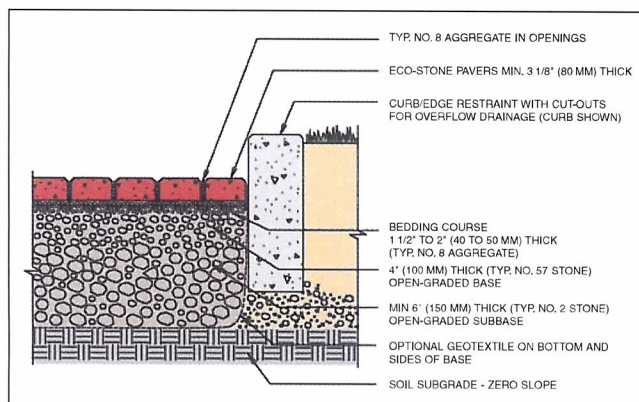
Figure 4 - Typical Cross-Section of an Eco-Stone® Permeable Pavement Full Infiltration

Current industry recommendations include a subbase of open-graded aggregate (typically ASTM No. 2 or No. 3, or equivalent) at a minimum thickness of 6 in. (150mm) for pedestrian applications and 8 in. (200mm) for vehicular applications. This makes it easier for contractors to install the base materials. A base layer of open-graded aggregate (typically ASTM No. 57 or equivalent) is installed over the subbase. This helps meet filter criteria between the layers. The recommended thickness for this layer is 4 in. (100mm). It may be possible, however, to use a single material for the base and subbase depending on project design parameters and contractor experience. Open-graded materials described here typically have a water storage void space between the aggregates of between 30-40%, which maximizes storage of infiltrated stormwater.

For the bedding layer, material equivalent to ASTM No. 8 stone is recommended. This same material is used to fill the drainage openings and joints. If desired, material equivalent to No. 87, 89, or 9 stone also may be used to fill smaller joints between the pavers. Bedding and jointing sand used in the construction of traditional interlocking concrete pavements should not be used for PICP.

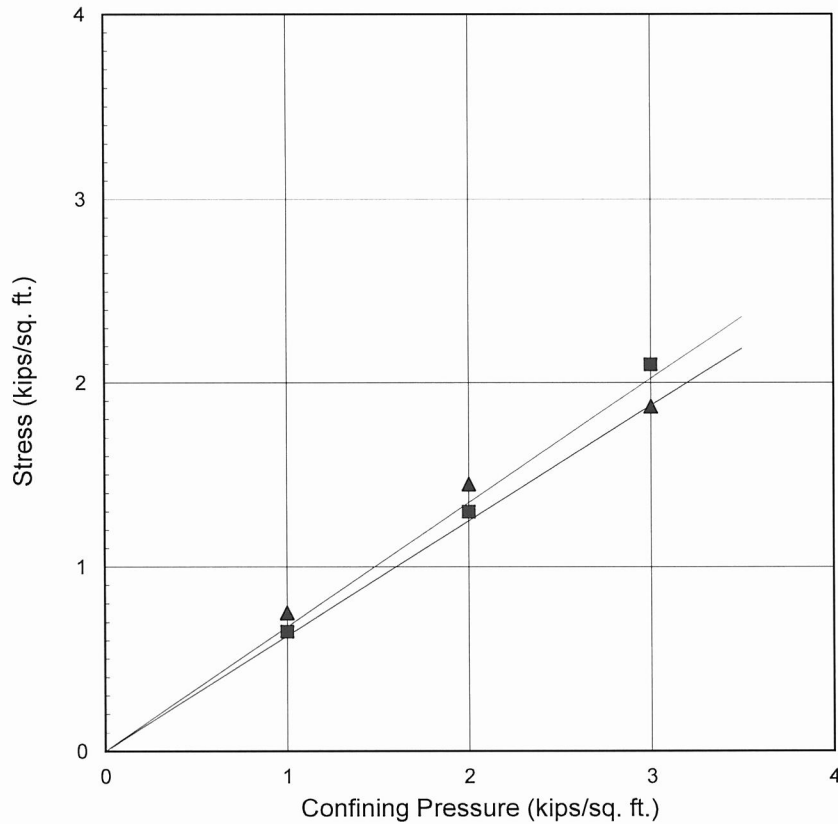
## SHEAR TEST RESULTS

All samples were tested at saturated conditions.
