# CALABAZAS CREEK

# REHABILITATION PROJECT

MILLER AVENUE TO BOLLINGER ROAD  
CUPERTINO, CALIFORNIA

SANTA CLARA VALLEY WATER DISTRICT

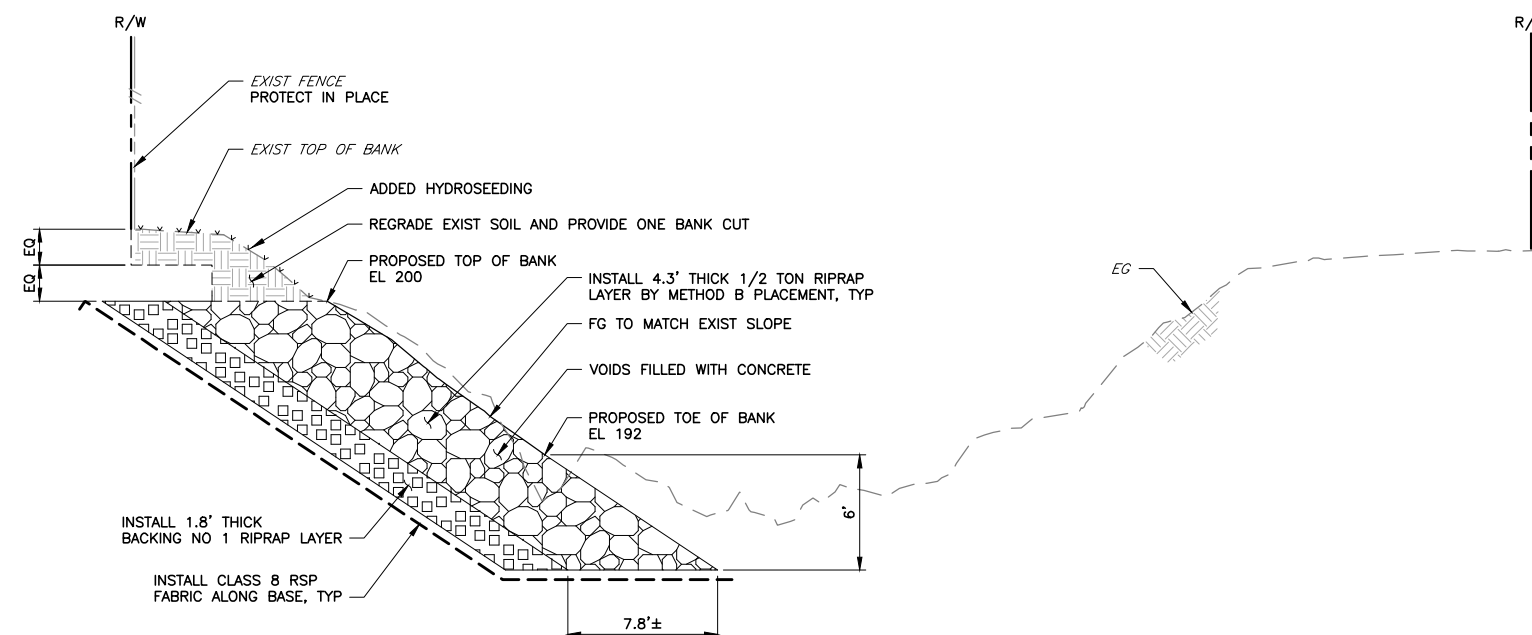
**TYPICAL SECTION** **(A)** **SITE 1 CONSTRUCTION CONTROL LINE**  
**STA 10+25± TO STA 10+50±**  
 SCALE: 1" = 5'

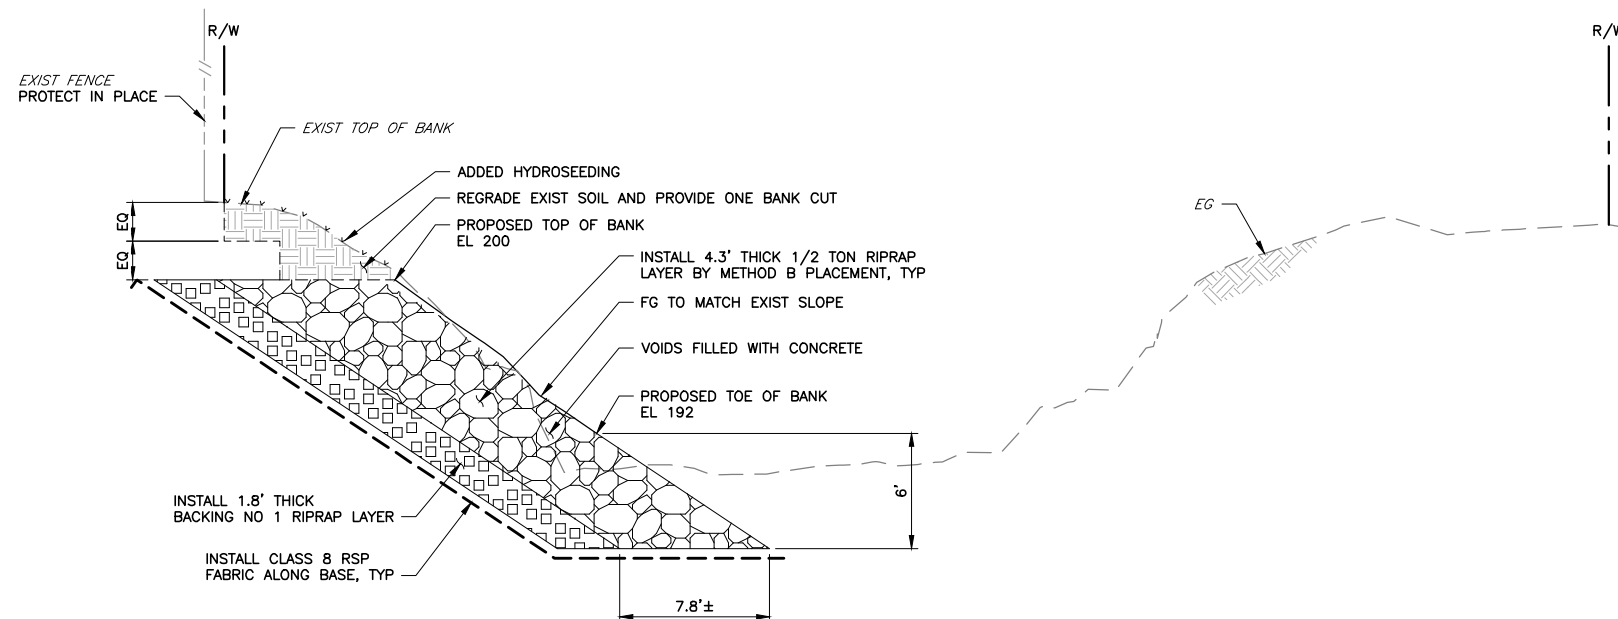
**TYPICAL SECTION** **(B)** **SITE 1 CONSTRUCTION CONTROL LINE**  
**C-01** **STA 10+50± TO STA 10+60±**  
 SCALE: 1" = 5'

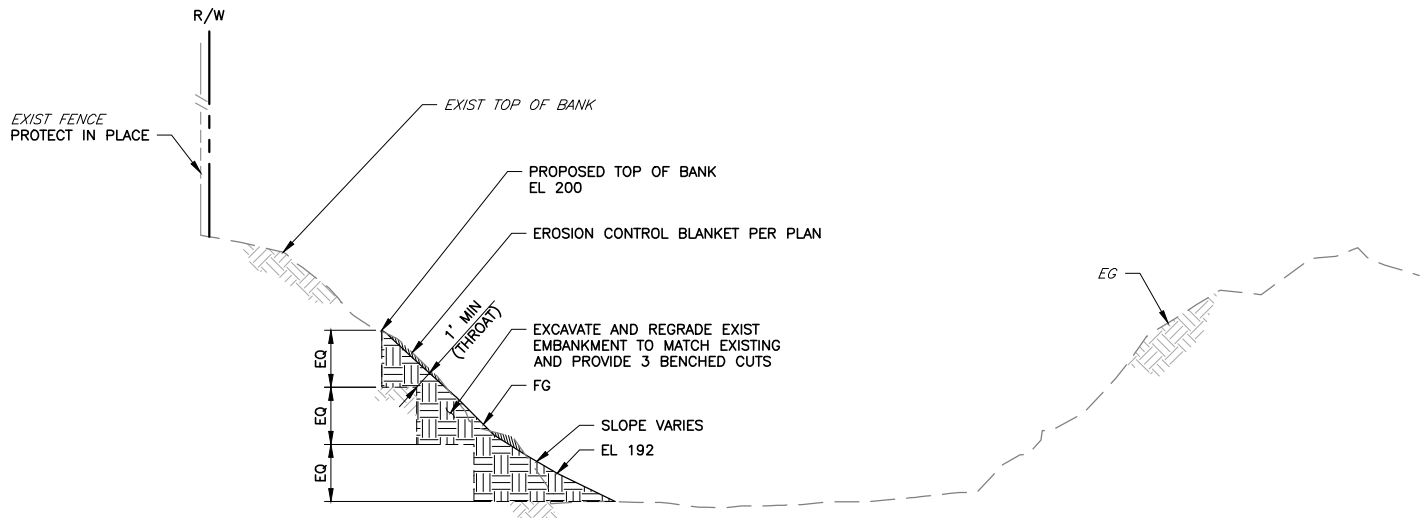
**TYPICAL SECTION** **C** **SITE 1 CONSTRUCTION CONTROL LINE**  
**C-01** **STA 10+60± TO STA 10+80±**  
SCALE: 1" = 5'

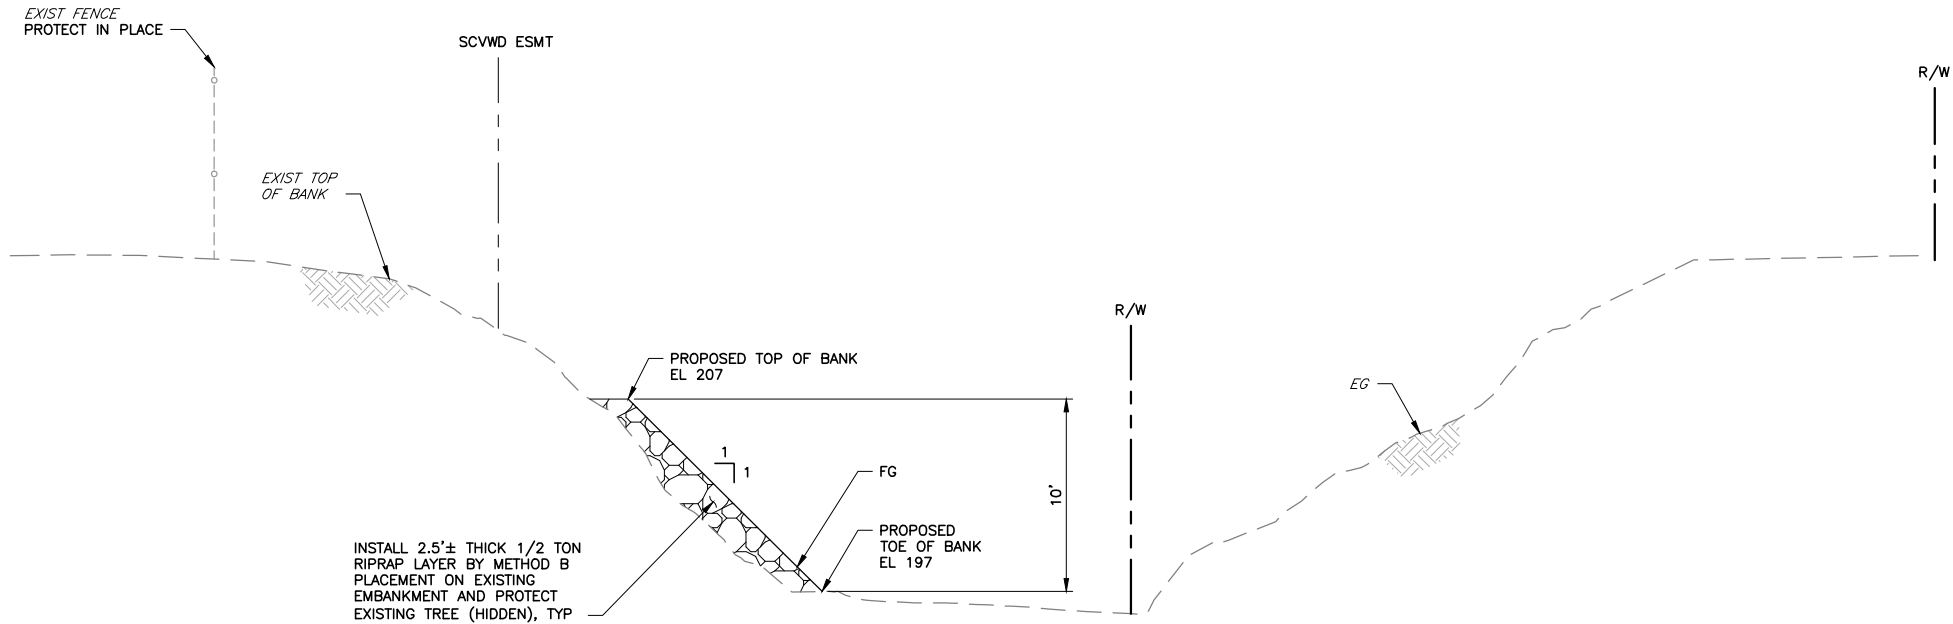
TYPICAL SECTION **F** SITE 3 CONSTRUCTION CONTROL LINE  
C-04 STA 19+57± TO STA 19+96±  
SCALE: 1" = 5'

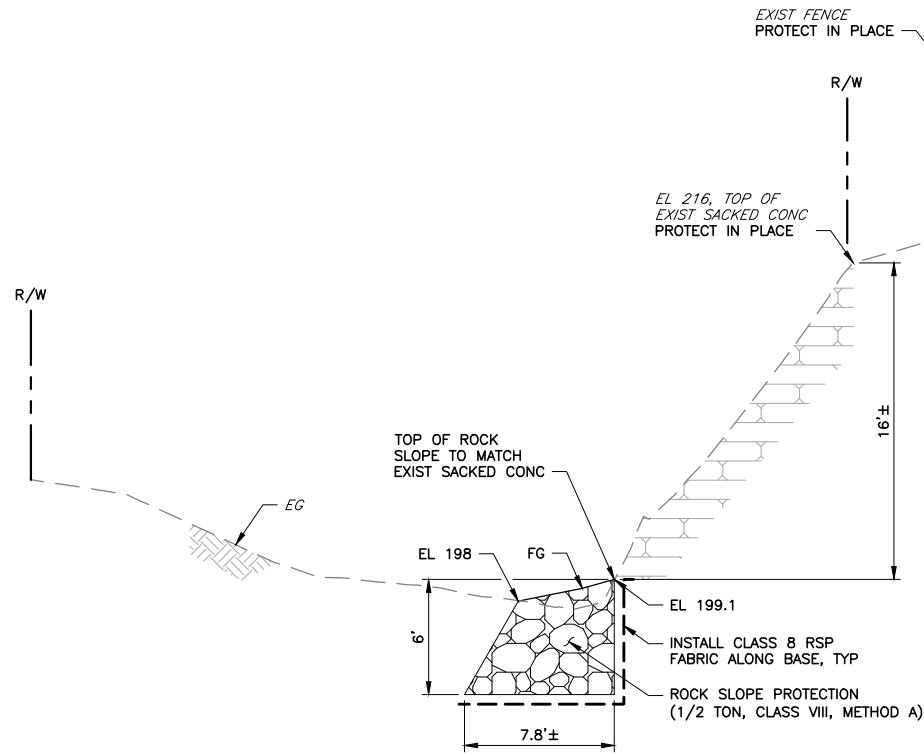
TYPICAL SECTION **G** SITE 4 CONSTRUCTION CONTROL LINE  
C-05 STA 23+53± TO STA 24+20±  
SCALE: 1" = 5'

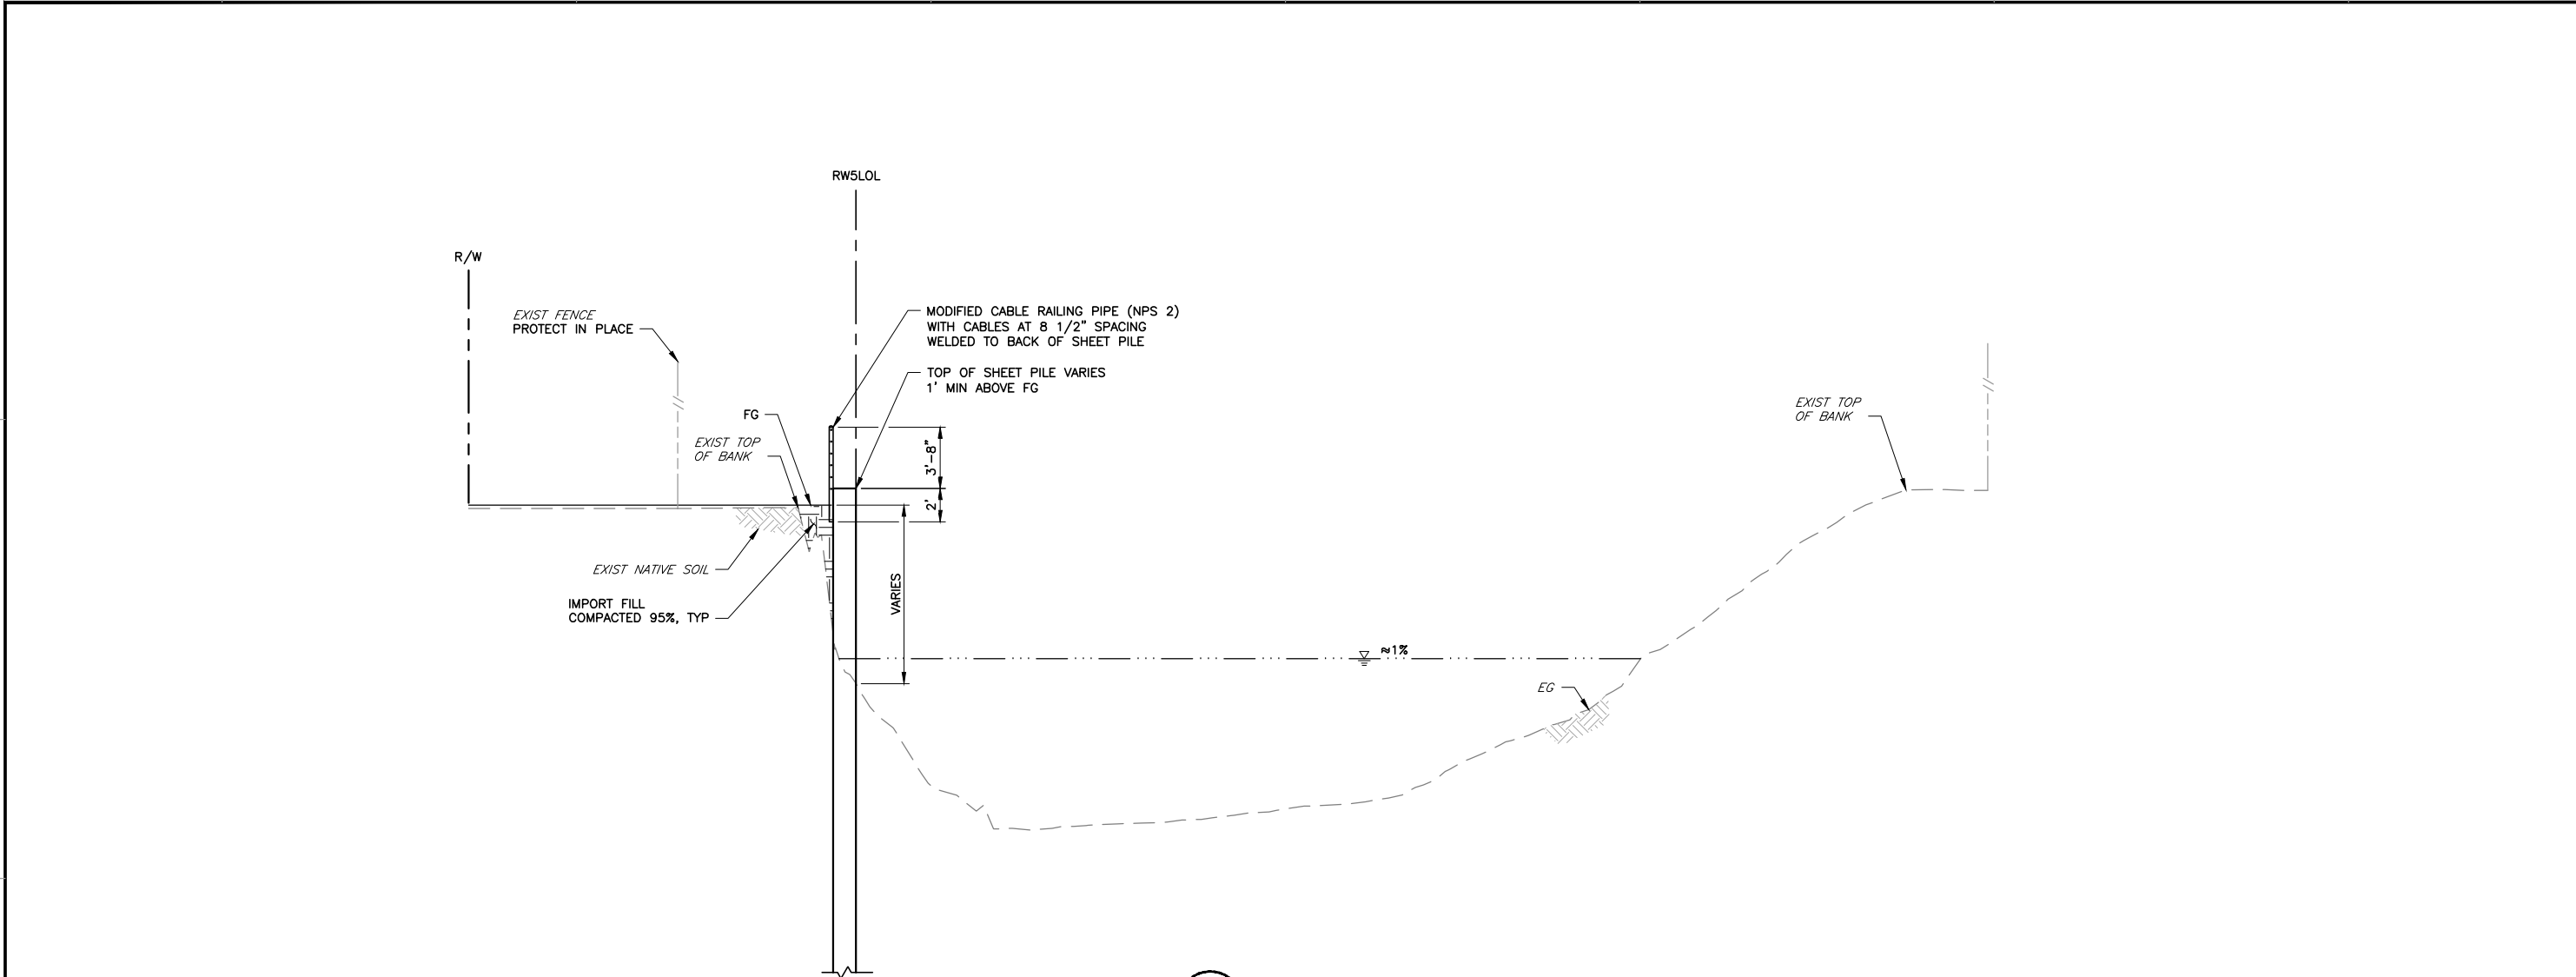
TYPICAL SECTION **H** SITE 5 CONSTRUCTION CONTROL LINE  
C-08 STA 33+00± TO STA 34+17±  
SCALE: 1" = 5'

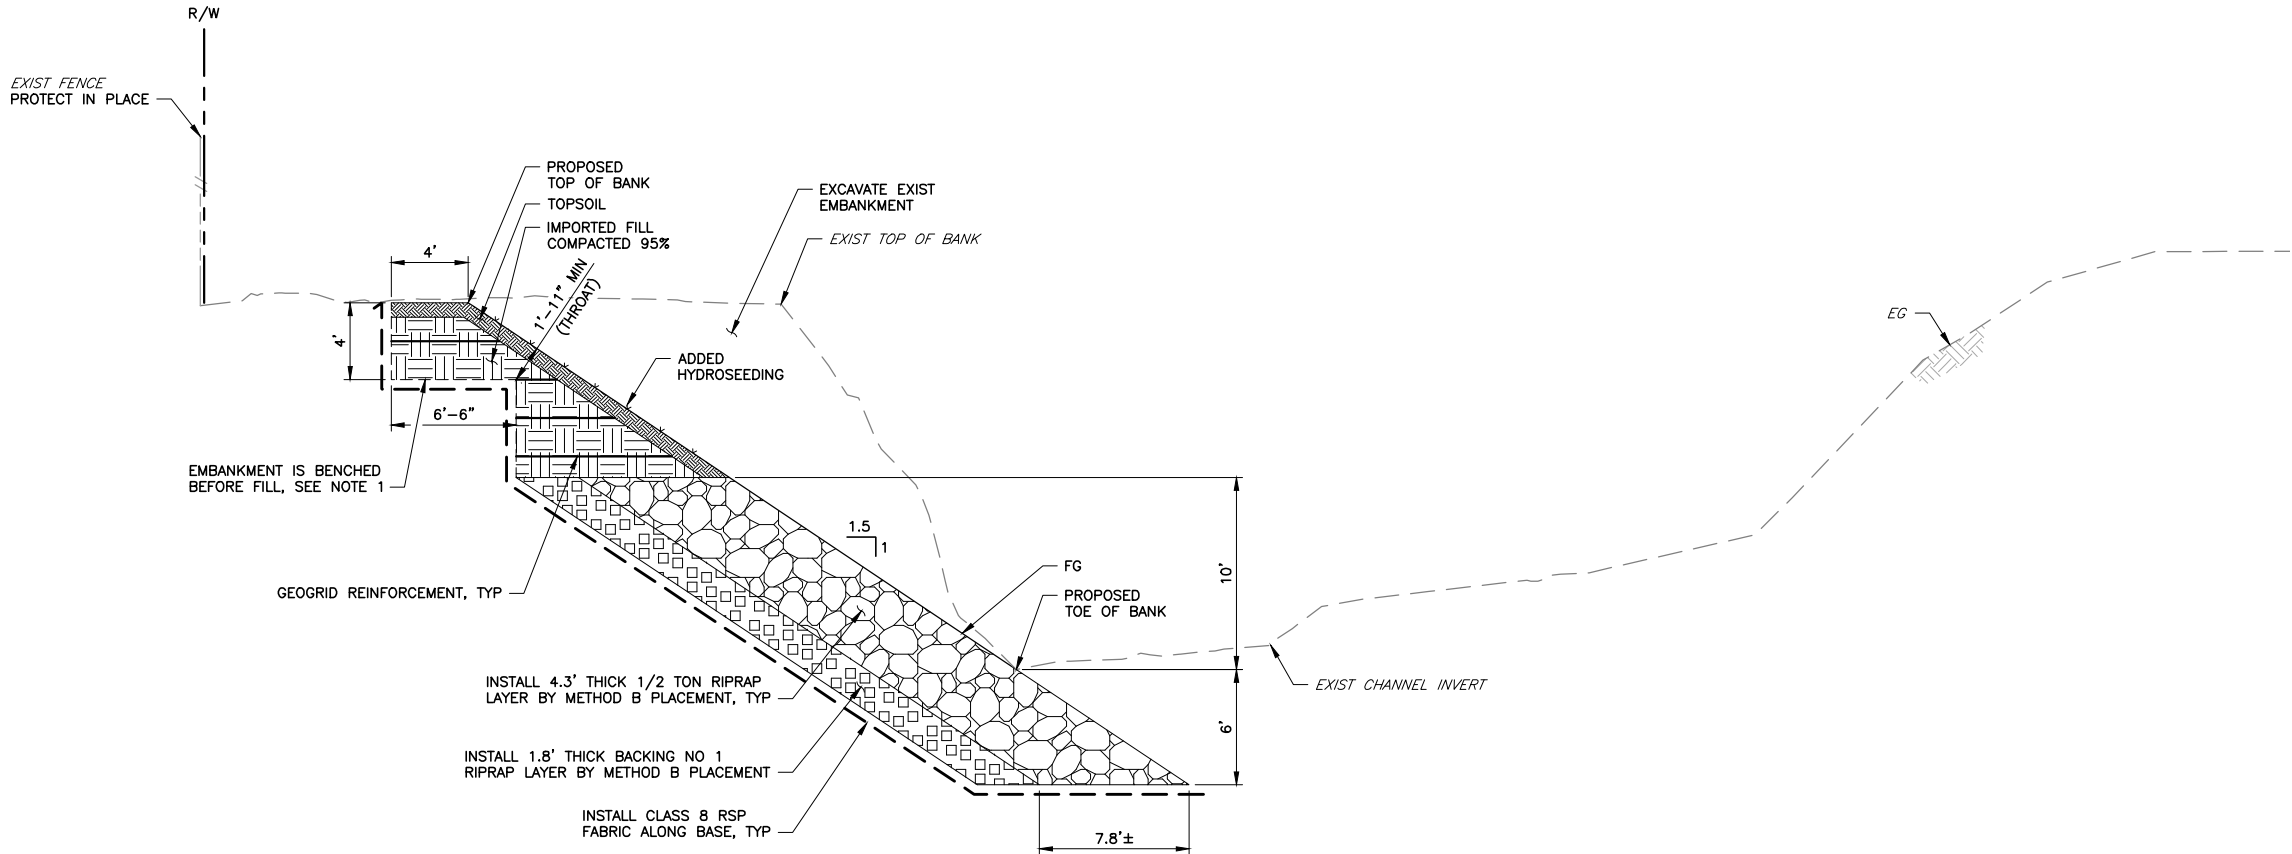
TYPICAL SECTION I SITE 6 CONSTRUCTION CONTROL LINE  
C-09 STA 36+31± TO STA 37+47±  
SCALE: 1" = 5'

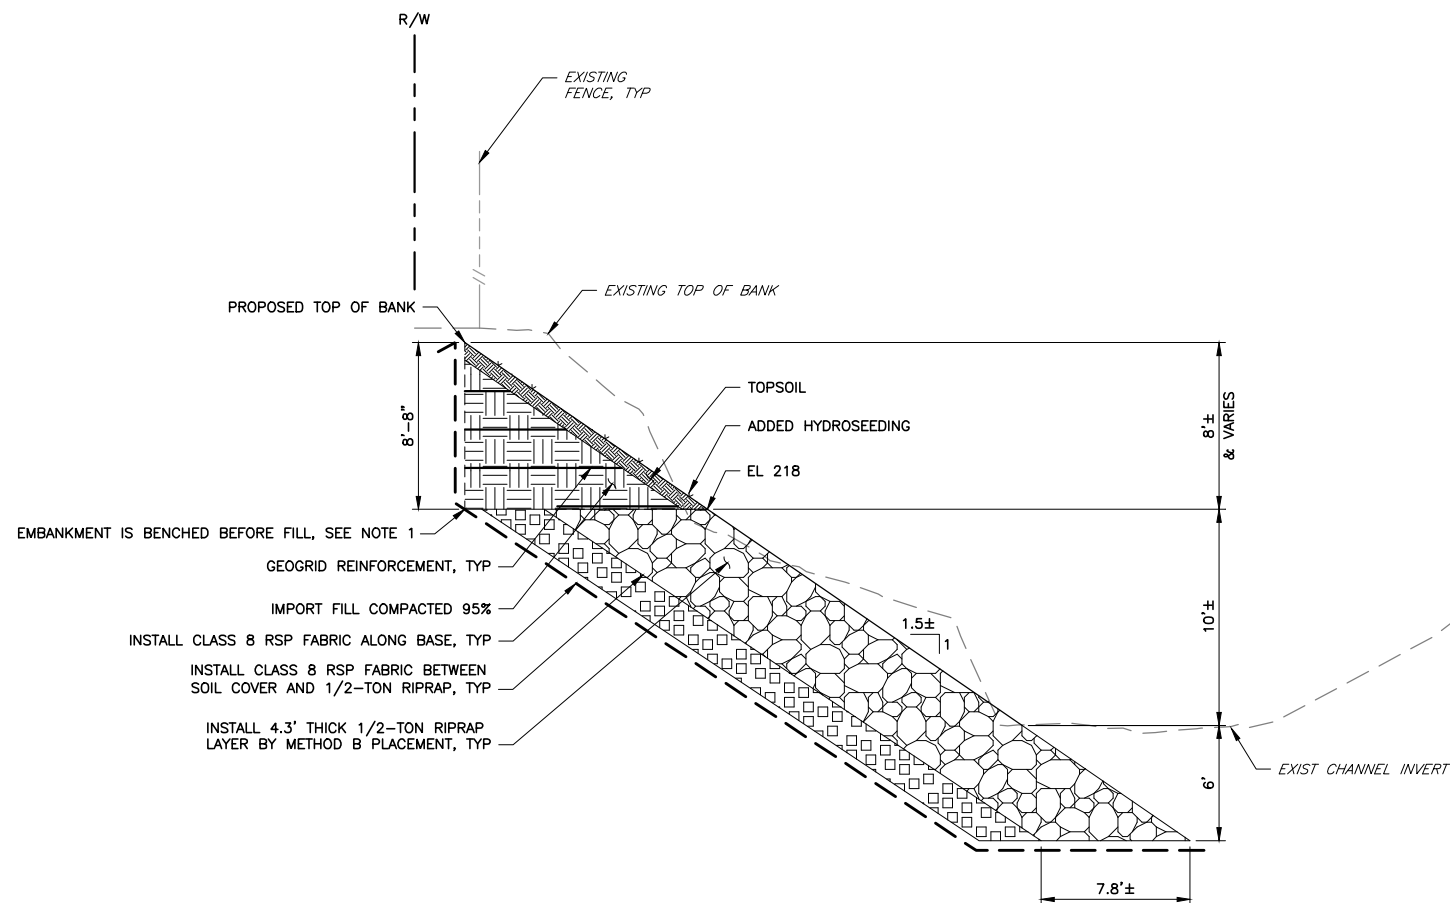
**TYPICAL SECTION**  **SITE 7 CONSTRUCTION CONTROL LINE**  
**STA 40+32± TO STA 41+14±**  
 SCALE: 1" = 5'

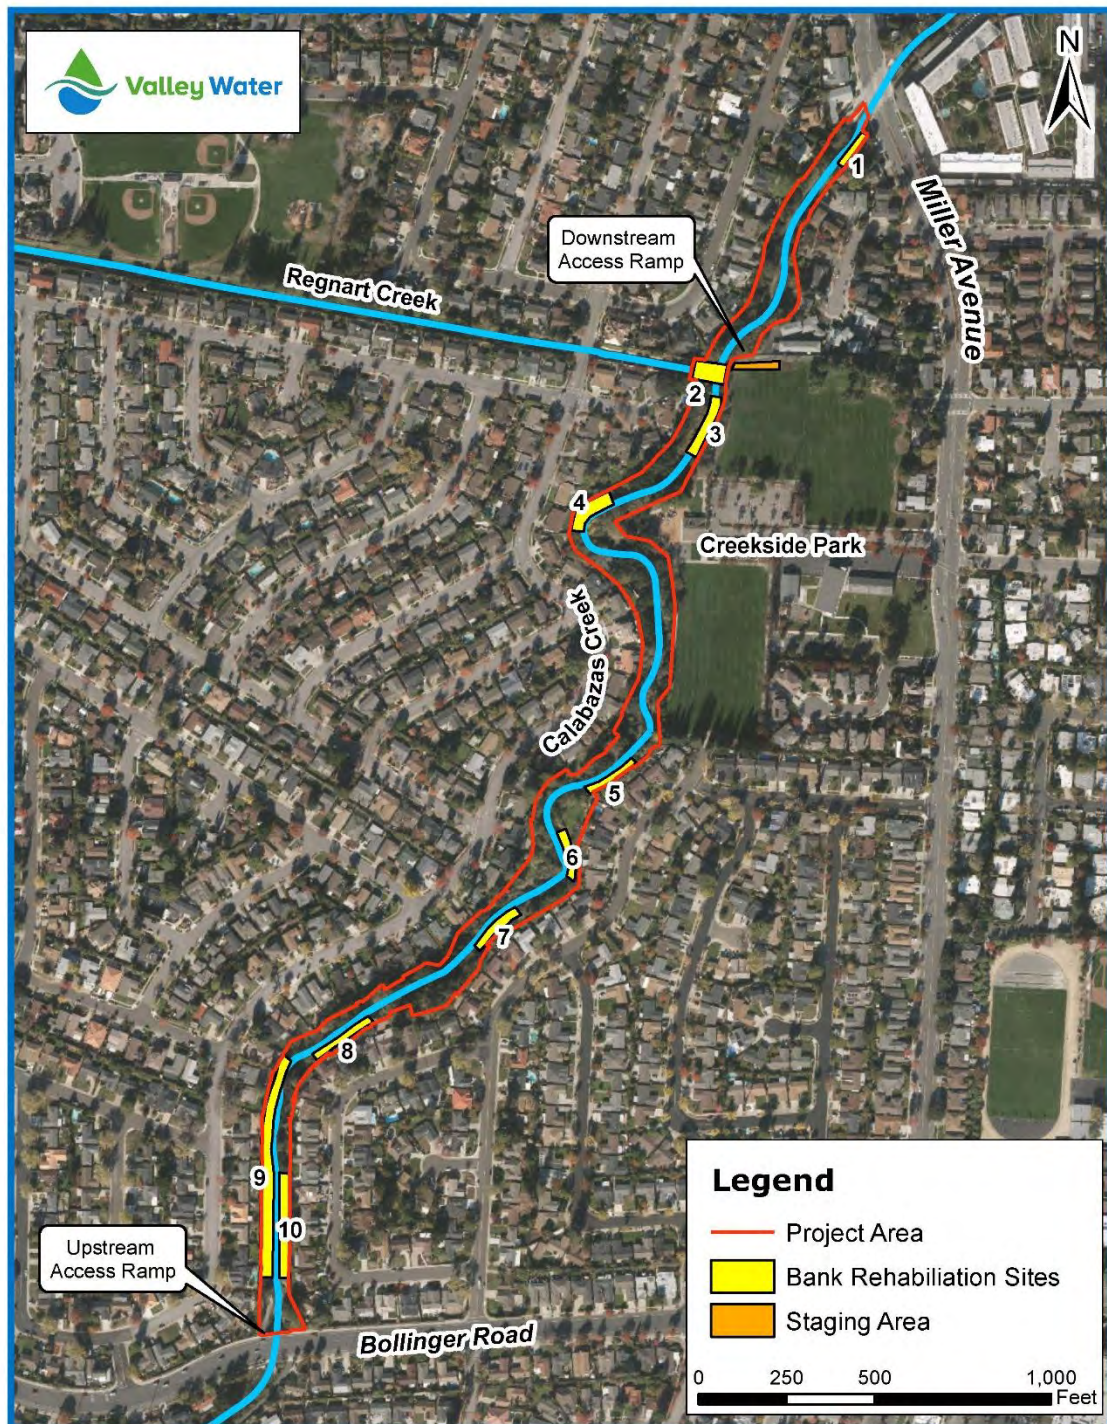
**Figure 2**  
Bank Rehabilitation Sites

**Figure 2** depicts the locations of the bank failure sites.

| Site No. | Bank Location | Proposed Repair | Length of Repair (LF) | Approx. Work Area(ft <sup>2</sup> ) | # Trees Removed |
|---|---|---|---|---|---|
| 1 | East Bank | Replace 25-foot section of eroded concreted half-ton riprap, extend this concreted riprap an additional 10 feet upstream, add 20 linear feet of erosion control blanket upstream to create an appropriate transition, and realign the low-flow channel to the center of the creek. | 55 | 575 | - |
| 2 | Confluence of Regnart - Calabazas Creek | Repair the eroding dirt embankment (on upstream end of confluence) with soil, compact, and hydroseed. Replace eroded portion of the existing concrete drop structure and place half-ton riprap in the scour hole that has formed where Regnart Creek discharges. | 60 | 750 | - |
| 5 | East Bank | Install sheet pile retaining wall about 2 feet in front of near-vertical failing bank. Backfill with clean fill behind the wall and compact. | 130 | 675 | - |
| 6 | East Bank | Repair erosion with half-ton riprap at 1.5:1 slope up to 10 feet above the channel and resurface the slope up to top of bank. | 120 | 3,200 | 3 |
| 7 | East Bank | Remove debris from landslide. Repair erosional feature with half-ton riprap at 1.5:1 slope up to 10 feet above the channel and resurface the slope up to top of bank. | 90 | 2,150 | 2 |
| 8 | East Bank | Install sheet pile retaining wall about 2 feet in front of vertical failing bank. Backfill with clean fill behind the wall and compact. | 165 | 3,000 | 5 |
| 9 | West Bank | Install sheet pile retaining wall to stabilize the failing bank (leaving existing soil and vegetation on the creek side of the wall). Excavate and regrade soil behind sheet pile wall at 1.5:1 slope to the top of proposed bank. Remove existing wooden log reinforcement and existing sewer line utility bridge and concrete abutments. | 565 | 8,500 | 14 |
| 10 | East Bank (overlaps with Site 9) | Install sheet pile retaining wall to stabilize the failing bank (leaving existing soil and vegetation on the creek side of the wall). Excavate and regrade soil behind sheet pile wall at 1.5:1 slope to the top of proposed bank. | 260 | 3,950 | 8 |

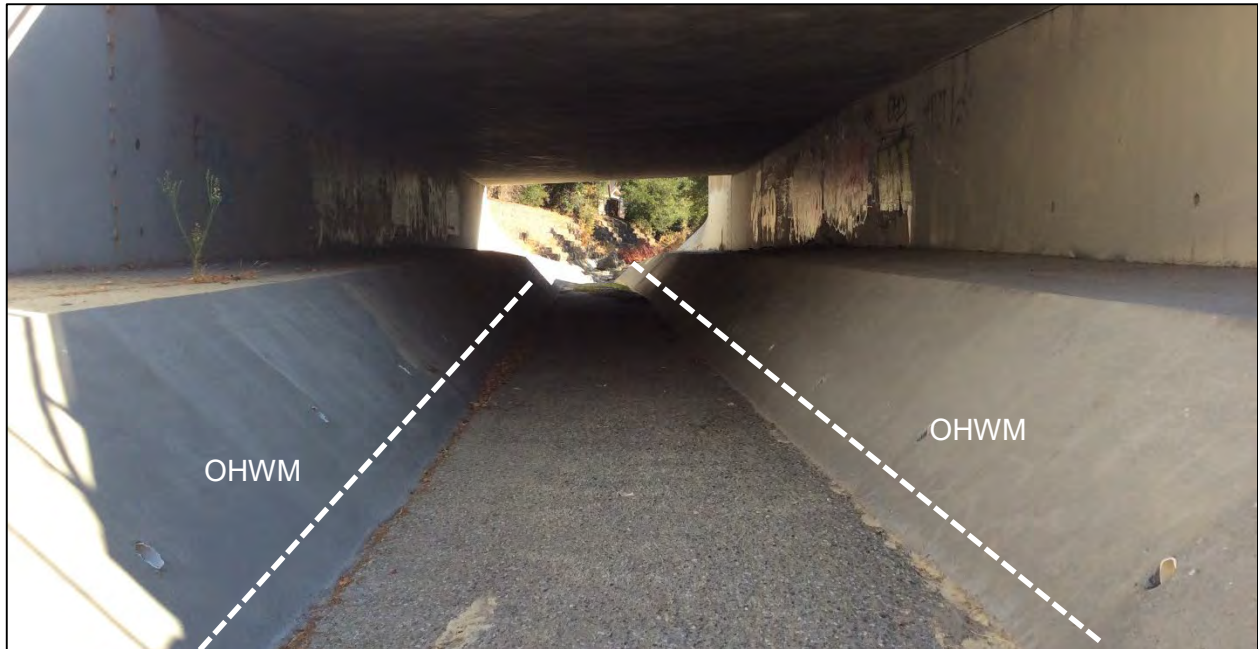
Photograph 1. Downstream (north-facing) view of Calabazas Creek channel (bottom of photo) at OHWM Transect 1. In this section, Calabazas Creek is contained by a cement channel flowing under Miller Avenue (top of photo). OHWM evident by water staining on cement banks.

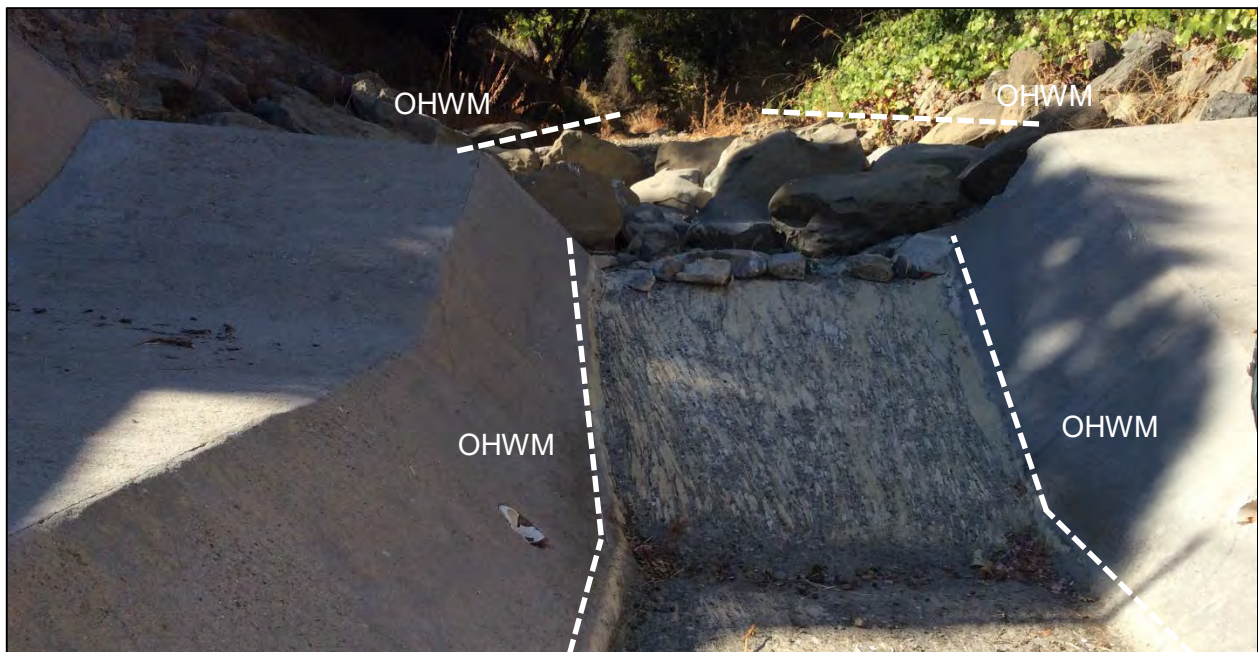
Photograph 2. Upstream (south-facing) view of Calabazas Creek channel just south of OHWM Transect 1. In this section, Calabazas Creek is contained by a cement channel flowing under Miller Avenue (top of photo). OHWM evident by water staining and algal mat in channel bed. Upstream in the earthen channel bed, change in vegetation cover is one of the OHWM indicators.

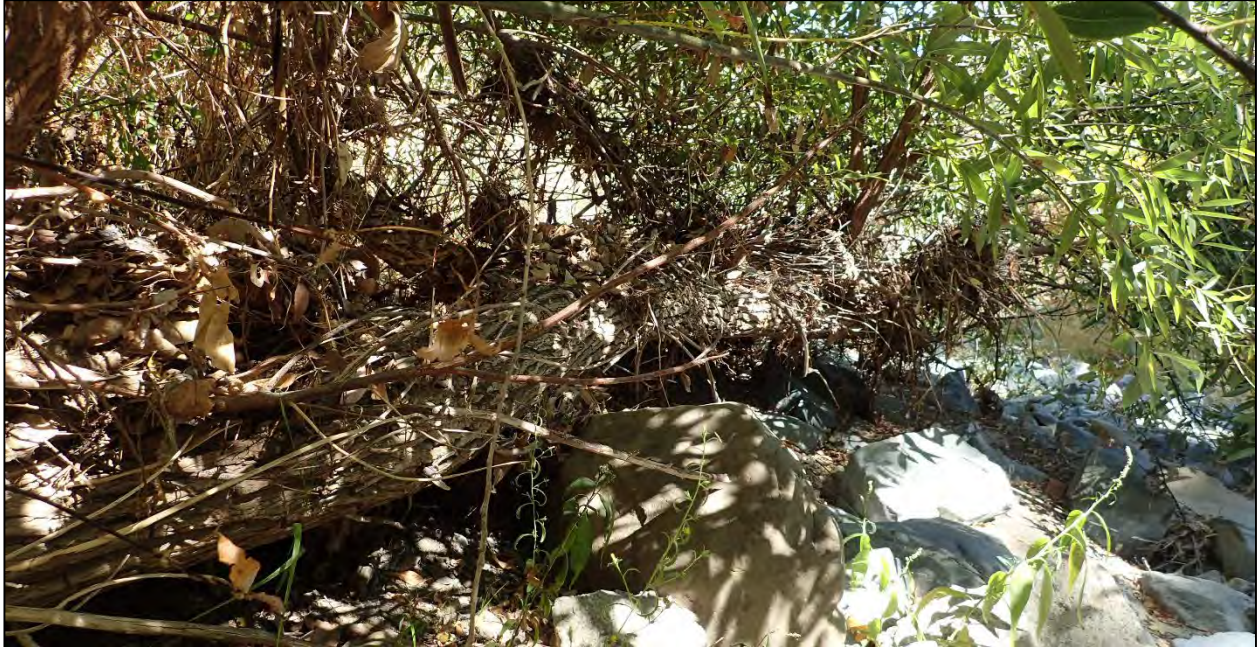
Photograph 3. West bank of Calabazas Creek at OHWM Transect 2, facing north. OHWM is evident under an overhanging willow (*Salix* sp.) by a change in wrack vegetation cover that corresponds to water staining on the east bank.

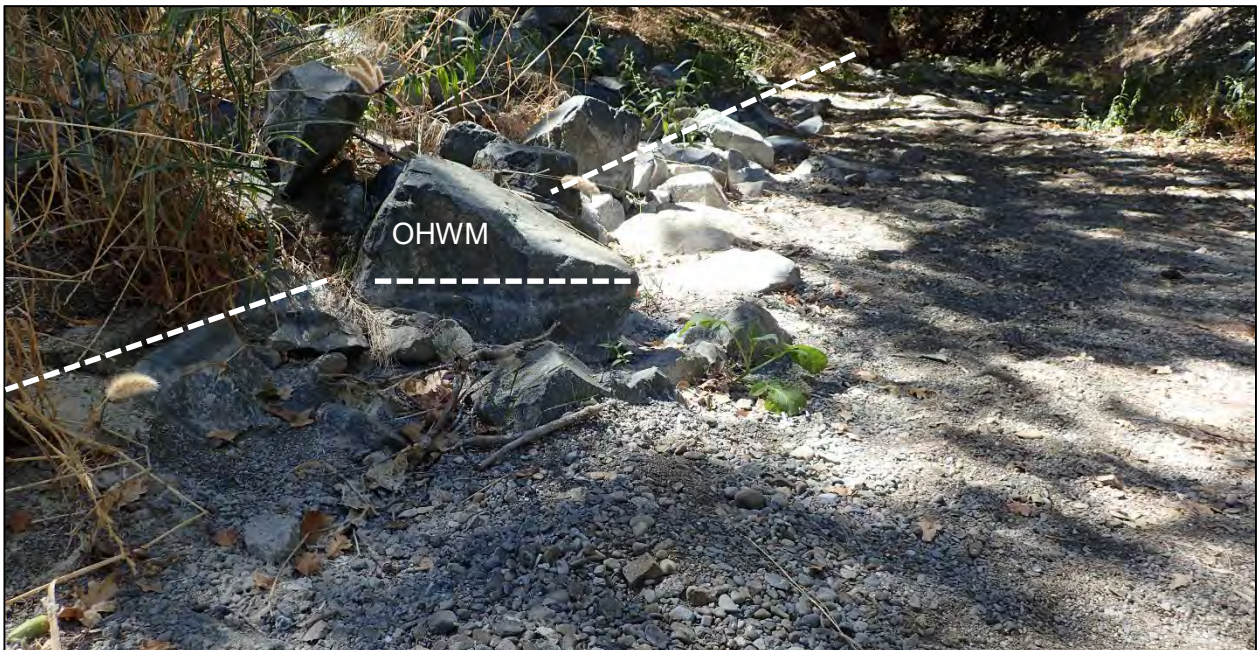
Photograph 4. East bank (facing south) of Calabazas Creek at OHWM Transect 2. OHWM is evident from a distinct water stain line on riprap placed along the bank. The sparsely vegetated gravel and coarse sand channel bed is covered in spots by a dried algal mat. Change in vegetation cover is apparent at the OHWM on the bank.

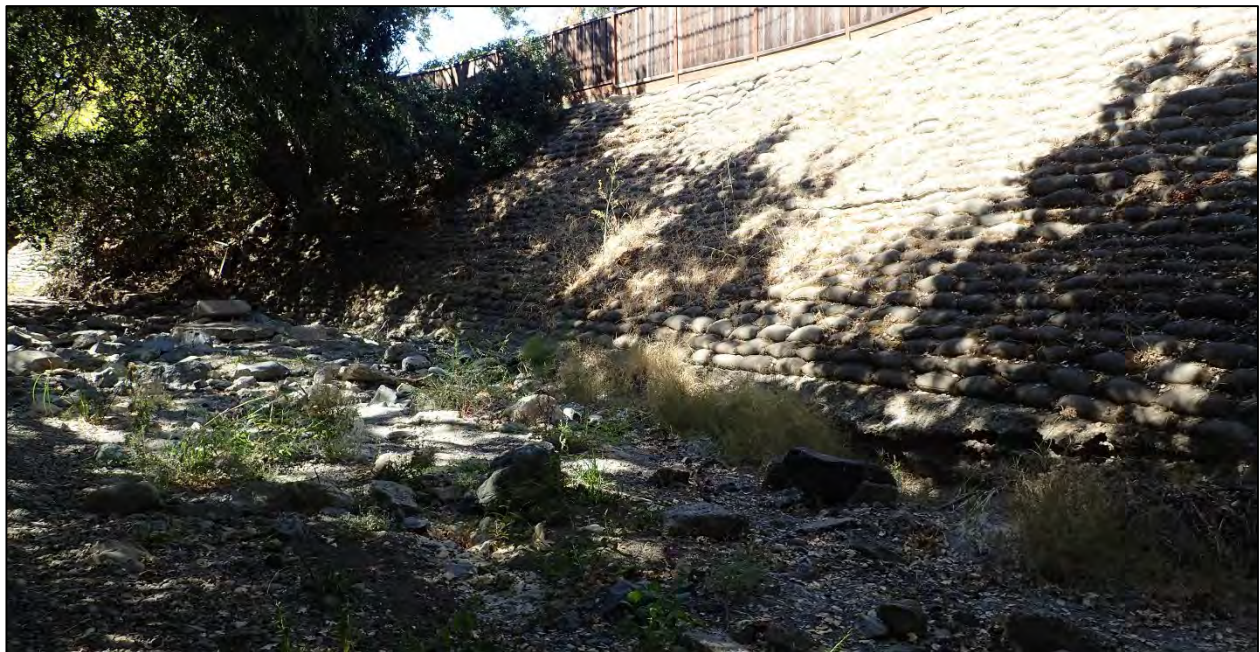
Photograph 6. Sack-crete wall stabilizing the west bank of Calabazas Creek south of OHWM Transect 2. Uninterrupted lines of residential fences (top) stretch along both sides of the creek just beyond the top of bank for the entirety of the survey area.

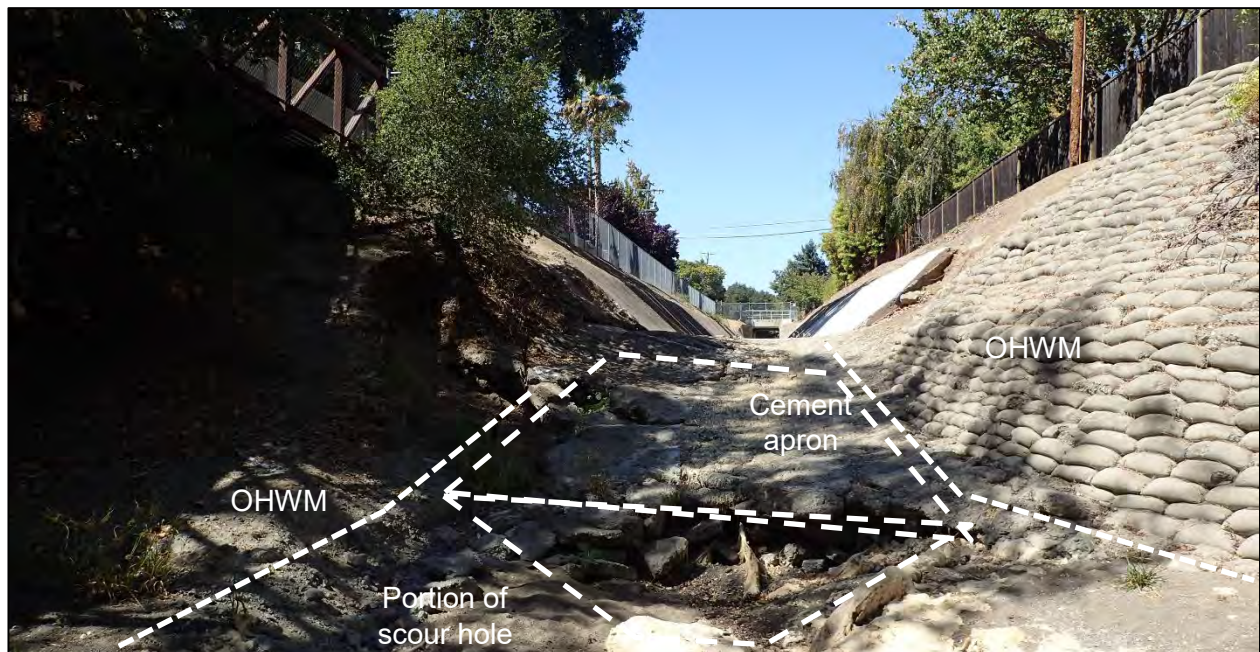
Photograph 8. The confluence of Regnart and Calabazas Creeks, viewed from Calabazas Creek facing west. At Regnart Creek, above the cement lined banks, bare earth banks rise to the top of bank. Regnart Creek is approximately eight feet higher than Calabazas Creek and a cement apron connects Regnart Creek to Calabazas Creek, below which a scour hole (bottom) has developed in the Calabazas Creek bed.

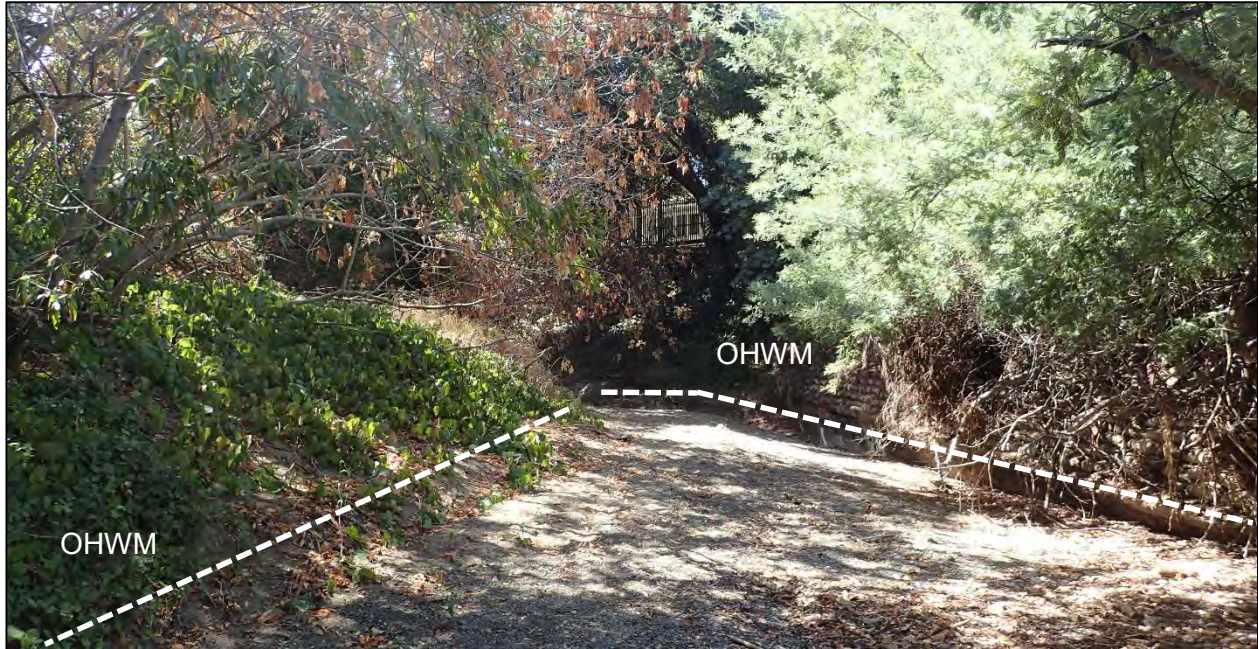
Photograph 11. Scour lines undercut a sack-crete lined bank indicating OHWM (right). On the opposite bank a break in bank slope and the change in vegetation cover marks the OHWM (left).

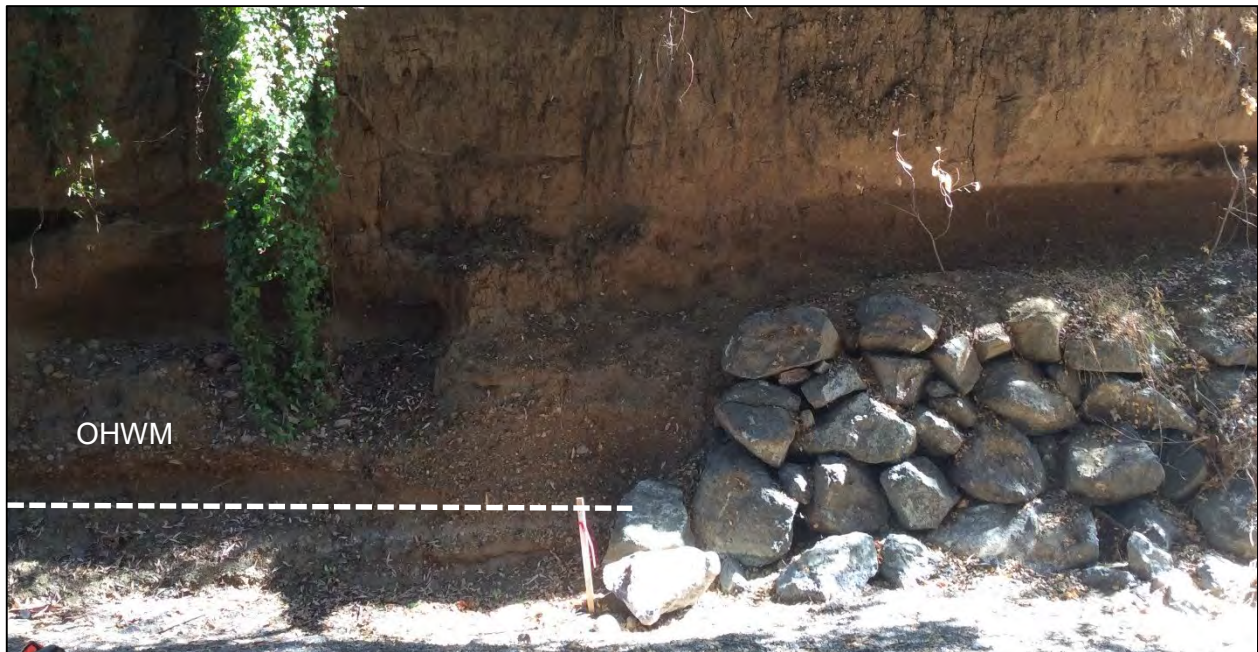
Photograph 12. An OHWM scour line (bottom left) along the steeply eroded east bank corresponds with the elevation of a break in bank slope on the opposite bank at OHMW Transect 4. Directly upstream is a reach of rock rip-rap bank stabilization.

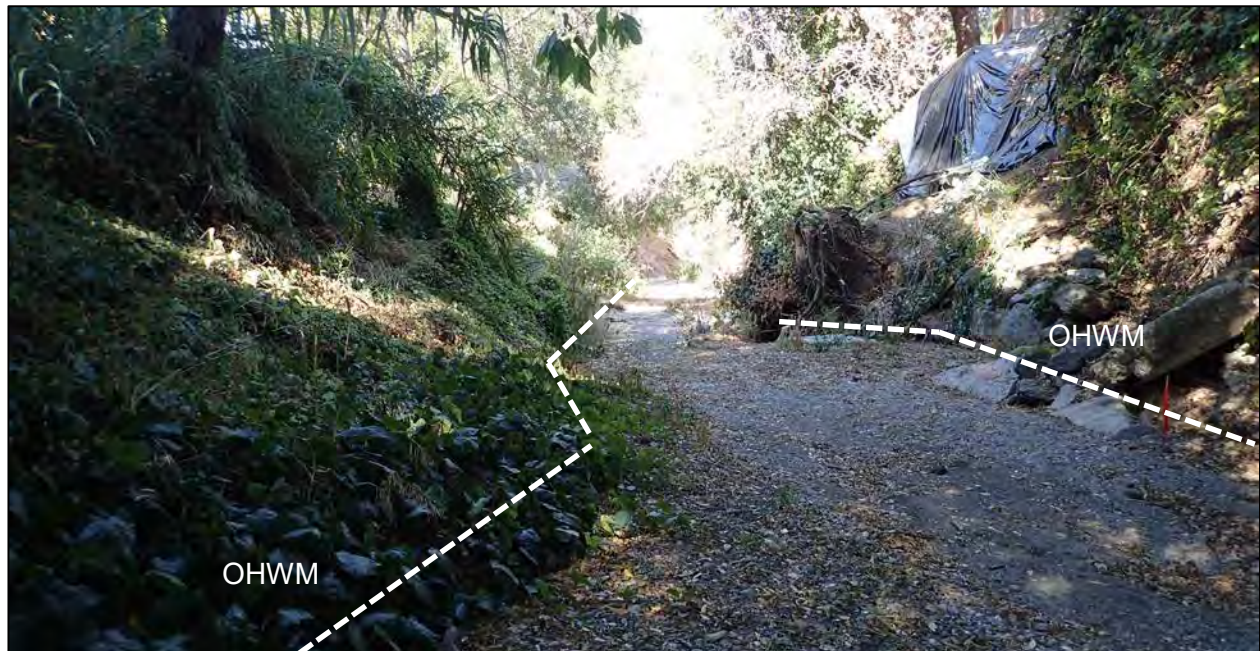
Photograph 13. An upstream (south-facing) view of Calabazas Creek at the location of a bank failure on the west bank. The collapse has narrowed the channel by approximately one foot in width. A scour hole has developed beneath the root system of the collapsed tree and the OHWM was measured on the west bank to the extent of the scouring.

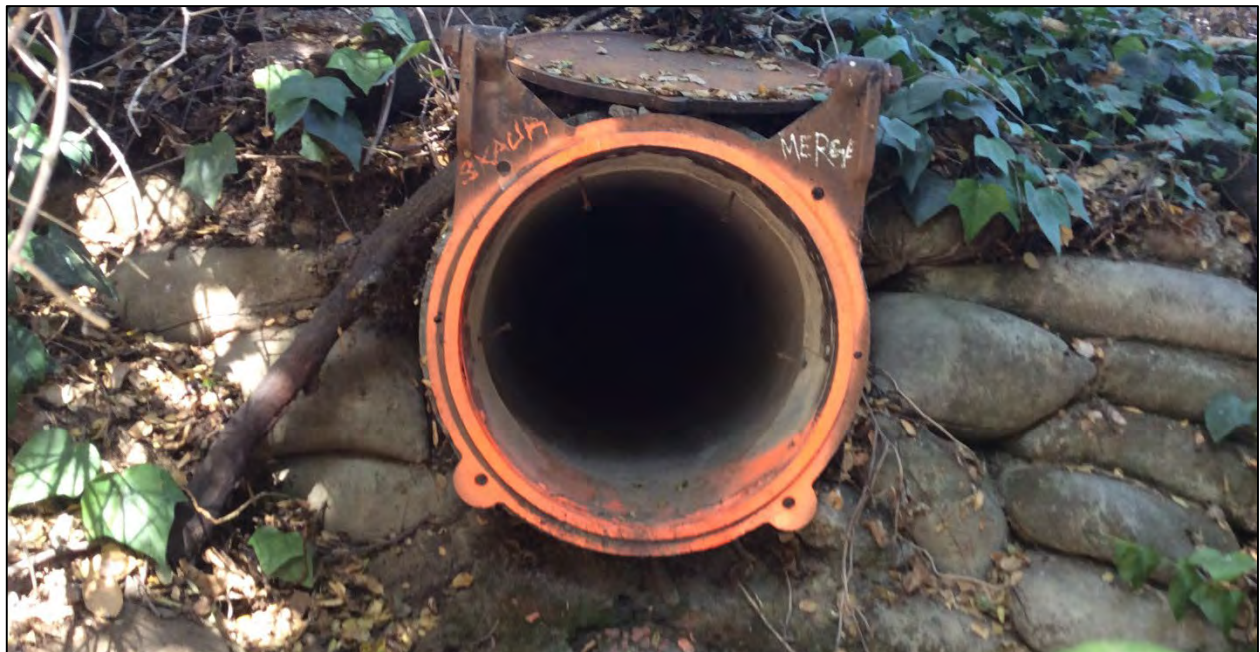
Photograph 14. A culvert outfall pipe (C3), embedded in a wall of sack-crete, empties from above the OHWM into Calabazas Creek.

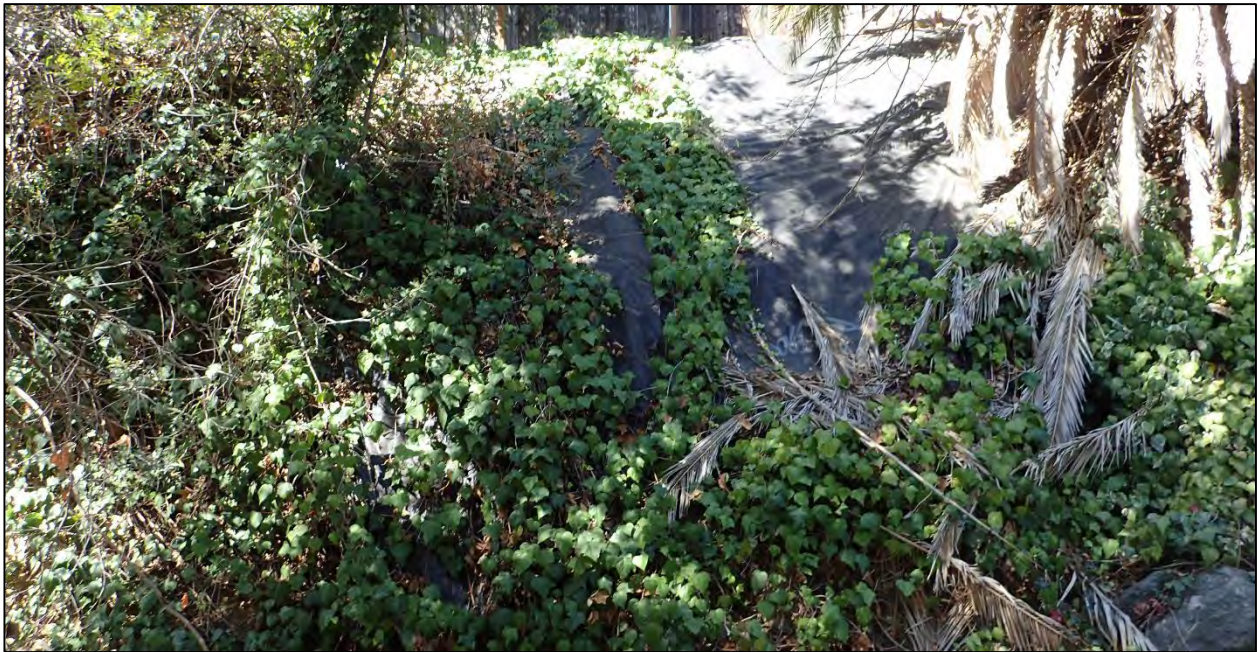
Photograph 18. A black tarp stabilizing riparian bank erosion on the west bank located at OHWM Transect 5.
