# CALABAZAS CREEK

# REHABILITATION PROJECT

MILLER AVENUE TO BOLLINGER ROAD  
CUPERTINO, CALIFORNIA

SANTA CLARA VALLEY WATER DISTRICT

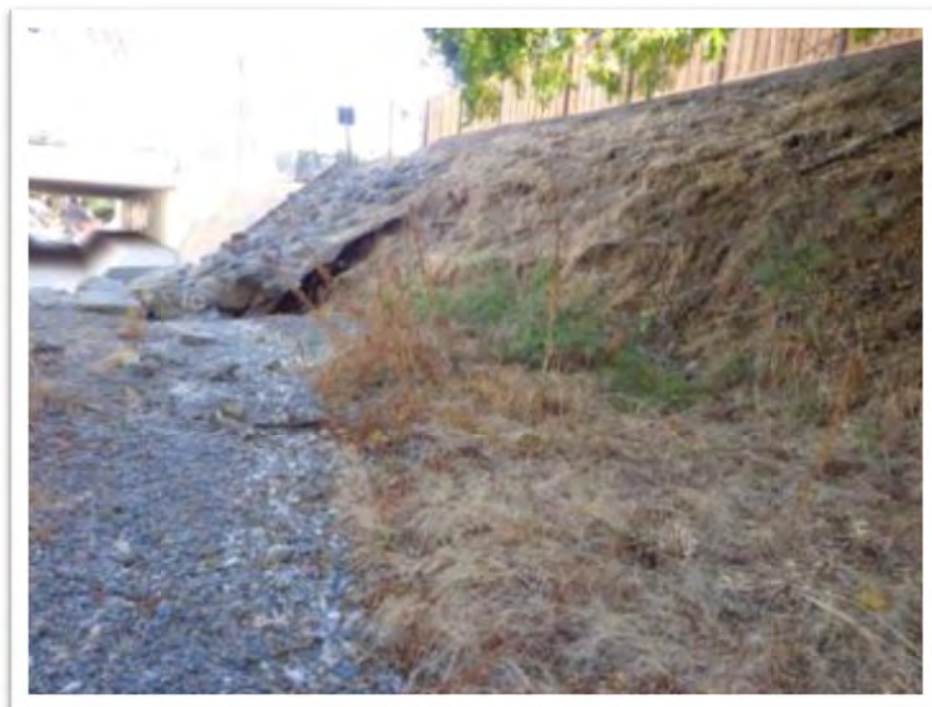
Overview of Area 1 showing undercut rip-rap on east bank.

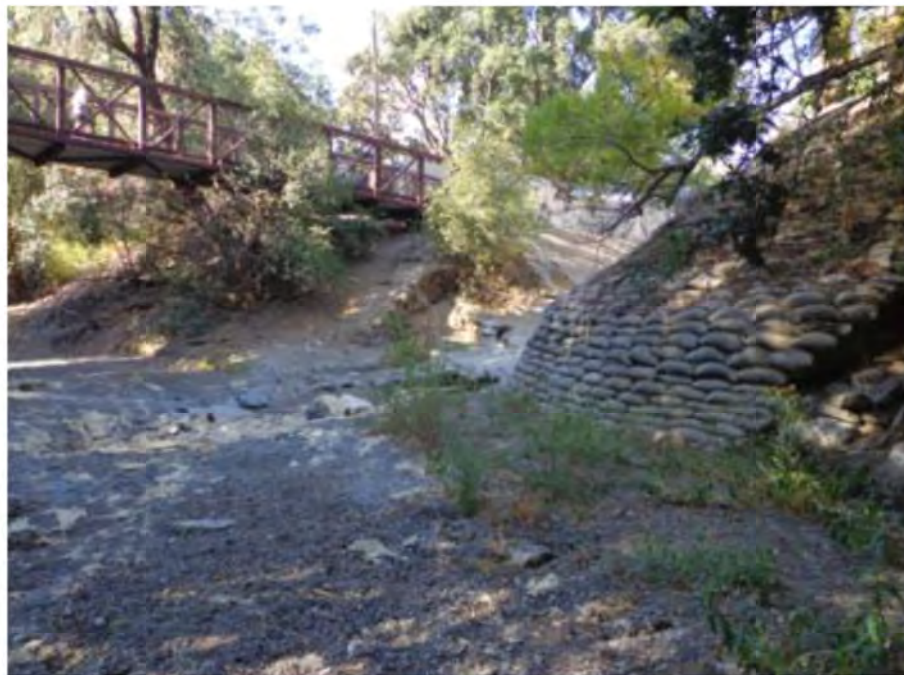
Overview of Area 2,  
west bank erosion at  
confluence with  
Regnart Creek.

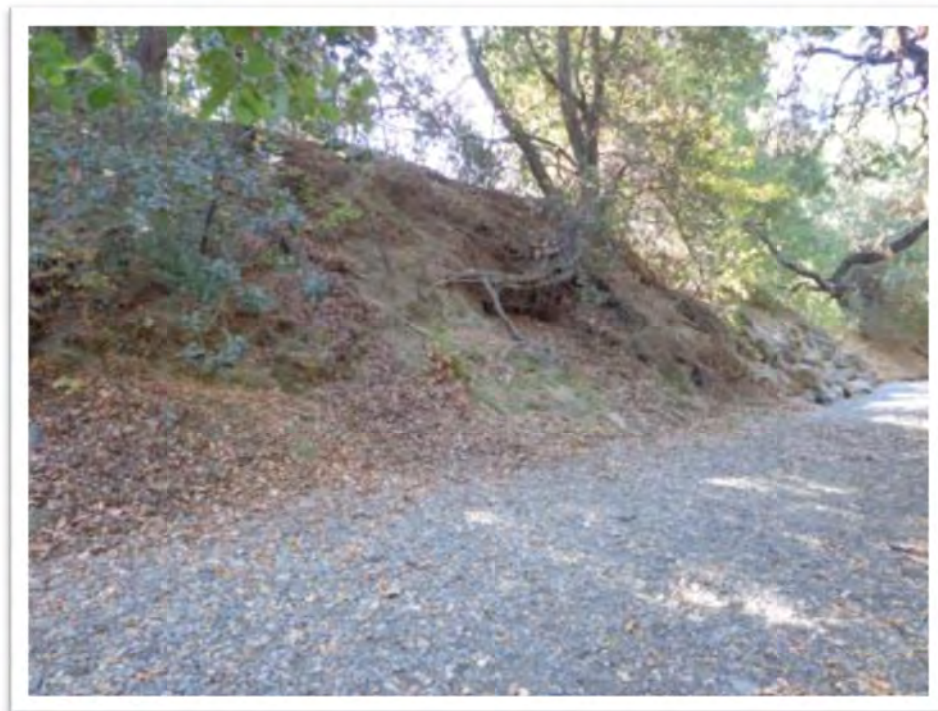
Overview of Area 3,  
tree root exposure  
on east bank.

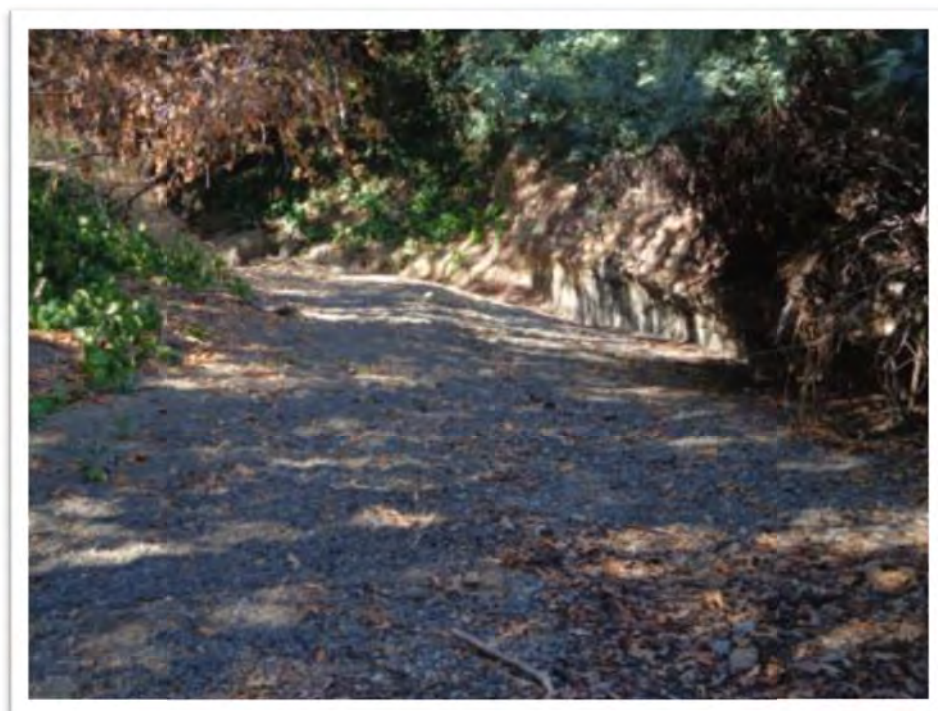
Overview of Area 4,  
undercut rip-rap on  
west bank.

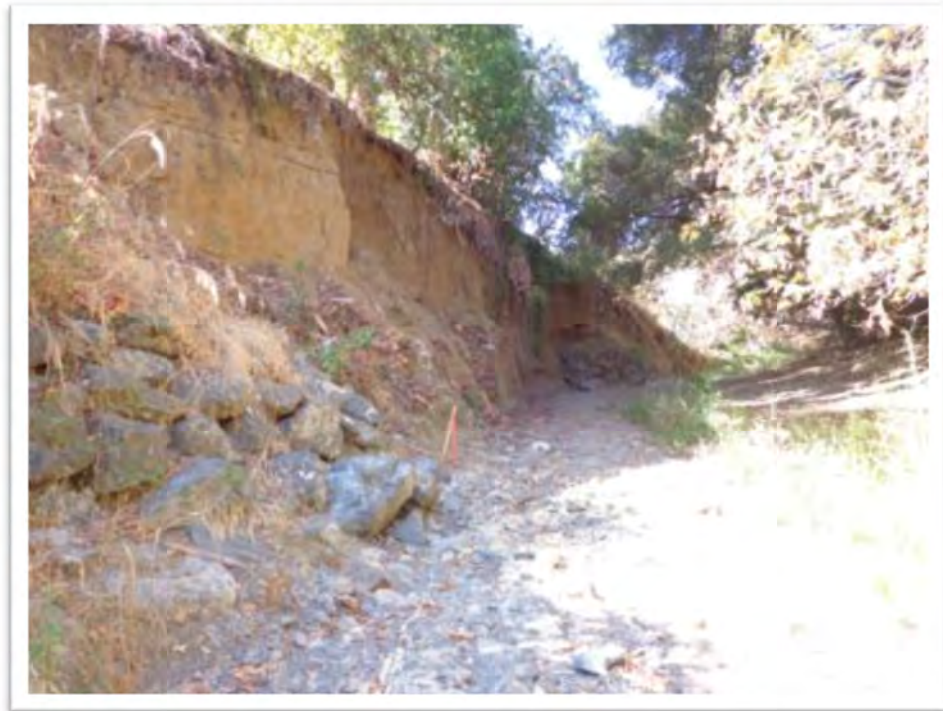
Overview of Area 5,  
eroding vertical east  
bank.

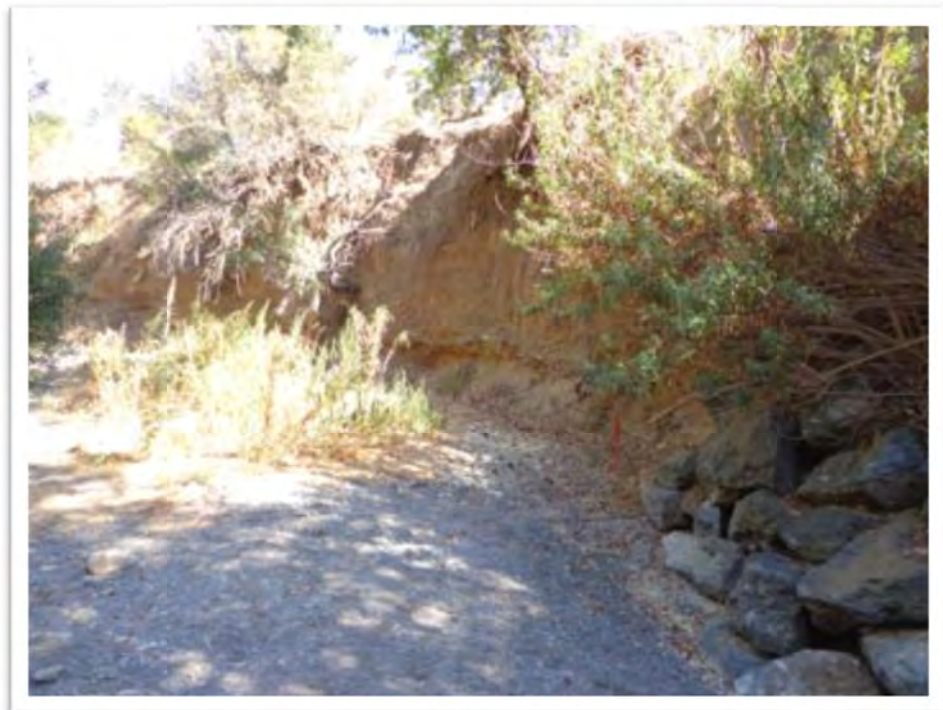
Overview of Area 6,  
eroding east bank.

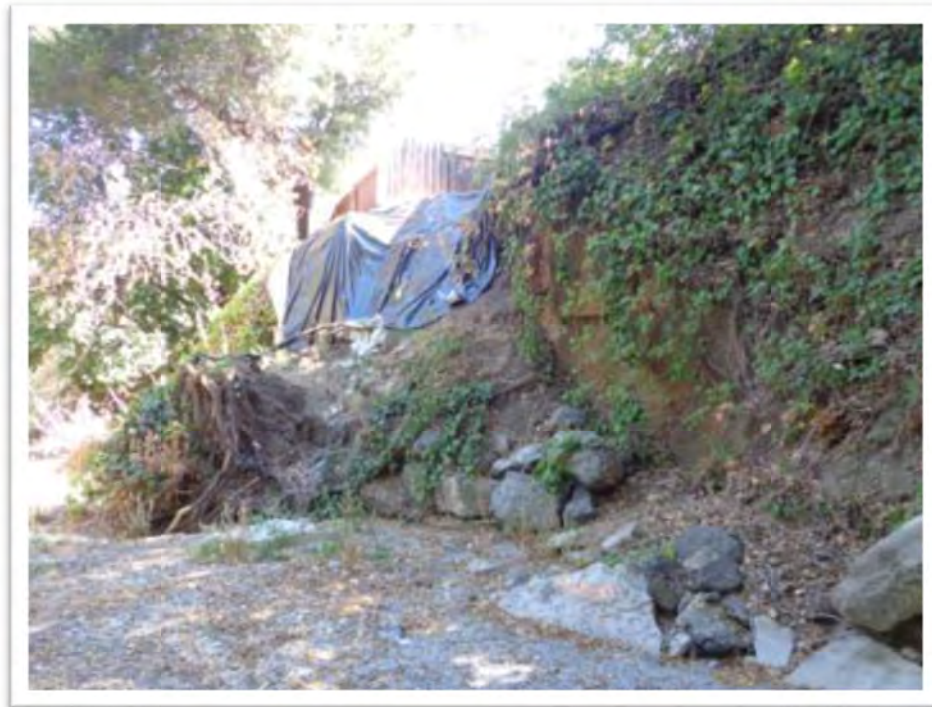
Overview of Area 7,  
east bank failure.

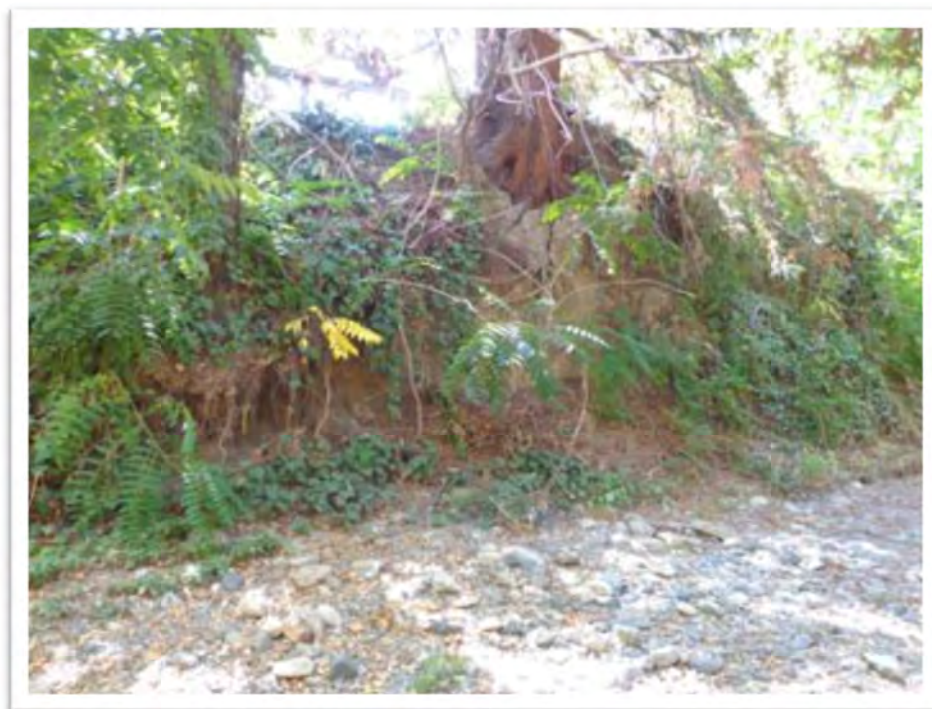
Overview of Area 8,  
east bank erosion.

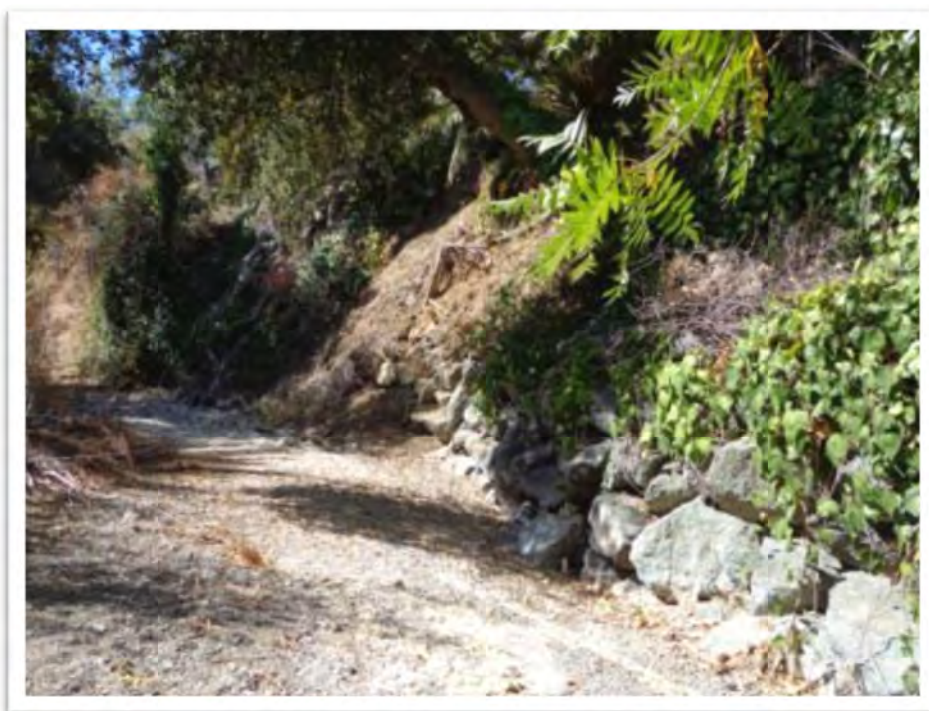
Overview of Area 9,  
west bank erosion.

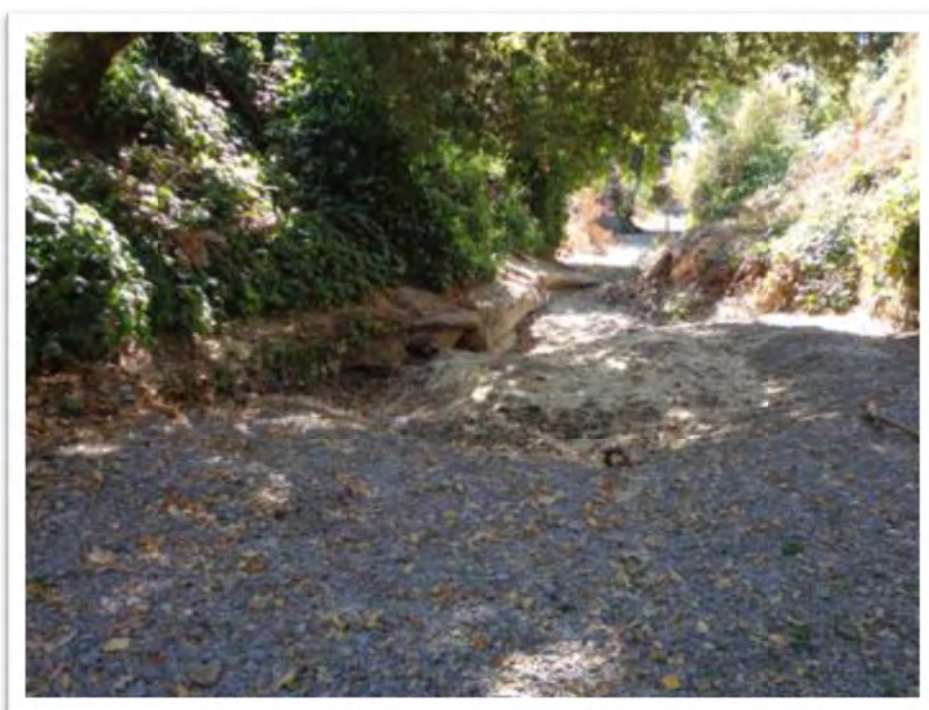
Overview of Area 10,  
east bank erosion at  
creek level.
