June 10, 2019

**Re: Water Resources Addendum to the Biological Resources Assessment for Four Cannabis Cultivation Project Sites in Santa Margarita, San Luis Obispo County**

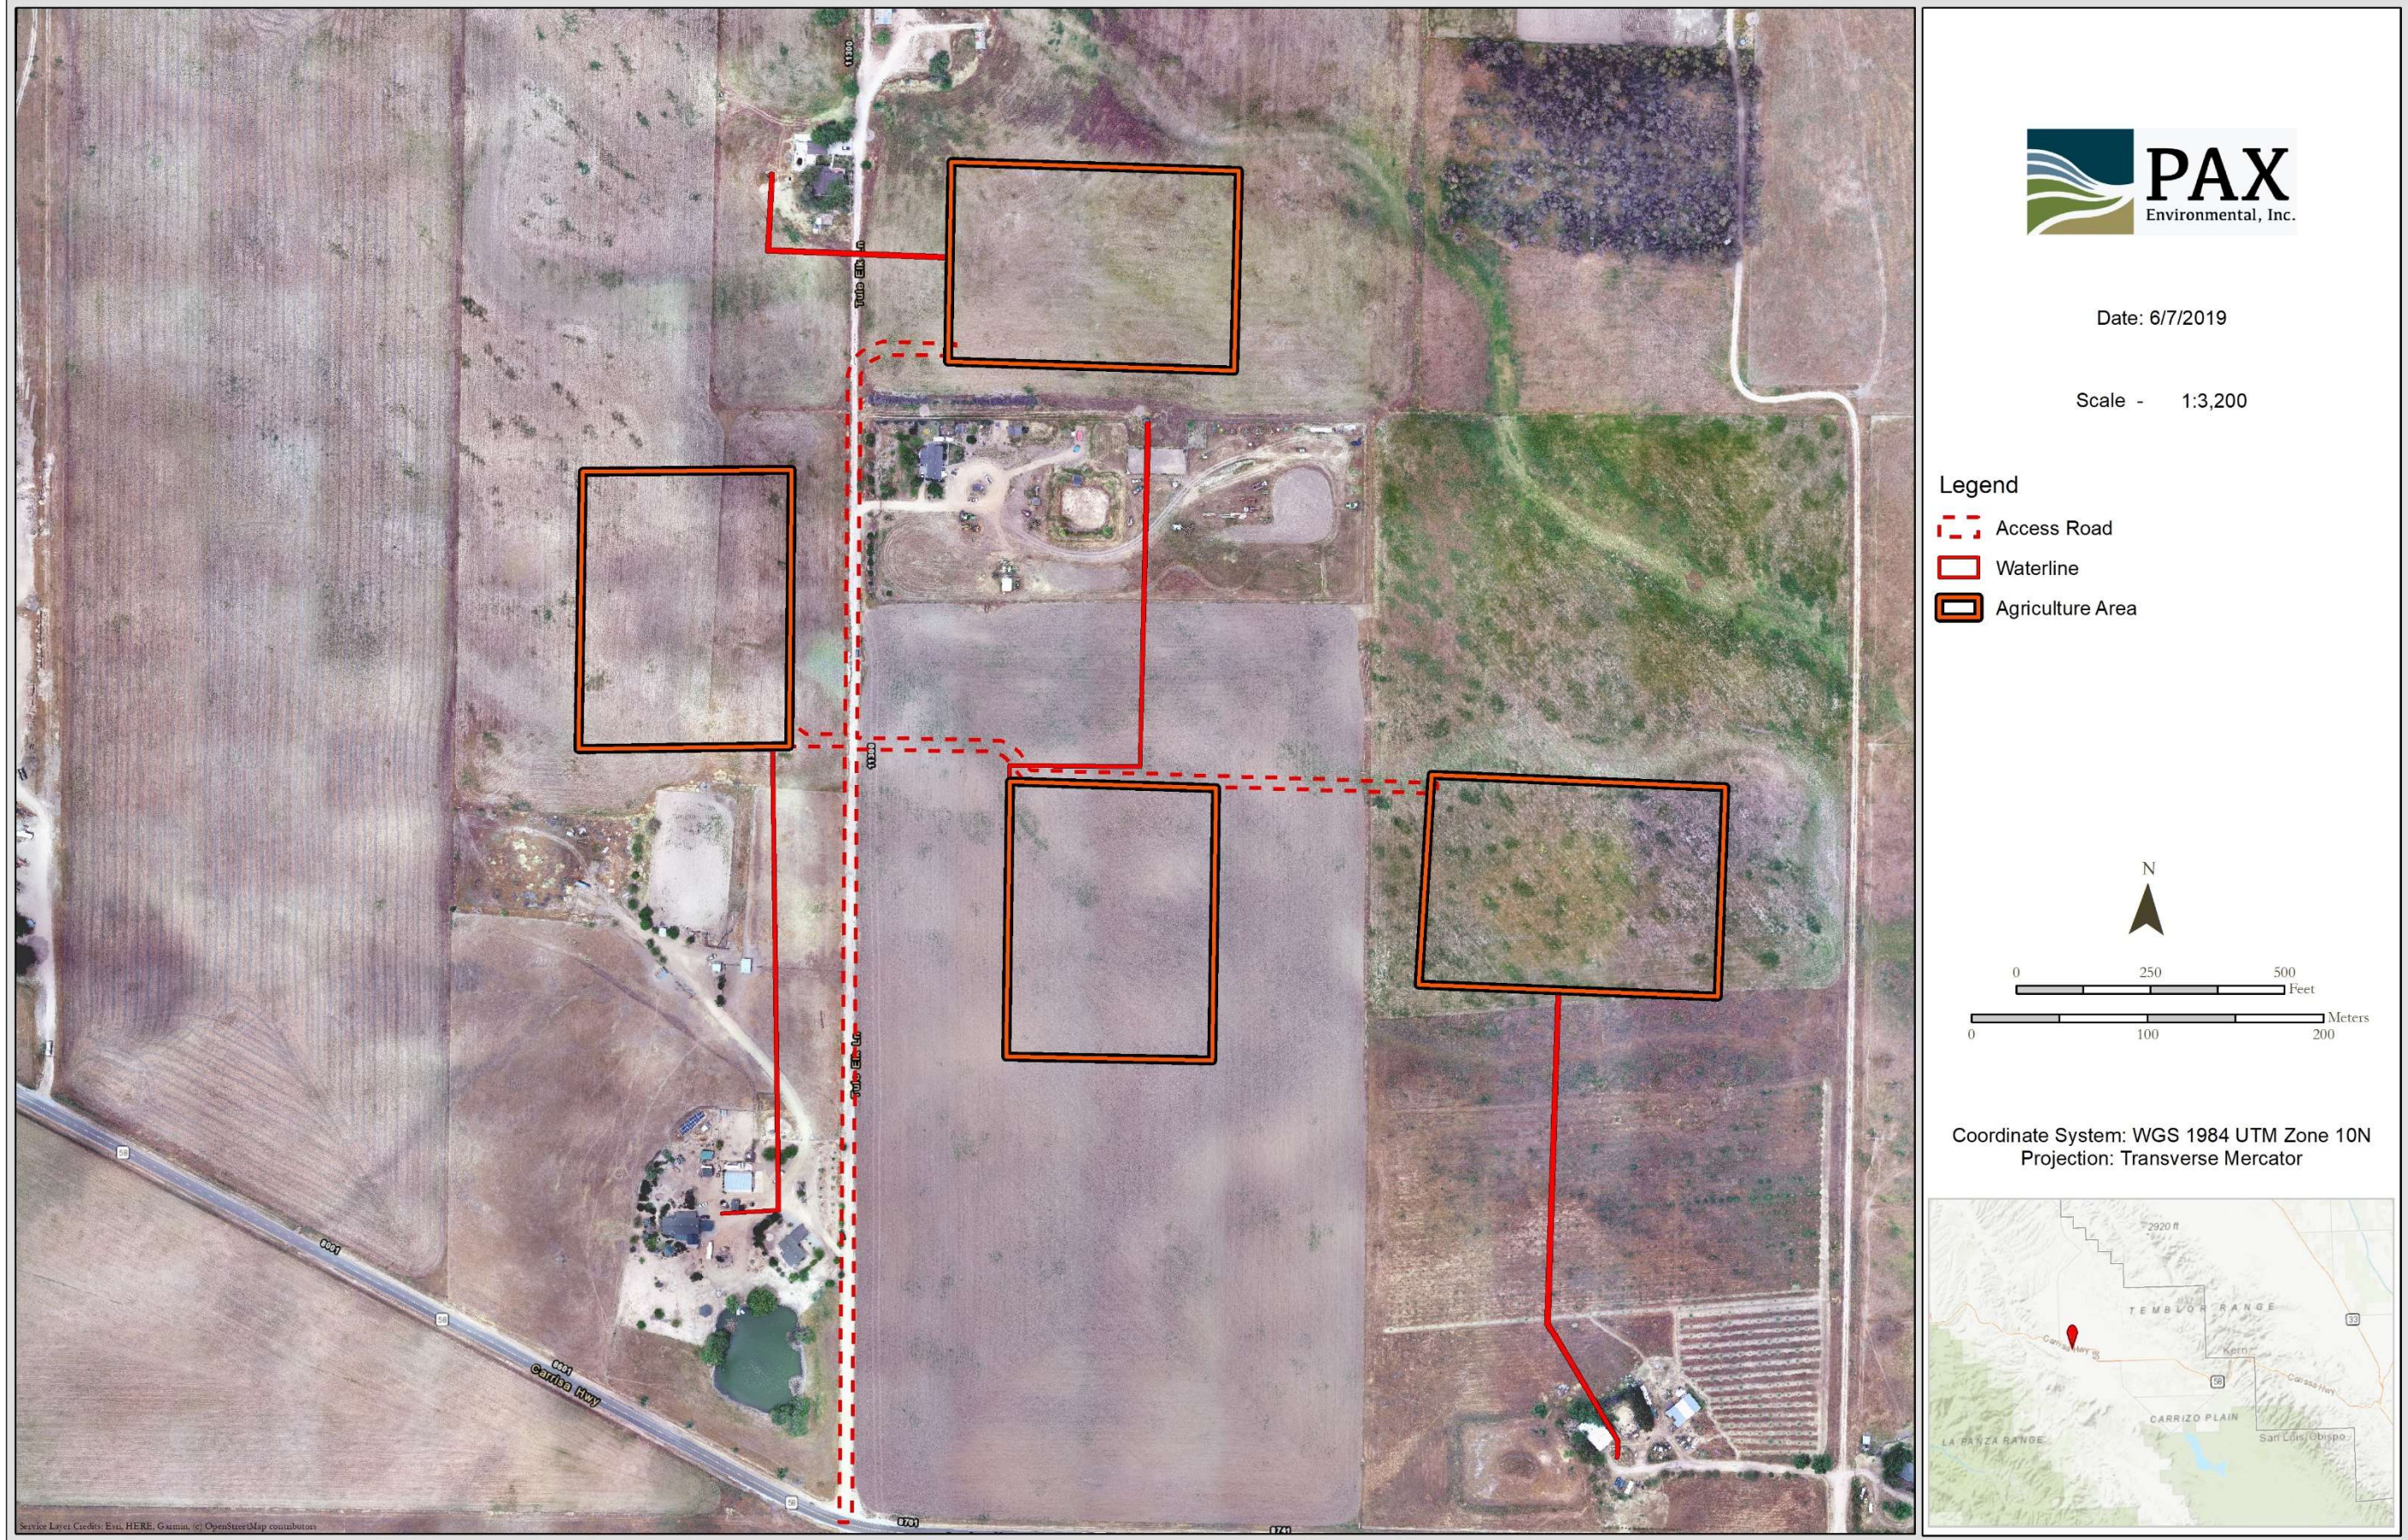
Figure 1. Drone aerial imagery with Project footprint.

Pax Environmental performed a drone flight of the Project site to obtain a high-resolution aerial image and three-dimensional topographic survey (Figures 1 & 2). The aerial was compared with historic aerial imagery, topographic maps, and online wetlands databases to identify wetland features and/or areas with evidence of water transport. Aerial imagery was evaluated in the context of antecedent moisture conditions as determined from rainfall records for the historic aerial timeframe. Sources used to identify waters on the project site include Google Earth imagery and topography (Digital Globe May 1994, September 1994, July 2003, July 2004, December 2004, August 2005, December 2005, August 2006, June 2009, September 2010, August 2011, March 2013, April 2015, October 2016, and September 2018), [www.historicaerials.com](http://www.historicaerials.com) (1964), National Wetlands Inventory (USFWS 2019), U.S. Geological Survey National Hydrography Dataset (USGS 2004), U.S. Department of Agriculture Soils Maps (USDA 2019), weather records from Cal Poly San Luis Obispo Irrigation Training and Research Center (ITRC 2019), and field surveys performed on December 15, 2018; January 4, 2019; and April 26, 2019.

One riverine feature (Feature 1, Figure 1) was identified in the northeastern portion of the study area and flows from northwest to southeast with the top of bank as close as 25 feet (ft) to the northeastern corner of the proposed perimeter fence at 11330 Tule Elk Lane. This drainage is the largest stream in the western Carrizo Valley and is tributary to Soda Lake, a closed endorheic basin. It is mapped as a blue-line stream by the U.S. Geological Survey (USGS) and classified in the National Wetlands Inventory (NWI) as R4SBC, a sparsely-vegetated, riverine system that is seasonally flooded with surface water for extended periods, especially early in the growing season, but is absent by the end of the growing season in most years. The water table after flooding ceases is variable in this classification, ranging from saturated soil to a water table well below the ground surface.

One depressional swale feature (Feature 2, Figure 1) was observed parallel to the south of the Feature 1 in the central portion of the study area. It is tributary to Feature 1 approximately 720 ft east of the Project site at 8710 Carissa Highway. Feature 2 is mapped and classified in the National Wetlands Inventory as PEM1A, a palustrine system characterized by surface water for brief periods (from a few days to a few weeks) during the growing season and a water table that lies well below the ground surface for most of the season. This feature has some areas of discernible OHWM, as well as bed and bank on aerials, but the course is not entirely consistent with NWI mapping and portions are not consistently discernible on historic aerials. OHWM is discernible in areas proximate to the 11330 Tule Elk Lane Project site from 1994, 2006, and 2010 aerials; and areas proximate to the 8710 Carissa Highway Project site from 1994, 2004, 2005, 2010, 2011, 2013, 2015 and 2016.

Three closed depressional wetlands with diameters ranging from 80 to 130 ft were observed in the western extent of the study area adjacent to the west of 11525 Tule Elk Lane (Feature 3, Figure 1). Feature 3 is not mapped or classified in the NWI but is evident from aerials dating back to 1964. Although there was no standing water present at the time of the field investigation, there was evidence that standing water had been present in recent weeks, including cracked surface soils, discernible OHWM, hydric soils as evidenced by oxidized rhizospheres in the upper twelve inches, and the presence of facultative wetland plants, including woolly marbles (*Psilocarpus brevissimus*), valley pineapple weed (*Matricaria occidentalis*), and popcornflower (*Plagiobothrys stipitatus*). Hydric soils were mostly dry to 12 in during an above-average rainfall year, suggesting a brief hydroperiod following rain events and a water table typically well below the ground surface. Based on field conditions, these wetlands have a lack of prevailing or annual surface water with aperiodic input by storm events that percolates into the underlying soil. Approximately 1,715 ft<sup>2</sup> of Feature 3 is within the impact footprint for 11520 Tule Elk Lane.

There are non-wetland depressions throughout the 11520 and 11525 Tule Elk Way project sites that are inconsistently represented on aerial imagery (Feature 4, Figure 1). None of these depressions are mapped or classified in the NWI. During field investigation, these depressions were not discernible within the Project boundaries but were more readily discerned in the study area to the southwest of the 11520 Tule Elk Way Project boundary. No ordinary high-water marks (OHWM) or bed and bank were observed. No facultative wetland species, surface moisture, or evidence of discharge were observed. Test pits did not reveal hydric soils in an above-average rainy season, suggesting a very brief hydroperiod during and following rain events, and a water table typically well below the ground surface. Based on field conditions, these depressions have a lack of prevailing or annual surface water with aperiodic input by storm events that percolates into the underlying soil. During percolation and evaporation, fine sediments transported to these areas may settle and leave a residue, or the slightly prolonged saturation results in a longer flowering period for non-wetland plants that is inconsistently evident on aerials. It is anticipated that Feature 4 is not subject to the jurisdiction of the ACOE or CDFW. Approximately 1.9 acres of Feature 4 is within the proposed impact areas for 11520 and 11525 Tule Elk Lane and 8710 Carissa Highway Project site.

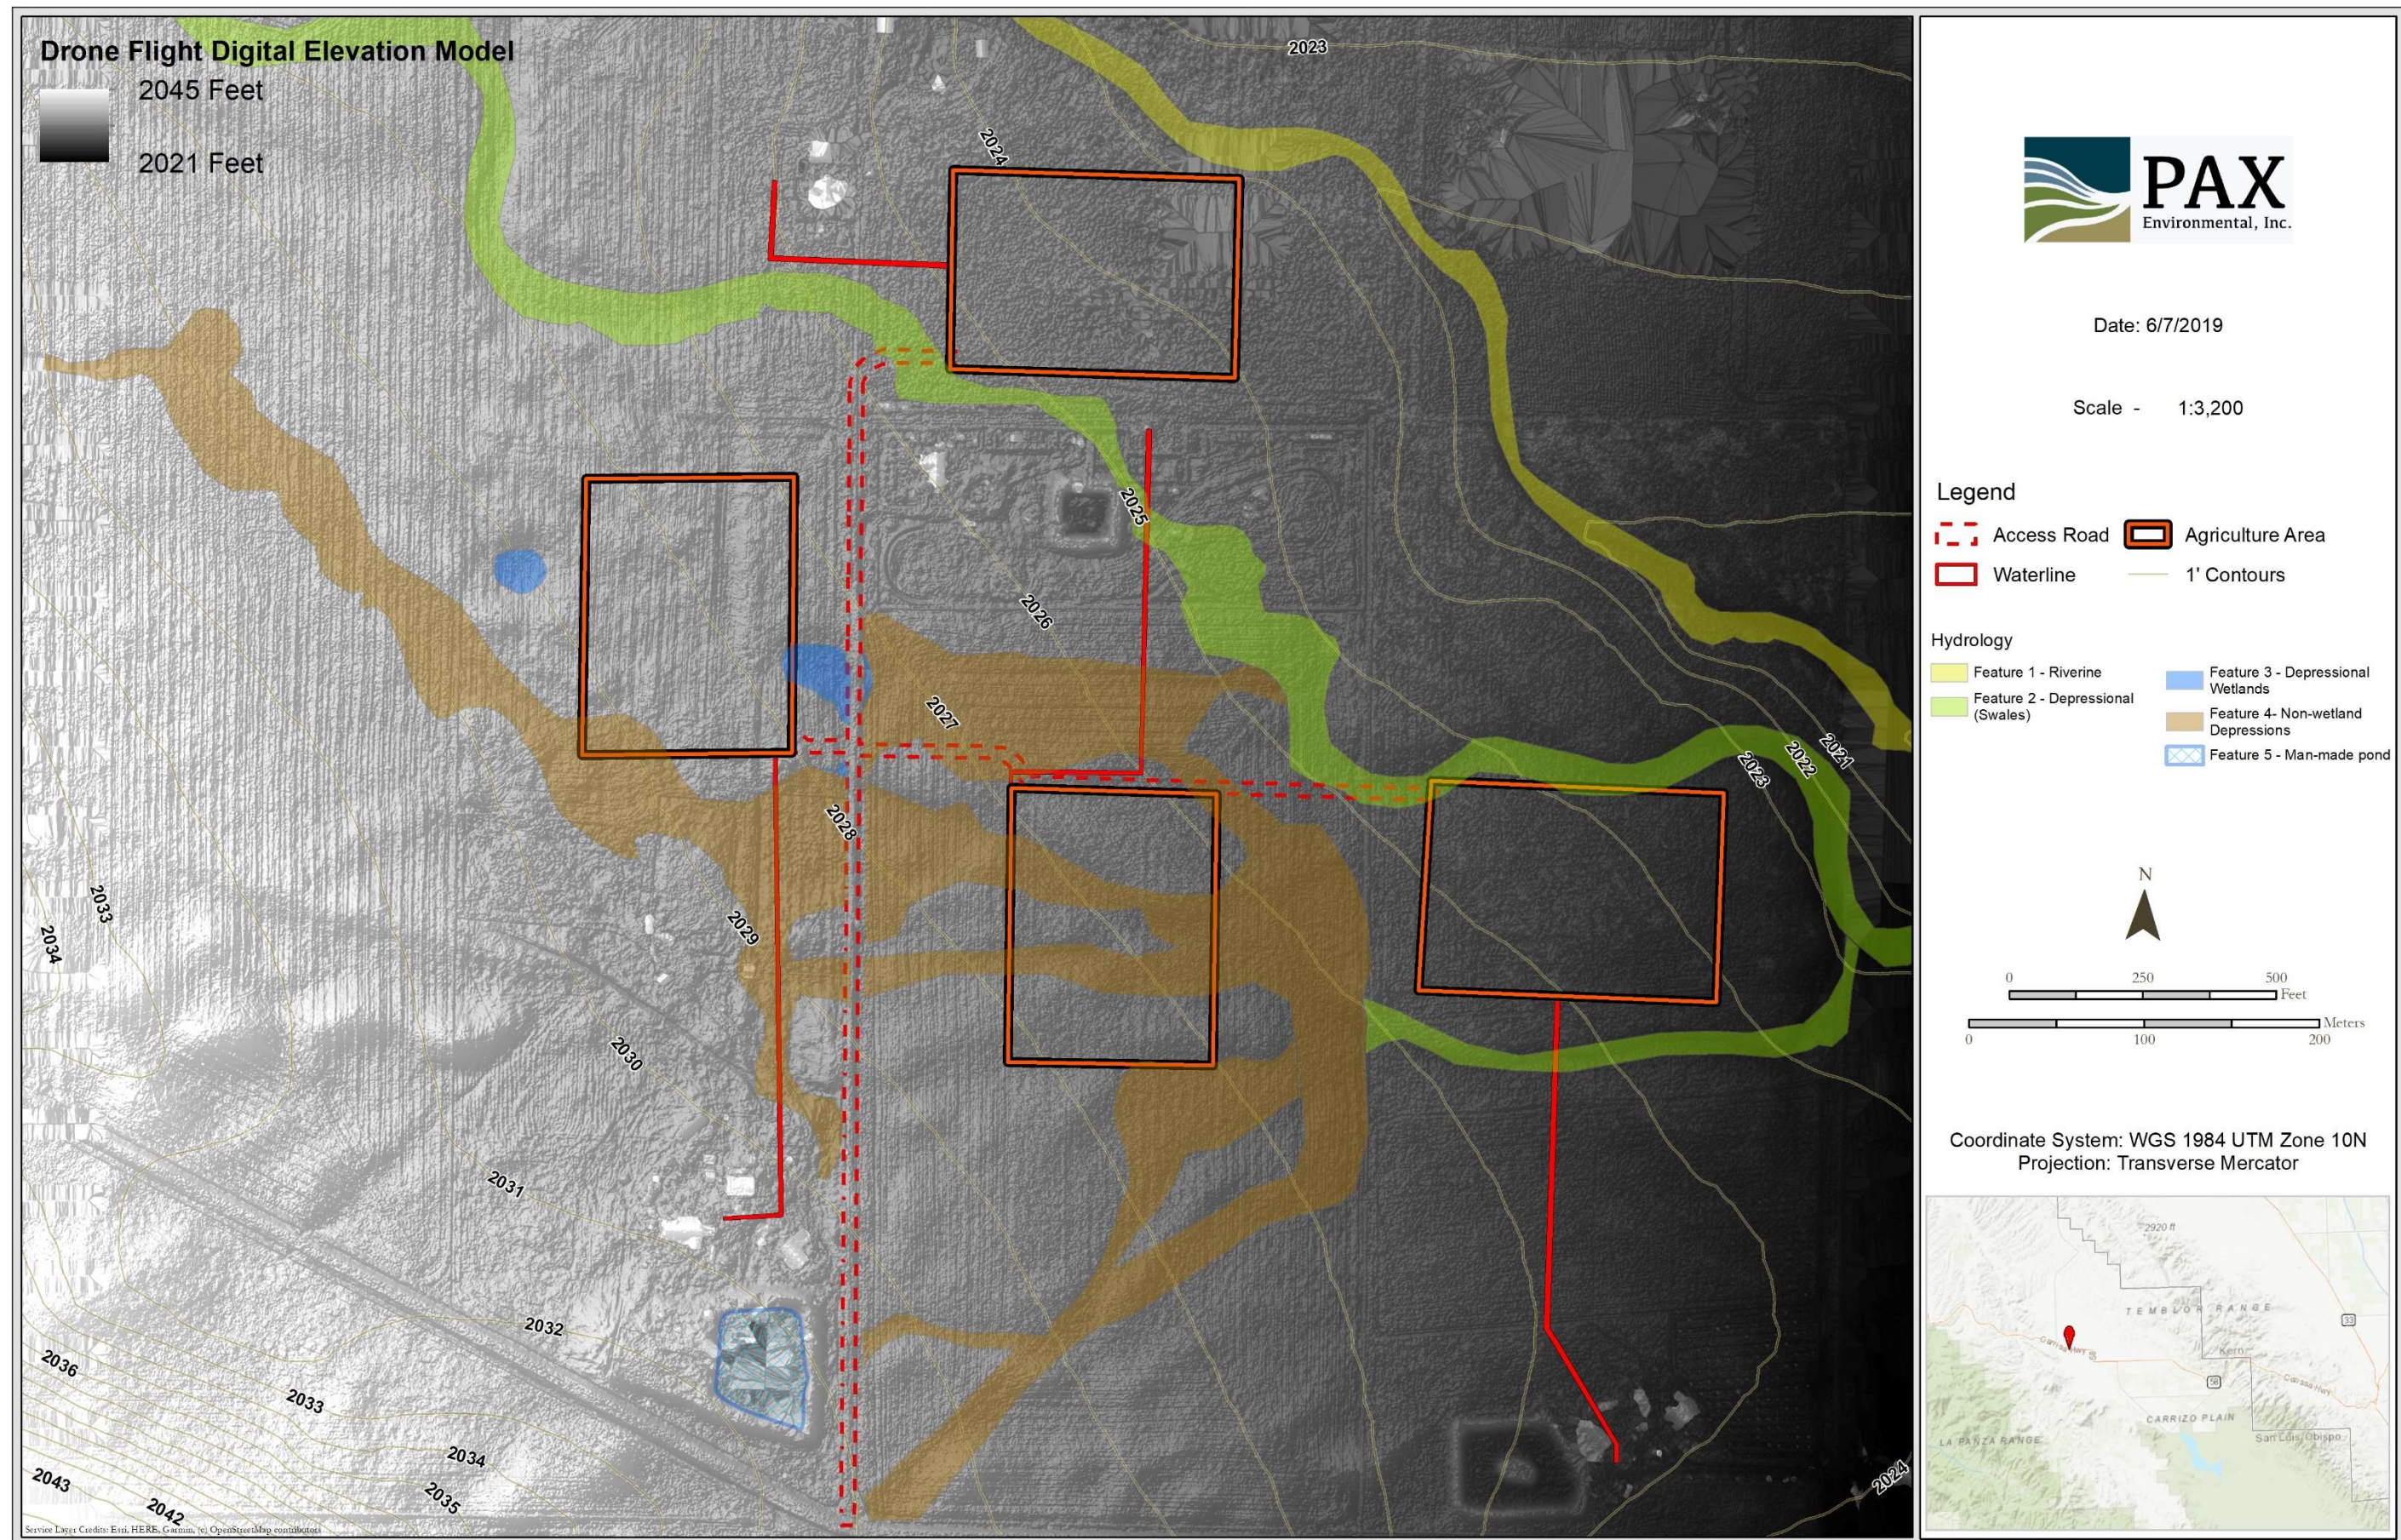
**Figure 3:** Drone flight topographic survey imagery with Project footprint and mapped hydrogeomorphic features.

Five sets of features classified as riverine or depressional were identified on the project site during data collection. Features are described below and summarized in Table 1. The project footprint relative to the features identified in the study area is presented in Figure 3.

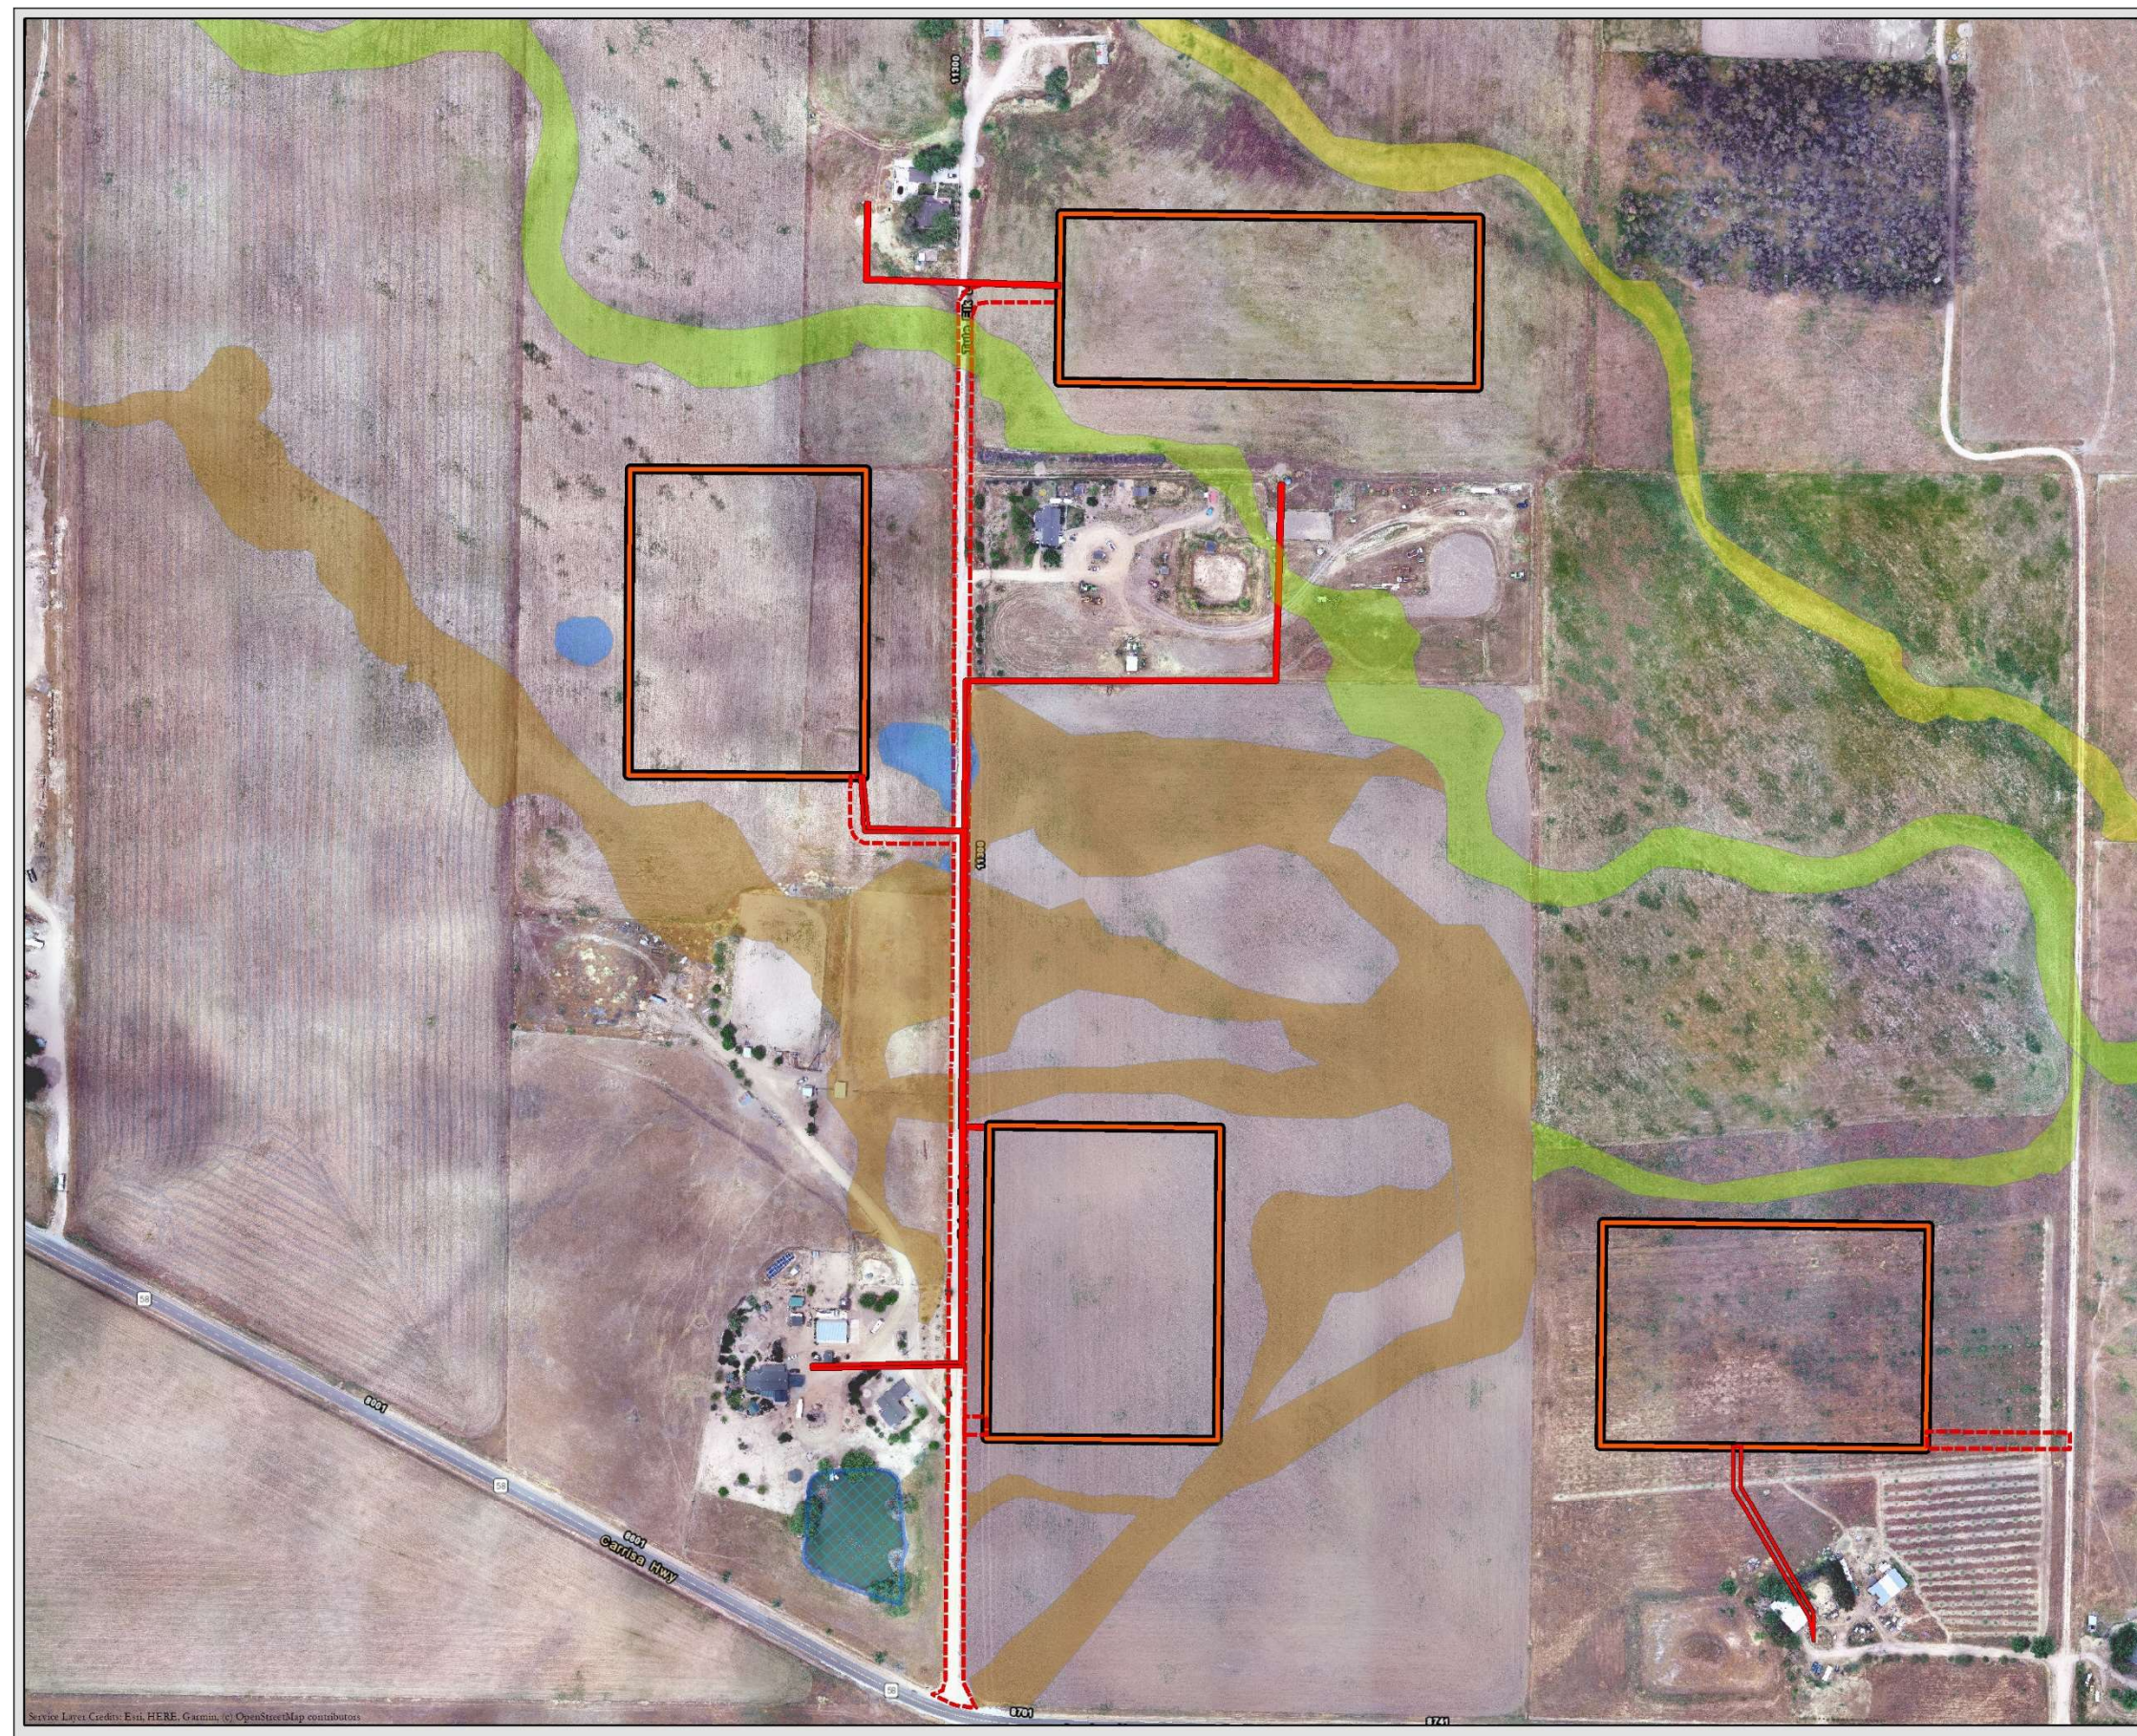
Figure 5: Drone flight aerial imagery with Project footprint and mapped hydrogeomorphic features.

Given the potential for impacts to federal- and state-regulated wetlands and non-wetland resources, an alternative footprint was developed that would avoid all wetland and non-wetland resources while accommodating the area required for project implementation. Figures 4 and 5 represent the alternative footprint relative to the mapped wetland and non-wetland resource subject to state and federal jurisdiction.
