Phase II Subsurface Investigation Report (August 29, 2018)

PHASE II SUBSURFACE INVESTIGATION REPORT

Industrial Land
517 Shinohara Lane
Chula Vista, California 91911

August 29, 2018
Partner Project Number: 17-199602.5

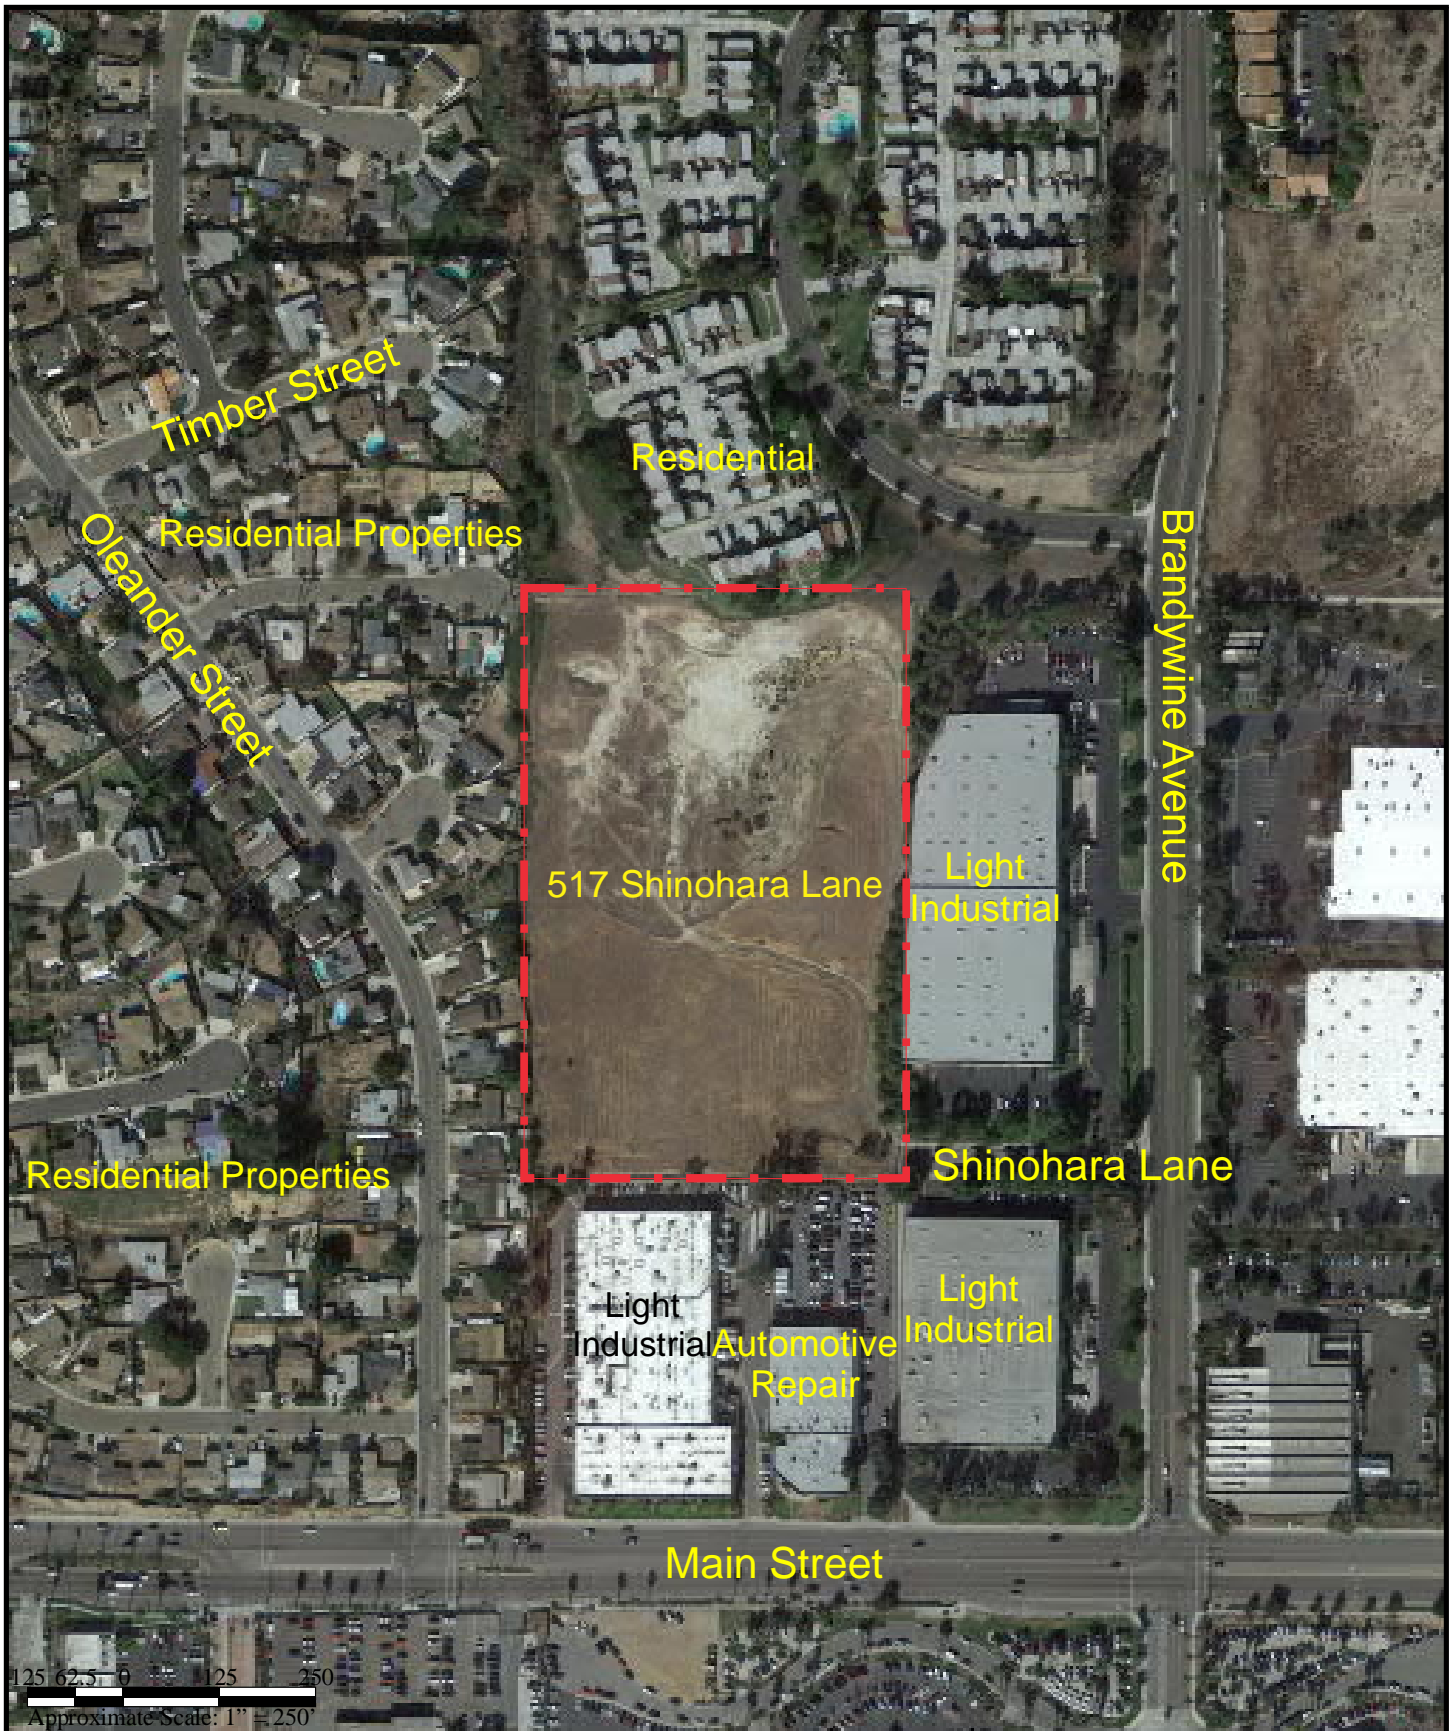
Figure	Prepared By	Date
1	M. Bullivant	August 2018
517 Shinohara Lane Chula Vista, California 91911

The subject property is bound by a residential condominium complex to the north, two light industrial properties and Shinohara Lane to the east, a light industrial property and an automotive repair facility to the south, and residential properties to the west. Refer to Figure 1 for a site plan showing site features and surrounding properties.

Site Plan
