# D-1 GATEWAY AVIATION CENTER PROJECT

## BIOLOGICAL TECHNICAL REPORT

Riverside County, California

April 21, 2022

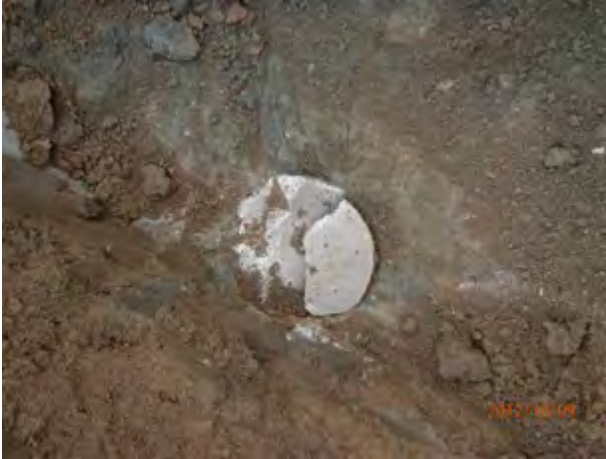
Observed grouted up soil boring penetrating gray soil

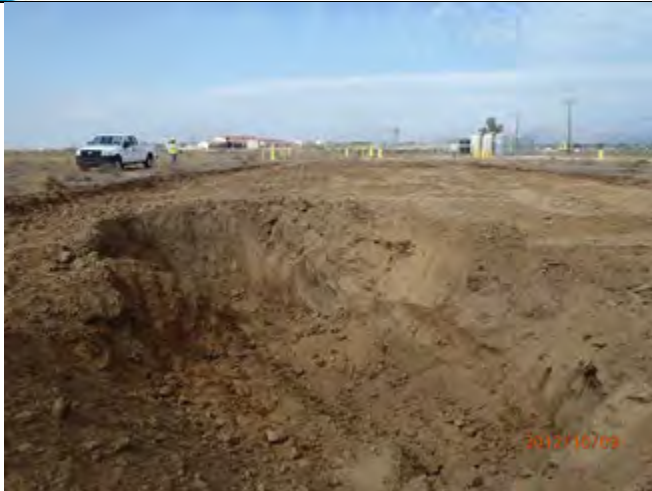
Hot spot area excavated out to brown soil, gray soil max depth observed was 6 feet

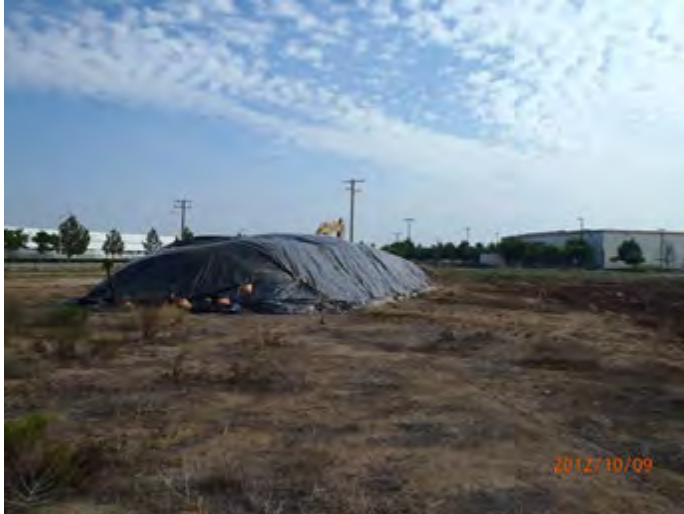
Stock pile approx. 8x25x70 feet = 518 cu yards, covered and secured awaiting analytical results

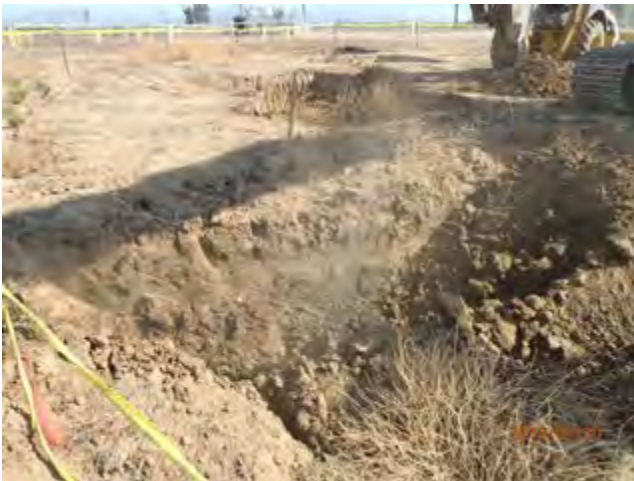
Slight gray staining observed. All discolored soil excavated out.

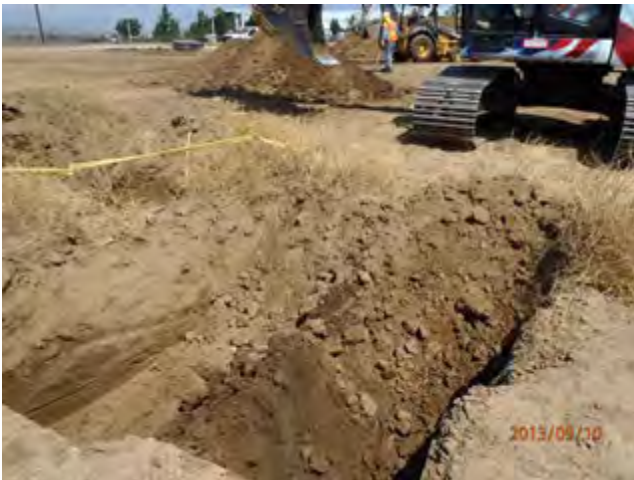
Slight gray staining observed. All discolored soil excavated out.

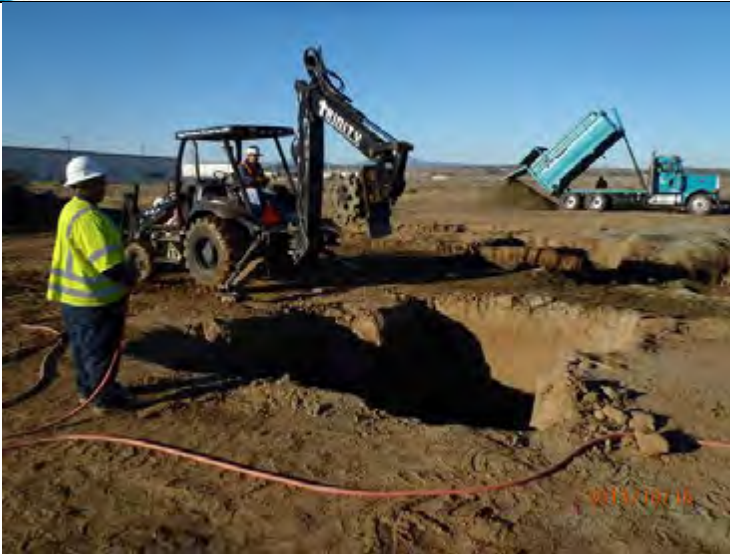
Importing soil, moisture conditioning and compacting 8" lifts to >90%

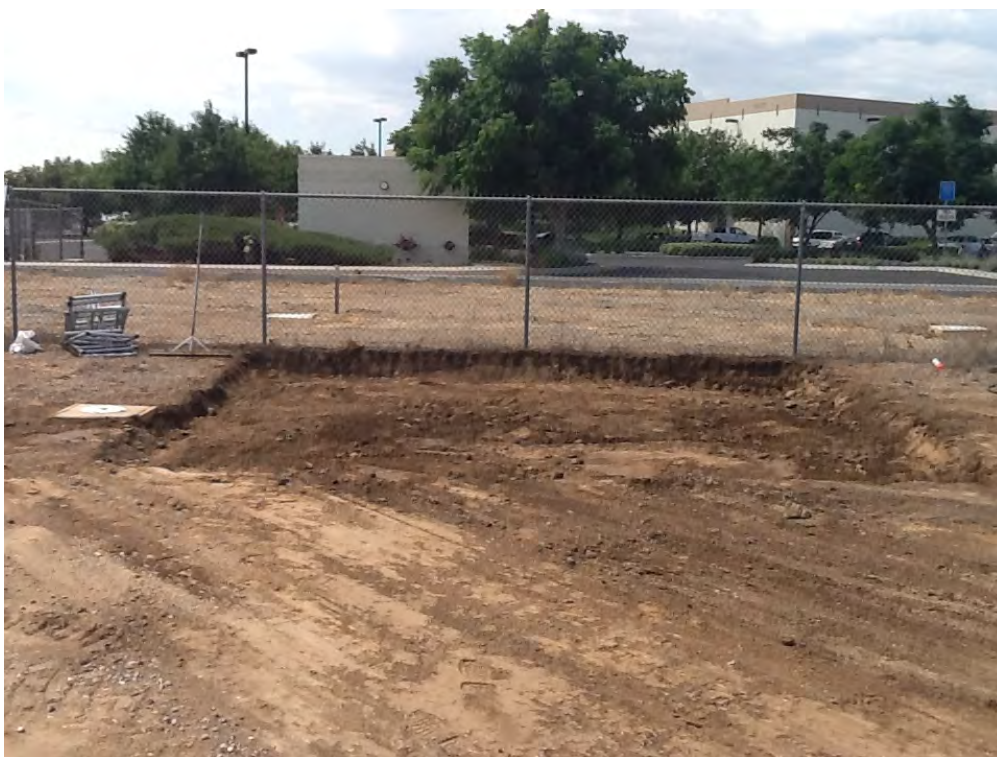
Soils were excavated to 6 inches below grade for the SVE pad.

Native soils were compacted and moisture was added prior to the placement of the Class 2 base materials. Approximately 25 tons of Class 2 base materials were delivered for the SVE pad. Base materials were placed, watered, and compacted in 2-4-inch lifts.

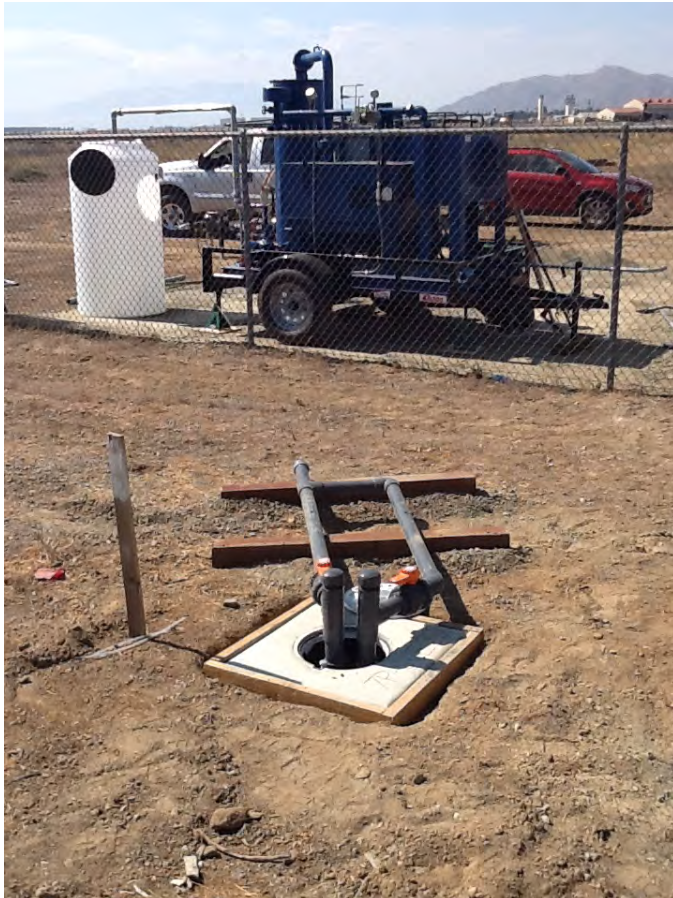
The location of the abandoned (and damaged) telephone wire was marked with 2 pieces of conduit and marking tape.

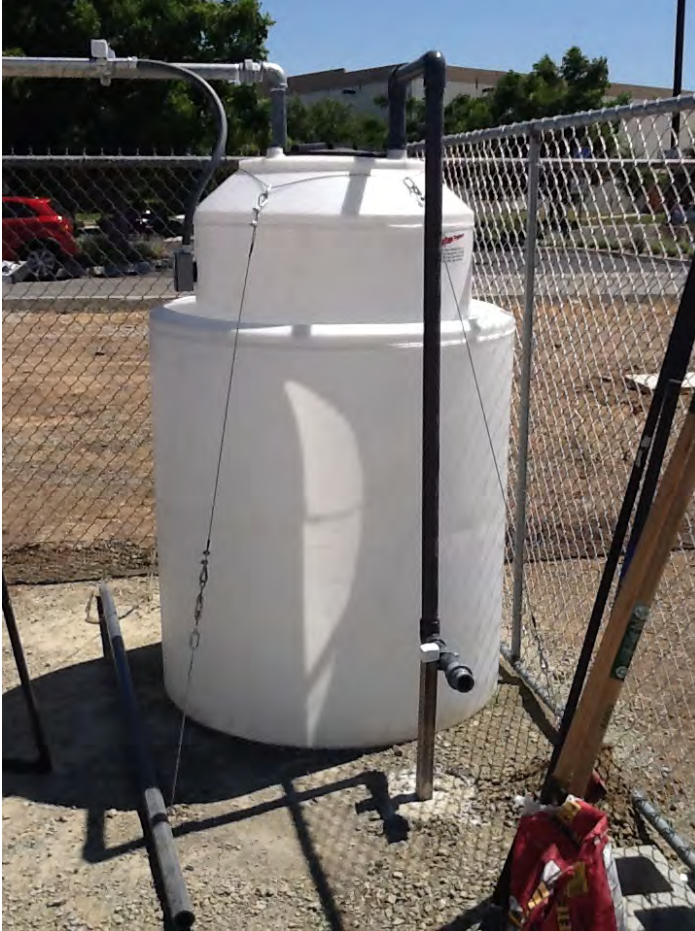
Rotation on the blower was checked and noted to be correct; however, an electrical issue with the SVE was identified.

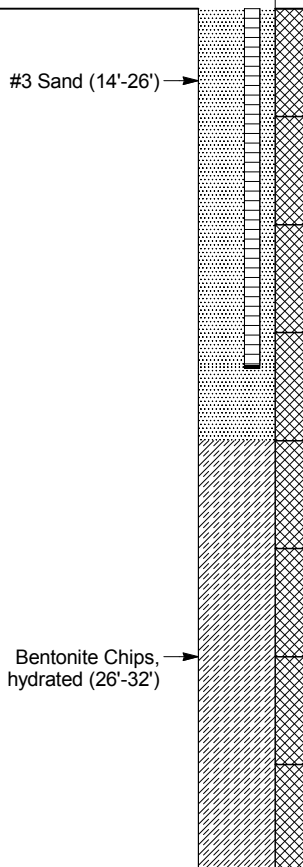
100	18	9.8		20		SM	Silty Sand, brown (7.5YR 4/4), moist to dry, dense, no odor, granite sand		15	40	30	15	
					21							increased fine sand with Mn oxides, 5% caliche	tr	tr	10	75	15
				100	16	9.6		22									
					17												
					19						SM	Silty Sand, brown (10YR 4/3), dense, moist, minor iron oxide staining		10	55	20	15
				67	16	4.2		24		SW-SM	Well Graded Sand with Silt, dark yellowish brown (10YR 4/4), medium dense, moist, non-cemented, no odor		20	50	20	10

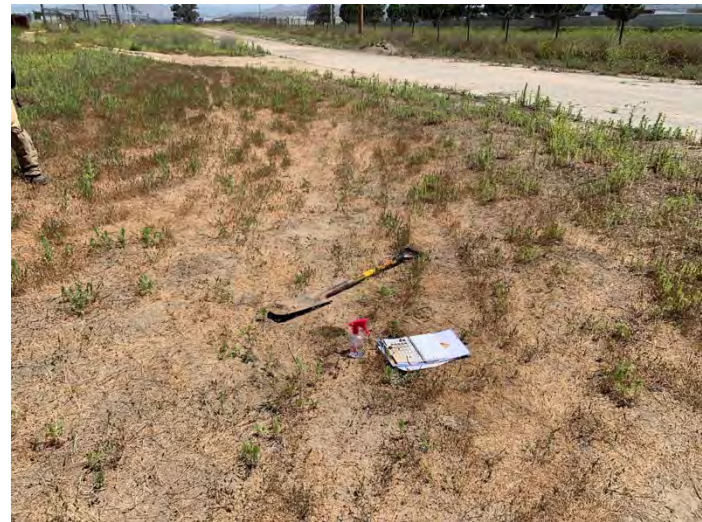
Photo 8. View of WDP 7, facing north. WDP 7 met the hydrophytic vegetation and wetland hydrology parameters; however, no hydric soil indicators were observed within WDP 7 (33.877058, -117.244062).

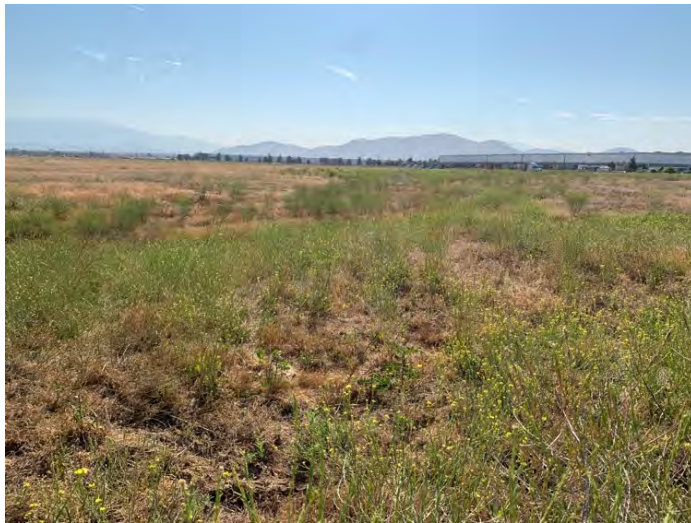
Photo 9. Overview of non-wetland feature, facing downstream/east. Photo taken in the western portion of the review area (33.876321, -117.250471).

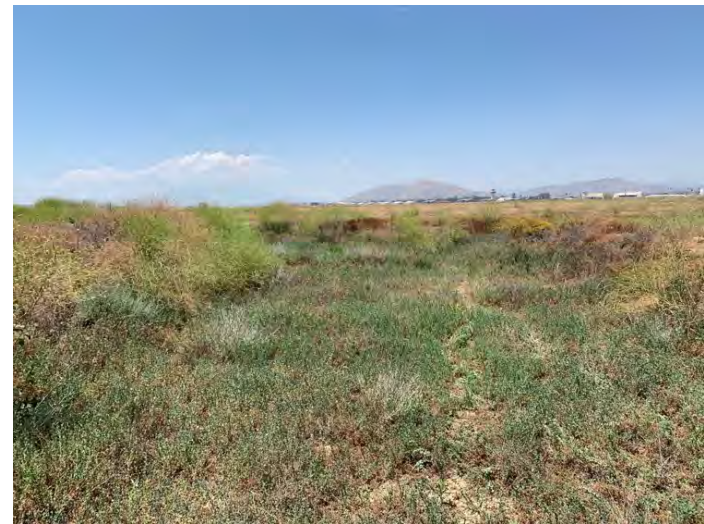
Photo 12. Upstream view of OHWM Datasheet Point (ODP) 4, facing north, within NWW-1A/NWW-1. The OHWM was primarily defined by a change in vegetation species, an artificial bed and bank, and soil cracking. (33.876193, -117.247755).

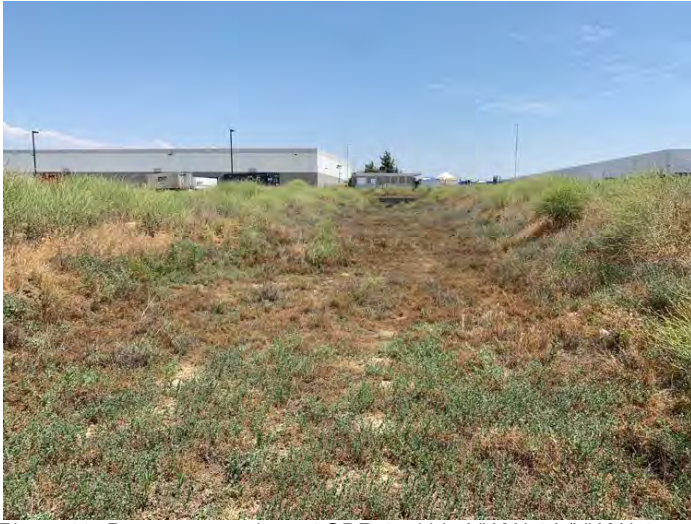
Photo 13. Downstream view of ODP 4 within NWW-1A/NWW-1, facing south. (33.876188, -117.247747).

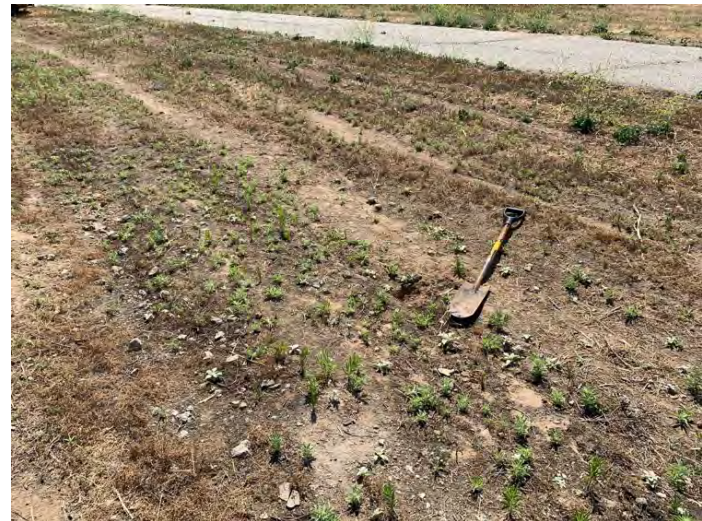
Photo 20. View of WDP 3, facing east. WDP 3 met the wetland hydrology parameter; however, no hydric soil or wetland hydrology indicators were observed within WDP 3 (33.875052, -117.249909).

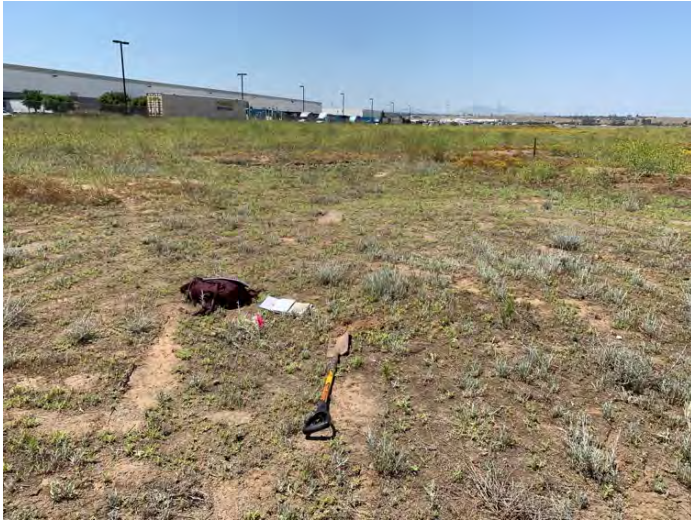
Photo 21. View of WDP 8, facing southwest. WDP 8 met the wetland hydrology parameter; however, no hydric soil or wetland hydrology indicators were observed within WDP 8 (33.877337, -117.244551).

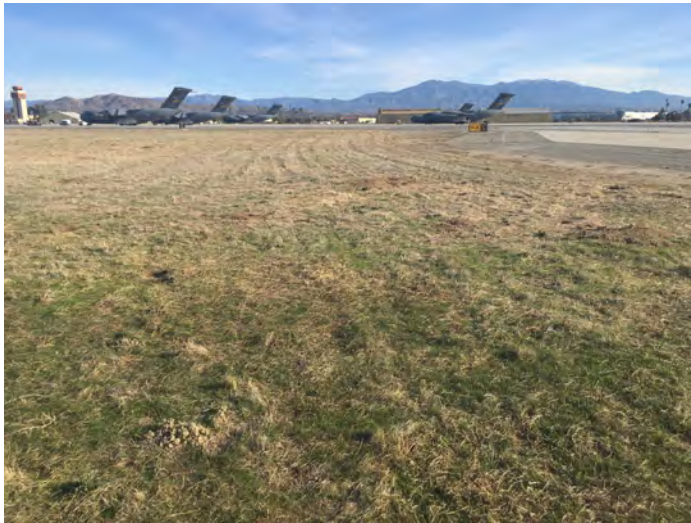
Photo 35. Overview of the 22.40-acre northern parcel that was added to the project footprint after the initial June 2020 survey. No potential ponding areas or other aquatic resources were observed within the northern parcel during the January 13, 2021 survey; therefore, a formal aquatic resources delineation was not performed in this portion of the project site (33.884970, -117.253027).
