Project Specific Water Quality Management Plan

Project Title: SWC Ramona & Perris Industrial

Development No: DPR19-00012

This Project-Specific Water Quality Management Plan (WQMP) has been prepared for PR Partners, LLC by United Engineering Group CA, Inc. for the SWC Ramona & Perris Industrial Project P19-00012.

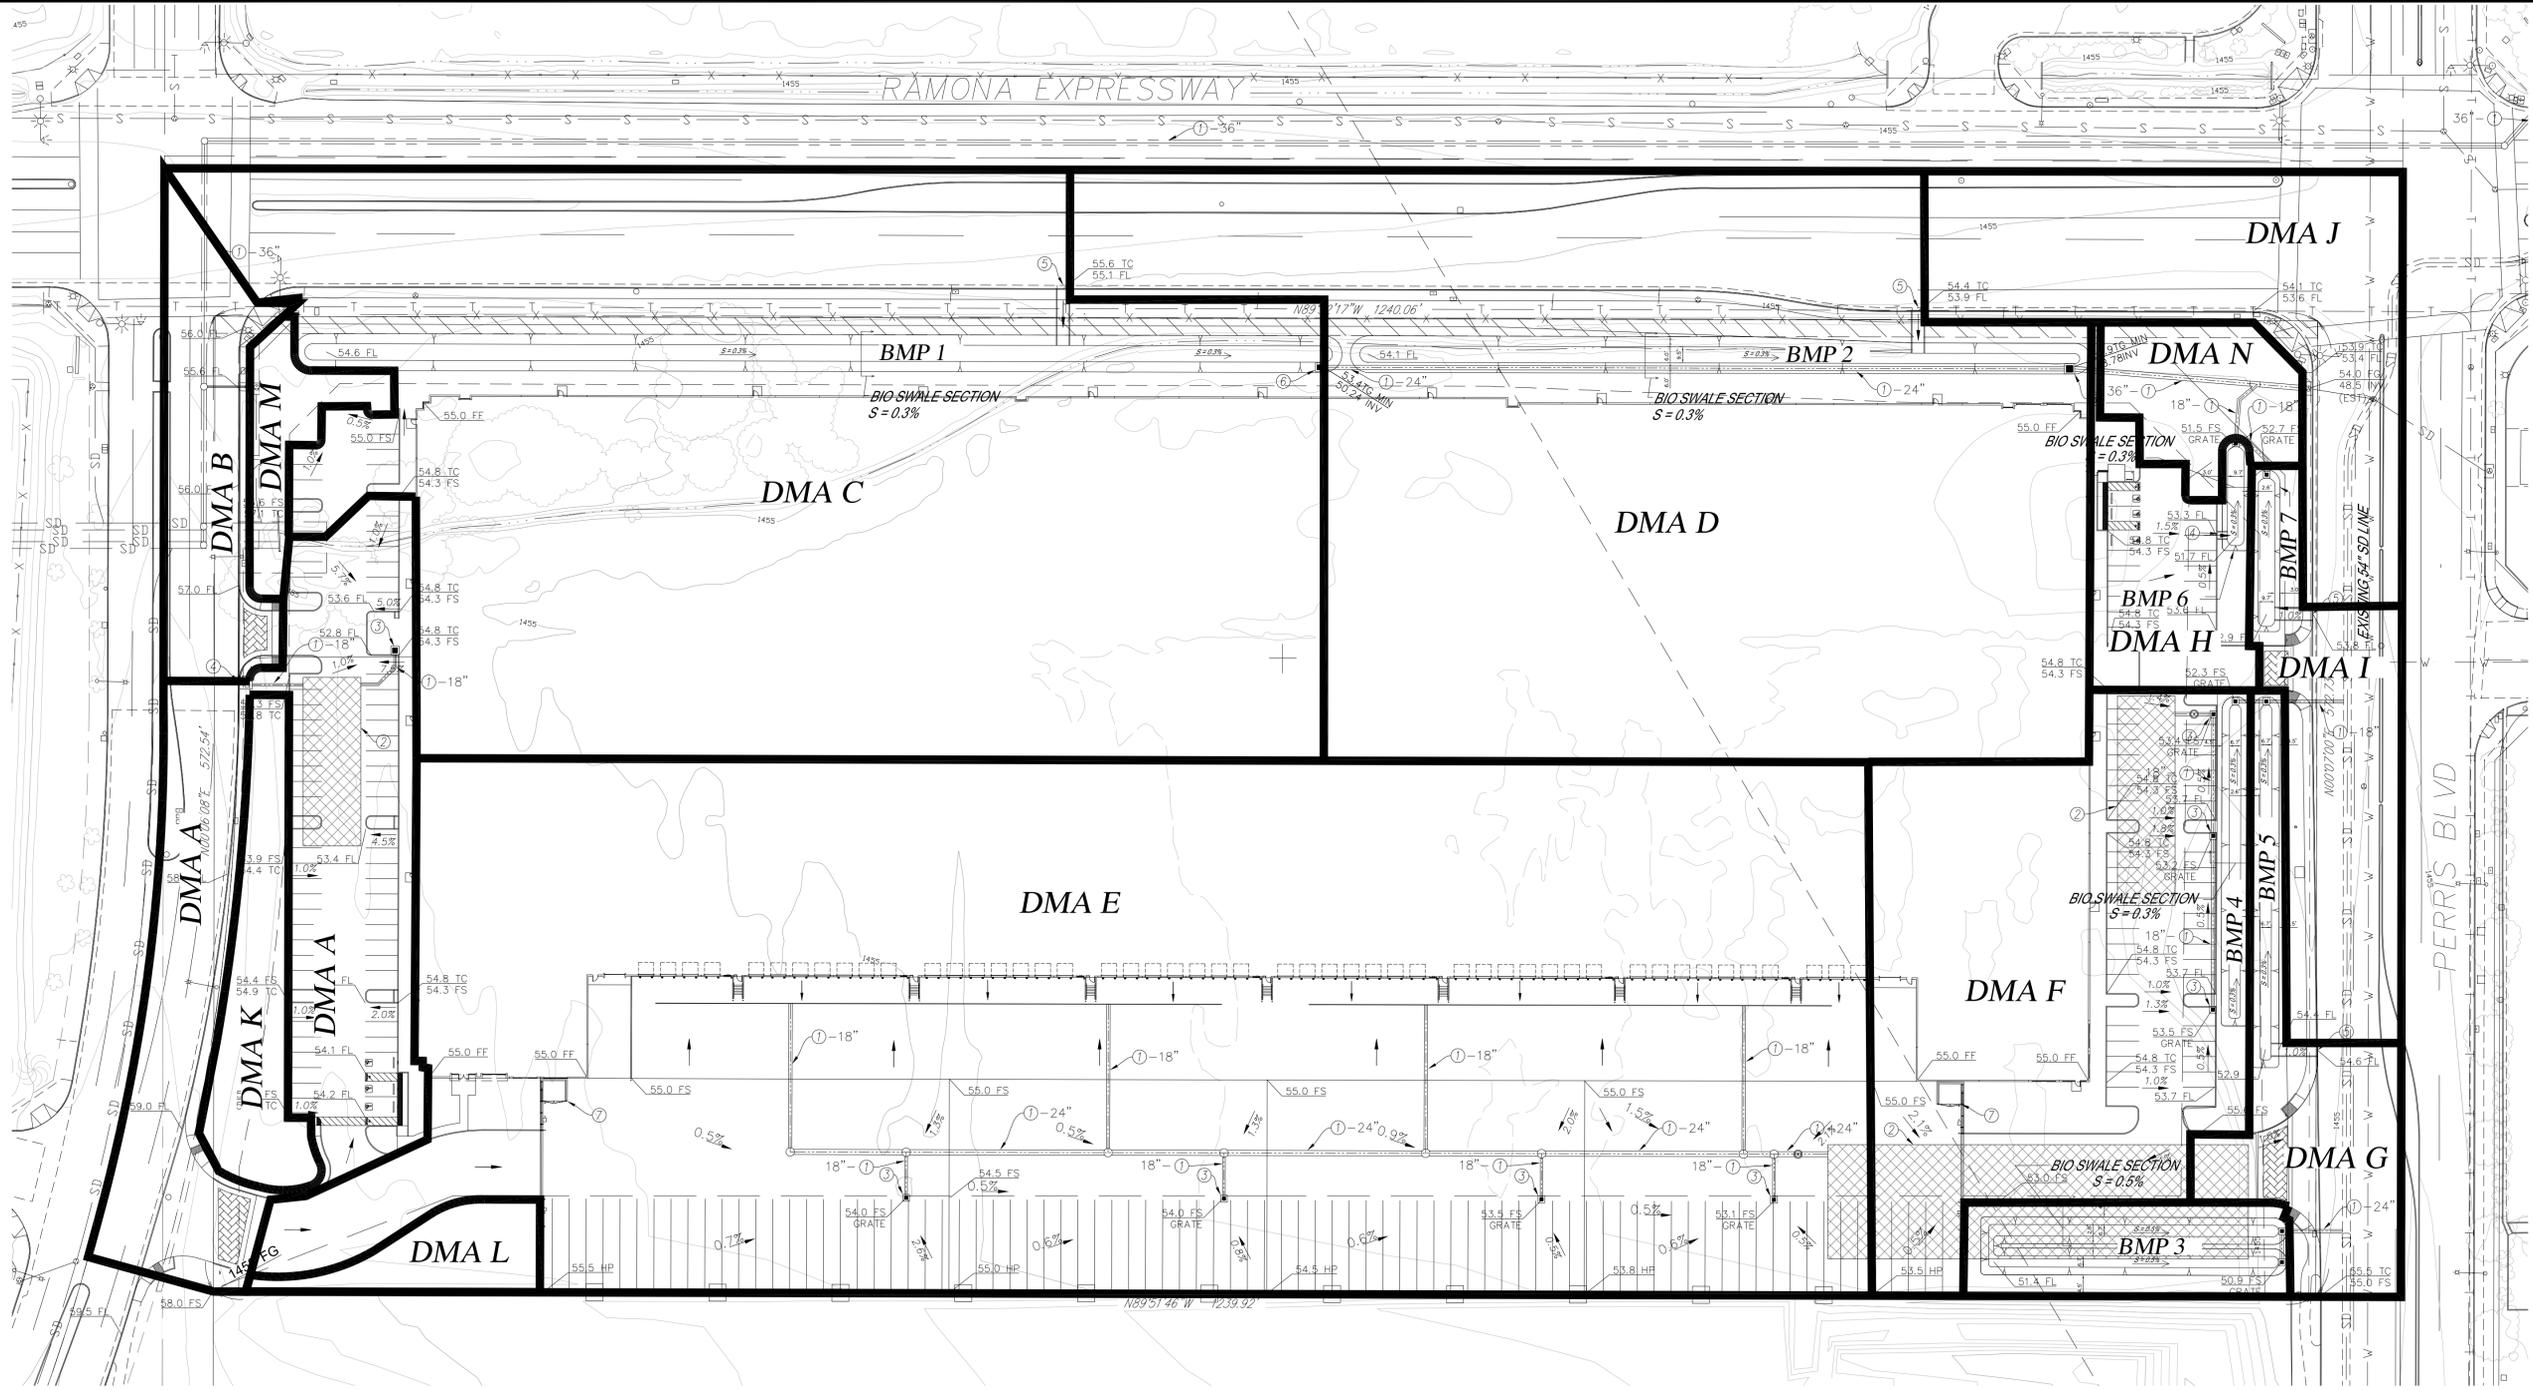
DMA	AREA [AC]	2YR 24HR FLOW [CFS] - Q _{bmp}	BMP
A	1.15	0.28	1
B	0.33	0.08	NONE
C	4.35	1.06	1
D	3.70	0.90	2
E	6.42	1.57	3
F	1.46	0.36	4
G	0.41	0.10	5
H	0.31	0.08	6
I	0.48	0.12	7
J	0.80	0.20	NONE
DMA	AREA [AC]	DESIGN STORM [CF] - V _{bmp}	BMP
K	0.25	57.3	SELF
L	0.13	29.4	SELF
M	0.13	29.7	SELF
N	0.21	49.0	SELF

BMP	LENGTH [FT]	WIDTH [FT]
1	606	10
2	425	10
3	342	6.7
4	184	6.7
5	209	6.7
6	84	10
7	97	10

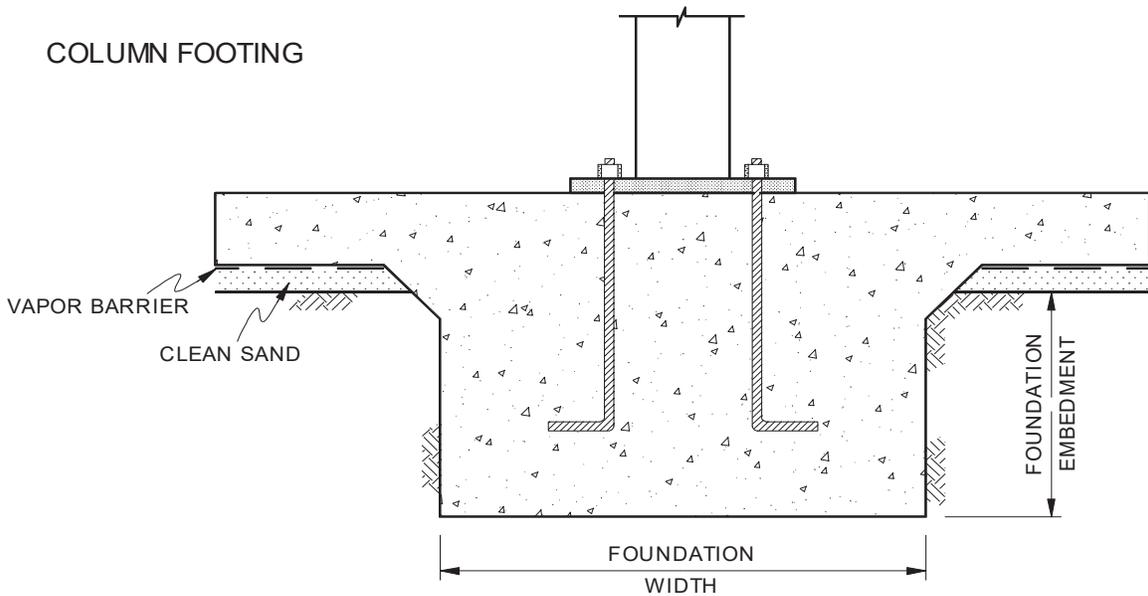
COLUMN FOOTING

NOTE: SEE REPORT FOR FOUNDATION WIDTH AND DEPTH RECOMMENDATION

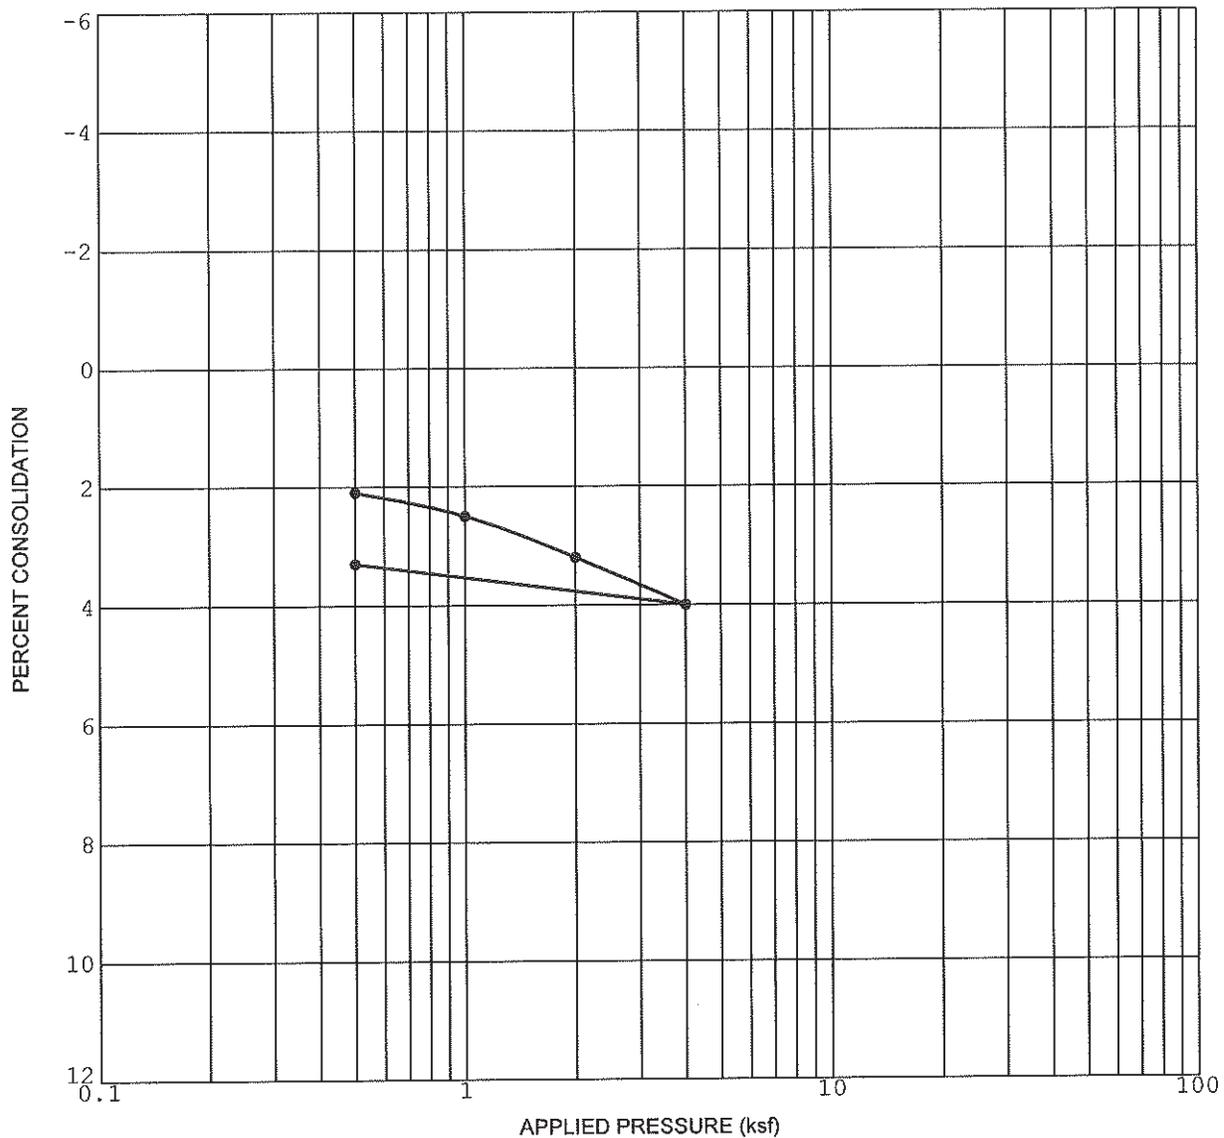
SAMPLE NO. B4-3

Initial Dry Density (pcf)	120.7
Initial Water Content (%)	12.5

Initial Saturation (%)	88.7
Sample Saturated at (ksf)	2.0

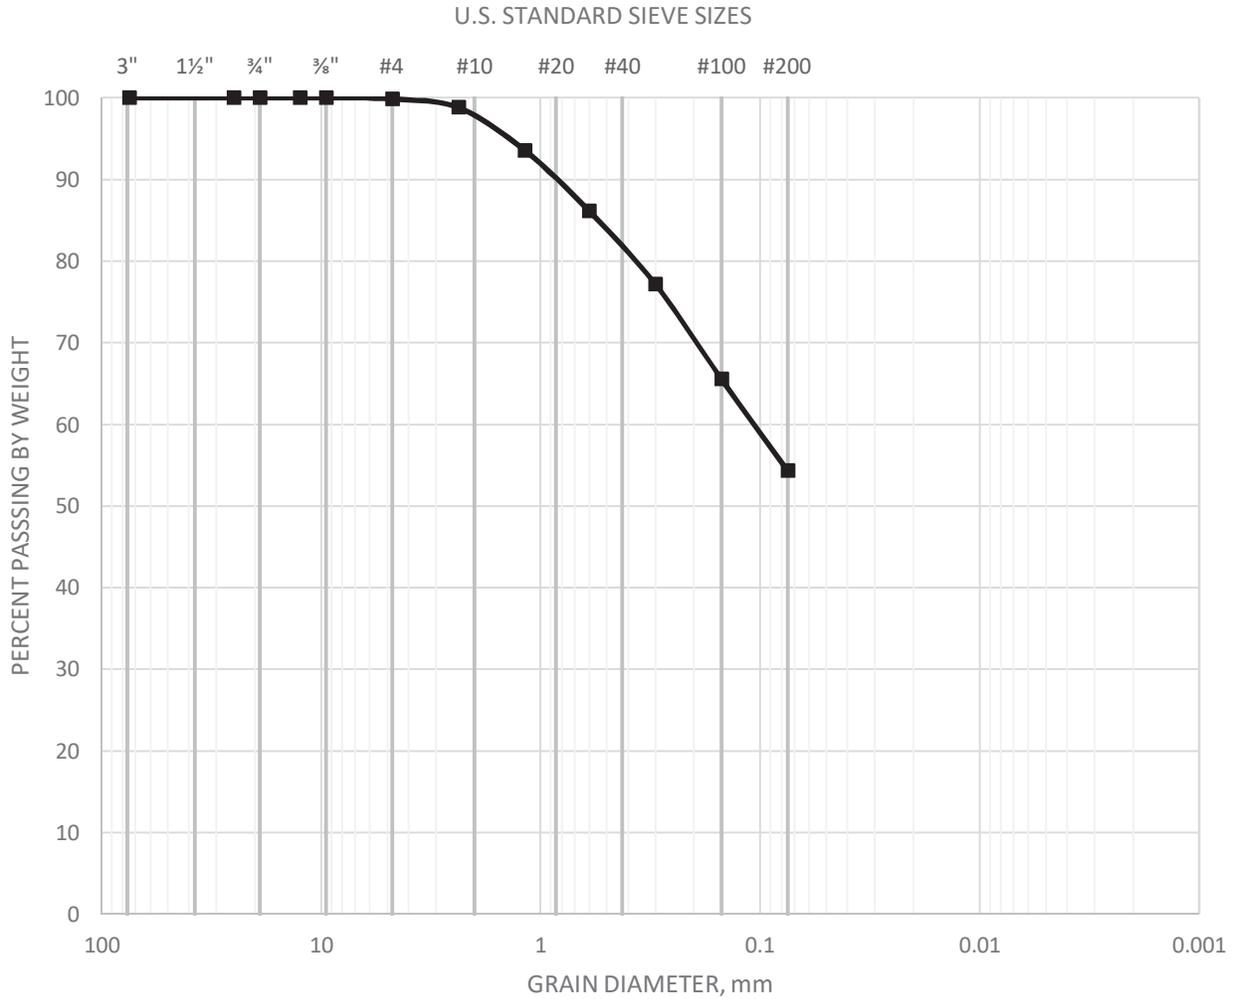
SAMPLE	CLASSIFICATION	D60	D30	D10
P1@4.5-5'	Sandy SILT (ML), dark brown

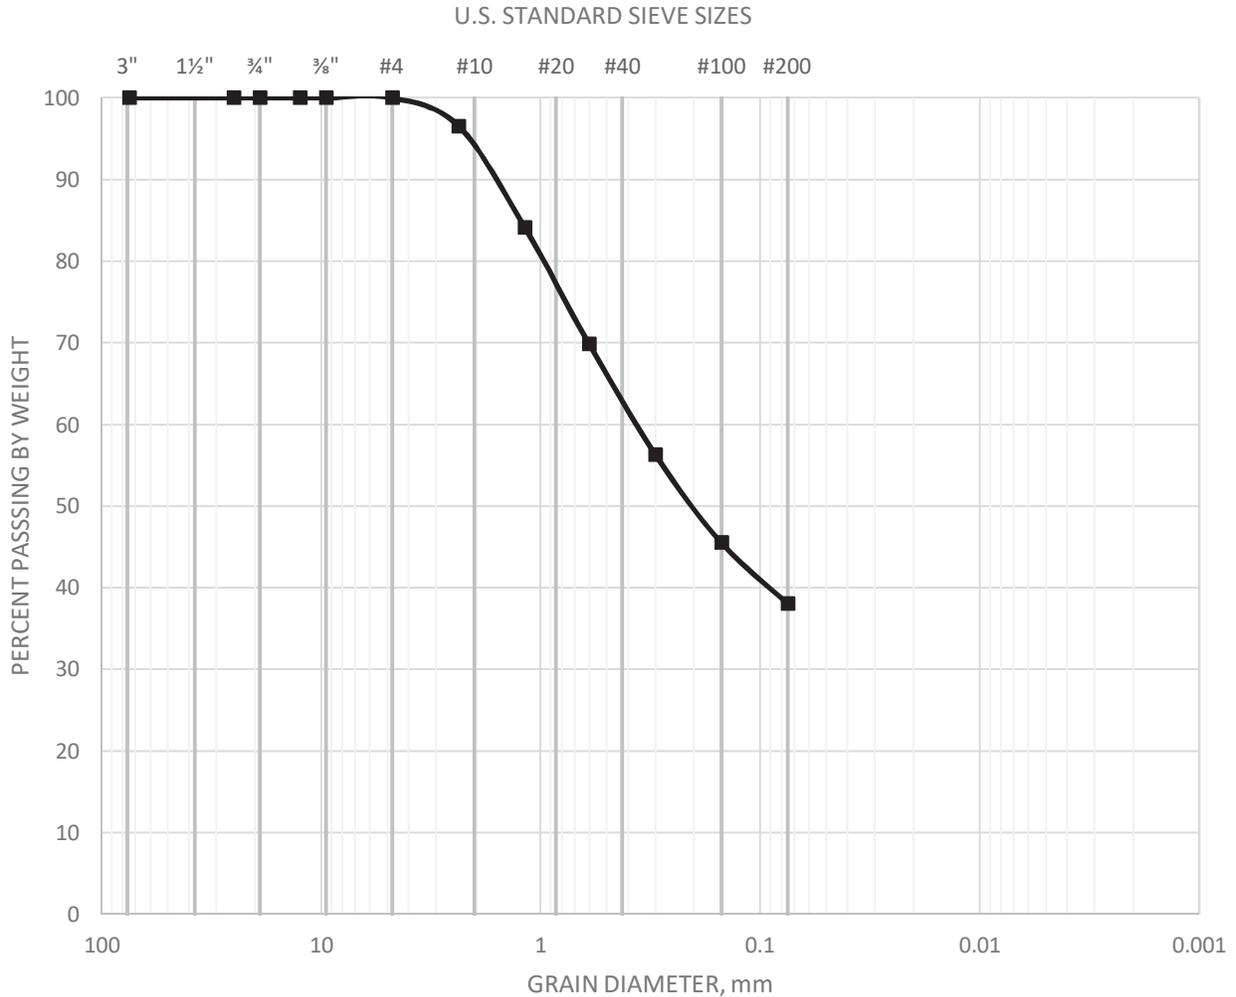
SAMPLE	CLASSIFICATION	D60	D30	D10
P2@4.5-5'	Silty SAND (SM), brown	0.38	0.04	0.005

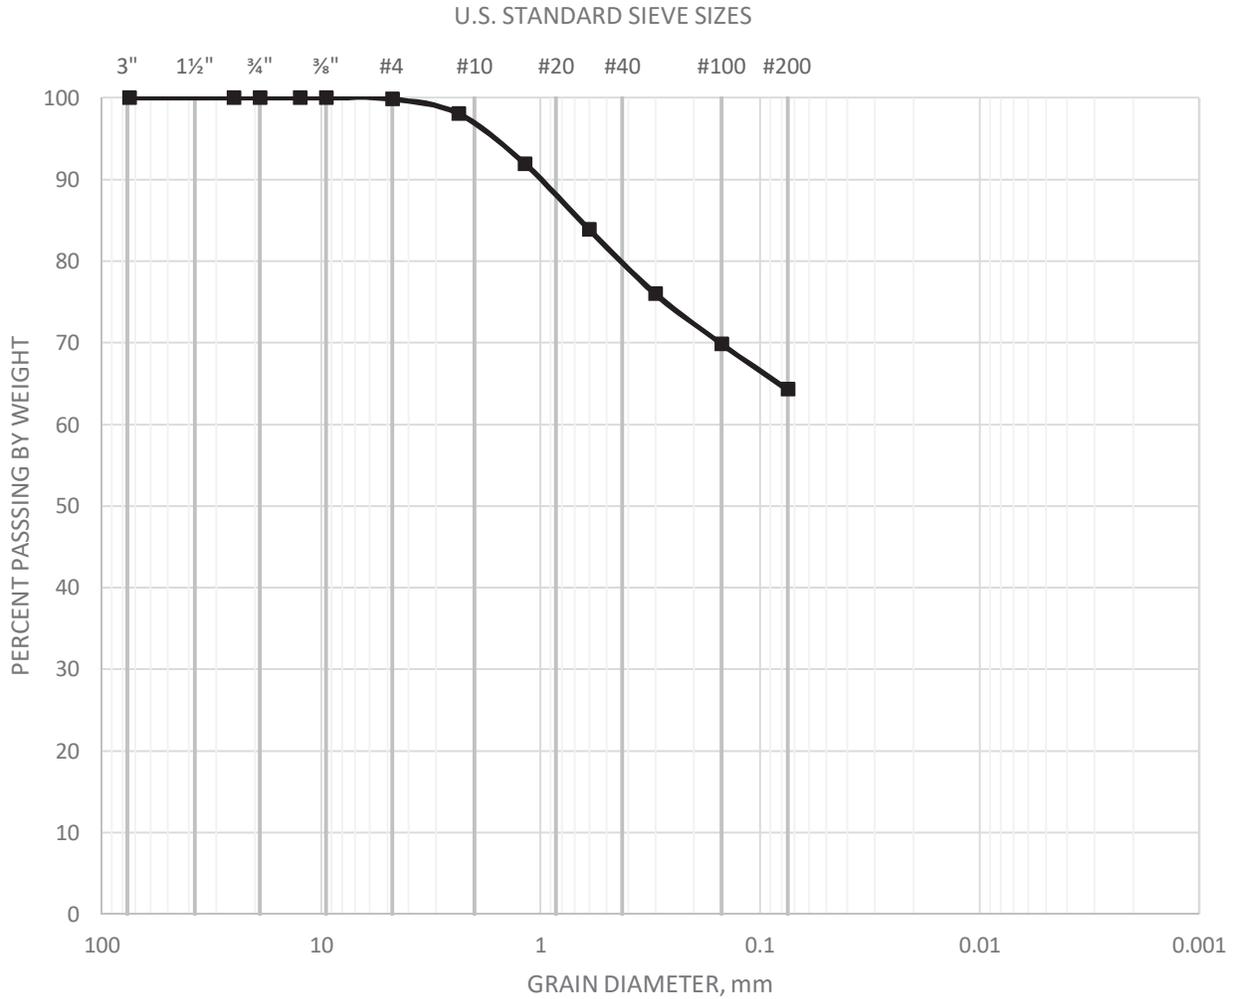
SAMPLE	CLASSIFICATION	D60	D30	D10
P3@10.5-11'	Sandy SILT (ML), reddish brown

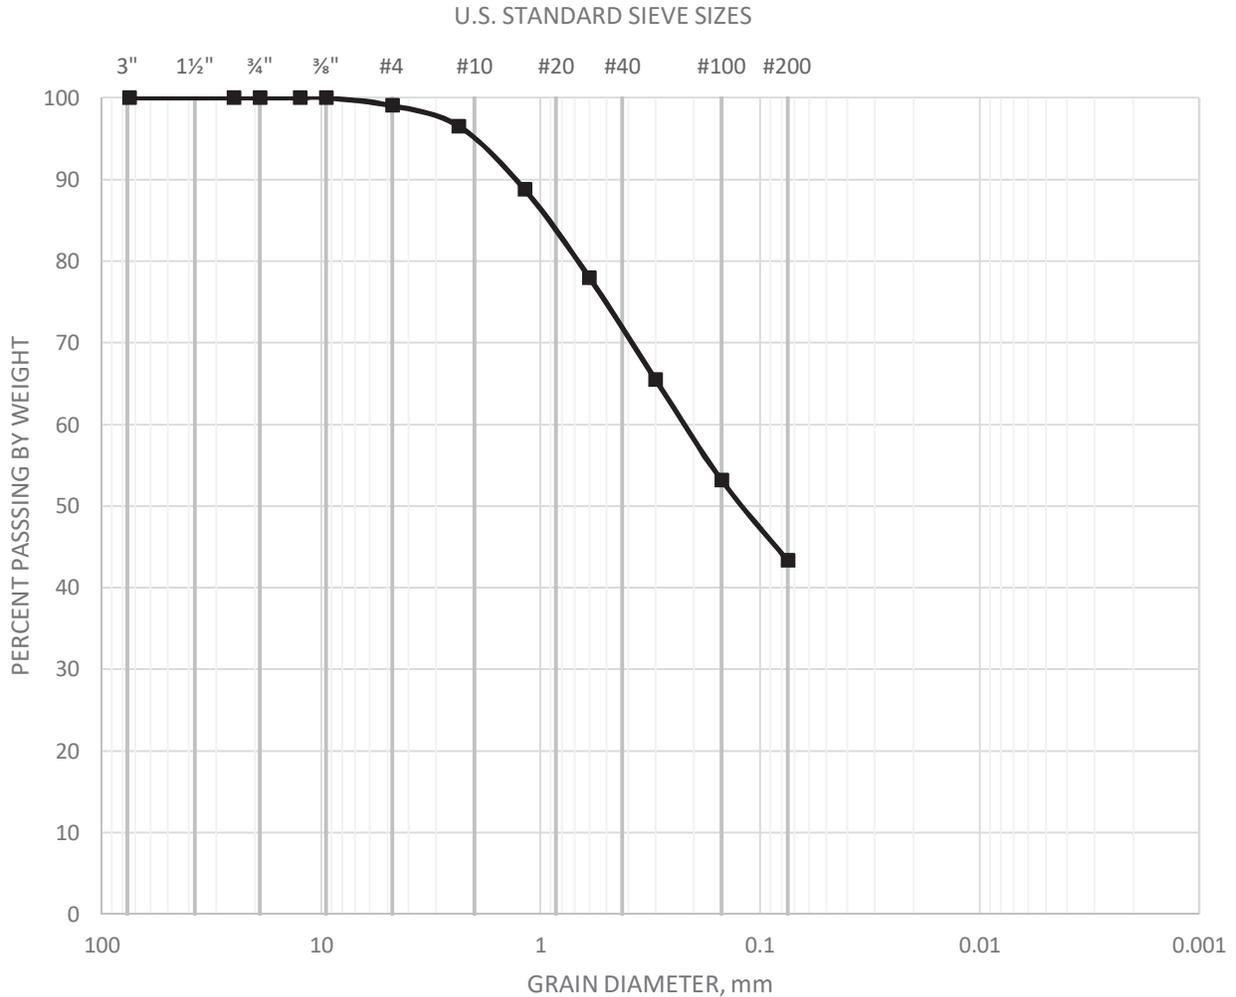
SAMPLE	CLASSIFICATION	D60	D30	D10
P4@4.5-5'	Silty SAND (SM), reddish brown	0.22	0.027	0.009

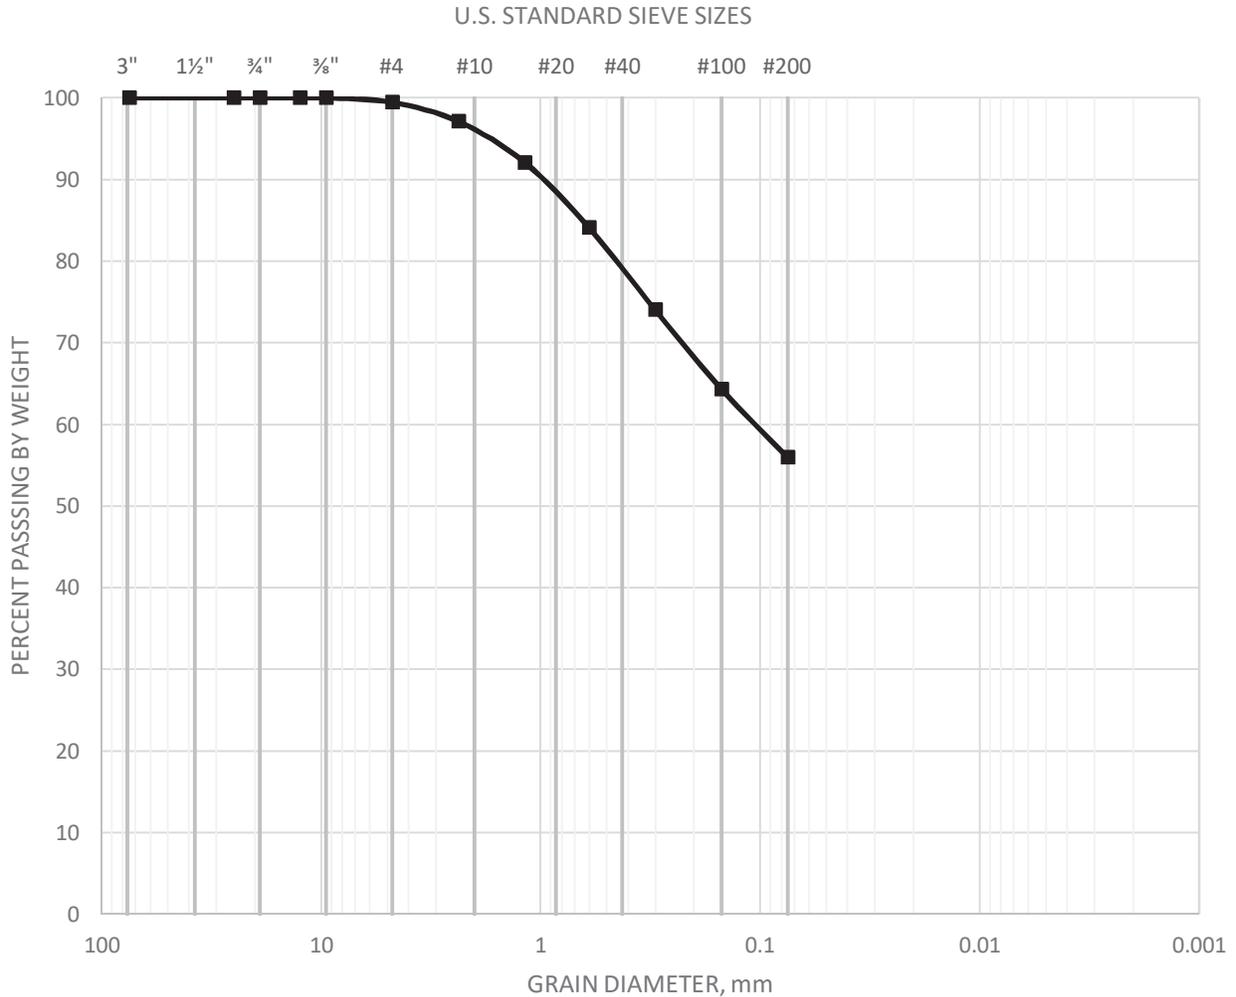
SAMPLE	CLASSIFICATION	D60	D30	D10
P5@4.5-5'	Sandy SILT (ML), dark reddish brown

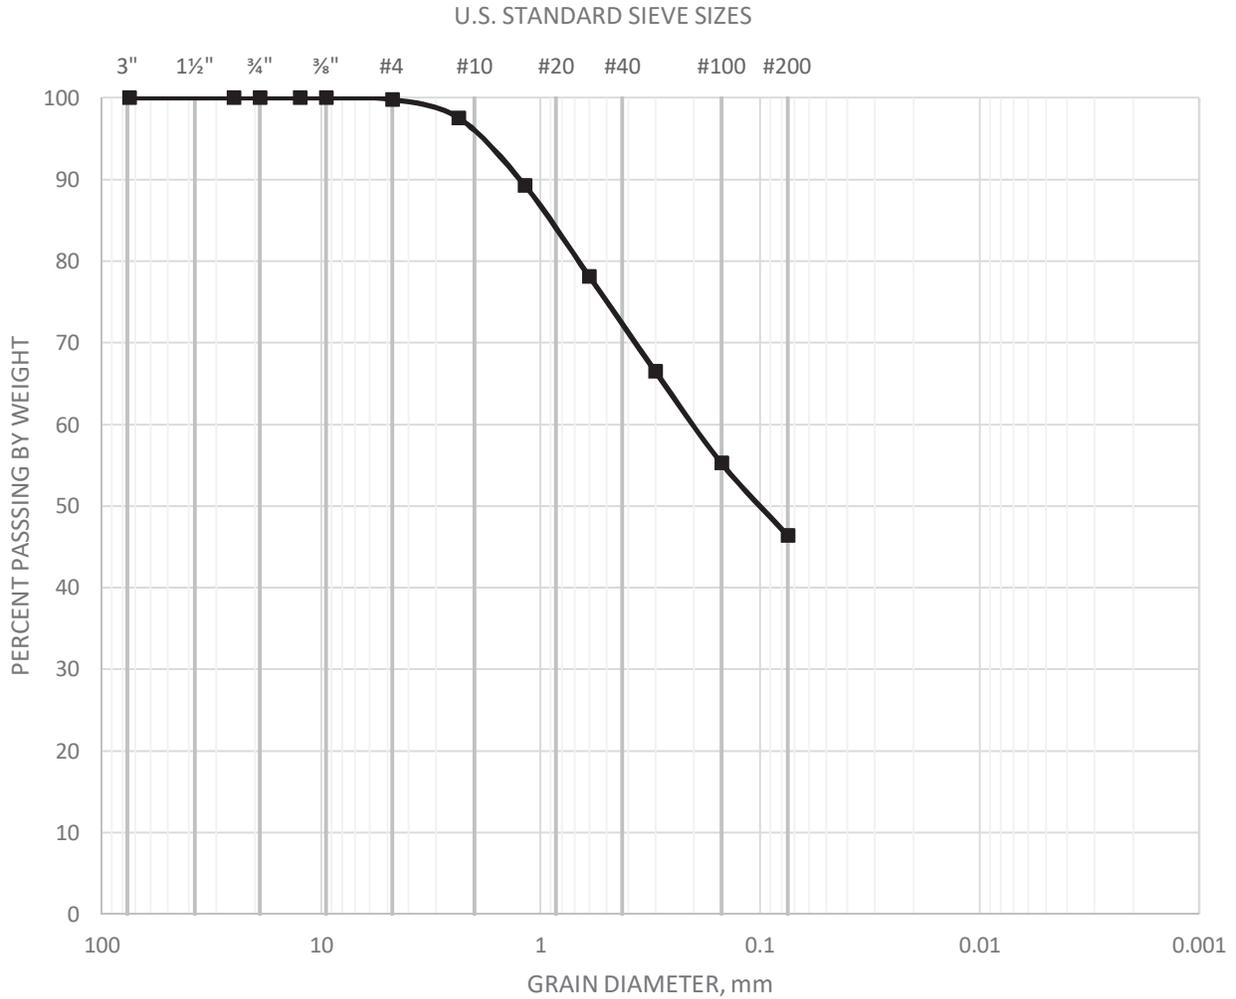
SAMPLE	CLASSIFICATION	D60	D30	D10
P6@10.5-11'	Silty SAND (SM), dark brown	0.21	0.02	0.004

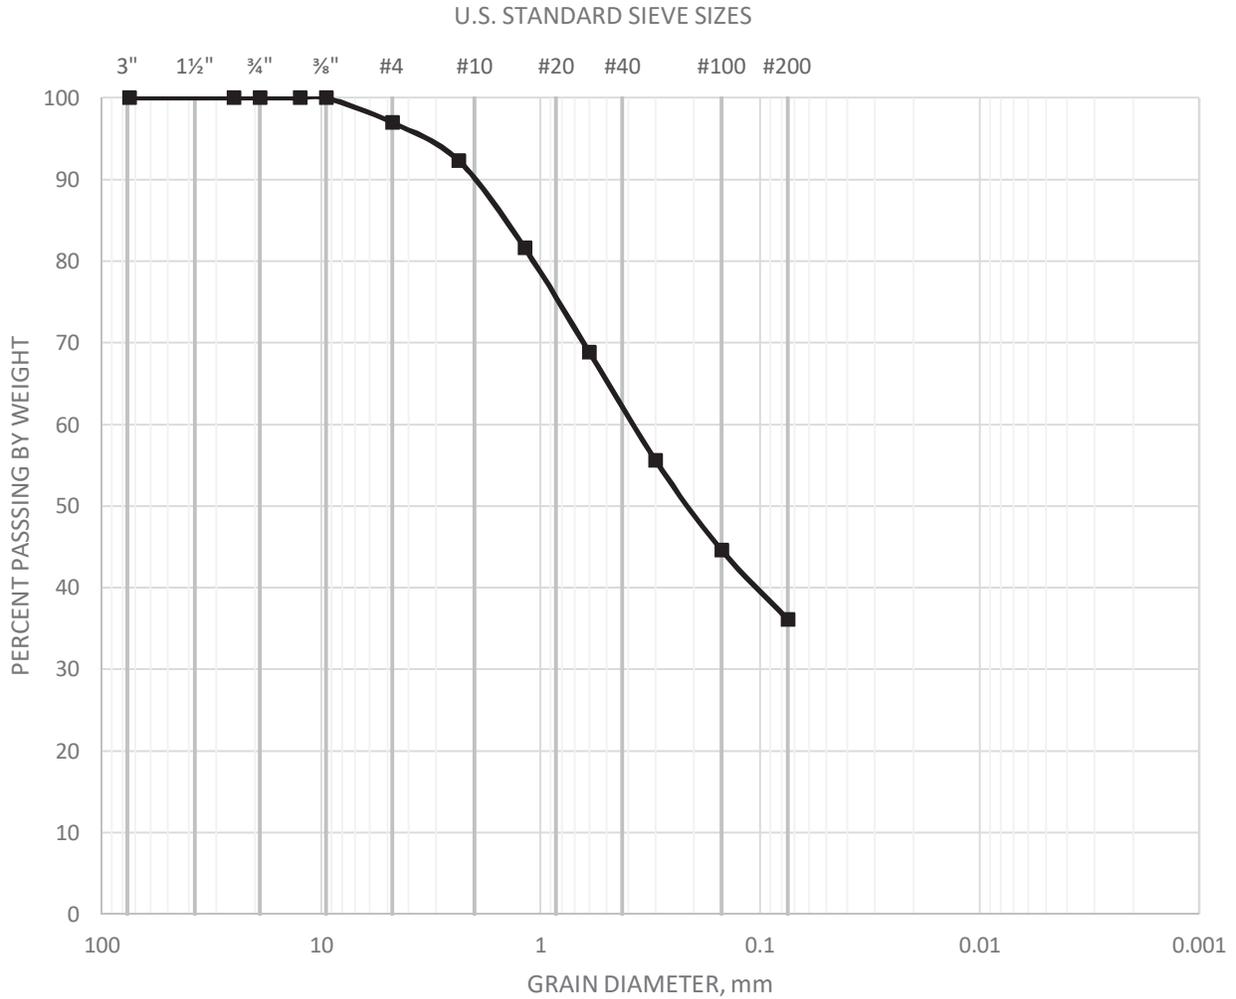
SAMPLE	CLASSIFICATION	D60	D30	D10
P7@4.5-5'	Silty SAND with trace gravel (SM), dark brown	0.4	0.044	0.008

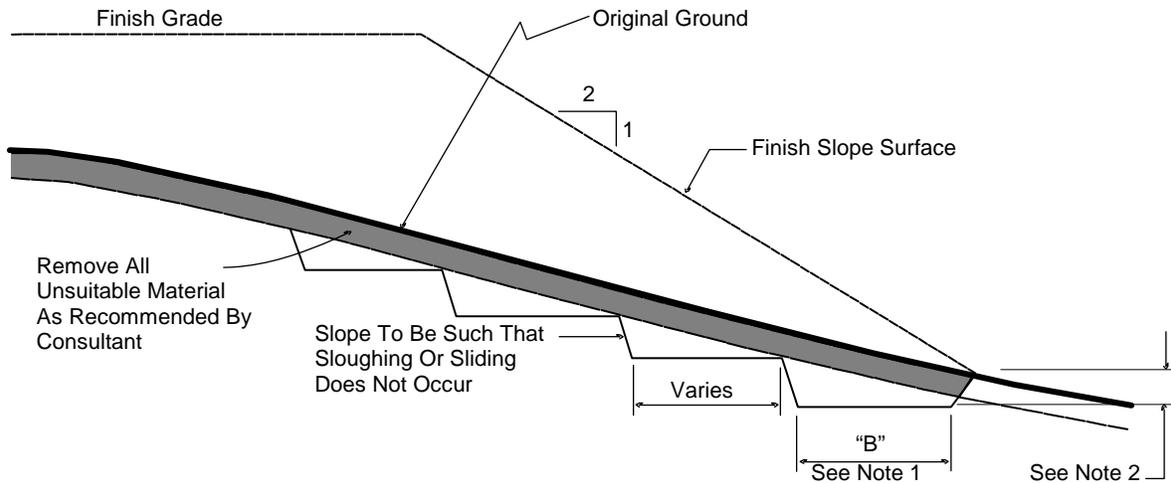
TYPICAL BENCHING DETAIL

- DETAIL NOTES: (1) Key width "B" should be a minimum of 10 feet, or sufficiently wide to permit complete coverage with the compaction equipment used. The base of the key should be graded horizontal, or inclined slightly into the natural slope.
- (2) The outside of the key should be below the topsoil or unsuitable surficial material and at least 2 feet into dense formational material. Where hard rock is exposed in the bottom of the key, the depth and configuration of the key may be modified as approved by the Consultant.

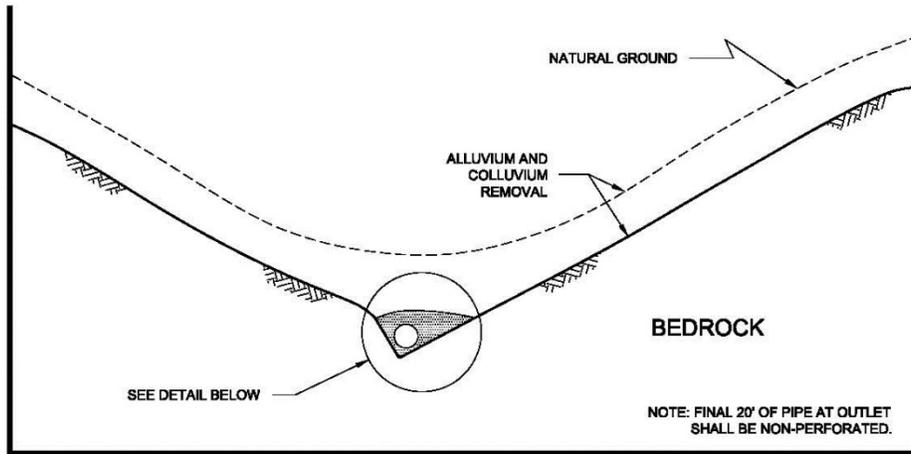
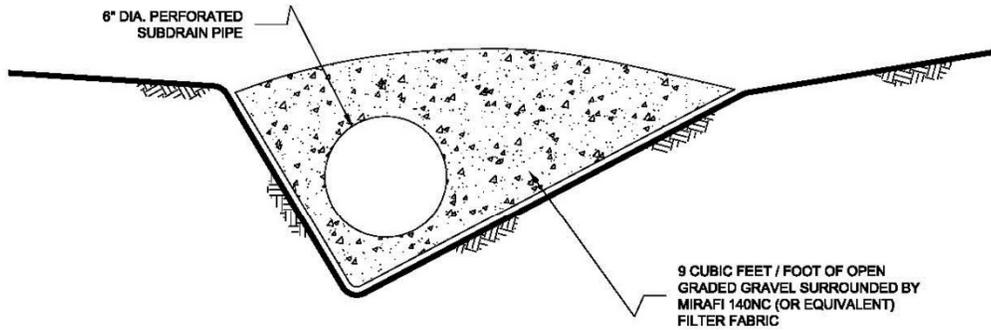
TYPICAL CANYON DRAIN DETAIL

- 1.....8-INCH DIAMETER, SCHEDULE 80 PVC PERFORATED PIPE FOR FILLS IN EXCESS OF 100-FEET IN DEPTH OR A PIPE LENGTH OF LONGER THAN 500 FEET.
- 2.....6-INCH DIAMETER, SCHEDULE 40 PVC PERFORATED PIPE FOR FILLS LESS THAN 100-FEET IN DEPTH OR A PIPE LENGTH SHORTER THAN 500 FEET.

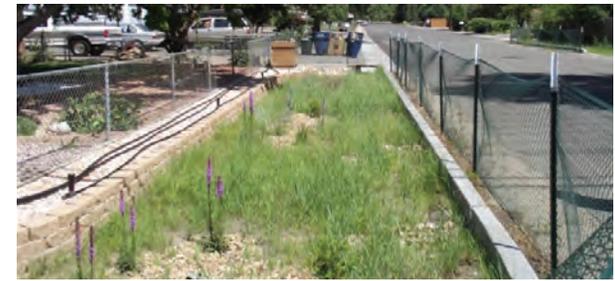
Small bioretention facilities that provide sparse vegetation may be suitable in an aviation environment.

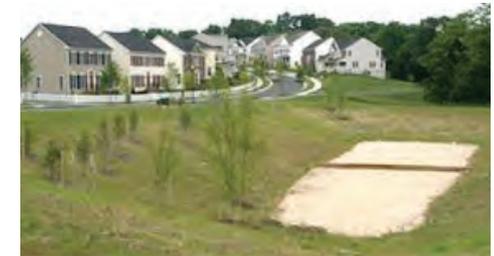
Sand filter at the base of the bioswale promotes infiltration.

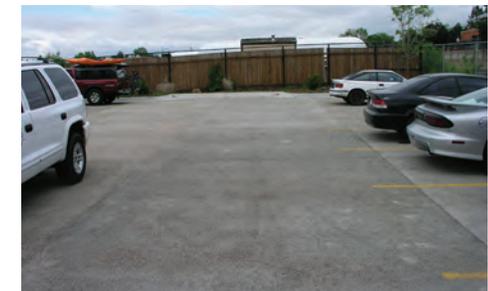
Porous pavements allow water to infiltrate to a soil layer below the surface.

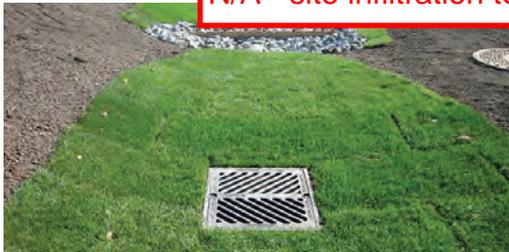
Infiltration trenches detain water for brief periods. This

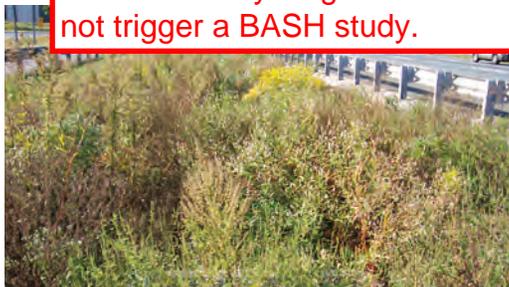
Bioretention facilities can provide food and shelter for potentially hazardous wildlife, but may be suitable with modification.

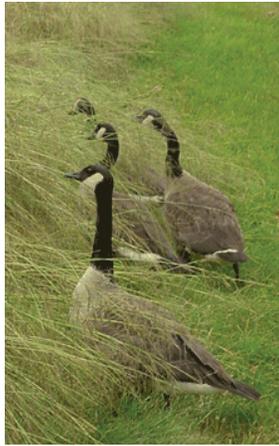
Vegetated bioswales improve water quality and prevent water accumulation. However, dense and tall vegetation may be attractive to hazardous wildlife.

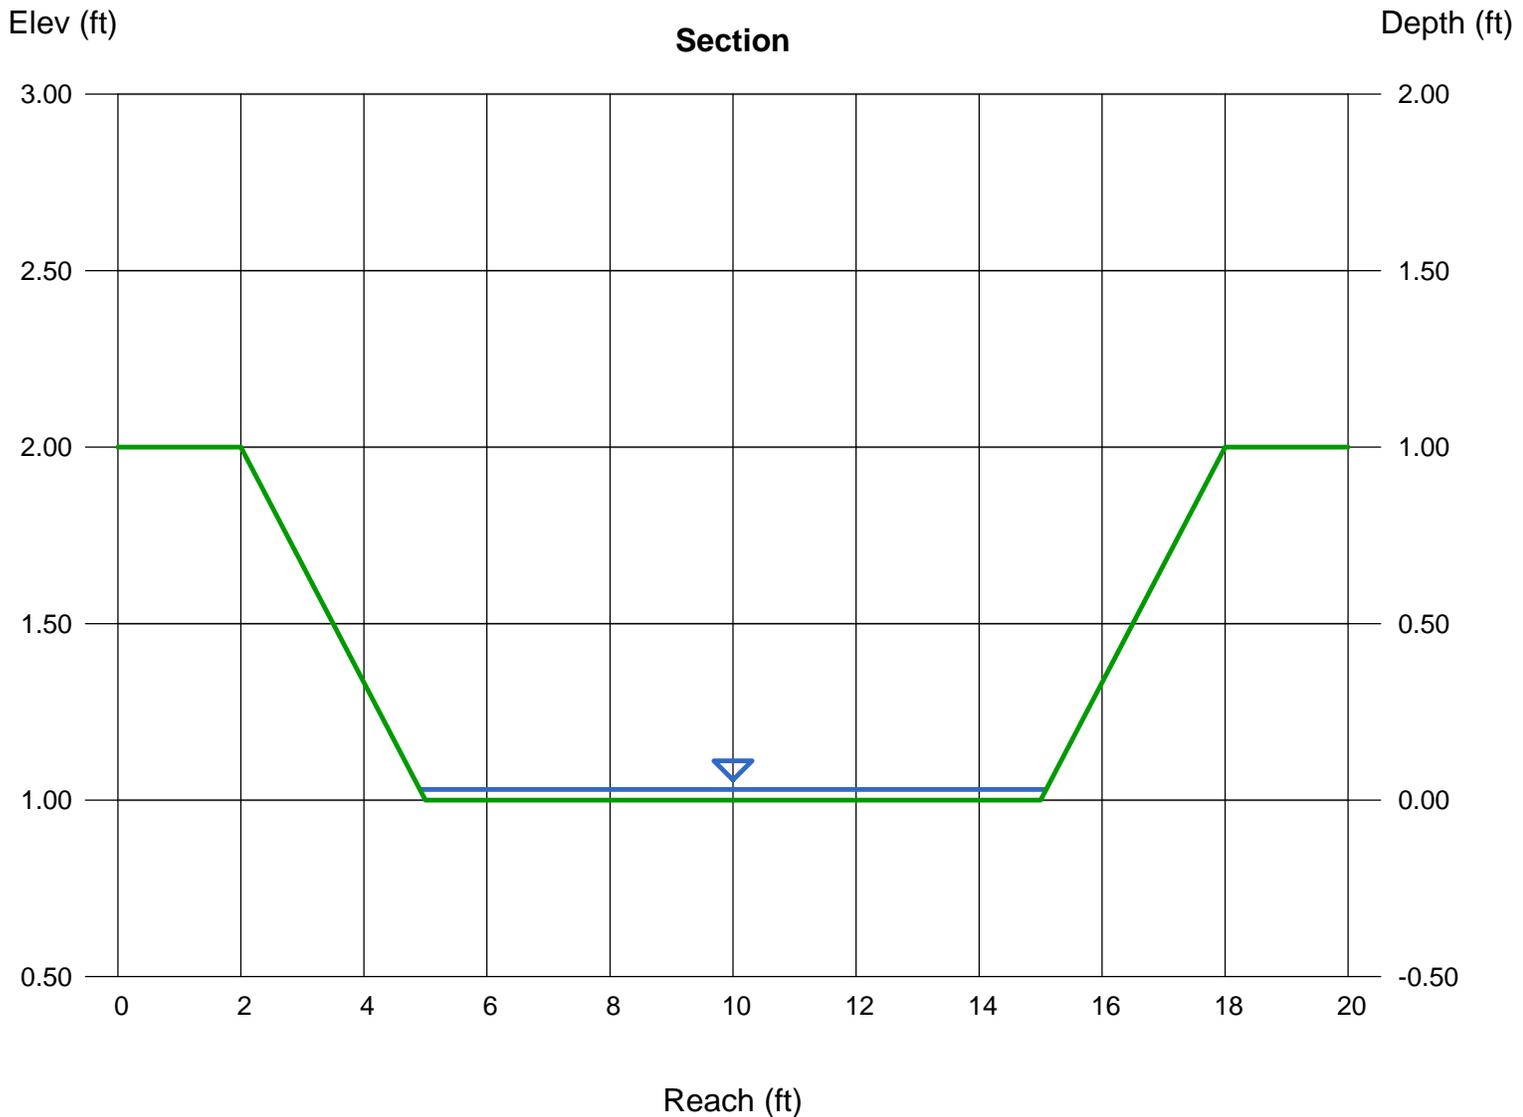
Channel Report

Compute by: Known Q
Known Q (cfs) = 0.07

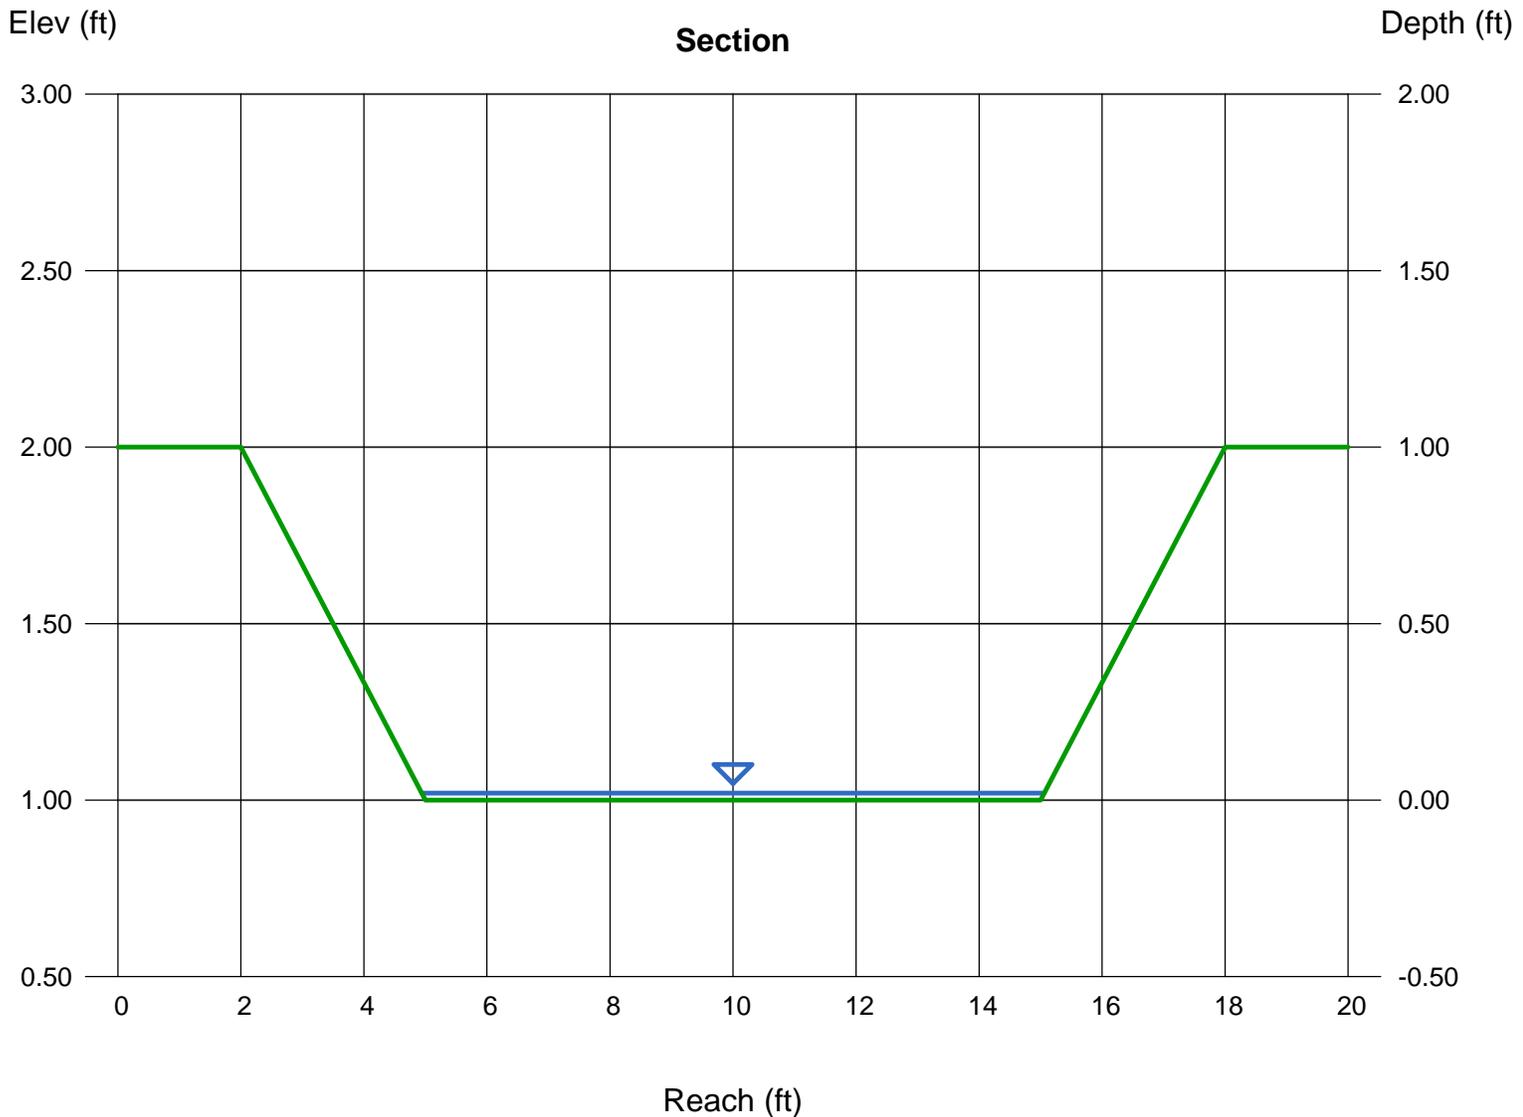
Channel Report

Compute by: Known Q
Known Q (cfs) = 0.04

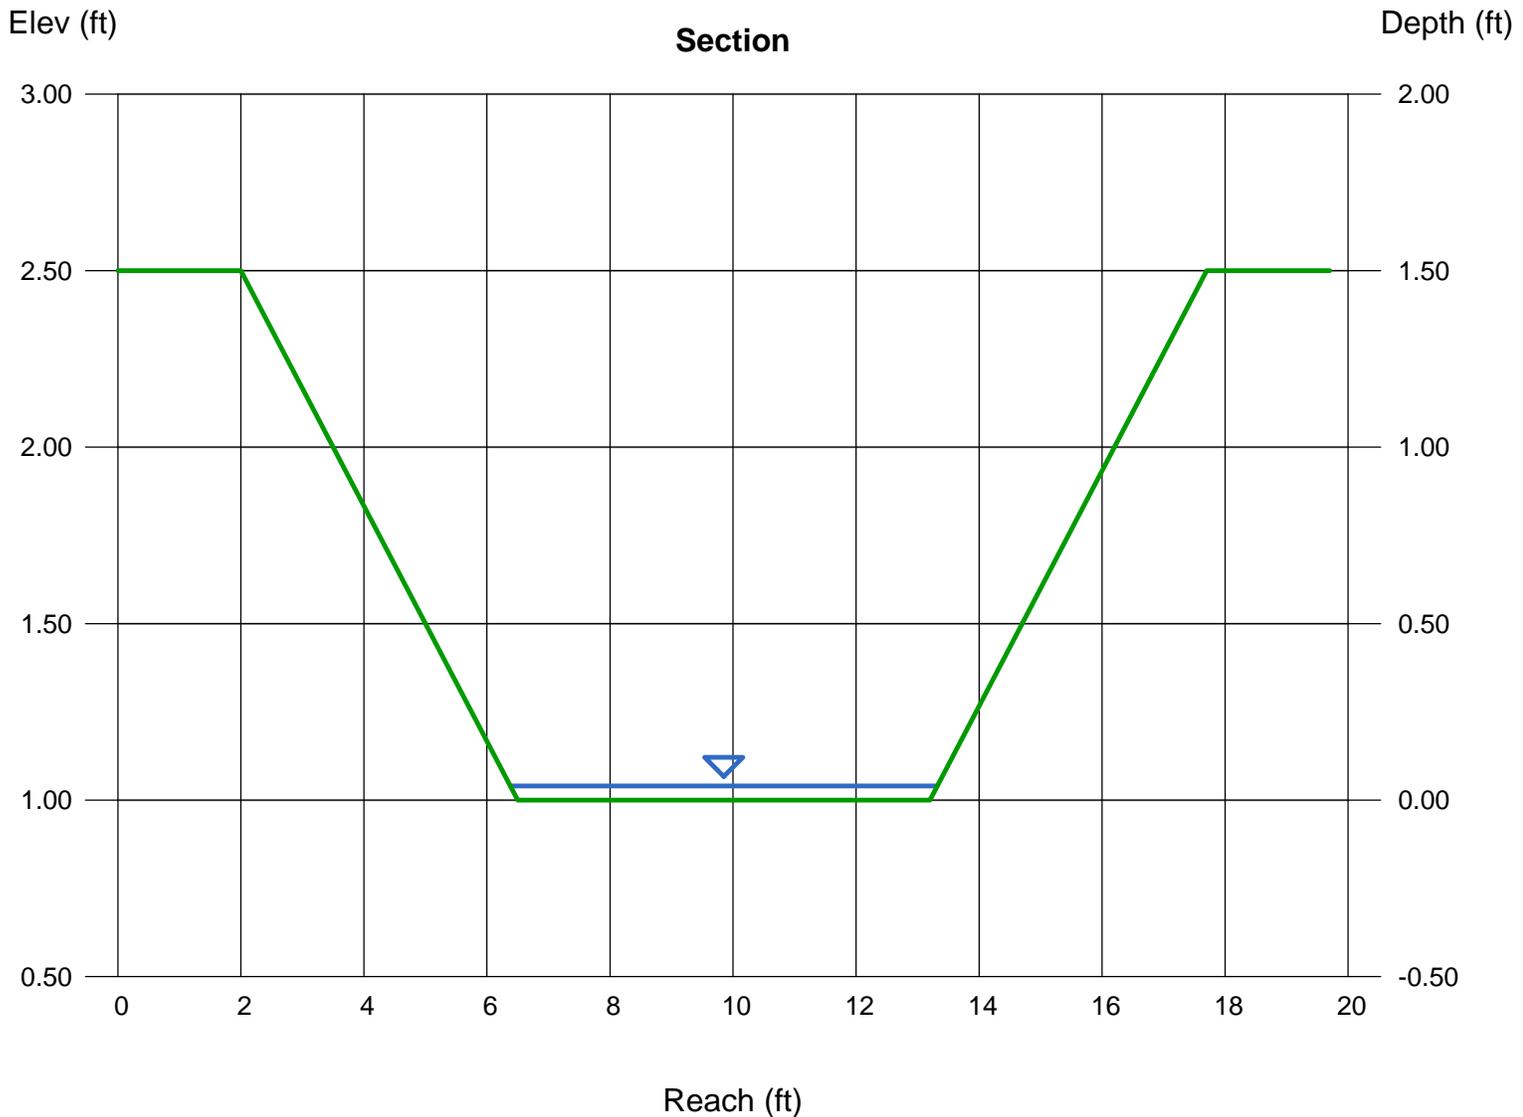
Channel Report

Compute by: Known Q
Known Q (cfs) = 0.10
