Project Specific Water Quality Management Plan

Project Title: SWC Ramona & Perris Industrial

Development No: DPR19-00012

This Project-Specific Water Quality Management Plan (WQMP) has been prepared for PR Partners, LLC by United Engineering Group CA, Inc. for the SWC Ramona & Perris Industrial Project P19-00012.

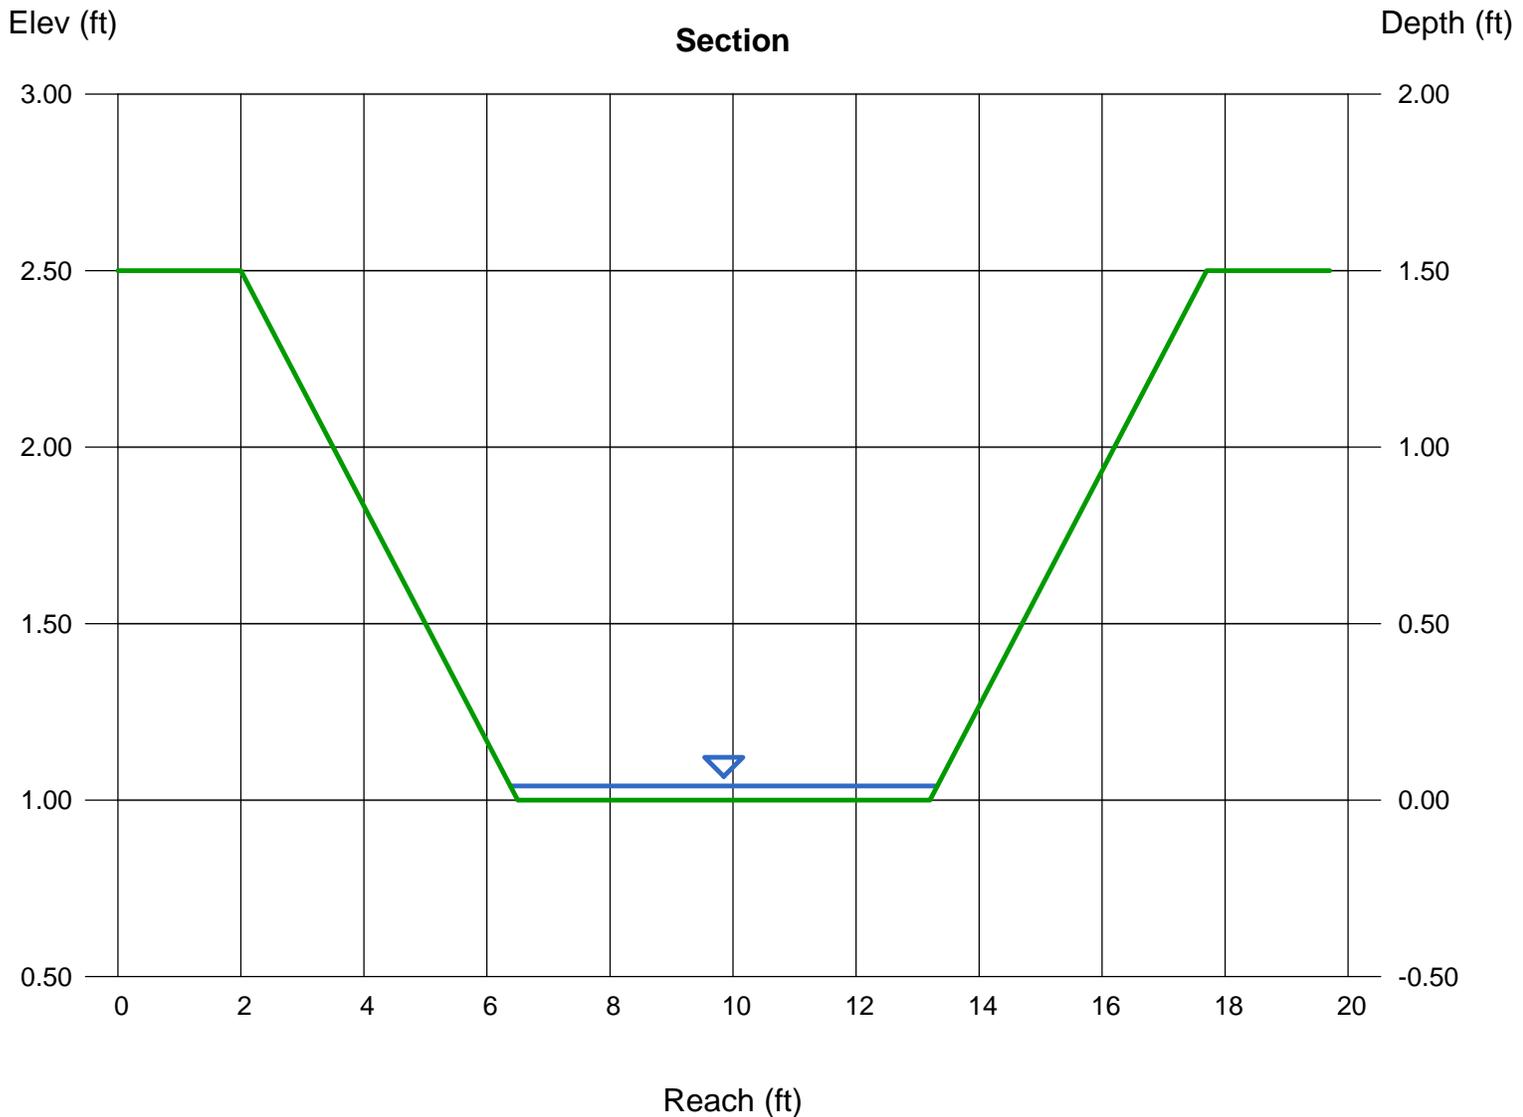
Channel Report

Compute by: Known Q
Known Q (cfs) = 0.10

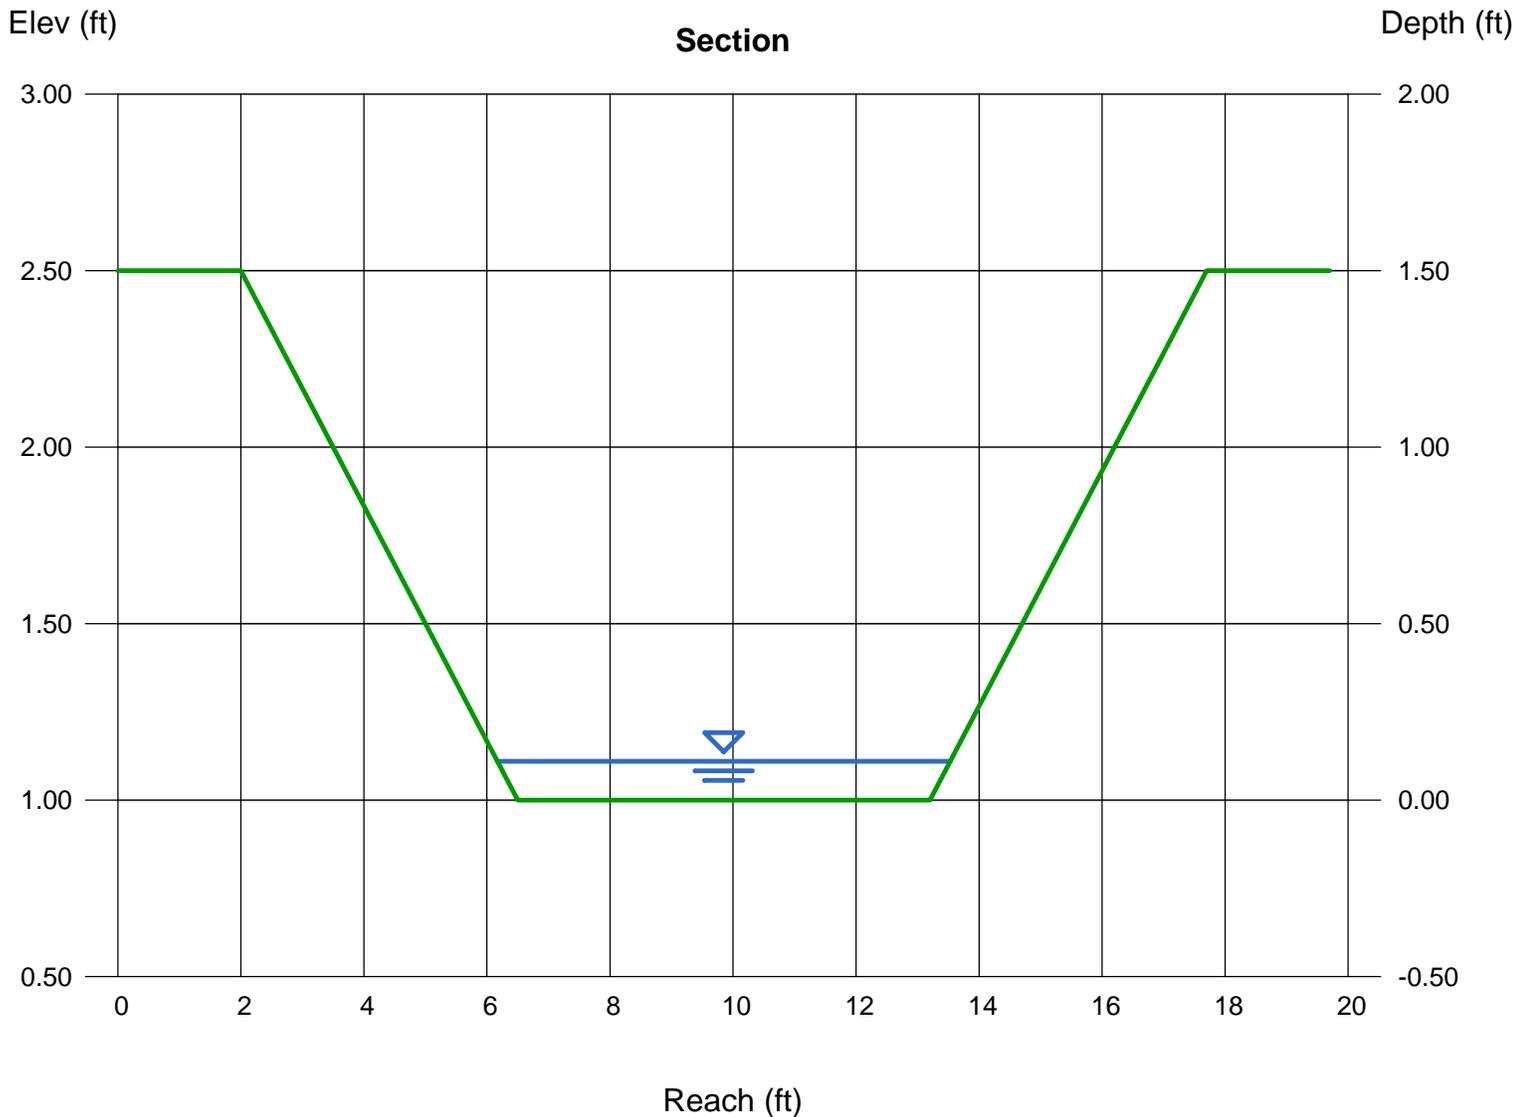
Channel Report

Compute by: Known Q
Known Q (cfs) = 0.60

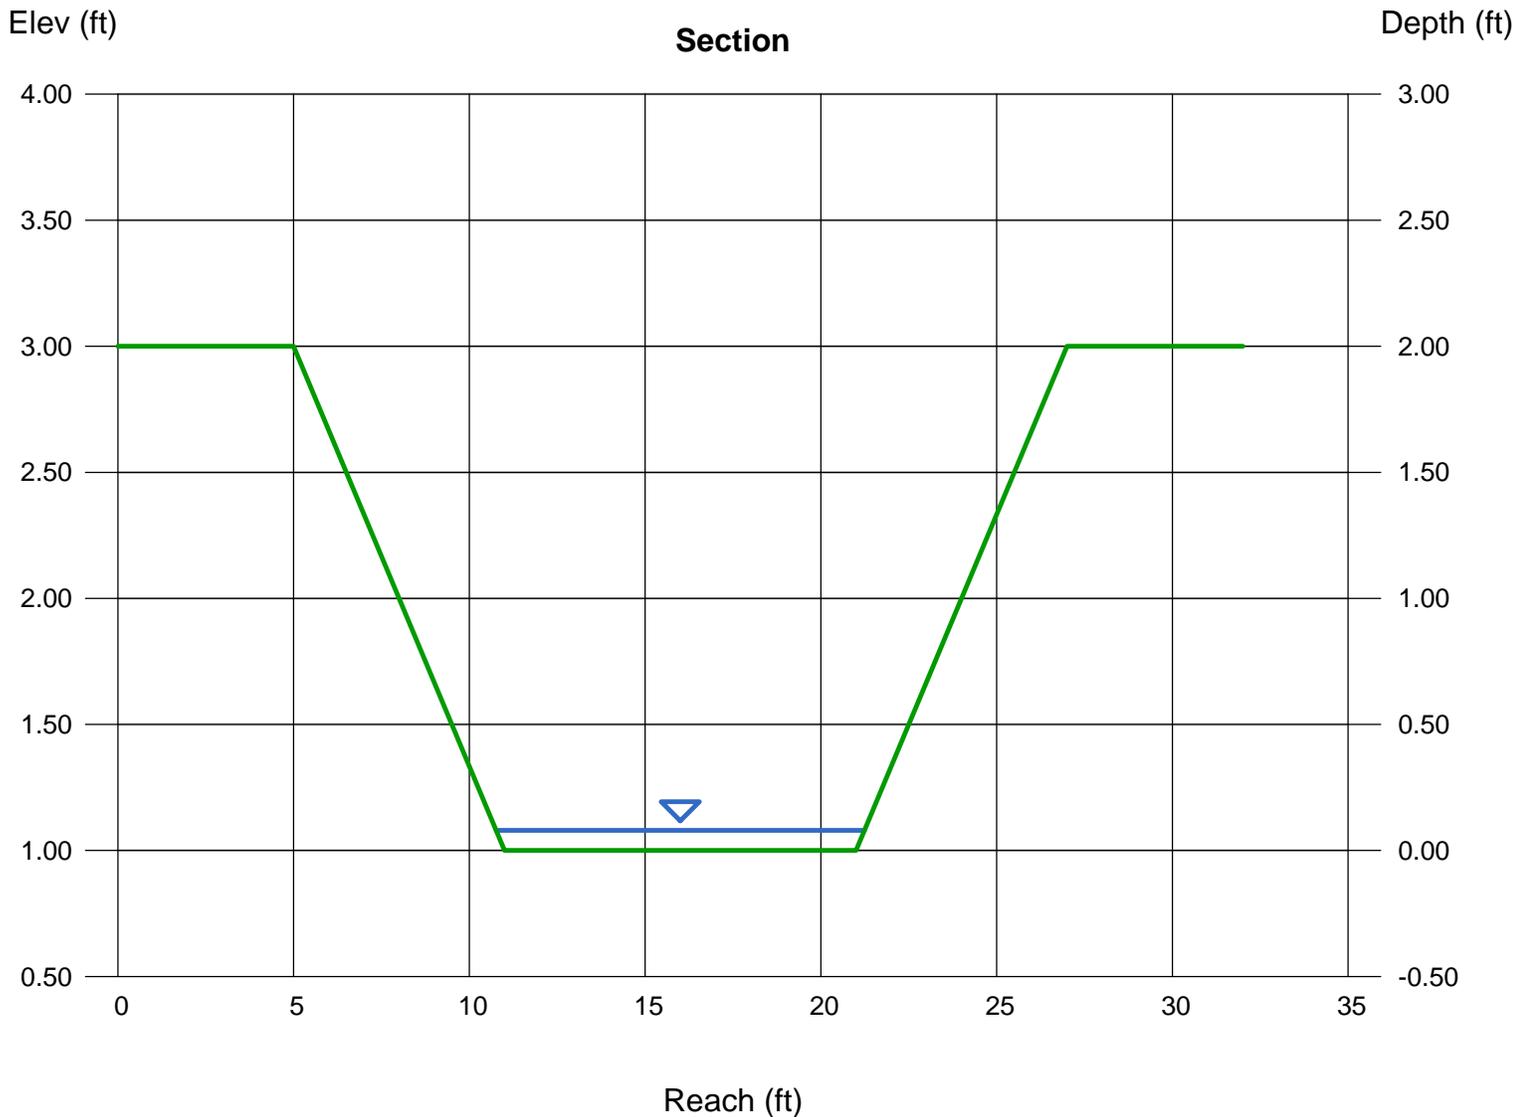
Channel Report

Compute by: Known Q
Known Q (cfs) = 0.50

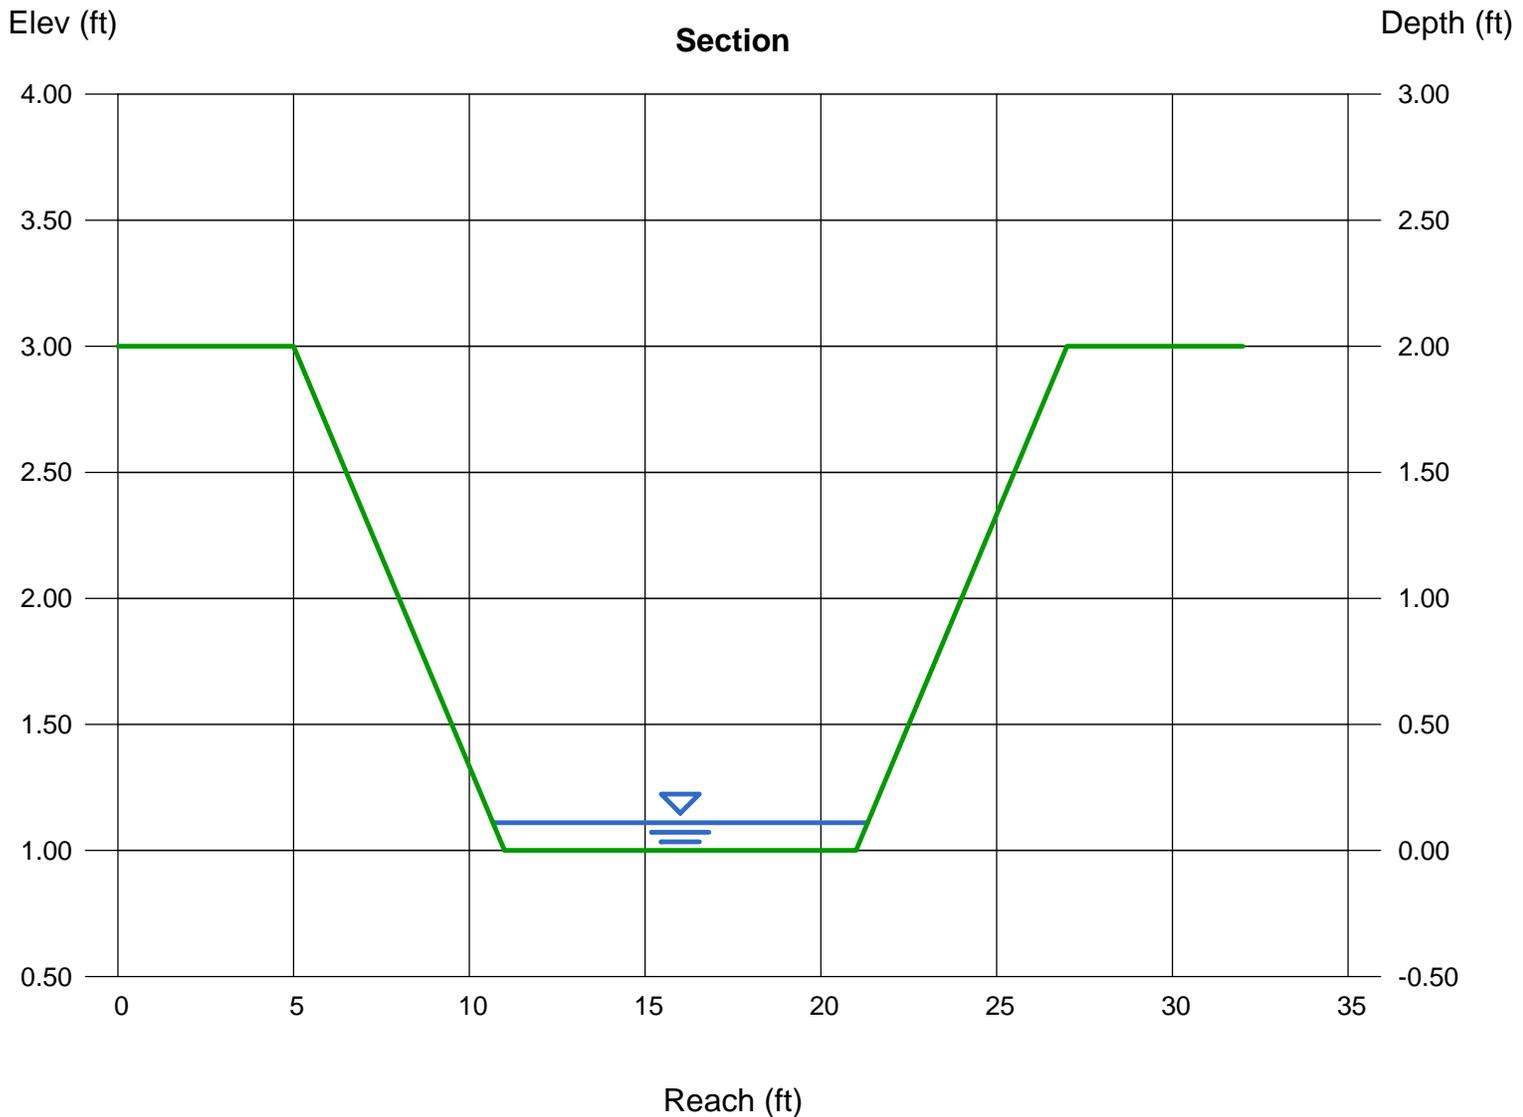
Compute by: Known Q
Known Q (cfs) = 0.90
