COUNTY OF SANTA BARBARA

# Draft Mitigated Negative Declaration

## Flood Ranch Bridge Replacement

### Case No. 20LUP-00277

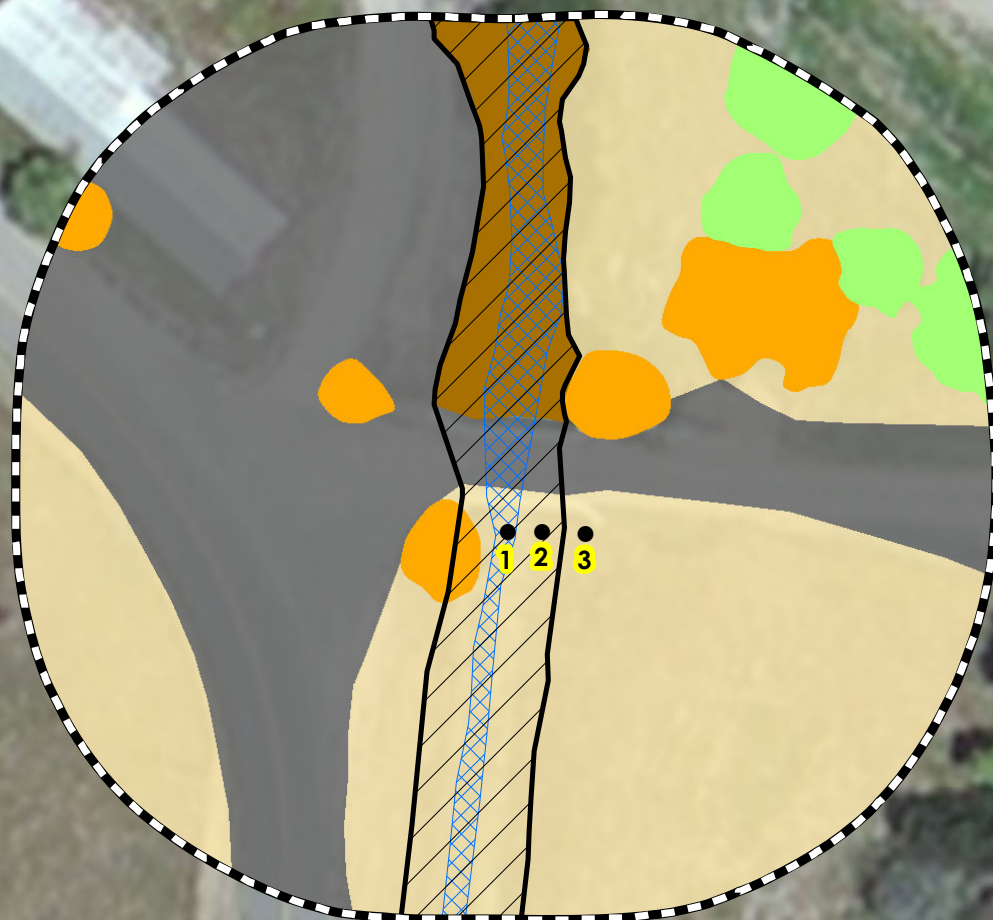
RWQCB/CDFW Jurisdiction (6,845 ft.<sup>2</sup>/ 0.16 acre)

1) Annual Grassland; 2) Developed/Ruderal; 3) Mule Fat Scrub; 4) Ornamental; and, 5) Sycamore Riparian. Each of these habitat types is described below. The areas occupied by these habitats are shown on Figure 3 and representative photographs are in Appendix C.

Annual Grassland was present in the upstream side of the channel, the former pond basin to the southeast of the bridge, in an open field to the west, and in the understory of trees to the northeast (Figure 3). The grassland area to the southeast was lightly to moderately grazed, and the area to the northeast was somewhat disturbed from nearby agricultural activities. The Annual Grassland habitat type was dominated by non-native grasses and herbs such as slender wild oat (*Avena barbata*), summer mustard (*Hirschfeldia incana*), ripgut brome (*Bromus diandrus*), soft chess (*Bromus hordeaceus*), foxtail barley (*Hordeum murinum* ssp. *leporinum*), tocalote (*Centaurea melitensis*), and bristly ox-tongue (*Helminthotheca echinoides*). These upland species occupied the Asphaltum Creek channel upstream from the bridge, and there were no hydrophytic plant species present. Areas away from the channel also had white horehound (*Marrubium vulgare*), Canada horseweed (*Erigeron canadensis*), downy chess (*Bromus tectorum*) and turkey-mullein (*Croton setiger*). This habitat type corresponds to the Non-native Grassland community described by Holland (1986) and the Wild Oats and Annual Brome Grasslands semi-natural alliance (CDFW 2020d).

No sensitive natural communities were recorded in the CNDDDB within five miles of the study area, but CDFW sensitive natural communities known to occur in the general vicinity of the site were evaluated (Appendix D). The Sycamore Riparian habitat in the study area occurred as patches of mature trees in a disturbed area along a ditch and at the edge of an agricultural field and roads (Figure 3). While it is unclear if these trees were planted, they have naturalized within the study area, and therefore could potentially be considered a sensitive natural community. The Sycamore Alluvial Woodland community has a State Rarity Rank S1.1 (CDFW 2020a), and the California Sycamore Woodlands alliance has a State Rarity Rank S3 (CDFW 2020d). This community is located in the northeastern part of the study area, away from the bridge and would not be affected by any project-related activities (Figure 3).

The Mule Fat Scrub habitat is not a sensitive natural community, but is a regulated natural resource since it is a form of riparian habitat and is growing in the channel and on the banks of Asphaltum Creek. As shown in Figure 3 and described in Section 3.2, the Asphaltum Creek channel contains areas that are expected to be regulated as Non-wetland Other Waters of the United States and Waters of the State. Mule Fat Scrub is common throughout the project region, and is not considered to be a sensitive natural community by Holland (1986) or the CDFW based on review of the CNDDDB. The Mulefat Thickets alliance has a State Rarity Rank of S4 (CDFW 2020d), which is not considered rare under CEQA. None-the-less, areas where Mule Fat Scrub occurs within the Asphaltum Creek channel would be regulated by CDFW pursuant to California Fish and Game Code and the RWQCB pursuant to the Clean Water Act and Porter-Cologne Water Quality Act.

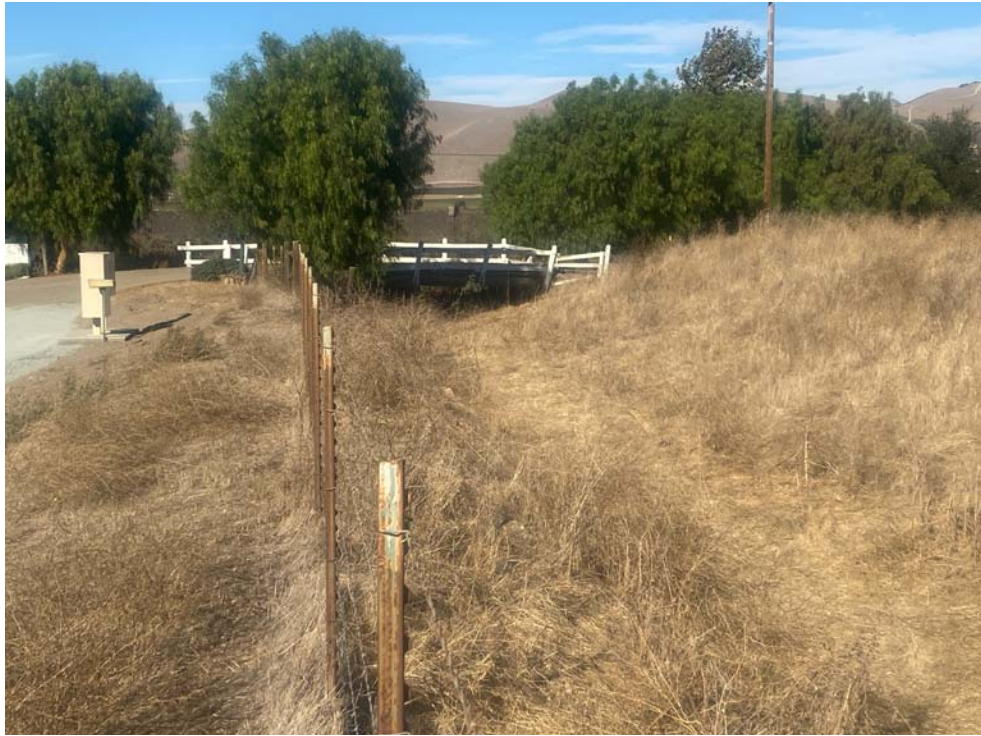
**Photo 1.** Annual Grassland habitat on the upstream side of the bridge, looking downstream (north). Non-native Peruvian pepper trees (*Schinus molle*) surround the bridge and represent the Ornamental habitat type.

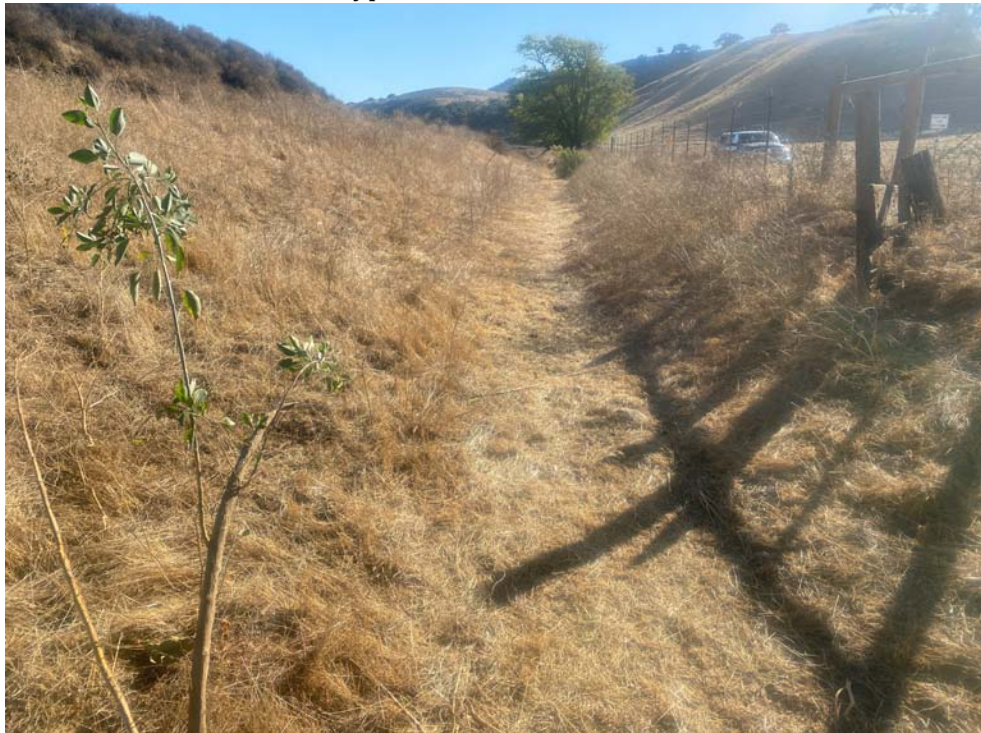
**Photo 2.** View of the Asphaltum Creek channel looking upstream. The Annual Grassland habitat in the channel had been trampled by cattle, but otherwise grazing was light to moderate. The channel appeared to have been modified into a ditch along the road.

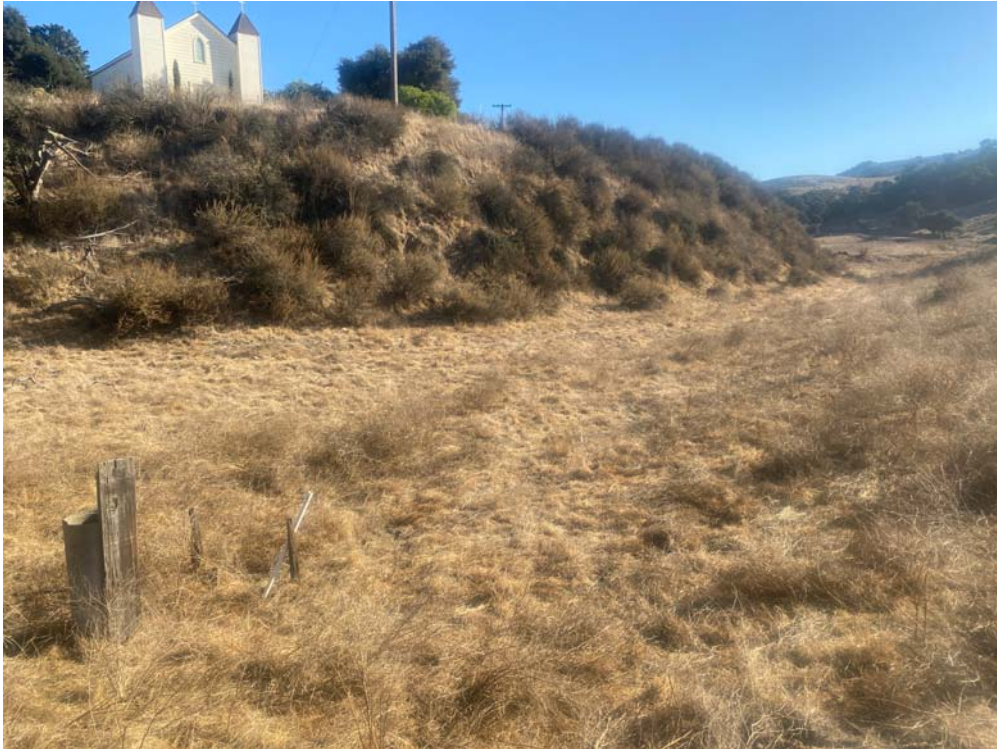
**Photo 3.** View of the former pond basin in the southeast part of the study area. It was vegetated by upland Annual Grassland species and had no indication of ponded water. A pipe that presumably drained it is seen on the left, and the San Ramon Chapel is on the hill.

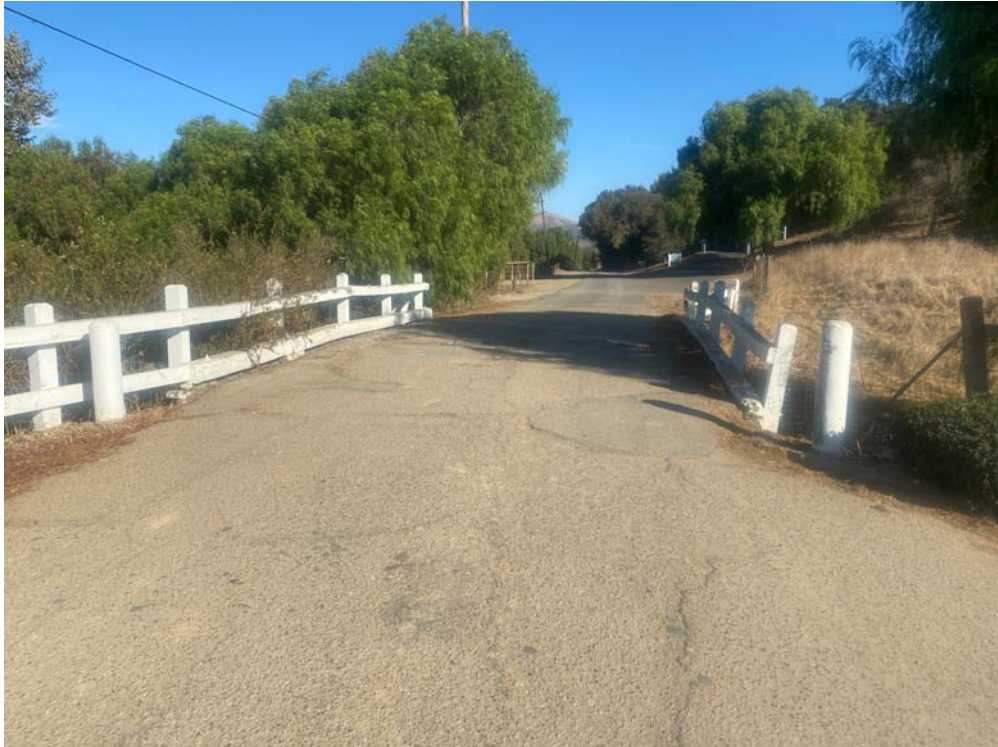
**Photo 5.** View of the bridge looking east along Forest Route 10N06 that accesses the winery property. This area was mapped as Developed/Ruderal.

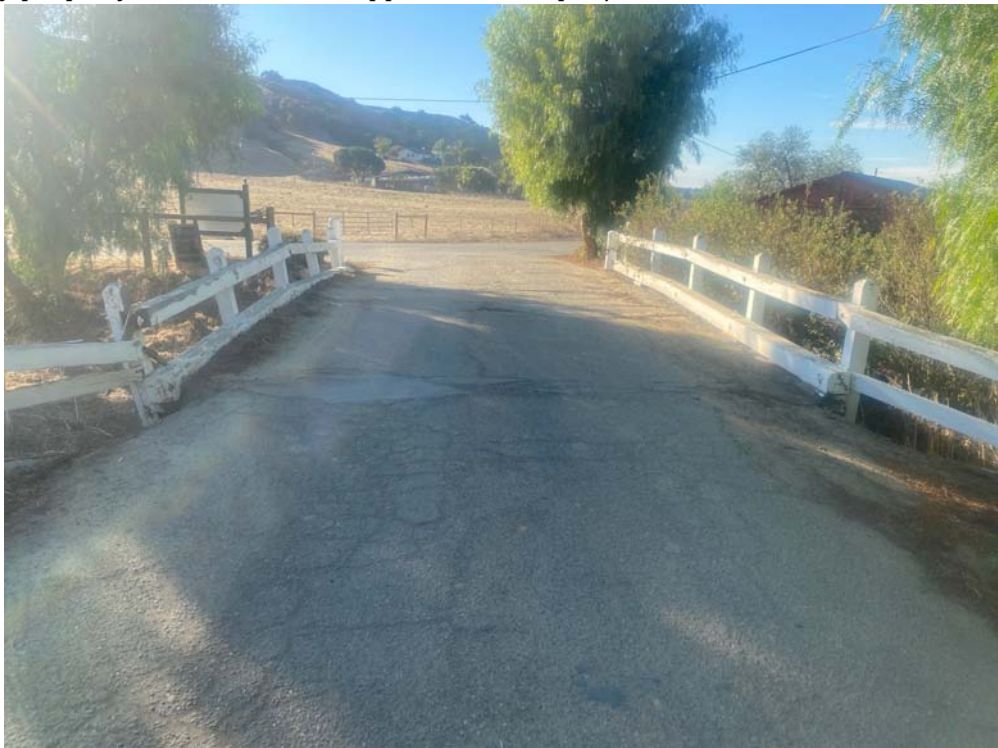
**Photo 6.** View of the bridge looking west toward Foxen Canyon Road.

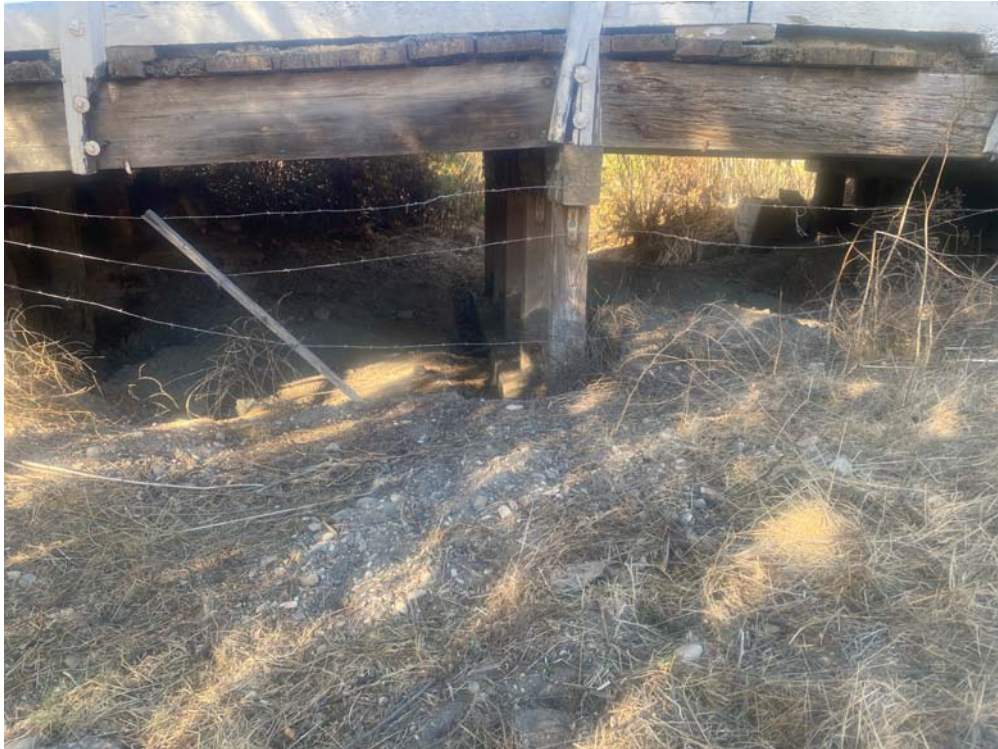
**Photo 7.** View under the bridge showing structural issues and sedimentation around the piers.

The existing bridge is a wooden structure that is unstable and requires replacement. The abutments are located on each creek bank and a pier is anchored in the stream channel. The proposal is to avoid work in the active channel and replace the bridge in a phased approach. New abutments would be installed in the existing roadway prism, and a 24-foot wide by 40-foot long pre-manufactured bridge deck would be laid on top of the new abutments. Construction would be phased to permit vehicle access on one lane of the bridge (see Appendix A for the Grading and Drainage Plan prepared by Above Grade Engineering on June 29, 2020). One lane would be closed, and trench plates cast for bridge abutments, then opened up to traffic. Then the other one-half of the road width would be closed and constructed. The existing railings, asphalt on the top of the bridge deck and the deck would be carefully removed in a manner to prevent material from falling into the creek channel. The existing wood piers would be carefully removed and the new bridge deck will span over their current elevation by several feet. The trench plates will be removed from protecting the new abutments, and the new bridge will be set in place and anchored per the manufacturer's specifications through the use of weld plates. Approach ramps will be constructed on both ends using Class 2 base and then covered with new paving. All work is proposed to be conducted when water is not present, from the top of bank of the existing road surface, and no vehicles or materials would be placed in the channel.

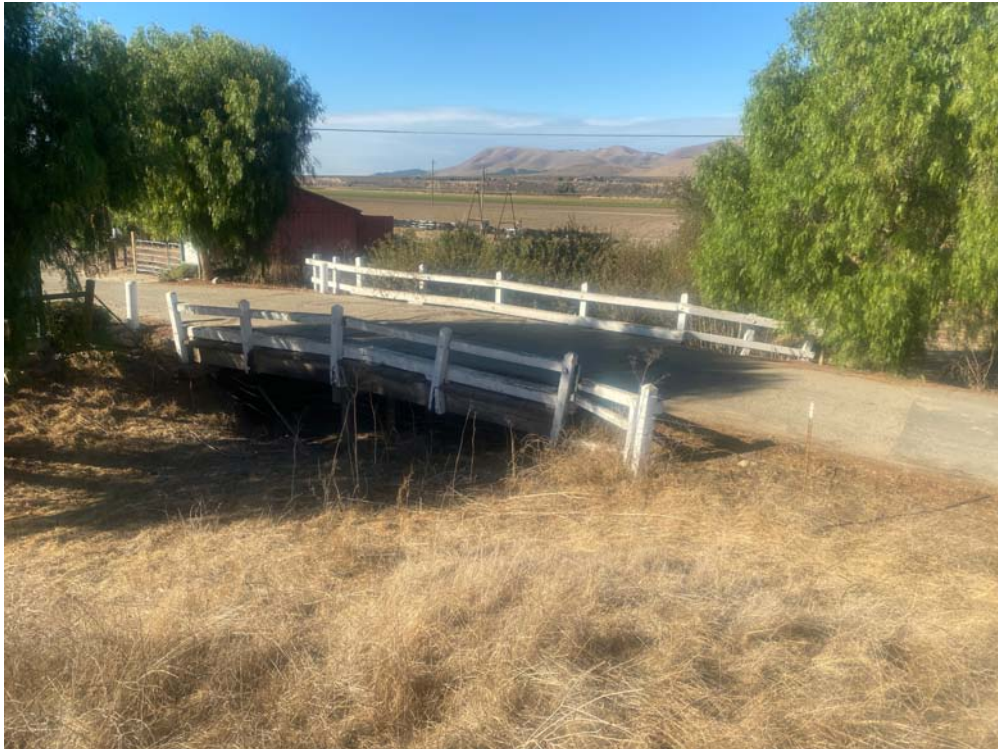
**Photo 8.** View of the immediate area surrounding the bridge, looking northwest. The banks on the upstream side are Annual Grassland (foreground) and there are Ornamental Peruvian pepper trees surrounding it. Agricultural land uses are in the larger area.

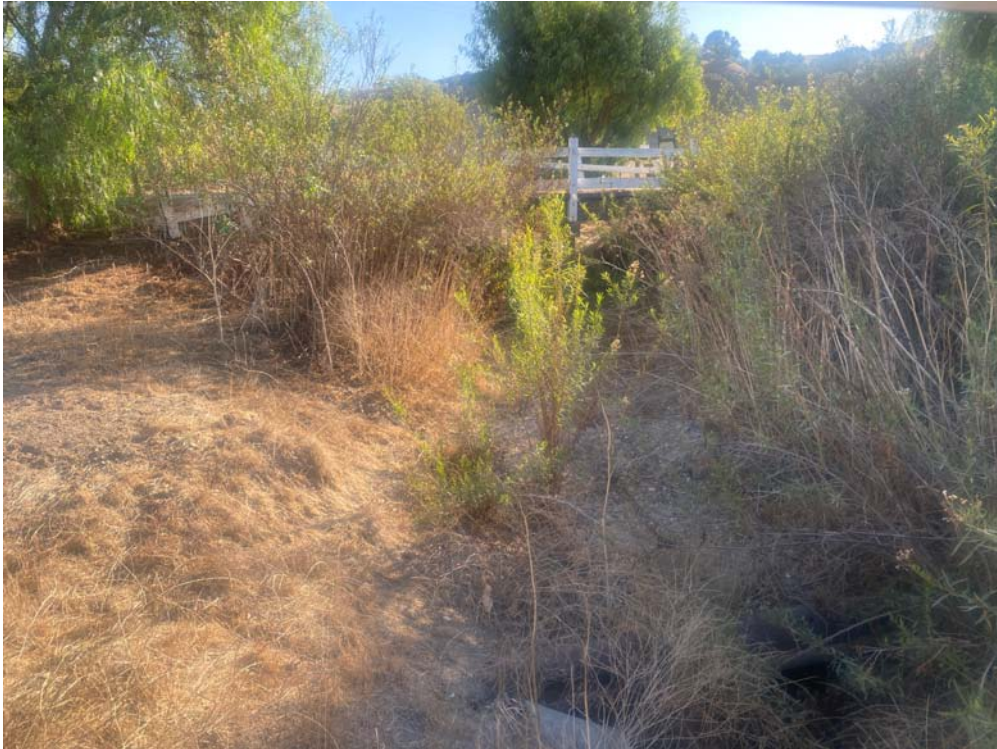
**Photo 9.** Mule Fat Scrub habitat downstream from the bridge, looking upstream. The channel bottom below the OHWM was determined to potentially be under USACE jurisdiction. The extent of the RWQCB/CDFW jurisdictional area was the top of bank or edge of riparian, whichever was further from the channel.

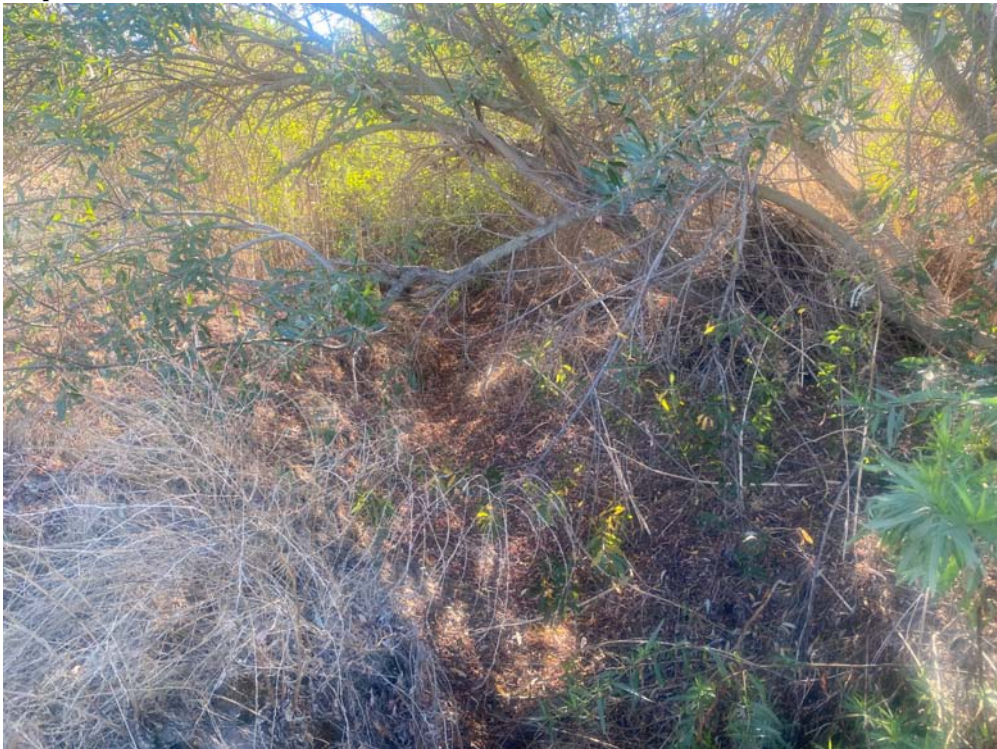
**Photo 10.** Additional view of the channel downstream from the bridge in Mule Fat Scrub habitat. Dominant species were mule fat (*Baccharis salicifolia*) and arroyo willow (*Salix lasiolepis*).

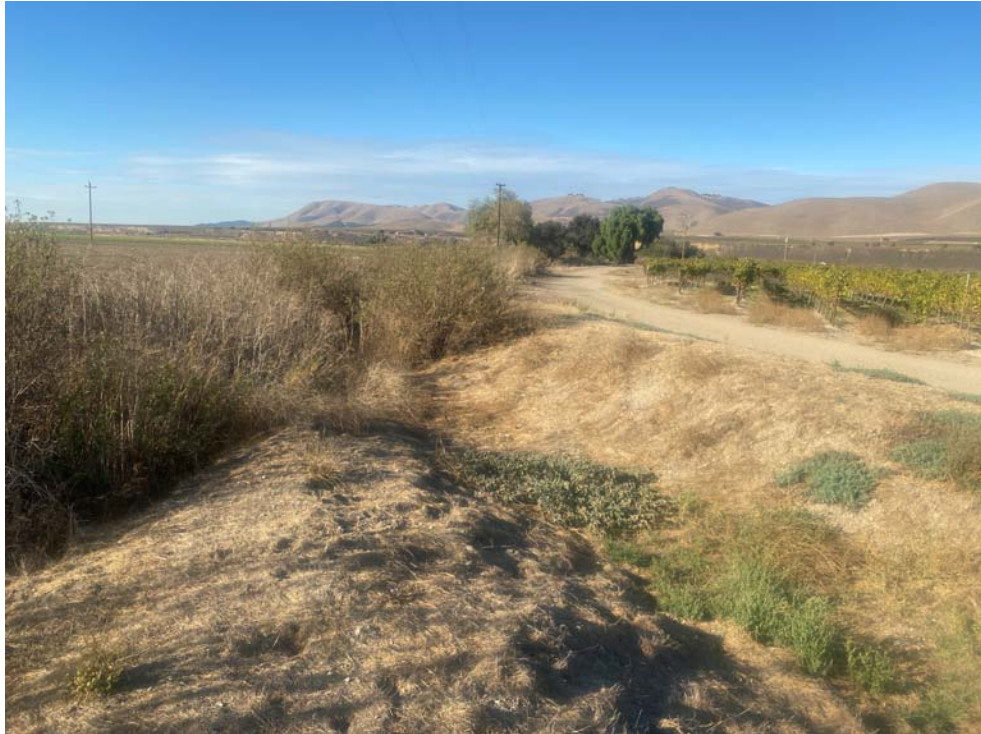
**Photo 11.** Northerly view of Asphaltum Creek at the confluence of a constructed ditch from the vineyard. The Sisquoc River channel is in the background, and the channel is surrounded by agricultural fields.

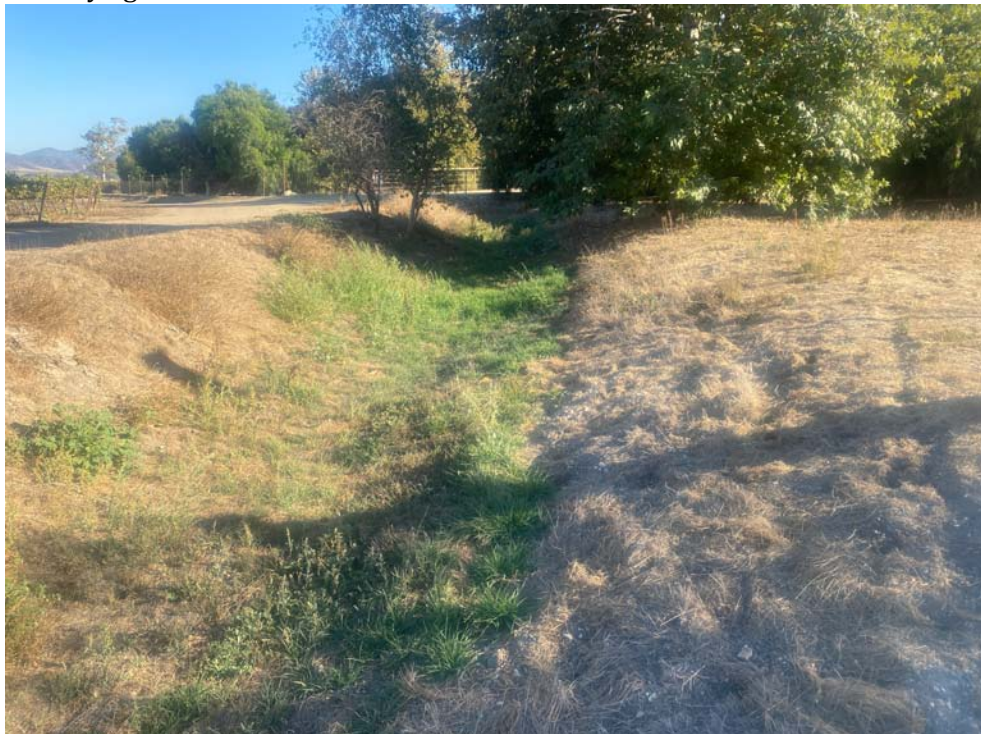
**Photo 12.** View of the ditch that runs along the edge of an agricultural field to the northeast of the bridge, which joins Asphaltum Creek downstream from the bridge. Sycamore Riparian occurred in patches along the ditch, and may be a remnant of historic Sycamore Alluvial Woodland along Sisquoc River. This area was disturbed by agricultural activities and roads; thus, was fragmented and did not function as an intact Riparian habitat.
