### **Phase II Investigation**

**Report of Phase II Investigation  
Northwest Corner of Milliken Avenue  
and Jersey Boulevard  
Rancho Cucamonga,  
San Bernardino County, California**

August 7, 2015

File No.: 08935-03  
Doc. No.: 15-08-703

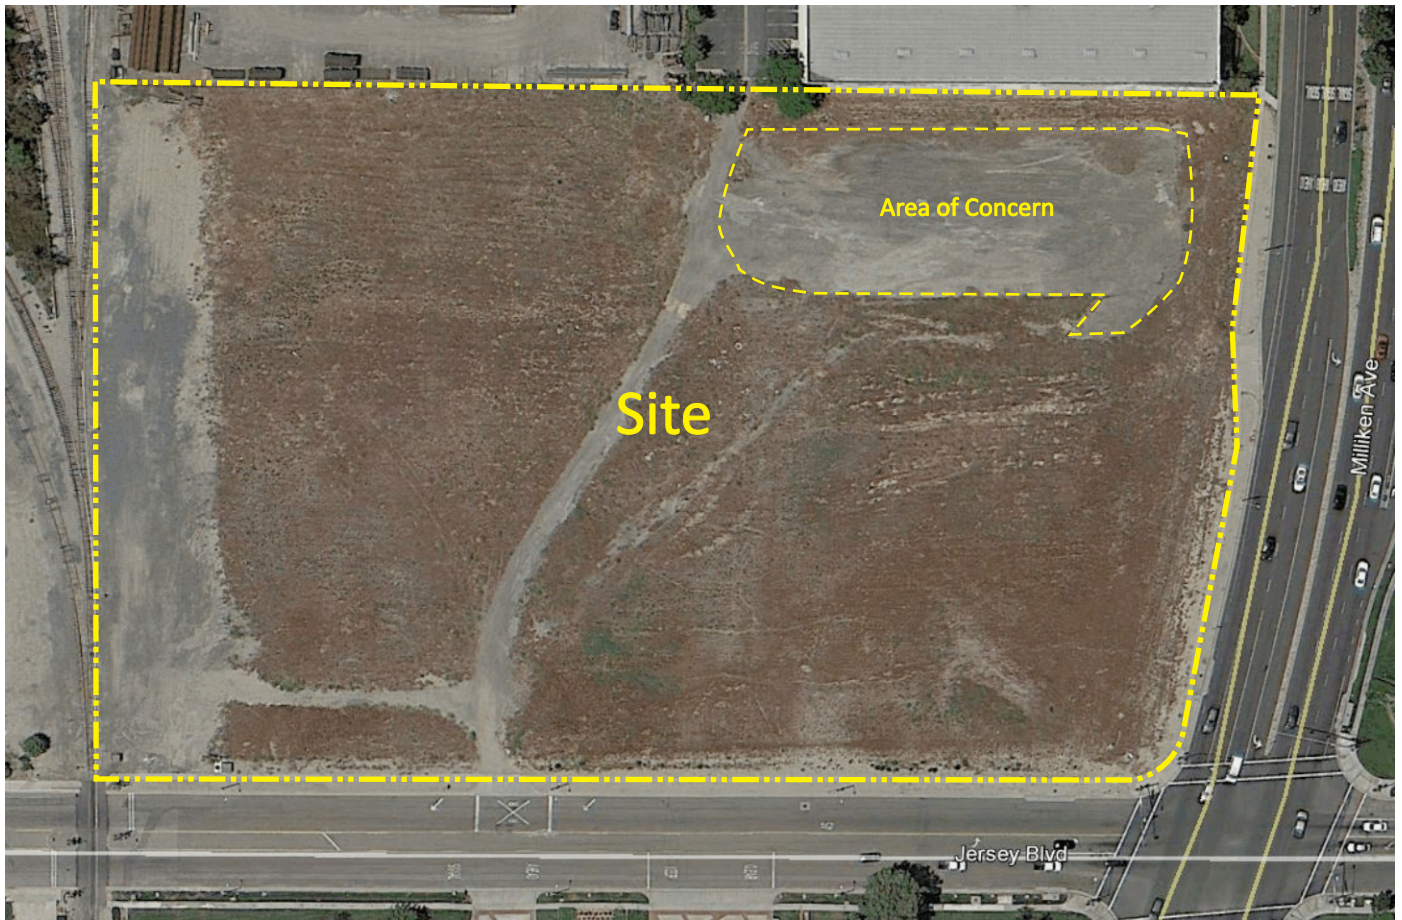
**Figure 2  
Site Layout**

The site consists of approximately 7.3 acres of undeveloped land located at the northwest corner of Milliken Avenue and Jersey Boulevard in Rancho Cucamonga, California (Figure 2, Appendix A). The site is bound by Jersey Boulevard to the south, Milliken Avenue to the east commercial/industrial developments to the north, and a BNSF Railroad spur right-of-way on the west. The site is relatively flat and elevated about 5 feet above Jersey Boulevard. An unpaved road bisects the property from north to south and leads to the slag area in the northeast quadrant of the site, which is devoid of vegetation (Figure 2).

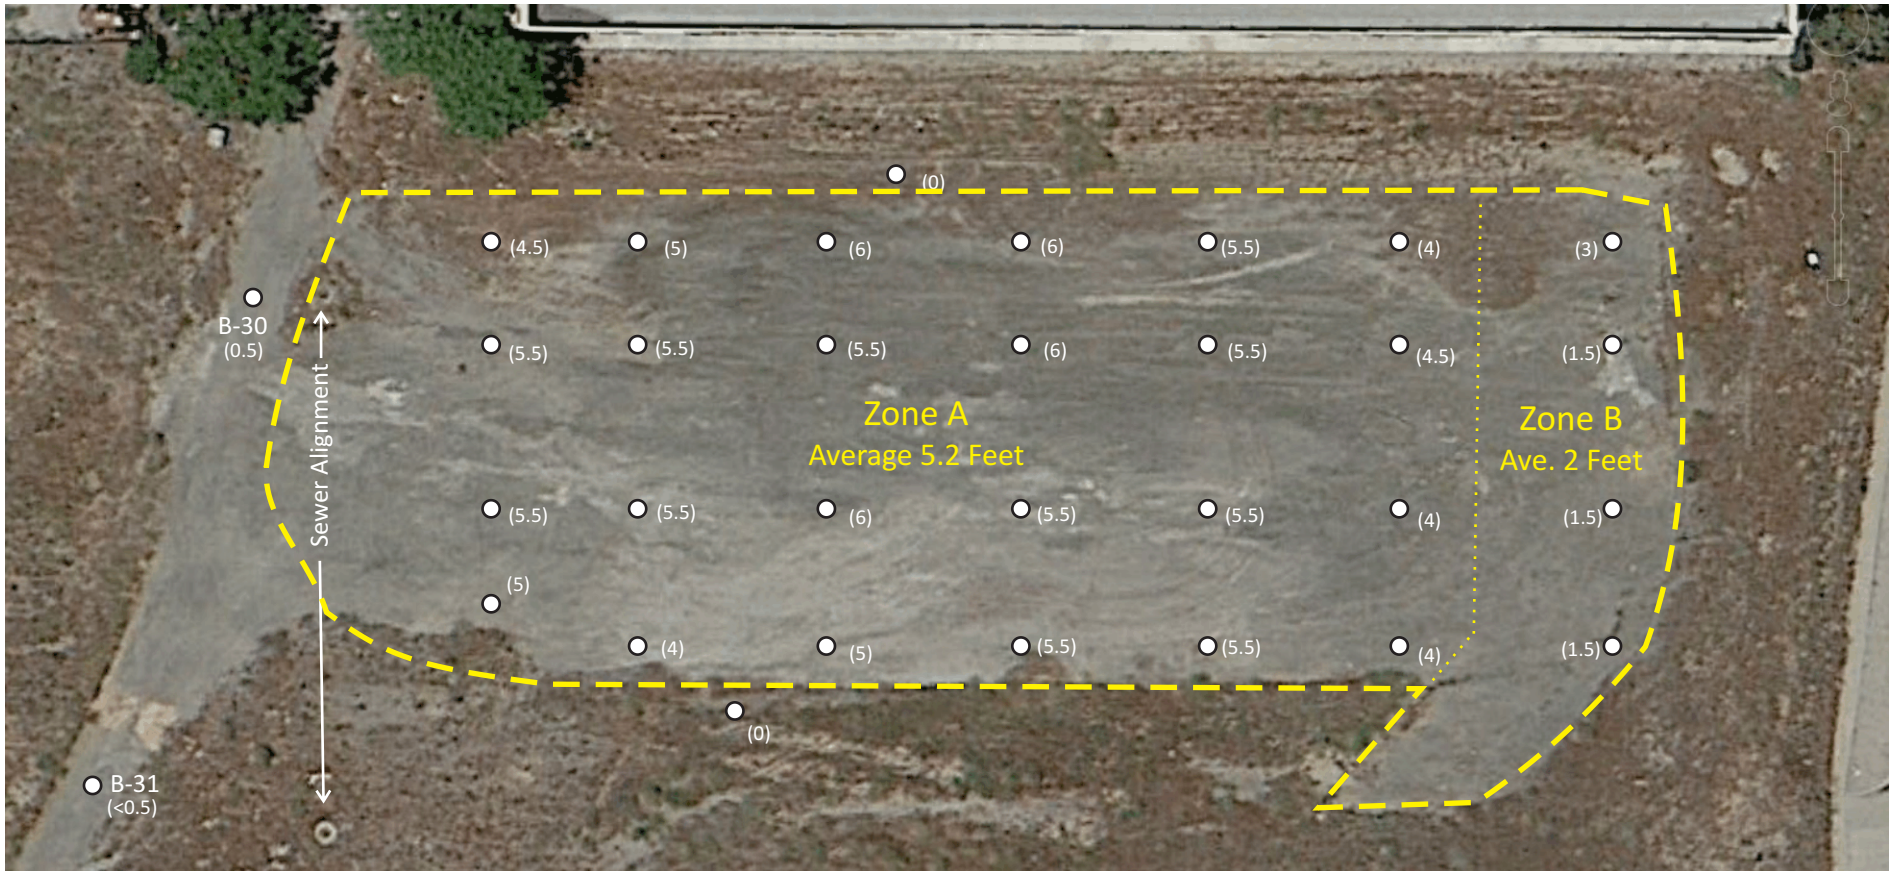
#### Figure 4 Fill Thickness Contours

The volume of slag and fine-grained material was estimated by dividing the area of investigation into 2 zones based on the thickness observed, then multiplying the lateral dimensions of each zone by the average thickness of each zone, as shown in Figure 4 and summarized as follows:

Zone A – Main slag area, approximately 250 feet east-west and 100 feet north-south, with an average thickness of 5.2 feet. Total volume is approximately 4,800 cubic yards.

Zone B - Eastern Edge, approximately 40 feet east-west and 130 feet north-south, with an average thickness of about 2 feet. Total volume is approximately 400 cubic yards.

The two zones total approximately 5,200 cubic yards of slag and associated fine-grained material. Assuming a density of 1.5 tons per cubic yard, the total weight is approximately 7,800 tons. At 15 tons per truck-load, that is equivalent to 520 truck-loads of material. Due to the uncertainty inherent in this evaluation methodology, it may be prudent to “round up” for budgeting purposes, and use a volume of 6,000 cubic yards and a weight of 9,000 tons, which is equivalent to about 600 truck-loads of material.

6. The volume of slag and fine-grained material is estimated to total 5,200 cubic yards. At 1.5 tons per cubic yard, this volume would weigh 7,800 tons and fill 520 trucks (at 15 tons per truck). Given the uncertainty of this analysis, it would be prudent to “round up” and assume a volume of 6,000 cubic yards and 9,000 tons, filling about 600 trucks.

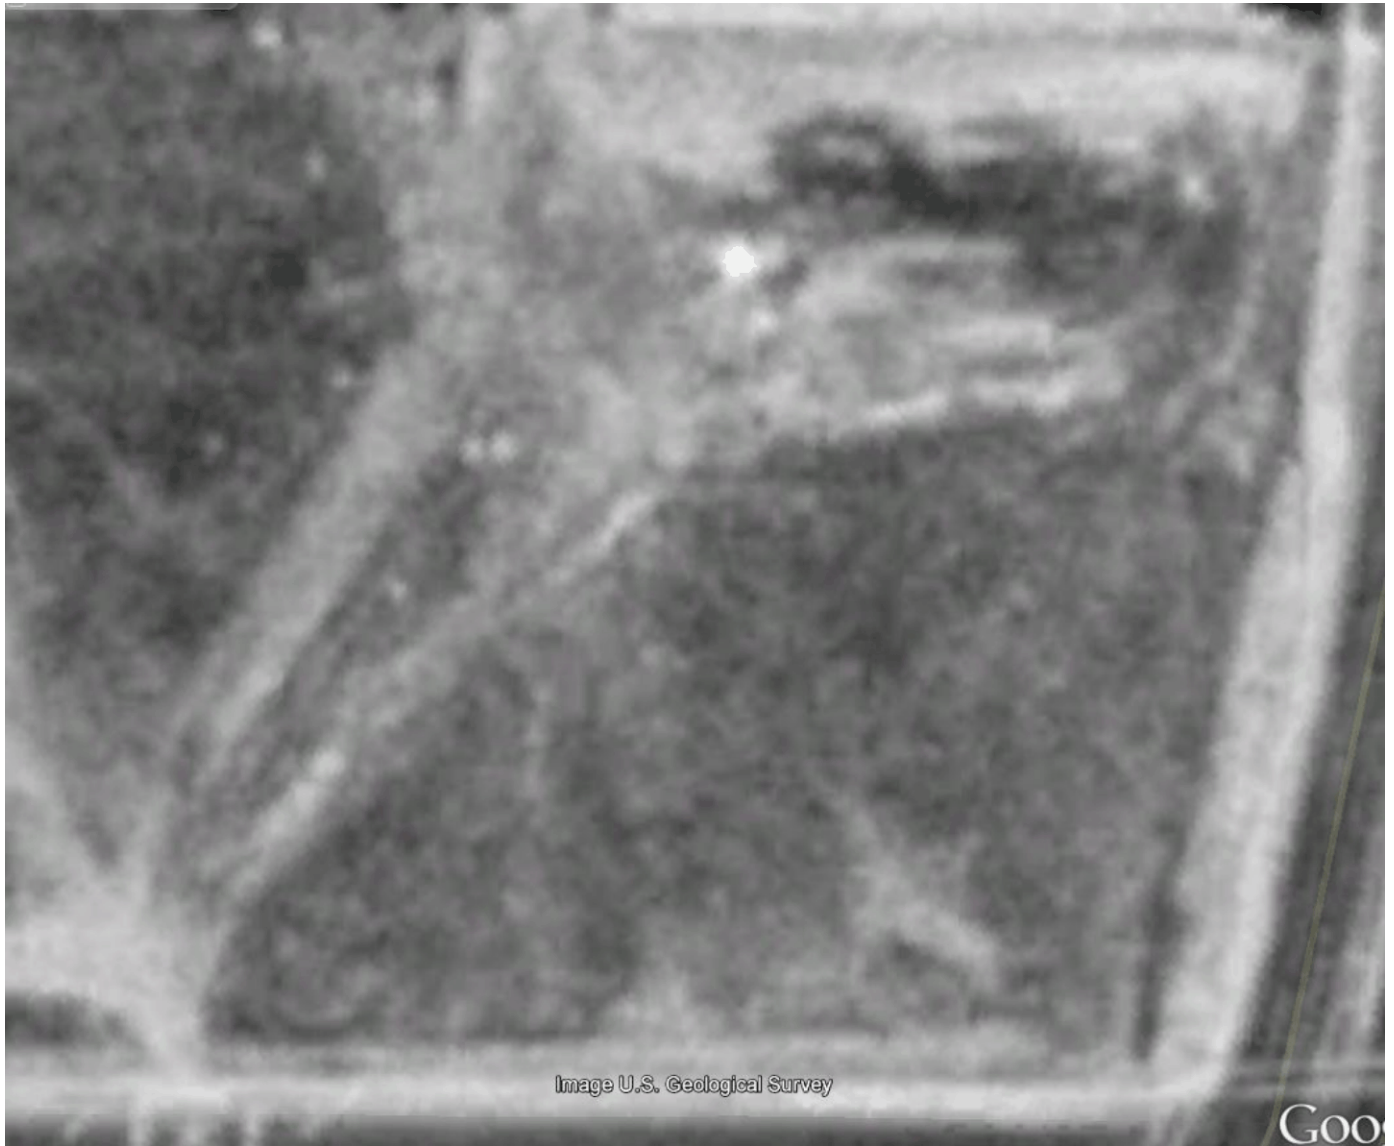
## **Figure 6** **2002 Google Earth Photo**

- On June 4, 2002, the next available photo on the Google Earth website, the building immediately north of the site had been constructed, the access road that crossed the site in a north-south alignment was present, and the slag area appeared different than the other portions of the site (Figure 6). Note that the quality of the photo was poor, so details concerning the slag area cannot be discerned.

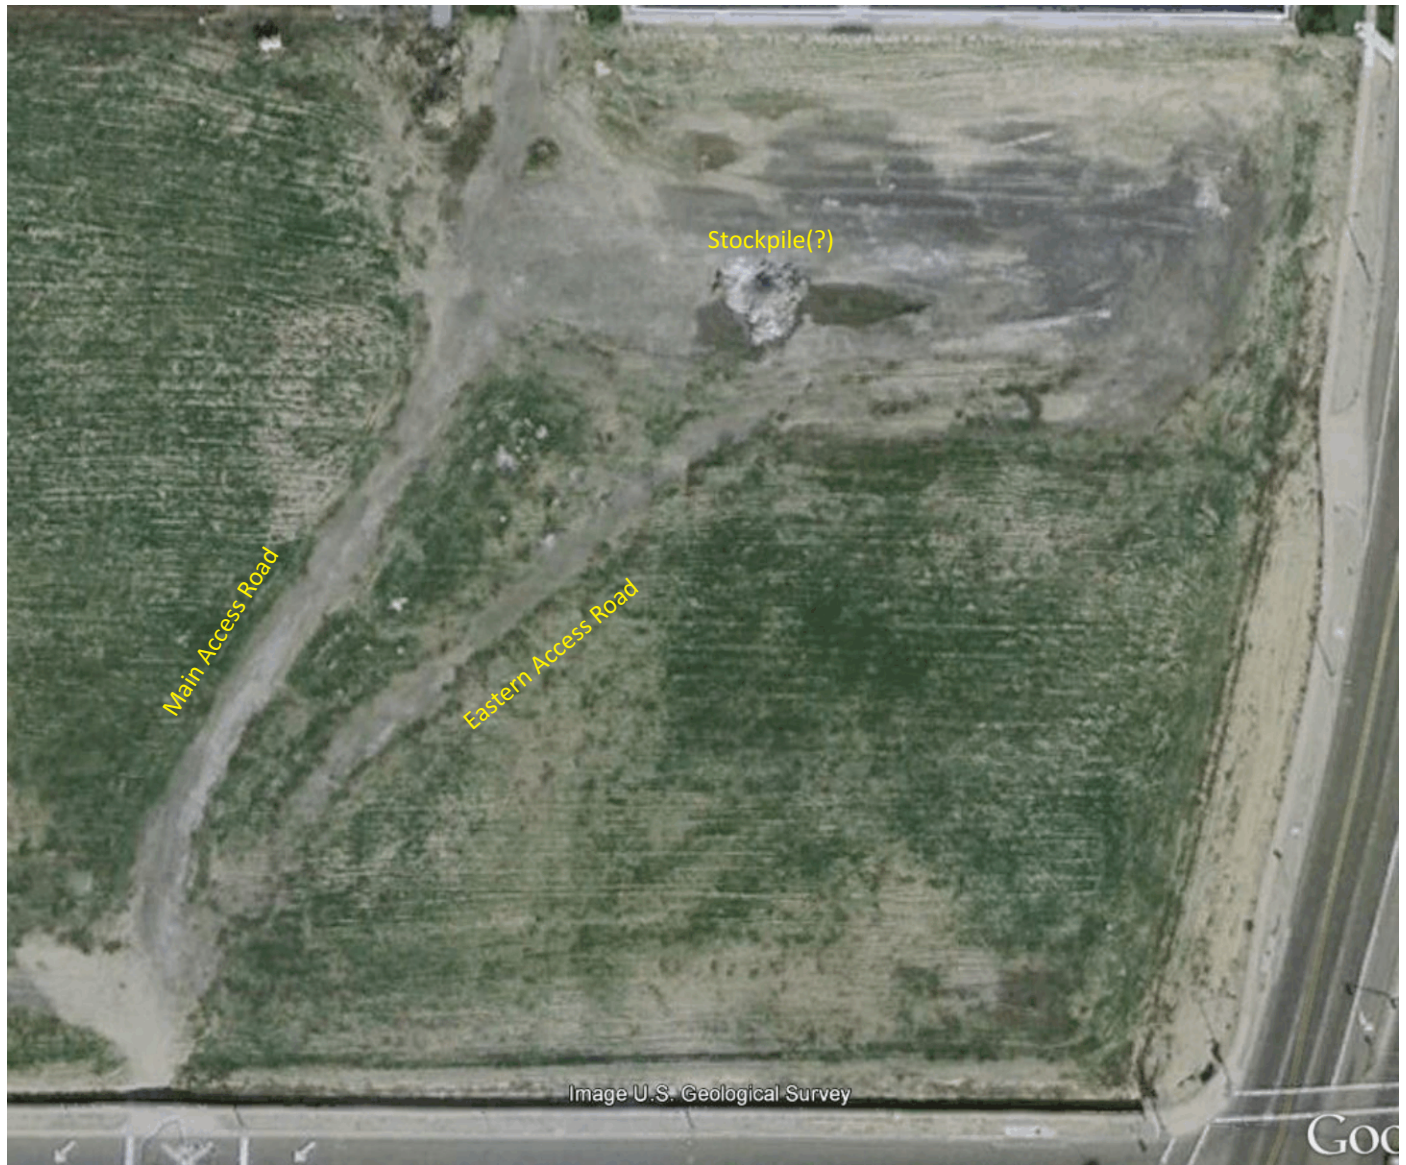
**Figure 7**  
**2003 Google Earth Photo**

- On December 30, 2003, the first good-quality photo on the Google Earth website, the site is green with vegetation except in the slag area, which is grey (Figure 7). Two access roads are visible; the main one and a smaller one to the east. Both enter the site at the same point near the central portion of the south edge, but the eastern road leads to the approximate middle of the slag area. What appears to be a stockpile is located in the south-central portion of the slag area, though the stockpile is gone by the next photo (May 30, 2004). The boundaries of the slag area are not clearly demarcated.

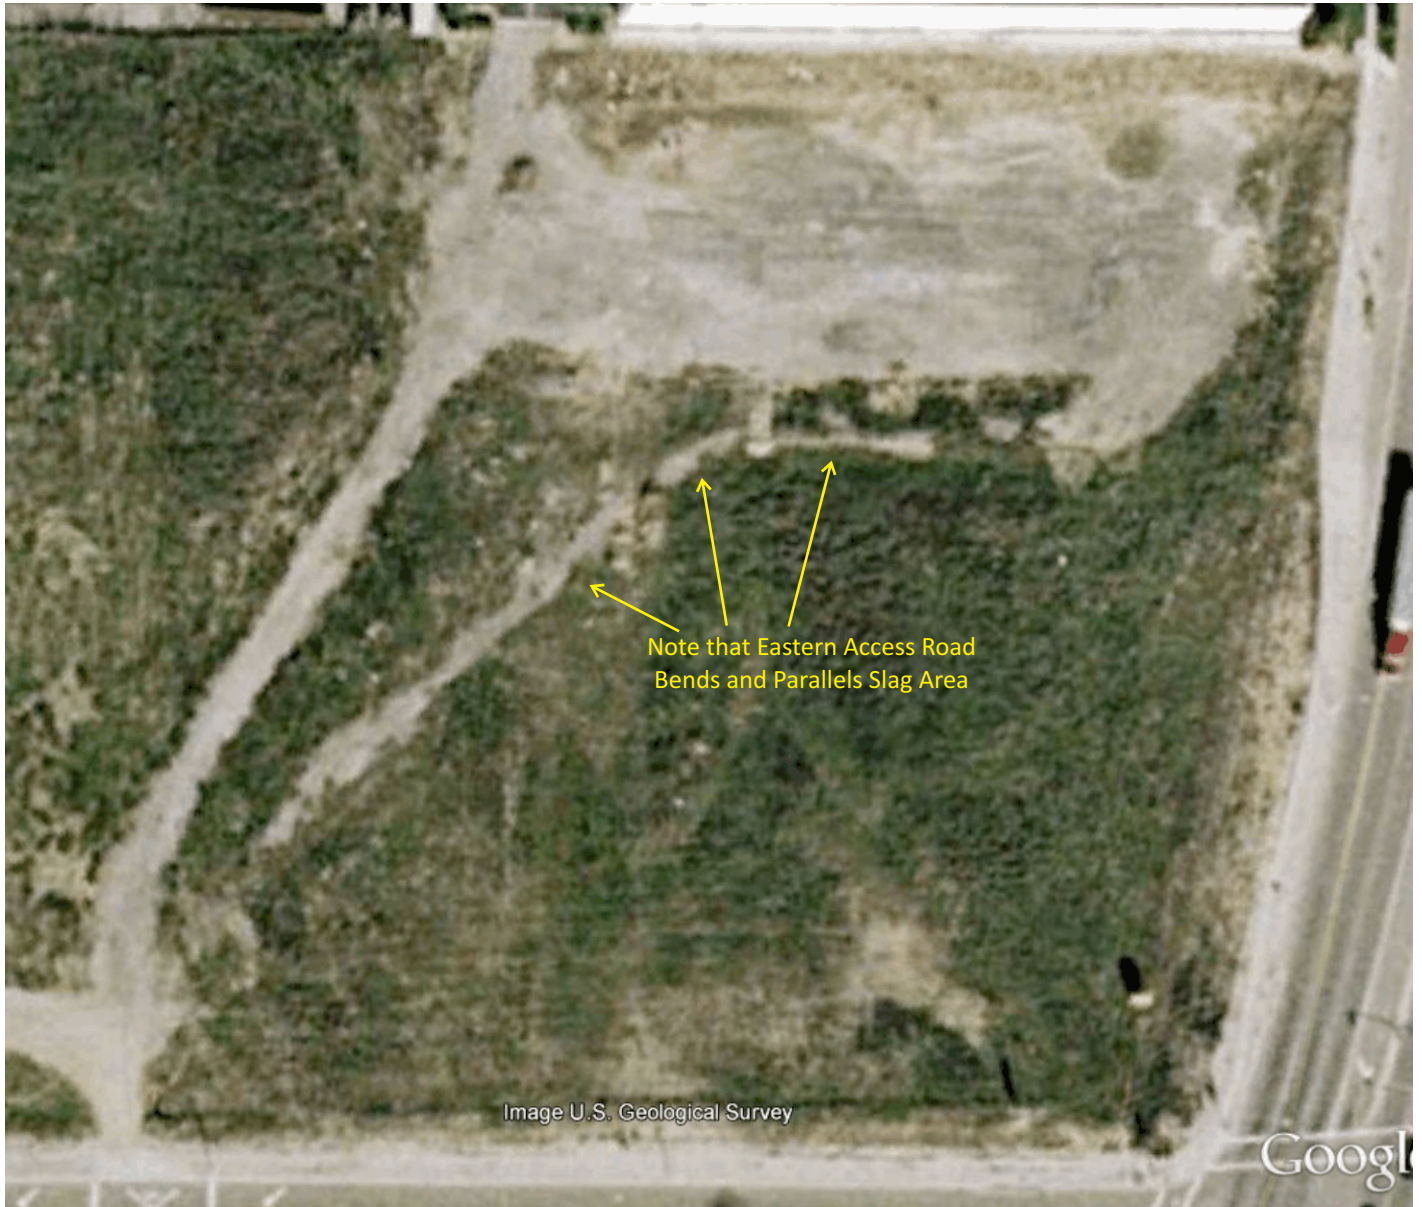
## **Figure 8** **2006 Google Earth Photo**

- On January 30, 2006, the southern boundary of the slag area appears to be a relatively sharp, straight line, though this could be due to landscape/brush-control activities (Figure 8). The paths of the two access roads are visible as barren areas within an otherwise over-grown site. The eastern pathway turns east and parallels the southern edge of the slag area until connecting to the slag area at the southeast corner of the slag area.

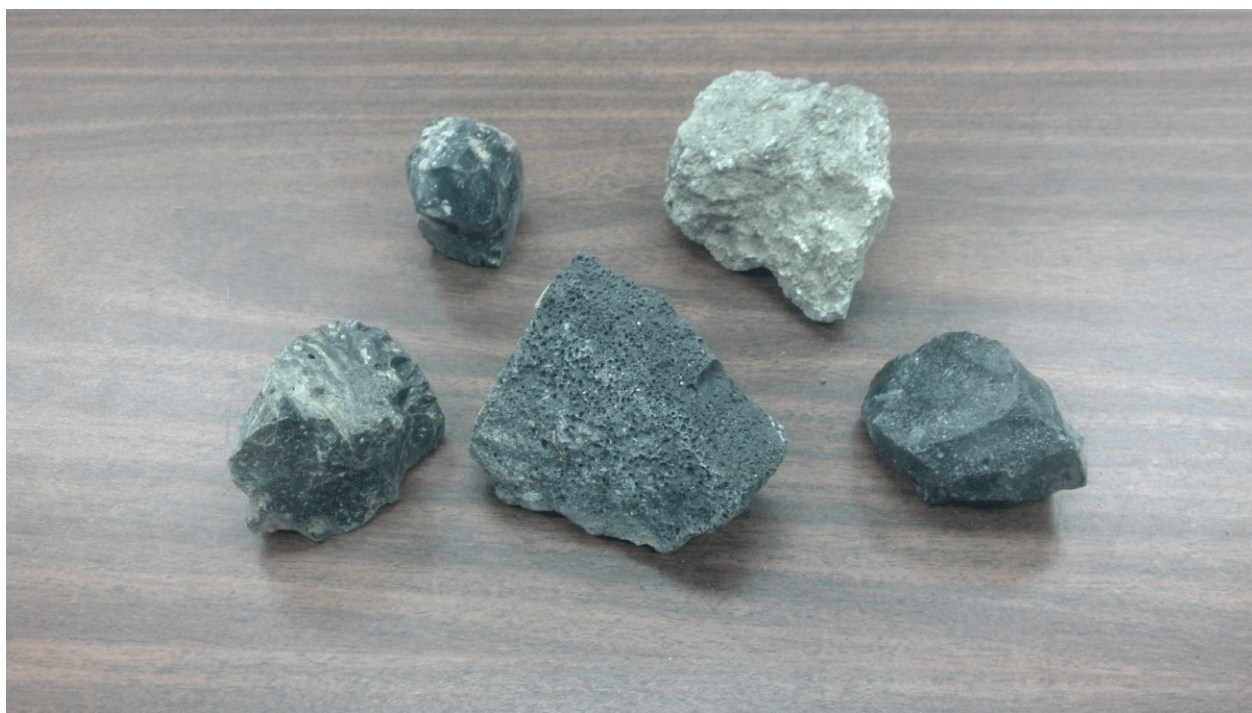
- The “slag” material was typically angular and very hard. Individual pieces were either vitreous (glassy), vesicular (frozen air bubbles) or a blend of granular materials. Color ranged from black to light green (see Photo 1). The vitreous and vesicular textures are indicative of having been melted and re-solidified.
- The fine-grained material was a blend of sand and finer grain sizes stuck together into gravel-sized pieces (see Photo 2). The gravel-sized pieces were too hard to break up by hand but were decomposing on their own, producing fine sand and dust. At ½ foot below the ground surface at the locations sampled, the fine-grained material appeared to be about 80 percent (by volume) of the total material. The fine-grained material was typically dark grey and fairly uniform in appearance.

Photo 1: Examples of “slag” material.

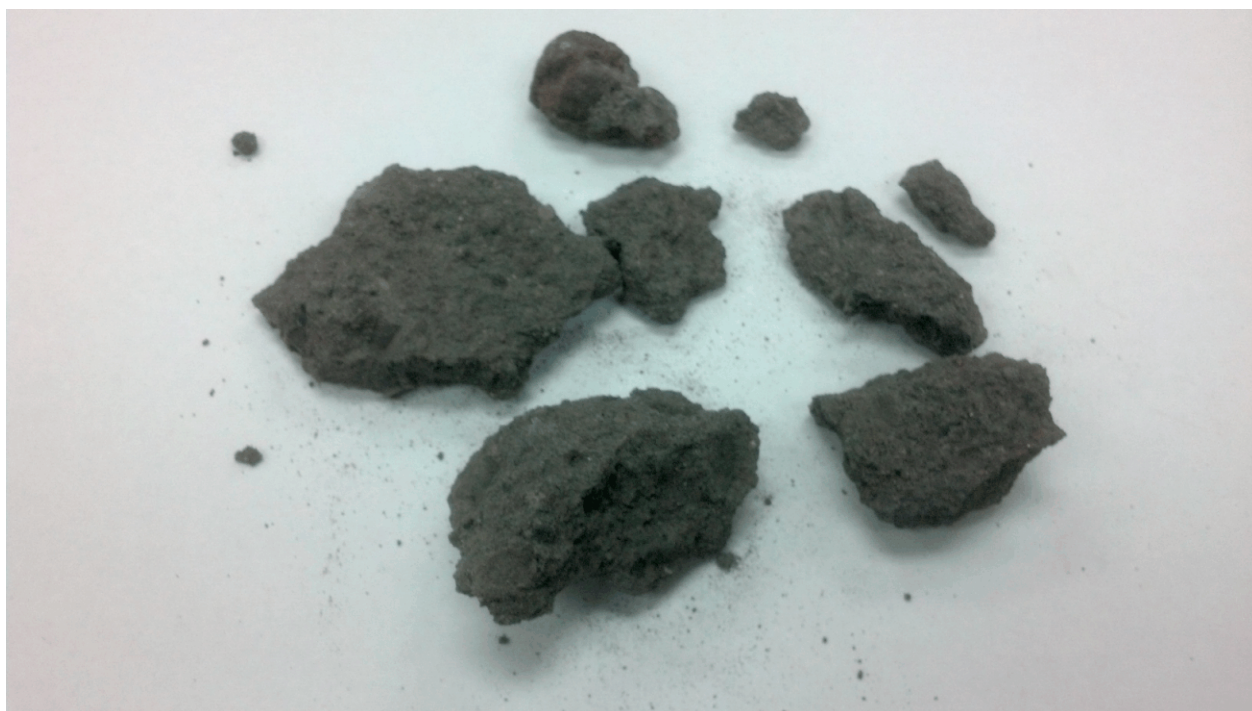
1. Two types of material were observed to comprise the “slag” deposit: (1) a blocky material that probably is slag and (2) a grey, fine-grained material that is not similar to typical slag and looked more like a cohesive sand and silt matrix. Given the high metal content, the fine-grained material may be “foundry sand”, which is a by-product of metal casting processes. The fine-grained material was the major constituent observed at a depth of 0.5 feet in the five locations sampled, comprising about 80 percent of the volume at those locations. The fine-grained material was fairly uniform in appearance while the slag ranged in appearance.

Photo 2: Examples of “fine-grained” material associated with the slag.
