CALIFORNIA ENVIRONMENTAL QUALITY ACT
 ENVIRONMENTAL INITIAL STUDY CHECKLIST FORM
Public Review Period July 2, 2021 – August 1, 2021

- 1. PROJECT TITLE:** GTC Development Plan
- Entitlements:** Planned Development (PD20-09)
 Conditional Use Permit (CUP21-19)
 Tentative Parcel Map (PR 20-0018)
 Septic Exception

- 7. PROJECT DESCRIPTION:** The project is a tentative parcel map to subdivide a single 6.54-acre parcel into two smaller parcels, a development plan for the construction of two 12,462sf buildings and associated parking and yard areas, a conditional use permit for a contracted services use on Parcel 2, and a waiver for two onsite wastewater treatment systems (septic systems).

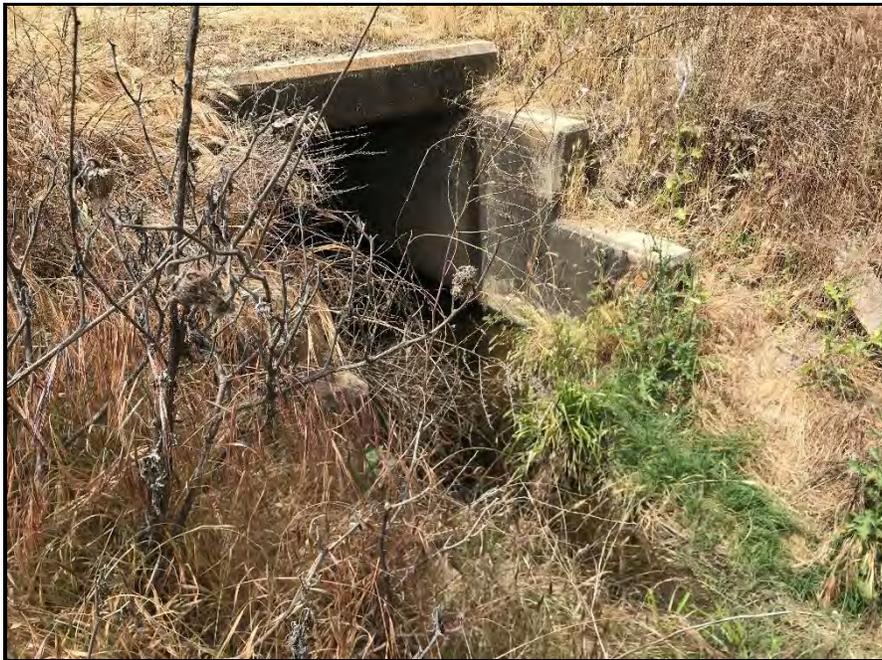
Photo 4. View of Drainage 1 culvert outlet at the southern end of the survey area, as it passes beneath Union Road (05-12-20).

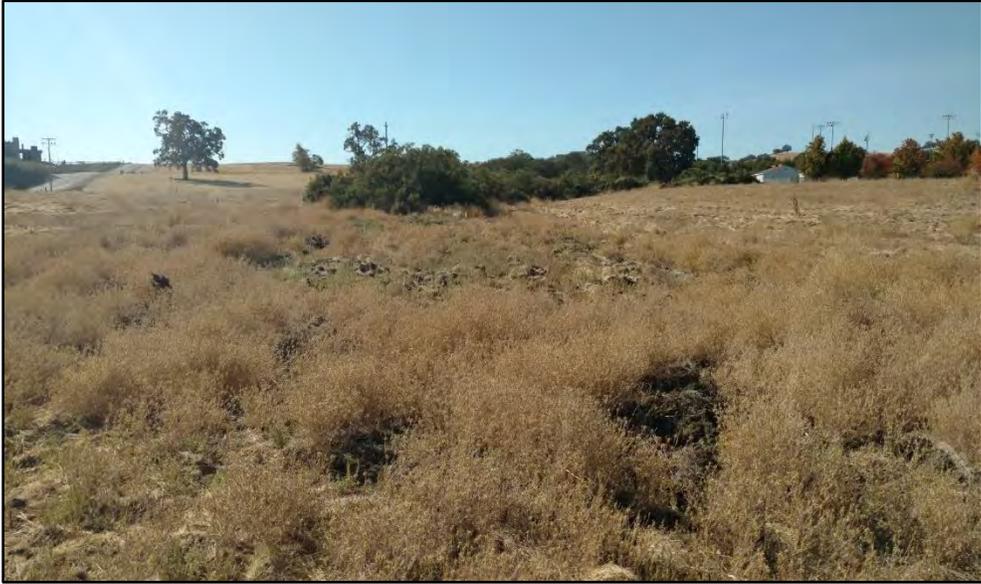
Photo 5. Looking south at the seasonal wetland within Drainage 1 (10-24-19).

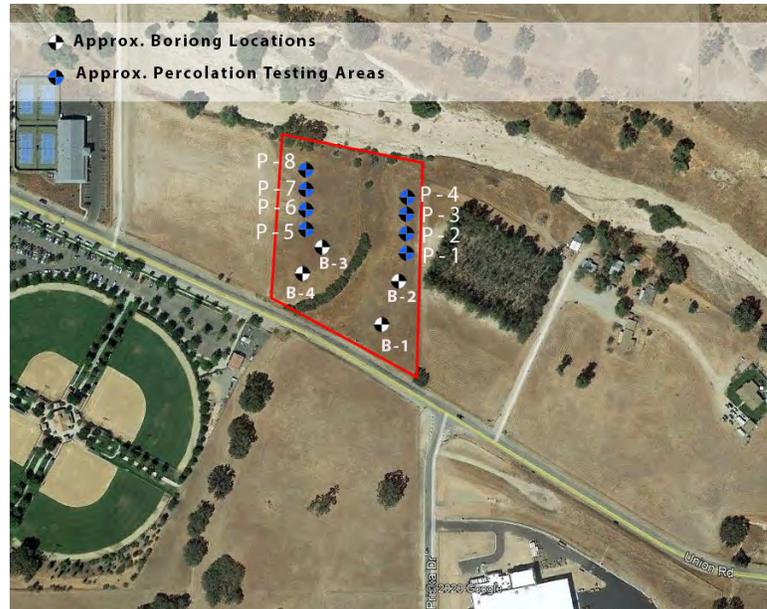
Figure 3: Field Investigation

Groundwater was not encountered in any of the borings. It should be expected that groundwater elevations may vary seasonally and with irrigation practices.

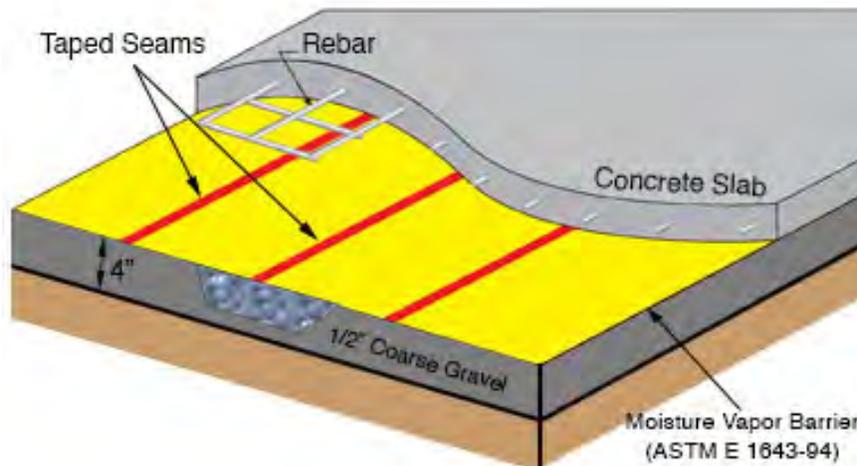
4. Where concrete slabs-on-grade are to be constructed for interior conditioned spaces, the slabs should be underlain by a minimum of four inches of clean free-draining material, such as a ¾ inch coarse aggregate mix, to serve as a cushion and a capillary break. Where moisture susceptible storage or floor coverings are anticipated, a 15-mil Stego Wrap membrane (or equivalent installed per manufacturer's specifications) should be placed between the free-draining material and the slab to minimize moisture condensation under the floor covering. See Figure 5: Sub-Slab Detail for the placement of under-slab drainage material. It is suggested, but not required, that a two-inch thick sand layer be placed on top of the membrane to assist in the curing of the concrete, increasing the depth of the under-slab material to a total of six inches. The sand should be lightly moistened prior to placing concrete.

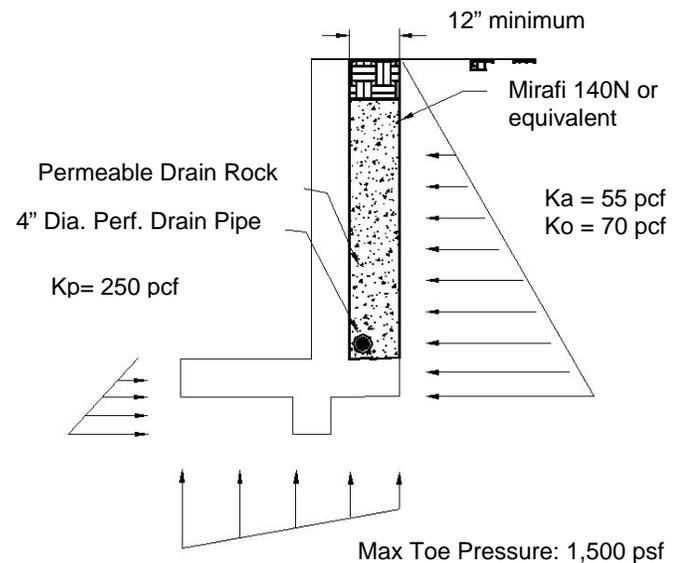
2. The above values for equivalent fluid pressure are based on retaining walls having level retained surfaces, having an approximately vertical surface against the retained material, and retaining granular backfill material or engineered fill composed of native soil within the active wedge. See Figure 6: Retaining Wall Detail and Figure 7: Retaining Wall Active and Passive Wedges for a description of the location of the active wedge behind a retaining wall.

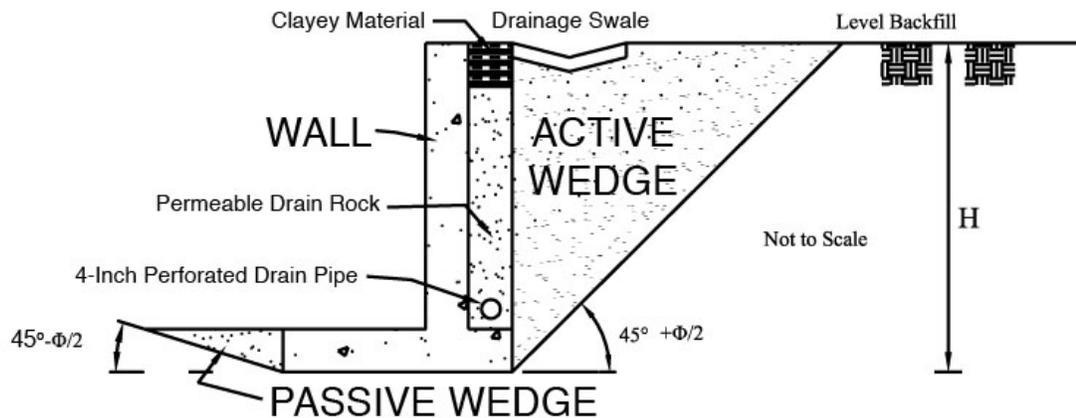
Figure 7: Retaining Wall Active and Passive Wedges

3. Proposed retaining walls having a retained surface that slopes upward from the top of the wall should be designed for an additional equivalent fluid pressure of 1 pcf for the active case and 1.5 pcf for the at-rest case, for every degree of slope inclination.
4. We recommend that the proposed retaining walls at the Site have an approximately vertical surface against the retained material. If the proposed retaining walls are to have sloped surfaces against the retained material, the project designers should contact the Soils Engineer to determine the appropriate lateral earth pressure values for retaining walls located at the Site.

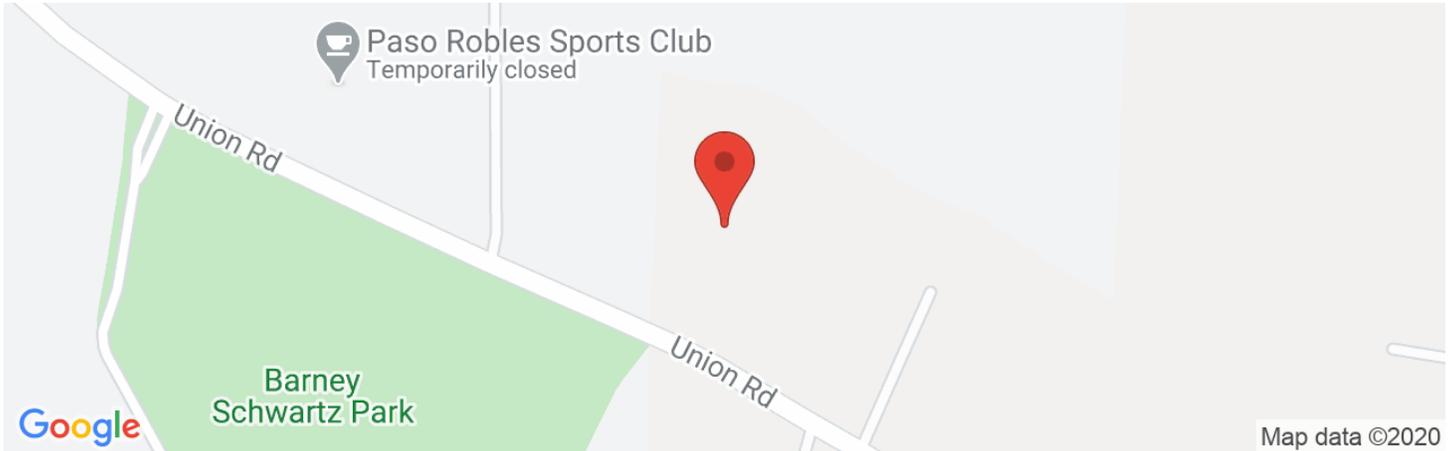
Date	5/21/2020, 7:05:39 PM
Design Code Reference Document	ASCE7-16
Risk Category	II
Site Class	D - Stiff Soil
