**Aquatic Resources Delineation Report Addendum for  
the Las Camas Solar Development Project**

# Memorandum

| <b>Re:</b> | <b>Aquatic Resources Delineation Report Addendum for the Las Camas Solar Development Project</b> |

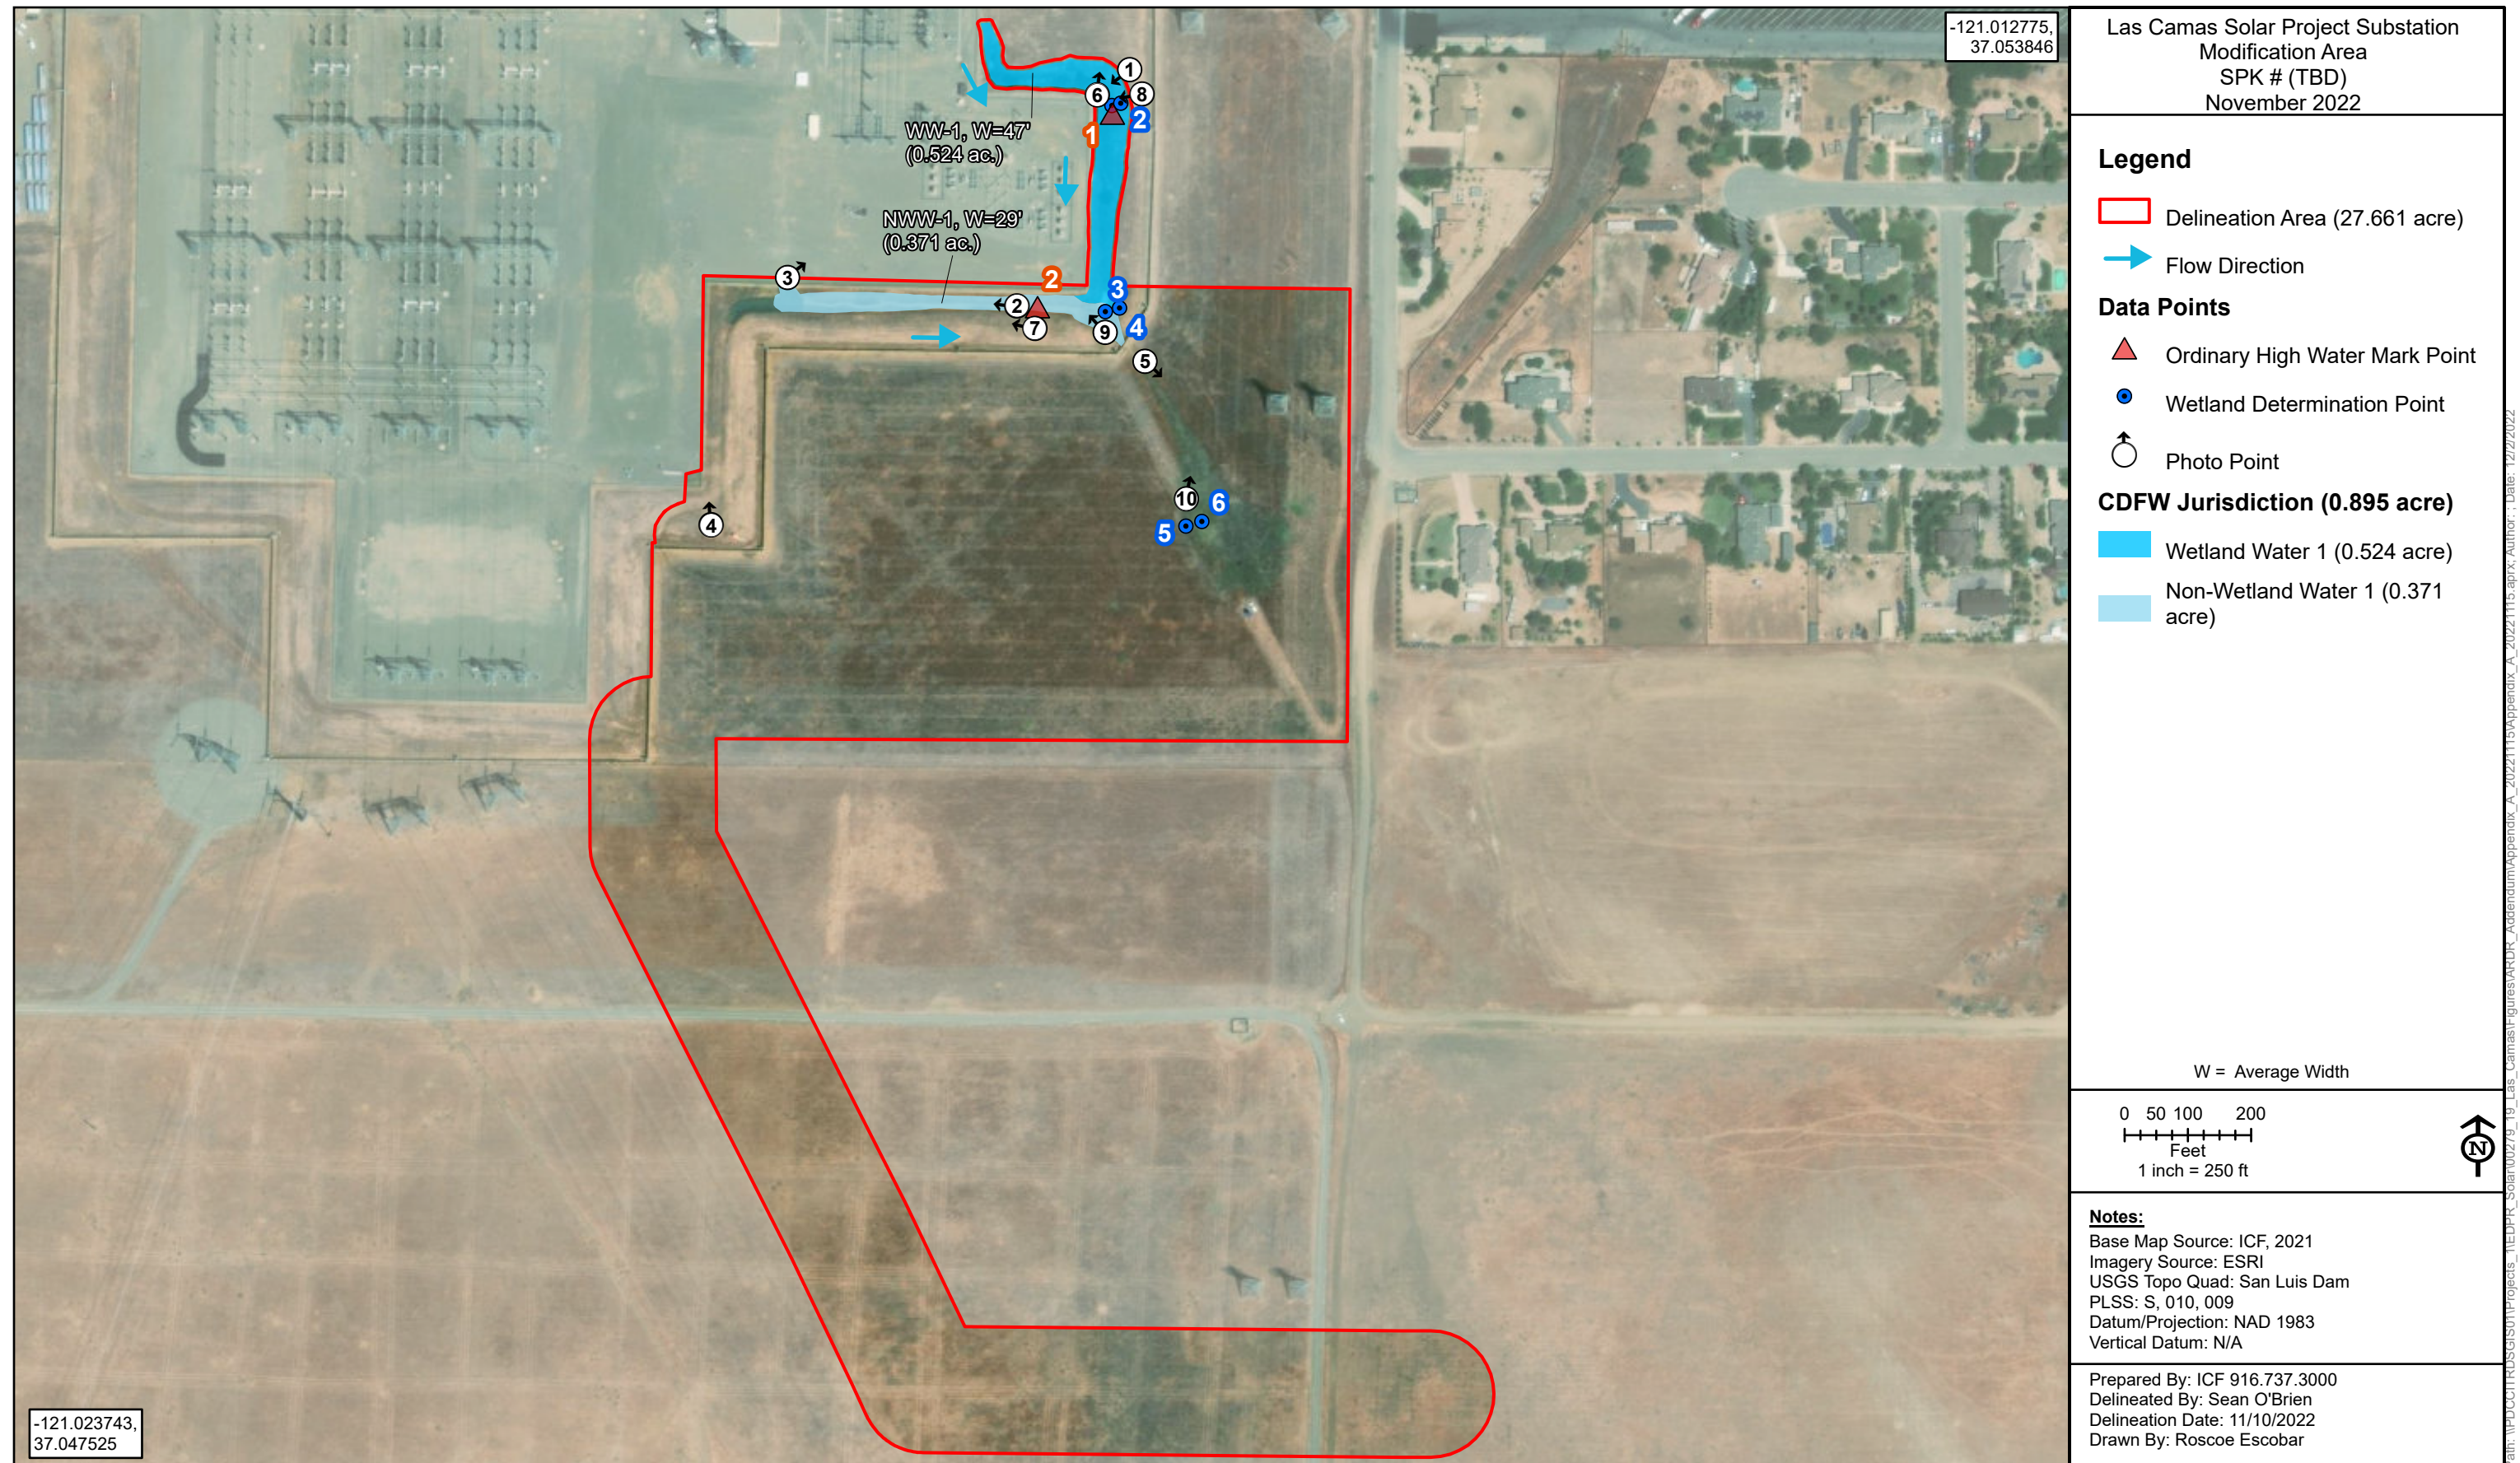
## **APPENDIX A: RWQCB AND CDFW JURISDICTION**

The substation modification delineation area contains two features (WW-1 and NWW-1) (please see Appendix A, Figures 1 and 2). A description of these features are provided below and representative site photographs are provided in Appendix B. An additional area identified during pre-field investigations as a potential wetland was assessed and found to be lacking wetland indicators. This area is further discussed below but was not delineated or mapped as it did not meet wetland criteria or exhibit an OHWM.

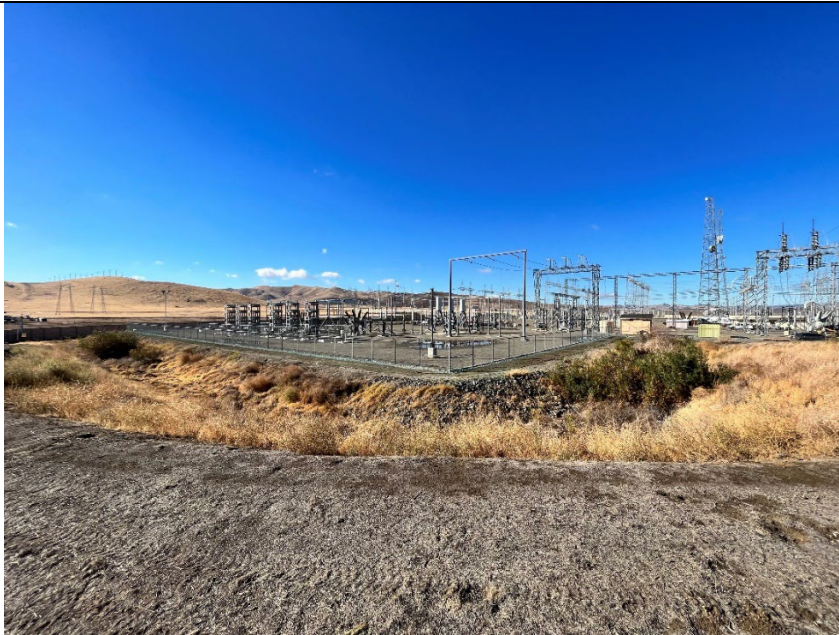
**Photograph 1**

**Wetland Waters 1 (WW-1)** is a drainage that occurs adjacent to the eastern boundary of the existing substation and is subject to jurisdiction of the RWQCB and CDFW. The northern part of WW-1 has wetland properties including hydric soils (see Appendix A, Figure 1, soil pits 1 and 2), hydrophytic vegetation, and evident hydrology. This feature receives hydrologic inputs from direct precipitation, surface runoff from the substation facility, and a leaky pipe located towards the feature's northern end. Vegetation in this area was dominated by Bermuda grass (*Cynodon dactylon*) (FACU), broadleaf cattail (*Typha latifolia*) (OBL), and Great Valley gumweed (*Grindelia camporum*) (FACW) with subdominant species including of Canada horseweed (*Erigeron canadensis*) (FACU), tall annual willowherb (*Epilobium brachycarpum*) (FAC), and narrow leaved plantain (*Plantago lanceolata*) (FAC). Occasional shrubs and trees also occurred within this habitat such as arroyo willow (*Salix lasiolepis*) (FACW), mule fat (*Baccharis salicifolia*) (FAC), and coyote brush (*Baccharis pilularis*) (UPL).

**Comments:** Representative view of wetland area of Feature 1.

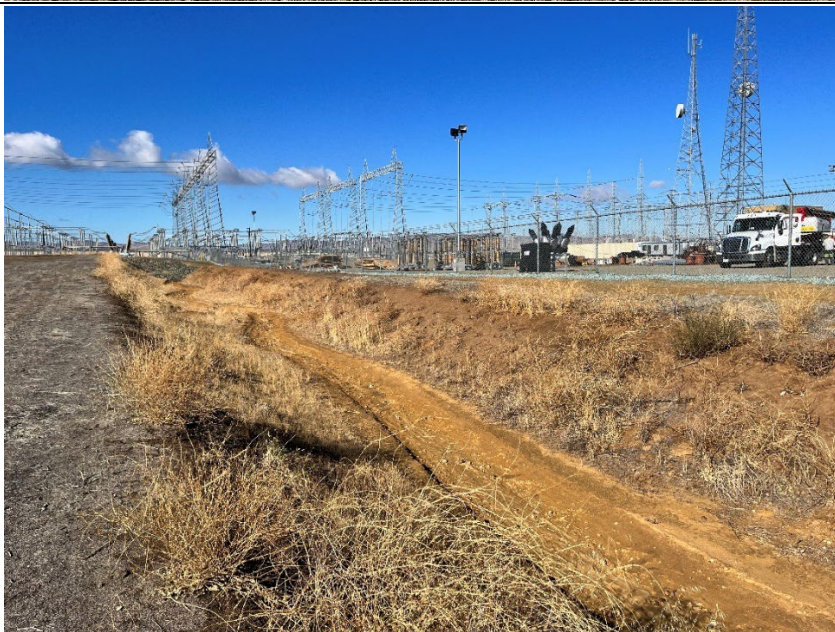
**Photograph 2.**

Sediment texture, vegetation species, and vegetative cover differed above and below the OHWM and there was an approximately 45° break in slope at the OHWM. The feature displayed the presence of a bed and bank, mud cracks, ripples, drift, and debris. Portions of the feature were saturated to the surface and other portions contained 0-2 inches of ponded, possibly slowing flowing, surface water. The OHWM width ranged from 5 to 25 feet and height ranged from 6 inches to 3 feet. The top of bank width ranged from 20 to 50 feet and height ranged from 3 to 15 feet.

**Comments:** Representative view of the non-wetland area of Feature 1.

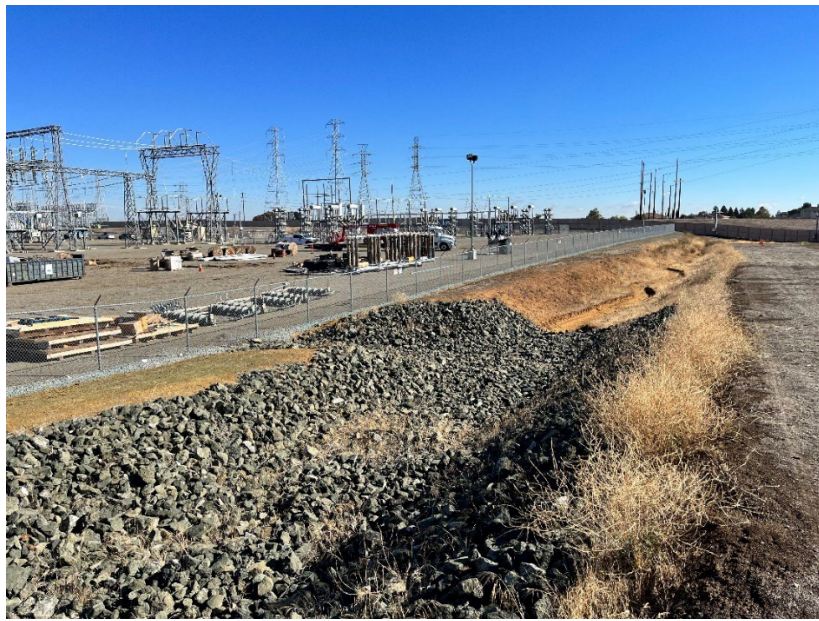
**Photograph 3**

**Comments:** Representative view of western terminus of the non-wetland area of Feature 1.

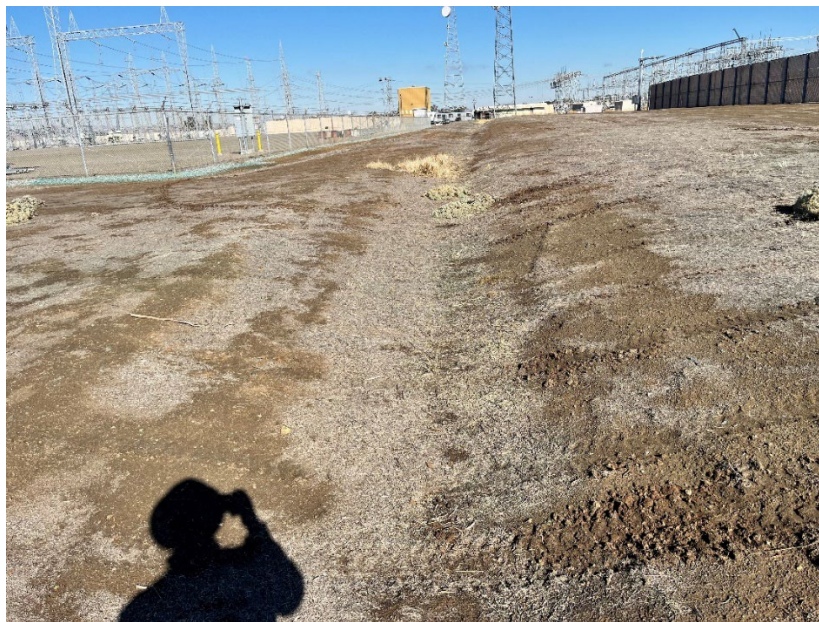
**Photograph 4**

The depressional area observed in the southeastern portion of the substation delineation area does not have hydric soils and does not have hydrophytic vegetation. The habitat is likely artificially formed and receives some hydrologic inputs from WW-1 and NWW-1. The depressional area displayed wetland hydrology indicators (e.g., surface soil cracks and drainage patterns) and portions of the habitat were saturated. However, soil pits 5 and 6 did not show any hydric soil indicators. The habitat was dominated by non-hydrophytic vegetation, including Bermuda grass (*Cynodon dactylon*) (FACU), whitetop (*Lepidium draba*) (UPL), and tumbleweed (*Salsola tragus*) (FACU). Occasional coyote brush (*Baccharis pilularis*) (UPL) shrubs, common rush (*Juncus effusus*) (FACW) and Great Valley gumweed (*Grindelia camporum*) (FACW) were observed.

**Comments:** Representative view of a depressional area lacking bed a bed bank, OHWM, wetland vegetation and hydrology. Area considered annual grassland habitat.

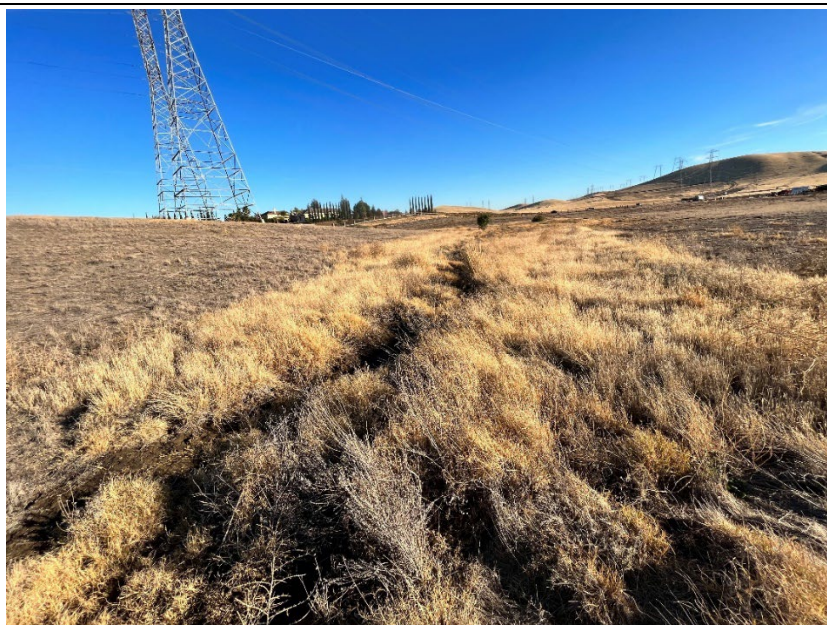
**Photograph 5**

**Comments:** Representative view of a depressional area evaluated but did not pass the 3-paratometer wetland test. There was no hydrophytic vegetation and no hydric soils.

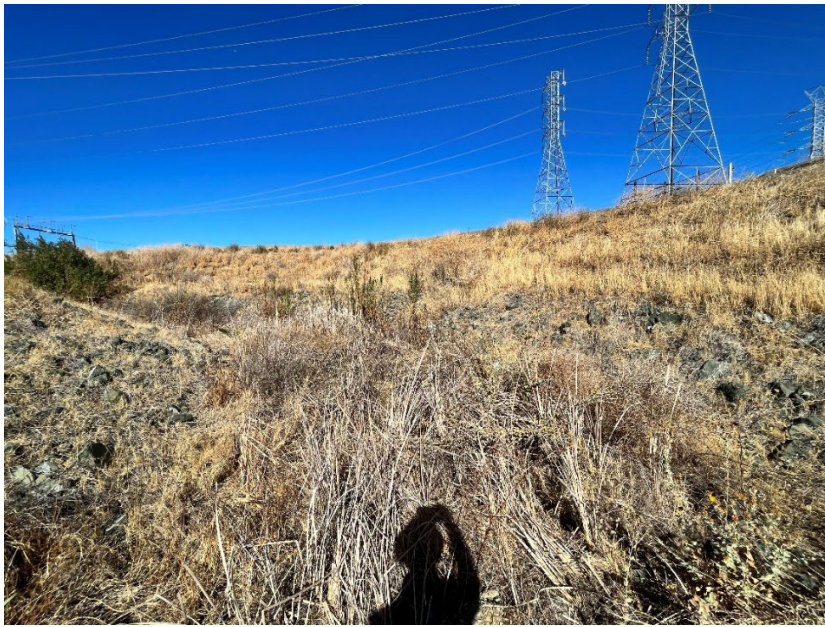
**Photograph 6**  
**Feature ID:** Feature 1  
**Direction:** Facing north  
**Comments:** View associated with OHWM Data Form 1.

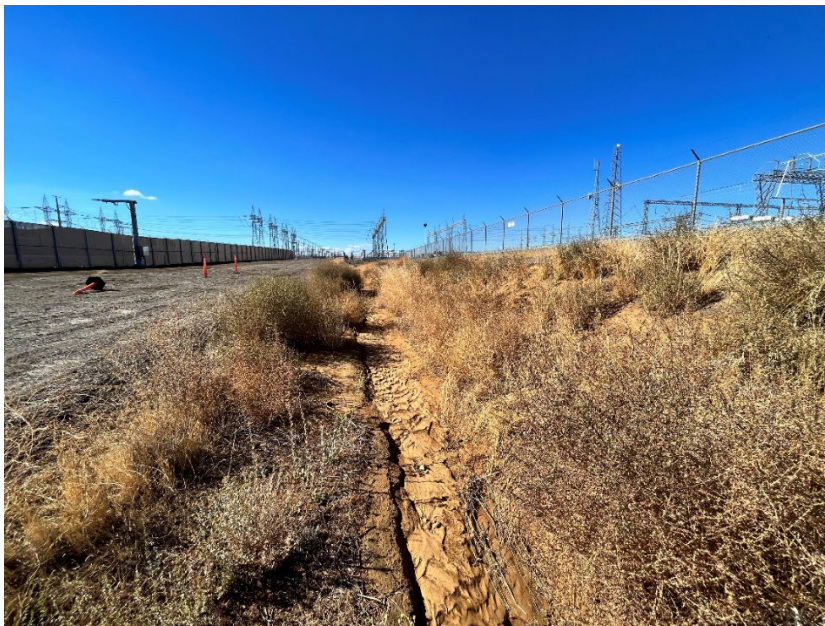
**Photograph 7**  
**Feature ID:** Feature 1  
**Direction:** Facing west  
**Comments:** View associated with OHWM Data Form 2.

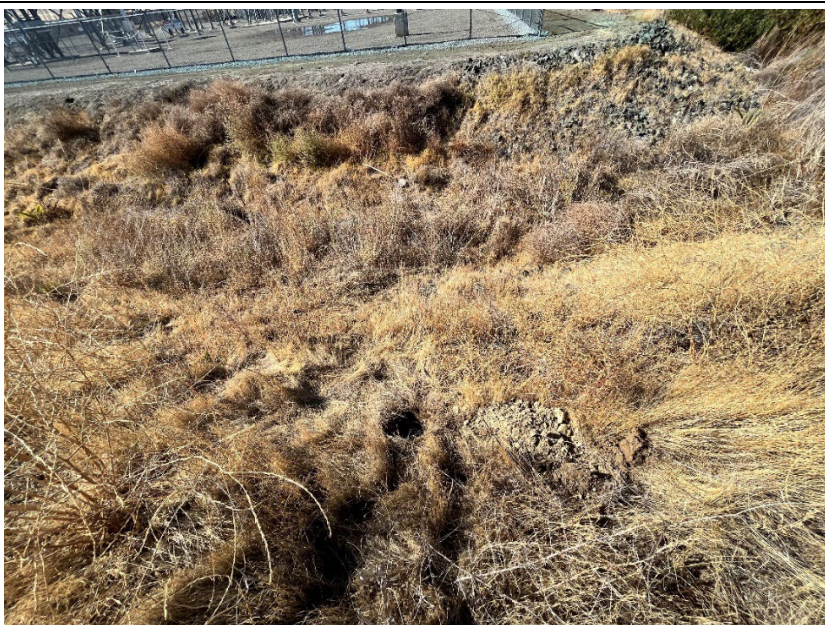
**Photograph 8**  
**Feature ID:** Feature 1  
**Direction:** Facing west  
**Comments:** View associated with Wetland Determination Data Forms 1 and 2.

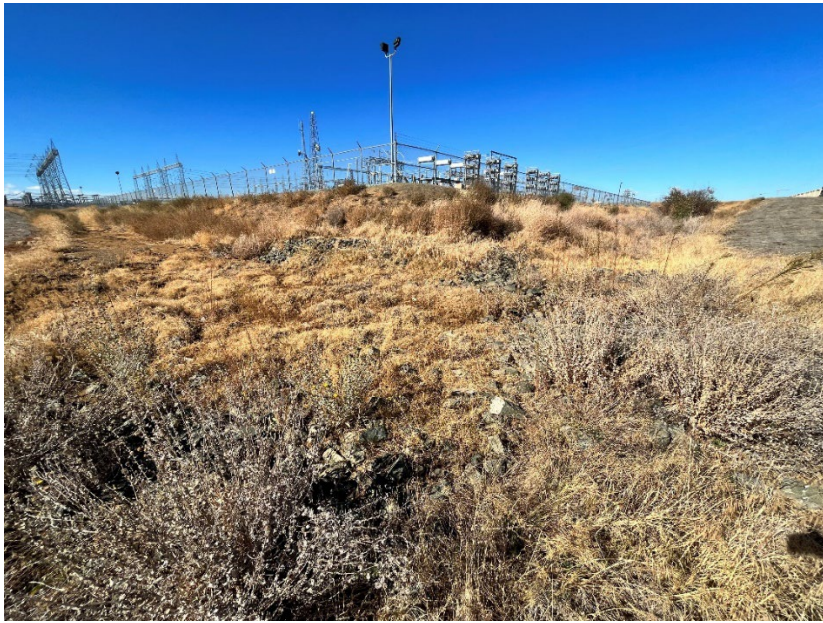
**Photograph 9**

**Comments:** View associated with Wetland Determination Data Forms 3 and 4 (facing northwest).
