Santee Arco Station Project

Initial Study/Mitigated Negative Declaration

December 2021 | 04779.00001.001

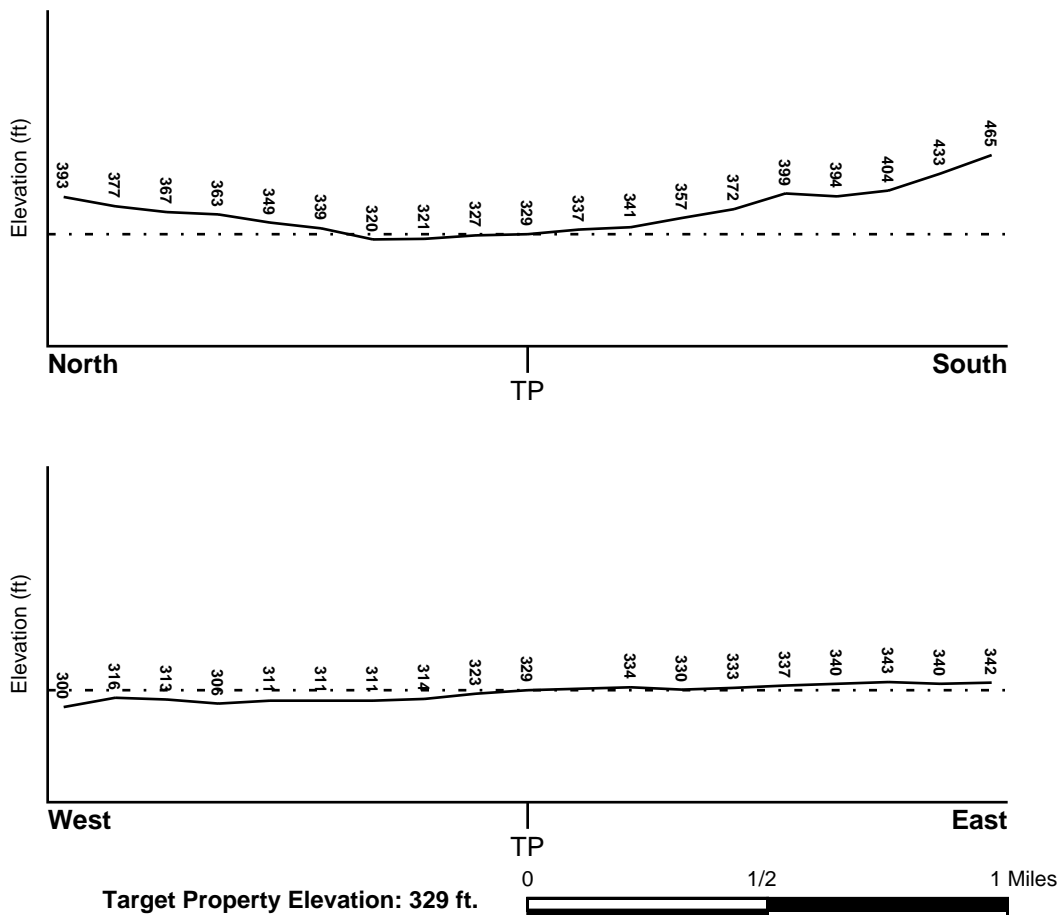
SURROUNDING TOPOGRAPHY: ELEVATION PROFILES

Source: Topography has been determined from the USGS 7.5' Digital Elevation Model and should be evaluated on a relative (not an absolute) basis. Relative elevation information between sites of close proximity should be field verified.

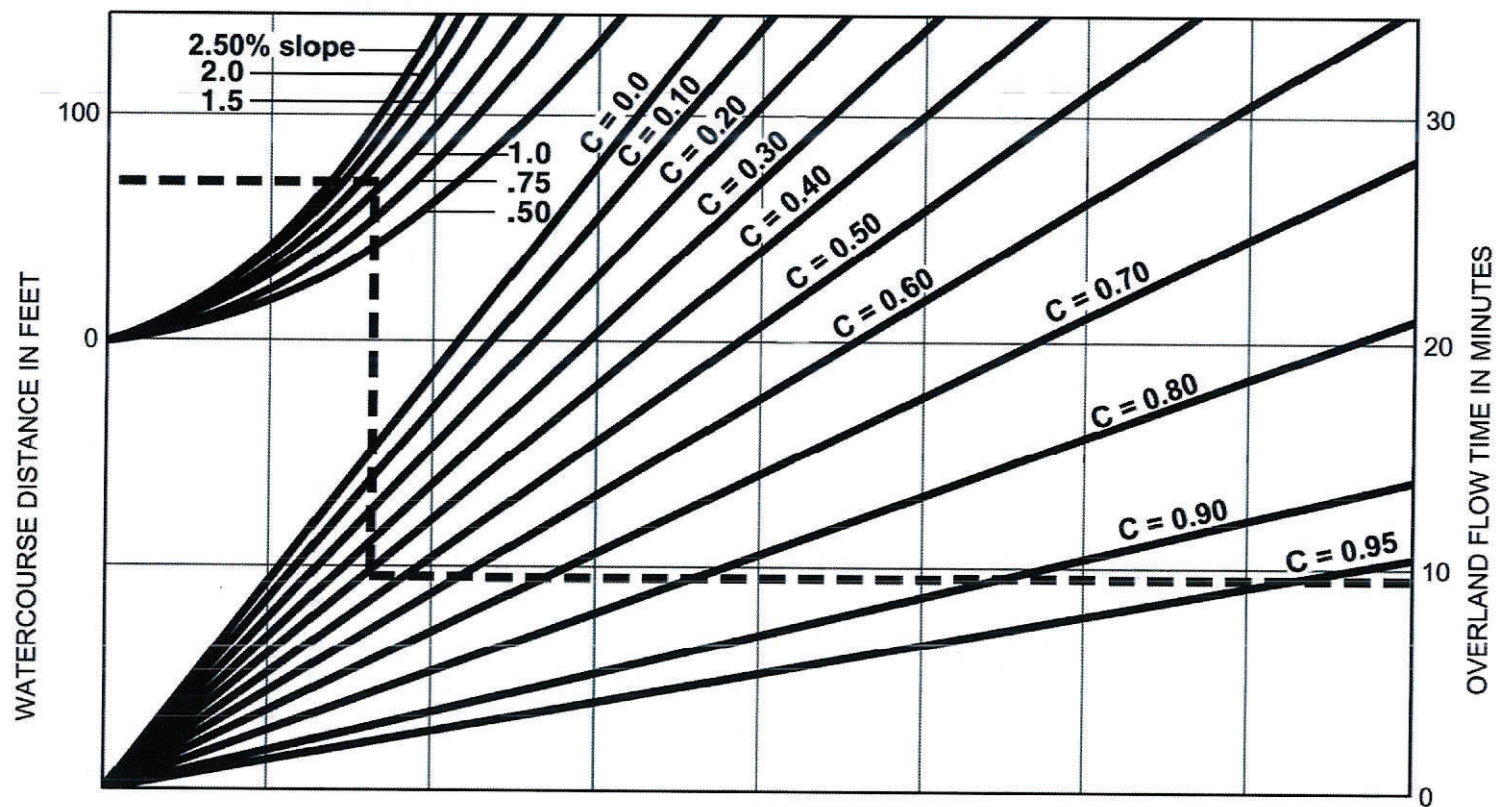
EXAMPLE:

Given: Watercourse Distance (D) = 70 Feet
 Slope (s) = 1.3%
 Runoff Coefficient (C) = 0.41
 Overland Flow Time (T) = 9.5 Minutes

Rational Formula - Overland Time of Flow Nomograph

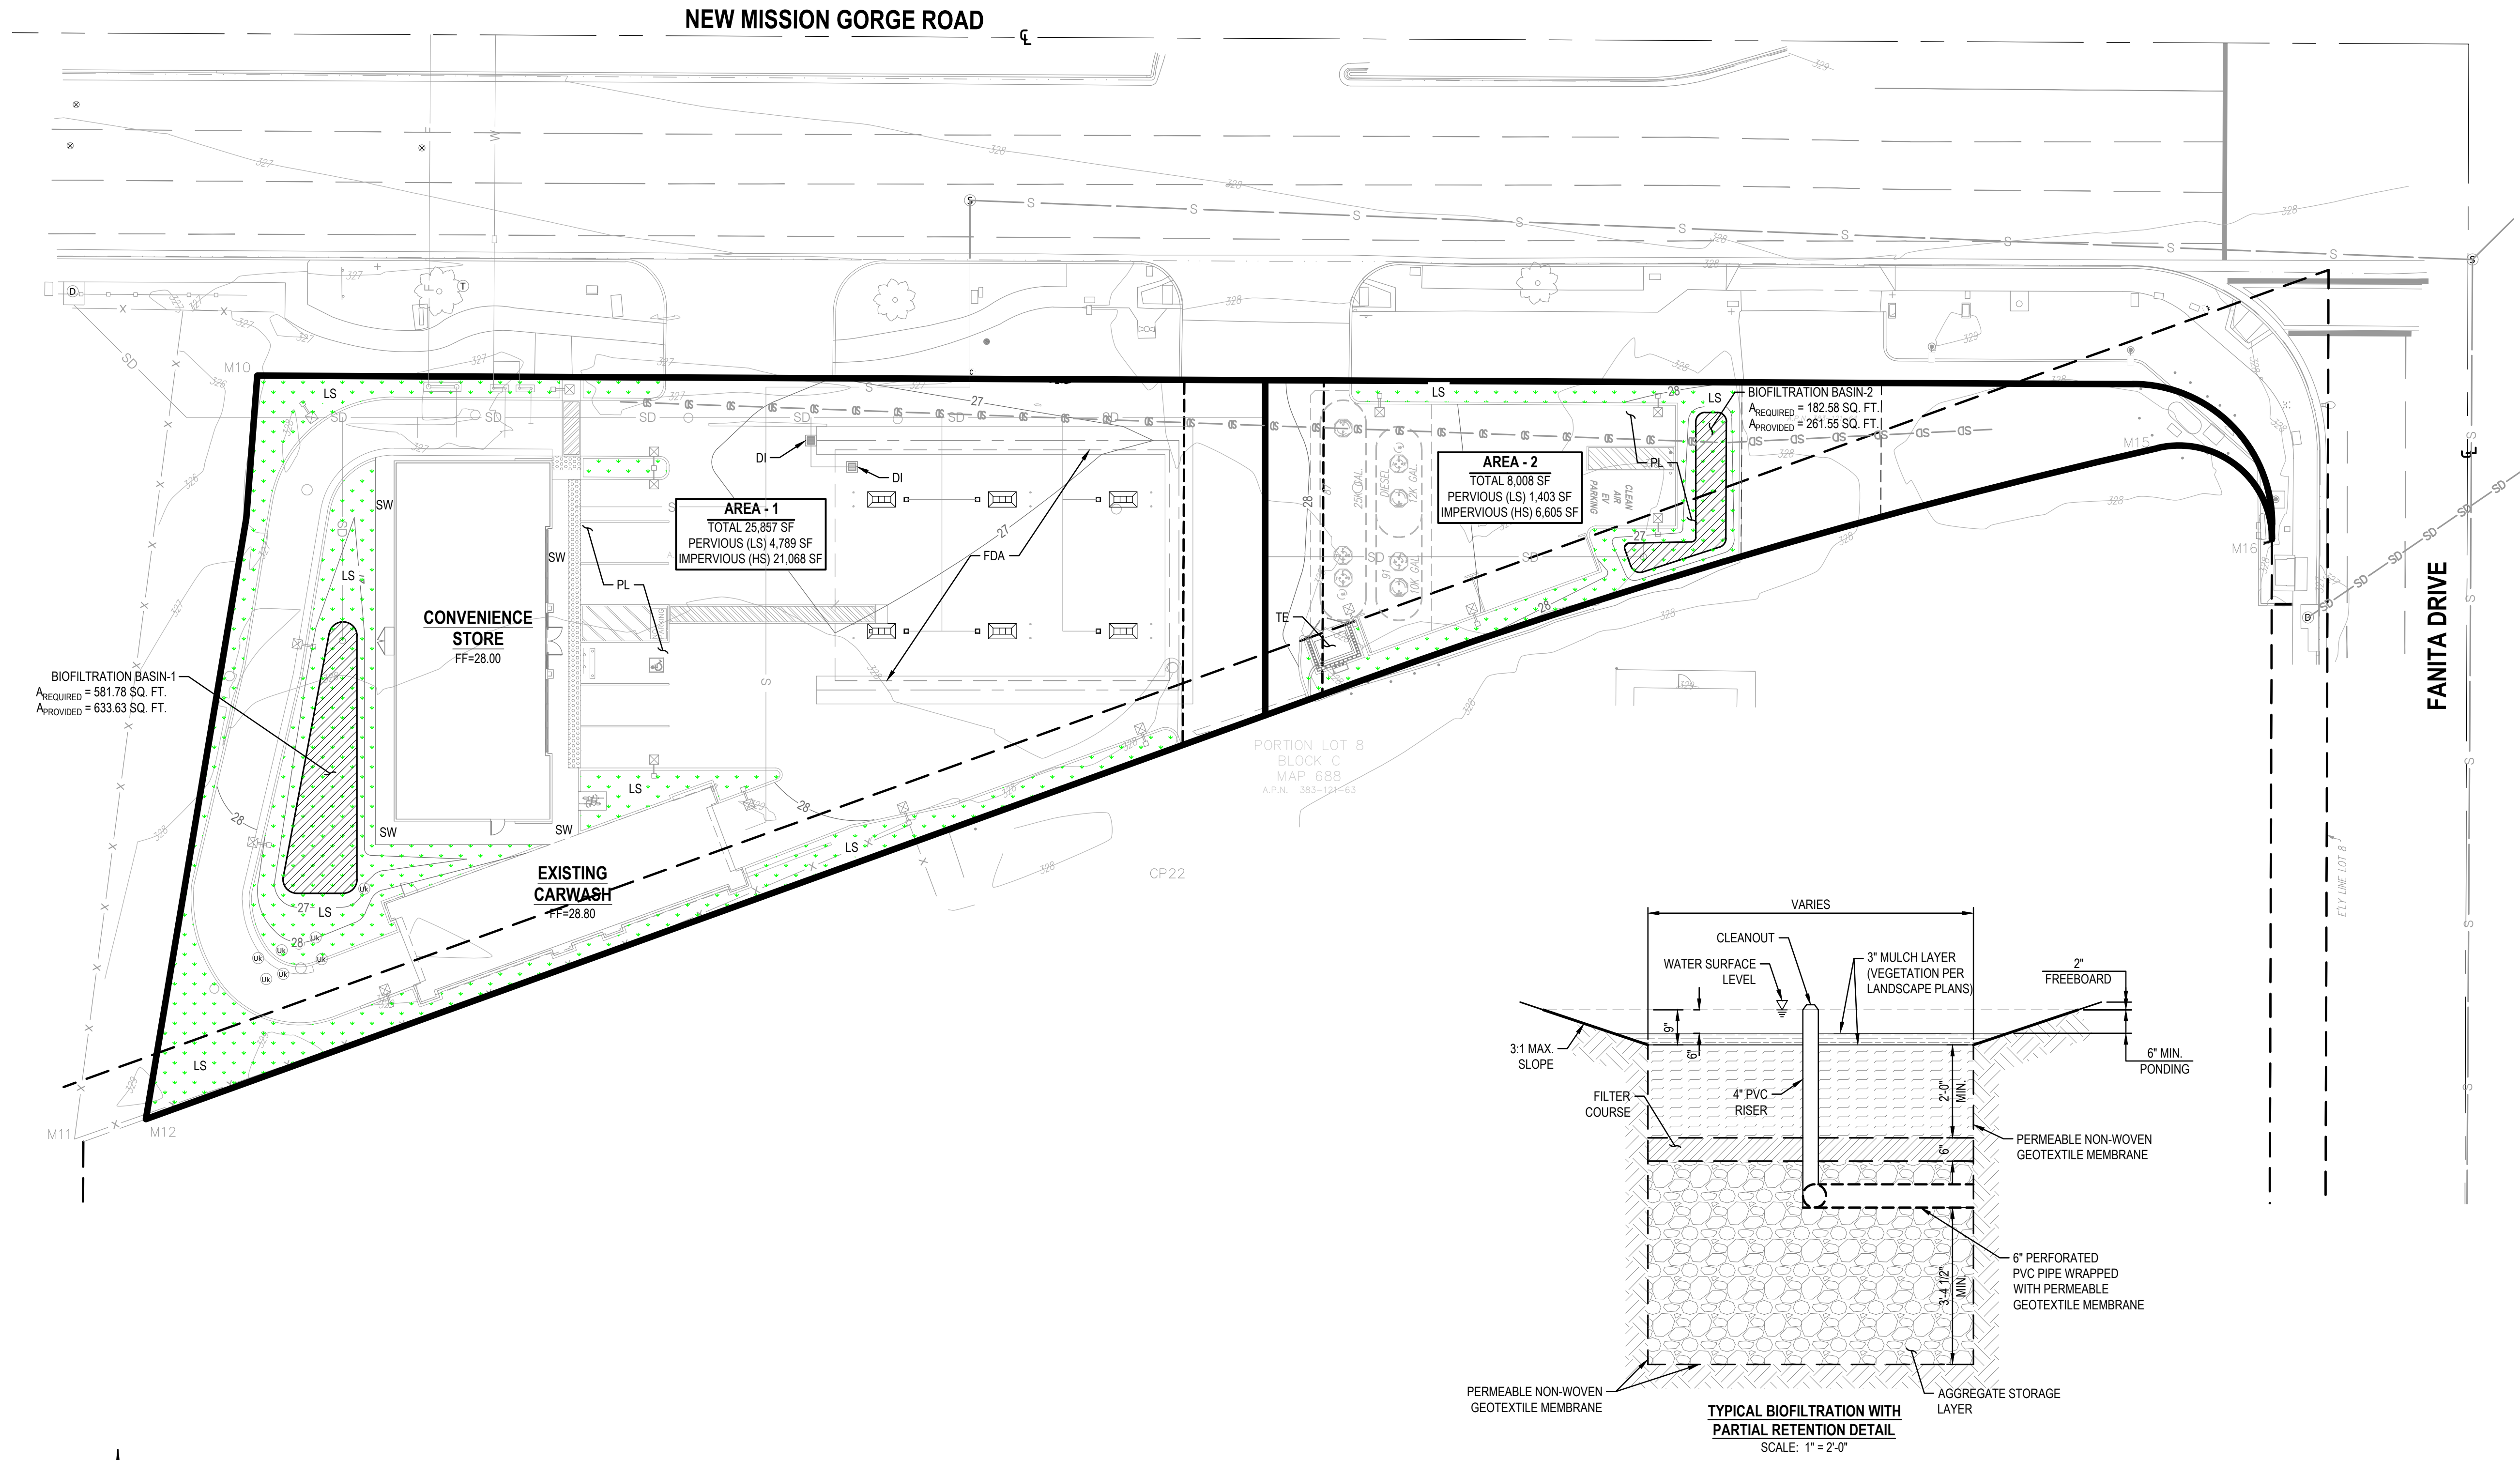
PROPOSED AREA SUMMARY				
	TOTAL AREA (SQ. FT.)	IMPERVIOUS AREA (SQ. FT.)	PERVIOUS AREA (SQ. FT.)	BMP Used
AREA-1	25,857	21,068	4,789	Biofiltration Basin with partial retention
AREA-2	8,008	6,738	1,270	
TOTAL	33,865	27,806	6,059

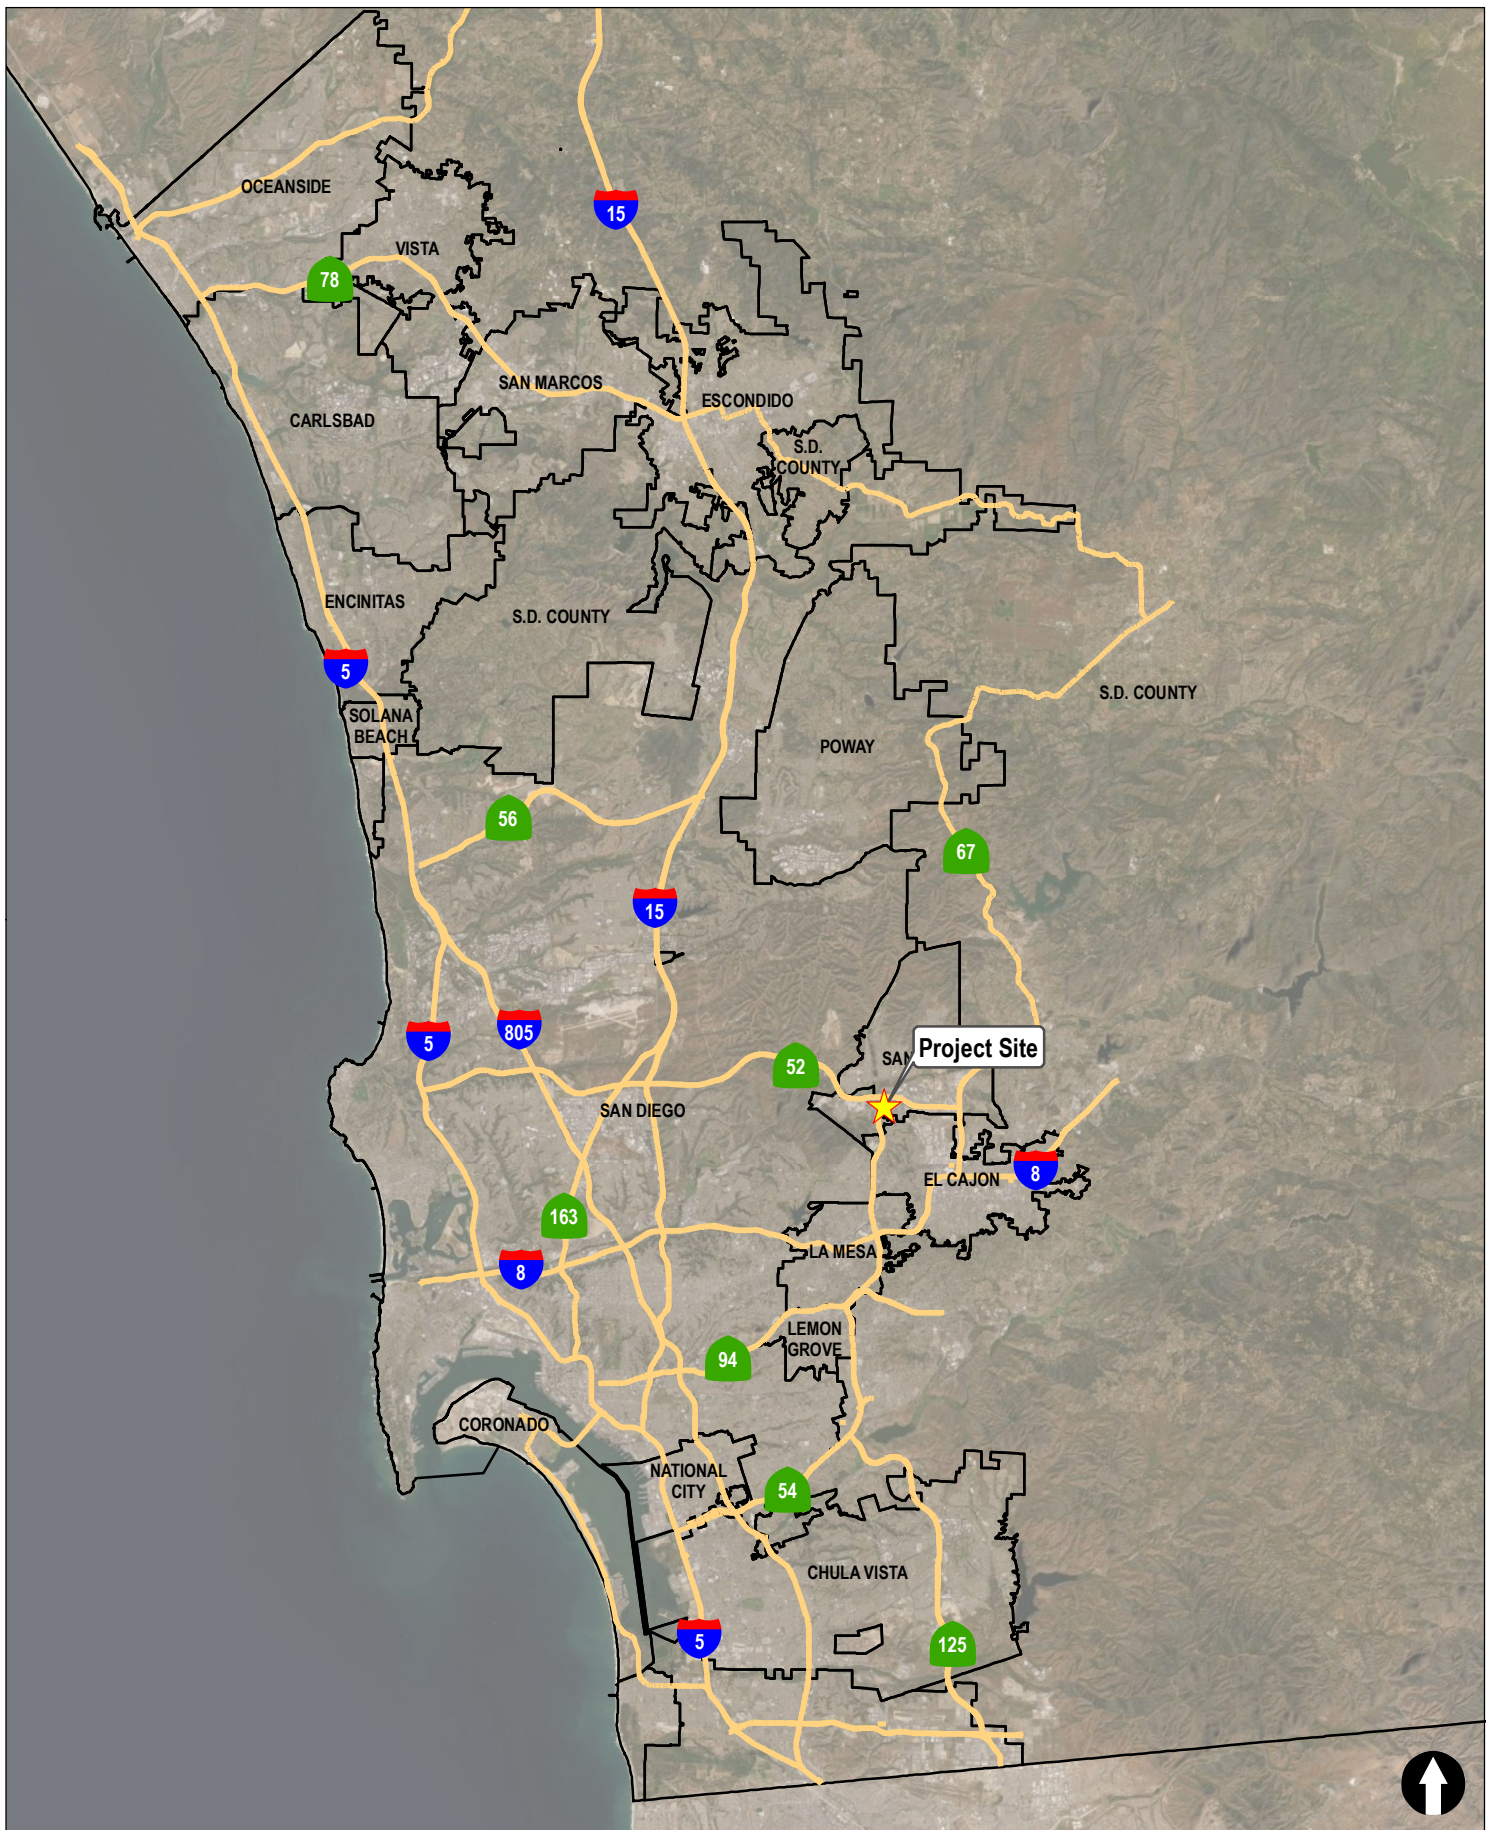
Figure 2–3 shows the conceptual site plan for the project.

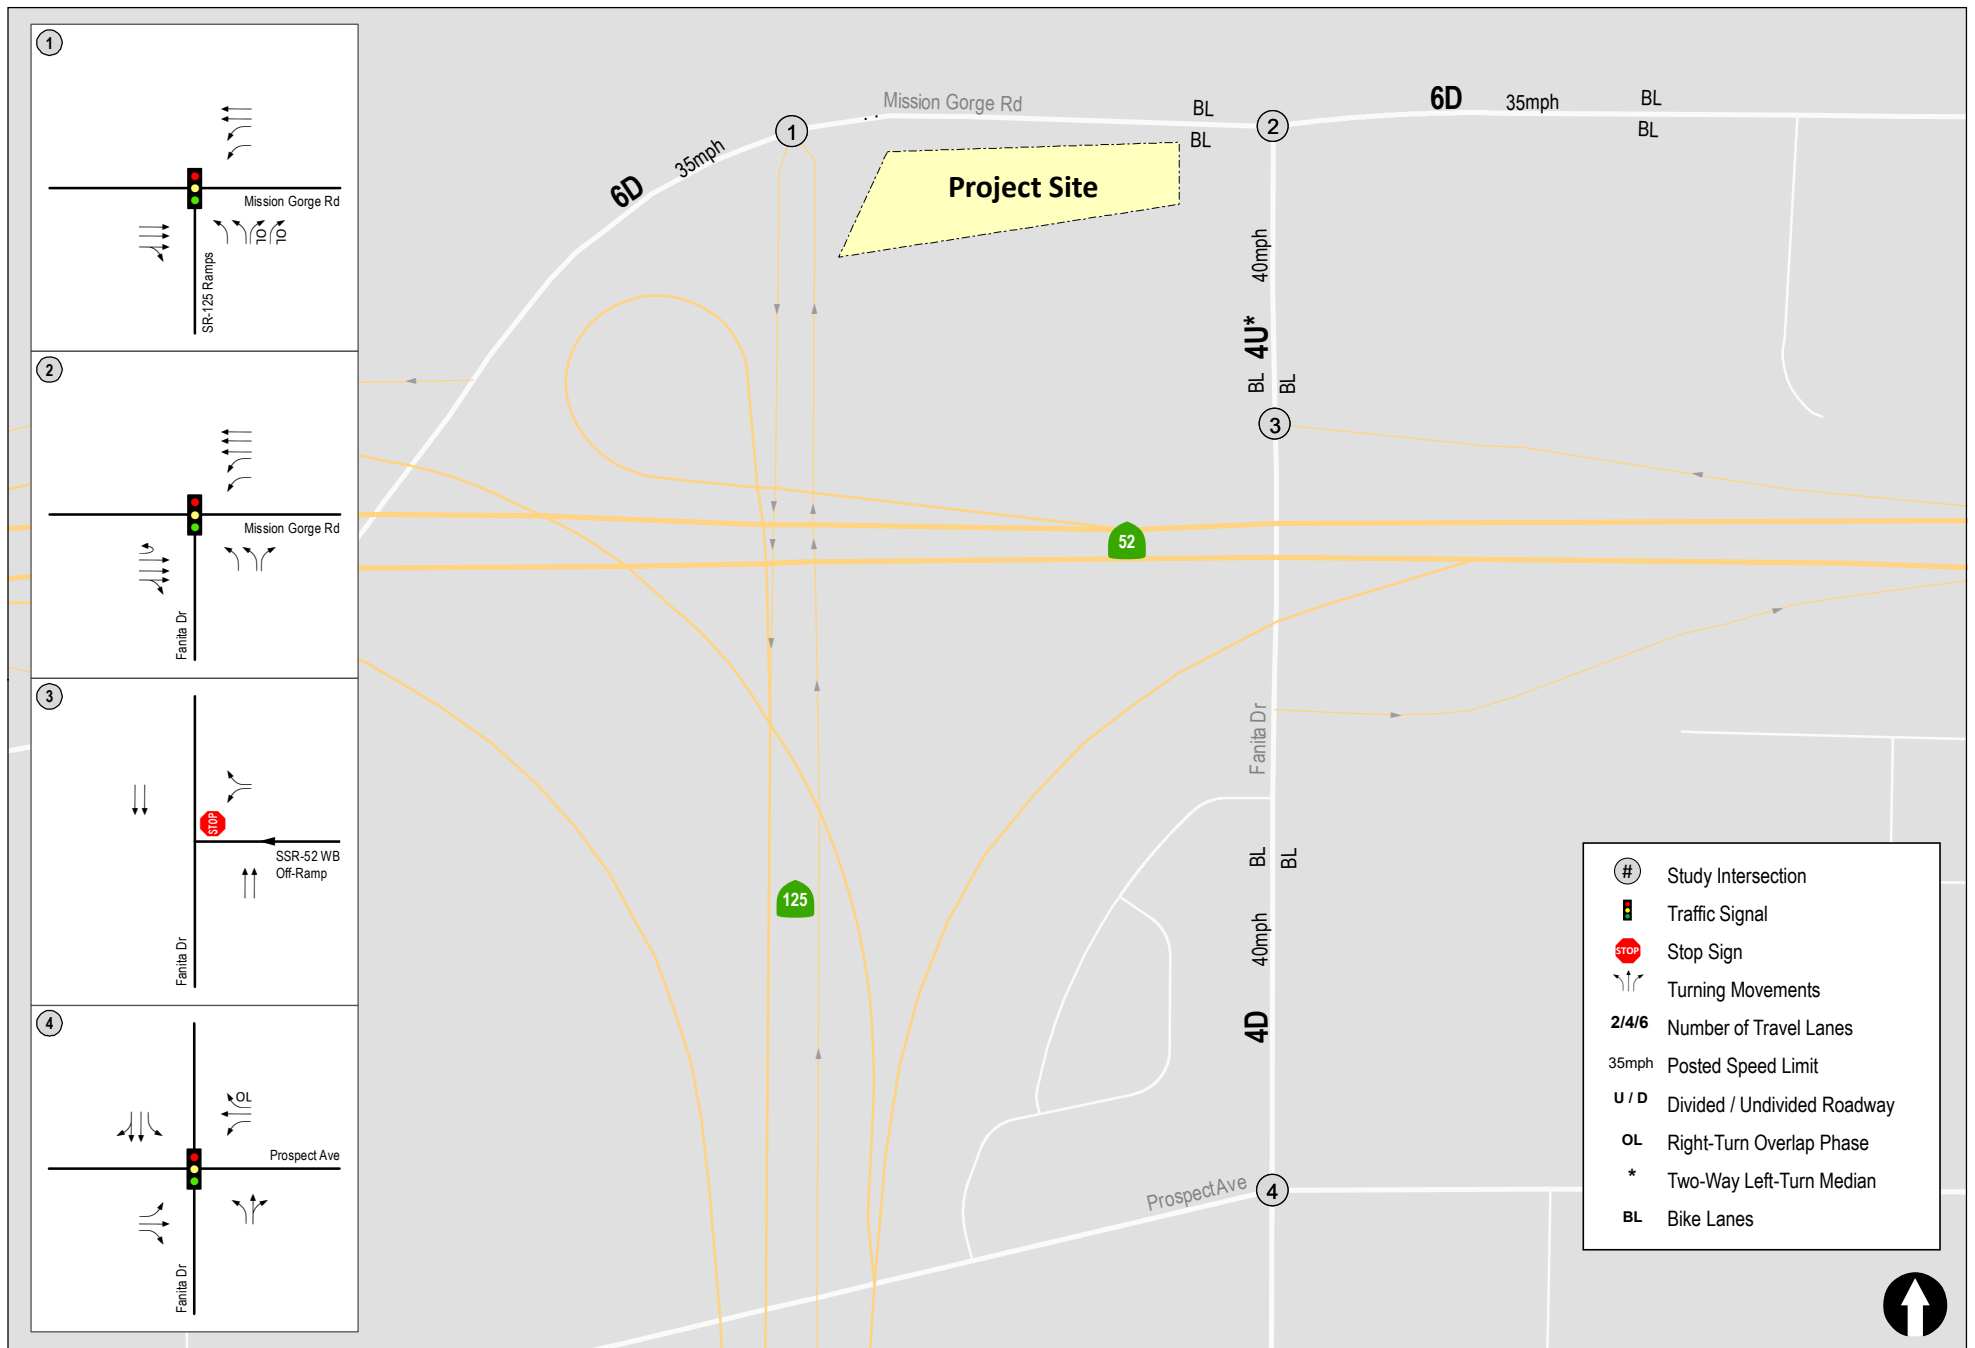
Figure 3-1
Existing Conditions Diagram

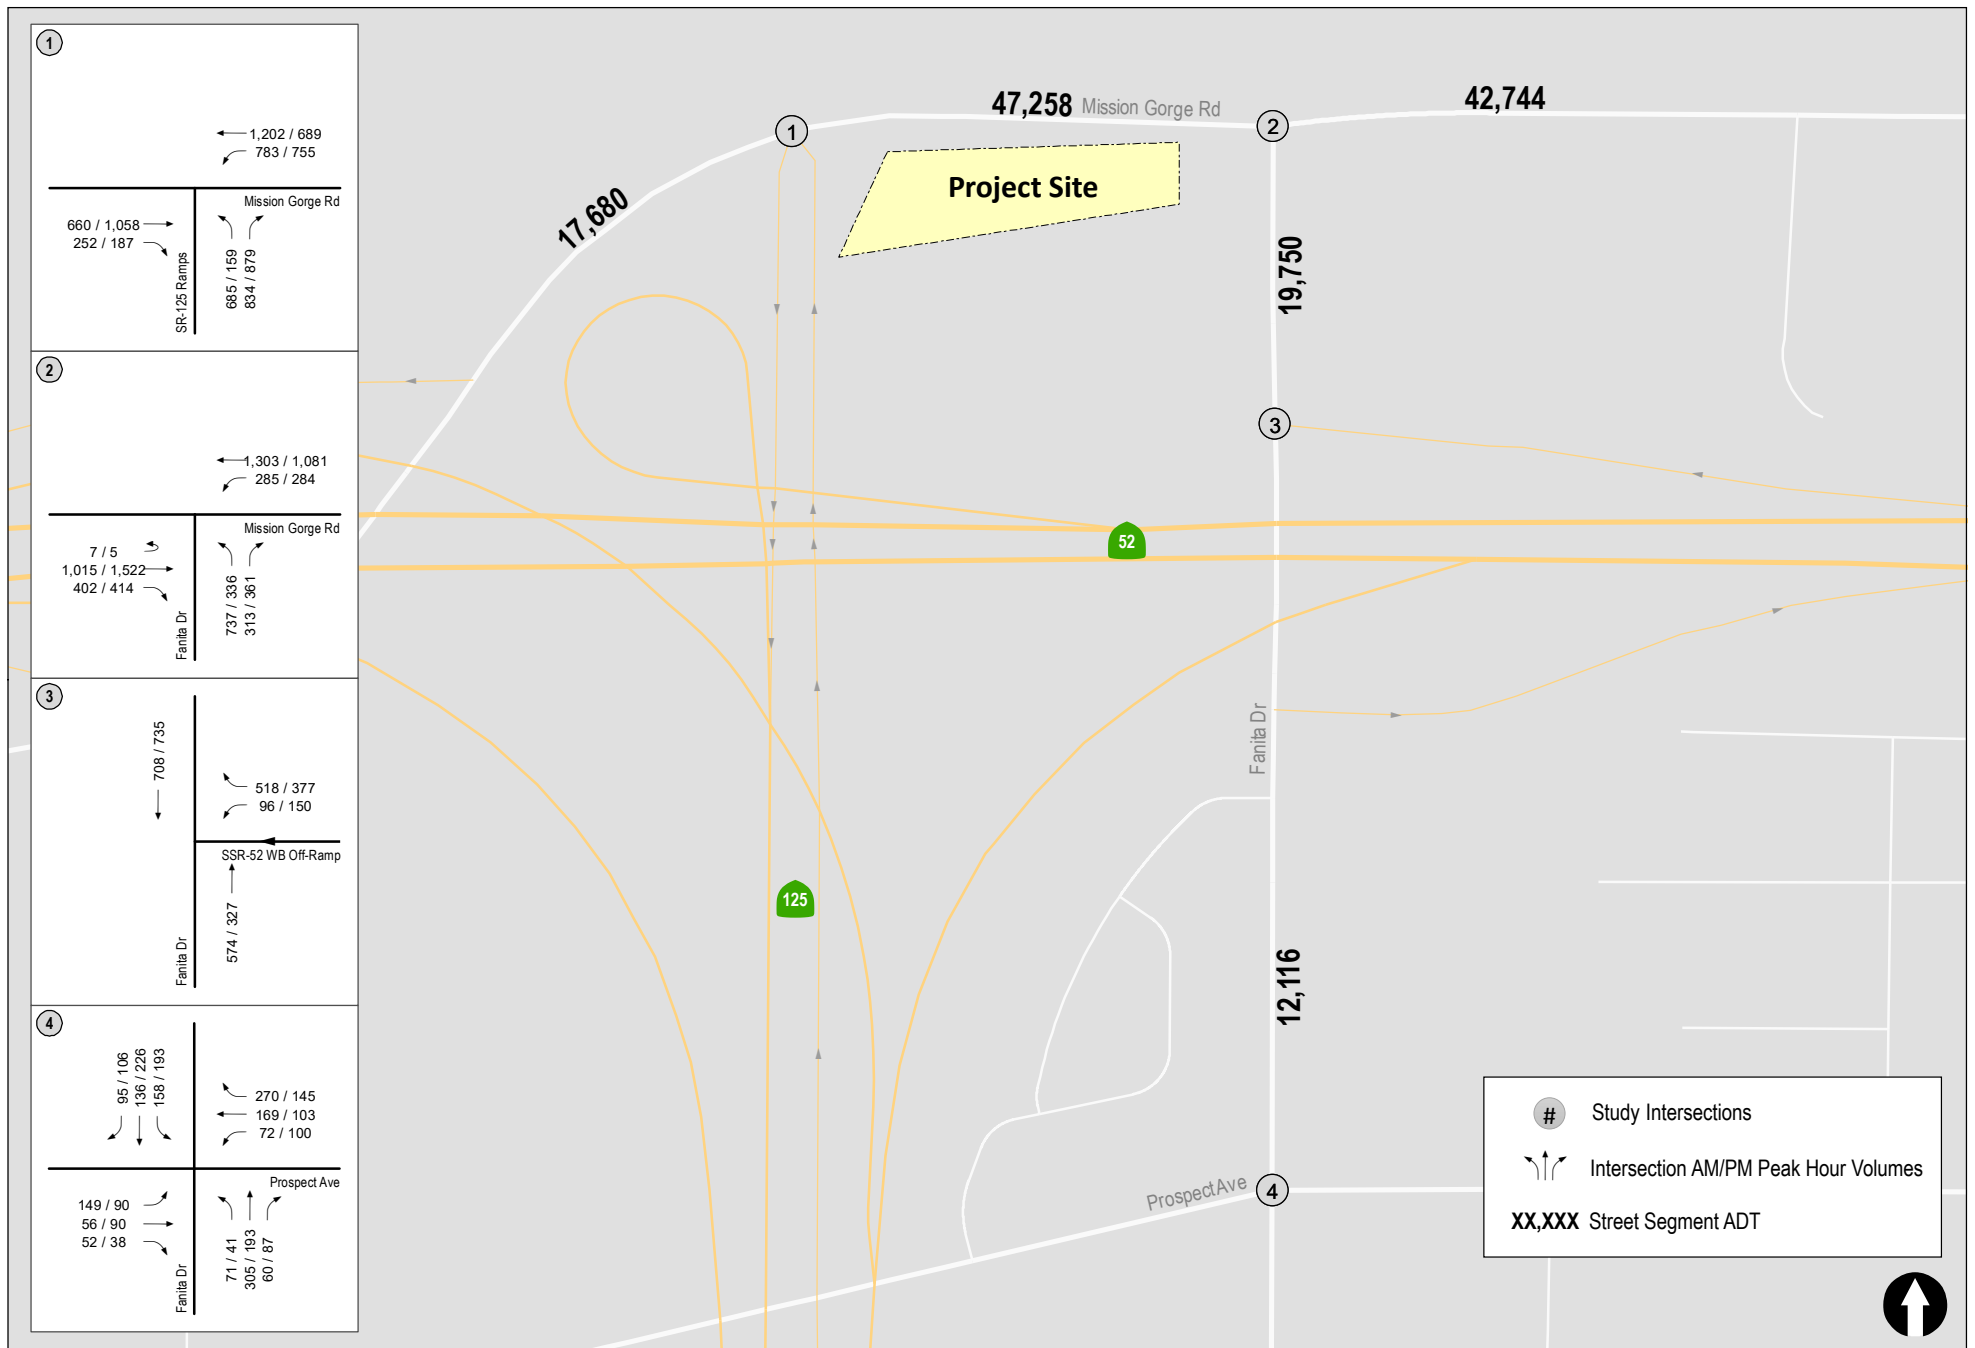
Figure 3-2
Existing Traffic Volumes

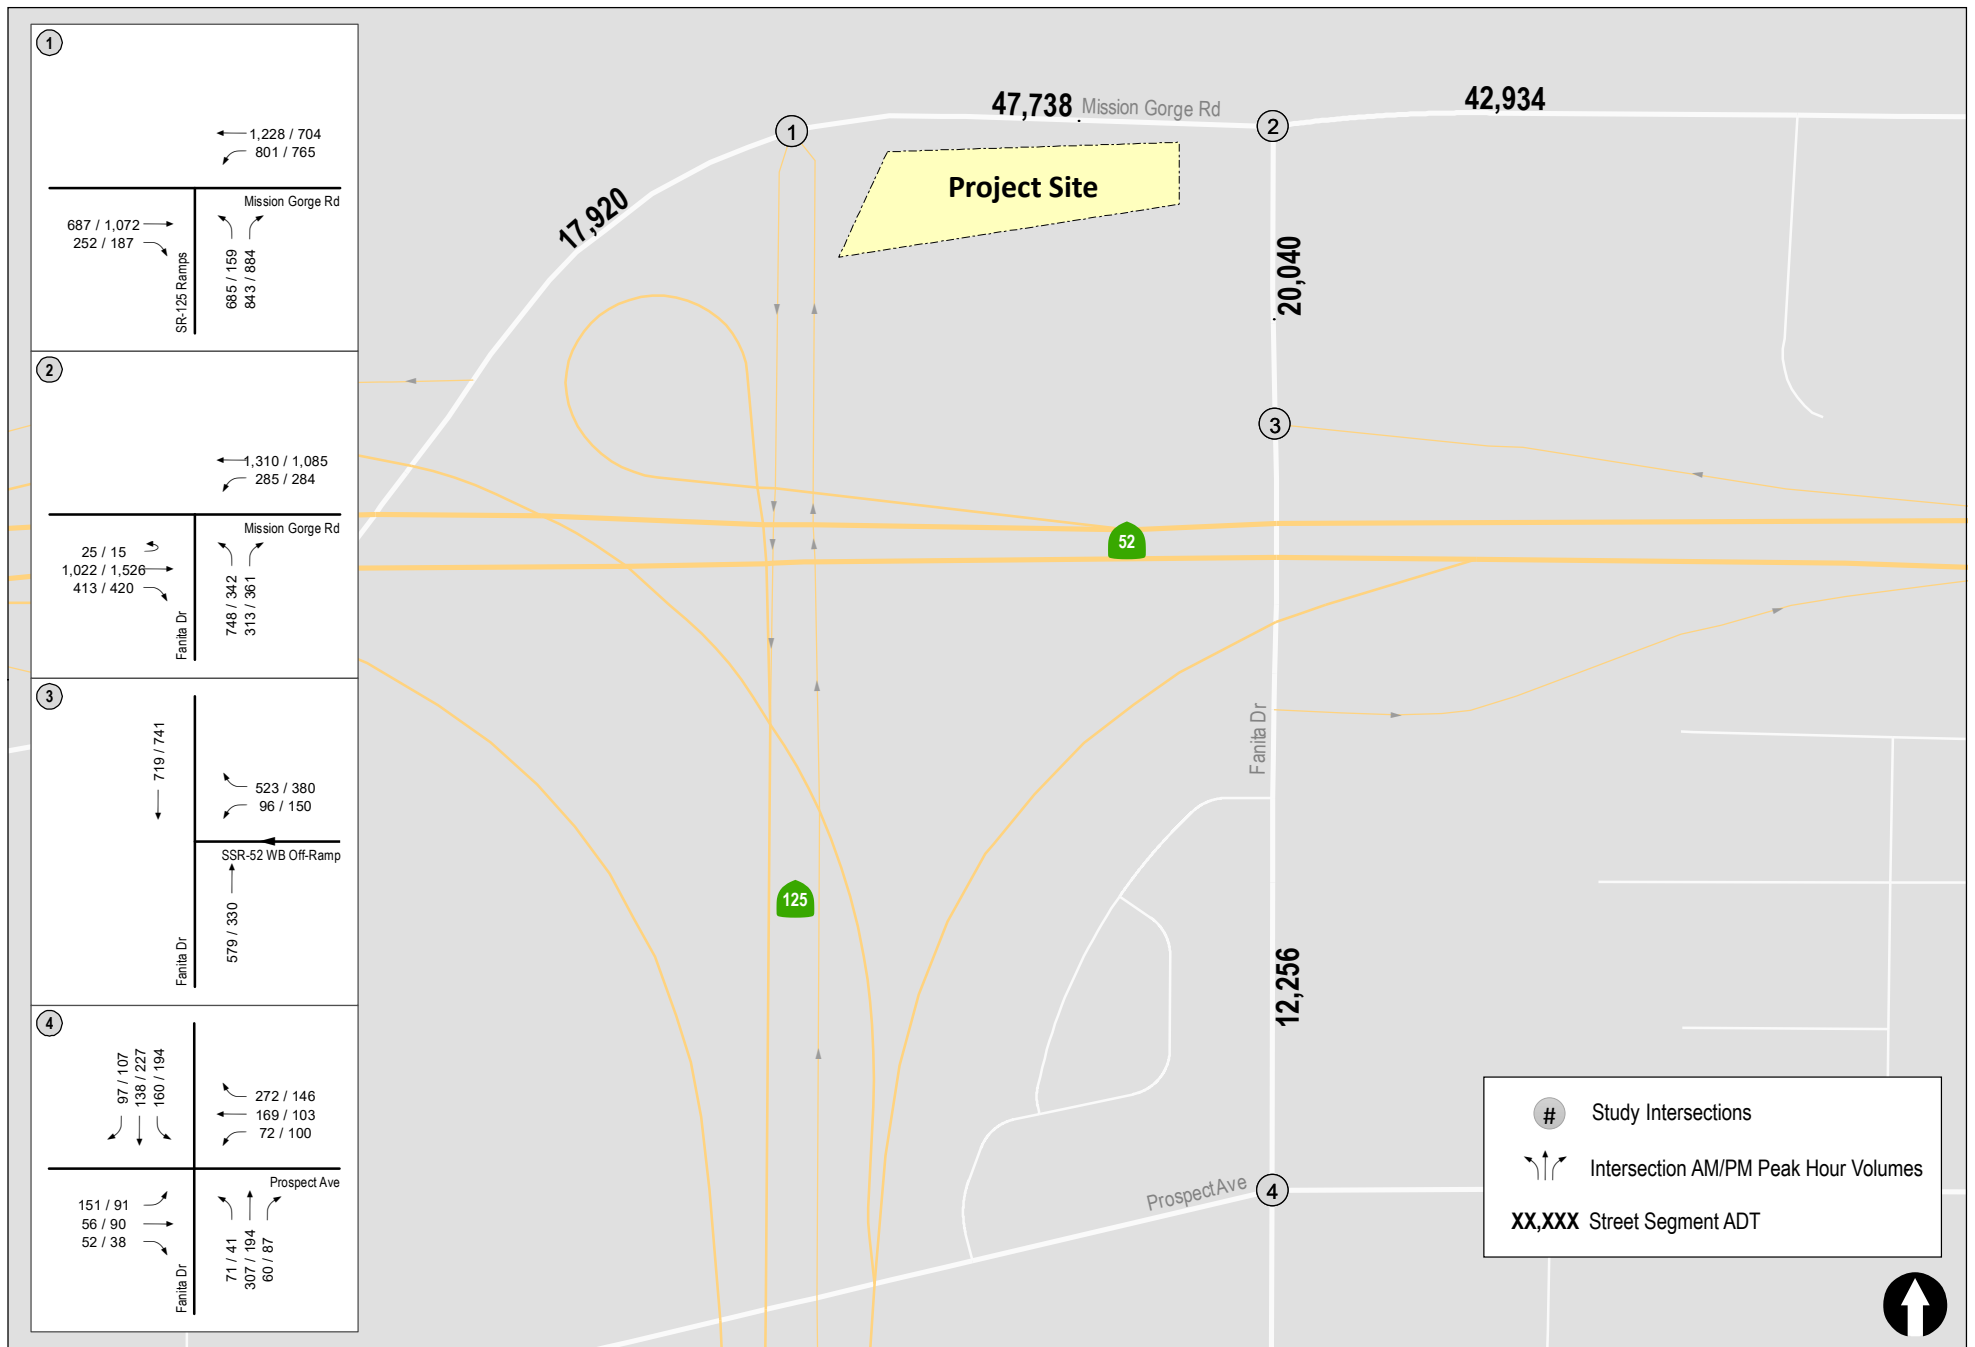
Figure 10-1
Existing + Project Traffic Volumes

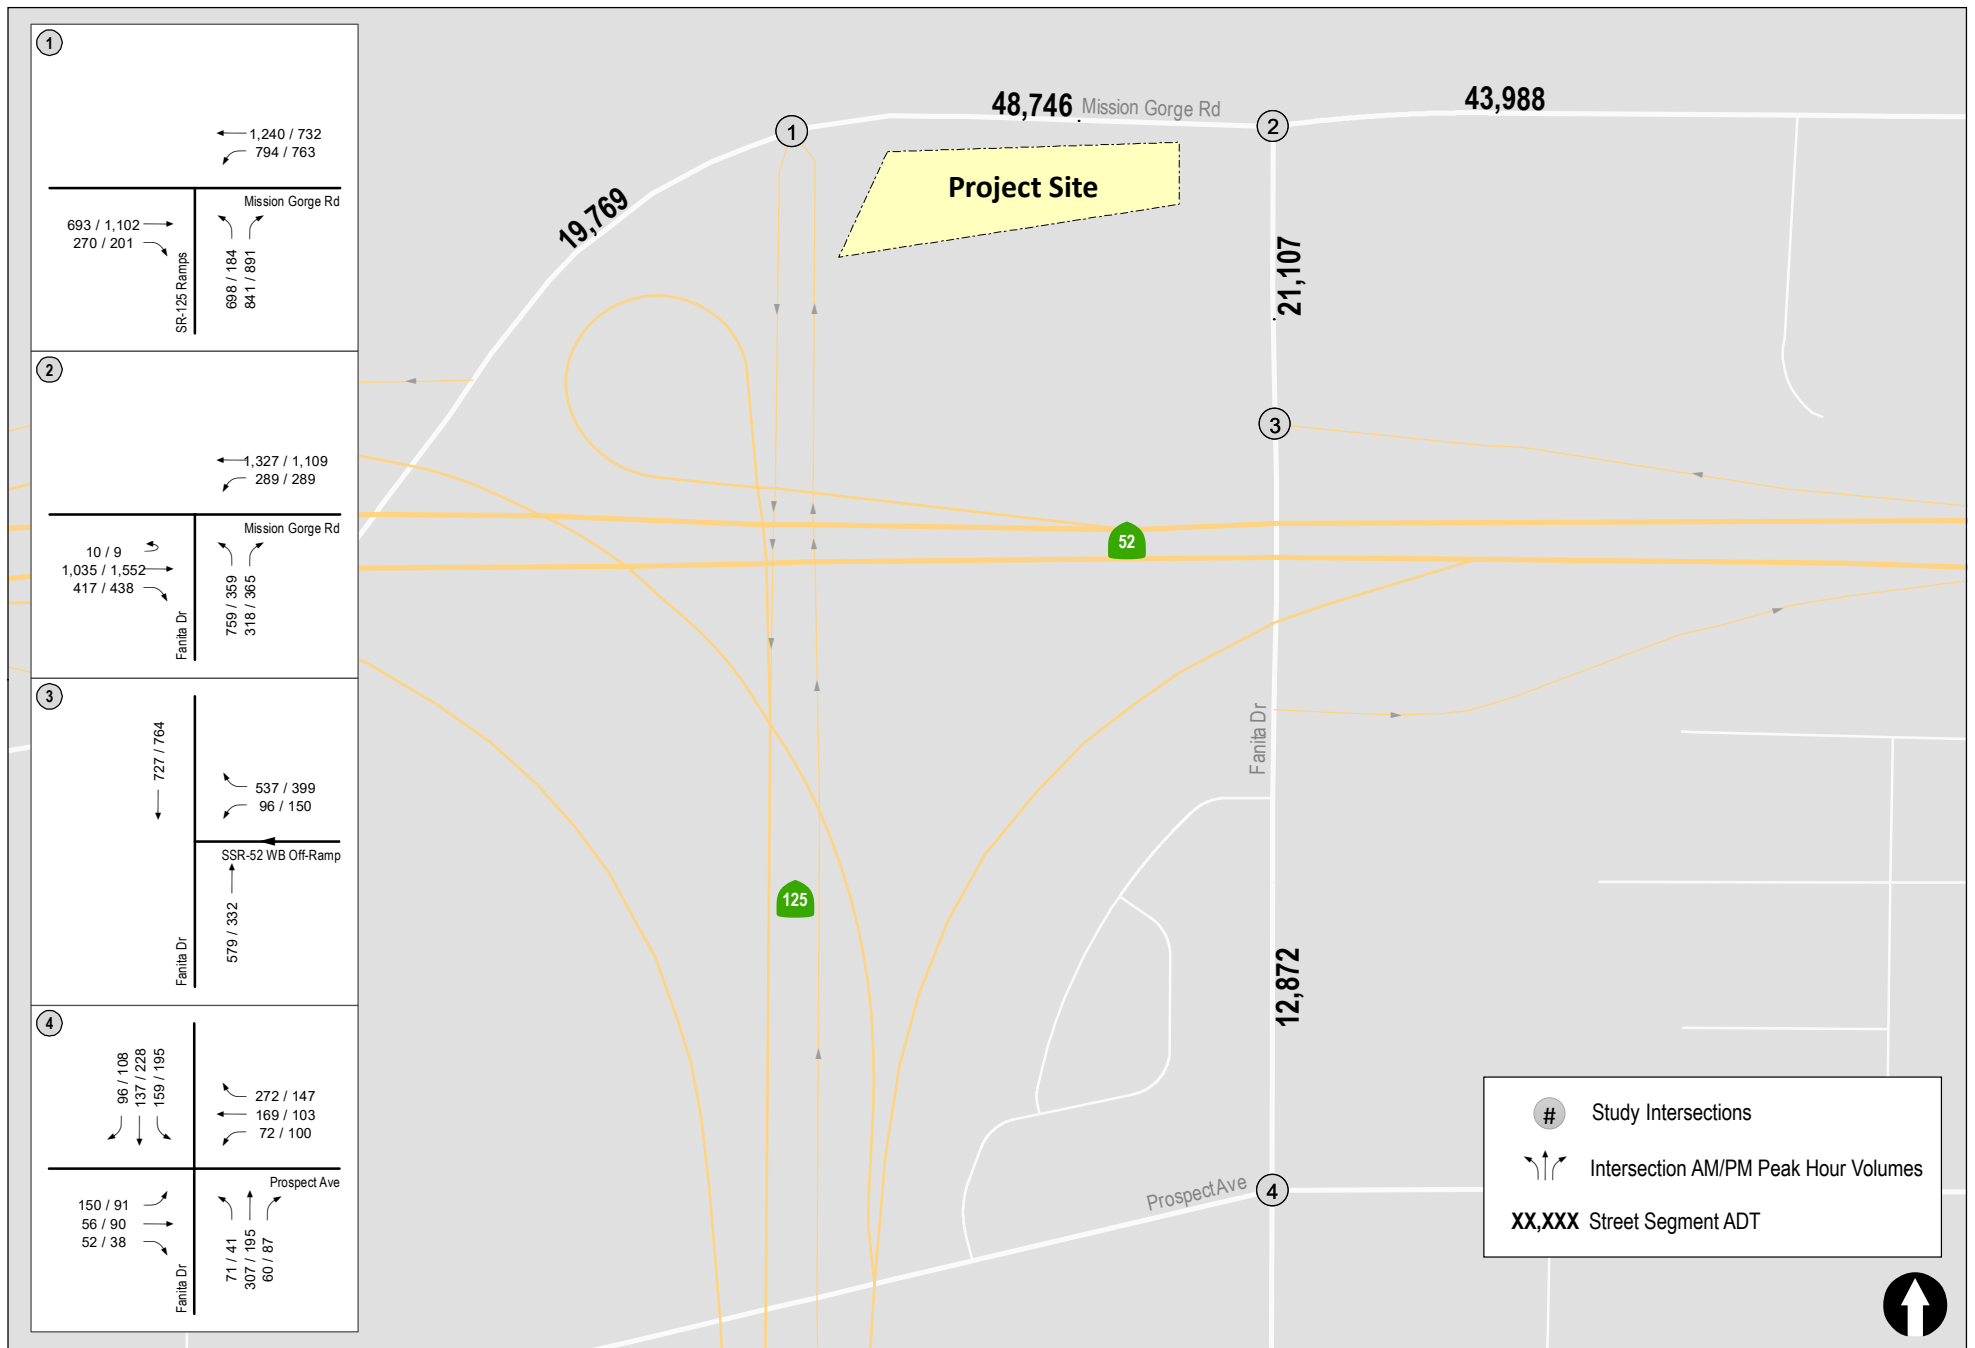
Figure 10-2
Existing + Cumulative Projects Traffic Volumes

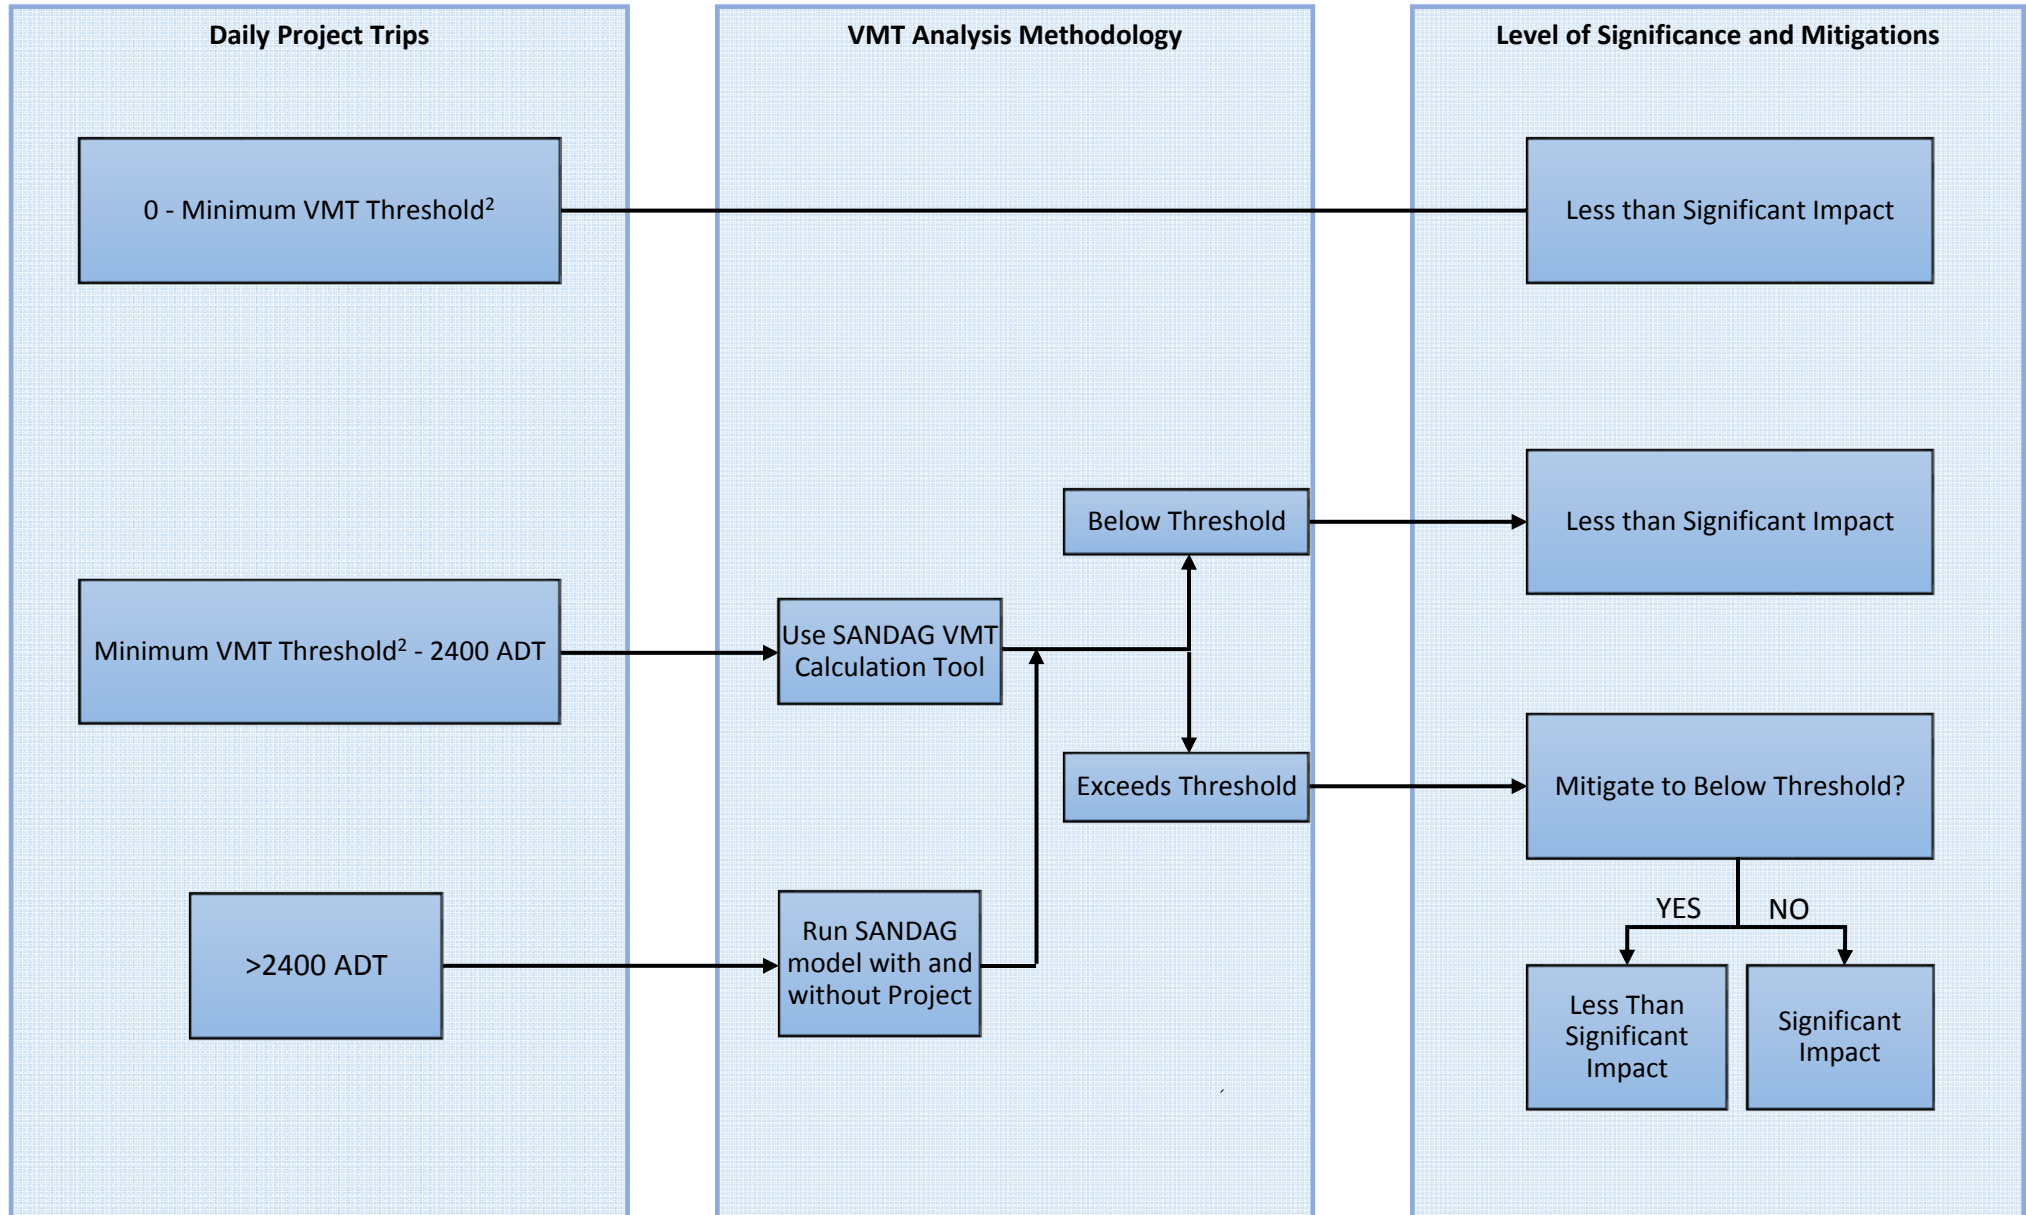
Figure 4-1
VMT Analysis for Individual Land Development Projects¹
