**Geotechnical Investigation Report Update  
Proposed Extended Stay Lodges at:  
25840 Idyllwild Road  
Idyllwild, Riverside County, California**

**Project No. GD19G508-1**

**July 7, 2020**

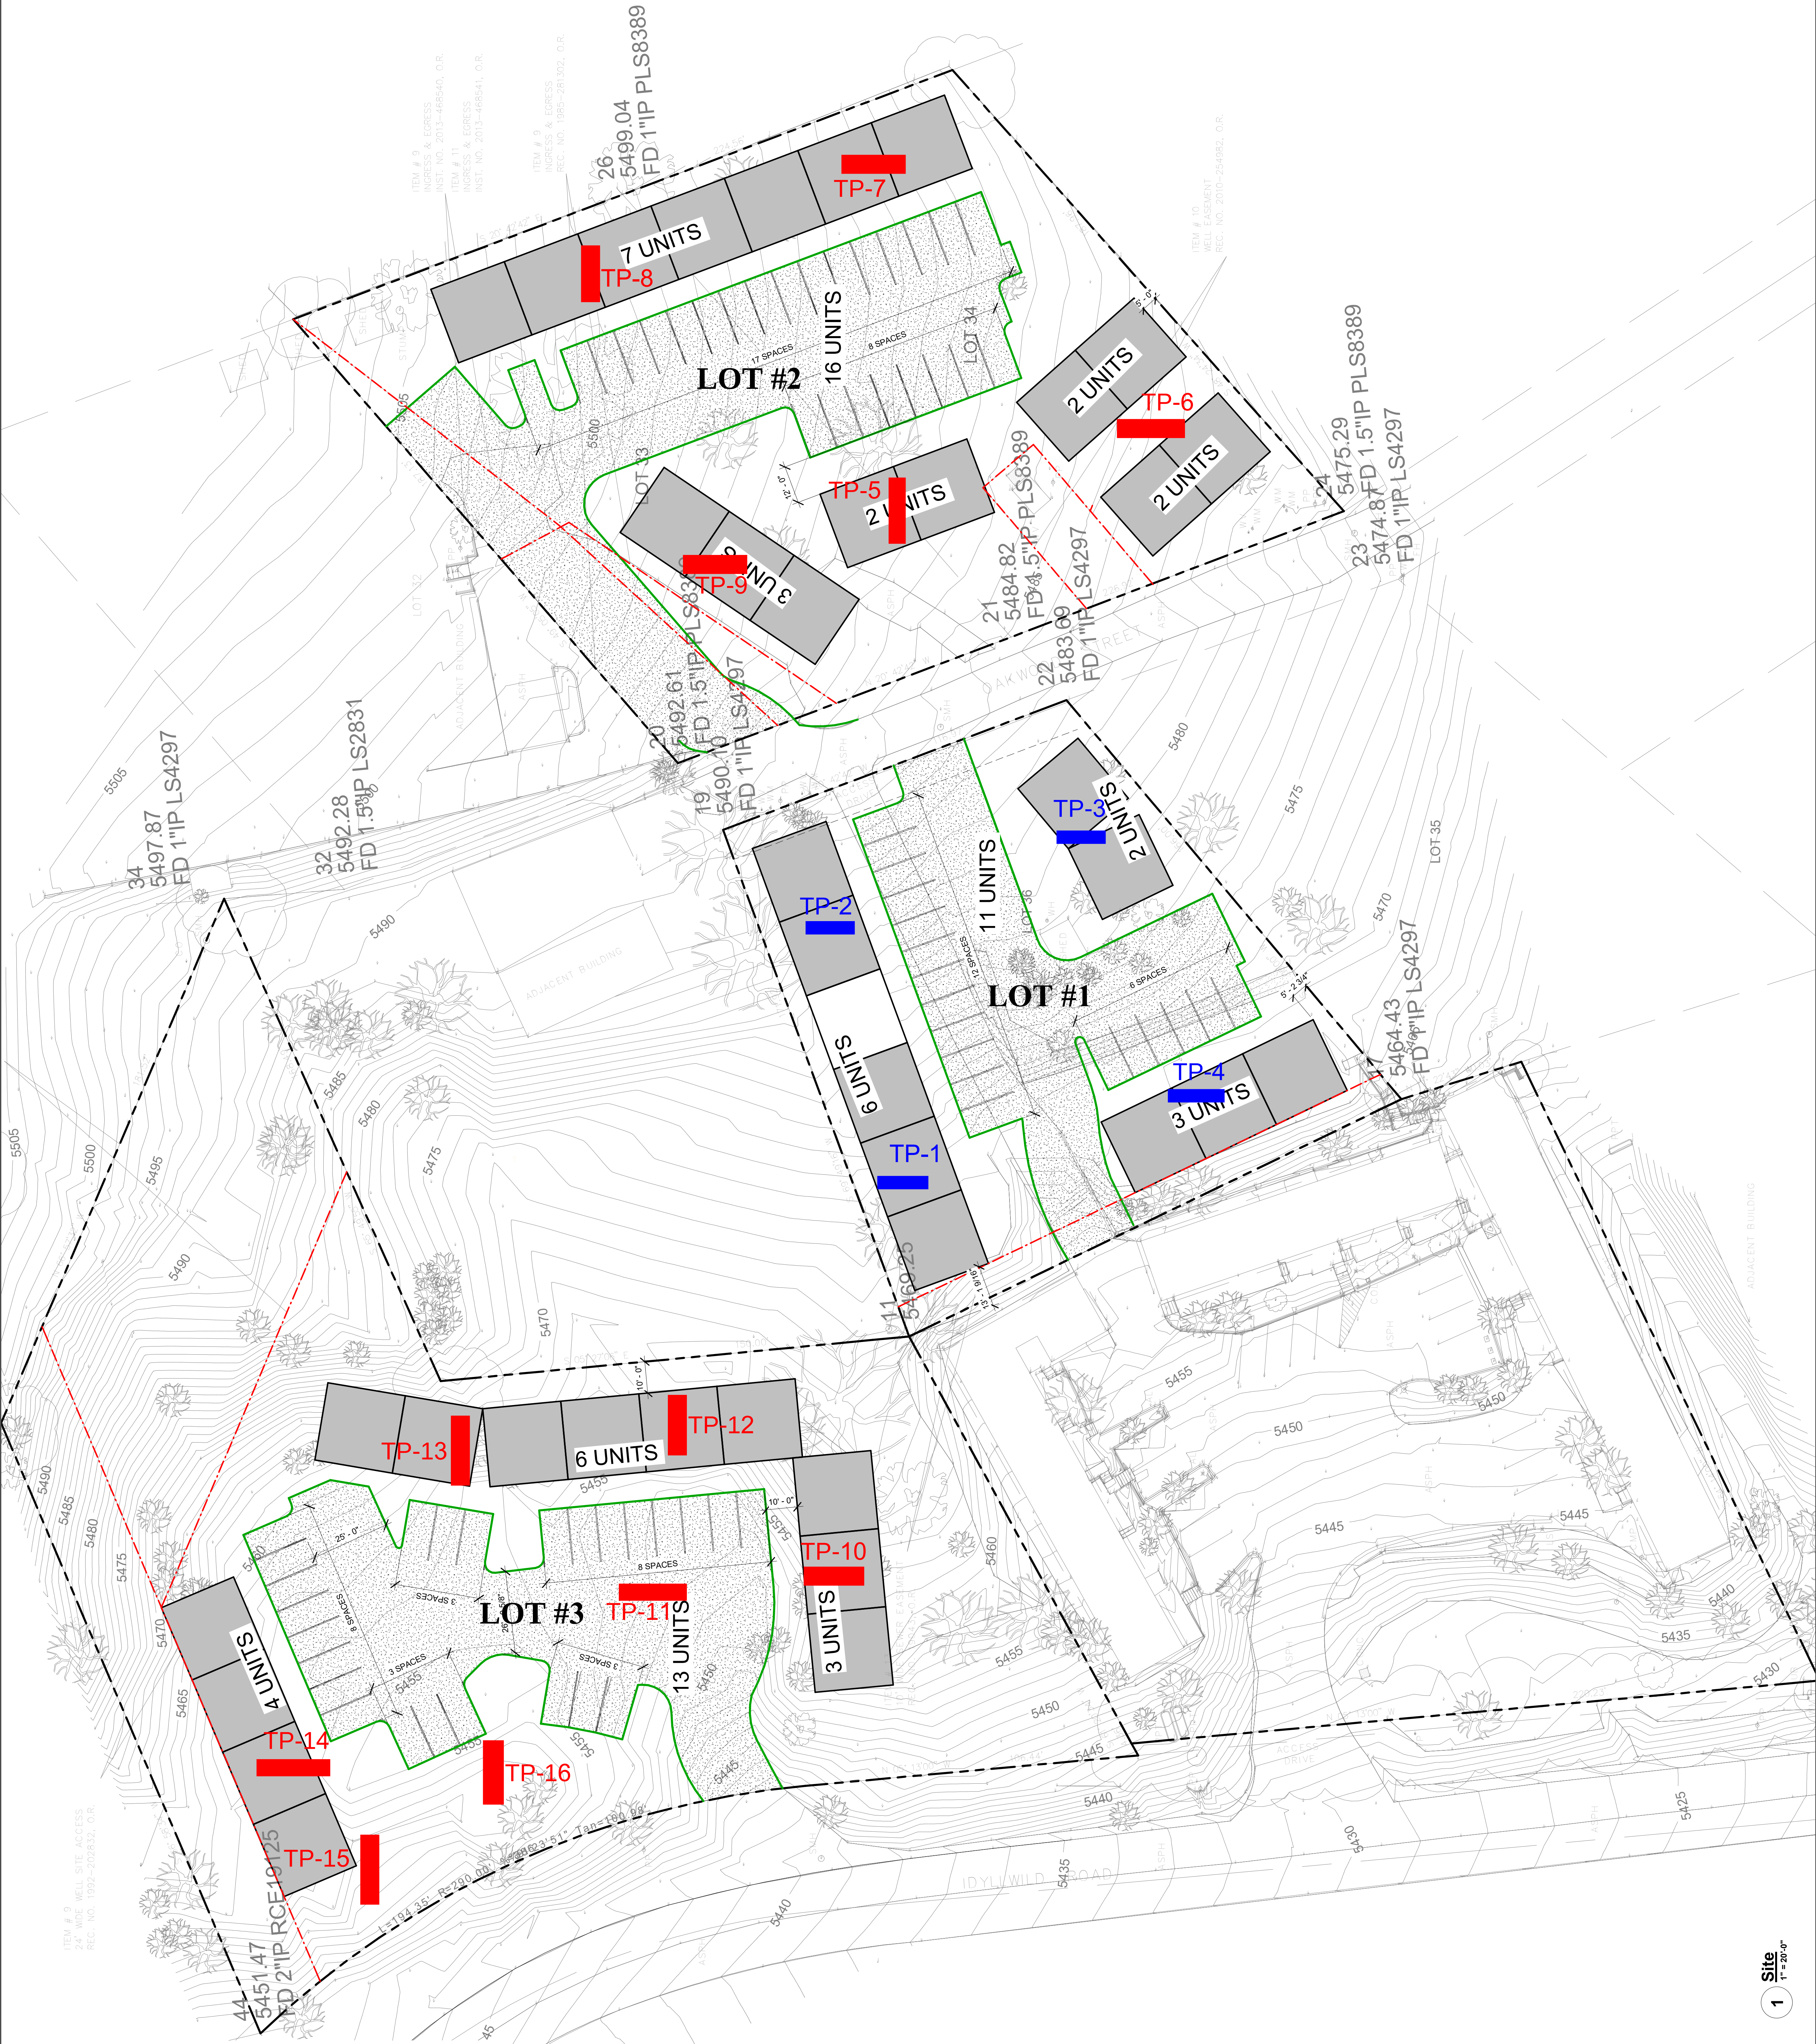
Figure: B

**GEODNEYE ENGINEERING, INC.**  
Geotechnical Map  
Geodyne Project No. GD19G508-1

Field work for our Limited Geotechnical Investigation was conducted on November 1 and 5, 2019 (Lot “1”) and June 23, 2020 (Lots “2” and “3”). For Lot “1”, our initial field work on November 1, 2019 at the site consisted of attempting the excavation of hand-dug exploratory test pits at the subject property. Due to difficult hand digging conditions and shallow refusal, field work was terminated and, with the concurrence of the Client, it was decided to use a backhoe at a later date to excavate the test pits. On November 5, 2019, a total of four (4) exploratory test pits (designated TP-1 through TP-4) were excavated at the subject property. The test pit excavations ranged in depth from approximately 2.5 feet to 7.5 feet below the existing ground surface (bgs). For Lots “2” and “3”, a total of twelve (12) additional exploratory test pits (designated TP-5 through TP-16) were excavated at the subject properties on June 23, 2020. The test pit excavations ranged in depth from approximately 1 foot to 8 feet below the existing ground surface (bgs). All test pit excavations were logged under the supervision of a Registered Professional Engineer and Certified Engineering Geologist at Geodyne Engineering, Inc. The approximate locations of the test pits are shown in Figure B, **Appendix A**.

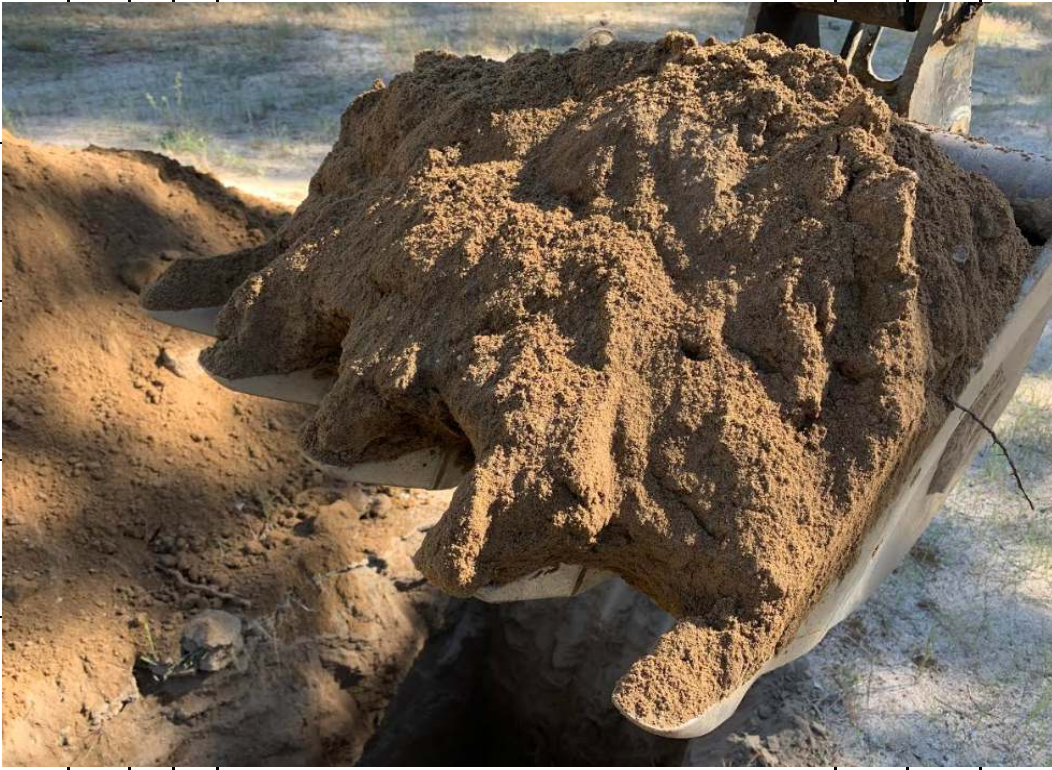
| Depth in Feet | Soil Type | Sample Type | | <div><div><input type="checkbox"/> Bulk Sample</div><div><input type="checkbox"/> Thin Wall Tube</div><div><input type="checkbox"/> Standard Split Spoon Sample</div><div><input checked="" type="checkbox"/> 2.5" Ring Sample</div><div><input type="checkbox"/> Static Water Table</div></div> | Blows/foot | Moisture Content, % | Dry Density, pcf | % Heave | % Collaps | Comments |
|---|---|---|---|---|---|---|---|---|---|---|
| 5 | | <input checked="" type="checkbox"/> | | <b><u>4.0'-6.0': Decompsed granite (DG)</u></b><br>Brownish olive gray, weathered, friable,<br>massive, | | 3.8 | 113.7 | | | |
| | | | | <b>End of Test Pit @ 6.0-feet</b><br><b>No groundwater or caving</b><br><b>Excavation backfilled with cutting spoil,</b> | | | | | | |

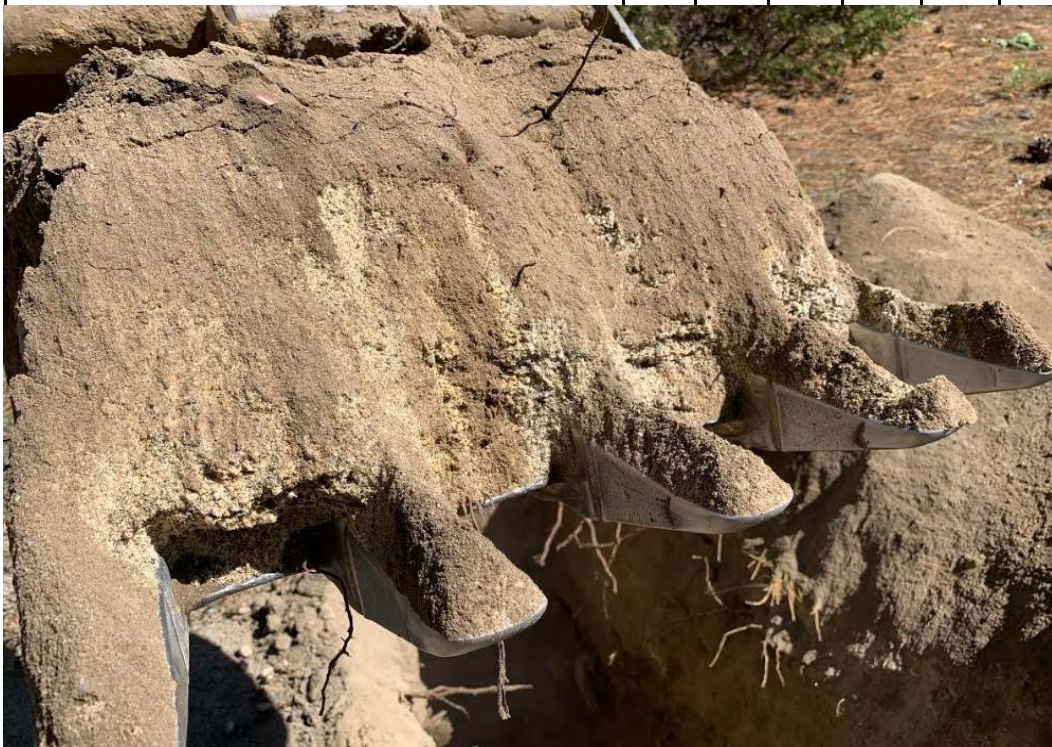
| Depth in Feet | Soil Type | Sample Type | | <div><div><div>Thin Wall Tube</div><div><input checked="" type="checkbox"/> 2.5" Ring Sample</div></div><div><div><input checked="" type="checkbox"/> Bulk Sample</div><div><input type="checkbox"/> Standard Split Spoon Sample</div><div><input type="checkbox"/> Static Water Table</div></div></div> | Blows/foot | Moisture Content, % | Dry Density, pcf | % Heave | % Collaps | Comments |
|---|---|---|---|---|---|---|---|---|---|---|
| | SW | | | Bareground,<br><b><u>0.0'-3.5': Topsoil/Artificial FILL (Qaf)</u></b><br>Brownish gray, fine-coarse SAND,<br>trace silt, with pebbles, loose, dry-damp,<br><br>rootlets,<br><br><b><u>4.0'-6.0': Decompsed granite (DG)</u></b><br>White, weathered, friable,<br>massive,<br><br><b>End of Test Pit @ 6.0-feet</b><br><b>No groundwater or caving</b><br><b>Excavation backfilled with cutting spoil,</b> | | | | | | |

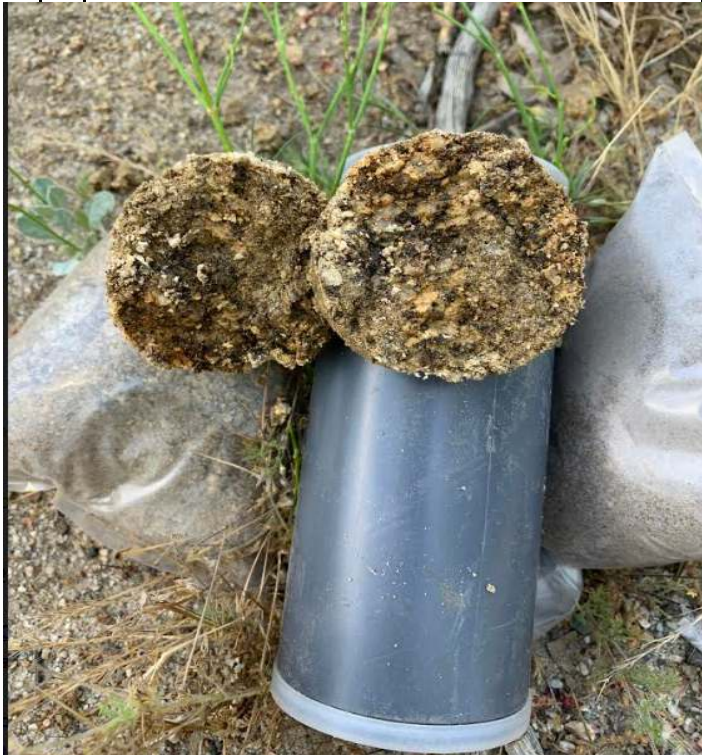
| Depth in Feet | Soil Type | Sample Type | | <div><div><input type="checkbox"/> Bulk Sample</div><div><input type="checkbox"/> Thin Wall Tube</div><div><input type="checkbox"/> Standard Split Spoon Sample</div><div><input checked="" type="checkbox"/> 2.5" Ring Sample</div><div><input type="checkbox"/> Static Water Table</div></div> | Blows/foot | Moisture Content, % | Dry Density, pcf | % Heave | % Collaps | Comments |
|---|---|---|---|---|---|---|---|---|---|---|
| | | | <b><u>4.0'-6.0': Decompsed granite (DG)</u></b><br>Yellow, white, gray ,weathered,<br>massive, | | | | | | | |
| | | | <b>End of Test Pit @ 6.0-feet</b><br><b>No groundwater or caving</b><br><b>Excavation backfilled with cutting spoil,</b> | | | | | | | |

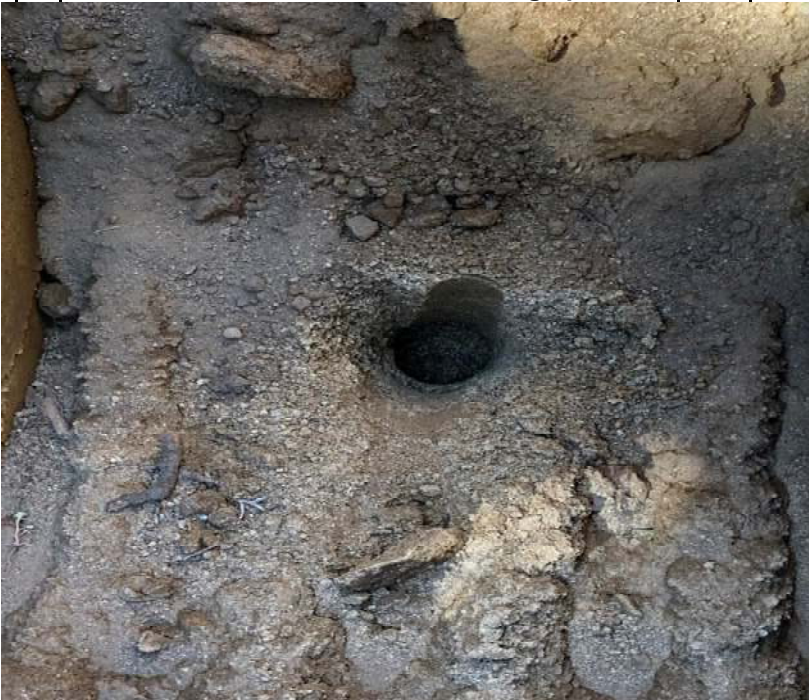
| Depth in Feet | Soil Type | Sample Type | | <div><div><div>Thin Wall Tube</div><div>2.5" Ring Sample</div></div><div><div>Bulk Sample</div><div>Standard Split Spoon Sample</div><div>Static Water Table</div></div></div> | Blows/foot | Moisture Content, % | Dry Density, pcf | % Heave | % Collaps | Comments |
|---|---|---|---|---|---|---|---|---|---|---|
| | | <div><div></div></div> | <b><u>3.5'-7.0': Decompsed granite (DG)</u></b><br>Light gray, white, brown, weathered, massive, | | | | | | | |
| | | | <b>End of Test Pit @ 7.0-feet</b><br><b>No groundwater or caving</b><br><b>Excavation backfilled with cutting spoil,</b> | | | | | | | |

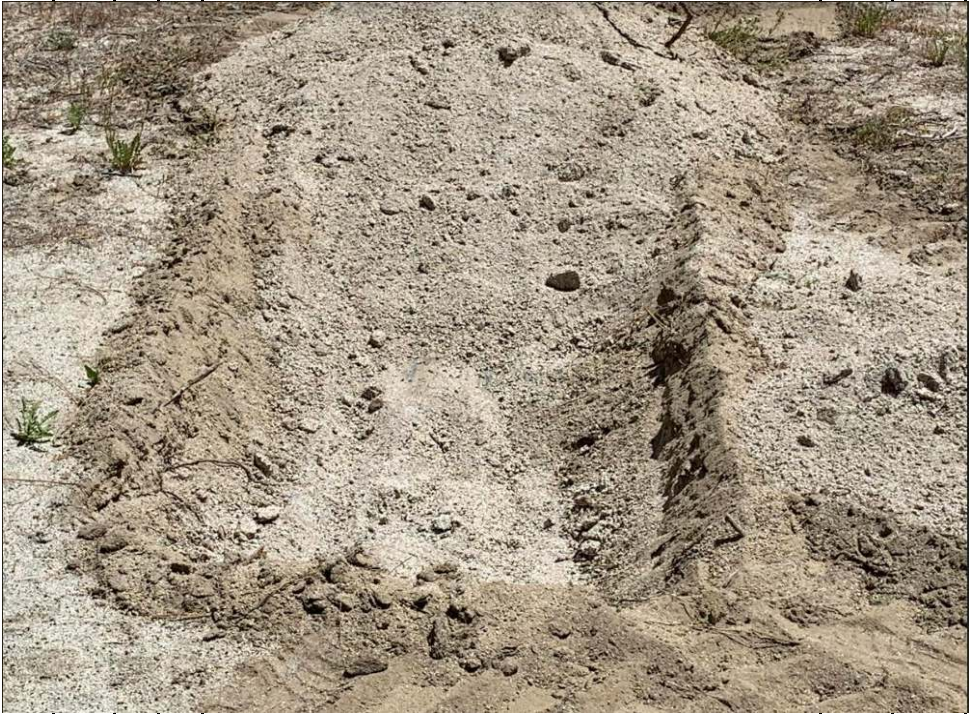
| Depth in Feet | Soil Type | Sample Type | | SOIL DESCRIPTION | Blows/foot | Moisture Content, % | Dry Density, pcf | % Heave | % Collaps | Comments | |
|---|---|---|---|---|---|---|---|---|---|---|---|
| | | | | Bareground/Topsoil<br><b><u>0.0'-1.0' Decompsed granite (DG)</u></b><br>Light gray and brown,<br>hard, slightly weathered,<br><br><b>End of Test Pit @ 1.0-ft</b> | | | | | | | Proposed Parking Area |

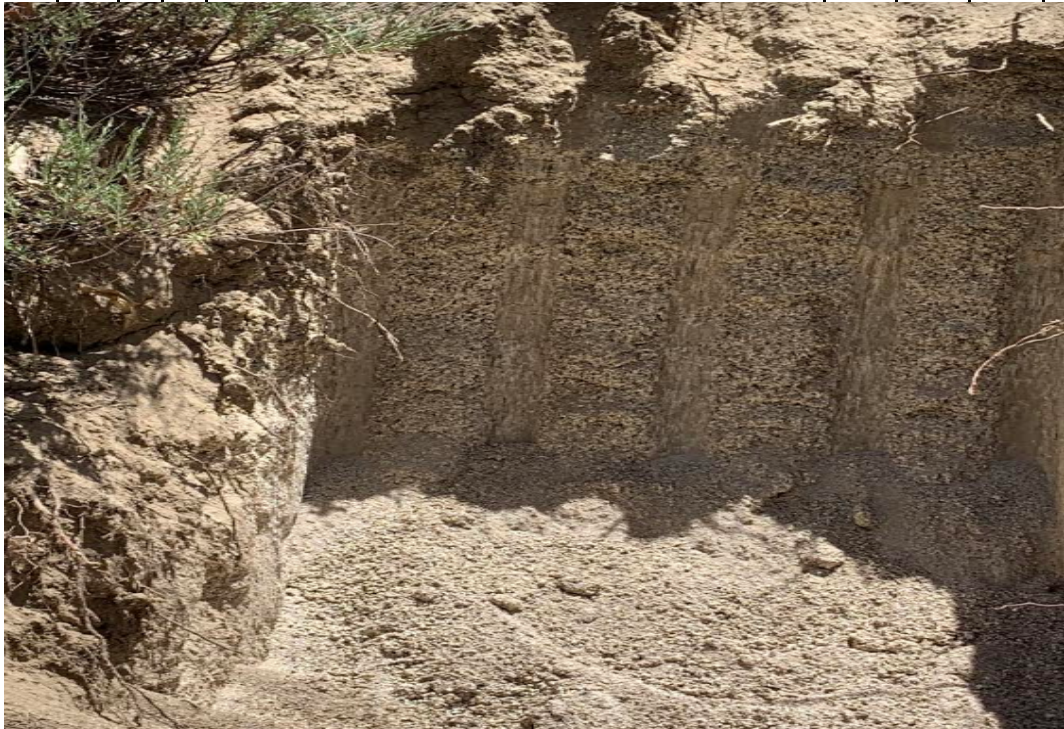
| Depth in Feet | Soil Type | Sample Type | | <div><div><div></div><div>Thin Wall Tube</div></div><div><div></div><div>2.5" Ring Sample</div></div><div><div></div><div>Bulk Sample</div></div><div><div></div><div>Standard Split Spoon Sample</div></div><div><div></div><div>Static Water Table</div></div></div> | Blows/foot | Moisture Content, % | Dry Density, pcf | % Heave | % Collaps | Comments |
|---|---|---|---|---|---|---|---|---|---|---|
| 5 | | | | <div>Bareground/Topsoil</div> <div><b><u>0.5'-3.0': Decompsed granite (DG)</u></b></div> <div>Light brownish gray,<br/>hard, slightly weathered,</div> | | | | | | |
| | | | | <div>End of Test Pit @ 3.0-feet</div> <div>No groundwater or caving</div> <div>Excavation backfilled wih cutting spoil,</div> | | | | | | |

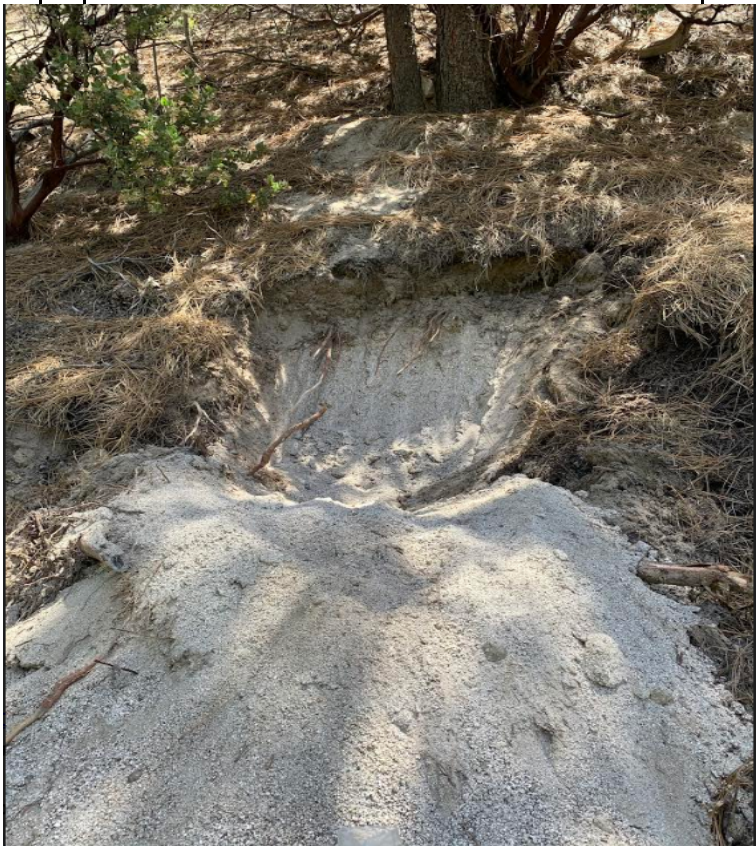
| Depth in Feet | Soil Type | Sample Type | | <div><div><div><div></div></div><div>Thin Wall Tube</div></div><div><div><div></div></div><div>2.5" Ring Sample</div></div><div><div><div></div></div><div>Bulk Sample</div></div><div><div><div></div></div><div>Standard Split Spoon Sample</div></div><div><div><div></div></div><div>Static Water Table</div></div></div> | Blows/foot | Moisture Content, % | Dry Density, pcf | % Heave | % Collaps | Comments |
|---|---|---|---|---|---|---|---|---|---|---|
| 5 | | | Bareground/Topsoil<br><b><u>0.5'-2.0': Decompsed granite (DG)</u></b><br>White to Light gray,<br>hard, slightly weathered, | | | | | | | |
| | | | <b>End of Test Pit @ 2.0-feet</b><br><b>No groundwater or caving</b><br><b>Excavation backfilled wih cutting spoil,</b> | | | | | | | |

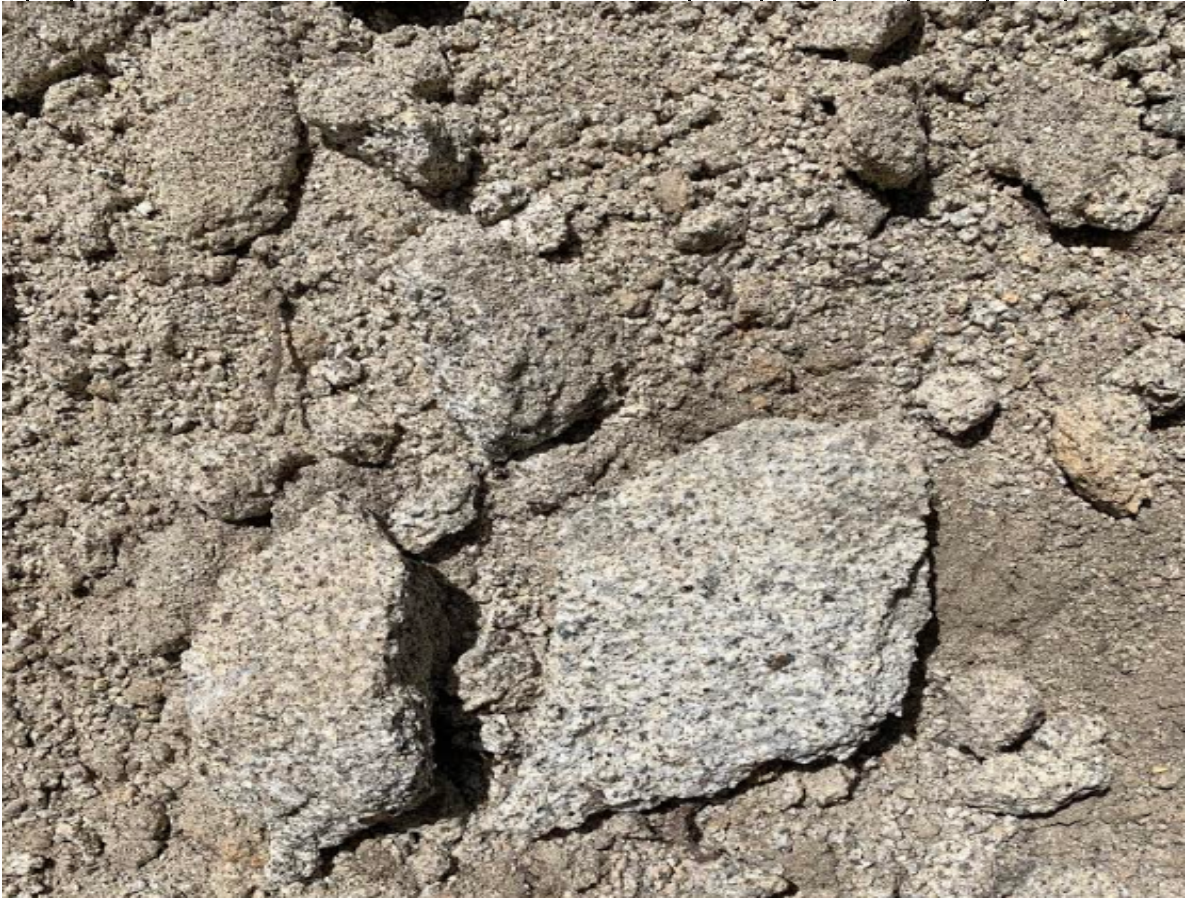
| Depth in Feet | Soil Type | Sample Type | | <input type="checkbox"/> Bulk Sample<br><input type="checkbox"/> Thin Wall Tube<br><input type="checkbox"/> Standard Split Spoon Sample<br><input type="checkbox"/> 2.5" Ring Sample<br><input type="checkbox"/> Static Water Table | Blows/foot | Moisture Content, % | Dry Density, pcf | % Heave | % Collaps | Comments |
|---|---|---|---|---|---|---|---|---|---|---|
| | | | | Bareground/Topsoil<br><b><u>0.5'-2.0': Decompsed granite (DG)</u></b><br>White to Light gray,<br>hard, weathered,<br><br><b>End of Test Pit @ 2.0-feet</b><br><b>No groundwater or caving</b><br><b>Excavation backfilled wih cutting spoil,</b> | | | | | | |

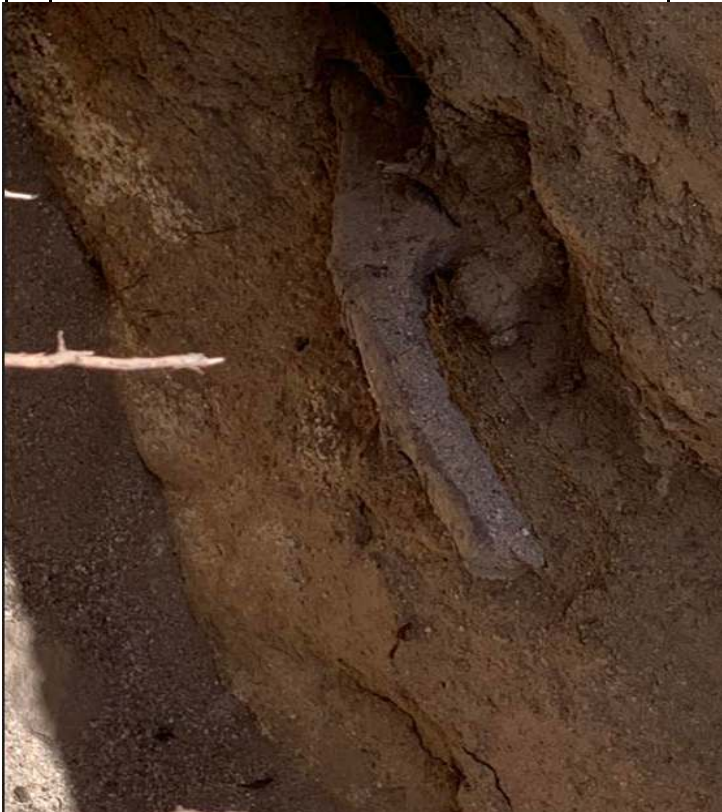
| Depth in Feet | Soil Type | Sample Type | | <div><div><input type="checkbox"/> Bulk Sample</div><div><input type="checkbox"/> Standard Split Spoon Sample</div><div><input checked="" type="checkbox"/> Thin Wall Tube</div><div><input checked="" type="checkbox"/> 2.5" Ring Sample</div><div><input type="checkbox"/> Static Water Table</div></div> | Blows/foot | Moisture Content, % | Dry Density, pcf | % Heave | % Collaps | Comments |
|---|---|---|---|---|---|---|---|---|---|---|
| | | | | <b>0.3'-5.0': Decompsed granite (DG)</b><br>White to Light gray, hard, slightly weathered, | | | | | | |
| | | | | <b>End of Test Pit @ 5.0-feet</b><br><b>No groundwater or caving</b><br><b>Excavation backfilled with cutting spoil,</b> | | | | | | |

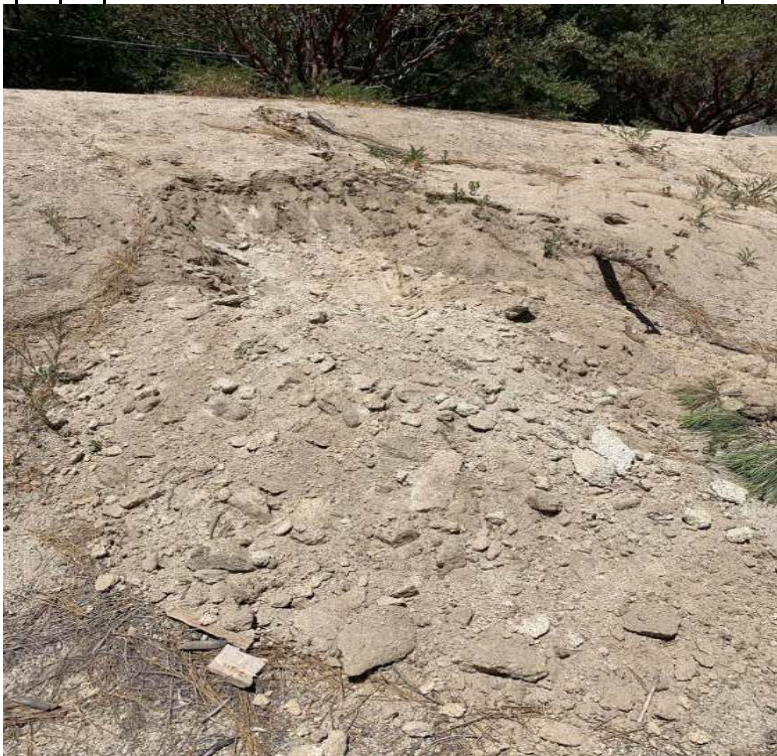
| Depth in Feet | Soil Type | Sample Type | | <div><div><div><input type="checkbox"/> Bulk Sample</div><div><input type="checkbox"/> Thin Wall Tube</div></div><div><div><input type="checkbox"/> Standard Split Spoon Sample</div><div><input checked="" type="checkbox"/> 2.5" Ring Sample</div></div><div><div><input type="checkbox"/> Static Water Table</div></div></div> | Blows/foot | Moisture Content, % | Dry Density, pcf | % Heave | % Collaps | Comments |
|---|---|---|---|---|---|---|---|---|---|---|
| | | | | <div>Bareground/Topsoil</div> <div><b><u>0.5'-2.0': Decompsed granite (DG)</u></b></div> <div>White to Light gray,<br/>hard, slightly weathered,</div> <div><b>End of Test Pit @ 2.0-feet</b></div> <div><b>No groundwater or caving</b></div> <div><b>Excavation backfilled wih cutting spoil,</b></div> | | | | | | |

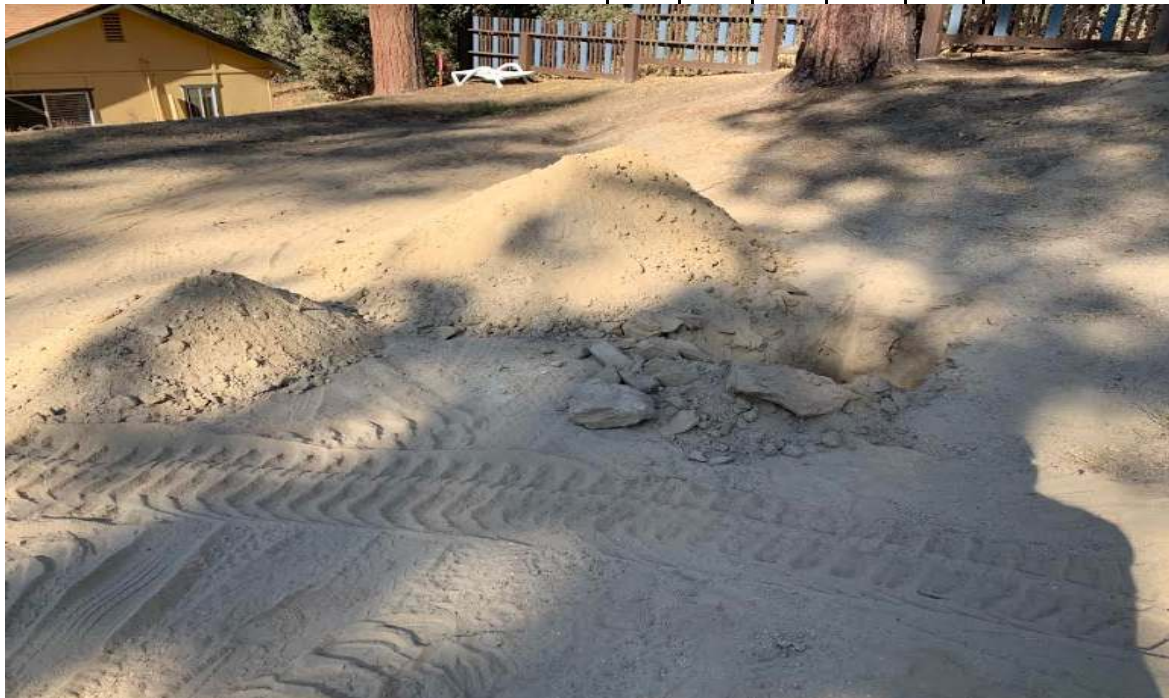
| Depth in Feet | Soil Type | Sample Type | | <div><div><div>Thin Wall Tube</div><div>2.5" Ring Sample</div></div><div><div>Bulk Sample</div><div>Standard Split Spoon Sample</div><div>Static Water Table</div></div></div> | Blows/foot | Moisture Content, % | Dry Density, pcf | % Heave | % Collaps | Comments |
|---|---|---|---|---|---|---|---|---|---|---|
| | | | | <u>3.0'-6.5': Decompsed granite (DG)</u><br>Tan-light brown, coarse texture, highly weathered, friable to touch, at 5.5' becomes mottled, white, black dots, | | | | | | |
| | | | | <b>End of Test Pit @ 6.5-feet</b><br><b>No groundwater or caving</b><br><b>Excavation backfilled with cutting spoil,</b> | | | | | | |

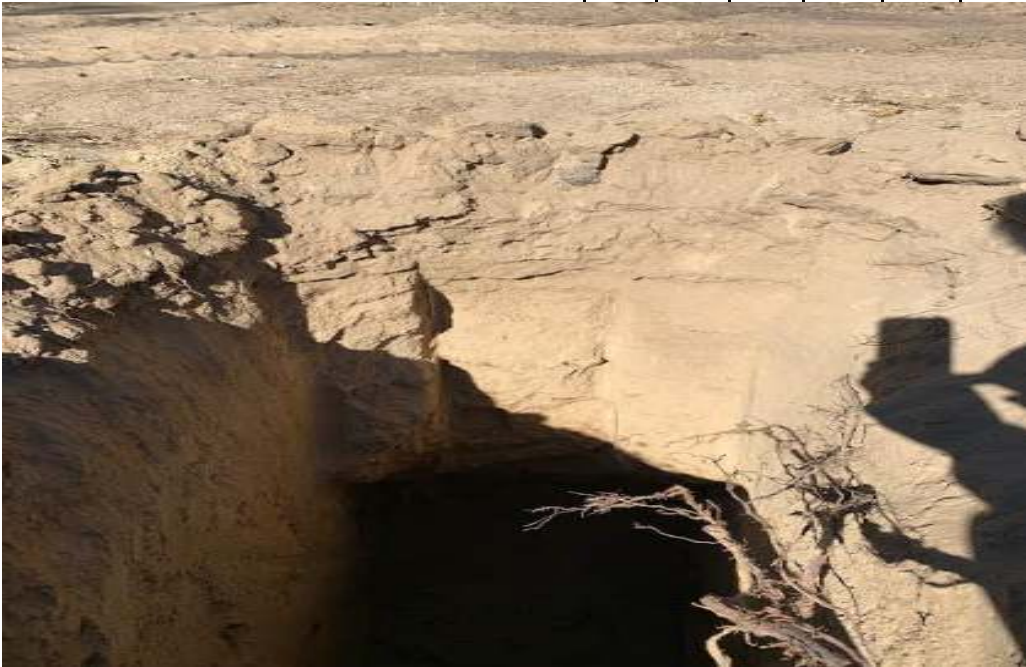
| Depth in Feet | Soil Type | Sample Type | | <div><div><div>Thin Wall Tube</div><div>2.5" Ring Sample</div></div><div><div>Bulk Sample</div><div>Standard Split Spoon Sample</div><div>Static Water Table</div></div></div> | Blows/foot | Moisture Content, % | Dry Density, pcf | % Heave | % Collaps | Comments |
|---|---|---|---|---|---|---|---|---|---|---|
| 5 | SW | <div><div></div><div></div></div> | Bareground,<br><u>0.0'-2.0': Artificial FILL (Qaf)</u><br>Light grayish brown SAND, slightly silty<br>fine-coarse, medium dense, dry-damp, | | | | | | No ring sample recovery<br><div></div> | |
| | | | <u>2.0'-7.0': Decomposed granite (DG)</u><br>Tan-light brown, fine-coarse texture, friable,<br>highly weathered, | | | | | | | |

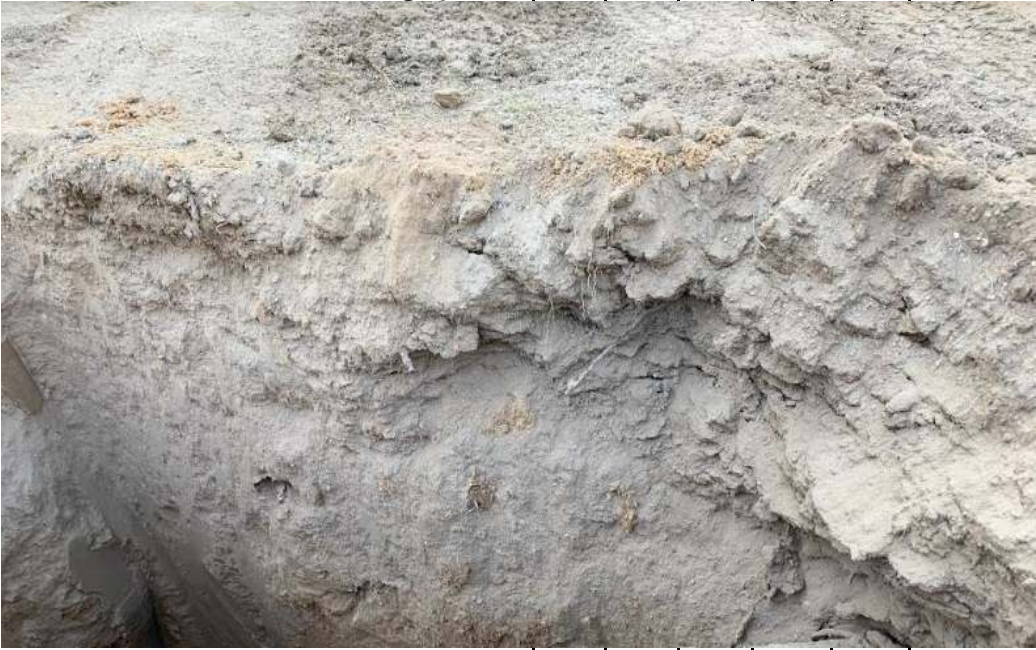
| Depth in Feet | Soil Type | Sample Type | | <input type="checkbox"/> Bulk Sample <input type="checkbox"/> Standard Split Spoon Sample <input checked="" type="checkbox"/> Thin Wall Tube <input checked="" type="checkbox"/> 2.5" Ring Sample <input type="checkbox"/> Static Water Table | Blows/foot | Moisture Content, % | Dry Density, pcf | % Heave | % Collaps | Comments |
|---|---|---|---|---|---|---|---|---|---|---|
| | | | | <u>3.0'-7.0': Decomposed granite (DG)</u><br>Grayish brown, fine-coarse texture, friable,<br>highly weathered, | | | | | | |
| | | | | <b>End of Test Pit @ 7.5-feet</b><br><b>No groundwater or caving</b><br><b>Excavation backfilled with cutting spoil,</b> | | | | | | |
