June 28, 2019  
Project No. SL10793-2

**Spanish Vineyards**  
**285 Bridge Street**  
San Luis Obispo, California 93401

Subject: **Engineering Geology Evaluation of Roadway Alignment**  
Driveway to Proposed Residence, APN: 079-251-005  
Pismo Beach Area, San Luis Obispo County, California

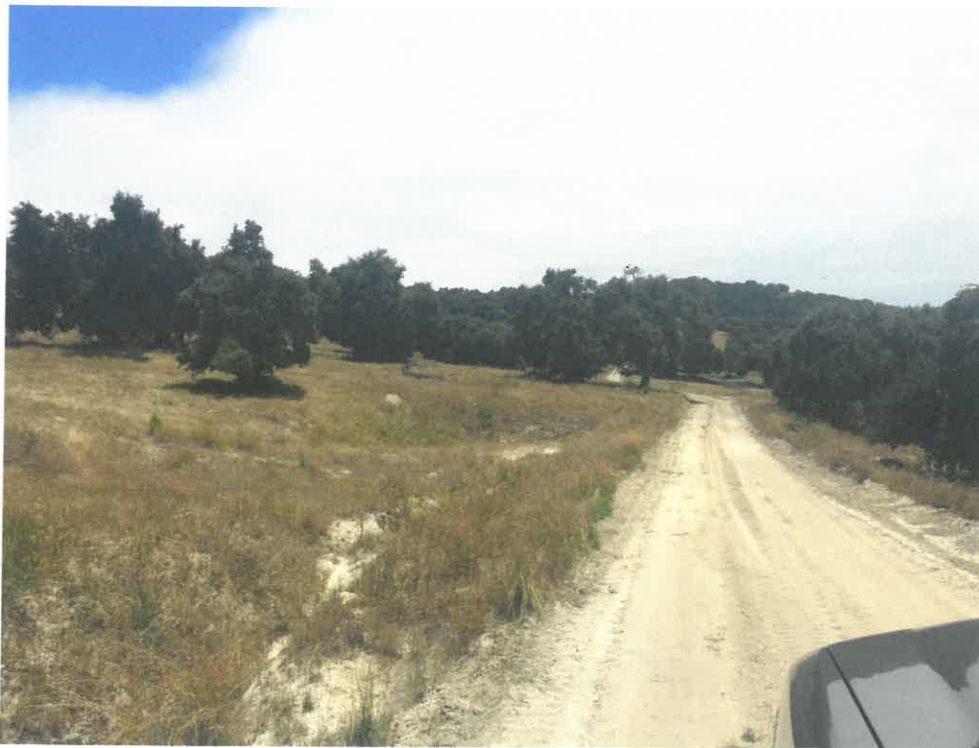
The proposed driveway alignment will extend along the existing ranch road, which traverses the northwest side of the northeast-southwest trending ridge for approximately 5000 feet from its start off Vetter Lane. Massive sandstone of the Squire Member of the Pismo formation (Tpsq) are exposed in the existing slopes along this section. See Figure 3. The existing ranch road is currently near existing ground elevation, with minor undulations for reflecting the natural topography. Minor cut slopes uphill of the existing ranch road alignment currently maintain established pasture growth, varying from approximately 1:1 to 3:1 (horizontal to vertical) in steepness, and appear to be stable with minor amounts of raveling where disturbed by cattle trails. The existing cut slopes are up a maximum height of 3 feet high and expose 0 to 2 feet of colluvium overlying sandstone. Should further excavation be necessary to improve the existing alignment cut slopes can be excavated at a 1:1 configuration, where massive sandstone is exposed, and 2:1 where colluvium or top soil is exposed. No substantial fill slopes exist along the alignment, however, should excavation be necessary to improve the existing alignment fill slopes can be constructed at a 2:1 configuration. All future excavation should be as per the attached grading recommendations.

Figure 3: Photograph looking south along existing ranch road and proposed alignment of driveway. Topographic high near boundary of Godfrey and Camino Cielo parcels in distance. Note typical terrain where underlain by massive sandstone of the Pismo formation type rocks.

Minor debris accumulation may occur along the base of cut and fill slopes pending establishment of permanent erosion control vegetation, therefore maintenance would be anticipated. As discussed with the owner, it is recommended that regular monitoring and maintenance be conducted to existing cut/fill slopes and erosion control features along the driveway alignment. All areas of fill or colluvium must be densified, and confined with aggregate base to minimize erosion potential. Any change in conditions, should be brought to the attention of the project Engineering Geologist.

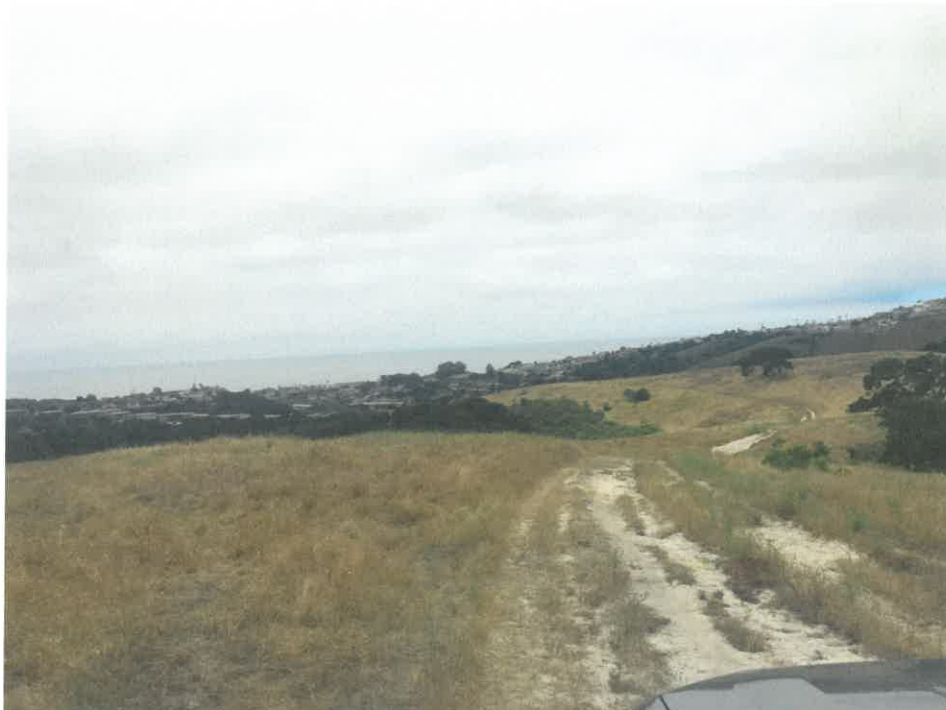
This section of proposed driveway alignment will also extend along existing ranch road, which traverses the wide natural slope of the northeast-southwest trending ridge for approximately 4000 feet from near the boundary of the Camino Cielo and Godfrey parcels in the area of the topographic high. Massive sandstone and siltstone of the Squire, Edna, and Miguelito Members of the Pismo formation (Tpsq, Tpe, & Tpm) are exposed in the existing slopes along this section. The existing ranch road is currently near existing ground elevation, with minor undulations for reflecting the very resistant natural topography. Due to the concentration of water flow along the existing ranch road, erosion of the underlying sandstone and siltstone is occurring. See Figure 4. Minor cut slopes uphill of the existing ranch road alignment currently maintain established pasture growth, varying from approximately 1:1 to 3:1 (horizontal to vertical) in steepness, less than 2 feet in height, and appear to be stable with minor amounts of raveling where disturbed by cattle trails. The existing cut slopes are up a maximum height of 3 feet high and expose 0 to 1 foot of colluvium overlying sandstone. Should further excavation be necessary to improve the existing alignment cut slopes can be excavated at a 1:1 configuration, where massive sandstone is exposed, and 2:1 where colluvium or top soil is exposed. There are no fill slopes along the alignment, however, should excavation be necessary to improve the existing alignment, fill slopes can be constructed at a 2:1 configuration. All future excavation should be as per the attached grading recommendations.

**Figure 4: Photograph looking southwest along existing ranch road and proposed alignment of driveway on Camino Cielo parcel. Note typical terrain where underlain by massive sandstone of the Pismo formation type rocks are exposed on the surface.**
