BIOLOGICAL TECHNICAL REPORT

WIFIA FY 27 Maintenance and Repair Project:

Van Dyke Pl at Van Dyke Ave SD SWD

WBS# B-25023

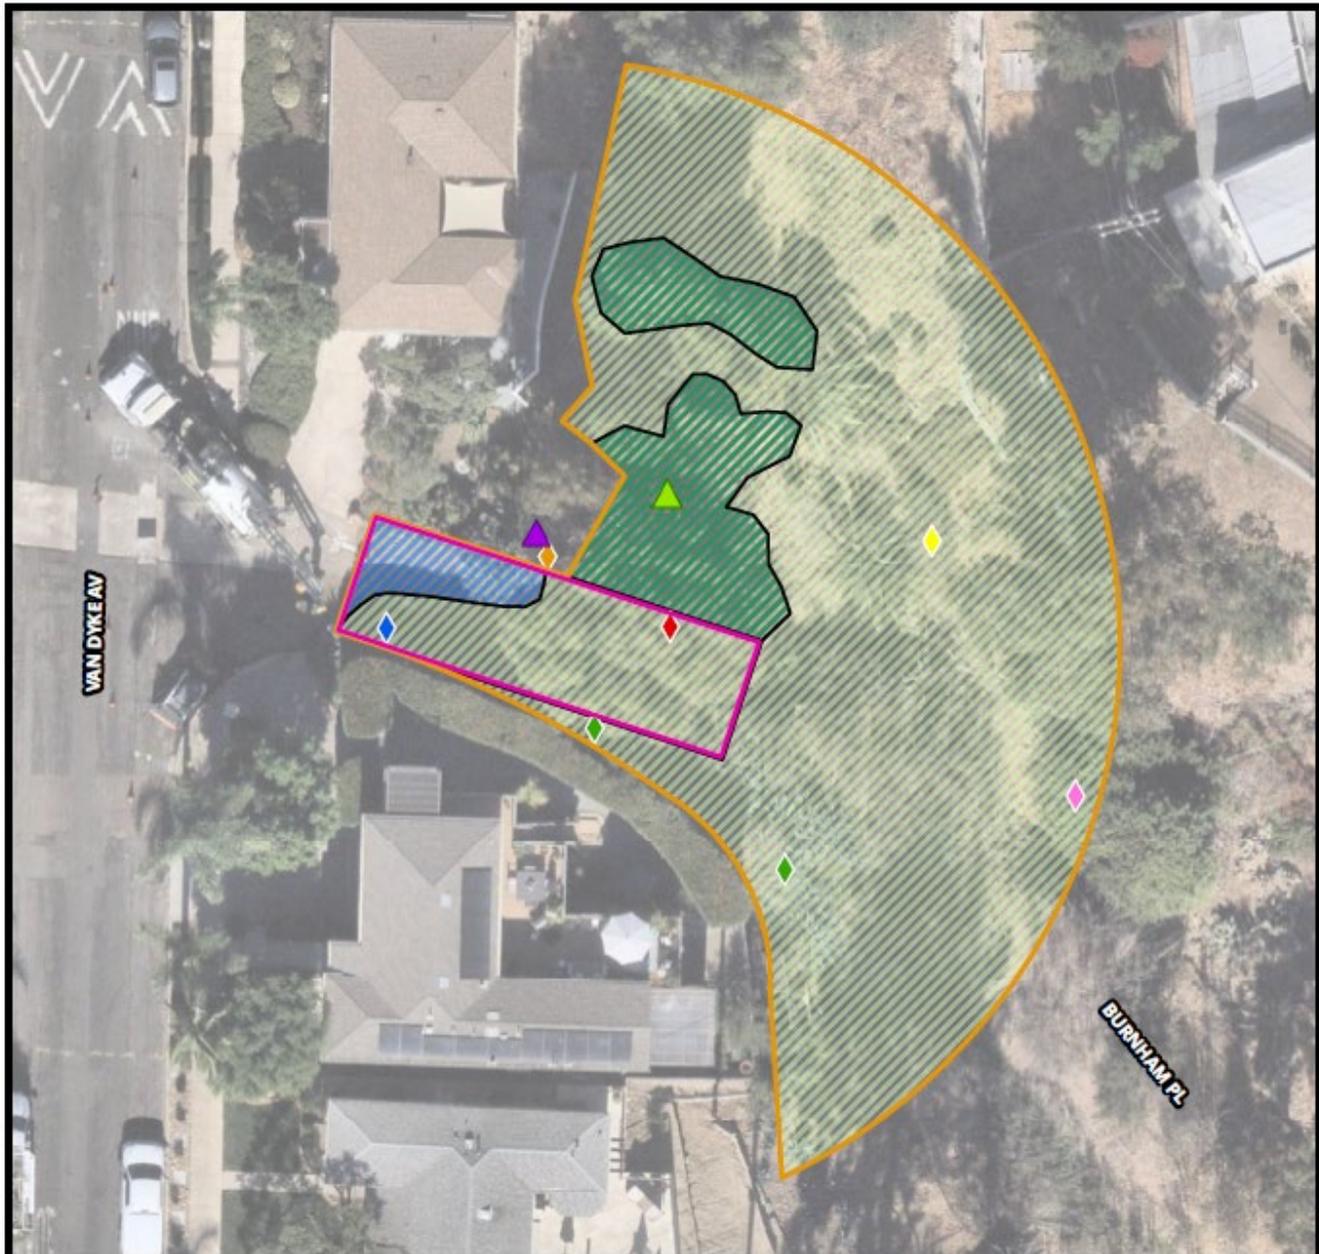
Attachment B: Survey Area & Survey Results/Vegetation Map

Species Sighting

- ◆ American Crow
- ◆ Anna's Hummingbird
- ◆ Domestic Cat
- ◆ House Finch
- ◆ House Sparrow
- ◆ Lesser Goldfinch

Three vegetation types were identified within the Survey Area during the biological survey conducted April 11, 2024. These identified vegetation types are considered upland habitats (i.e., City MSCP IV). The vegetation types within the Survey Area are Non-Native Vegetation, Urban/Developed Habitat, and Eucalyptus Woodland. For a full listing of the plants found during the surveys, refer to Attachment A. For a map of the Survey Area and locations of the habitats, refer to Attachment B.

A total of five bird species and one mammal species were observed in the Survey Area and are listed in Table 3 below and in Attachment A. A map of where all the wildlife was observed in the Survey Area is found in Attachment B.

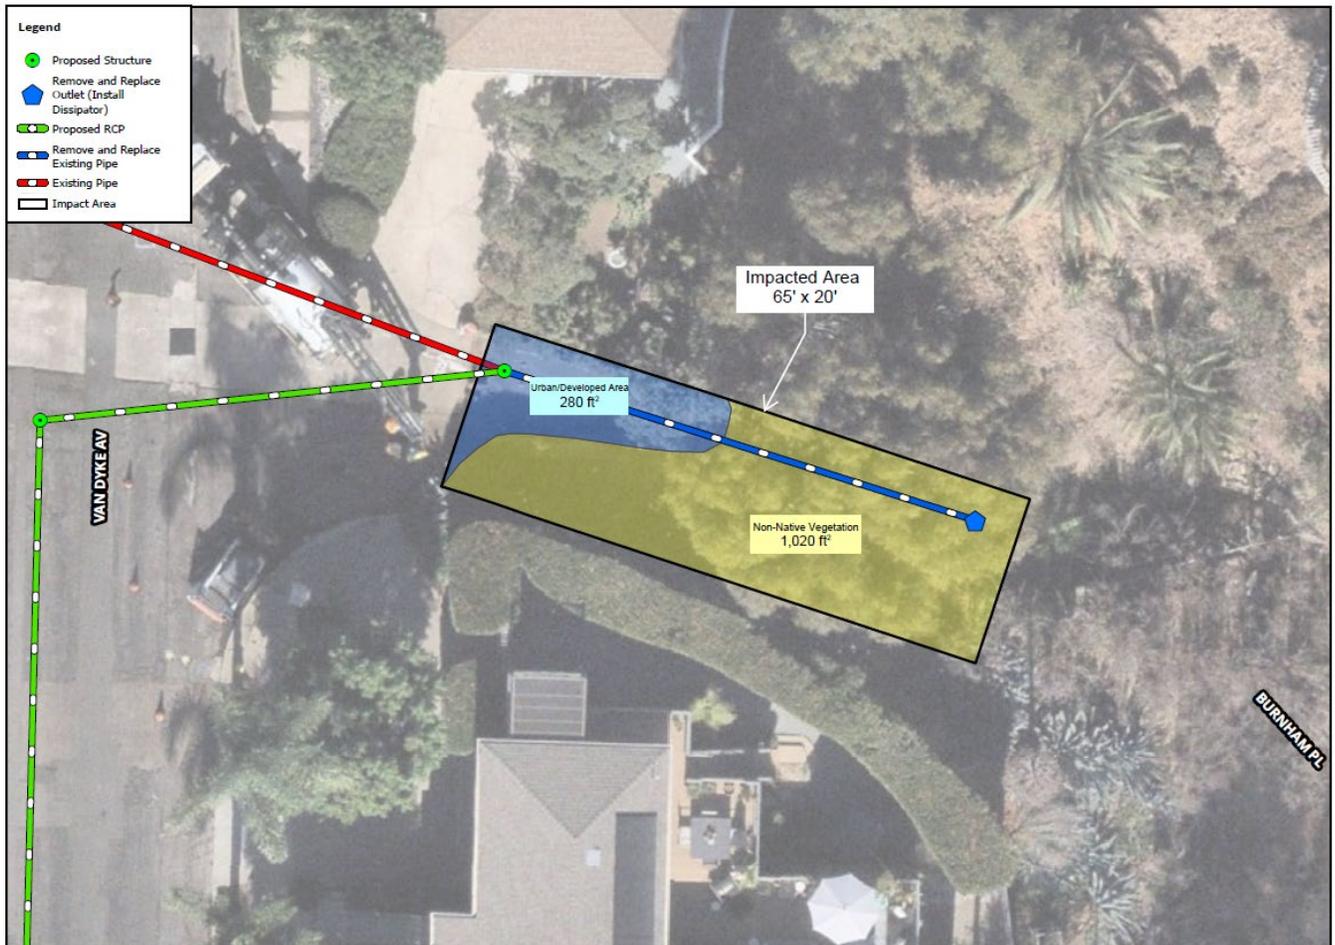
Attachment D: Ortho/ Impact Area

The **Impact Area** is where areas of deteriorated hardscape, concrete and non-native vegetation are located and the dissipator will be installed at the northern terminus of the stormwater system alignment (Attachment D).

This assessment covers the Survey Area which also includes the Impact Area. The Impact Area is located at the northern terminus of the stormwater system alignment on Van Dyke Avenue and Burnham Place (Attachment D). The Survey Area includes the Impact Area and a buffer that expands approximately 100 feet east into the urban canyon (Attachment B). The Survey Area includes a stormwater outfall and deteriorated hardscape, which stormwater presently flows through (Attachment E).

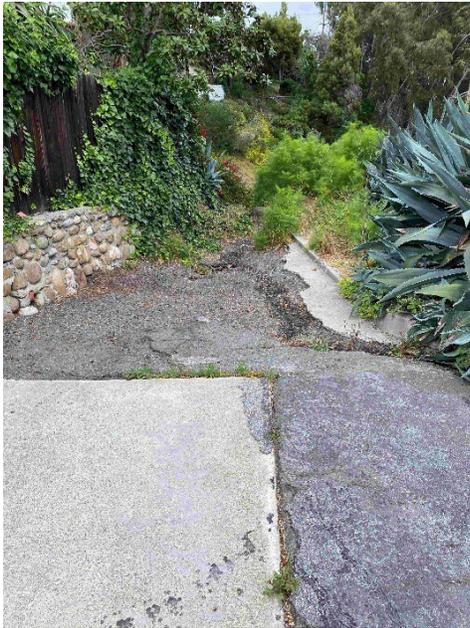
Figure 1 (F1 - looking east). Previously disturbed hardscape (asphalt/concrete) for surface drainage to be repaired/improved. Fennel (*Foeniculum vulgare*) and Agave Americana on the right and Agave Americana, bougainvillea, and English Ivy on the left.

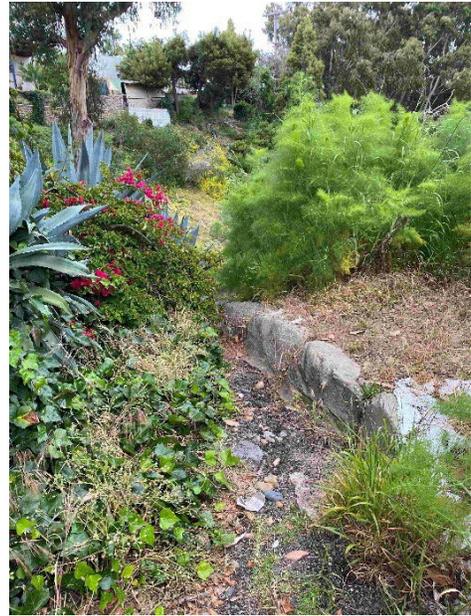
Figure 2 (F2 - looking east). Fennel (*Foeniculum vulgare*) on right and on the left is Agave Americana, bougainvillea, and English Ivy surrounding hardscape (asphalt/concrete to be repaired/improved. Eucalyptus tree will not be affected.

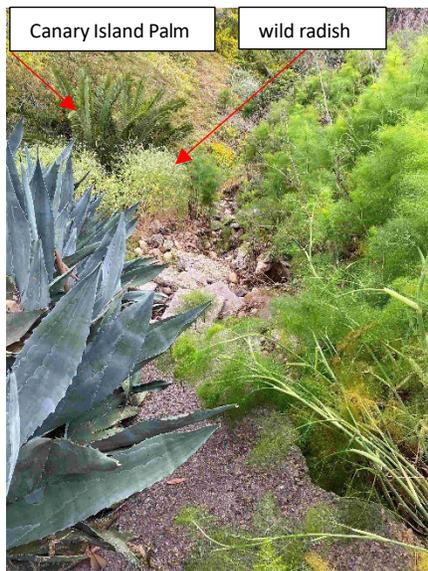
Figure 3 (F3-looking east). Area of proposed work underlain by deteriorated asphalt/concrete with Agave Americana on left, Fennel on right. Further east wild radish (*Raphanus raphanistrum*) with Canary Island Palm (*Phoenix canariensis*) outside of the project Impact Area.

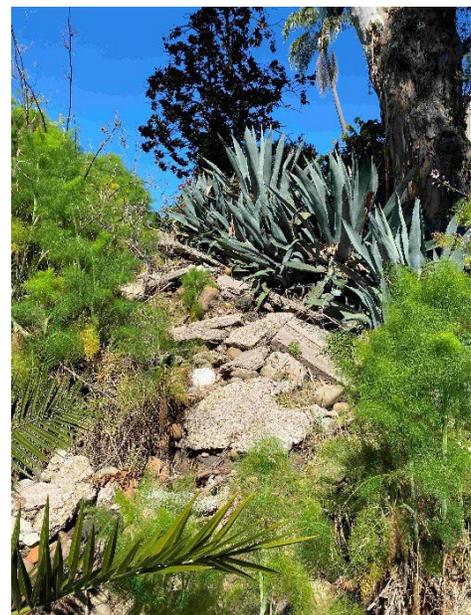
Figure 4 (F4-looking west). Deteriorated concrete to be removed/repaired/improved. Fennel on the left to be removed. Agave Americana on the right to be partially removed and a Eucalyptus tree on the right that will not be impacted.

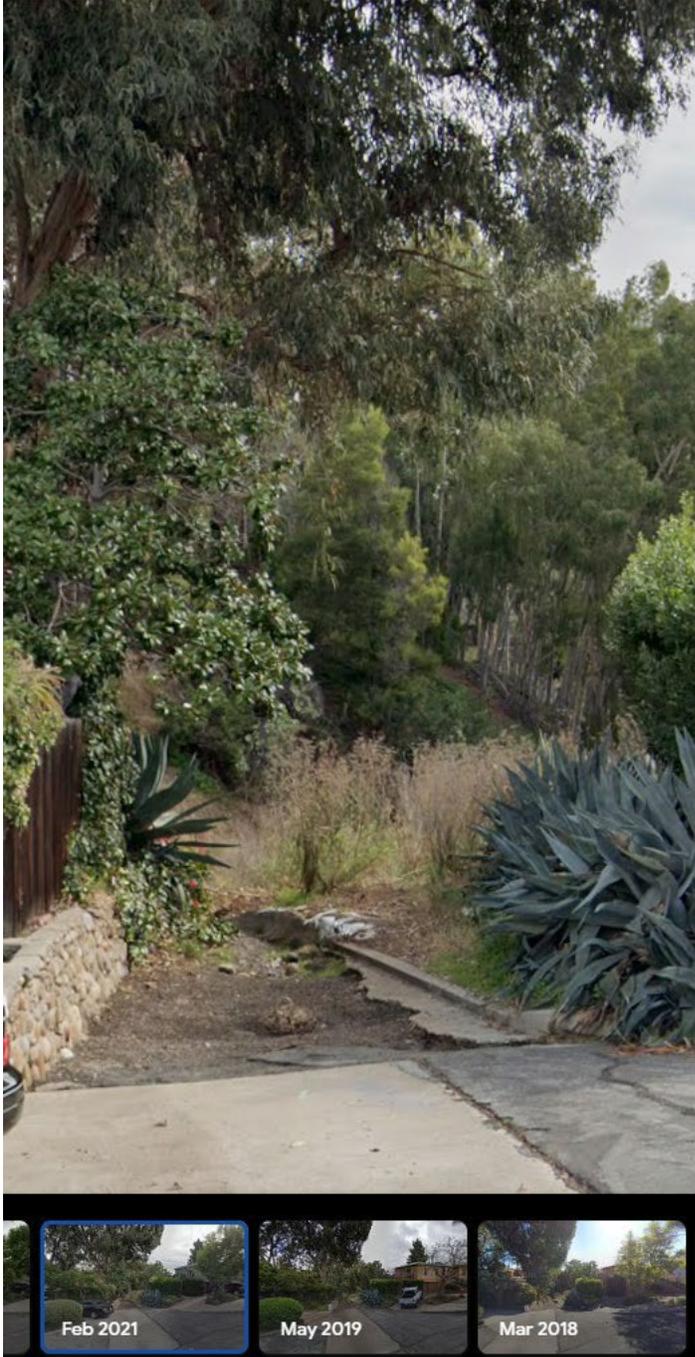
Attachment F: 2021 Google View

2021 Google View east onto the Work Area (shows site conditions)

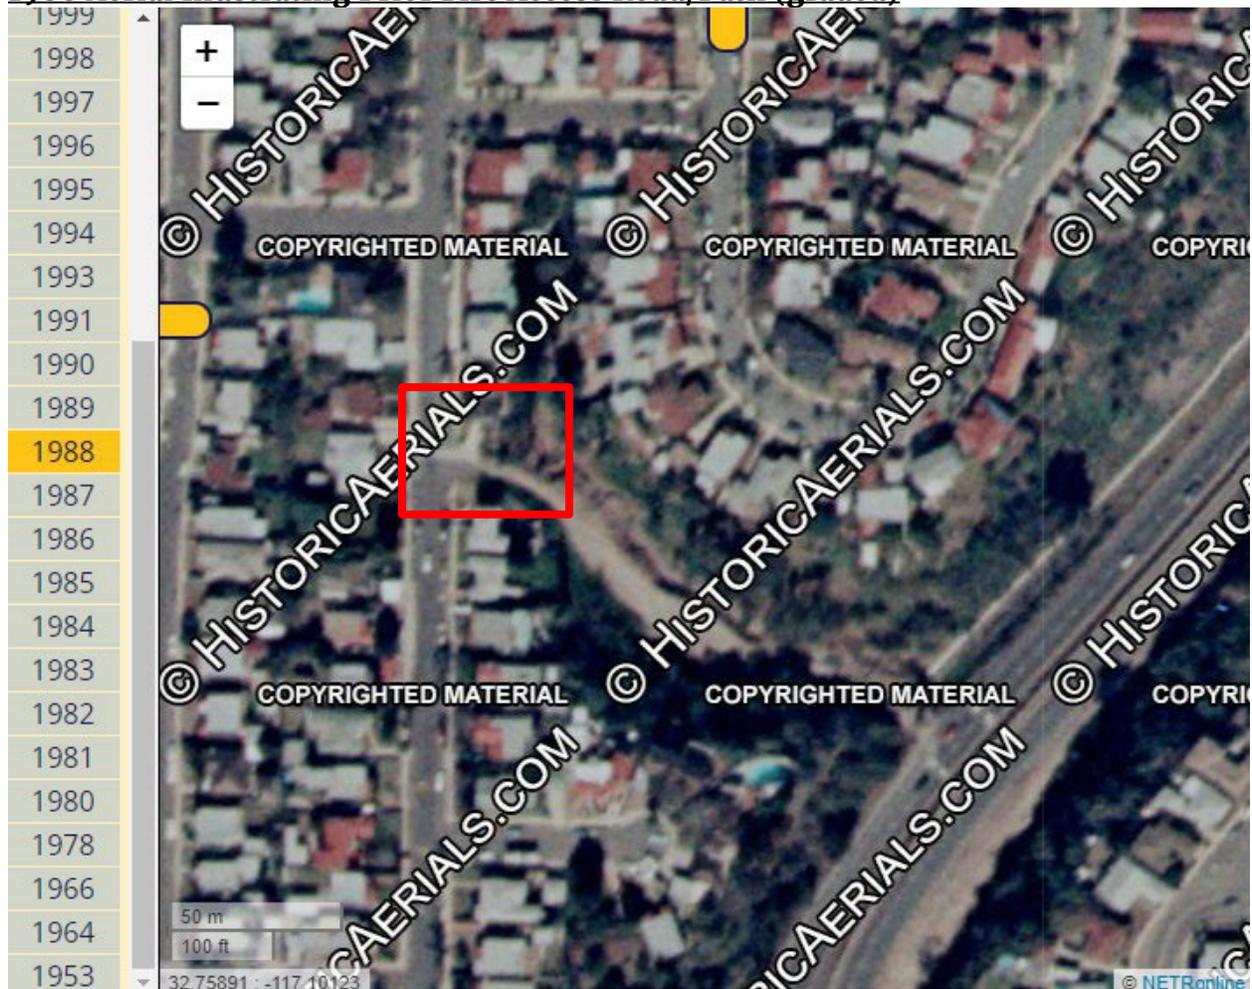
Attachment G: Aerial/Prior Disturbance

1988 Aerial Illustrating Prior Fire Access Road/Path (graded)

Portions of the Survey Area have previously been disturbed by grading activities for the fire department’s emergency access along Burnham Place, a paper street. The area consists of a mix of existing and deteriorated hardscape (concrete/asphalt), dirt, and non-native vegetation.

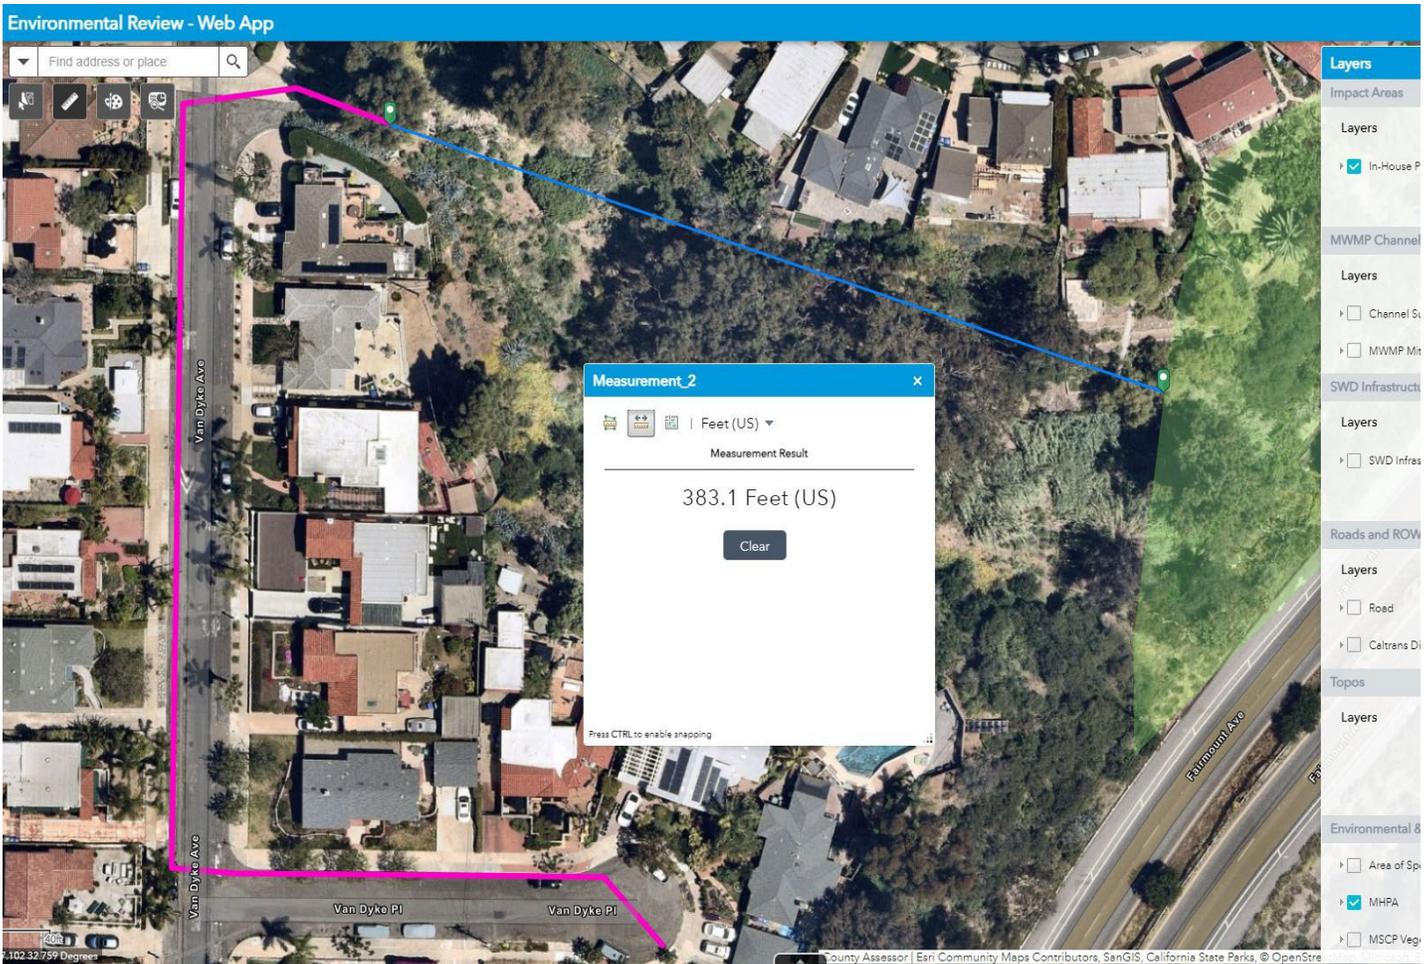
Attachment H: MHPA Proximity

*Note: - the project drains to the dissipator that is over 380-LF away from the MHPA and vegetated buffers exist before any drainage enters the MHPA.

The project is not located within or adjacent to the City’s MHPA, and no encroachment into the MHPA would occur. However, the Cooper’s hawk is a MSCP covered species that was not observed in the Survey Area but has a high potential to occur on site. Protection of this species is ensured through project compliance with the MSCP, and implementation of the conditions of coverage identified for the specific species in the Subarea Plan. Further, since construction is anticipated to occur during the avian breeding season (January 15 -September 15), a preconstruction nesting bird survey will be completed by a qualified biologist 72 hours prior to the start of any construction activities. In the event an active nest is discovered, the project would implement a 300-foot avoidance buffer around the active nest to protect the Cooper’s hawk. Additionally, the biological monitor would remain on site during construction to monitor all the work, noise levels, and any active nests, and to stop work as necessary. By implementing these measures and the MSCP species specific conditions of coverage, the project would be in compliance with the MSCP and potential impacts to the Cooper’s hawk would be avoided.

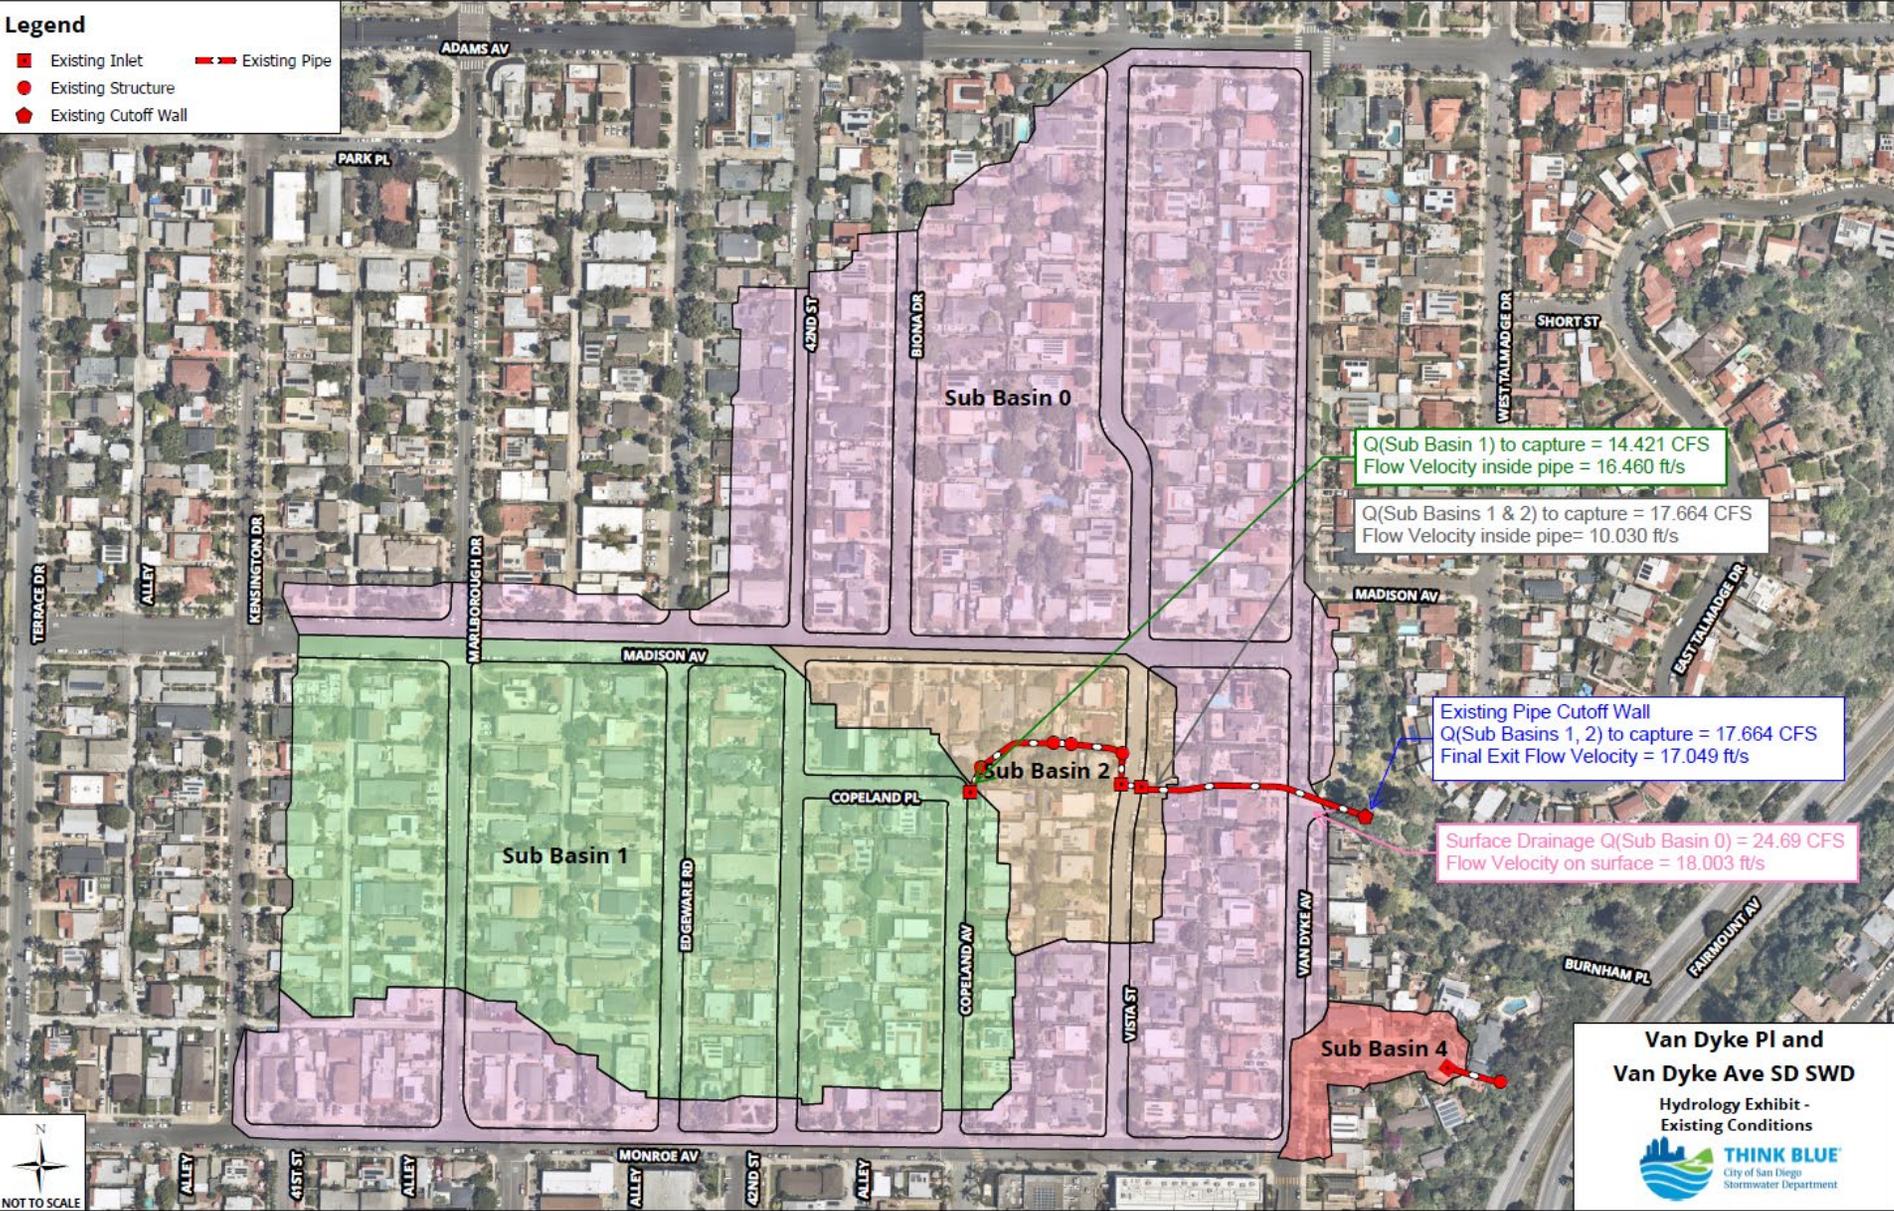
Attachment J: Hydrology Exhibit

Existing Conditions: The following stated conditions were provided by City of San Diego Stormwater Engineering (Attachment J). The project site consists of multiple sub basins draining into the adjacent urban canyon. Currently, a curb inlet and corrugated metal pipe collects and conveys surface drainage from Sub Basin 4. Three curb inlets and storm drainpipes collect and convey surface drainage from Sub Basin 1 and Sub Basin 2 and discharge the flow into the urban canyon from an existing pipe cutoff wall that has deteriorated/eroded. The total flow exiting the outfall is 17.664 Cubic Feet per Second (CFS) with a final exit velocity 17.049 feet per second (ft/sec). Sub Basin 0 (24.69 CFS) flows as surface runoff into the urban canyon with a velocity of 18.003 ft/sec. Both existing velocities entering the urban canyon are beyond the permissible velocity of 3.75 ft/sec (Attachment J).

Proposed Conditions: The calculations developed for this study are based on the methodology in the City of San Diego's Drainage Design Manual. The proposed pipes include appropriately sized inlets to fully capture a 50-year storm event and appropriately sized pipes to handle a 100-year storm. Surface drainage from Sub Basin 1, 2, 0 and 4 will discharge into the urban canyon from a standard 24" energy dissipator with rip rap. The total flow exiting the outfall is 44.57 CFS with a final exit velocity of 2.447 ft/sec. The proposed velocity is less than the permissible velocity of 3.75 ft/sec for this location. Under the proposed conditions, there will no longer be any uncontrolled surface runoff from Sub Basin 0 into the urban canyon within the Survey Area (Attachment J).

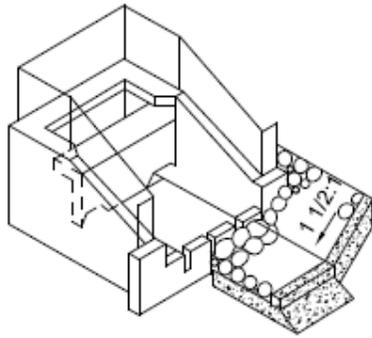
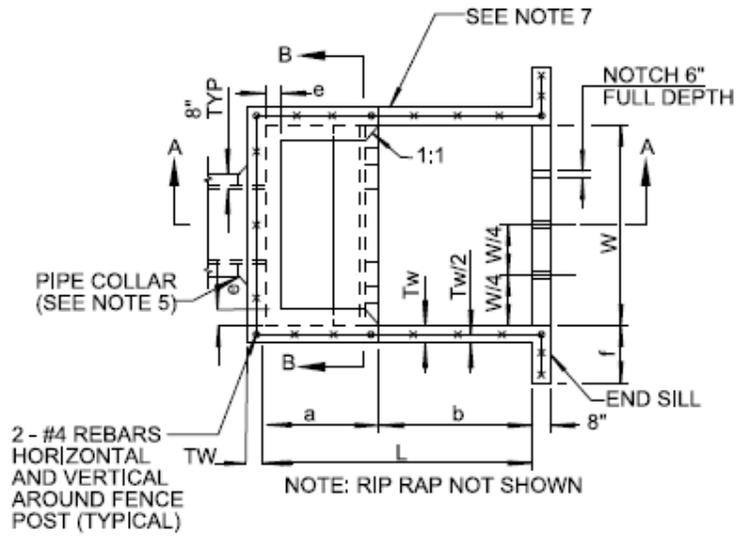
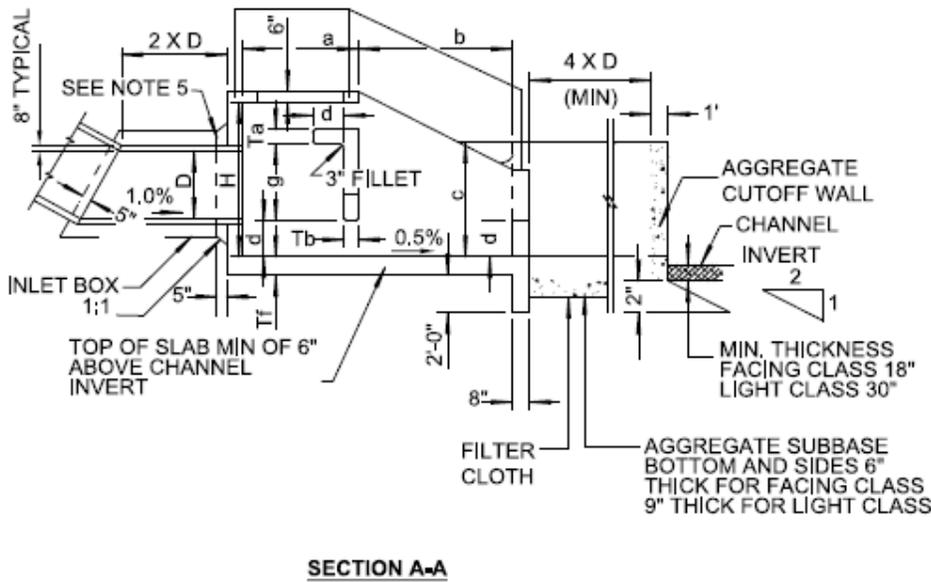
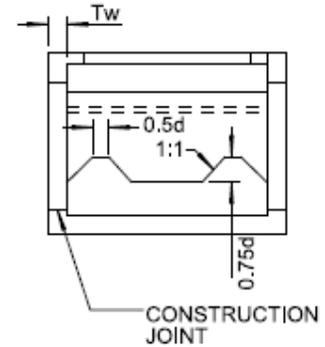
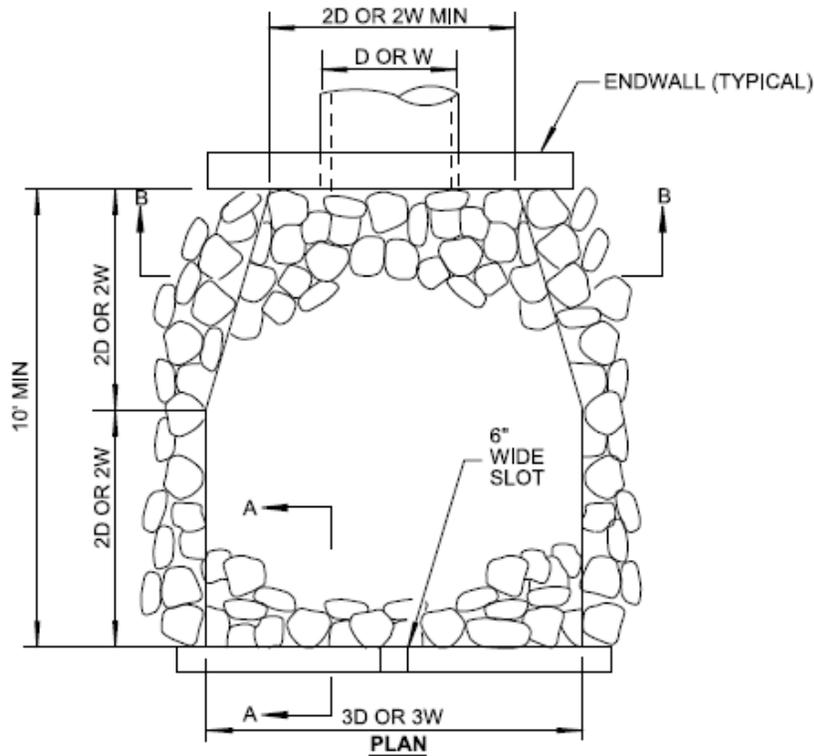
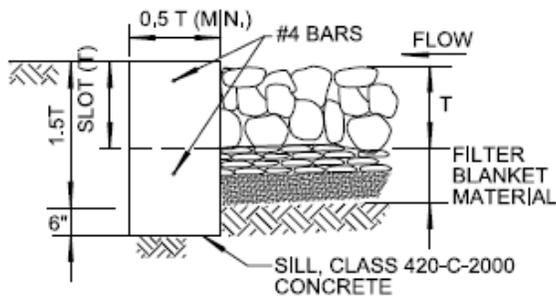
DRAWING
NUMBER **SDD-104**

PICTORIAL VIEW

PLAN

SECTION A-A

SECTION B-B

D = PIPE DIAMETER
W = BOTTOM WIDTH OF CHANNEL

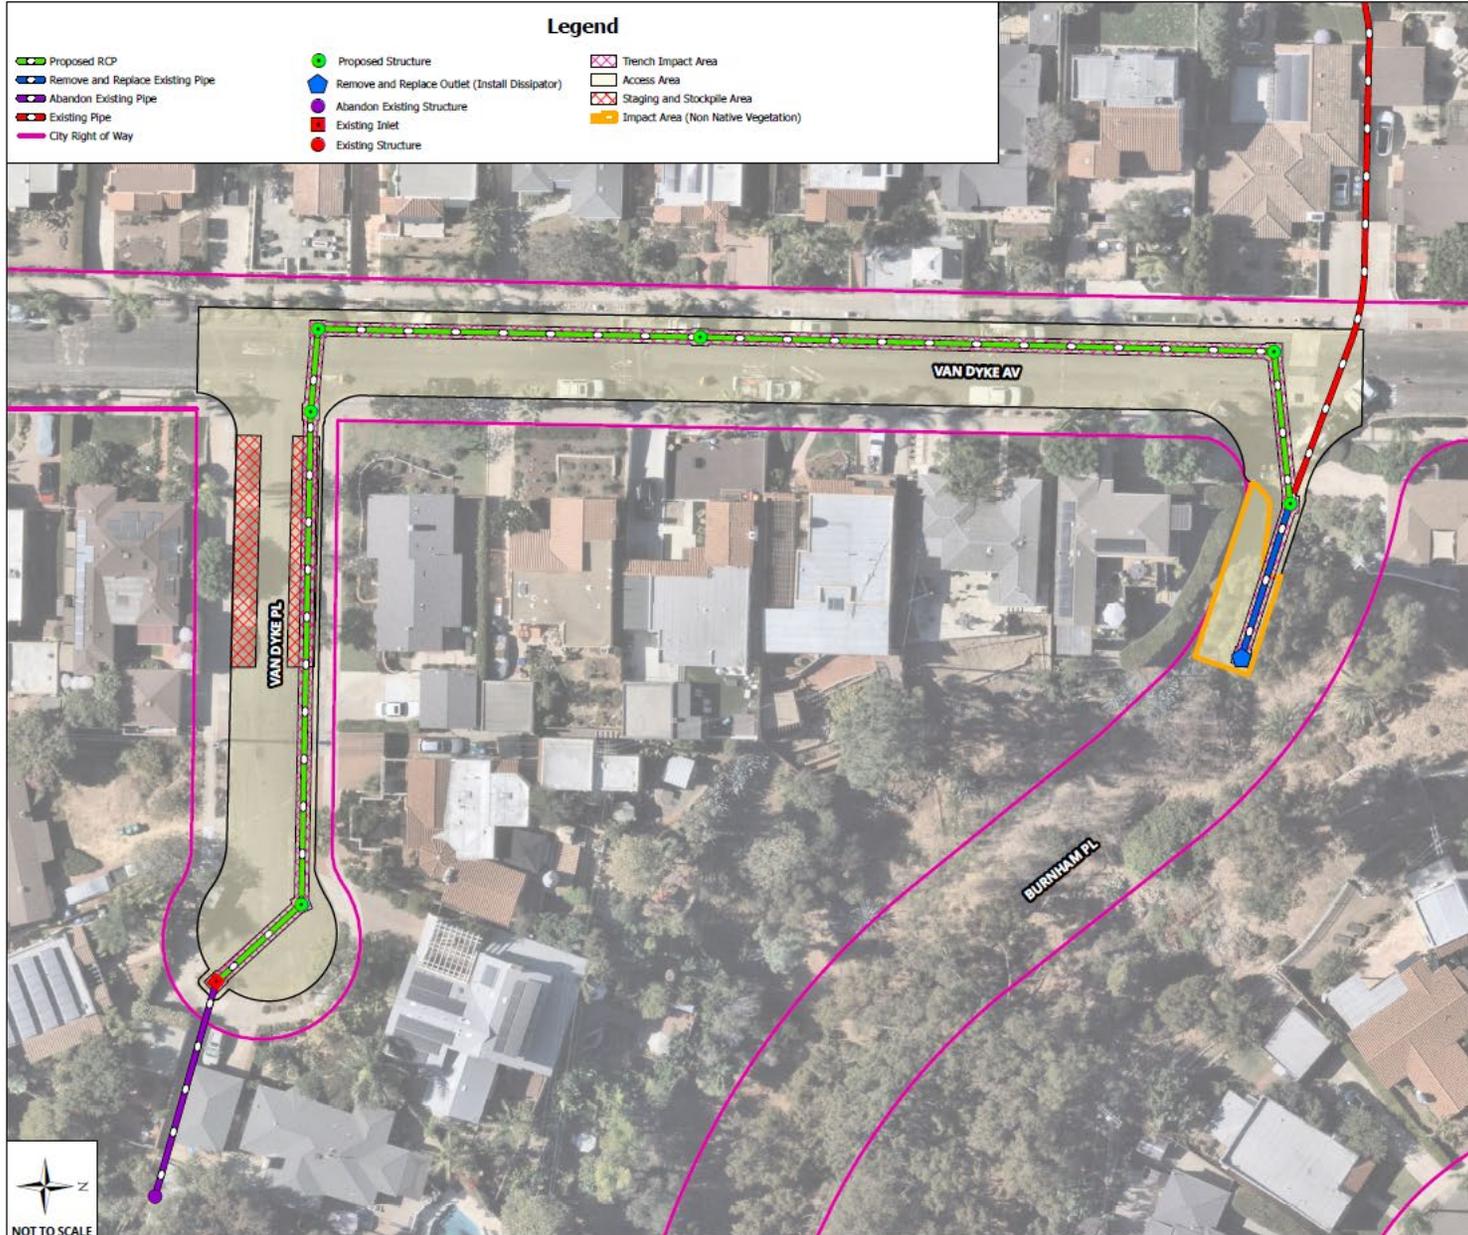
Attachment L: Site Plan

The Project will install approximately 712 Linear Feet (LF) of 18-inch Reinforced Concrete Pipe (RCP). This involves removal and replacement of 57 LF of 18-inch concrete pipe and abandonment of 90 LF of Corrugated Metal Pipe (CMP) in place. Six storm drain structures and a dissipator at the outfall will be installed. The maximum depth of excavation will be approximately 14 feet.

The stormwater drainage pipe project (Project) will install approximately 712 Linear Feet (LF) of 18-inch Reinforced Concrete Pipe (RCP). This involves removal and replacement of 57 LF of 18-inch concrete pipe and abandonment of 90 LF of Corrugated Metal Pipe (CMP) in place. Six storm drain structures and a dissipator at the outfall will be installed. The maximum depth of excavation will be approximately 14 feet (Attachment L). The Project is located entirely within the Public Right of Way (PROW). Installation of the dissipator will impact approximately 1,020 Square Feet (Sq-Ft) of previously disturbed non-native vegetation to allow continued and controlled drainage into the adjacent urban canyon where the stormwater conveyance system outfall presently flows (Attachment D). No impacts to Environmentally Sensitive Lands (ESL) will occur. Staging and stockpile areas will be on Van Dyke Place within the PROW and will occupy approximately 1,560 Sq-Ft (Attachment L).

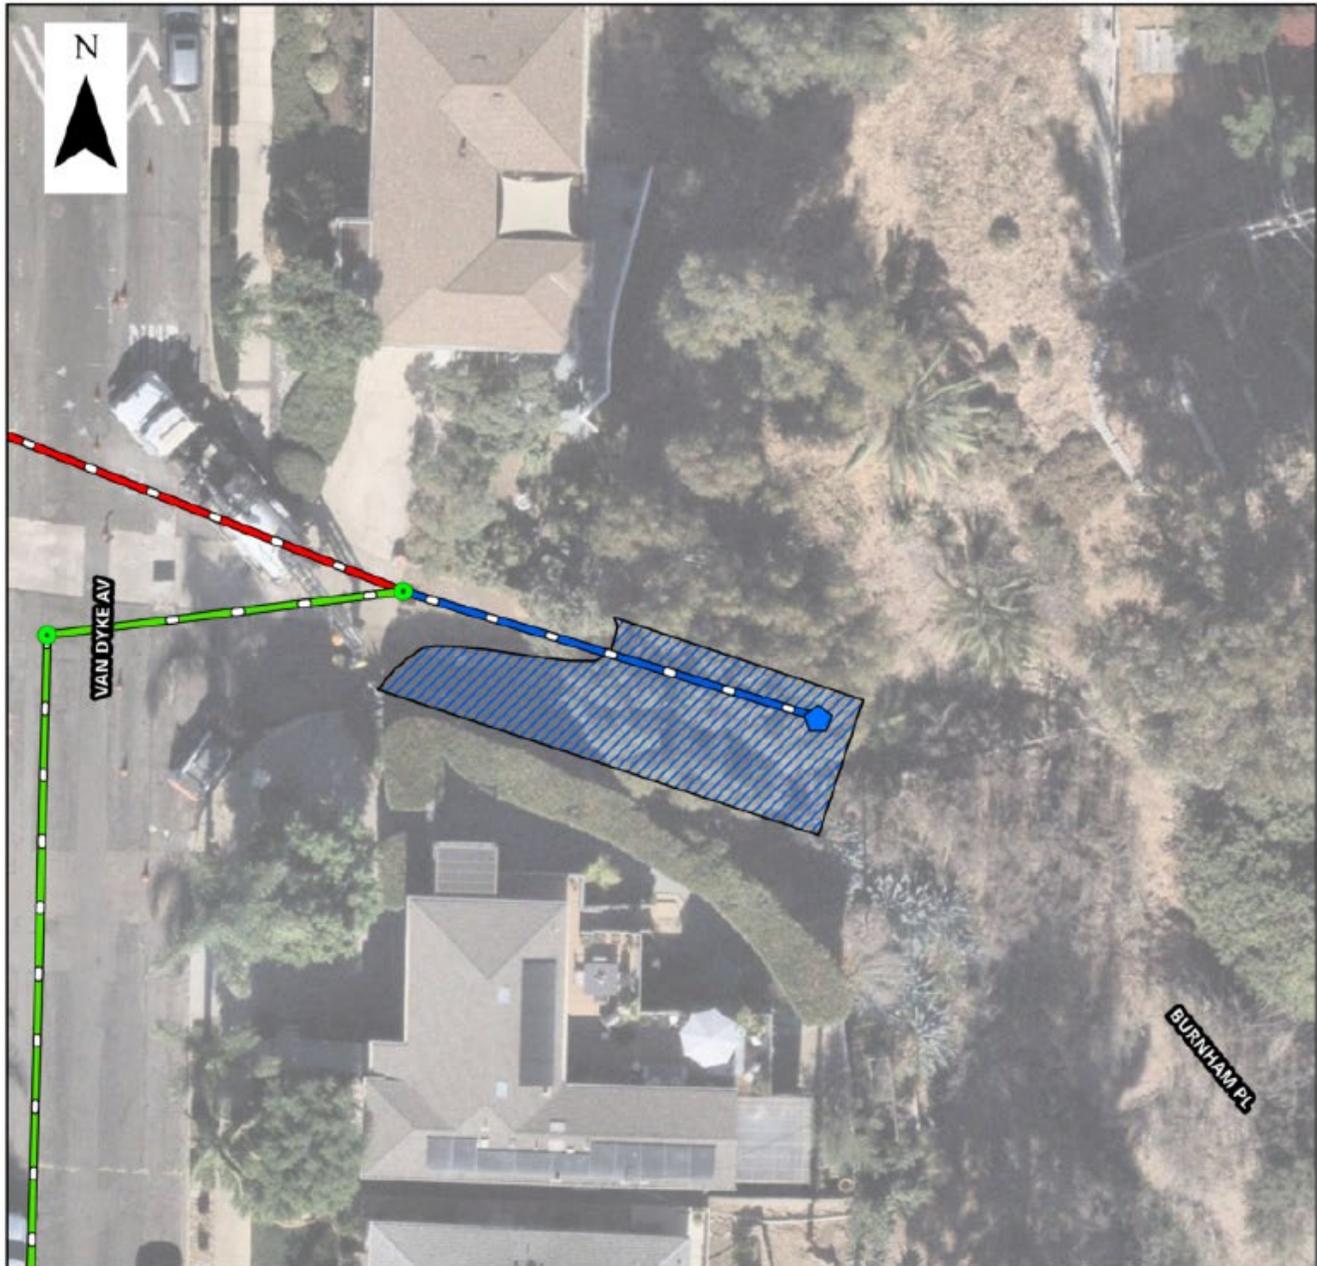
ATTACHMENT B: Revegetation Area/Plan

Van Dyke Pl at Van Dyke Ave SD SWD
Revegetation Area

During construction, temporary erosion control methods such as silt fence and fiber rolls will be used for both erosion control and water quality, and after construction the area will be revegetated for erosion control with native coastal sage scrub plants and mulched. Native coastal sage scrub will replace what was formerly non-native vegetation.

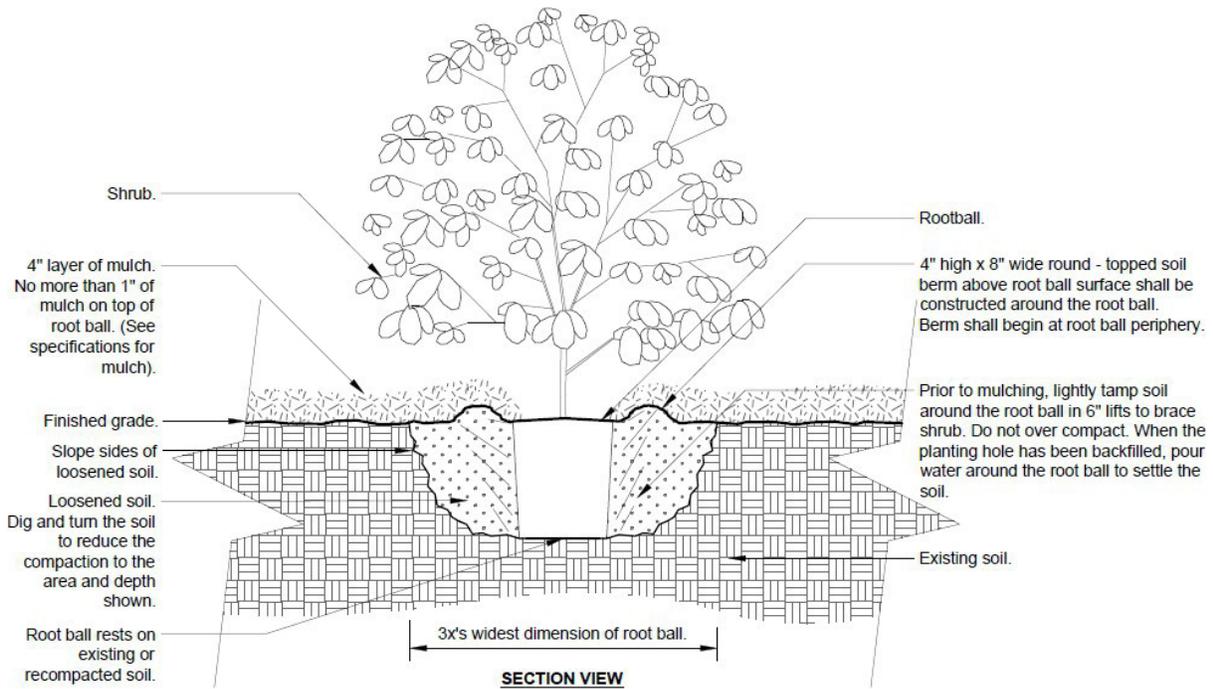
ATTACHMENT C: Container Plant Installation Diagram

SHRUB - UNMODIFIED SOIL
