Re: Tree Protection for Proposed Power Line for Data Center on Camino Arroyo in Gilroy  
(AWS SFO069)

### **Summary:**

There are 38 trees present on and adjacent to the power line: two private protected trees on the neighboring property; 24 private non-protected trees on the neighboring property; and 12 street trees.

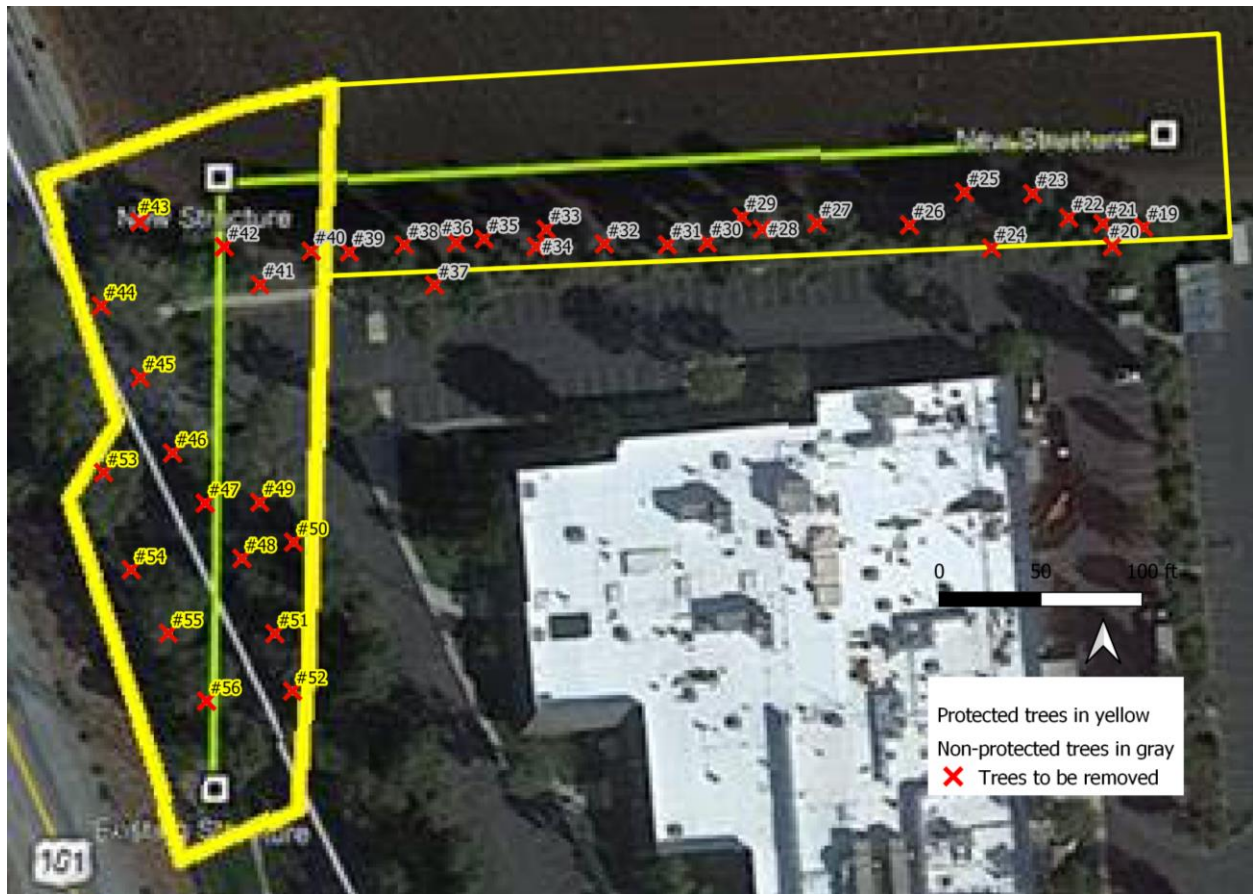
## Tree Map

Trees #19-56 lie within or just beyond the edge of the assumed 50-foot border zone on either side of the proposed transmission line. If the border zone were reduced by PG&E, then some of these trees might be outside it.

Tree location data was collected using a GPS smartphone application and processed in GIS software to create the maps included in this report. Due to the error inherent in GPS data collection, tree locations shown on the map below are approximate.

1. Remove trees #19-56

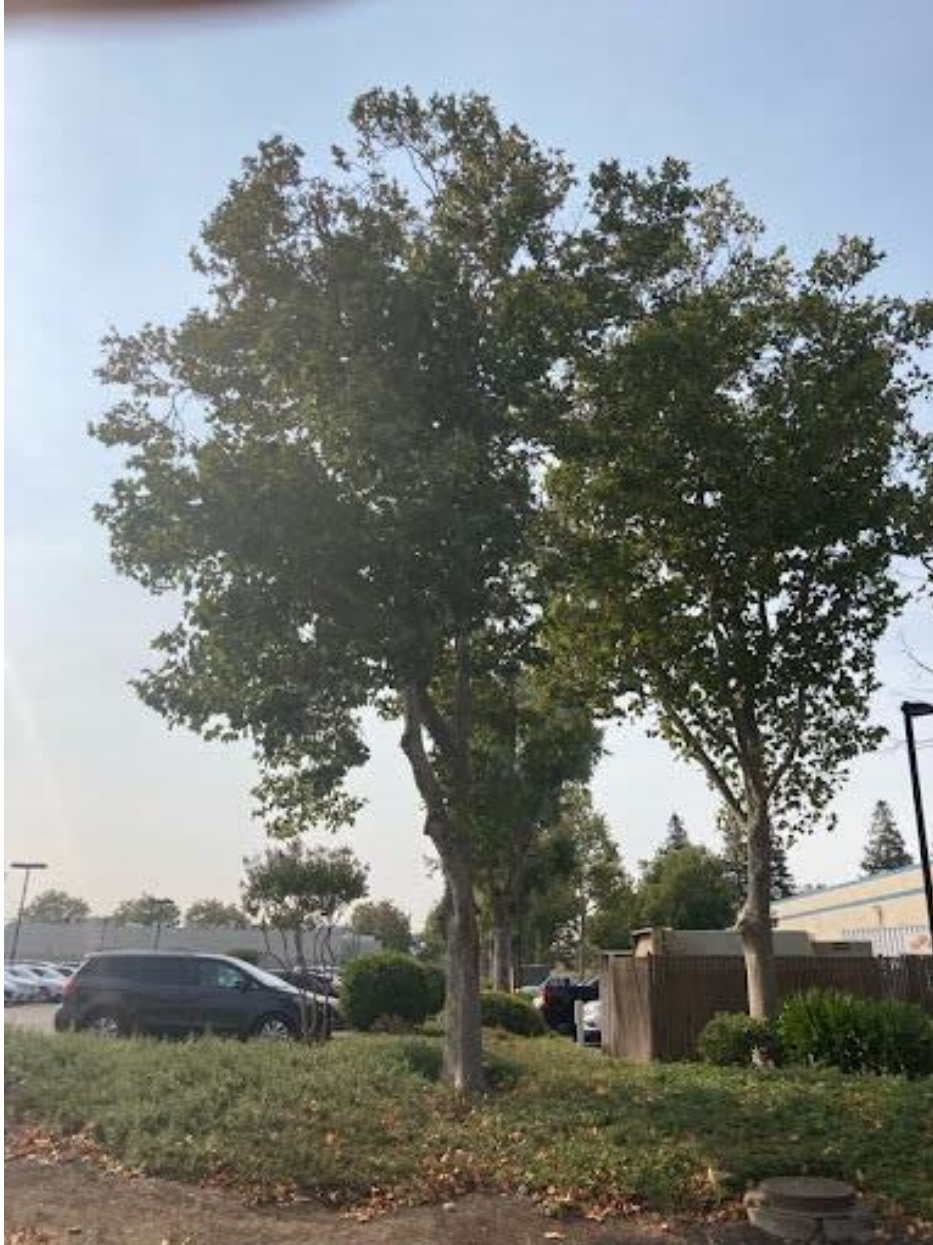
**Image 1: London plane #19**

| Tree # | Common Name | Species | DBH (inches) | Height (estimated visually) | Protected tree? | Vitality (0 = dead, 3 = healthy) | Project Impacts | Disposition | Replacement Requirement |
|---|---|---|---|---|---|---|---|---|---|
| 19 | London plane | Platanus x acerifolia | 13.8 | 45 | - | 2 | Incompatible with transmission line | REMOVE | N/A |

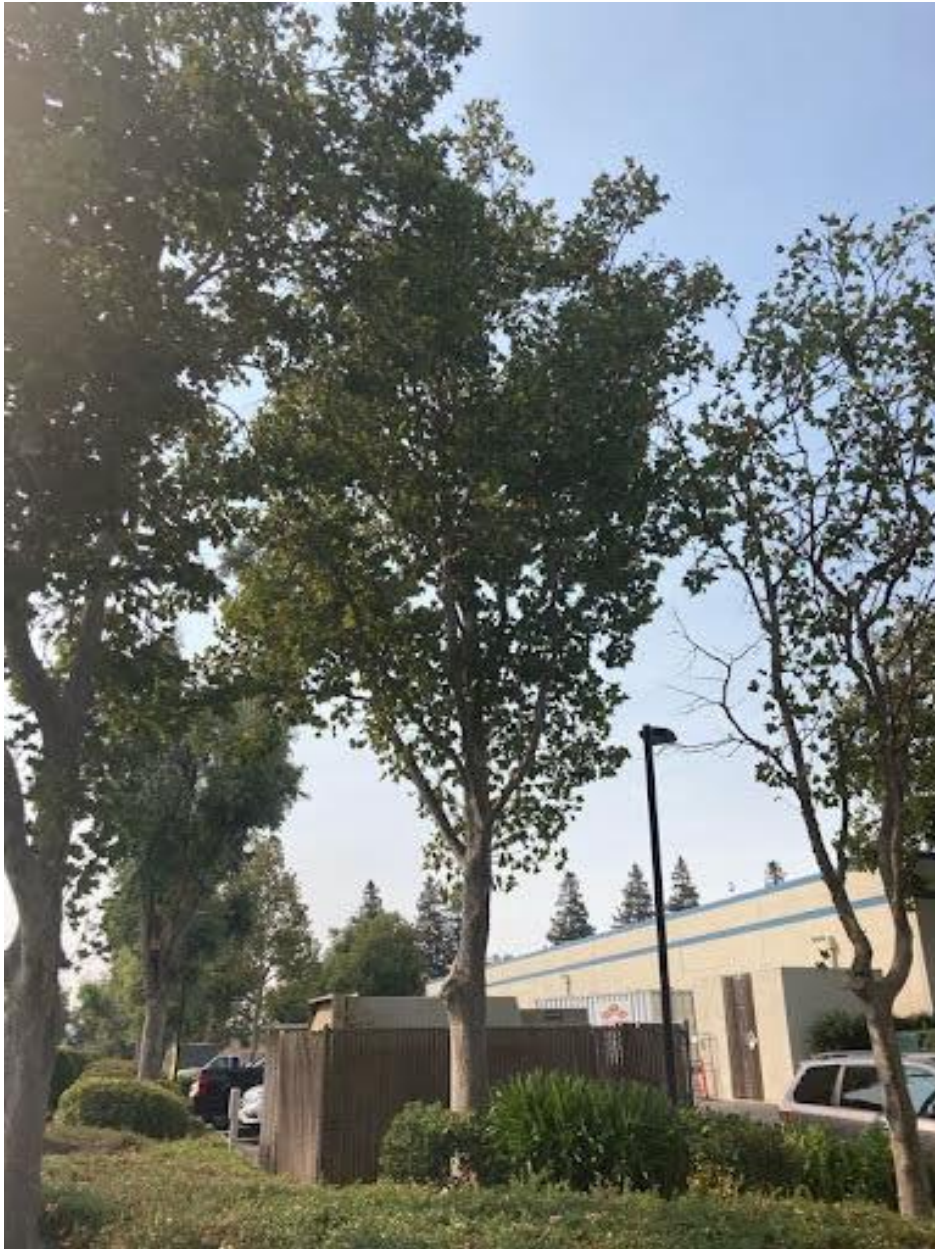
**Image 2: London plane #20**

| Tree # | Common Name | Species | DBH (inches) | Height (estimated visually) | Protected tree? | Vitality (0 = dead, 3 = healthy) | Project Impacts | Disposition | Replacement Requirement |
|---|---|---|---|---|---|---|---|---|---|
| 20 | London plane | Platanus x acerifolia | 13.3 | 45 | - | 2 | Incompatible with transmission line | REMOVE | N/A |

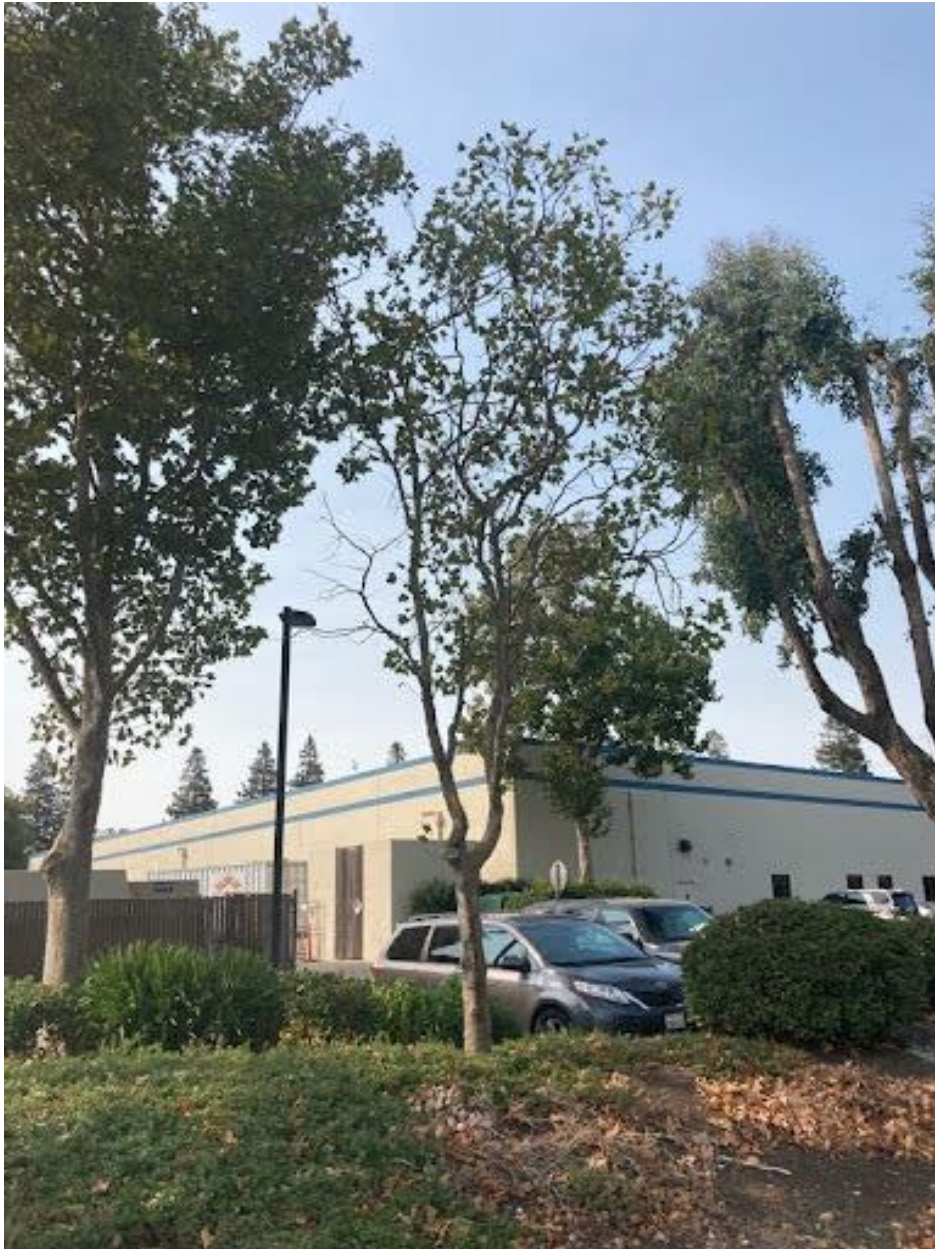
**Image 3: London plane #21**

| Tree # | Common Name | Species | DBH (inches) | Height (estimated visually) | Protected tree? | Vitality (0 = dead, 3 = healthy) | Project Impacts | Disposition | Replacement Requirement |
|---|---|---|---|---|---|---|---|---|---|
| 21 | London plane | Platanus x acerifolia | 5.8 | 20 | - | 2 | Incompatible with transmission line | REMOVE | N/A |

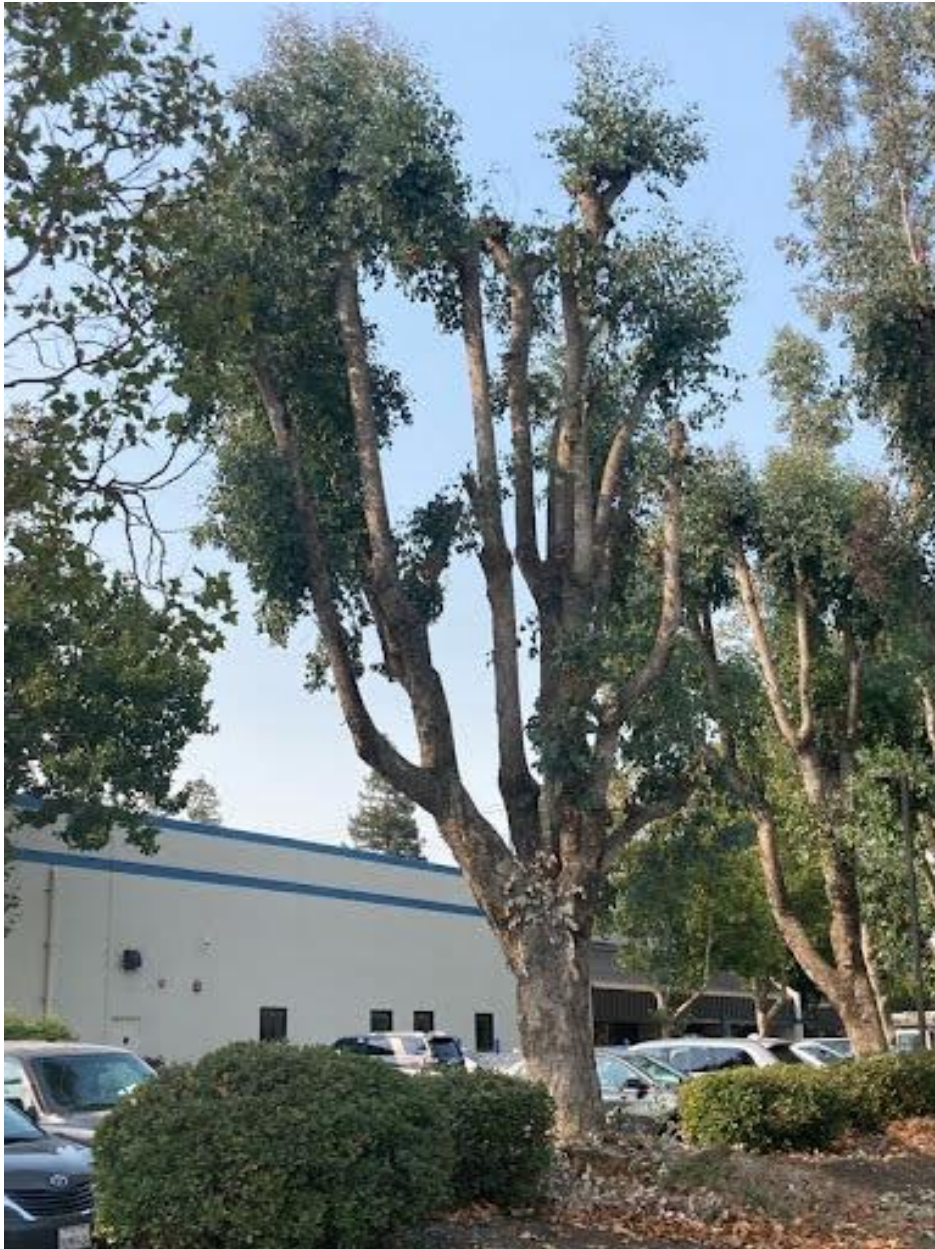
**Image 4: silver dollar gum #22**

| Tree # | Common Name | Species | DBH (inches) | Height (estimated visually) | Protected tree? | Vitality (0 = dead, 3 = healthy) | Project Impacts | Disposition | Replacement Requirement |
|---|---|---|---|---|---|---|---|---|---|
| 22 | Silver dollar gum | Eucalyptus polyanthemos | 23.0 | 35 | - | 3 | Incompatible with transmission line | REMOVE | N/A |

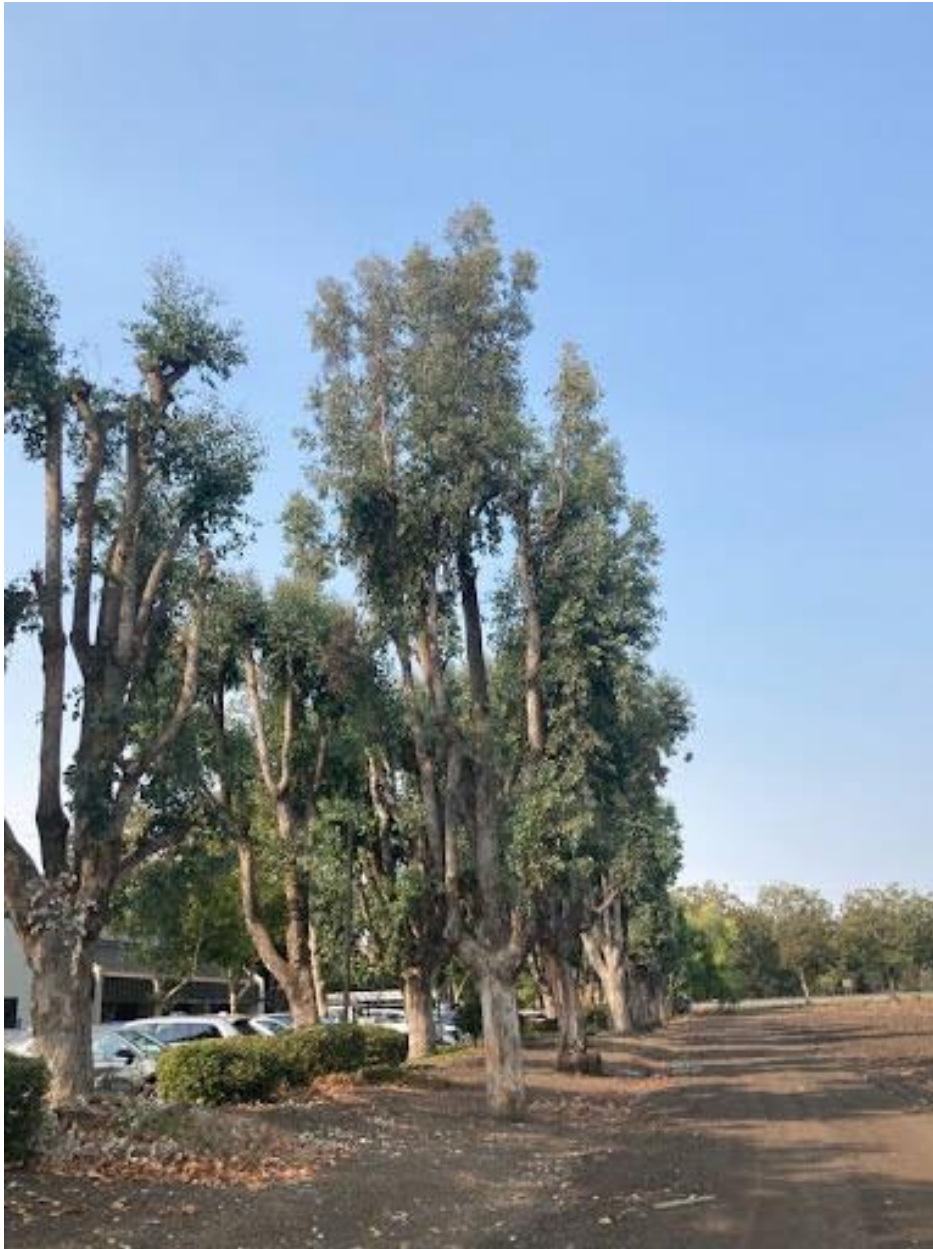
**Image 5: silver dollar gum #23**

| Tree # | Common Name | Species | DBH (inches) | Height (estimated visually) | Protected tree? | Vitality (0 = dead, 3 = healthy) | Project Impacts | Disposition | Replacement Requirement |
|---|---|---|---|---|---|---|---|---|---|
| 23 | Silver dollar gum | Eucalyptus polyanthemos | 20.0 | 35 | - | 3 | Incompatible with transmission line | REMOVE | N/A |

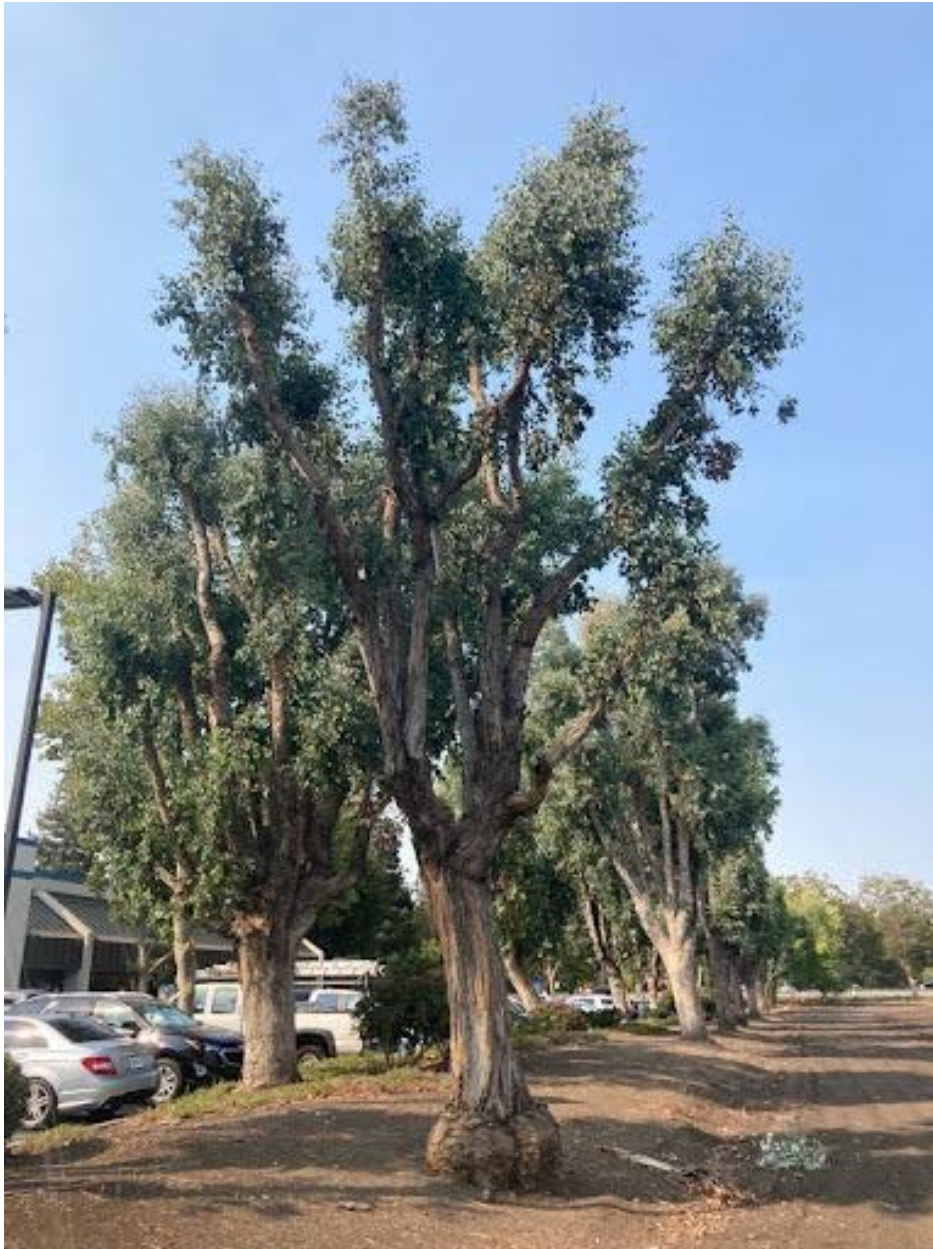
**Image 6: silver dollar gum #24**

| Tree # | Common Name | Species | DBH (inches) | Height (estimated visually) | Protected tree? | Vitality (0 = dead, 3 = healthy) | Project Impacts | Disposition | Replacement Requirement |
|---|---|---|---|---|---|---|---|---|---|
| 24 | Silver dollar gum | Eucalyptus polyanthemos | 16.5 | 35 | - | 3 | Incompatible with transmission line | REMOVE | N/A |

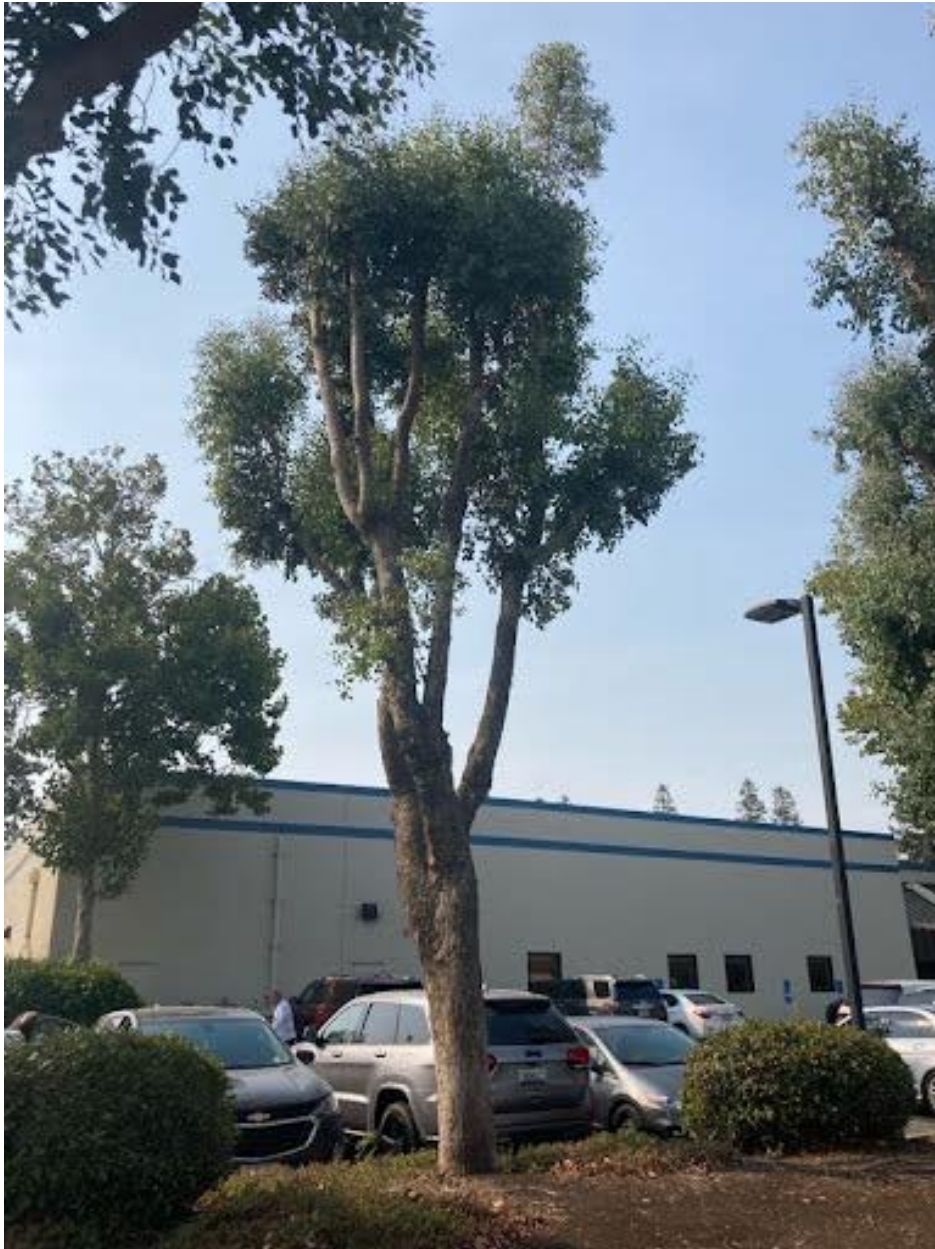
**Image 7: silver dollar gum #25**

| Tree # | Common Name | Species | DBH (inches) | Height (estimated visually) | Protected tree? | Vitality (0 = dead, 3 = healthy) | Project Impacts | Disposition | Replacement Requirement |
|---|---|---|---|---|---|---|---|---|---|
| 25 | Silver dollar gum | Eucalyptus polyanthemos | 19.8 | 35 | - | 3 | Incompatible with transmission line | REMOVE | N/A |

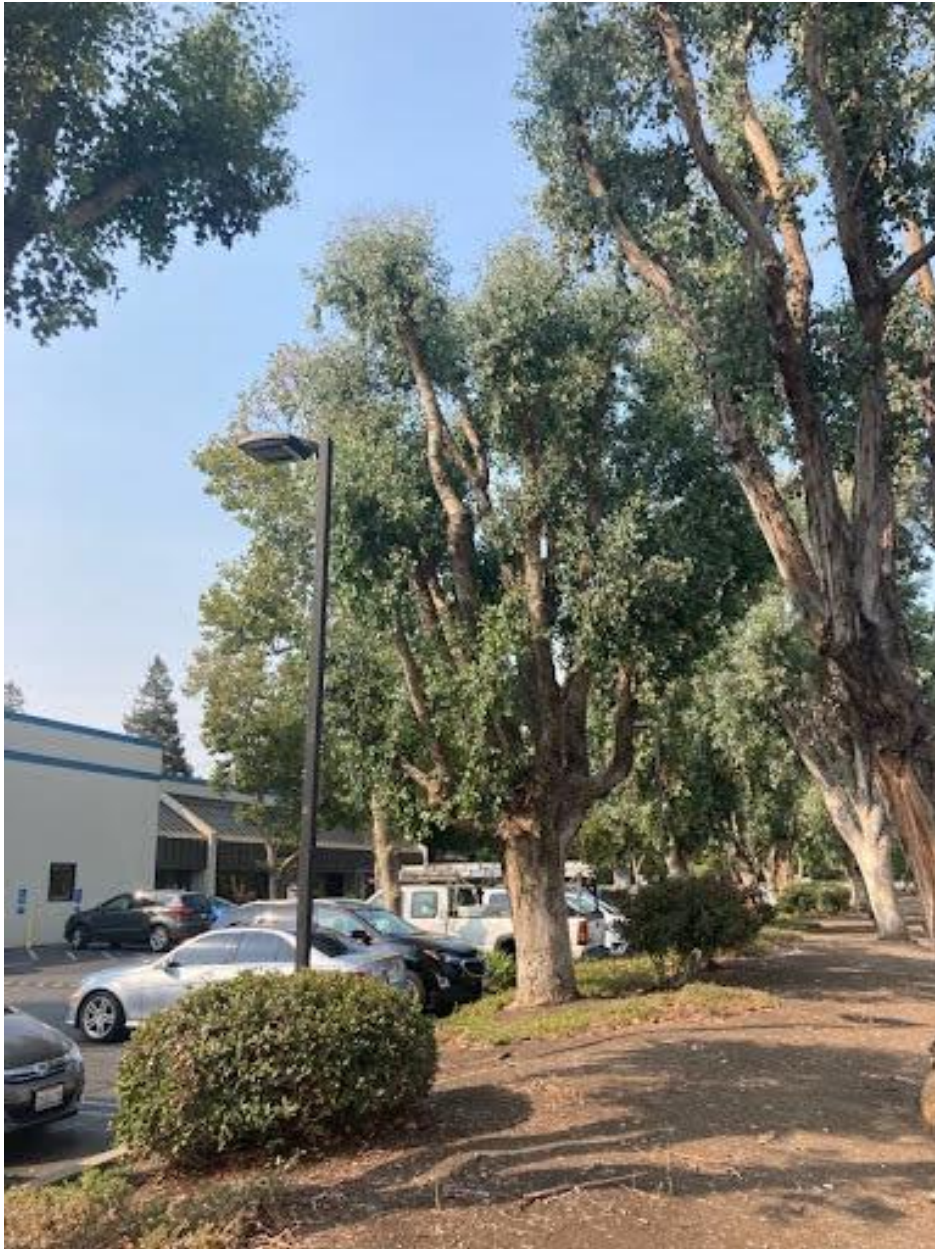
**Image 8: silver dollar gum #26**

| Tree # | Common Name | Species | DBH (inches) | Height (estimated visually) | Protected tree? | Vitality (0 = dead, 3 = healthy) | Project Impacts | Disposition | Replacement Requirement |
|---|---|---|---|---|---|---|---|---|---|
| 26 | Silver dollar gum | Eucalyptus polyanthemos | 26.7 | 35 | - | 3 | Incompatible with transmission line | REMOVE | N/A |

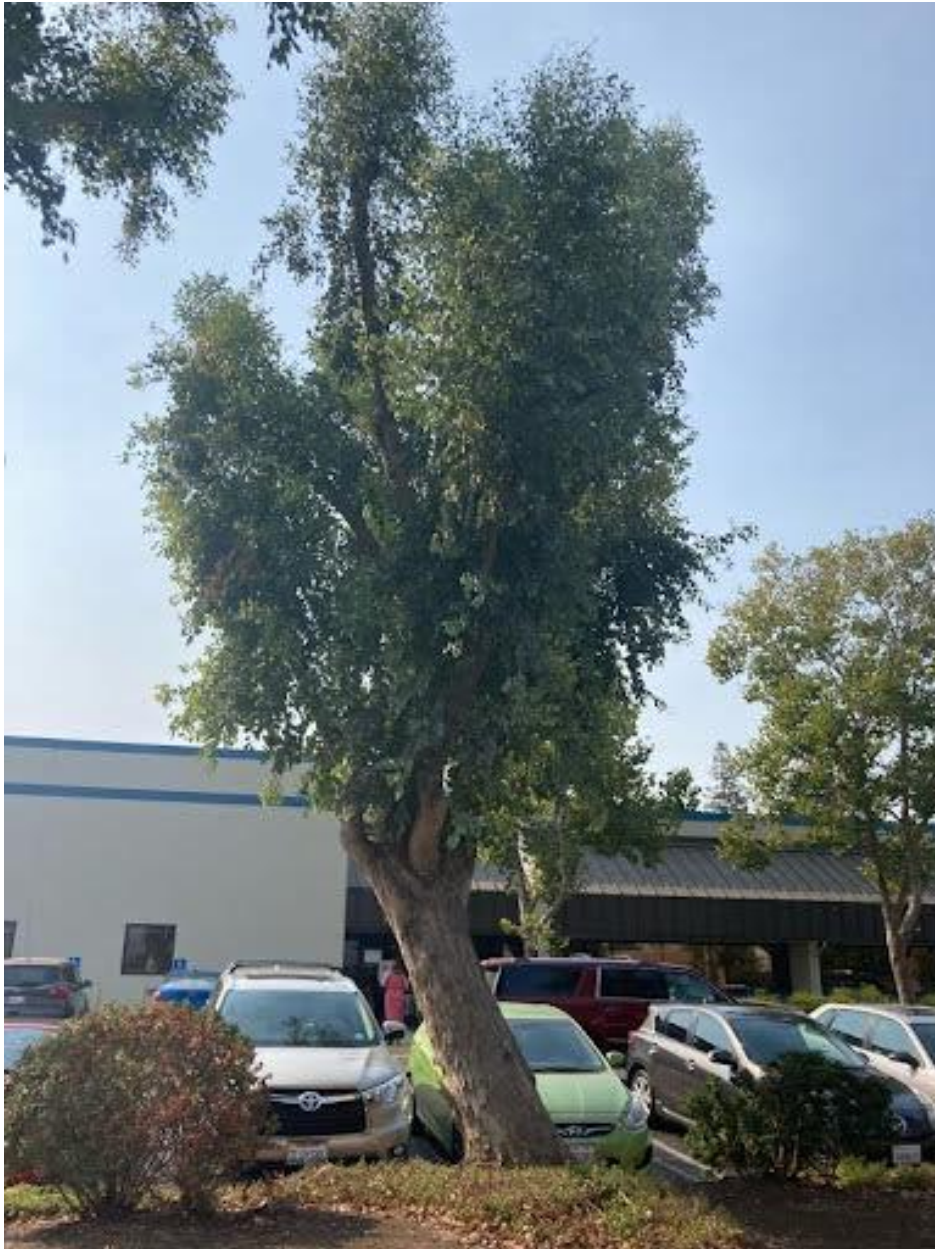
**Image 9: silver dollar gum #27**

| Tree # | Common Name | Species | DBH (inches) | Height (estimated visually) | Protected tree? | Vitality (0 = dead, 3 = healthy) | Project Impacts | Disposition | Replacement Requirement |
|---|---|---|---|---|---|---|---|---|---|
| 27 | Silver dollar gum | Eucalyptus polyanthemos | 23.1 | 35 | - | 3 | Incompatible with transmission line | REMOVE | N/A |

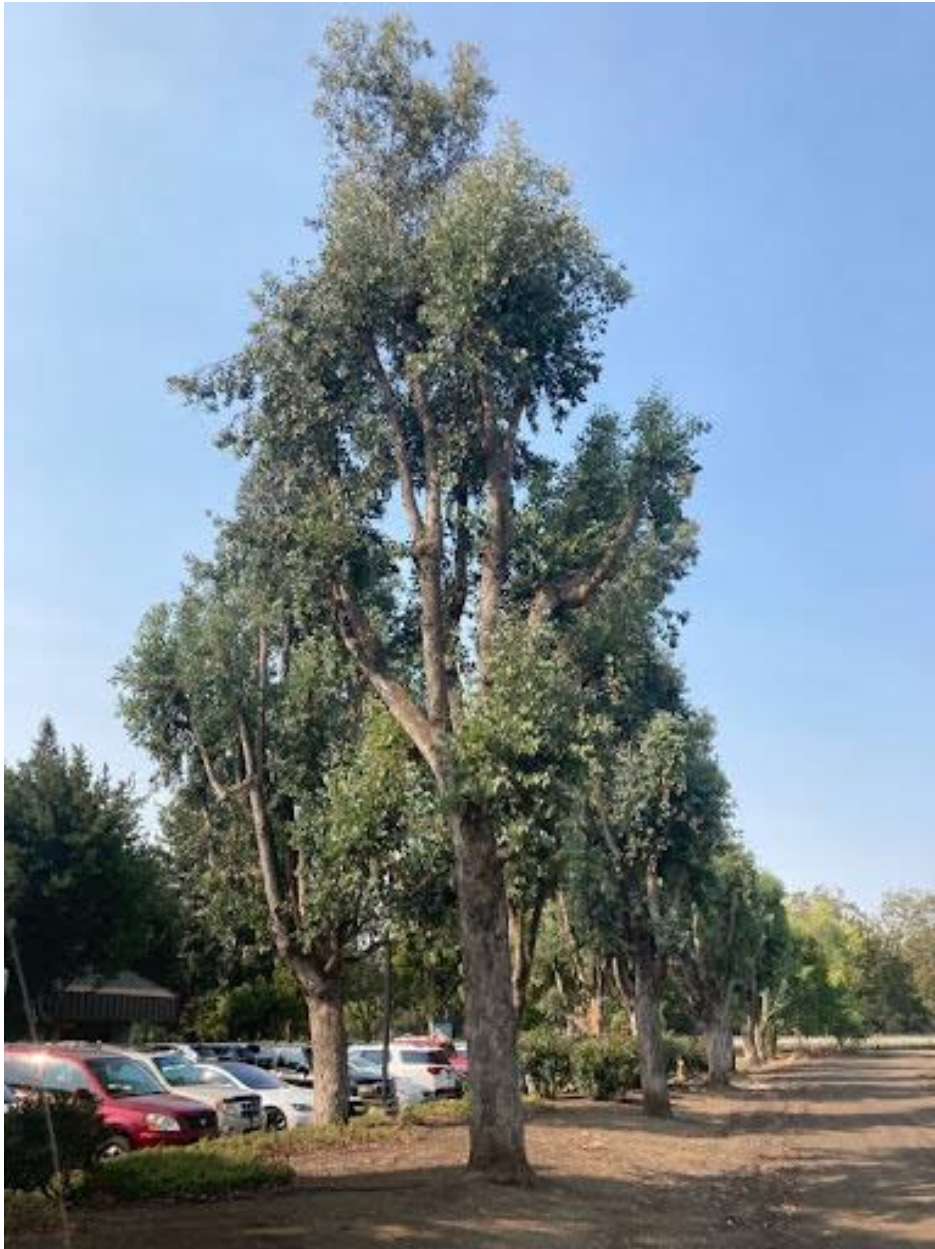
**Image 10: silver dollar gum #28**

| Tree # | Common Name | Species | DBH (inches) | Height (estimated visually) | Protected tree? | Vitality (0 = dead, 3 = healthy) | Project Impacts | Disposition | Replacement Requirement |
|---|---|---|---|---|---|---|---|---|---|
| 28 | Silver dollar gum | Eucalyptus polyanthemos | 20.5 | 35 | - | 3 | Incompatible with transmission line | REMOVE | N/A |

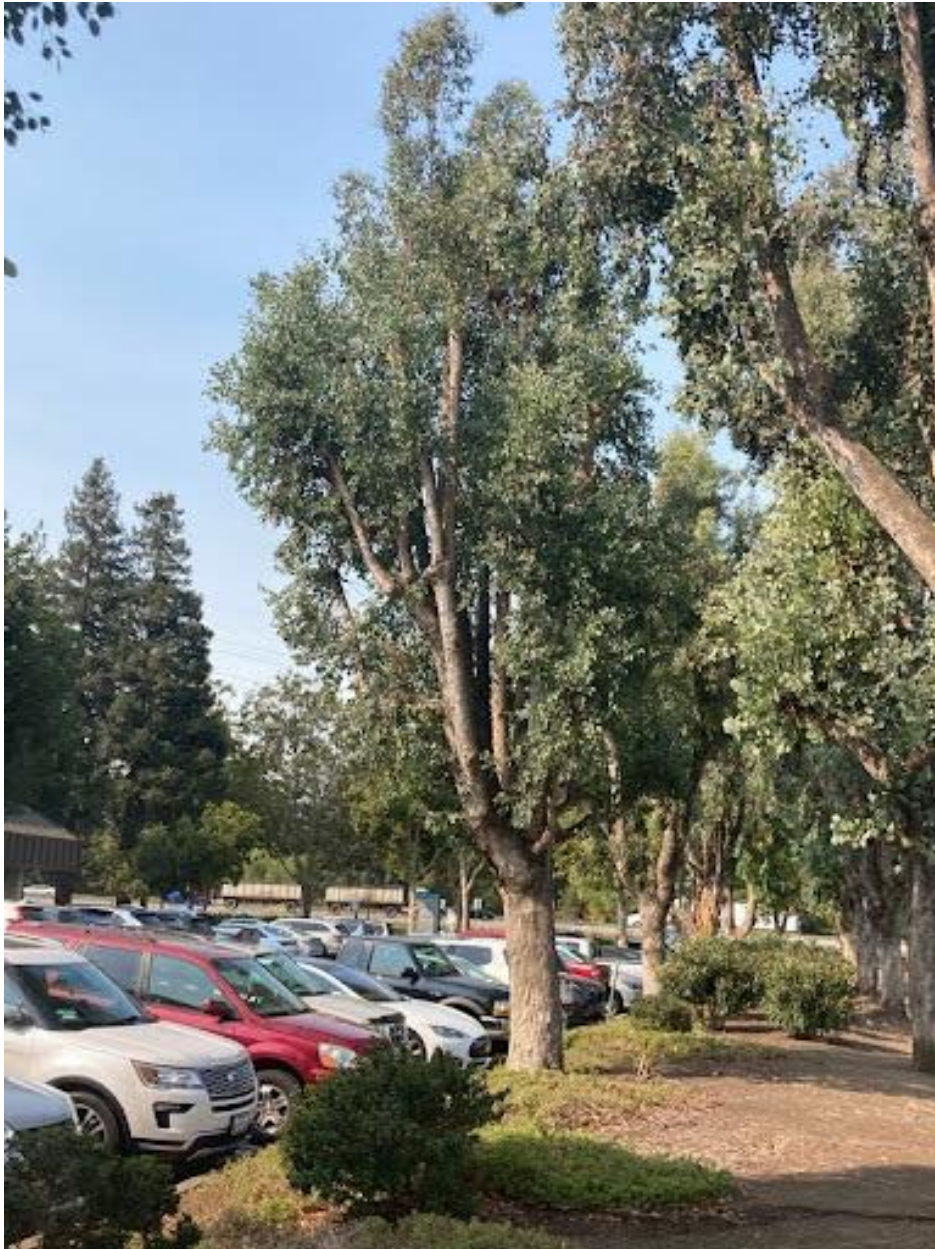
**Image 11: silver dollar gum #29**

| Tree # | Common Name | Species | DBH (inches) | Height (estimated visually) | Protected tree? | Vitality (0 = dead, 3 = healthy) | Project Impacts | Disposition | Replacement Requirement |
|---|---|---|---|---|---|---|---|---|---|
| 29 | Silver dollar gum | Eucalyptus polyanthemos | 17.8 | 35 | - | 3 | Incompatible with transmission line | REMOVE | N/A |

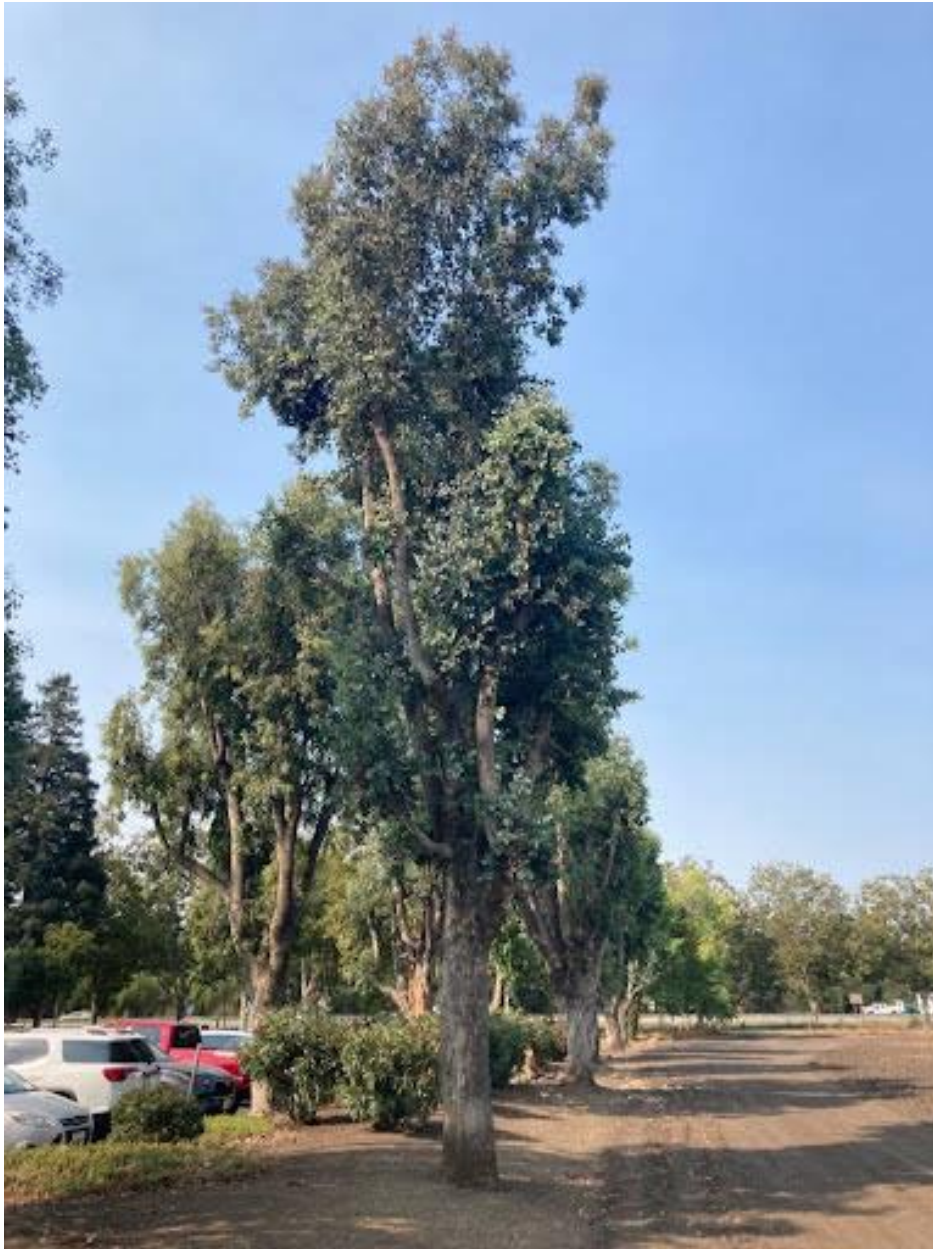
**Image 12: silver dollar gum #30**

| Tree # | Common Name | Species | DBH (inches) | Height (estimated visually) | Protected tree? | Vitality (0 = dead, 3 = healthy) | Project Impacts | Disposition | Replacement Requirement |
|---|---|---|---|---|---|---|---|---|---|
| 30 | Silver dollar gum | Eucalyptus polyanthemos | 21.5 | 35 | - | 3 | Incompatible with transmission line | REMOVE | N/A |

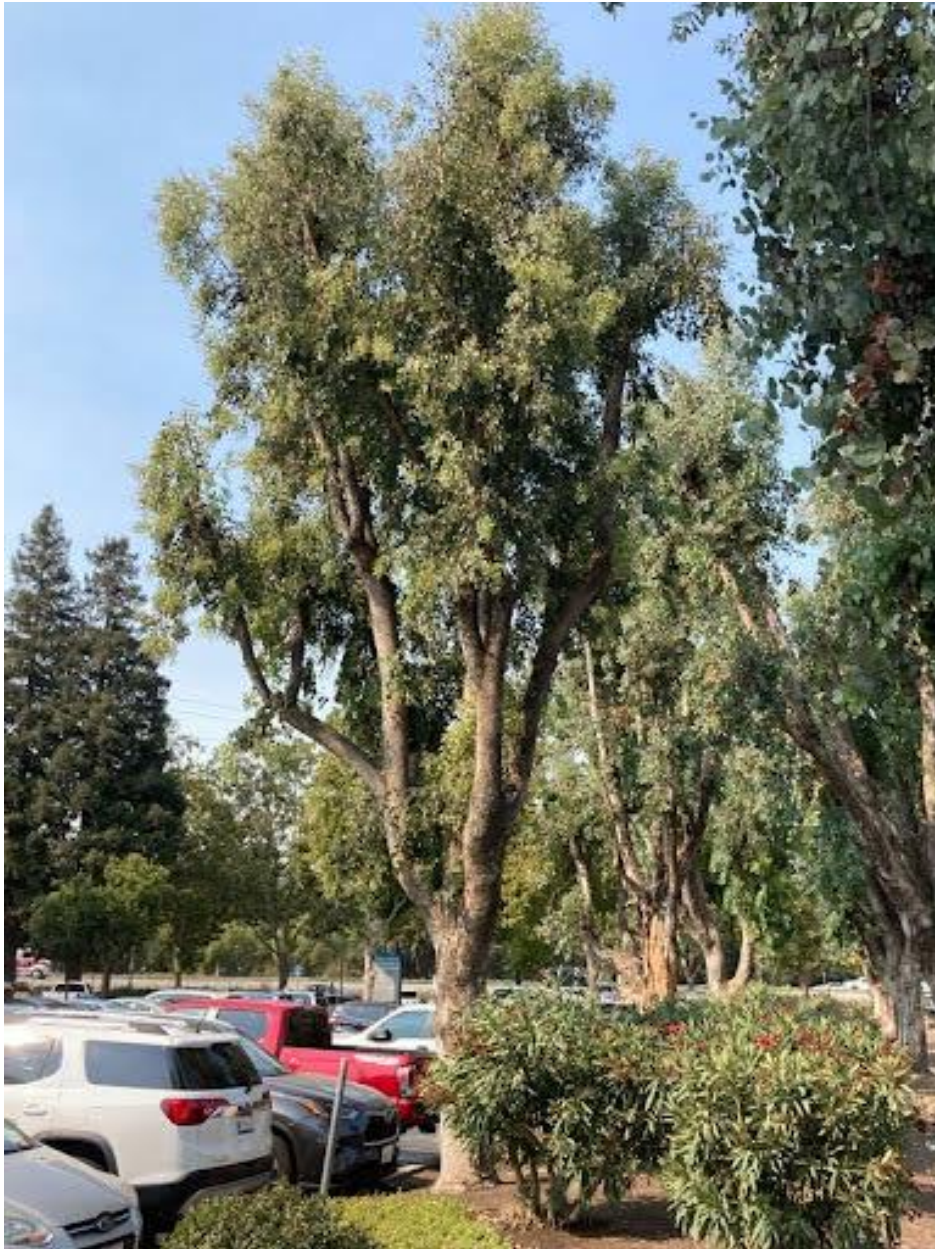
**Image 13: silver dollar gum #31**

| Tree # | Common Name | Species | DBH (inches) | Height (estimated visually) | Protected tree? | Vitality (0 = dead, 3 = healthy) | Project Impacts | Disposition | Replacement Requirement |
|---|---|---|---|---|---|---|---|---|---|
| 31 | Silver dollar gum | Eucalyptus polyanthemos | 18.0 | 35 | - | 3 | Incompatible with transmission line | REMOVE | N/A |

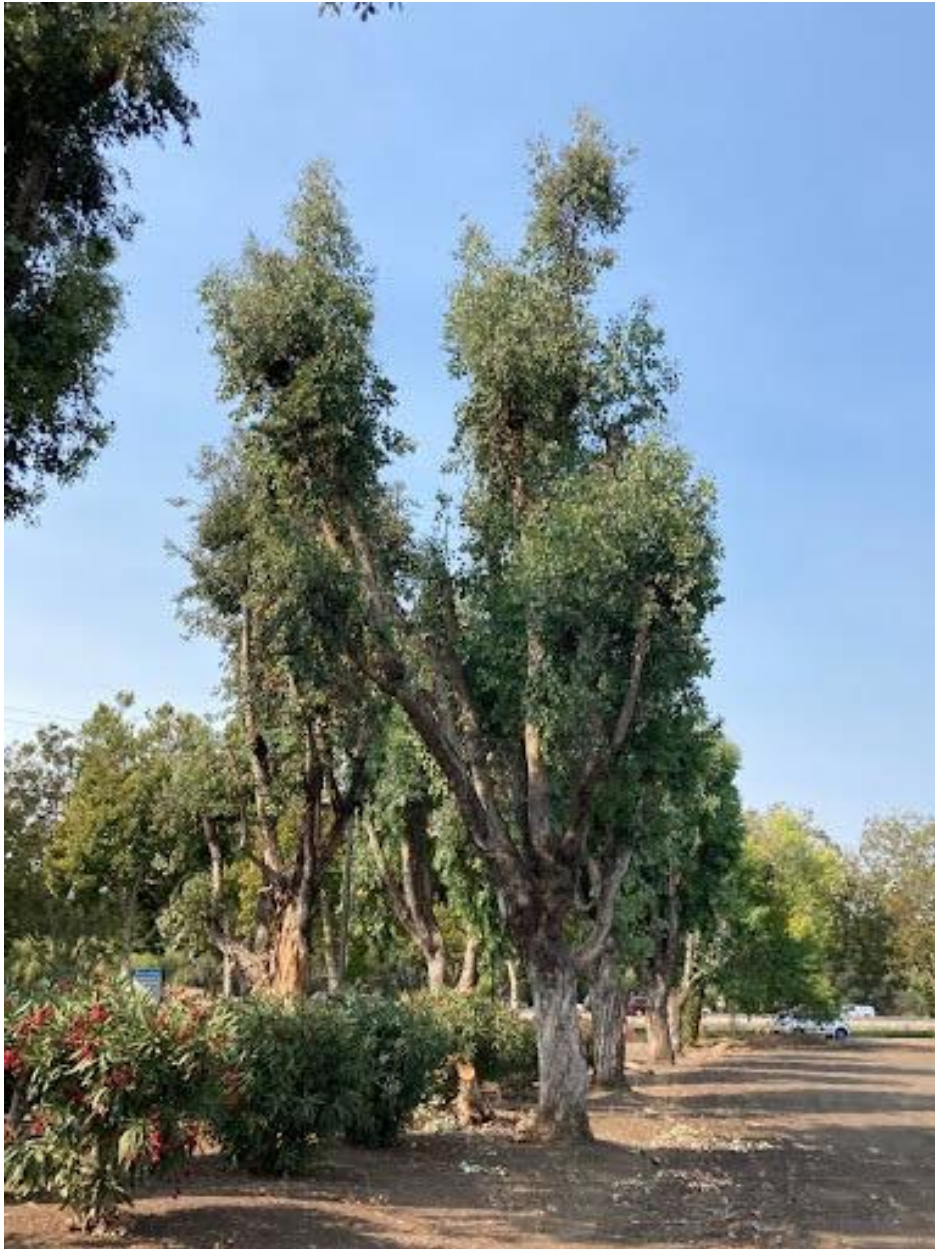
**Image 14: silver dollar gum #32**

| Tree # | Common Name | Species | DBH (inches) | Height (estimated visually) | Protected tree? | Vitality (0 = dead, 3 = healthy) | Project Impacts | Disposition | Replacement Requirement |
|---|---|---|---|---|---|---|---|---|---|
| 32 | Silver dollar gum | Eucalyptus polyanthemos | 16.8 | 35 | - | 3 | Incompatible with transmission line | REMOVE | N/A |

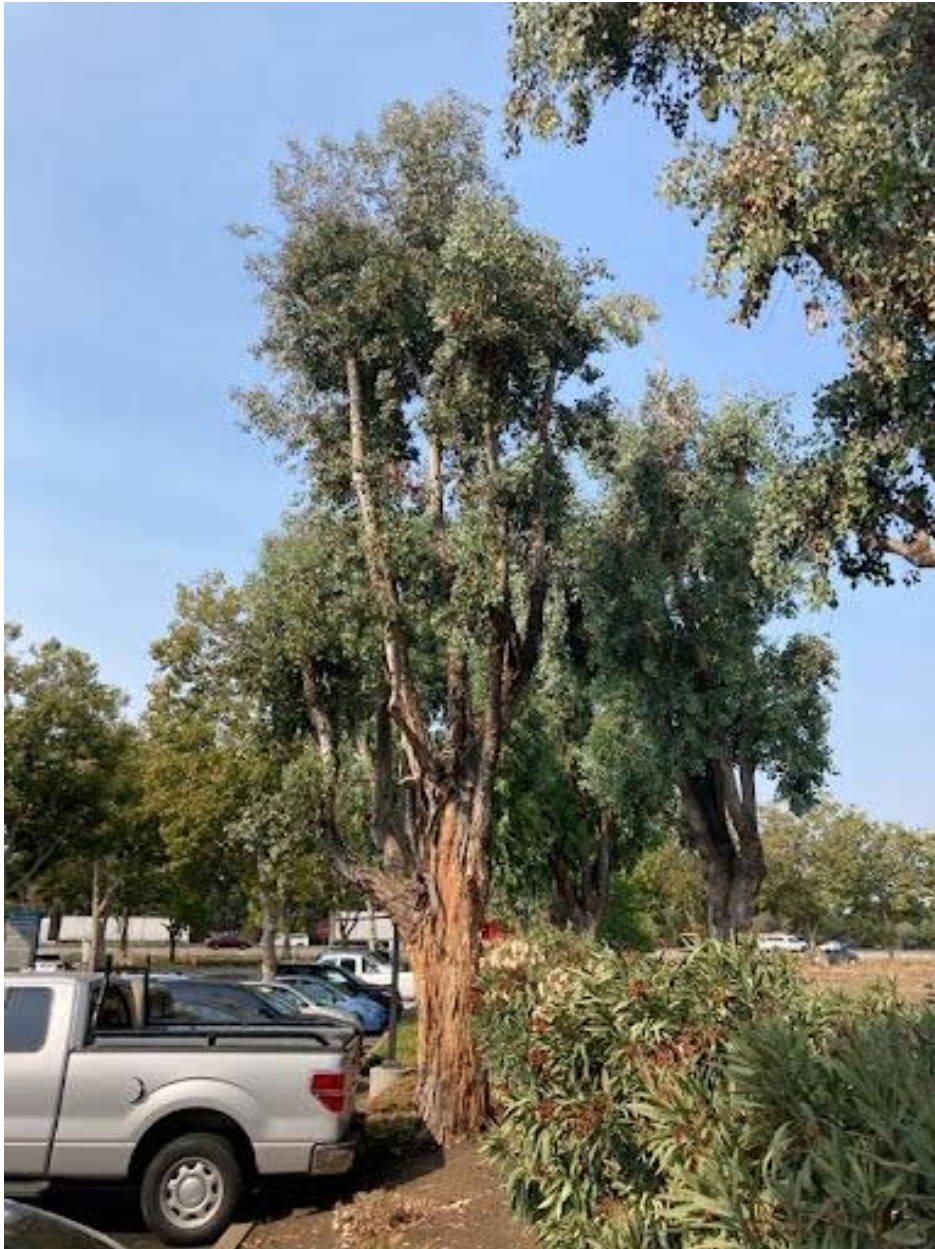
**Image 15: silver dollar gum #33**

| Tree # | Common Name | Species | DBH (inches) | Height (estimated visually) | Protected tree? | Vitality (0 = dead, 3 = healthy) | Project Impacts | Disposition | Replacement Requirement |
|---|---|---|---|---|---|---|---|---|---|
| 33 | Silver dollar gum | Eucalyptus polyanthemos | 19.1 | 35 | - | 3 | Incompatible with transmission line | REMOVE | N/A |

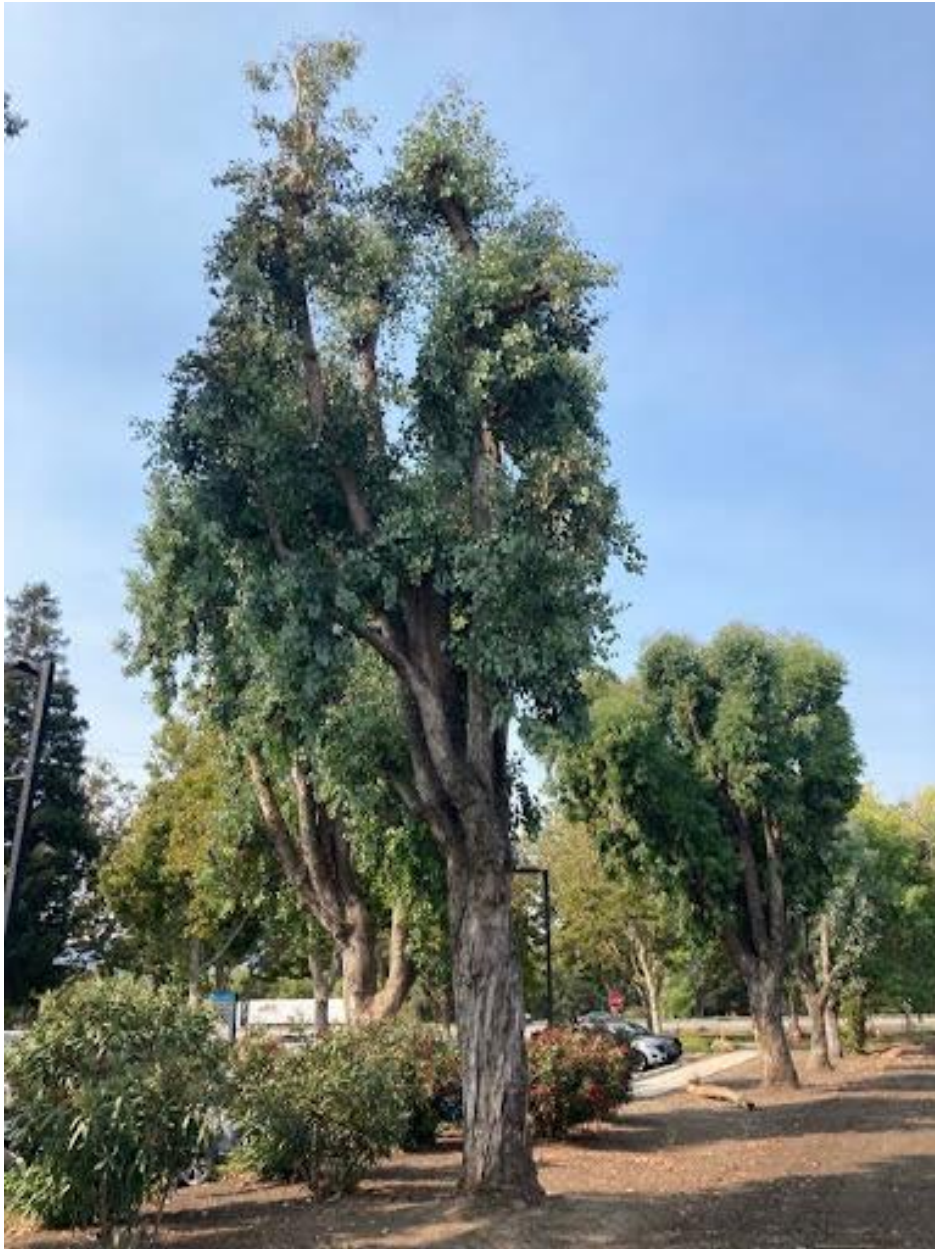
**Image 16: silver dollar gum #34**

| Tree # | Common Name | Species | DBH (inches) | Height (estimated visually) | Protected tree? | Vitality (0 = dead, 3 = healthy) | Project Impacts | Disposition | Replacement Requirement |
|---|---|---|---|---|---|---|---|---|---|
| 34 | Silver dollar gum | Eucalyptus polyanthemos | 23.0 | 35 | - | 3 | Incompatible with transmission line | REMOVE | N/A |

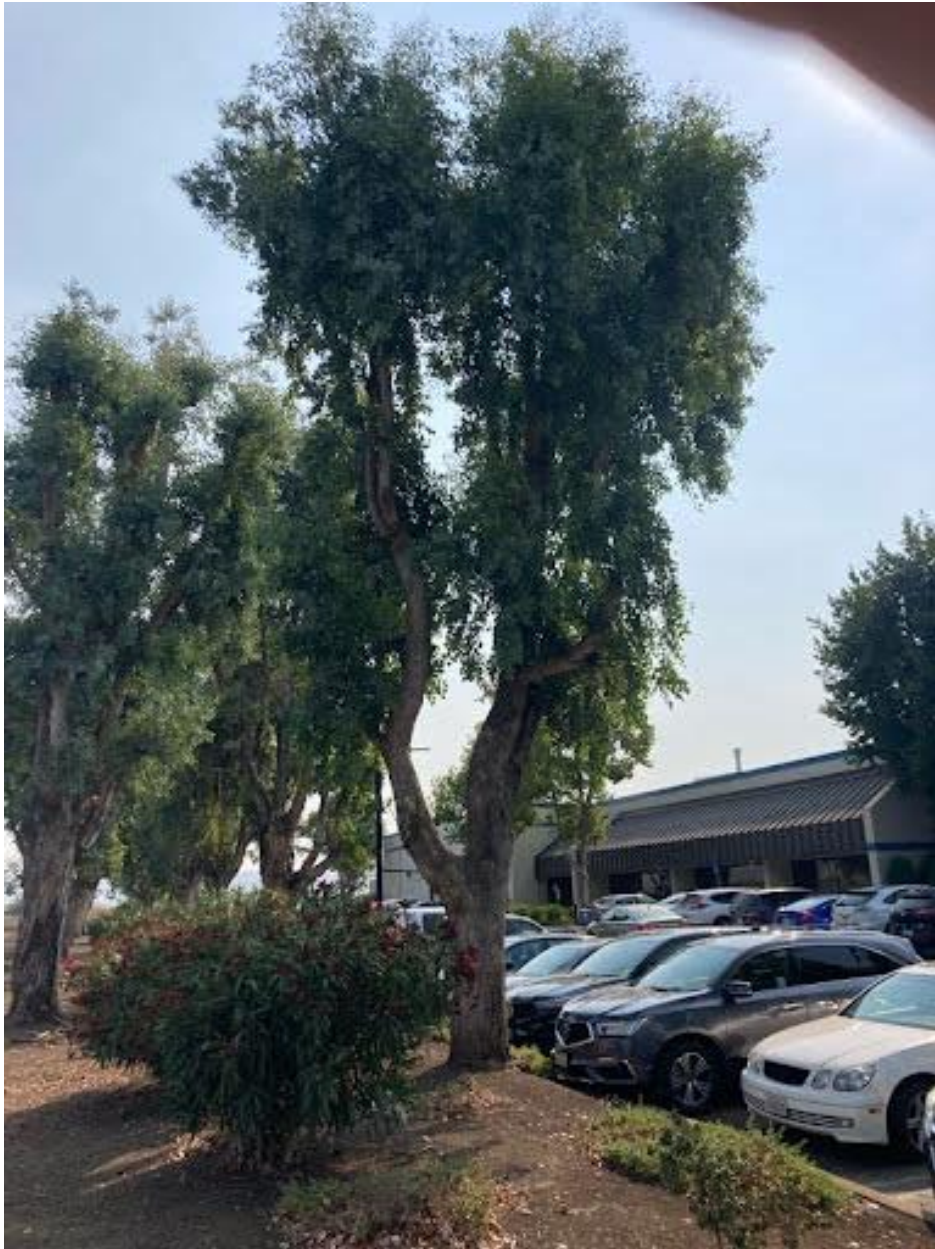
**Image 17: silver dollar gum #35**

| Tree # | Common Name | Species | DBH (inches) | Height (estimated visually) | Protected tree? | Vitality (0 = dead, 3 = healthy) | Project Impacts | Disposition | Replacement Requirement |
|---|---|---|---|---|---|---|---|---|---|
| 35 | Silver dollar gum | Eucalyptus polyanthemos | 22.4 | 35 | - | 3 | Incompatible with transmission line | REMOVE | N/A |
