Re: Tree Protection for Proposed Power Line for Data Center on Camino Arroyo in Gilroy  
(AWS SFO069)

### **Summary:**

There are 38 trees present on and adjacent to the power line: two private protected trees on the neighboring property; 24 private non-protected trees on the neighboring property; and 12 street trees.

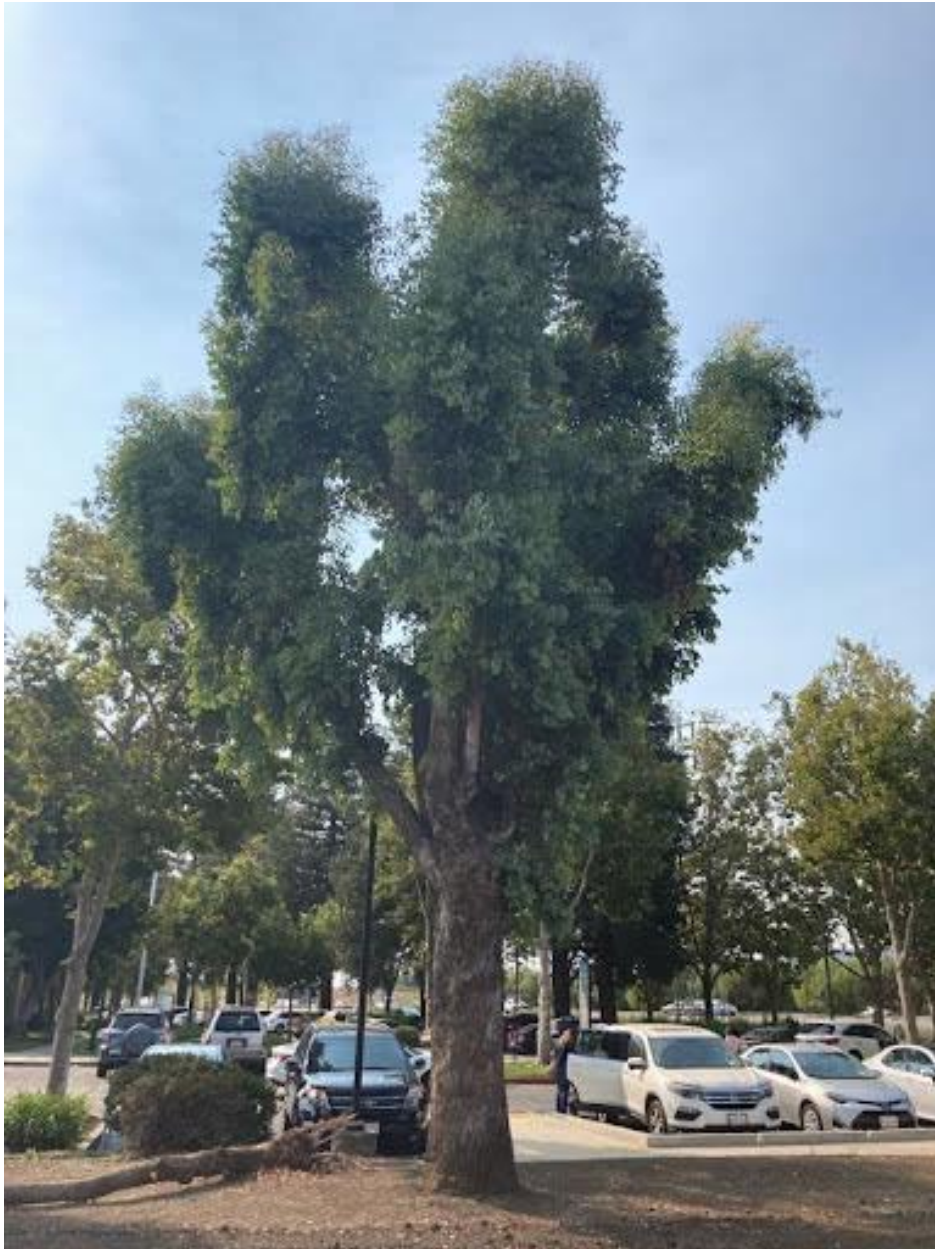
**Image 18: silver dollar gum #36**

| Tree # | Common Name | Species | DBH (inches) | Height (estimated visually) | Protected tree? | Vitality (0 = dead, 3 = healthy) | Project Impacts | Disposition | Replacement Requirement |
|---|---|---|---|---|---|---|---|---|---|
| 36 | Silver dollar gum | Eucalyptus polyanthemos | 21.0 | 35 | - | 3 | Incompatible with transmission line | REMOVE | N/A |

1. Remove trees #19-56

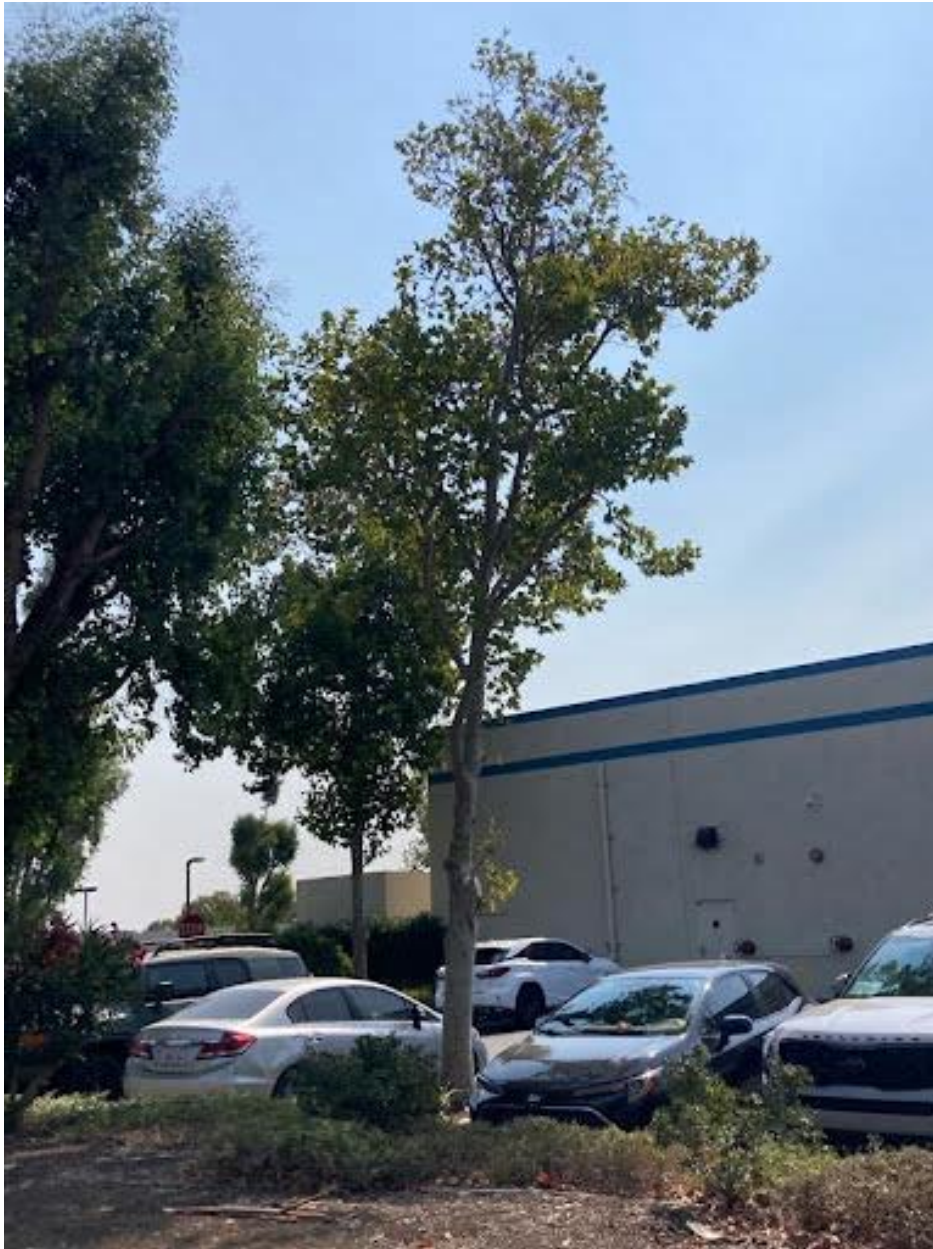
**Image 19: London plane #37**

| Tree # | Common Name | Species | DBH (inches) | Height (estimated visually) | Protected tree? | Vitality (0 = dead, 3 = healthy) | Project Impacts | Disposition | Replacement Requirement |
|---|---|---|---|---|---|---|---|---|---|
| 37 | London plane | Platanus x acerifolia | 11.5 | 40 | - | 2 | Incompatible with transmission line | REMOVE | N/A |

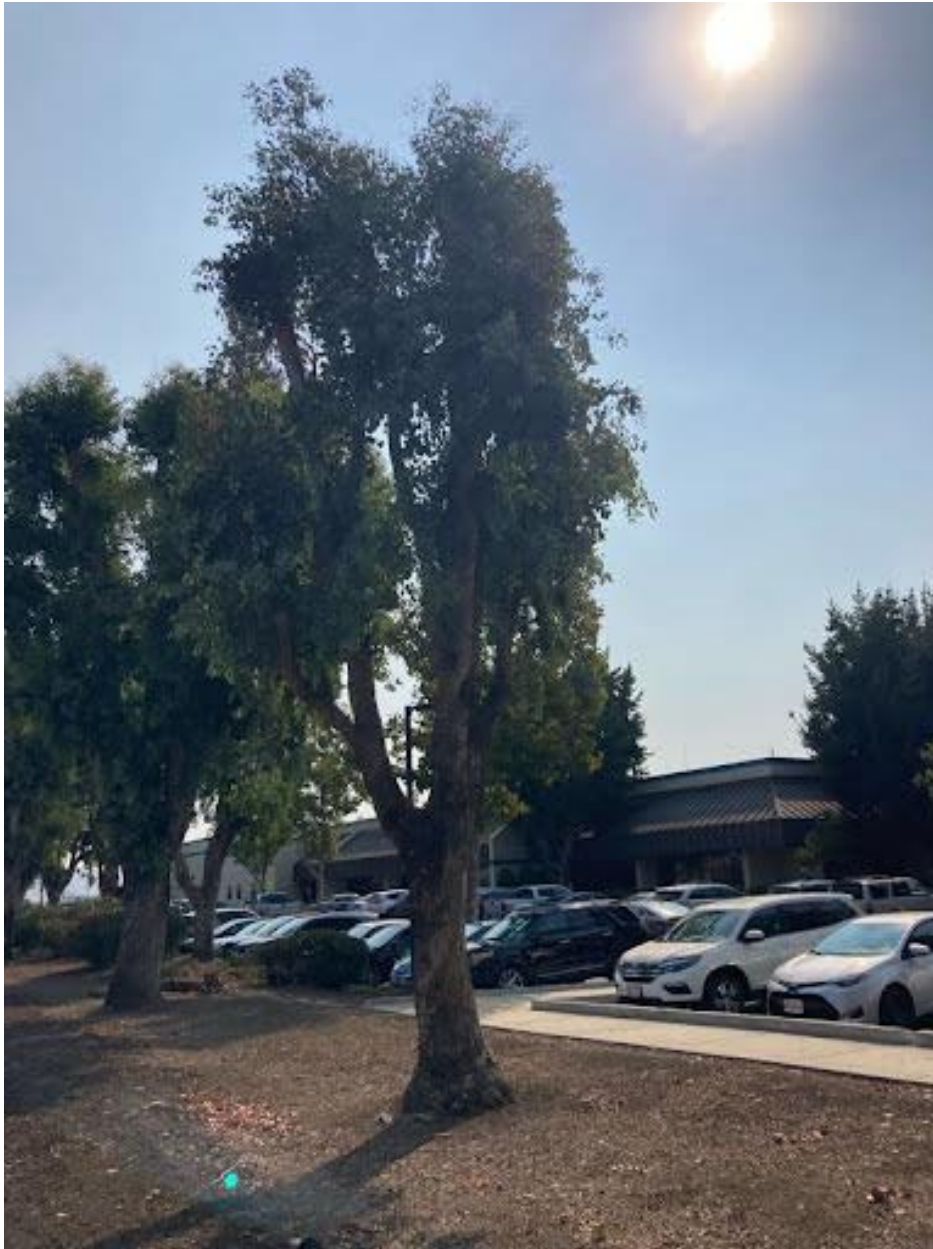
**Image 20: silver dollar gum #38**

| Tree # | Common Name | Species | DBH (inches) | Height (estimated visually) | Protected tree? | Vitality (0 = dead, 3 = healthy) | Project Impacts | Disposition | Replacement Requirement |
|---|---|---|---|---|---|---|---|---|---|
| 38 | Silver dollar gum | Eucalyptus polyanthemos | 26.4 | 35 | - | 3 | Incompatible with transmission line | REMOVE | N/A |

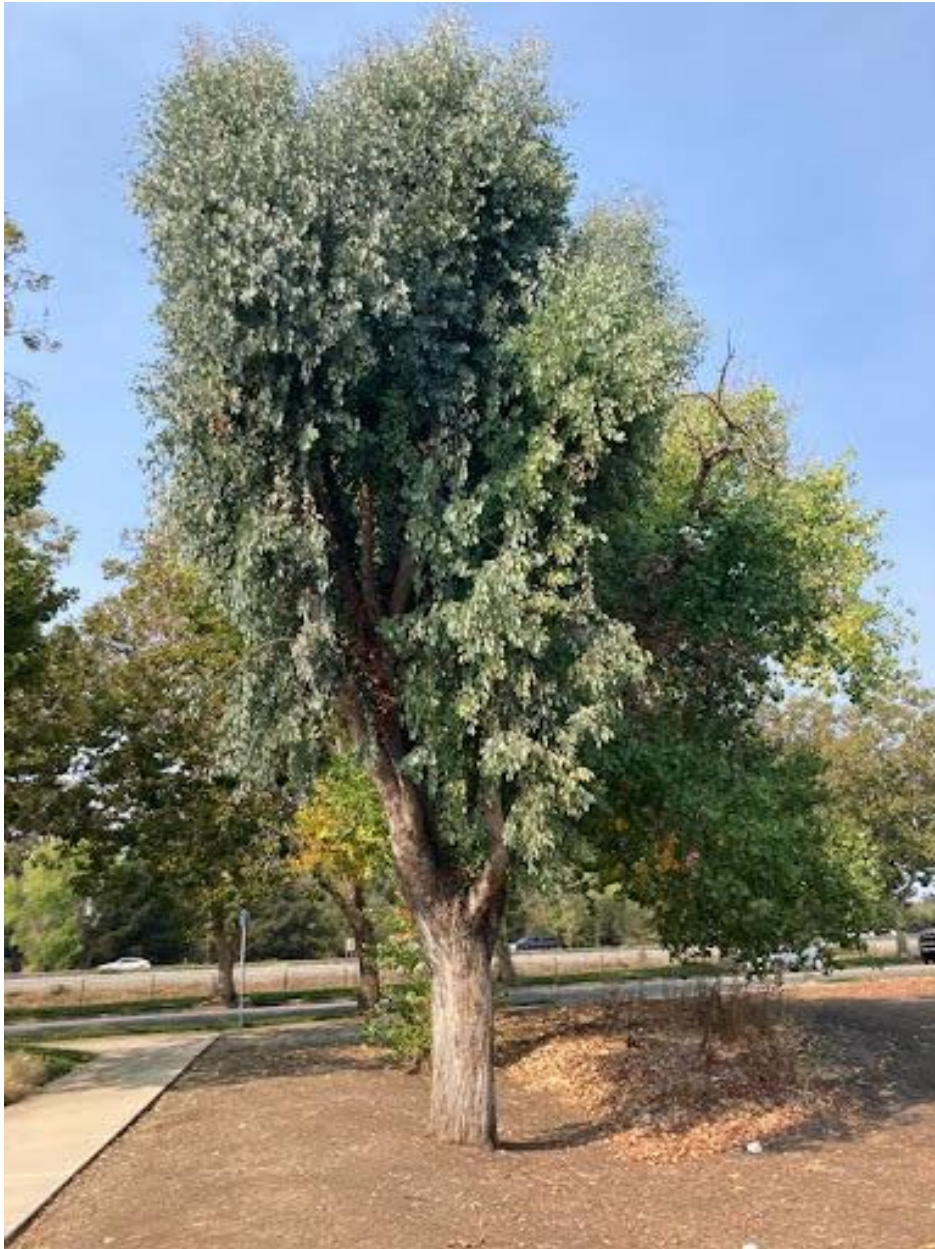
**Image 21: silver dollar gum #39**

| Tree # | Common Name | Species | DBH (inches) | Height (estimated visually) | Protected tree? | Vitality (0 = dead, 3 = healthy) | Project Impacts | Disposition | Replacement Requirement |
|---|---|---|---|---|---|---|---|---|---|
| 39 | Silver dollar gum | Eucalyptus polyanthemos | 16.8 | 35 | - | 3 | Incompatible with transmission line | REMOVE | N/A |

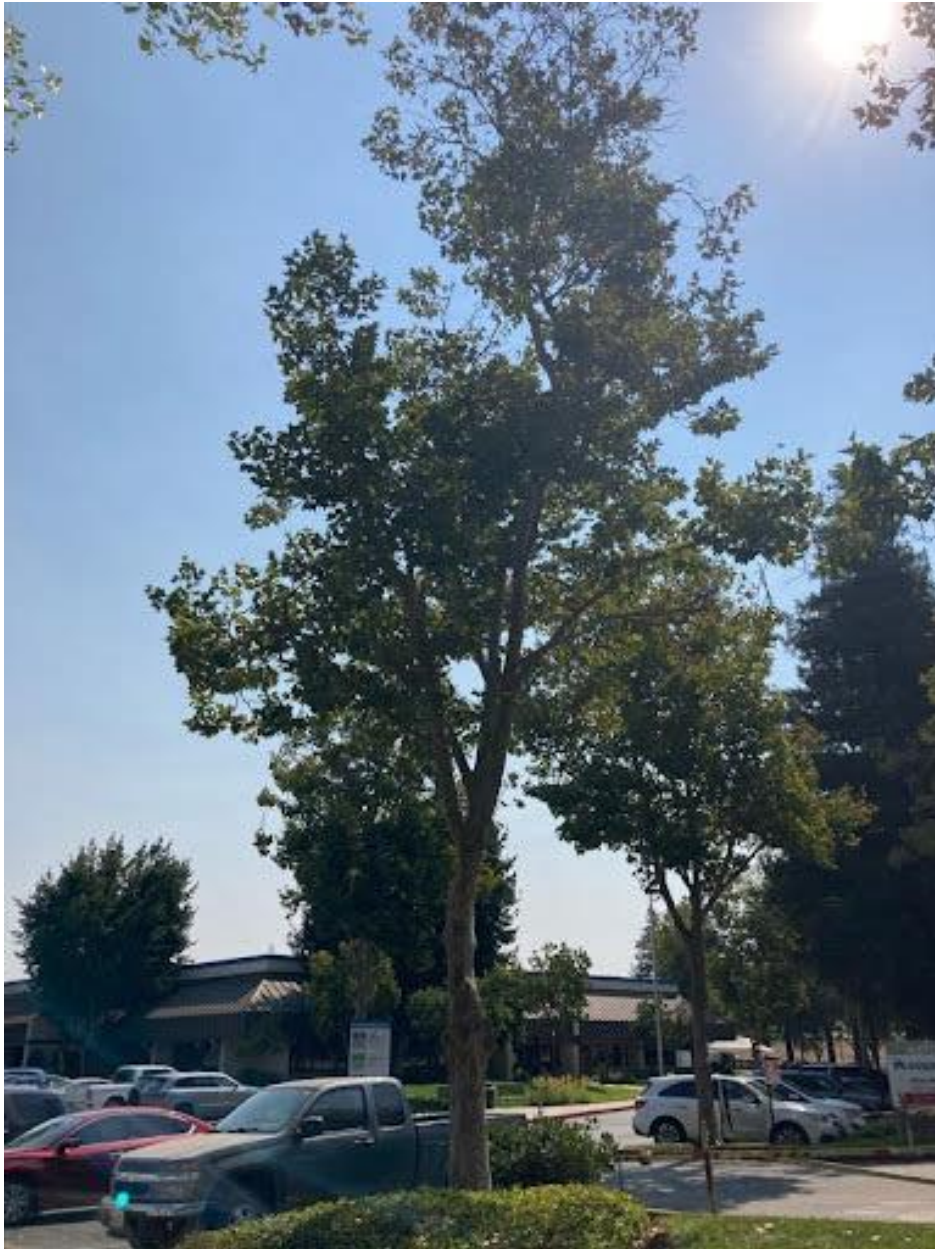
**Image 22: London plane #41**

| Tree # | Common Name | Species | DBH (inches) | Height (estimated visually) | Protected tree? | Vitality (0 = dead, 3 = healthy) | Project Impacts | Disposition | Replacement Requirement |
|---|---|---|---|---|---|---|---|---|---|
| 41 | London plane | Platanus x acerifolia | 14.2 | 40 | - | 2 | Incompatible with transmission line | REMOVE | N/A |

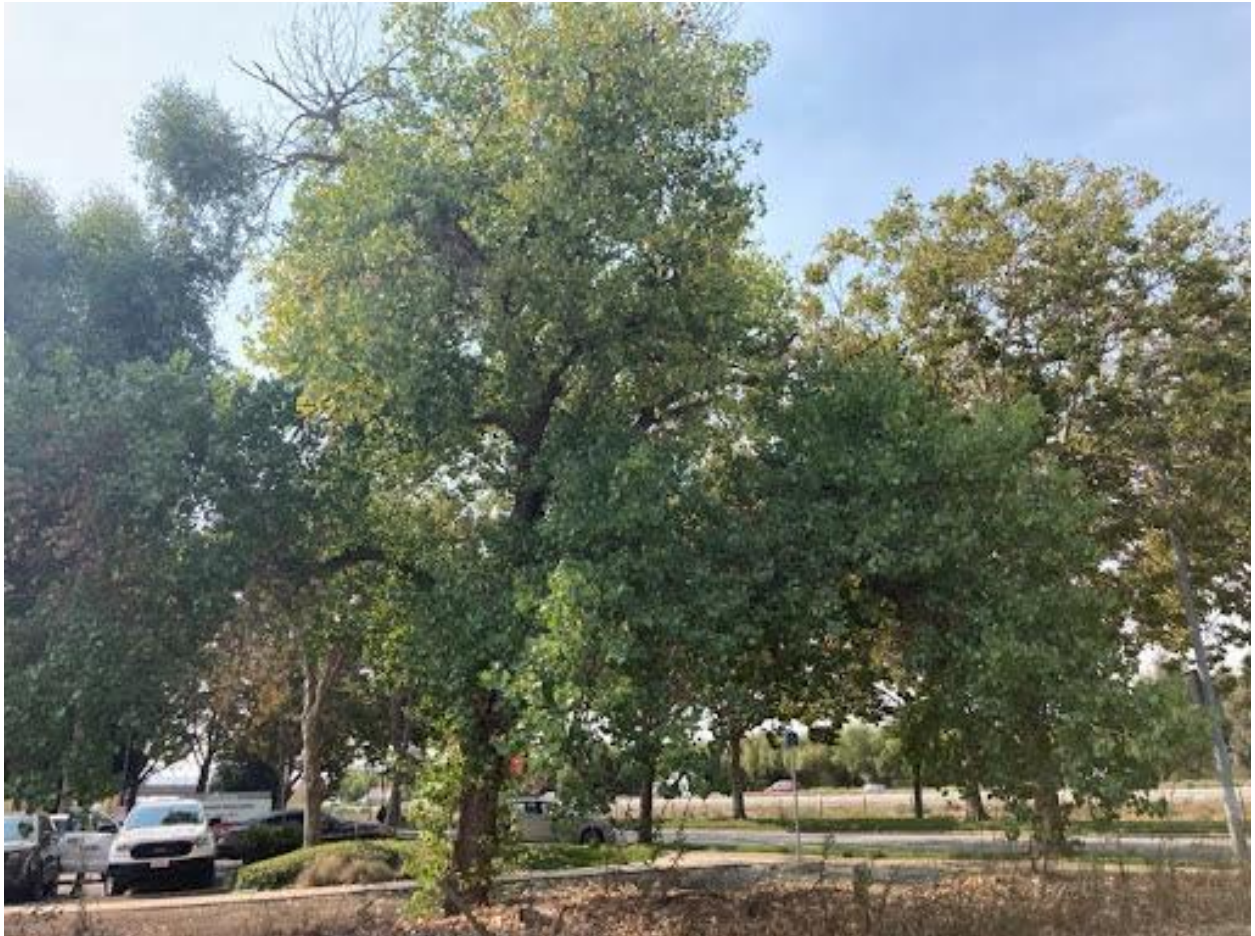
**Image 23: western cottonwood #42**

| Tree # | Common Name | Species | DBH (inches) | Height (estimated visually) | Protected tree? | Vitality (0 = dead, 3 = healthy) | Project Impacts | Disposition | Replacement Requirement |
|---|---|---|---|---|---|---|---|---|---|
| 42 | Western cottonwood | Populus fremontii | 21.0 | 40 | - | 2 | Incompatible with transmission line | REMOVE | N/A |

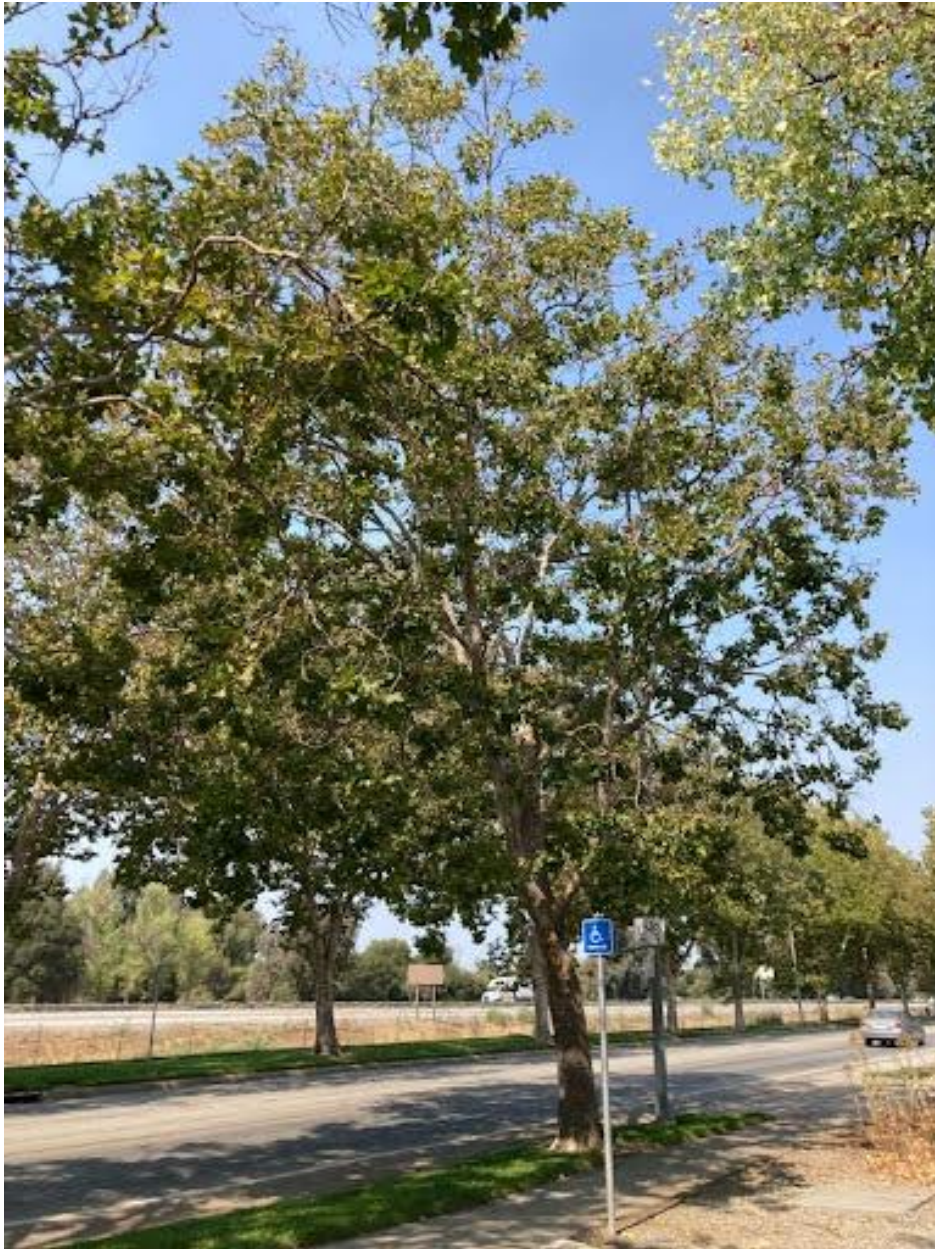
**Image 24: London plane #44**

| Tree # | Common Name | Species | DBH (inches) | Height (estimated visually) | Protected tree? | Vitality (0 = dead, 3 = healthy) | Project Impacts | Disposition | Replacement Requirement |
|---|---|---|---|---|---|---|---|---|---|
| 44 | London plane | Platanus x acerifolia | 15.6 | 50 | Y | 3 | Incompatible with transmission line | REMOVE | Two 24-inch boxes |

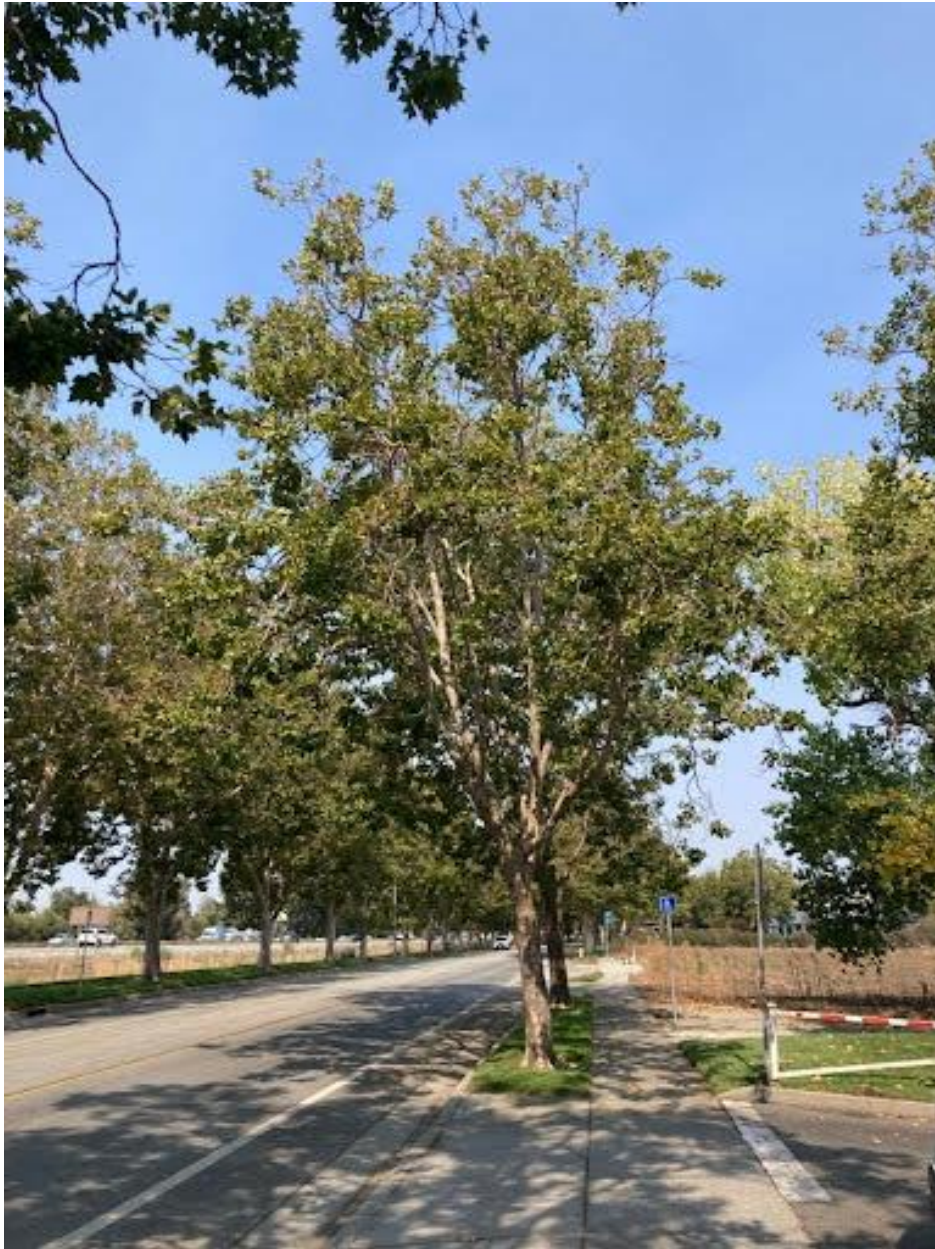
**Image 25: London plane #45**

| Tree # | Common Name | Species | DBH (inches) | Height (estimated visually) | Protected tree? | Vitality (0 = dead, 3 = healthy) | Project Impacts | Disposition | Replacement Requirement |
|---|---|---|---|---|---|---|---|---|---|
| 45 | London plane | Platanus x acerifolia | 12.5 | 50 | Y | 3 | Incompatible with transmission line | REMOVE | Two 24-inch boxes |

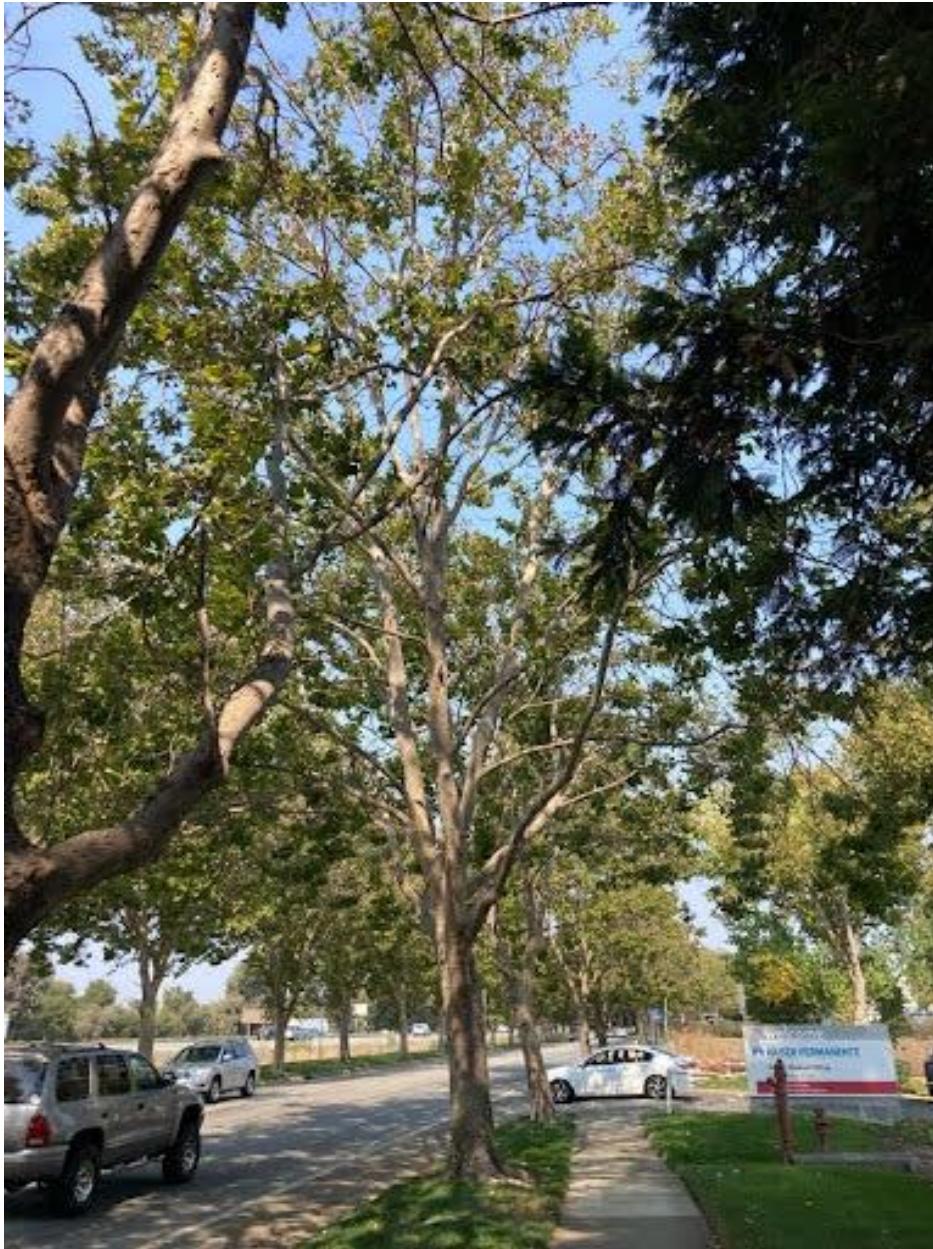
**Image 27: London plane #47**

| Tree # | Common Name | Species | DBH (inches) | Height (estimated visually) | Protected tree? | Vitality (0 = dead, 3 = healthy) | Project Impacts | Disposition | Replacement Requirement |
|---|---|---|---|---|---|---|---|---|---|
| 47 | London plane | Platanus x acerifolia | 18.0 | 50 | Y | 3 | Incompatible with transmission line | REMOVE | Two 24-inch boxes |

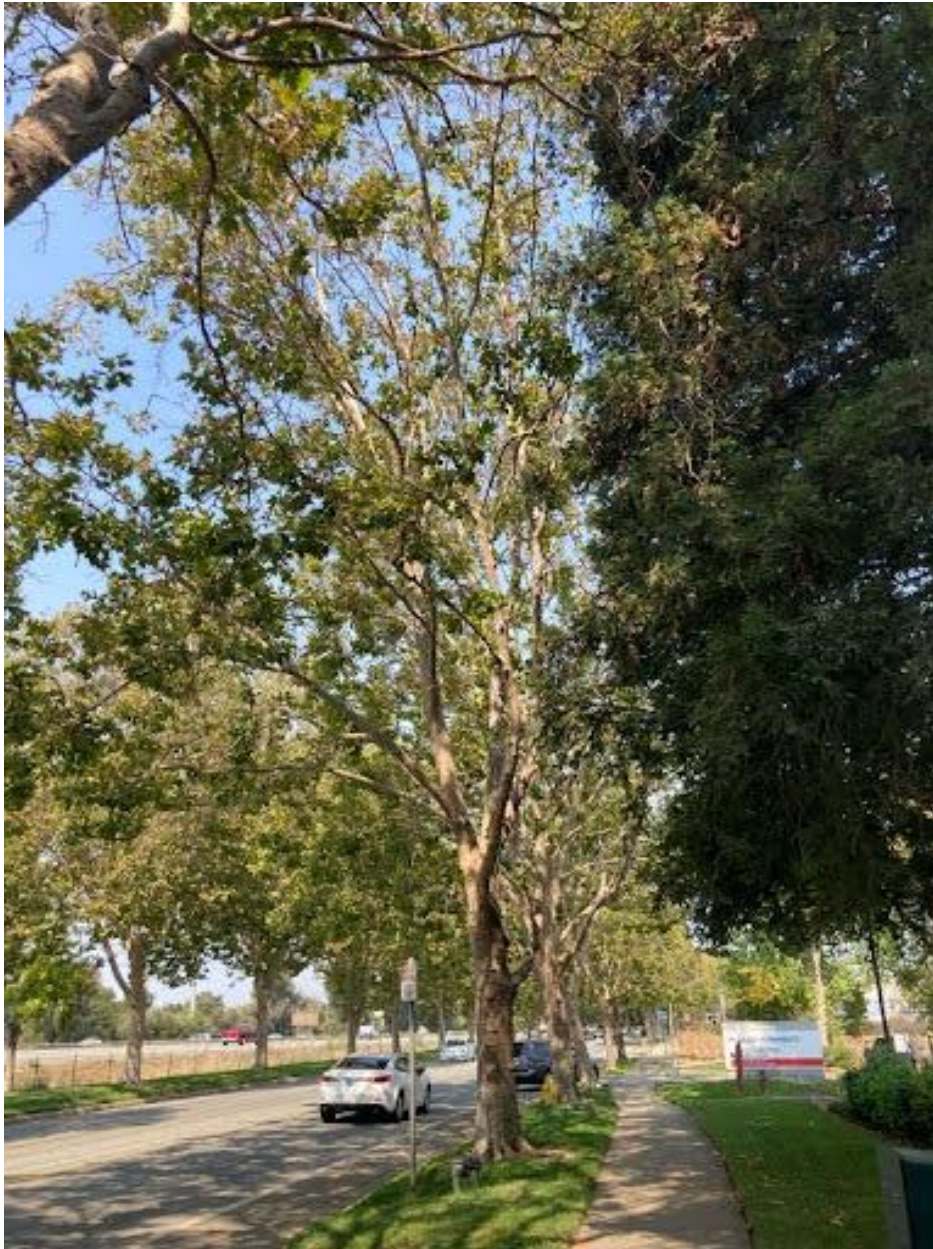
**Image 28: London plane #48**

| Tree # | Common Name | Species | DBH (inches) | Height (estimated visually) | Protected tree? | Vitality (0 = dead, 3 = healthy) | Project Impacts | Disposition | Replacement Requirement |
|---|---|---|---|---|---|---|---|---|---|
| 48 | London plane | Platanus x acerifolia | 17.0 | 50 | Y | 3 | Incompatible with transmission line | REMOVE | Two 24-inch boxes |

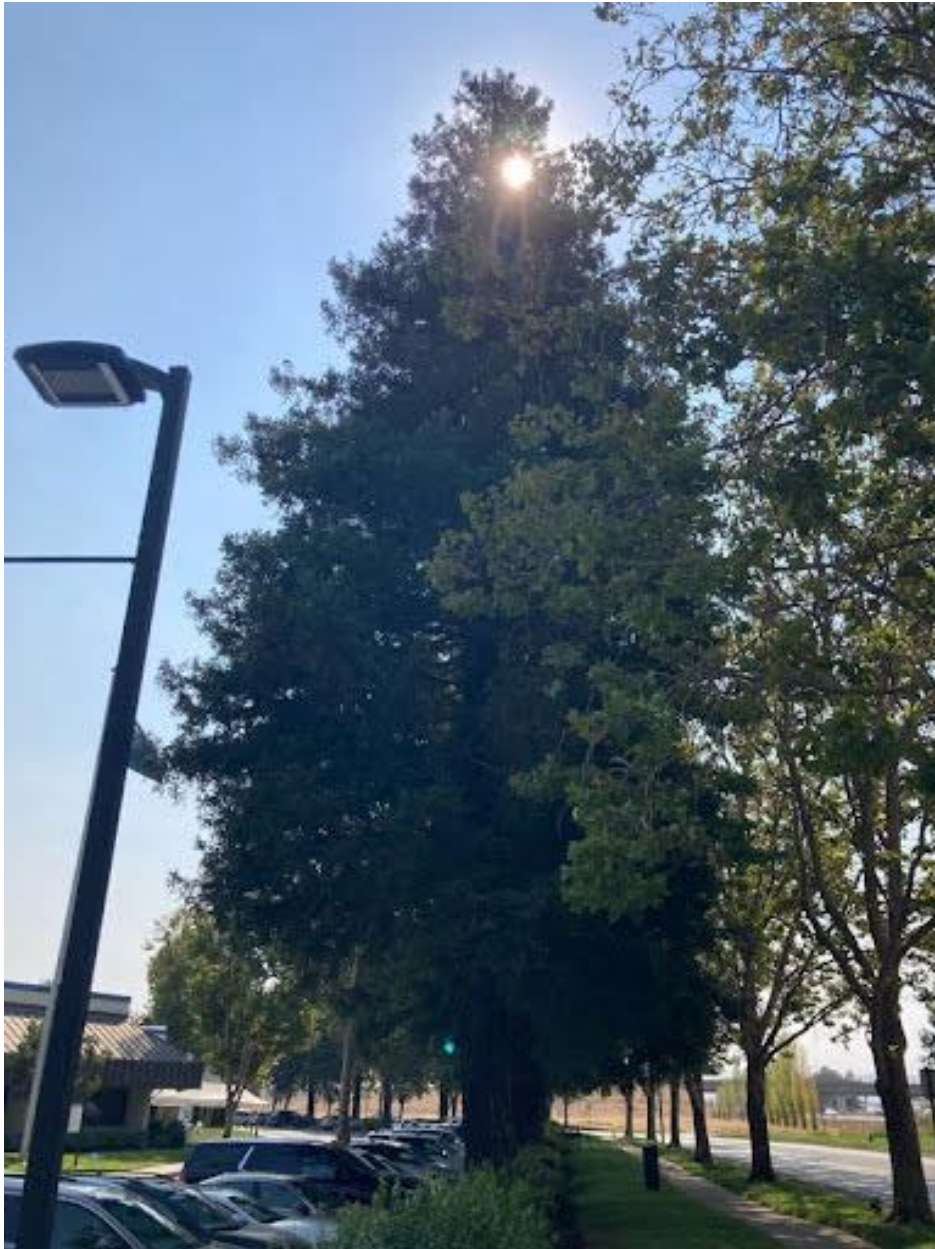
**Image 29: coast redwood #49**

| Tree # | Common Name | Species | DBH (inches) | Height (estimated visually) | Protected tree? | Vitality (0 = dead, 3 = healthy) | Project Impacts | Disposition | Replacement Requirement |
|---|---|---|---|---|---|---|---|---|---|
| 49 | Coast redwood | Sequoia sempervirens | 33.0 | 90 | Y | 3 | Incompatible with transmission line | REMOVE | Two 48-inch boxes |

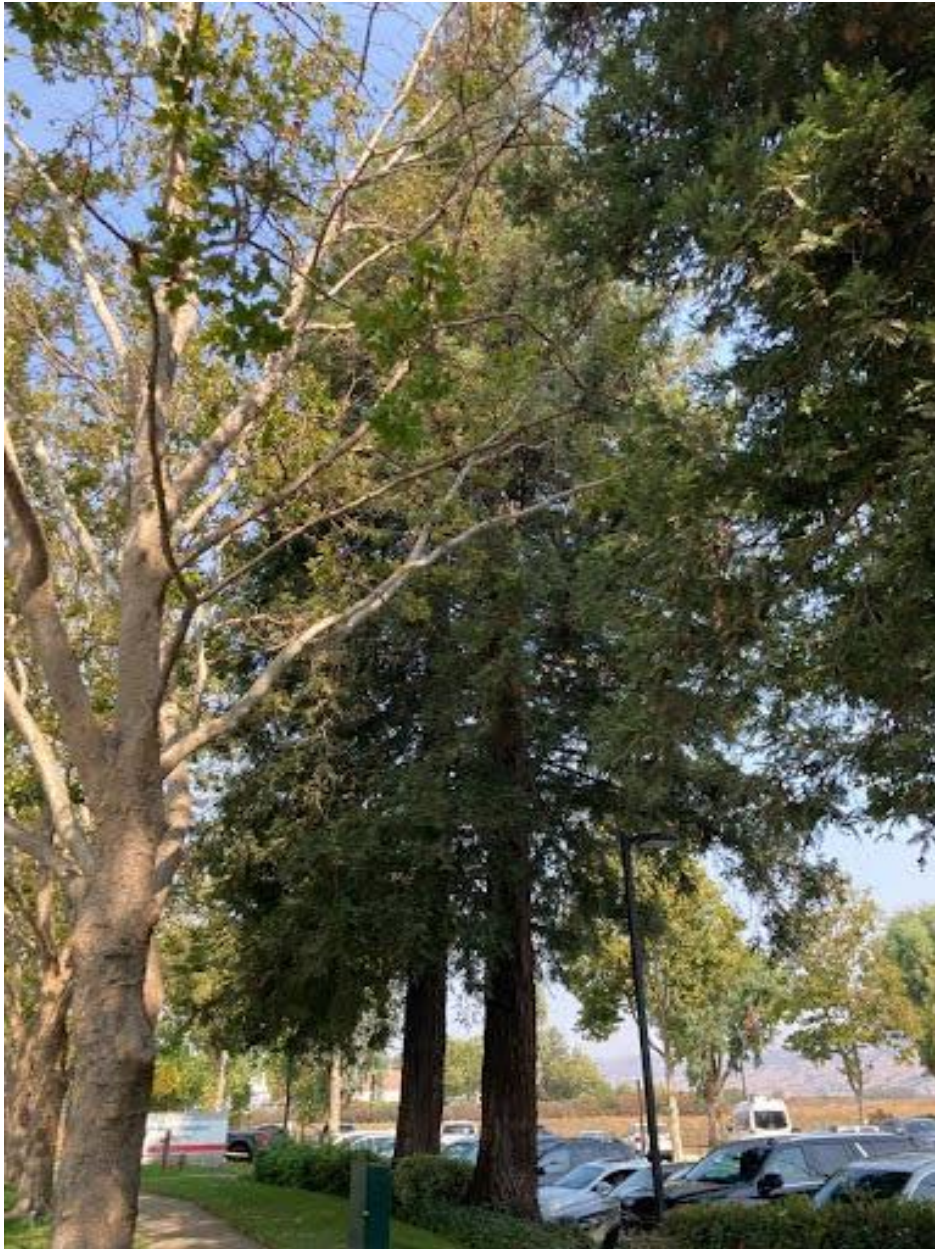
**Image 30: coast redwood #50**

| Tree # | Common Name | Species | DBH (inches) | Height (estimated visually) | Protected tree? | Vitality (0 = dead, 3 = healthy) | Project Impacts | Disposition | Replacement Requirement |
|---|---|---|---|---|---|---|---|---|---|
| 50 | Coast redwood | Sequoia sempervirens | 35.2 | 90 | Y | 3 | Incompatible with transmission line | REMOVE | Two 48-inch boxes |

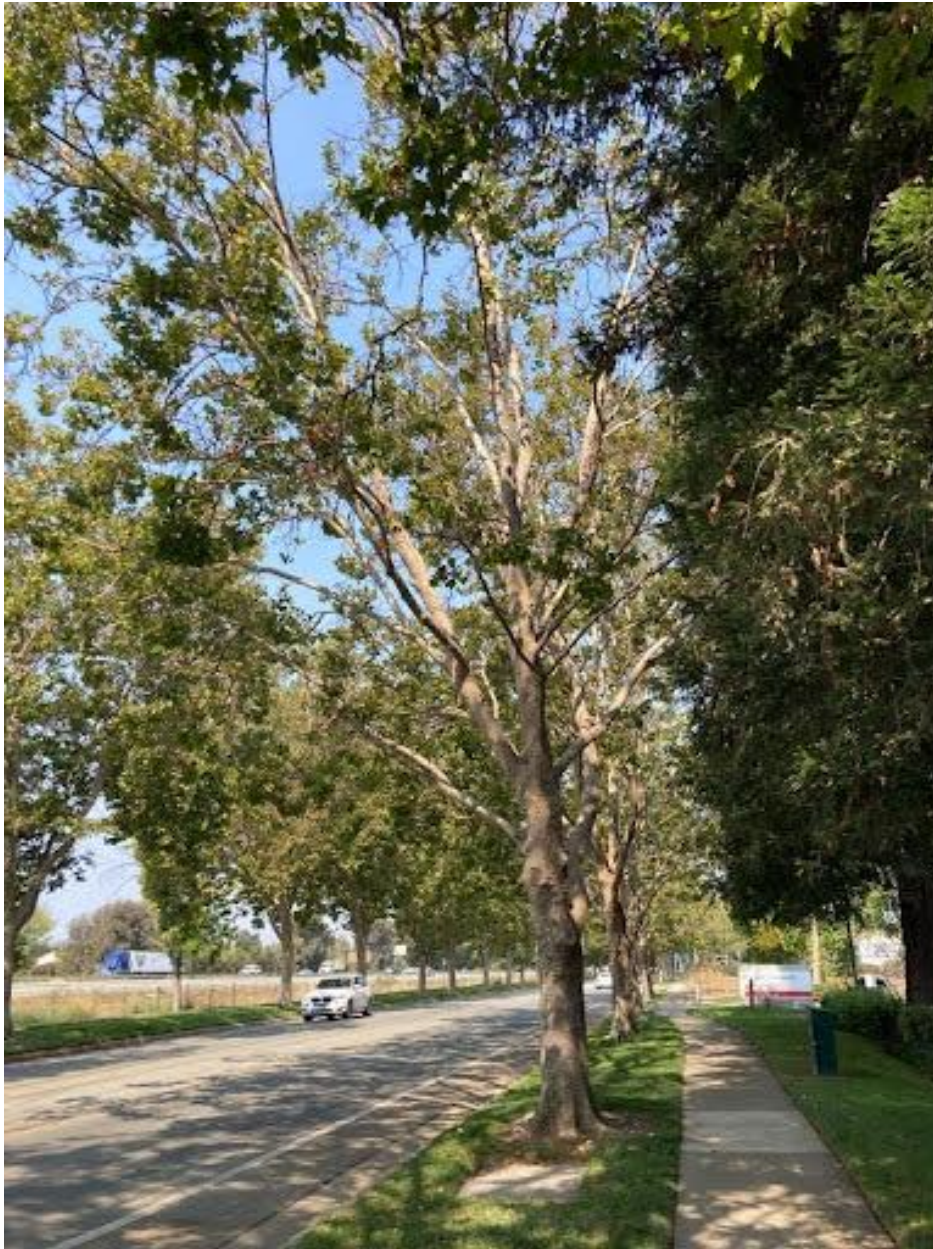
**Image 31: London plane #51**

| Tree # | Common Name | Species | DBH (inches) | Height (estimated visually) | Protected tree? | Vitality (0 = dead, 3 = healthy) | Project Impacts | Disposition | Replacement Requirement |
|---|---|---|---|---|---|---|---|---|---|
| 51 | London plane | Platanus x acerifolia | 19.1 | 50 | Y | 3 | Incompatible with transmission line | REMOVE | Two 24-inch boxes |

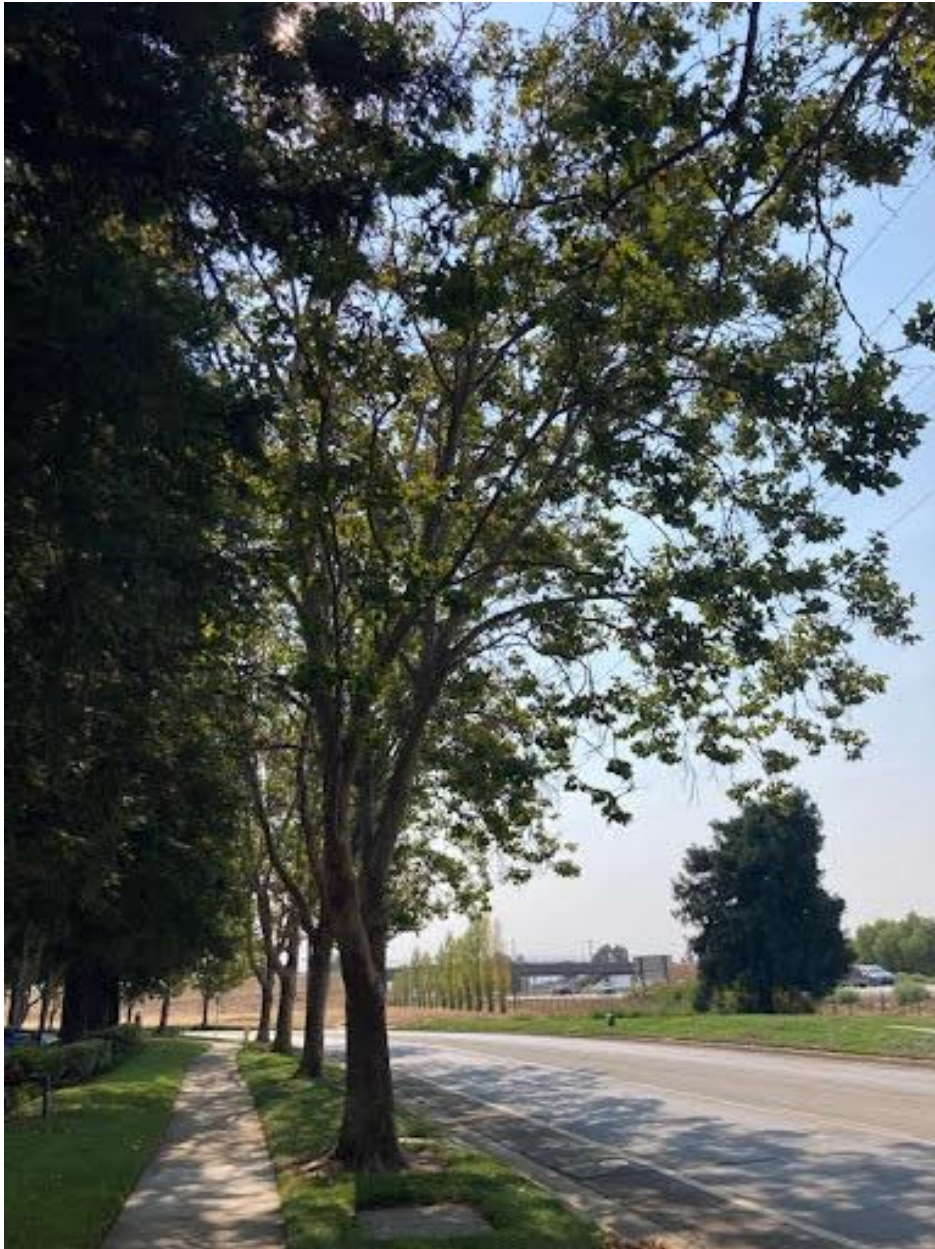
**Image 32: London plane #52**

| Tree # | Common Name | Species | DBH (inches) | Height (estimated visually) | Protected tree? | Vitality (0 = dead, 3 = healthy) | Project Impacts | Disposition | Replacement Requirement |
|---|---|---|---|---|---|---|---|---|---|
| 52 | London plane | Platanus x acerifolia | 17.8 | 50 | Y | 3 | Incompatible with transmission line | REMOVE | Two 24-inch boxes |

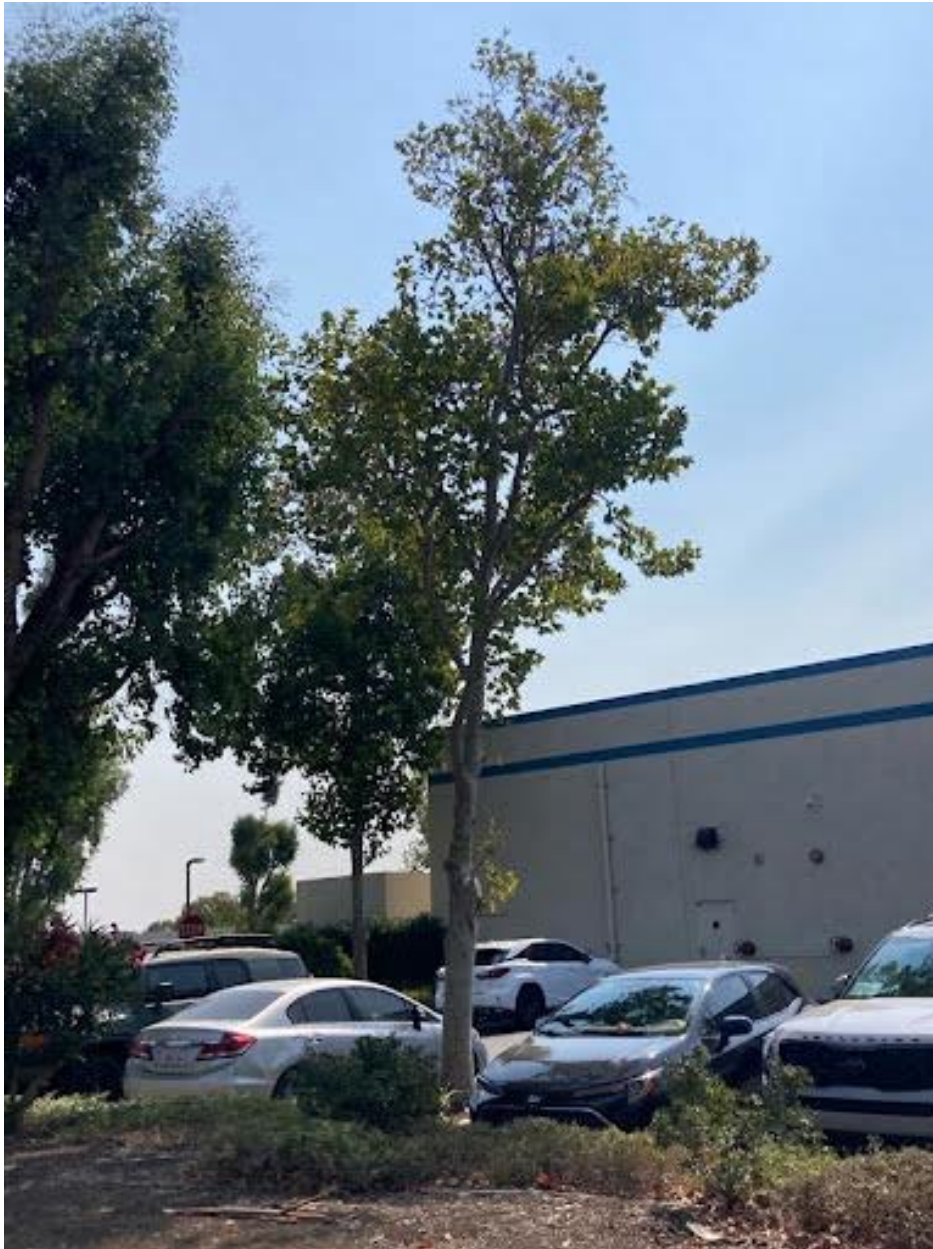
**Image 33: London plane #53**

| Tree # | Common Name | Species | DBH (inches) | Height (estimated visually) | Protected tree? | Vitality (0 = dead, 3 = healthy) | Project Impacts | Disposition | Replacement Requirement |
|---|---|---|---|---|---|---|---|---|---|
| 53 | London plane | Platanus x acerifolia | 18.0 | 50 | Y | 3 | Incompatible with transmission line | REMOVE | Two 24-inch boxes |

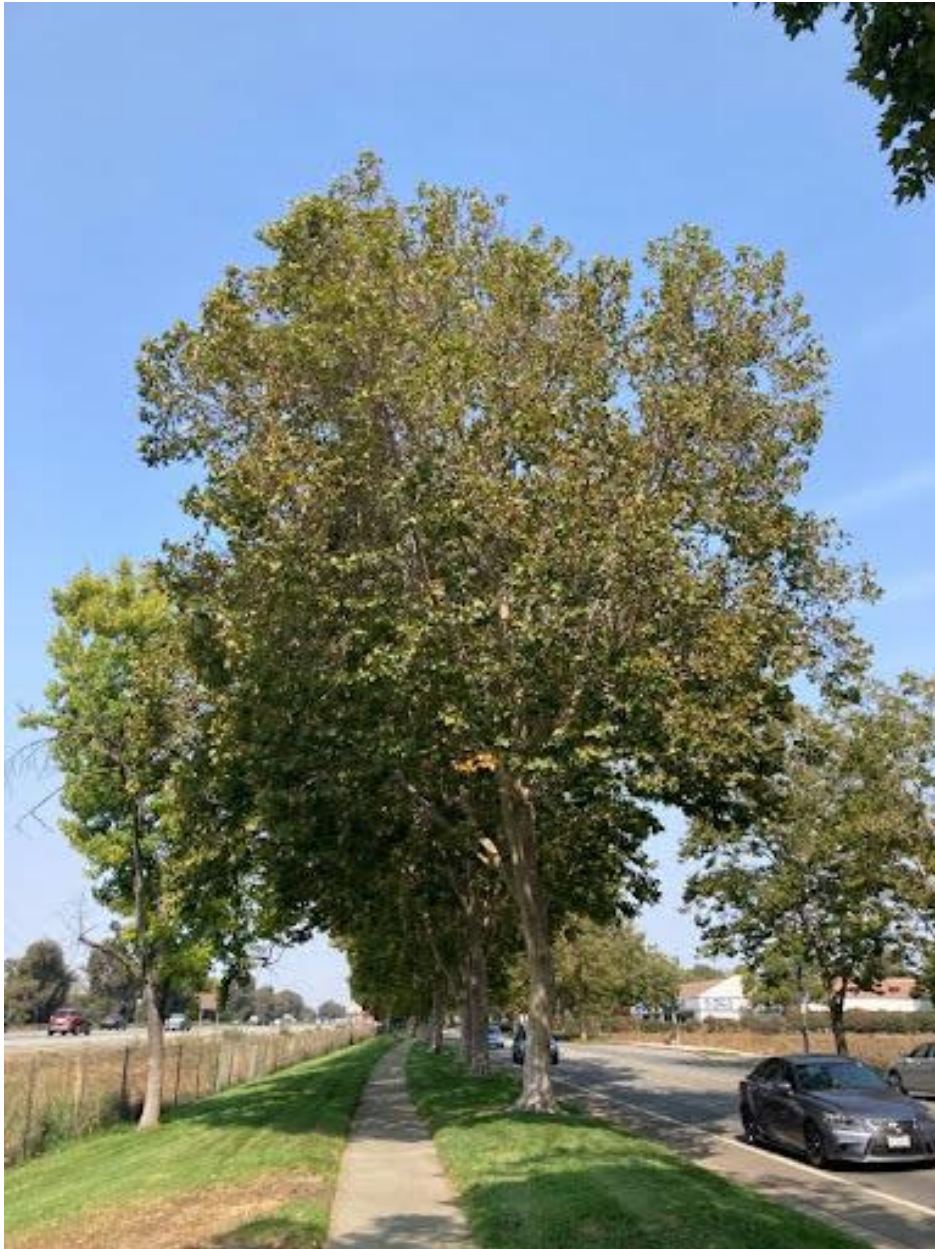
**Image 34: London plane #54**

| Tree # | Common Name | Species | DBH (inches) | Height (estimated visually) | Protected tree? | Vitality (0 = dead, 3 = healthy) | Project Impacts | Disposition | Replacement Requirement |
|---|---|---|---|---|---|---|---|---|---|
| 54 | London plane | Platanus x acerifolia | 16.5 | 50 | Y | 3 | Incompatible with transmission line | REMOVE | Two 24-inch boxes |

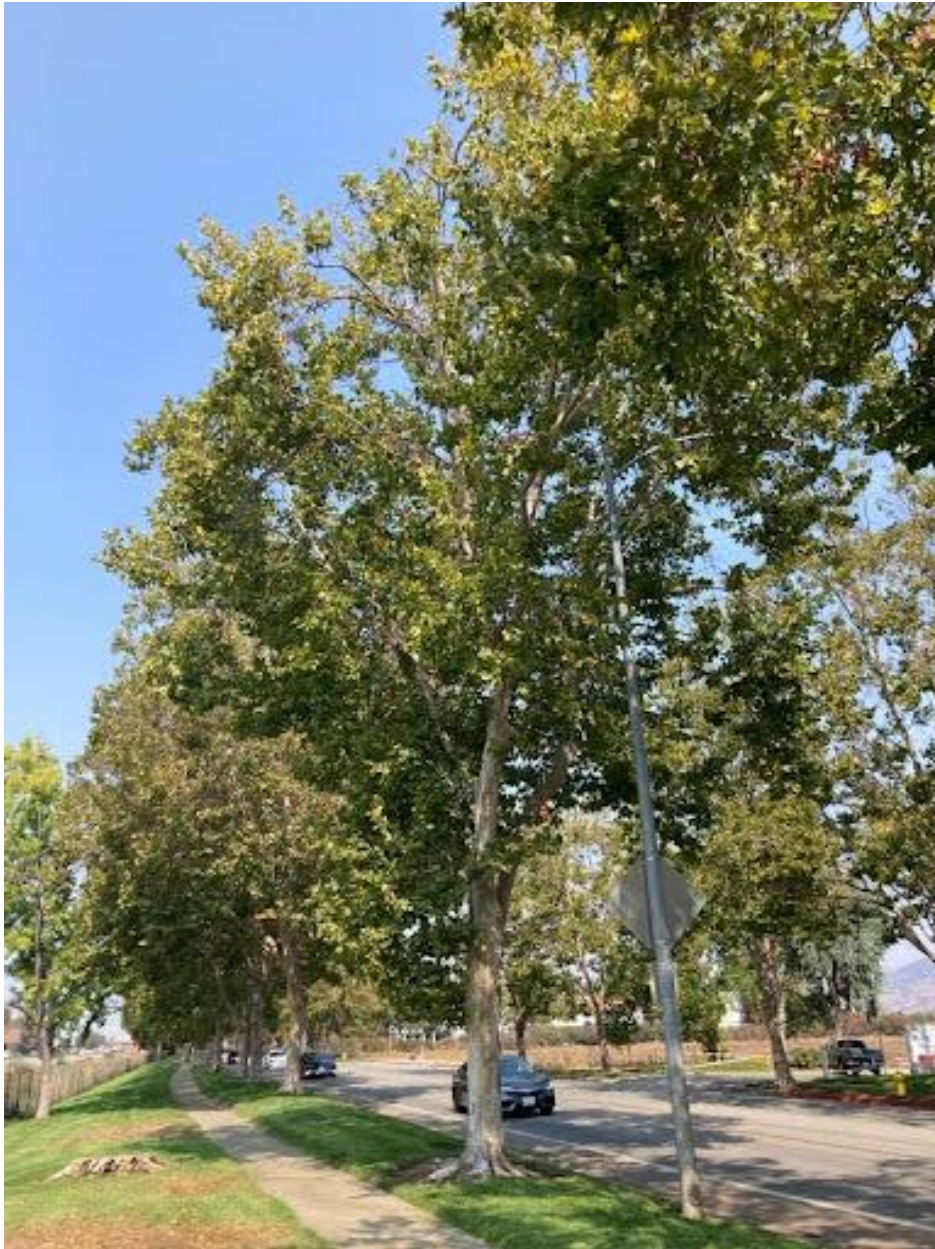
**Image 35: London plane #55**

| Tree # | Common Name | Species | DBH (inches) | Height (estimated visually) | Protected tree? | Vitality (0 = dead, 3 = healthy) | Project Impacts | Disposition | Replacement Requirement |
|---|---|---|---|---|---|---|---|---|---|
| 55 | London plane | Platanus x acerifolia | 15.8 | 50 | Y | 3 | Incompatible with transmission line | REMOVE | Two 24-inch boxes |

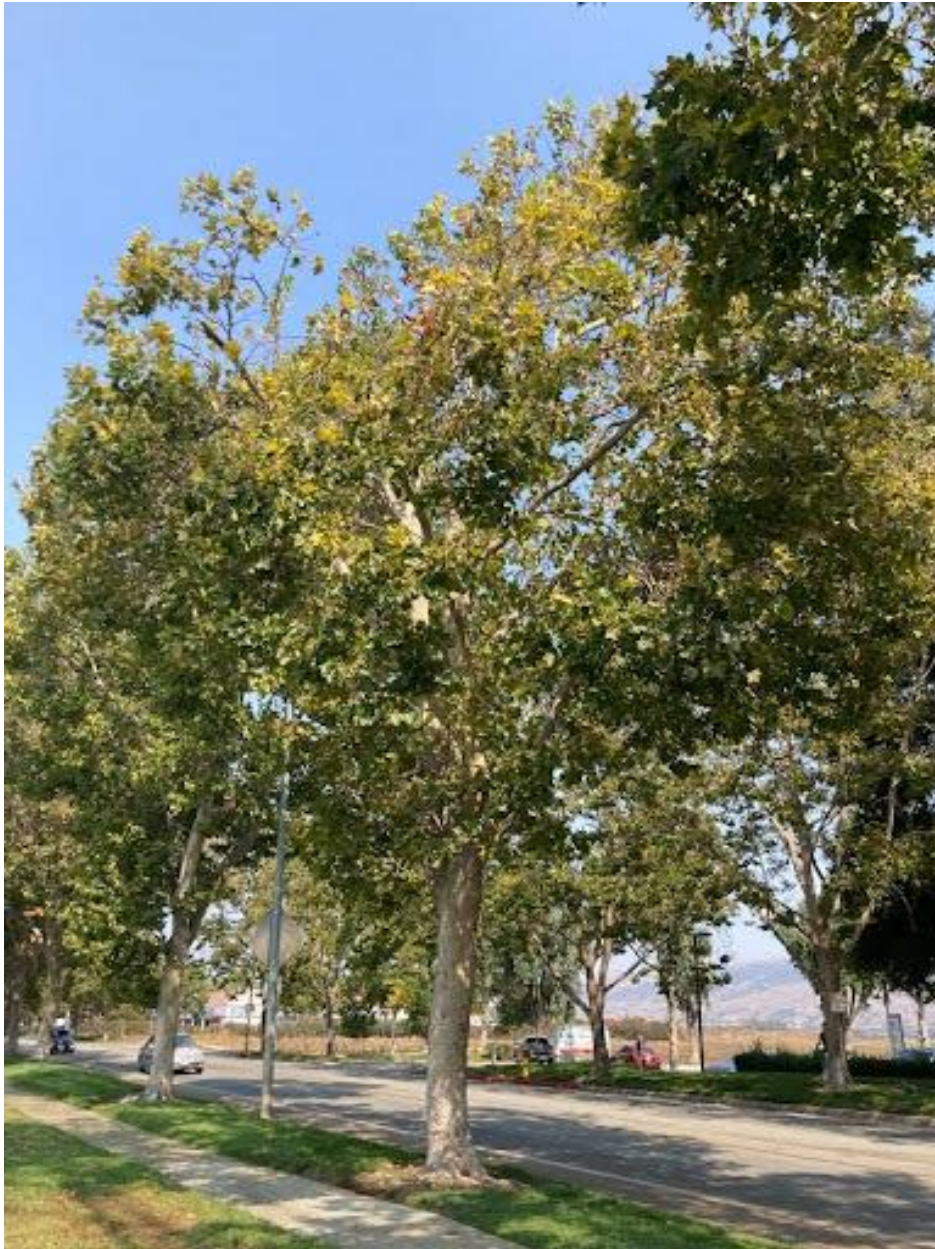
**Image 36: London plane #56**

| Tree # | Common Name | Species | DBH (inches) | Height (estimated visually) | Protected tree? | Vitality (0 = dead, 3 = healthy) | Project Impacts | Disposition | Replacement Requirement |
|---|---|---|---|---|---|---|---|---|---|
| 56 | London plane | Platanus x acerifolia | 18.0 | 50 | Y | 3 | Incompatible with transmission line | REMOVE | Two 24-inch boxes |
