COUNTY OF SAN MATEO - PLANNING AND BUILDING DEPARTMENT

ANIMAL SANCTUARY
PENINSULA HUMANE SOCIETY & SPCA

PENINSULA HUMANE SOCIETY

ANIMAL SANCTUARY

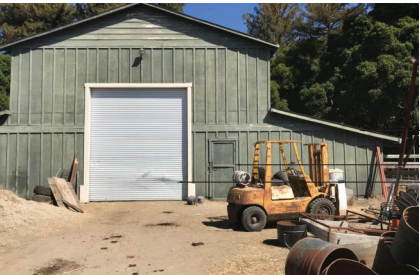
INTERIOR TO REMAIN UNPAINTED
NEW 8' LIGHTS SUSPENDED
FROM EXISTING TRUSSES
